Maintainable Weep Hole Drains

NATIONAL BRIDGE PRESERVATION PARTNERSHIP CONFERENCE 2018

PRACTICES WE CAN NOT AFFORD TO DEFER

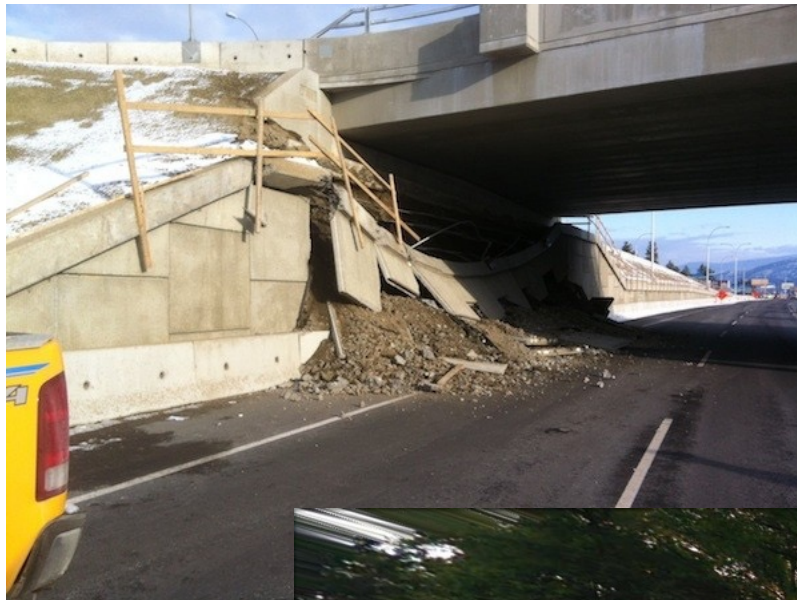
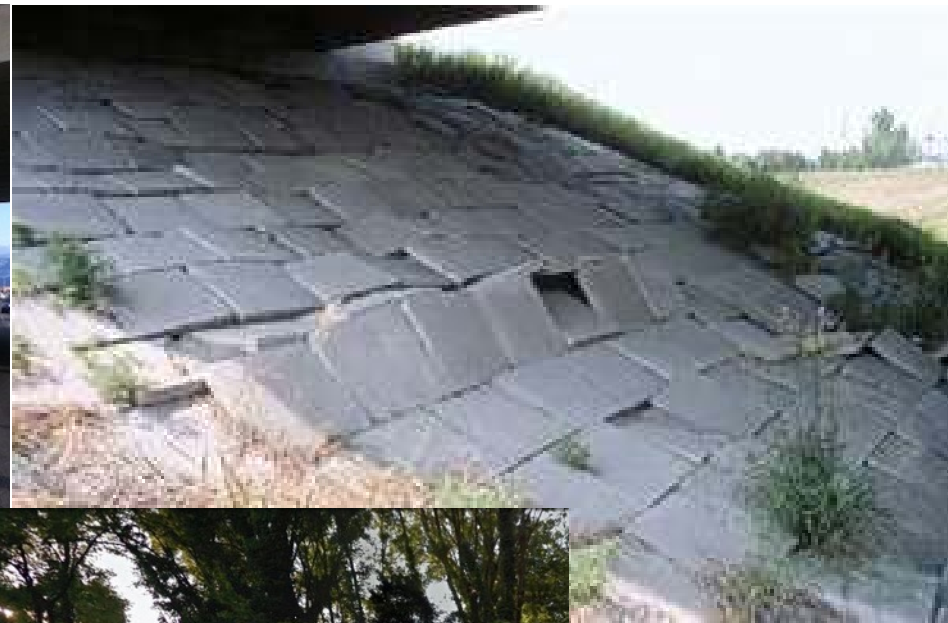
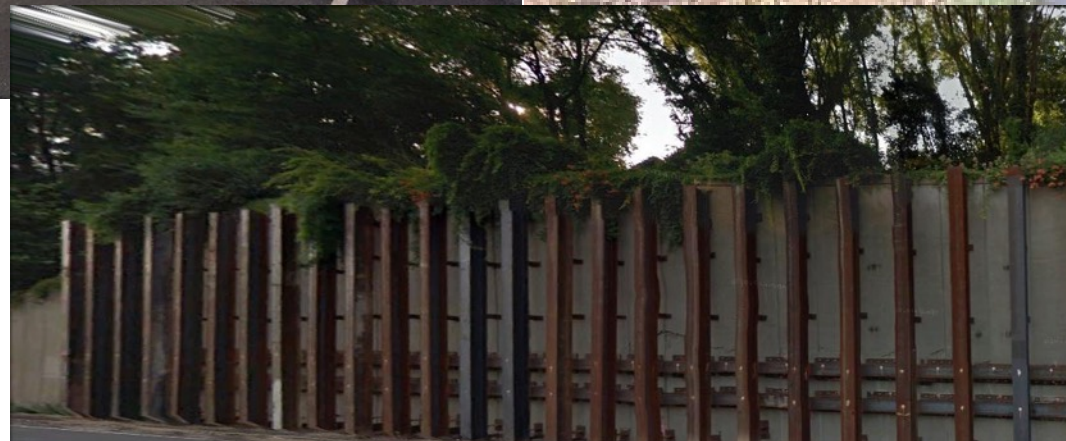
WALL FAILURES

"Failure" of a retaining wall does not necessarily mean total collapse, but rather signs of impending collapse.

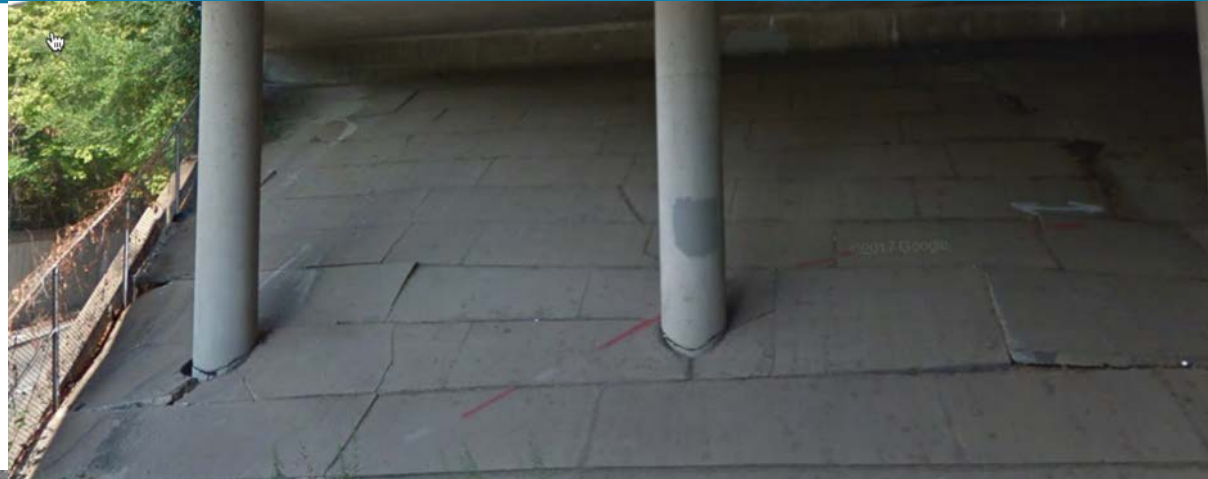
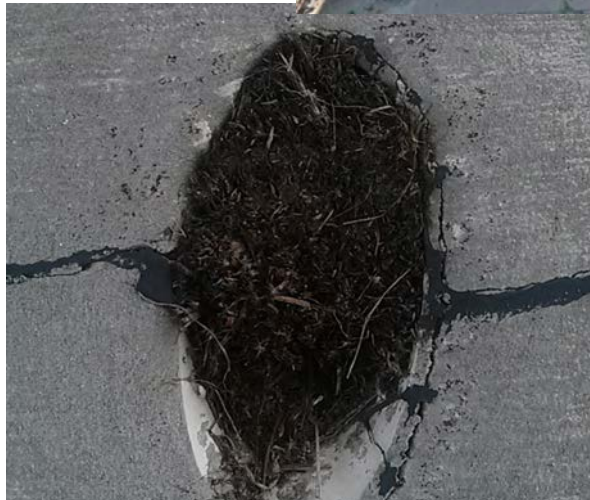
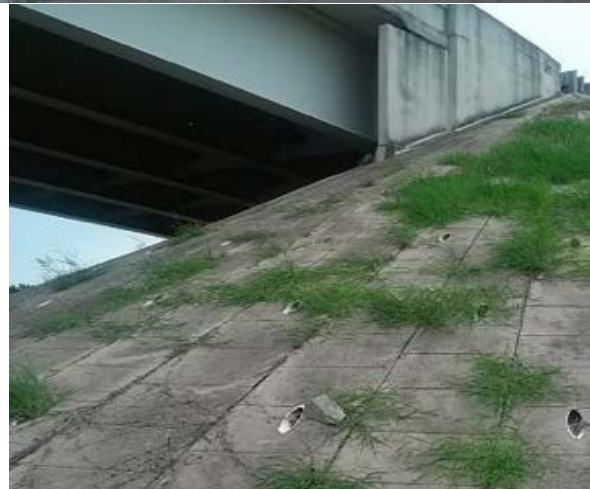
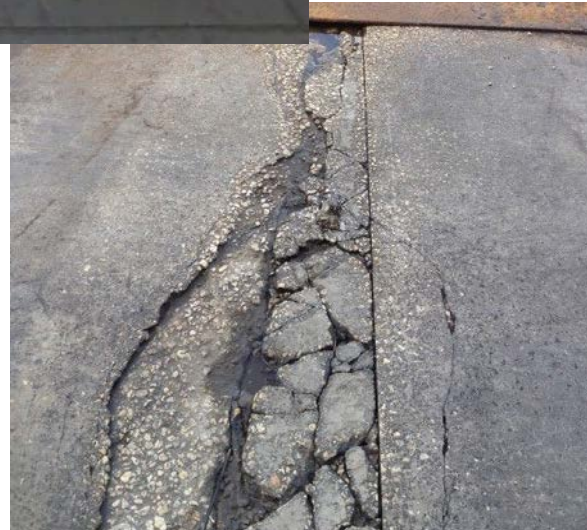
SIGNS OF FAILURE

Fortunately, retaining walls are quite forgiving, nearly always displaying telltale signs of trouble.

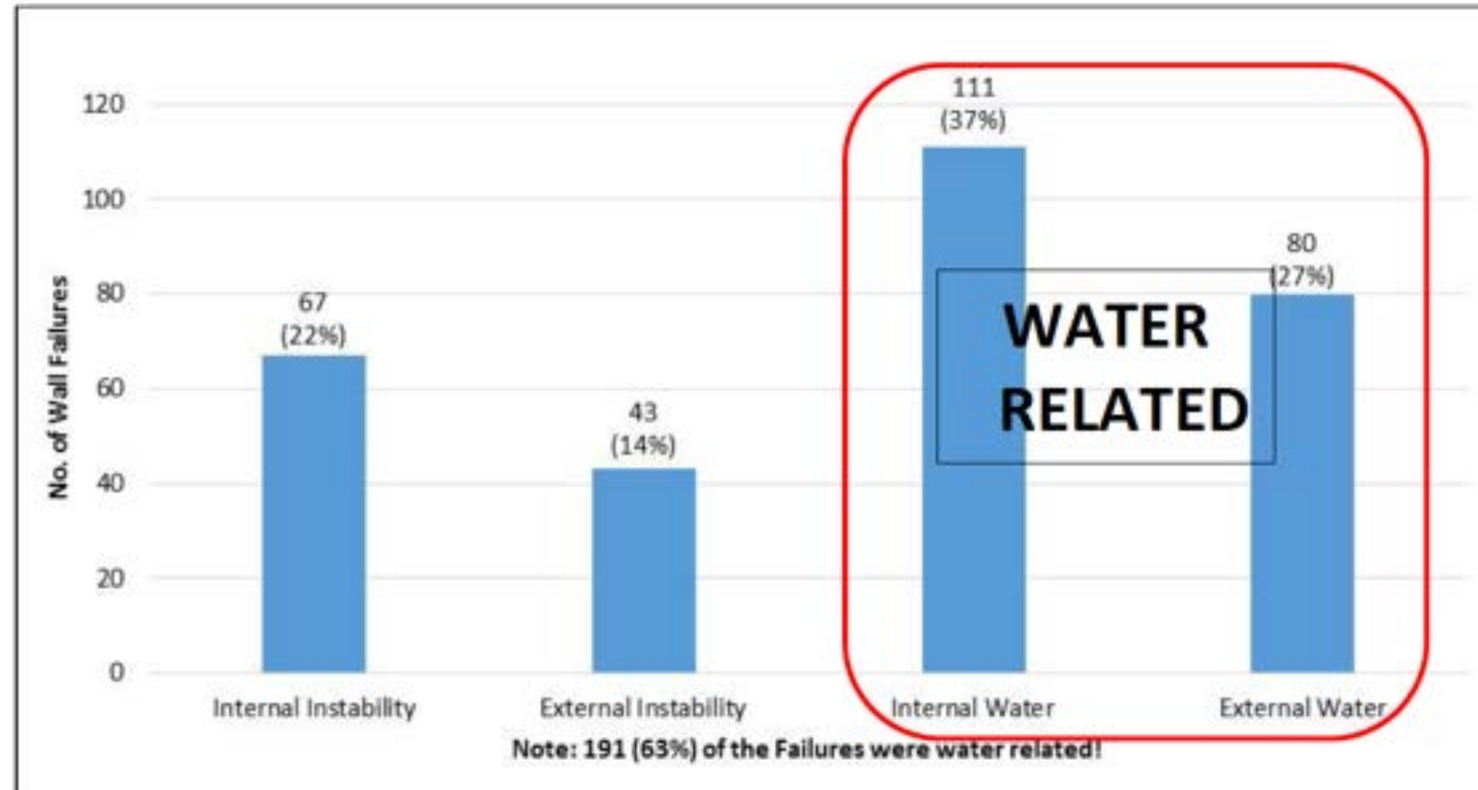
ANALYSIS OF MSE WALL FAILURES

Water related failures accounted for 63% of total failures.

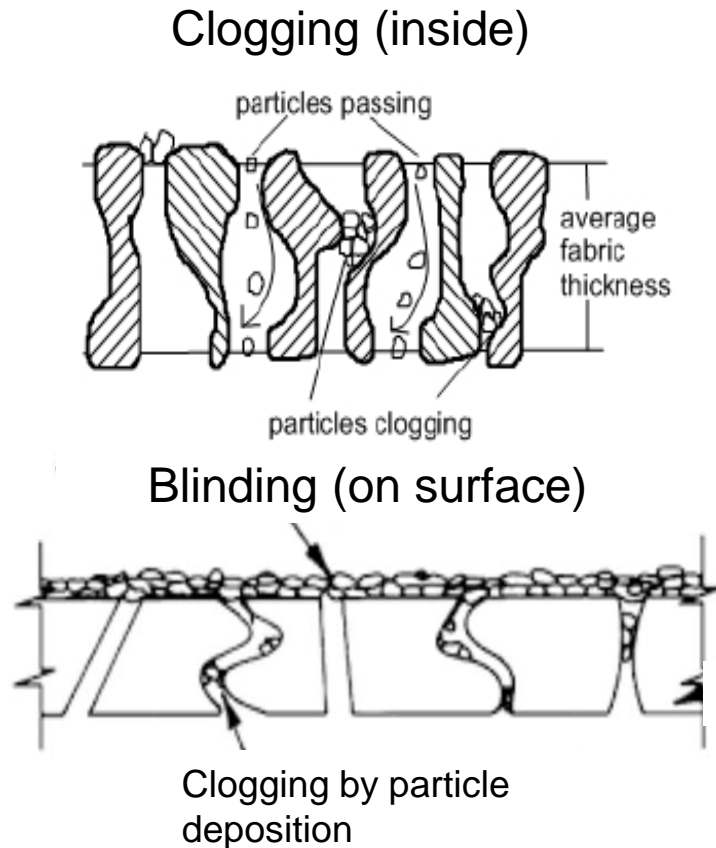
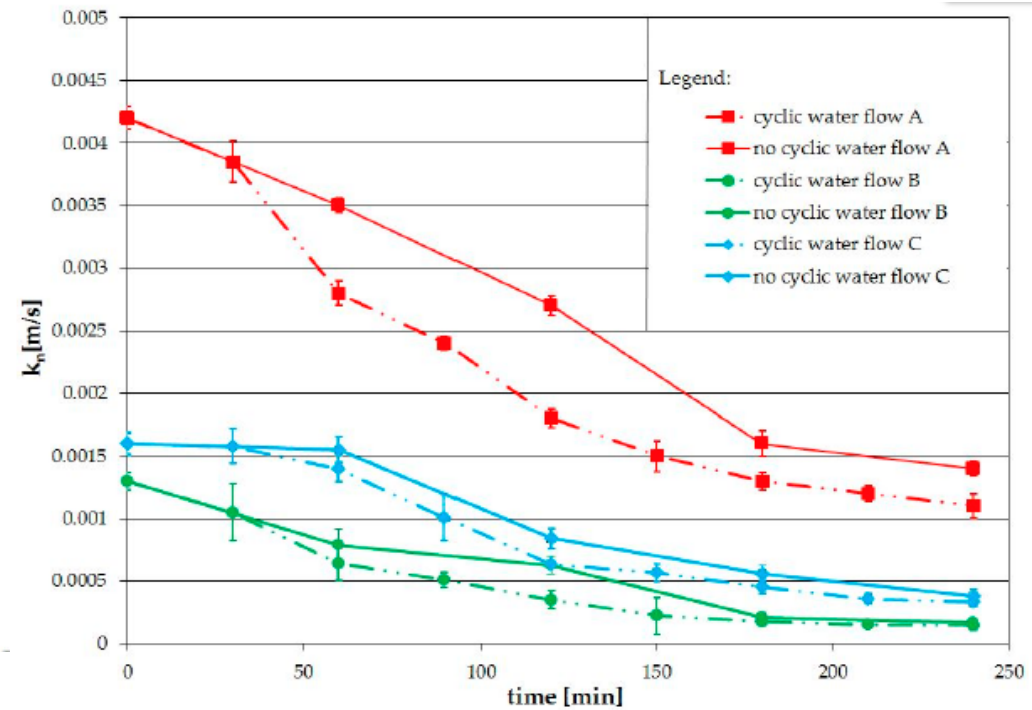
DECREASING OF WATER PERMEABILITY COEFFICIENTS WITH TIME

Testing 3 Nonwoven Geotextiles

Effectiveness quickly begins to decline; cyclic water flow declines faster.

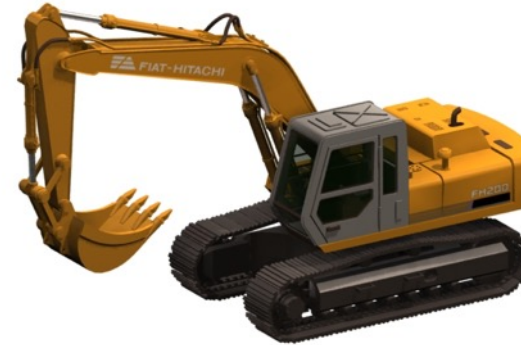
USE A WRENCH NOT A BACKHOE

Fixing traditional drainage systems that have failed requires costly excavation to rip up, replace and rebuild. Can run tens of thousands of dollars or more.

With traditional systems, the balance between drainage & erosion control is not sustainable.

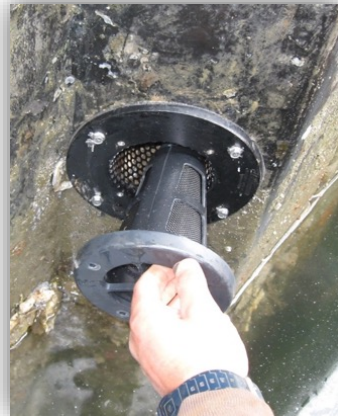
A “maintainable drain”:

- installs from the front of the wall
- contains a cleanable/replaceable filter
- improves drainage

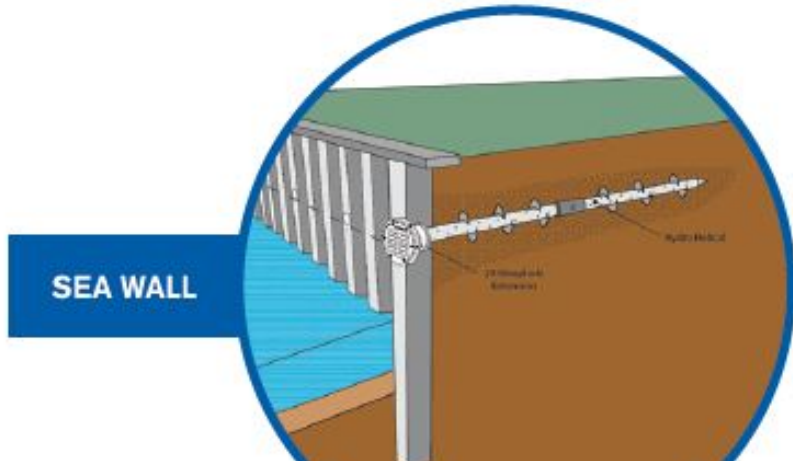
HYDRO HELICAL - WALL APPLICATION

CORE DRILL 10" HOLE THROUGH WALL (SEAL AROUND WEEPHOLE EXTENSION WITH 30000 PSI MIN. GROUT)

FINISHED GRADE

JET FILTER ASSEMBLY
3.0" SCH 80 PVC PIPE

TRANSITION 2.875" MALE QUE CPLG TO 3" PVC

HYDROHELICAL LEAD SECTION

1% MIN. TO ENSURE WATER DRAINS OUT TO WEEPHOLE

The Hydrohelical reduces pressure at the wall and drains water heading toward the wall

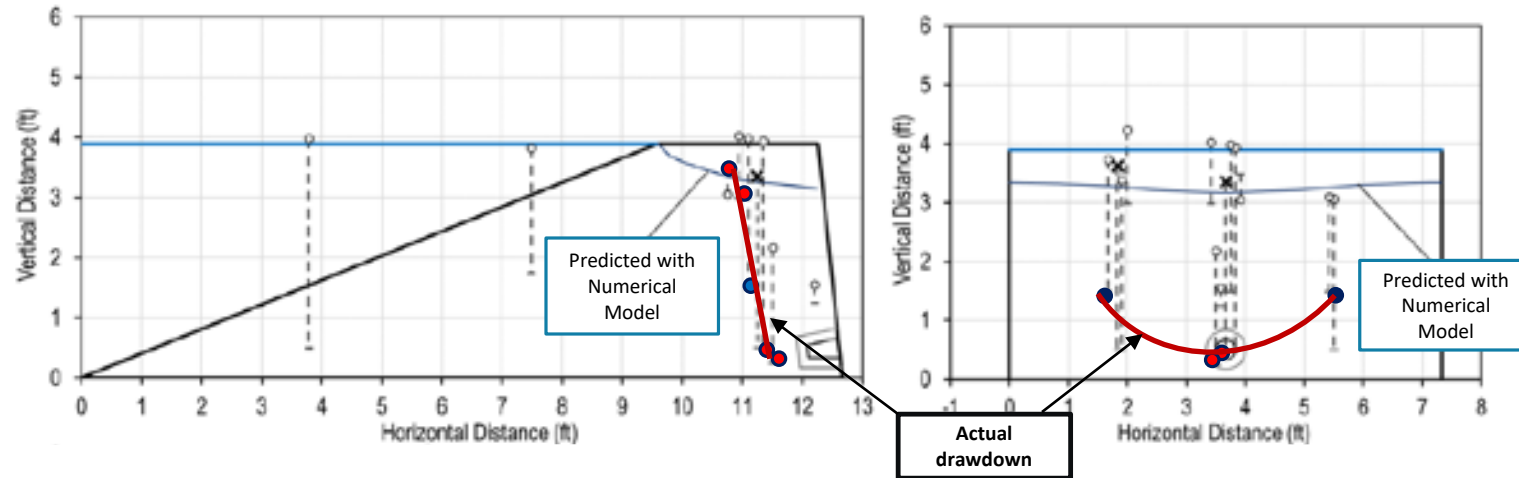
UNIVERSITY OF MISSOURI - TESTING

Comparison Maintainable Drain vs. A Weep Hole of the same size			
Diameter	6"	4"	2.5"
Estimated Flow Rate Improvement	270%	210%	50%
Physical Model Test* Flow Rate Improvement	220%	200%	110%

* Physical Test performed on 6" & 2.5". Four inch was modeled

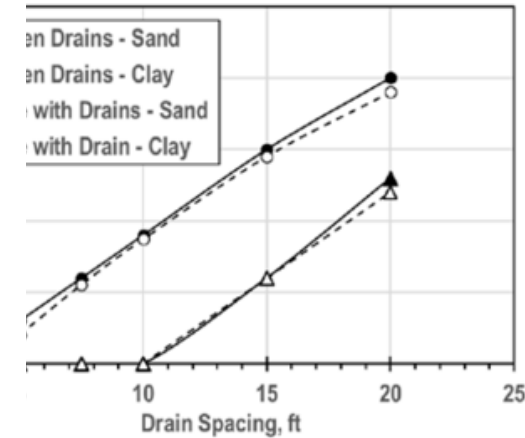
In constant groundwater testing the 4" Maintainable Drain reduced in-line pressure significantly more than predicted with numerical modeling.

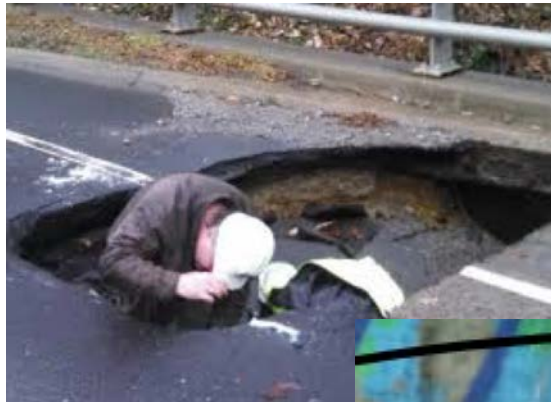
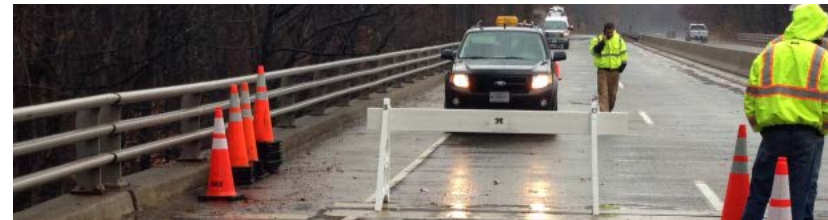
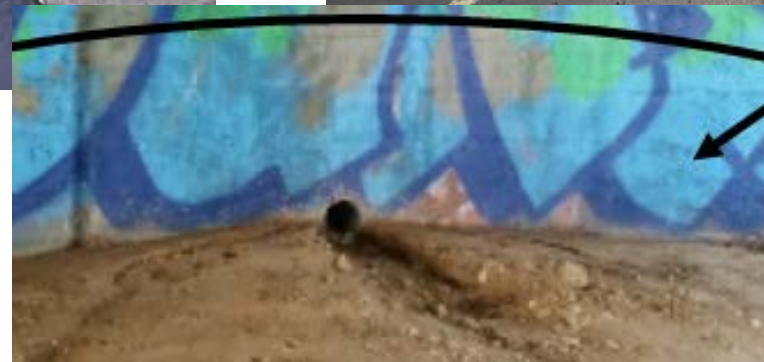
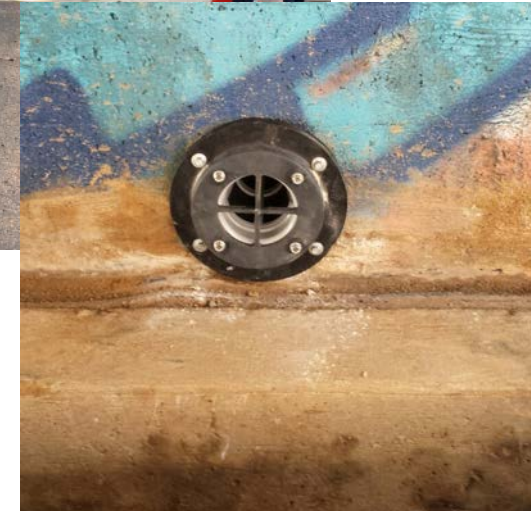
GEORGE WASHINGTON MEMORIAL PARKWAY

Issue: Soil eroded through weep holes under the bridge causing a sinkhole, 5' x 10' and 30' deep, to open under approach.

Solution: Installed 4" P.C. Open-End maintainable drains to stop future erosion

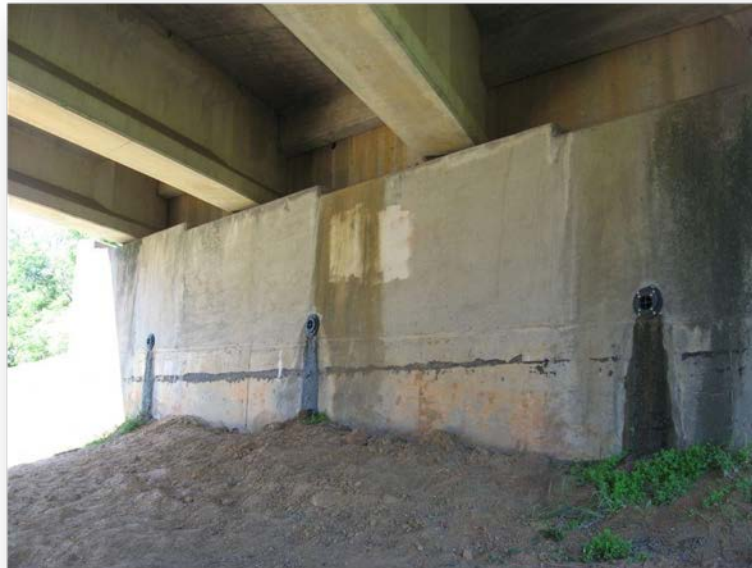
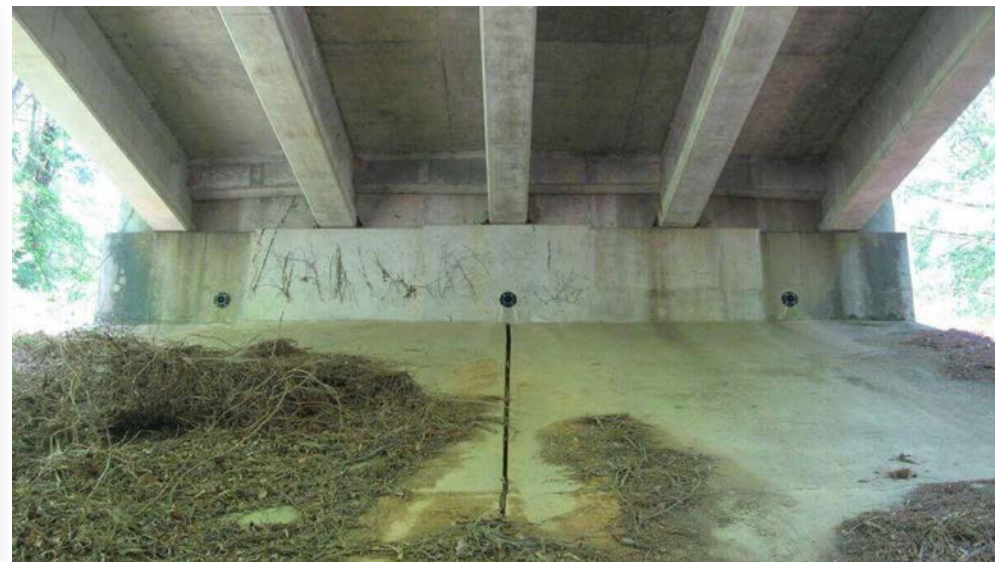
Solution: 4" powder coated steel units in concrete abutments

Results: Extended life of current walls and allowed teams to focus on more critical projects.

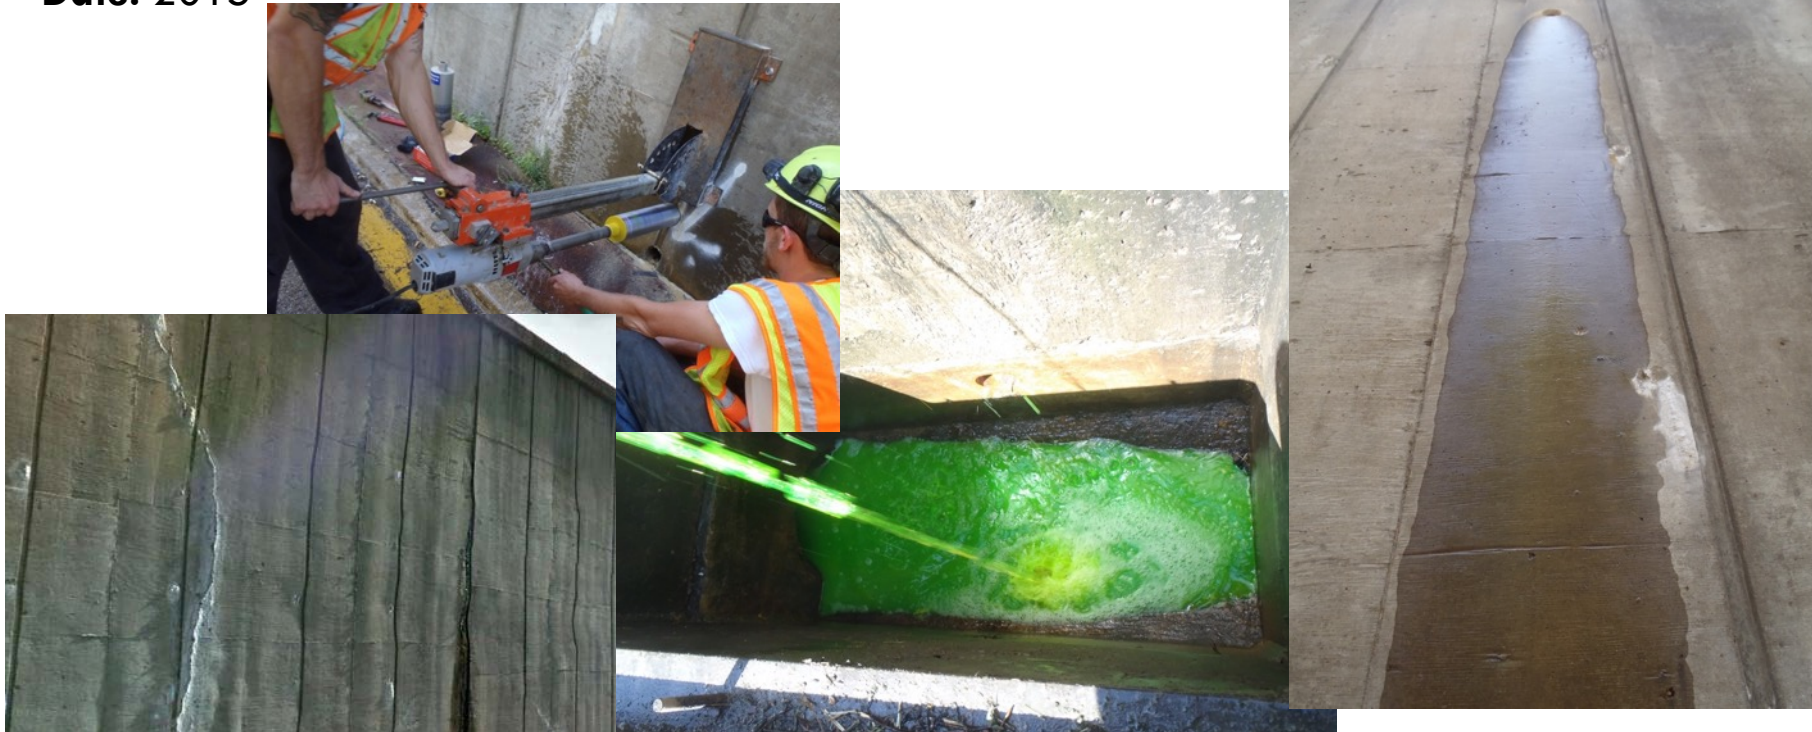
ST. LOUIS OVERPASS RETAINING WALL

Issue: Tall retaining wall stressed by pressure. Cracks, seam splitting, wall movement.

Solution: Installed 20, 4" S.S Open-End units into concrete retaining wall.

Results: Completed Successfully with dye test showing water flow.

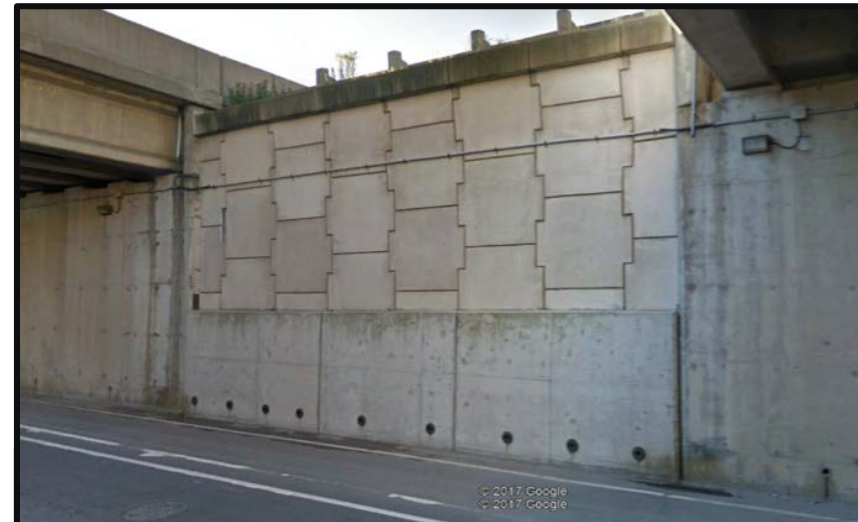
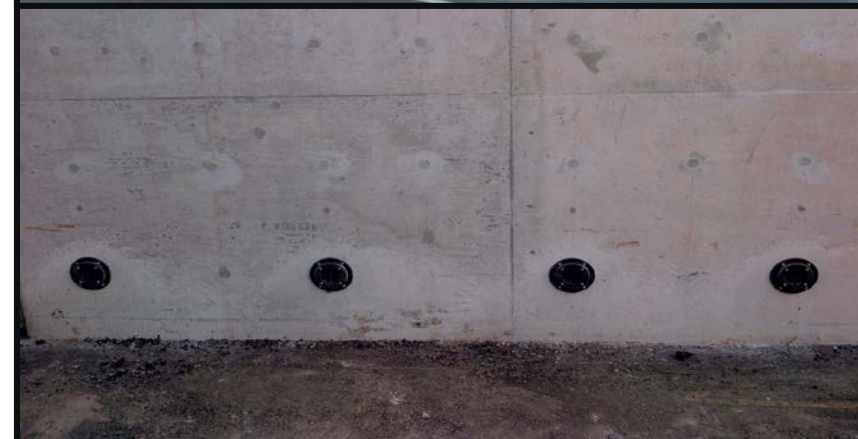
Kings Hwy 7 & 404 Markham Project, Canada
Ontario Ministry of Transportation
20 4" units

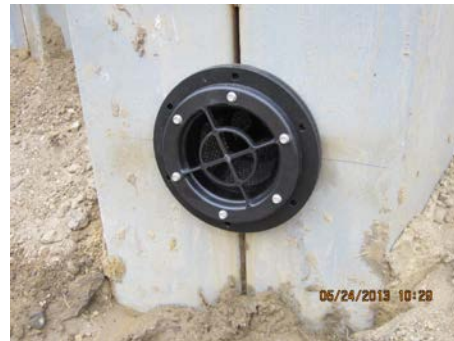
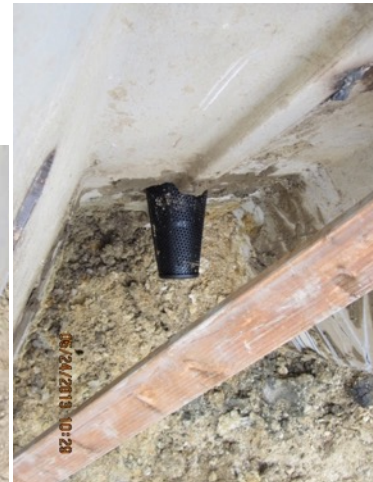
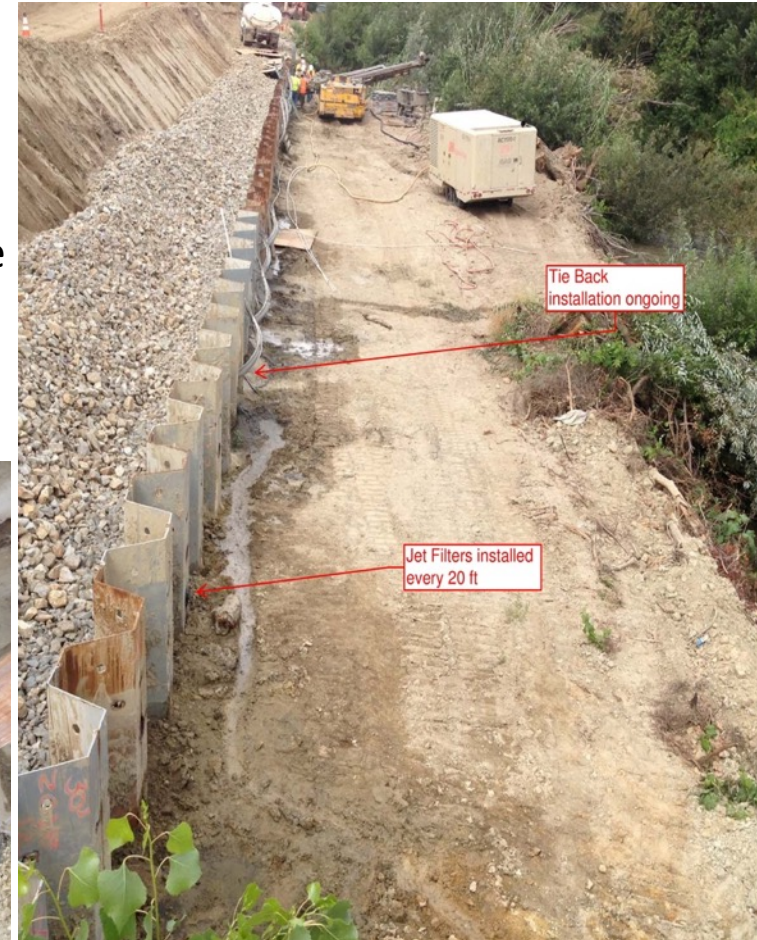
SANTA ANA RIVER CHANNEL REACH 9

Issue: Flood protection - channel widening, bank armoring, slope stabilization and environmental restoration

Solution: Two phases 160 - 6" PC units in Steel Sheet Pile

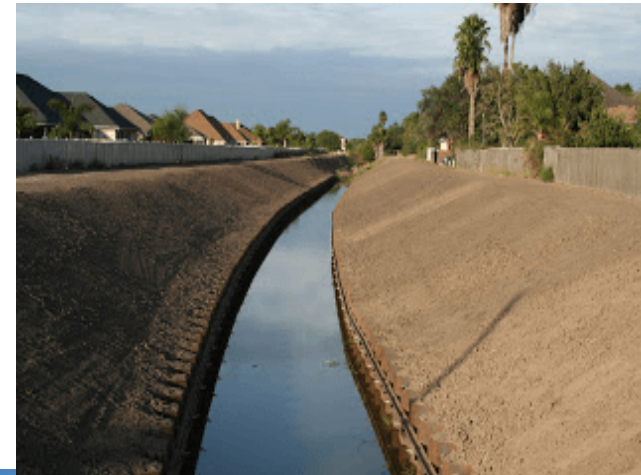
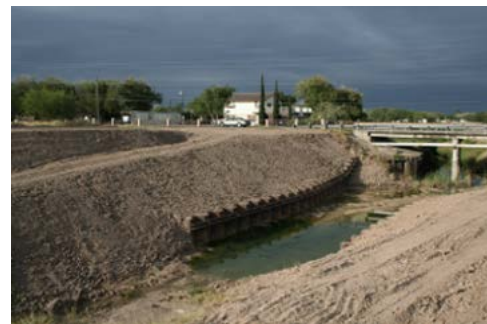
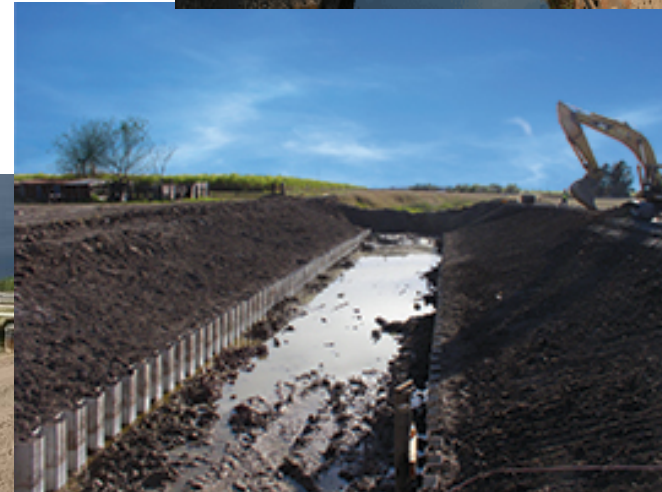
HARLINGEN IRRIGATION DISTRICT

Issue: Meet 100-year flood control requiring 2,900 In. ft. of **Drainage Channel Slope Stabilization**

Solution: Vinyl Sheet Pile with 400 - 2.5" ABS units every 6'

Result: "Now, excess runoff flows through the coarse gravel and the weep hole filters into the channel sediment-free."

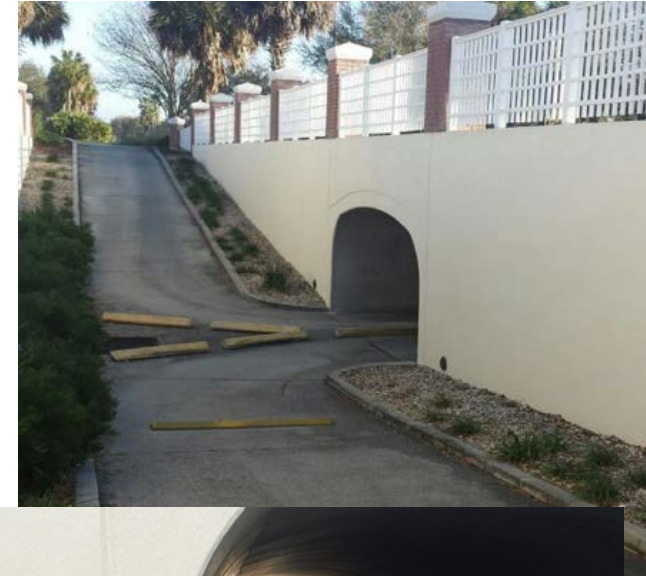
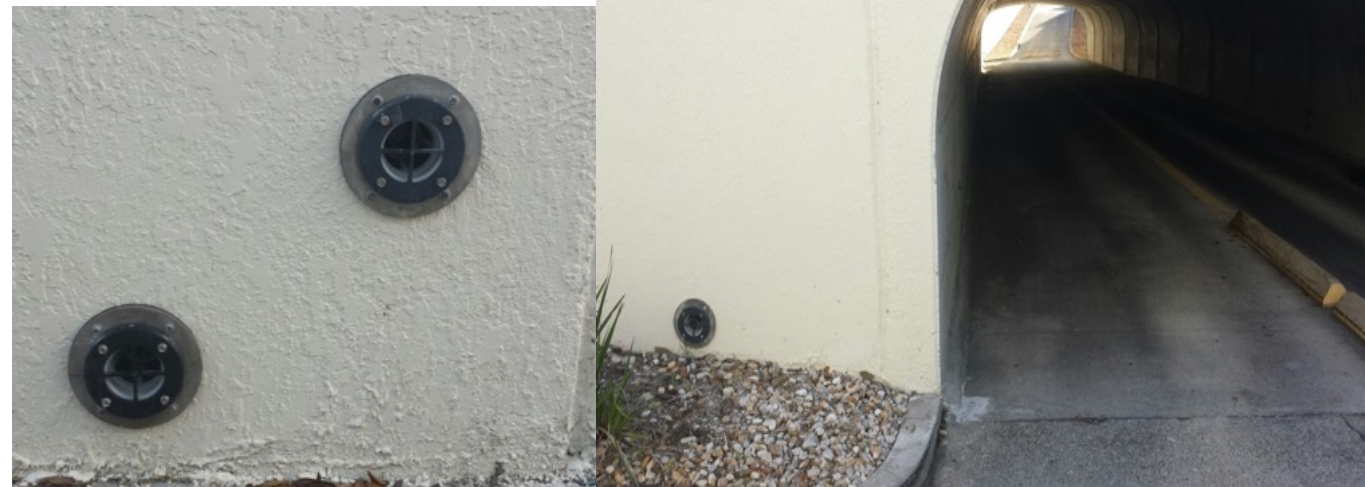
AESTHETIC COATINGS - CONCRETE RETAINING WALLS

Issue: Hydrostatic pressure bleeding through seams caused continuous **peeling of aesthetic coatings**

Solution: 4" S.S. Open-End maintainable drains installed on wing walls.

Result: After 1st year success, installed more maintainable drains in other locations. **No sign of wall damage** or peeling, drains working as intoned.
