HAMPTON ROADS BRIDGE TUNNEL APPROACH STRUCTURES

DEVELOPING A CORROSION MITIGATION STRATEGY FOR SERVICE LIFE EXTENSION

NATIONAL BRIDGE PRESERVATION PARTNERSHIP

CONFERENCE, ORLANDO, 2018

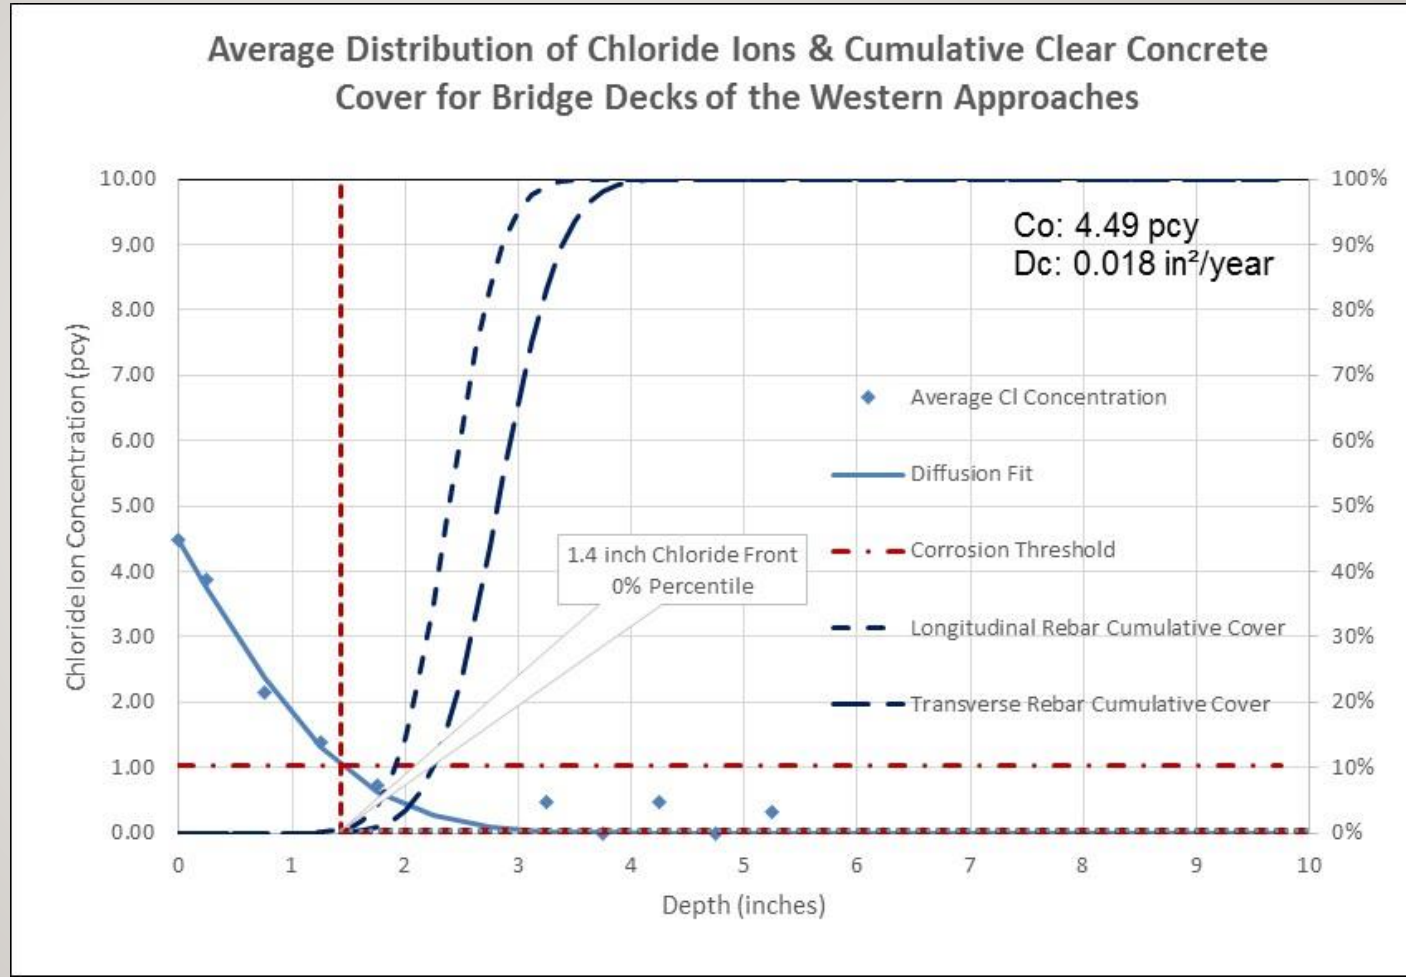
DECK CONDITION

Western Approaches

- In good condition
- Minimal damage (0.3%), mostly concentrated at joints
- Thin polyester overlay at the end of its service life

- 1. Install lightning protection system on all four bridge structures.**
- 2. Repair and make operational the existing impressed current cathodic protection systems on the NE and SE approaches.**
- 3. Perform Type B Patch repairs, mill off the top 1.25 inches of concrete, and install a rigid concrete (a latex modified concrete) overlay on decks of the NW and SW approaches.**

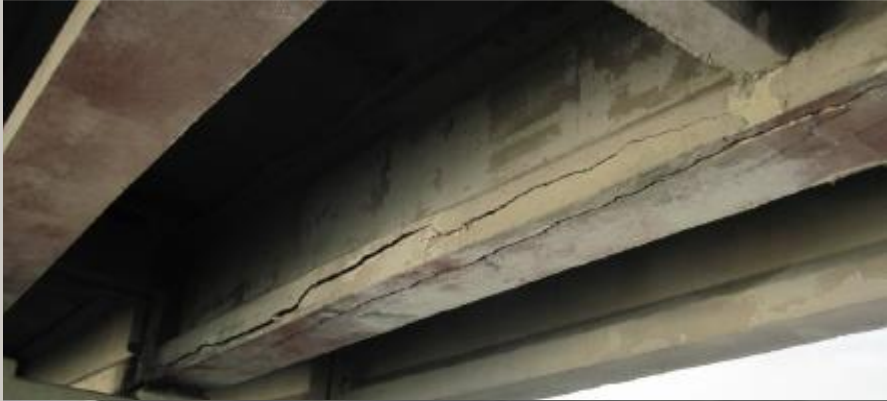
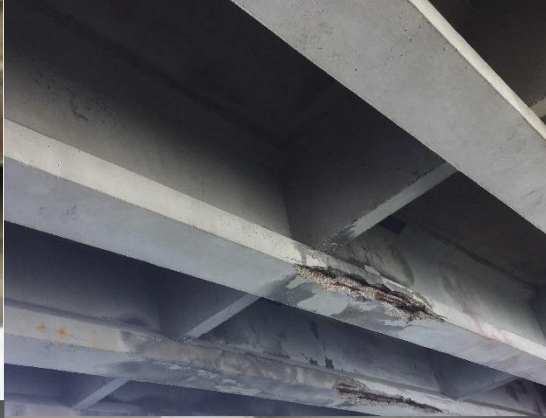
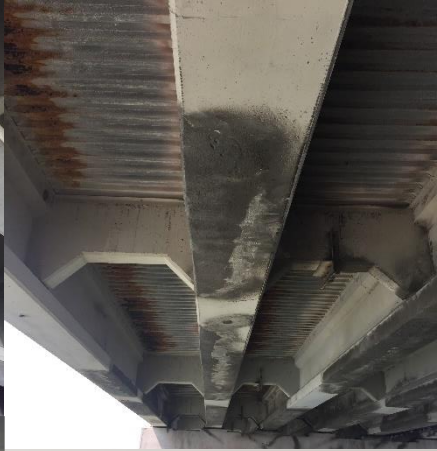
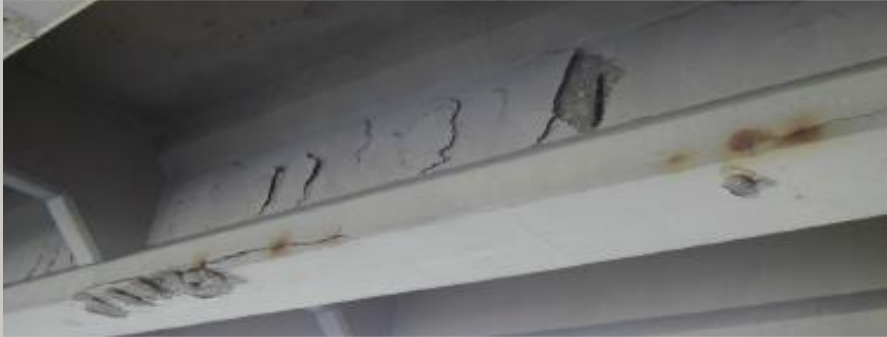
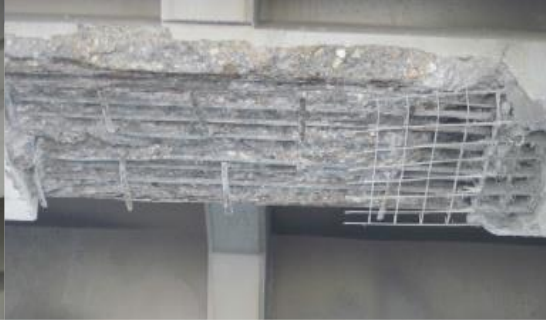
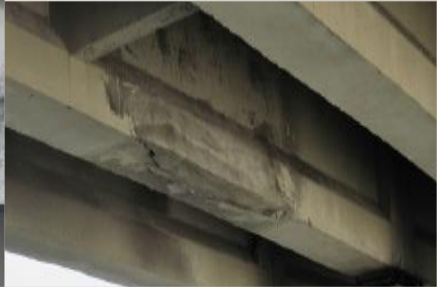
BEAM DAMAGE ON SW APPROACH

- **Southern approaches exhibit higher damage than the Northern approaches. SW Approach exhibits damage an order of magnitude higher than the other 3 approaches.**
- **Significantly lower cover (2.78 vs 4.0) on the bottom surface is likely responsible.**
- **Beams experience wave action during big storms.**

- 1. Replace 51 beams which exhibit damage in excess of 15%.**
- 2. Patch repair all damage on all beams including those that will not receive a cathodic protection system.**
- 3. Install hybrid cathodic protection system on all beams except those replaced during immediate repairs, beams with damage in excess of 15% and beams constructed in 1996.**

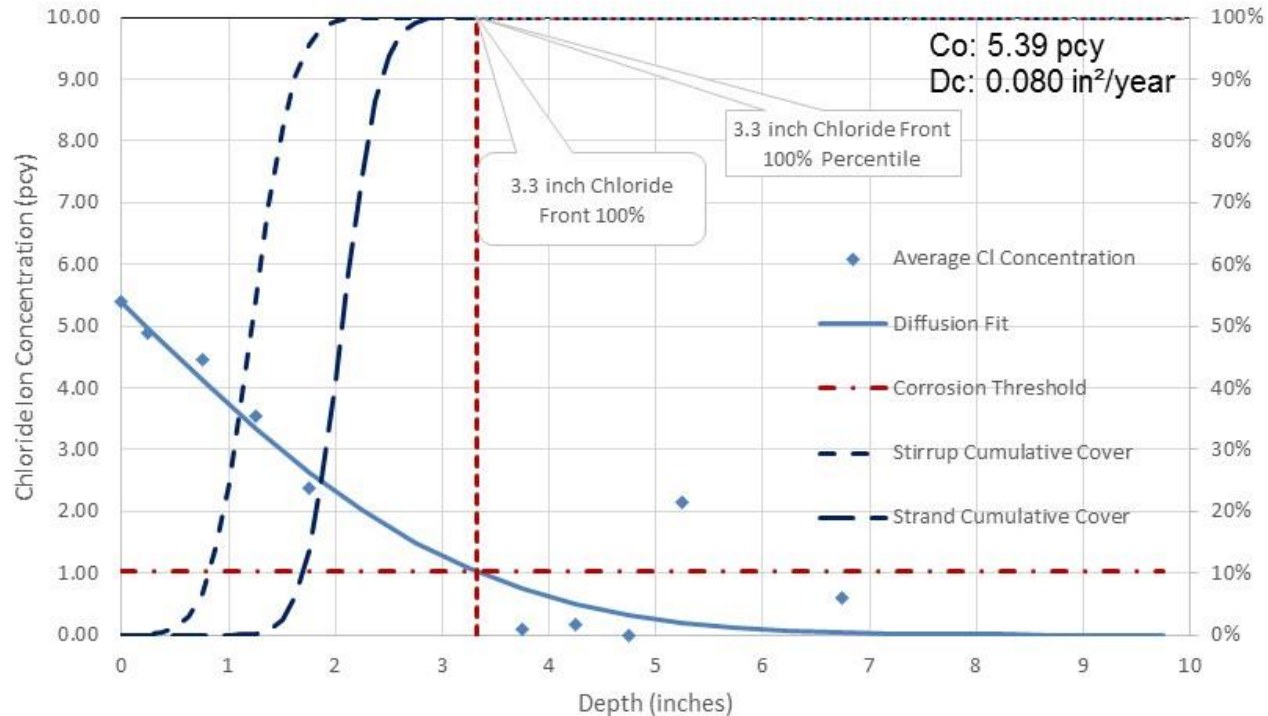
SW APPROACH (1974)

Average Distribution of Chloride Ions & Cumulative Clear Concrete Cover
for Bridge SW Beam Element Type BM-75-III-74

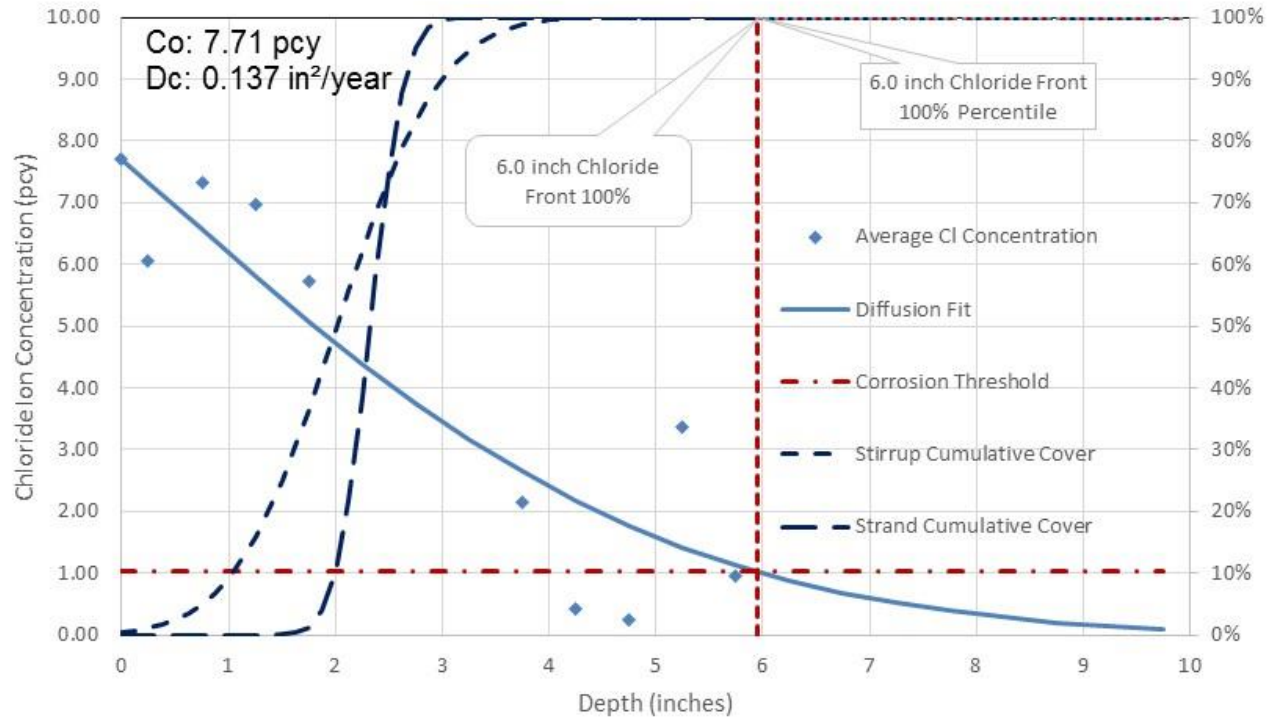
SE APPROACH (1957)

Average Distribution of Chloride Ions & Cumulative Clear Concrete Cover for Bridge SE Beam Element Type BM-50-ORG-57

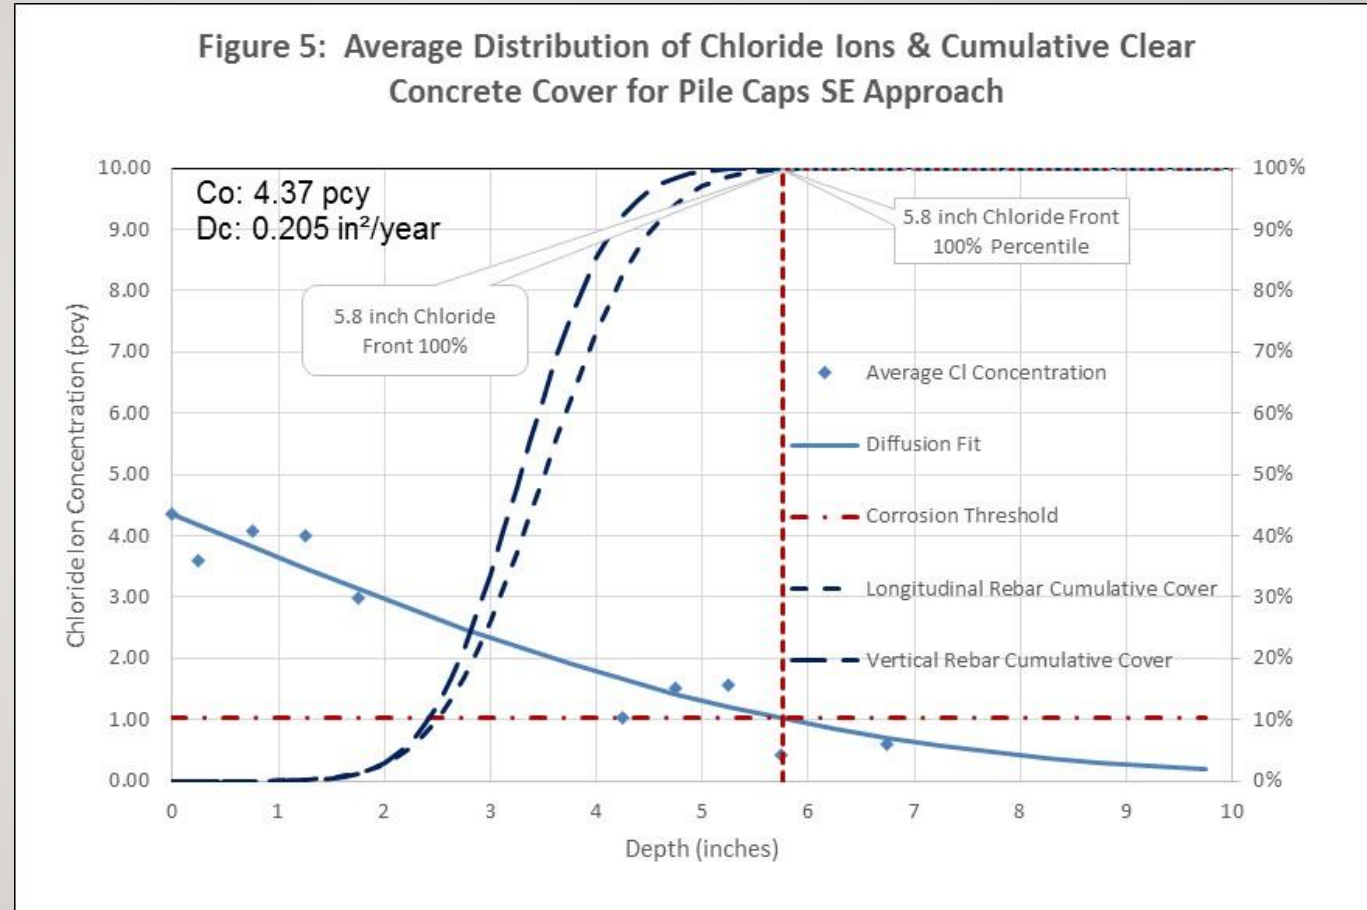
PILE CAPS CONDITION & CHLORIDE CONTAMINATION

- Eastern and Western Approaches have suffered 3.4% and 0.5% damage, respectively.
- Chloride front on the Eastern and Western Approaches range from 4.1 to 5.8 inches and 1.3 to 2.8 inches, respectively.

1. Patch repair all damage with discrete anodes on the pile caps of the **NW** and the **SW Approaches**.
2. Patch repair all damage and install titanium ribbon anode in slots on the caps of the **NE** and **SE Approaches**.

1. Patch repair all damage.
2. Install titanium Ribbon anode in slots on all pile caps.

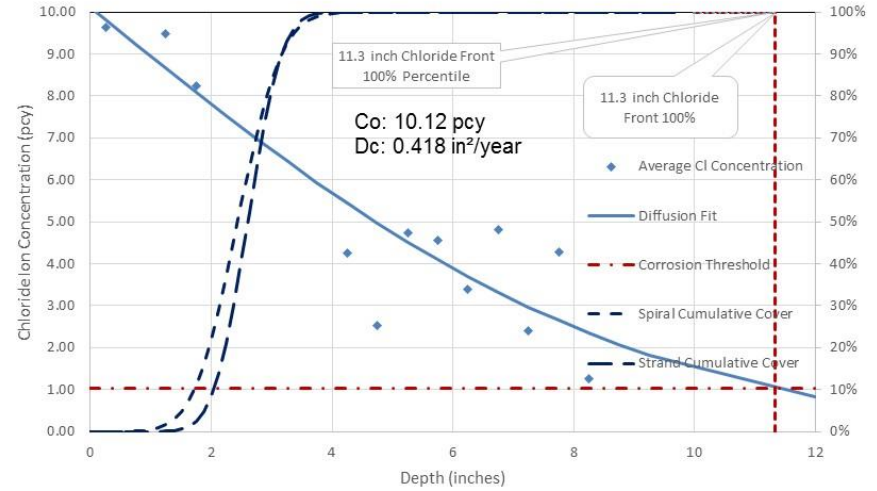
SQUARE PILES SE APPROACH

Average Distribution of Chloride Ions & Cumulative Clear Concrete Cover for Square Piles of SE Approach

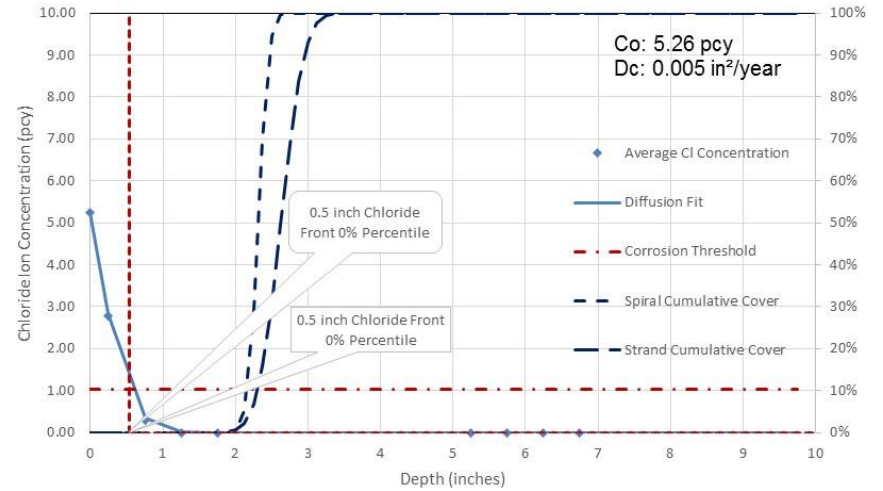
SQUARE PILES NE APPROACH

Average Distribution of Chloride Ions & Cumulative Clear Concrete Cover for NE Bridge Square Piles
