Grout Evaluation of External PT Tendons

STEPHEN SCHORN

NATIONAL BRIDGE PRESERVATION PARTNERSHIP CONFERENCE 2018

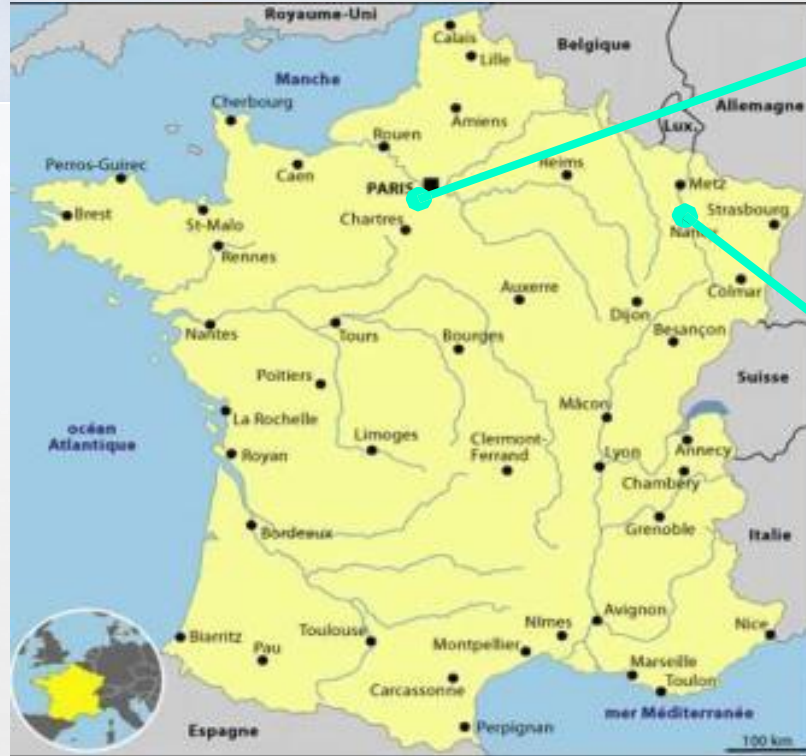
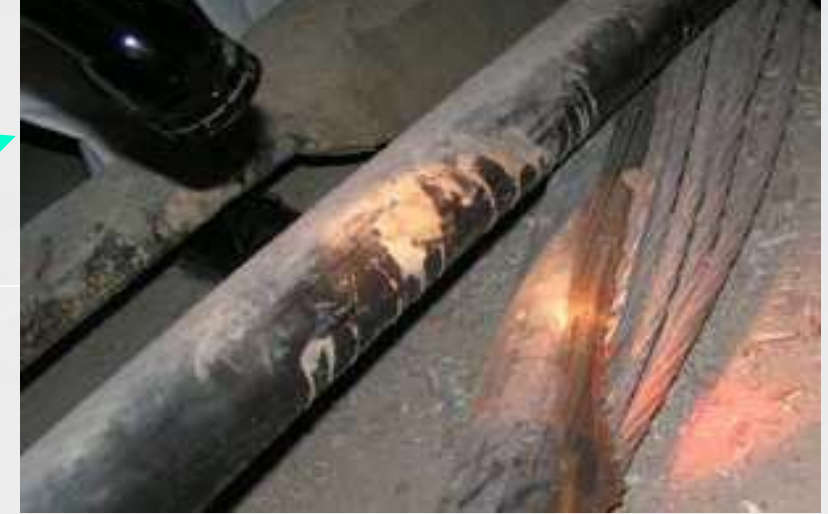
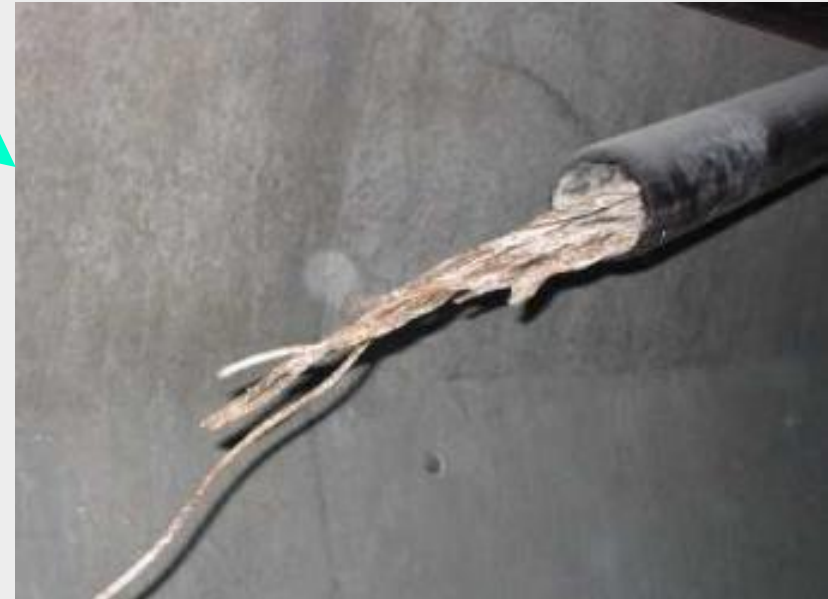
Inspections in France

- During routine inspection, broken PT ducts were found
 - Detection of lack of cement grout (voids), white paste, corrosion of the steel cables

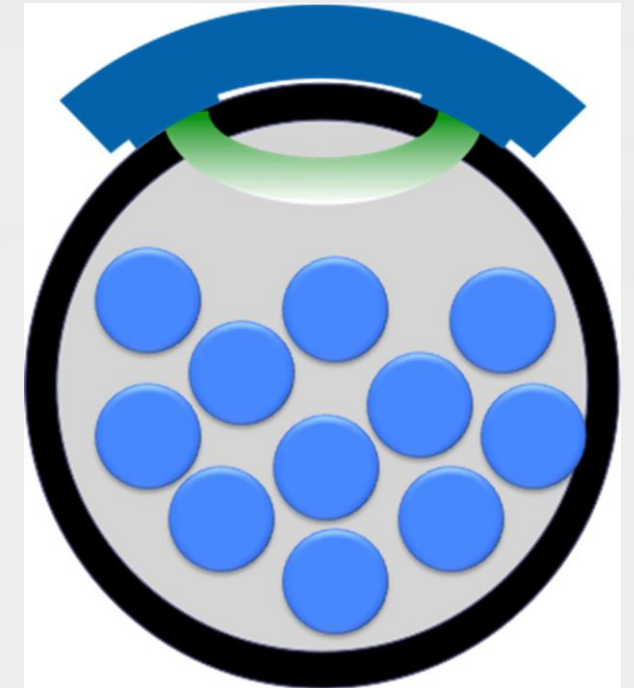
Capacitive Principle

- Capacitive method
- Sensitive to differences in electrical properties of materials
- This will indicate the material or combination of materials present
 - Reveal air voids
 - White paste
 - Soft grout
 - Areas of increased potential for corrosion
- Inspection depth of 1.5in

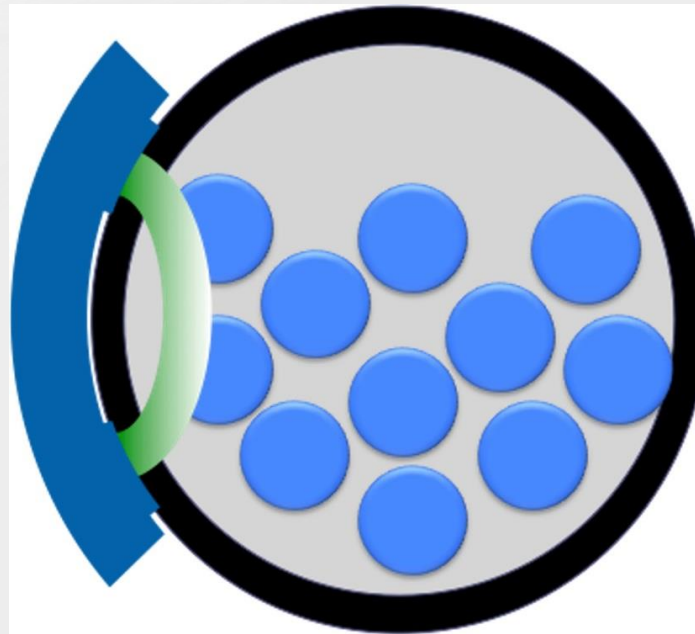
- It can be moved along or around the duct
- To provide a full mapping of the cross section, do a 360 degree rotation

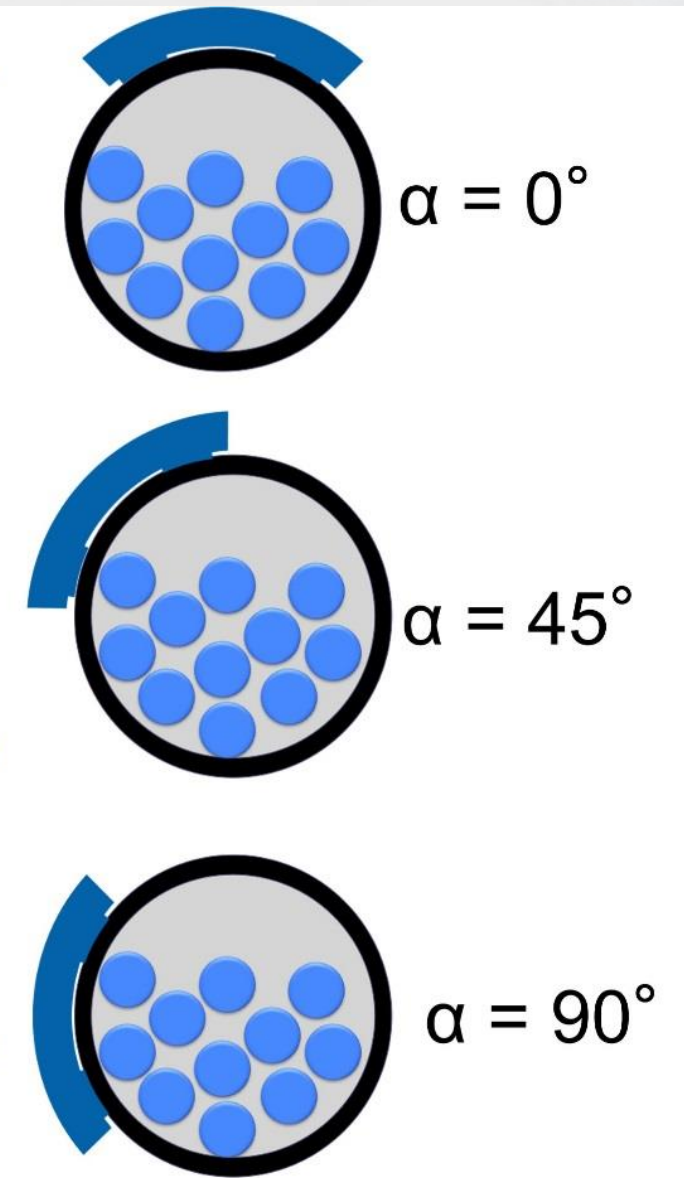
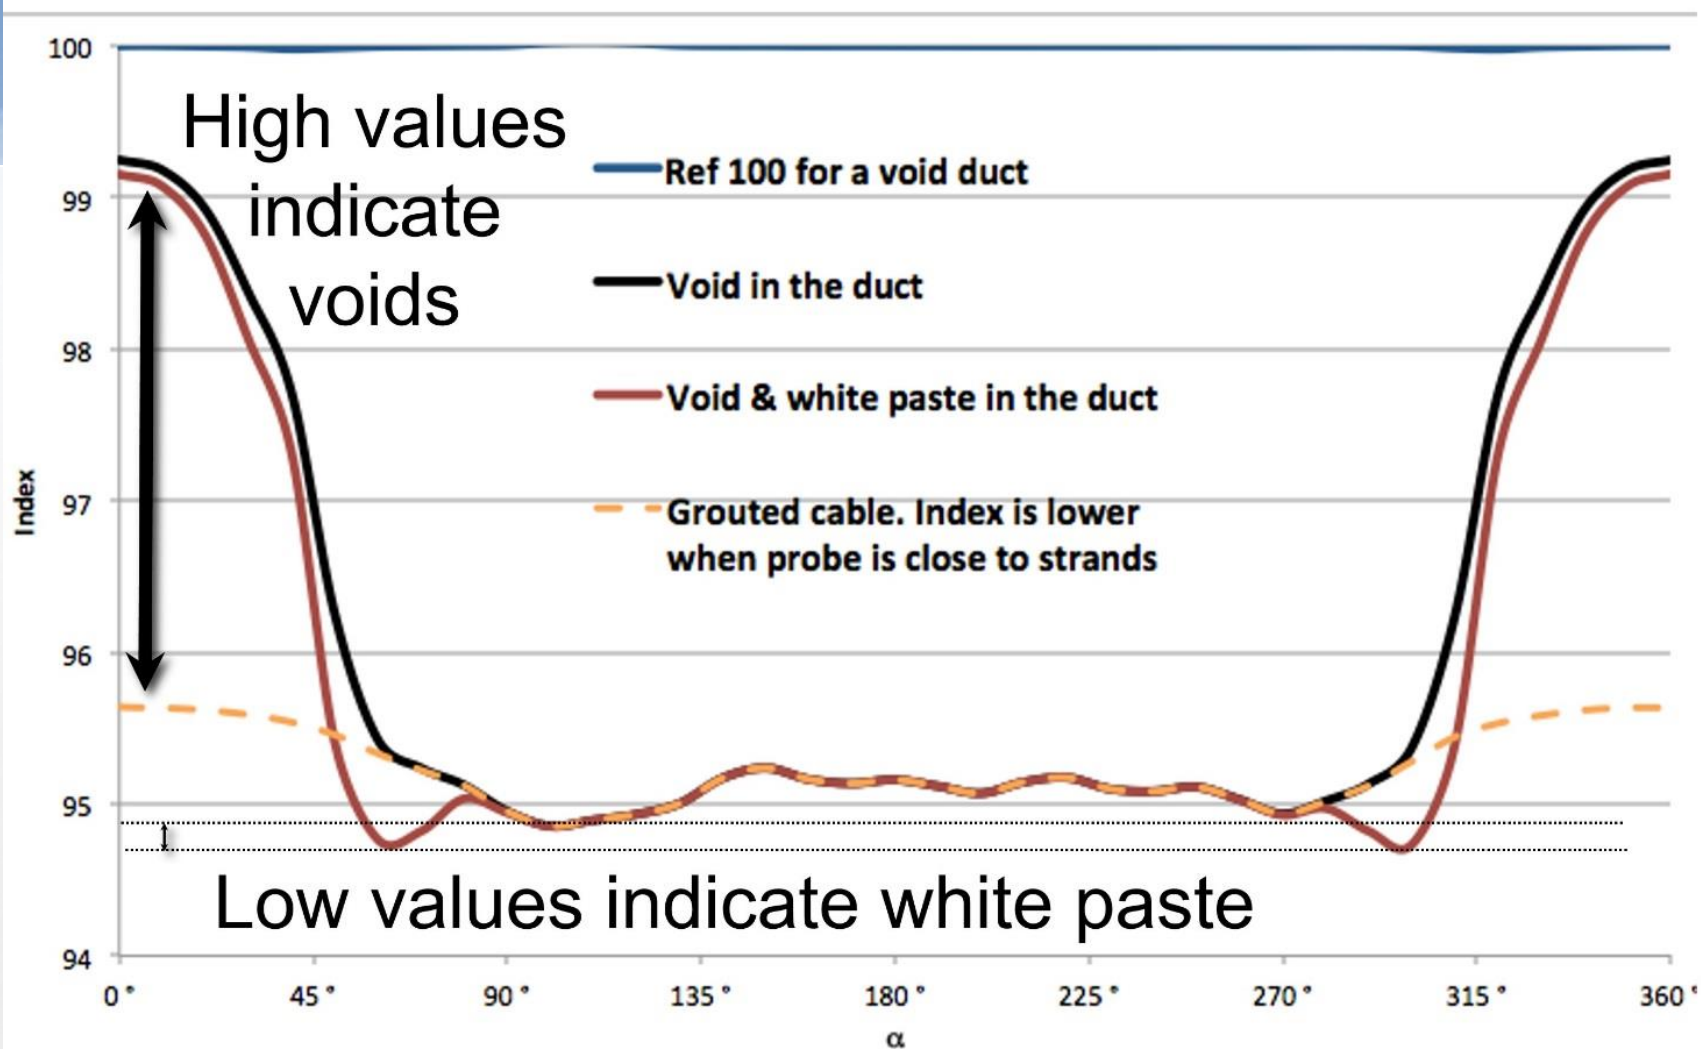
Typical readings for a cable with no grouting defect

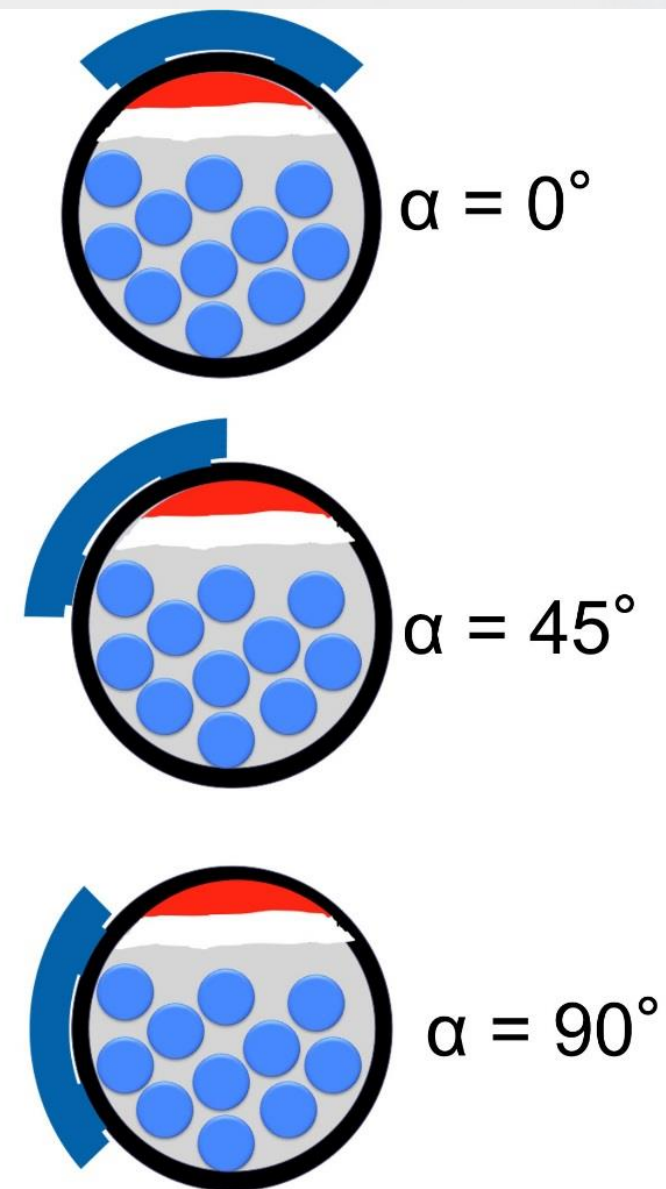
Typical readings for a cable with grouting defect

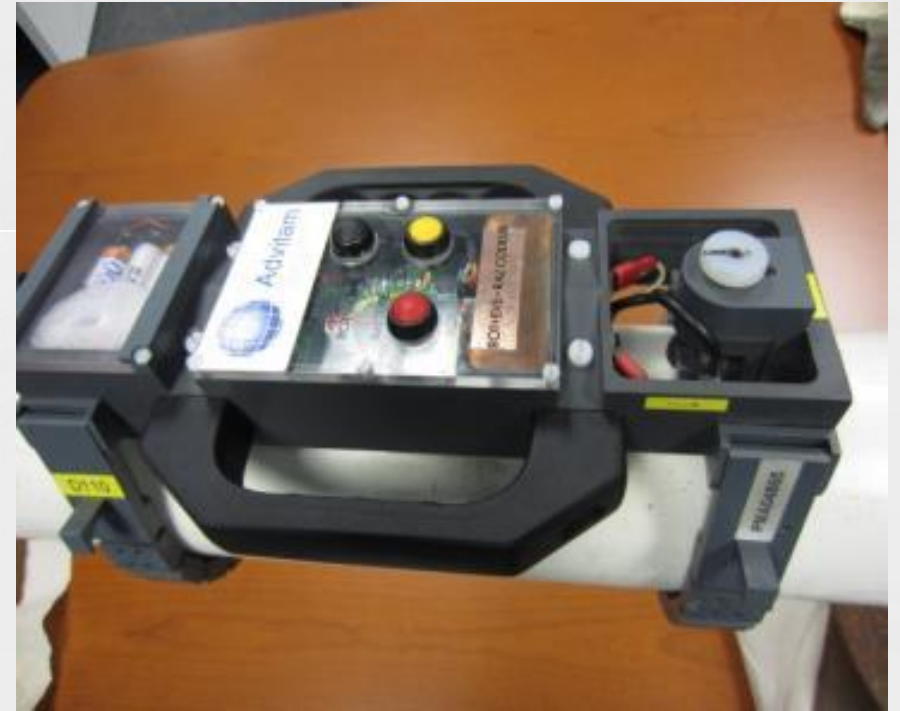
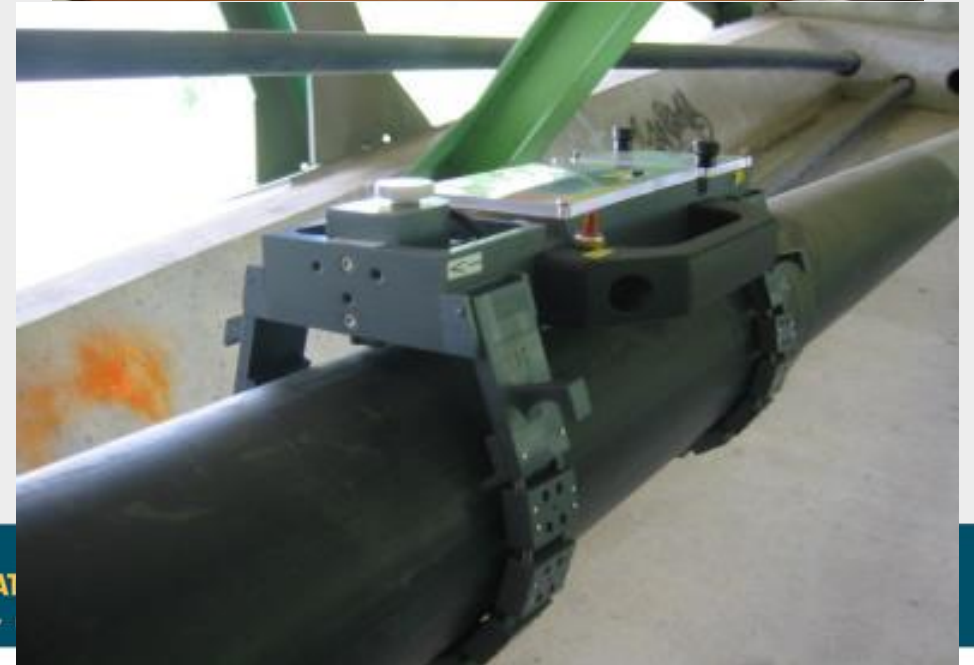
Testing

1. Clean or wipe the duct surface (e.g. dried burrs of grout with a painter's knife) to allow for passage of the sensor
2. Turn the sensor on and get a baseline reading of the ambient air temperature
3. Place the sensor on the pipe and attach the two straps/collars to hold it in place
4. Open the PC program and enter relevant information about pipe diameter, tester name, notes, etc.
5. Move the sensor along the duct and obtain measurements in real time

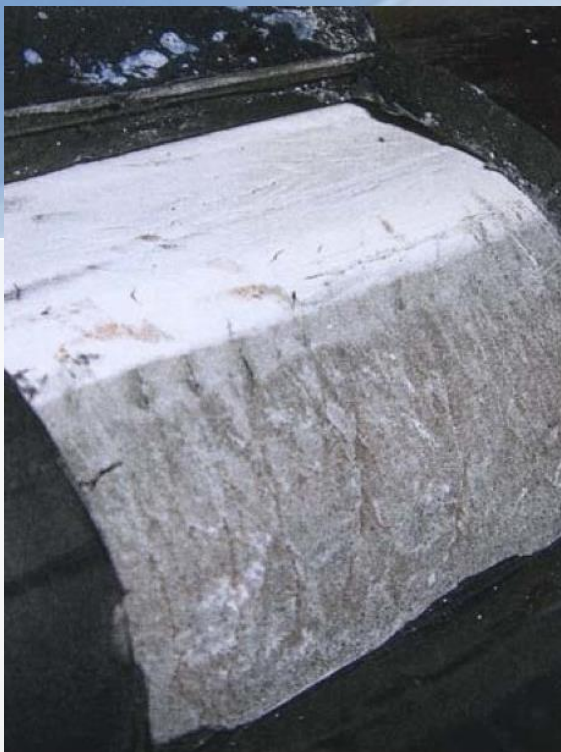
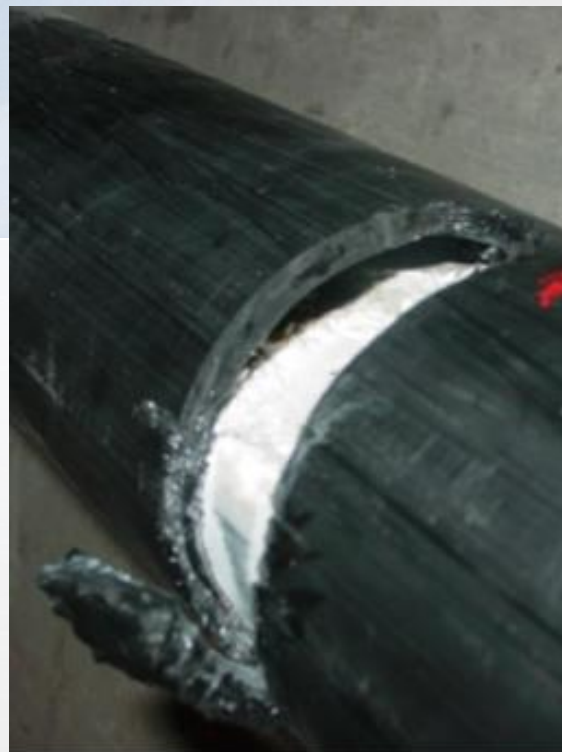
Examples of white paste

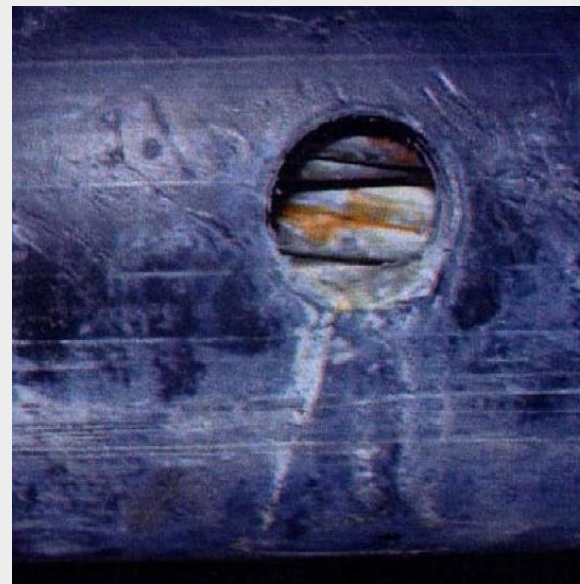
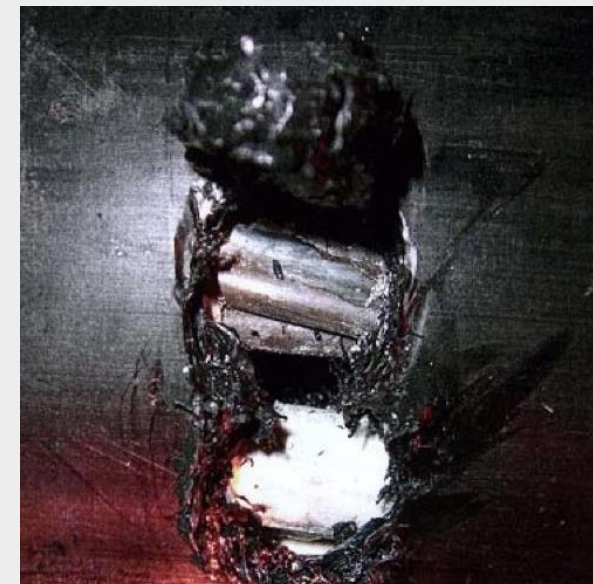
Examples of voids

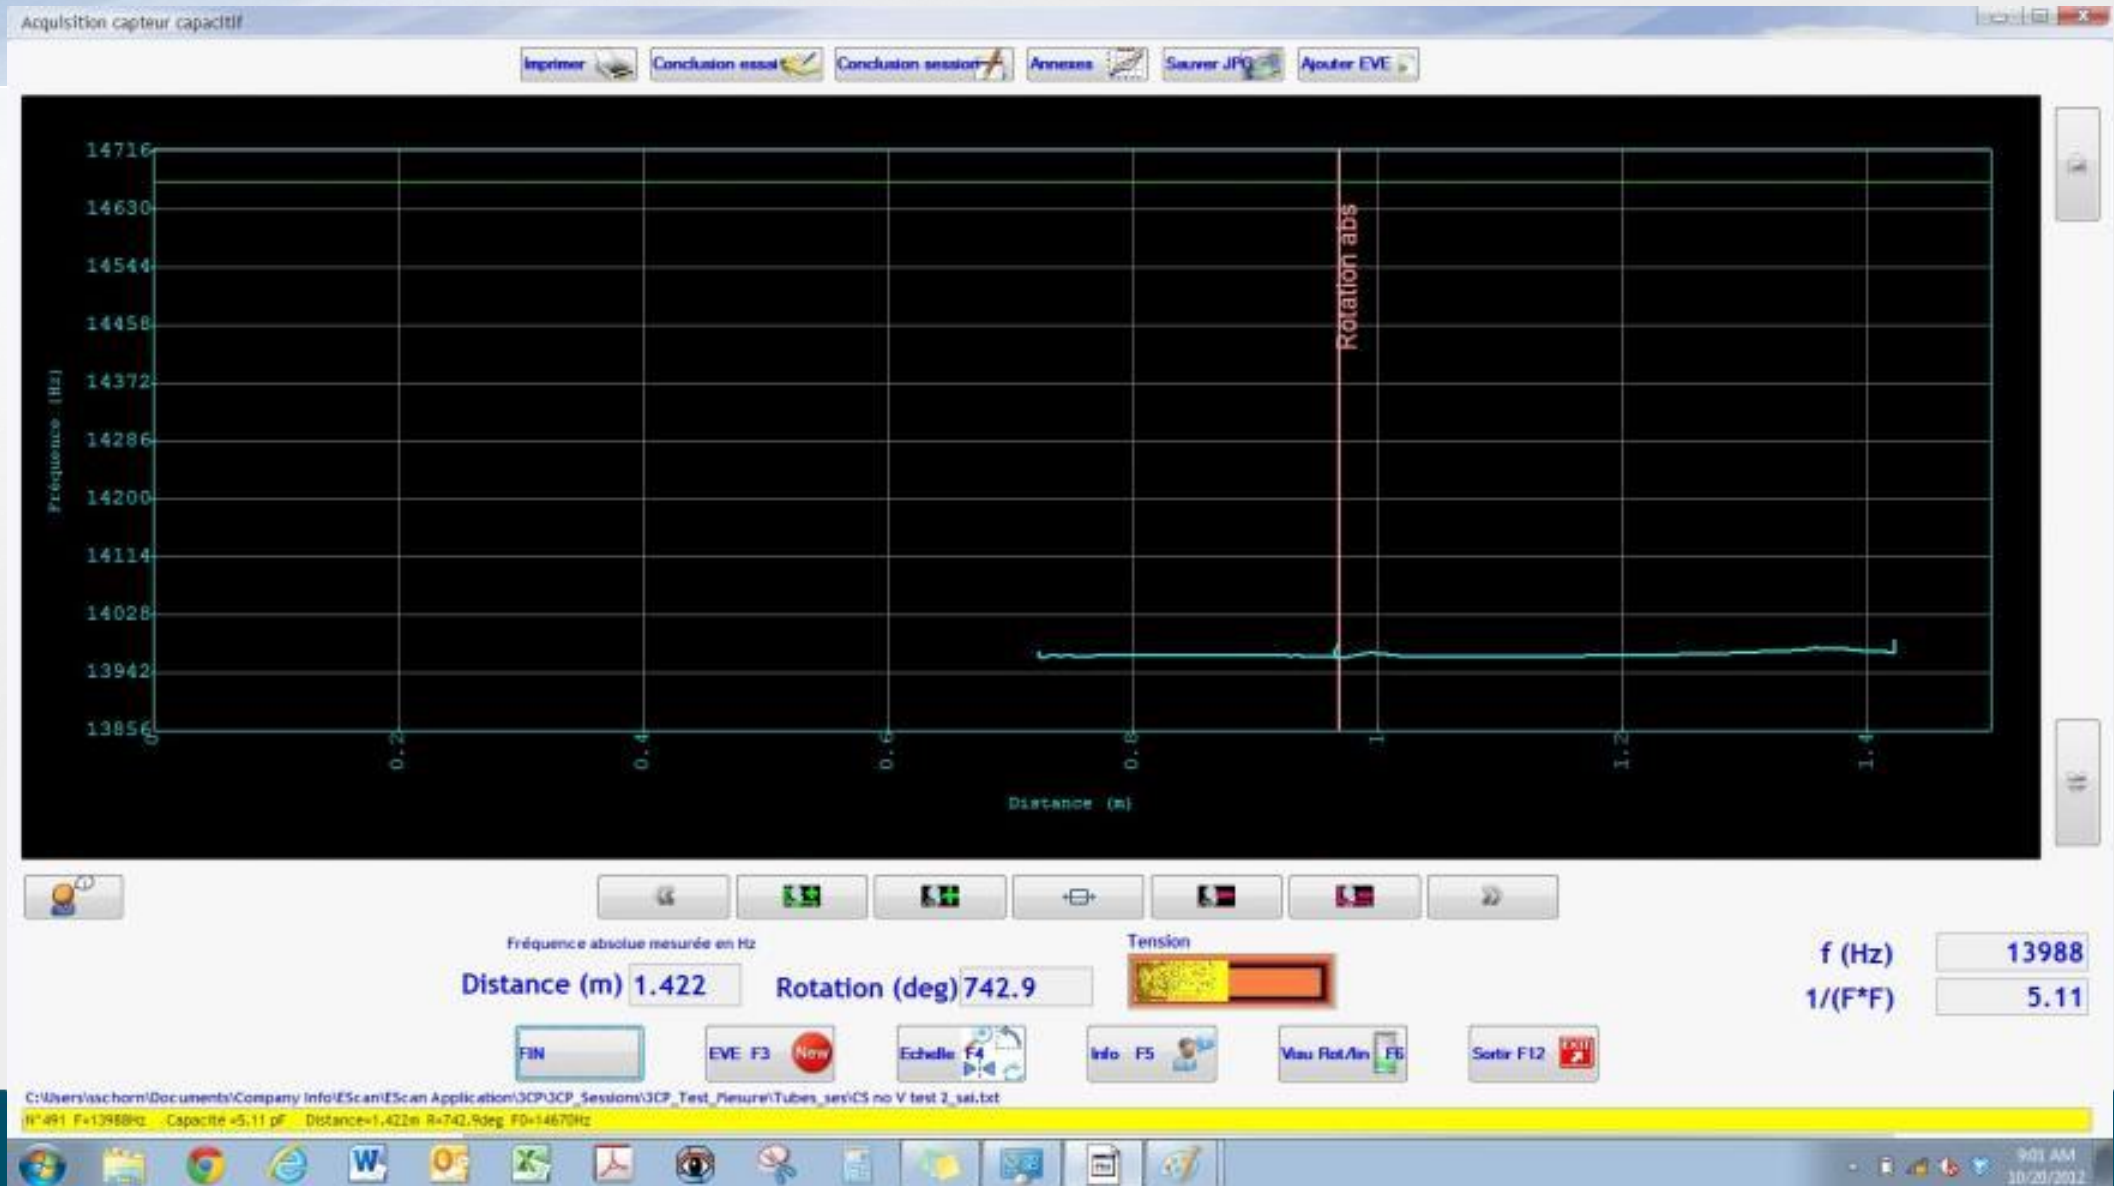
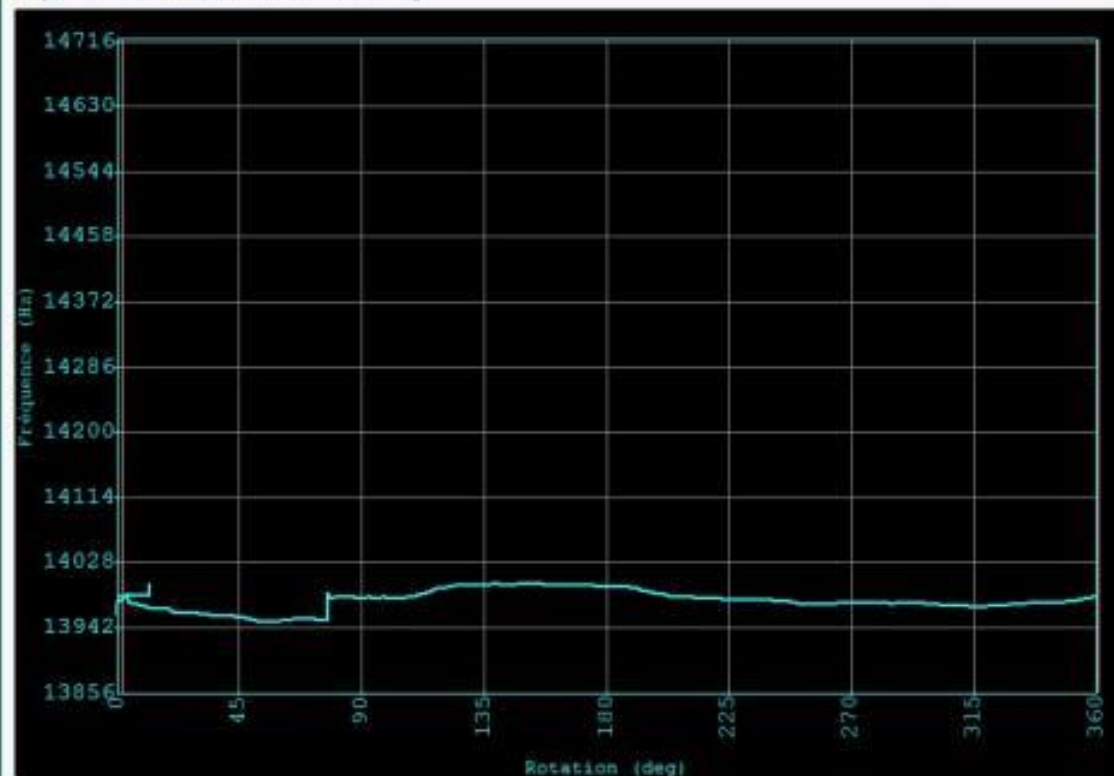
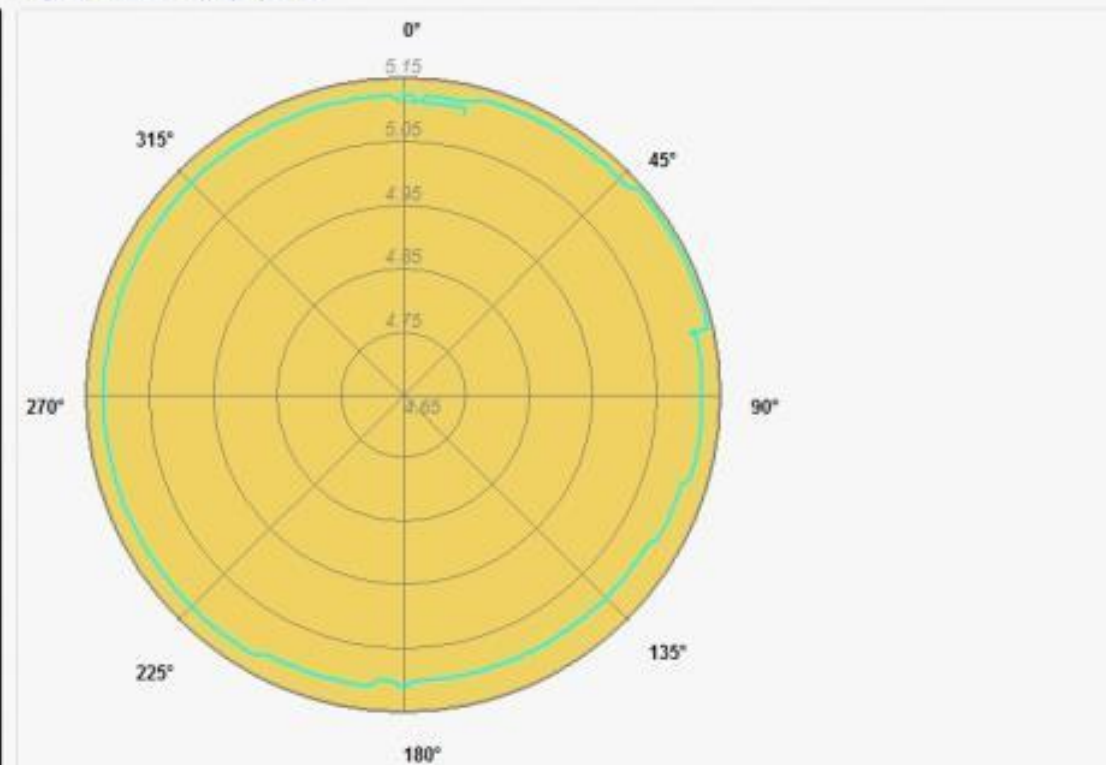
Real-Time visualization with Software

N° 520 F=13999Hz Capacité =5.1 pF Distance=0.48m R=372.3deg F0=14670Hz
