Grout Evaluation of External PT Tendons

STEPHEN SCHORN

NATIONAL BRIDGE PRESERVATION PARTNERSHIP CONFERENCE 2018

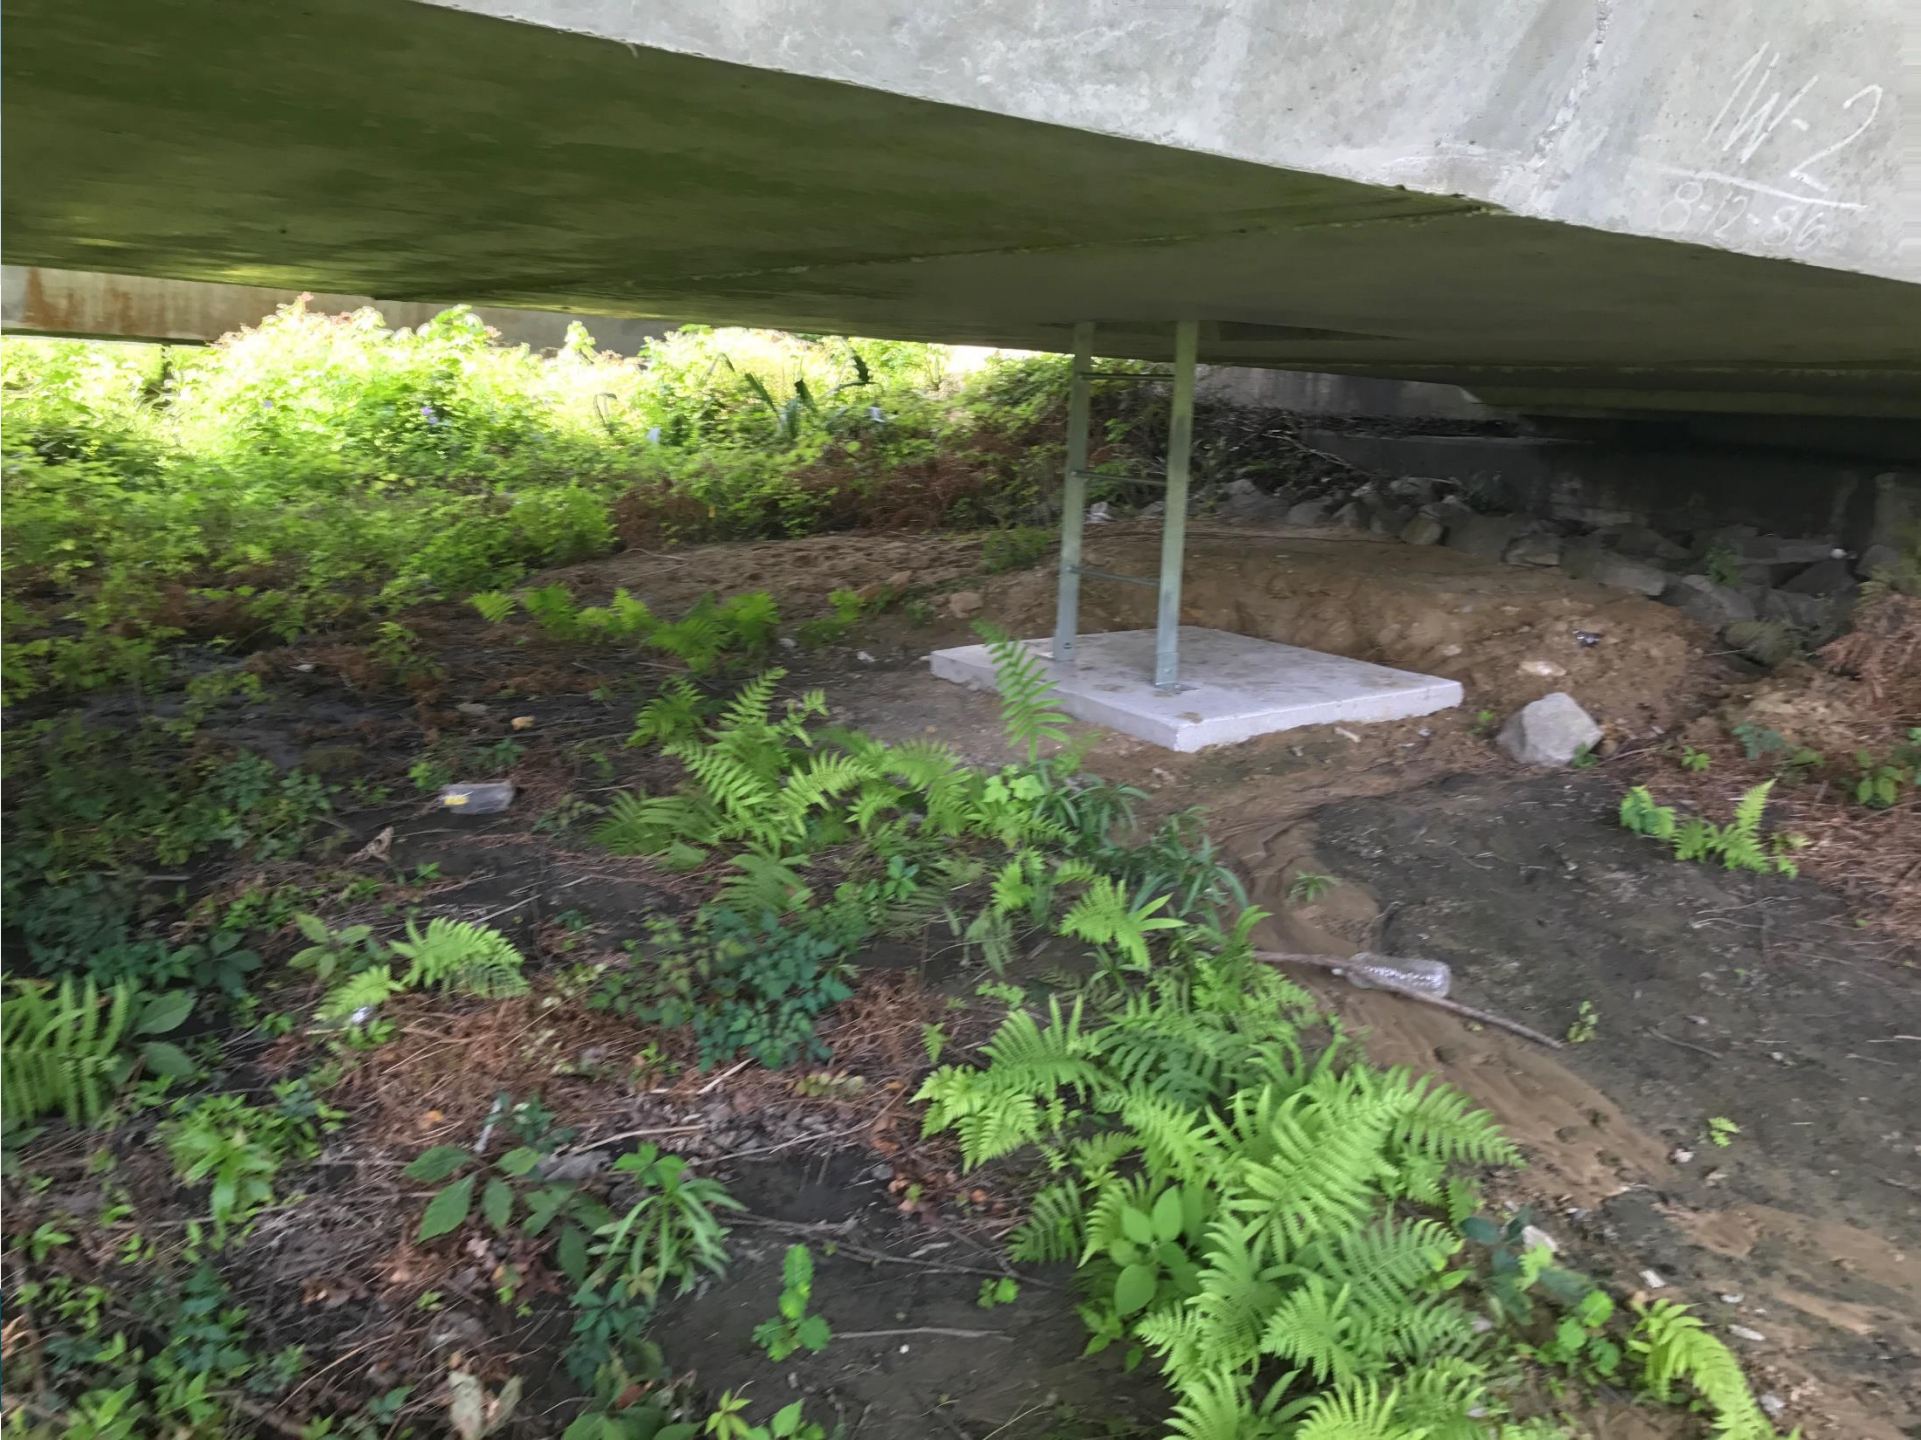
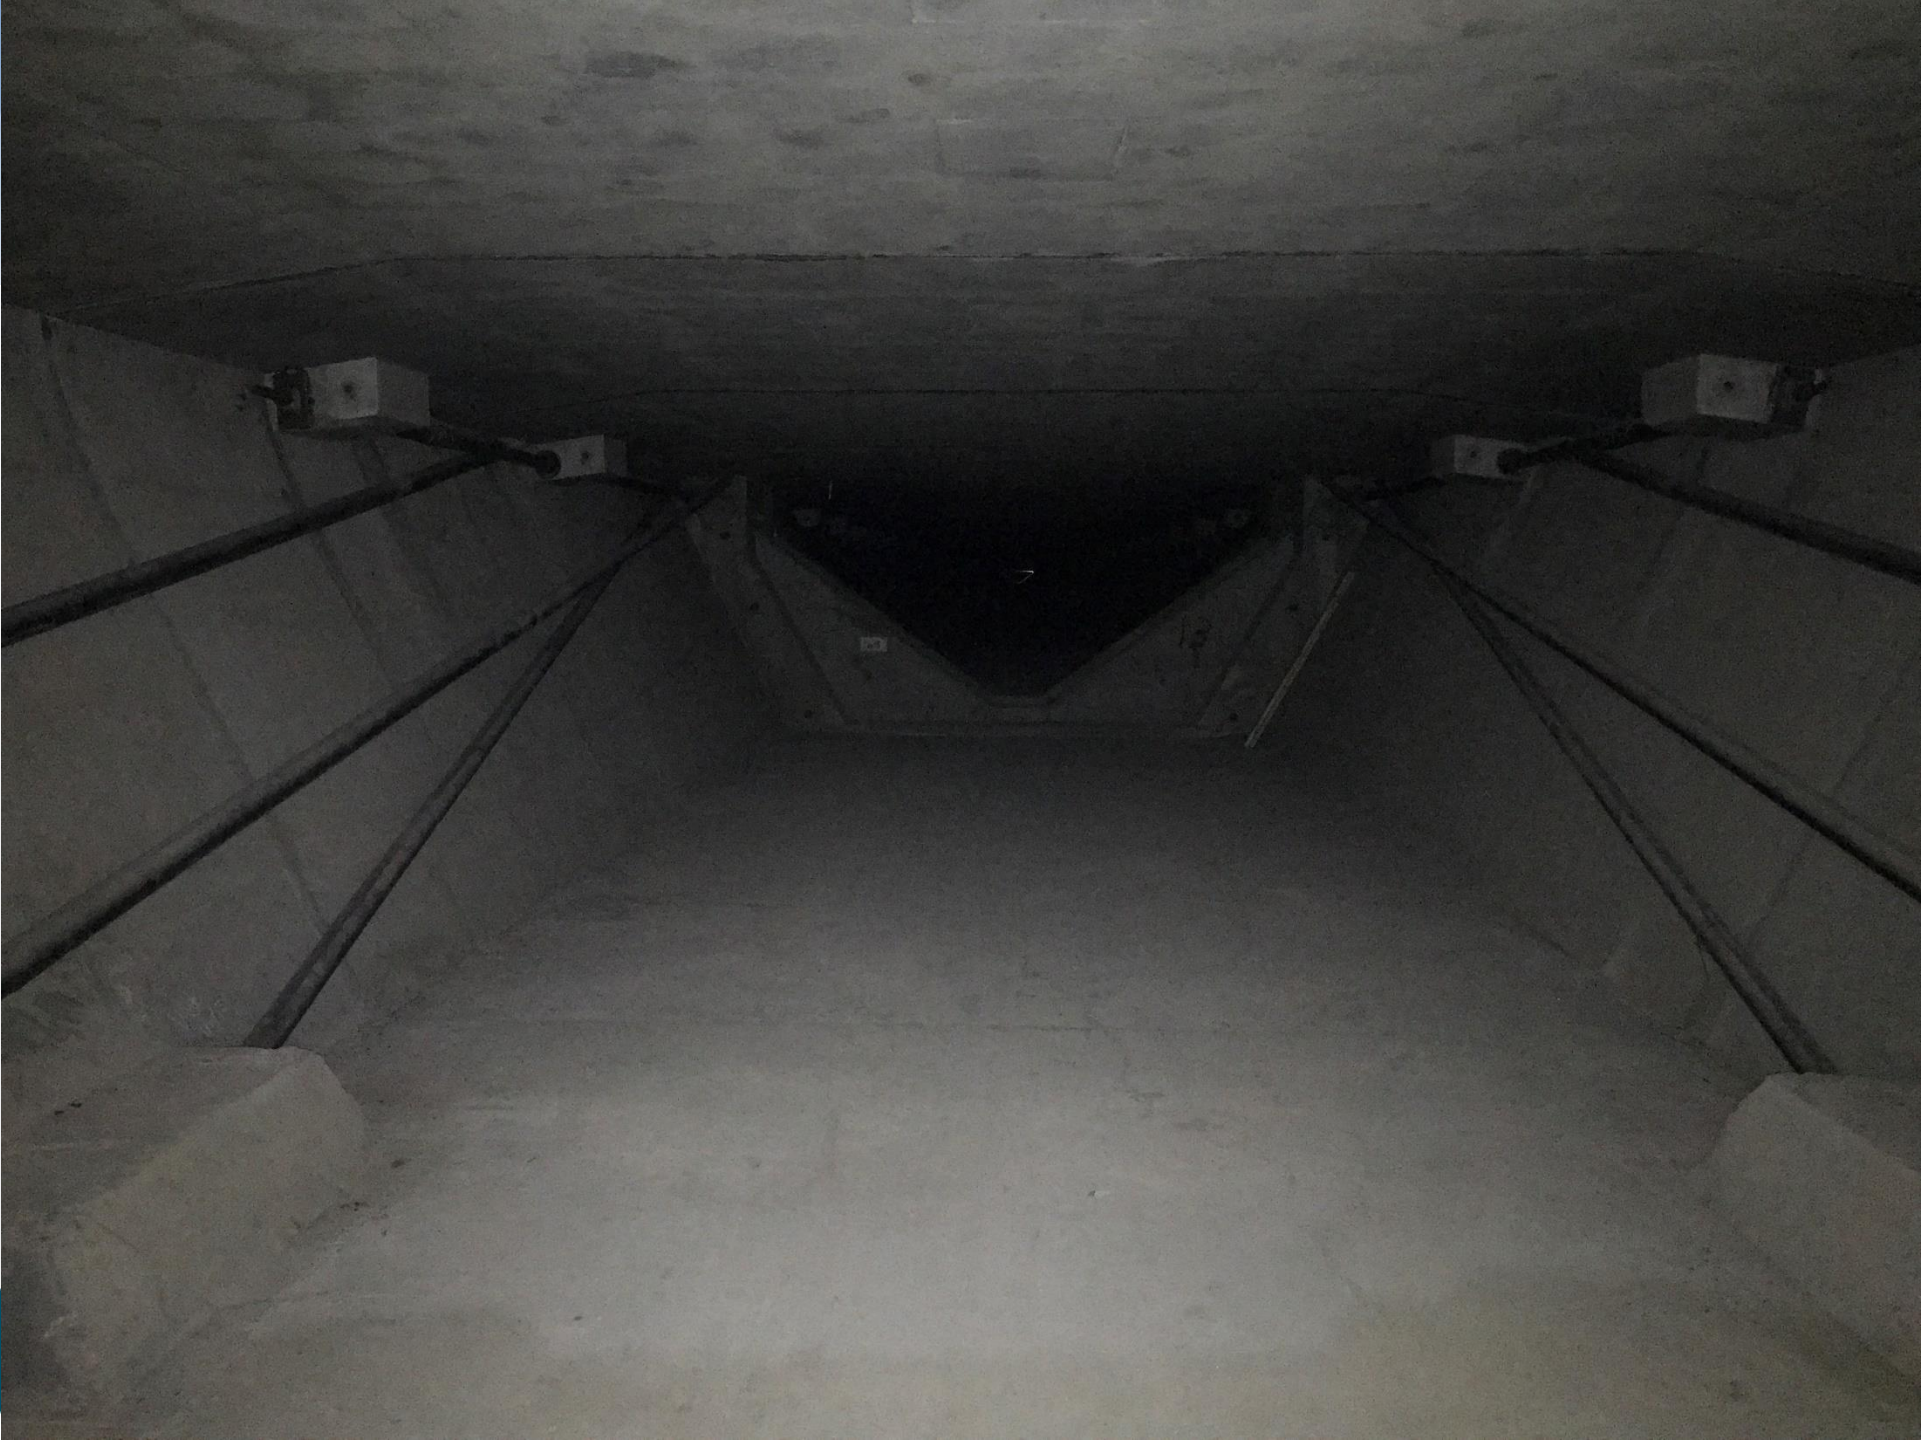
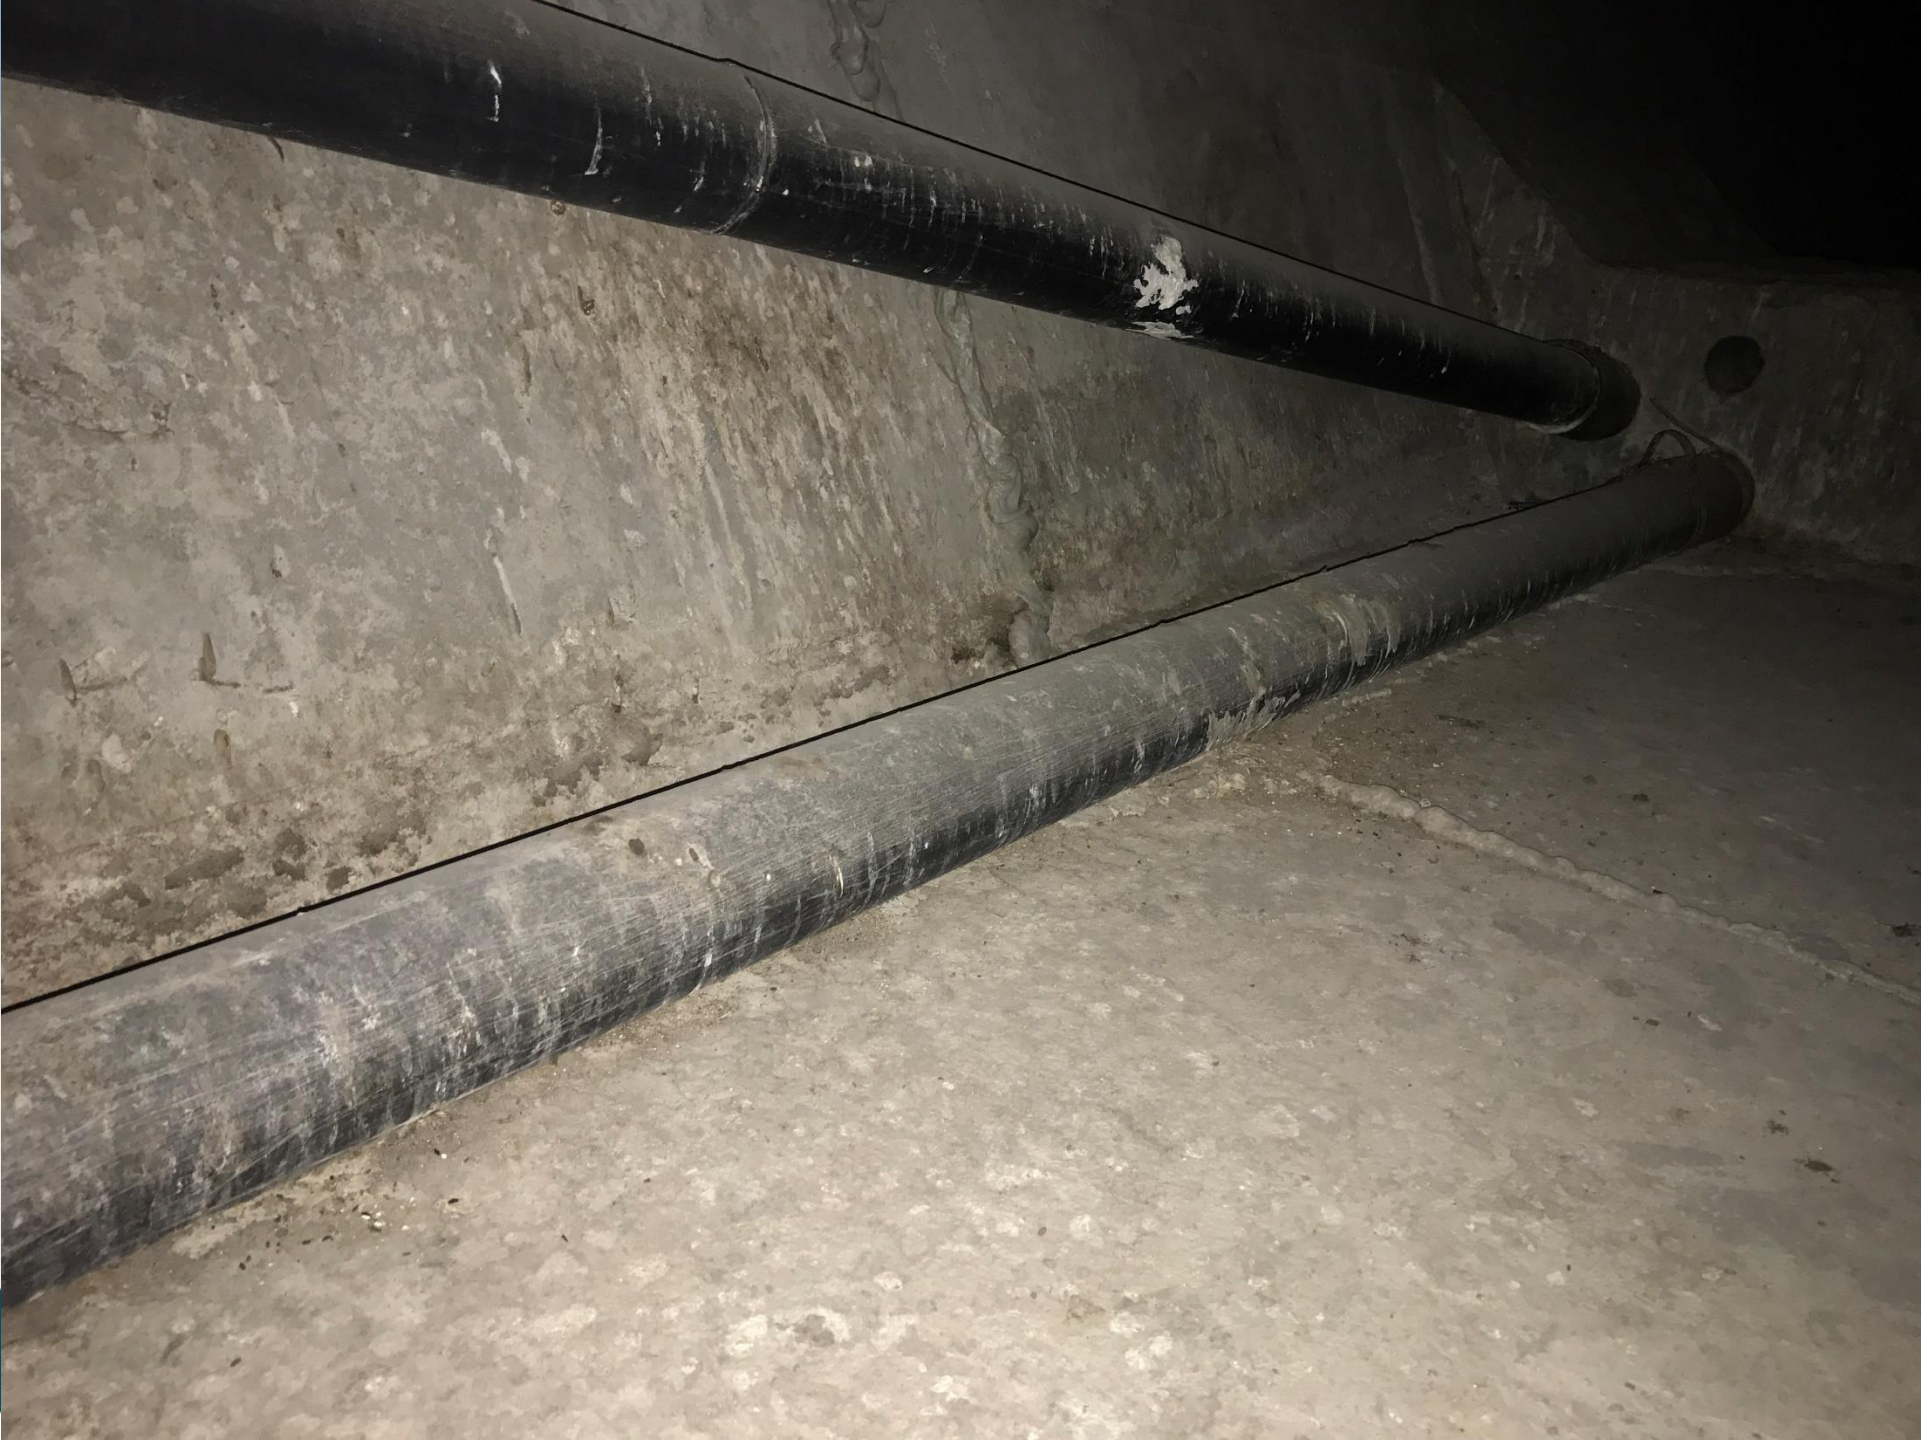
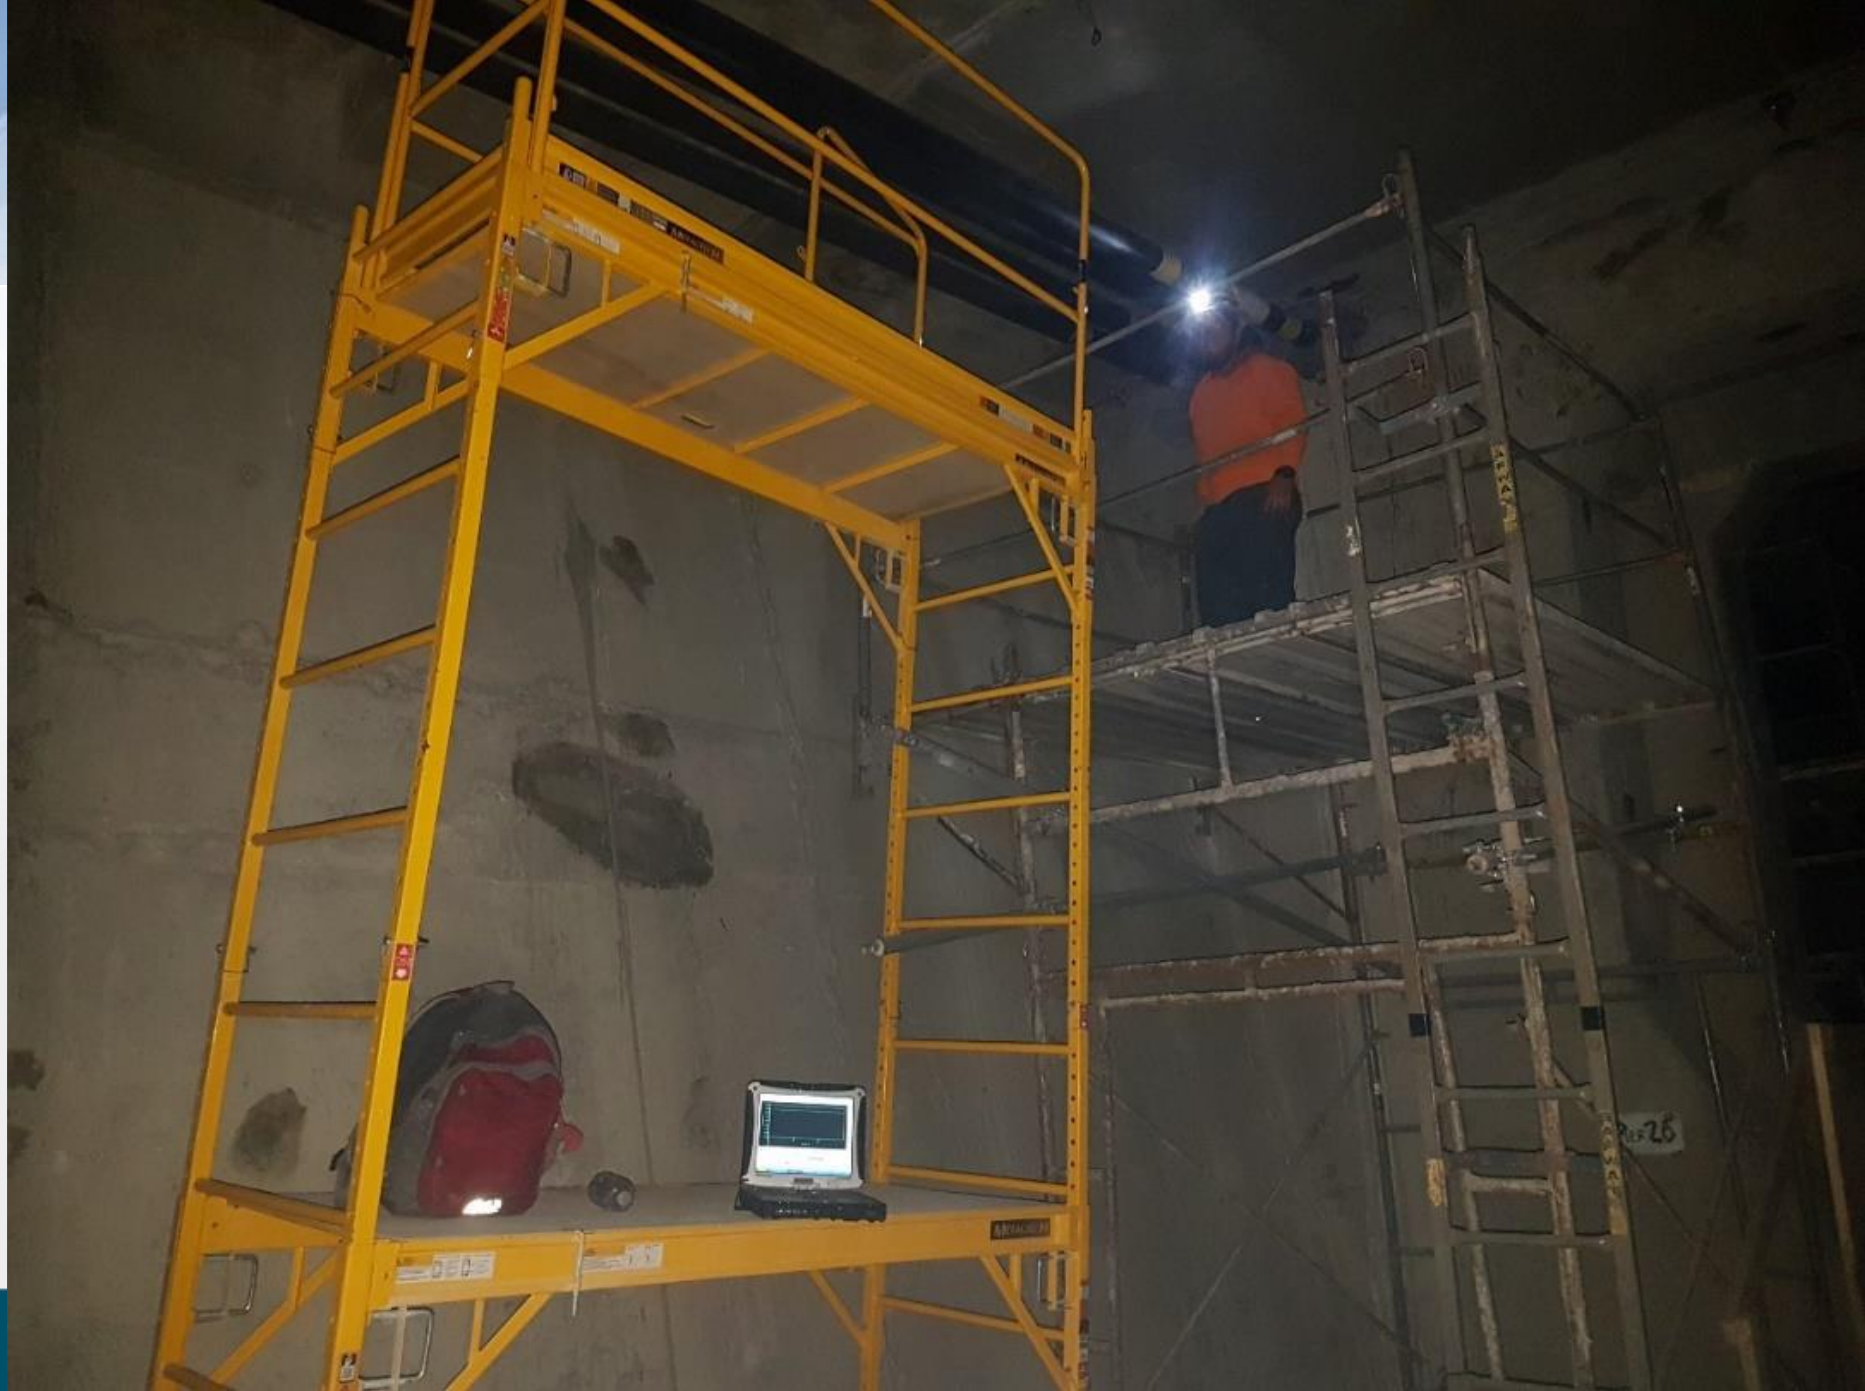
Project Example

- September to December 2017
- 434 tendons inspected
- West bridge
 - 88 sections with significant defects
 - 151 sections with probable defects (small voids)
 - 17 tendons with no defects
- East Bridge
 - 60 sections with significant defects
 - 163 sections with probably defects (small voids)
 - 22 tendons with no defects
