# The Opportunity to Reduce Bridge Preservation Demands through Enhanced Quality Expansion Joint and Bearing Installation and Inspection

Ralph J. Dornsife P.E., S.E.  
Washington State Dept. of Transportation  
Bridge & Structures Office  
Olympia Washington USA

# Expansion Joint / Bearing Case Studies

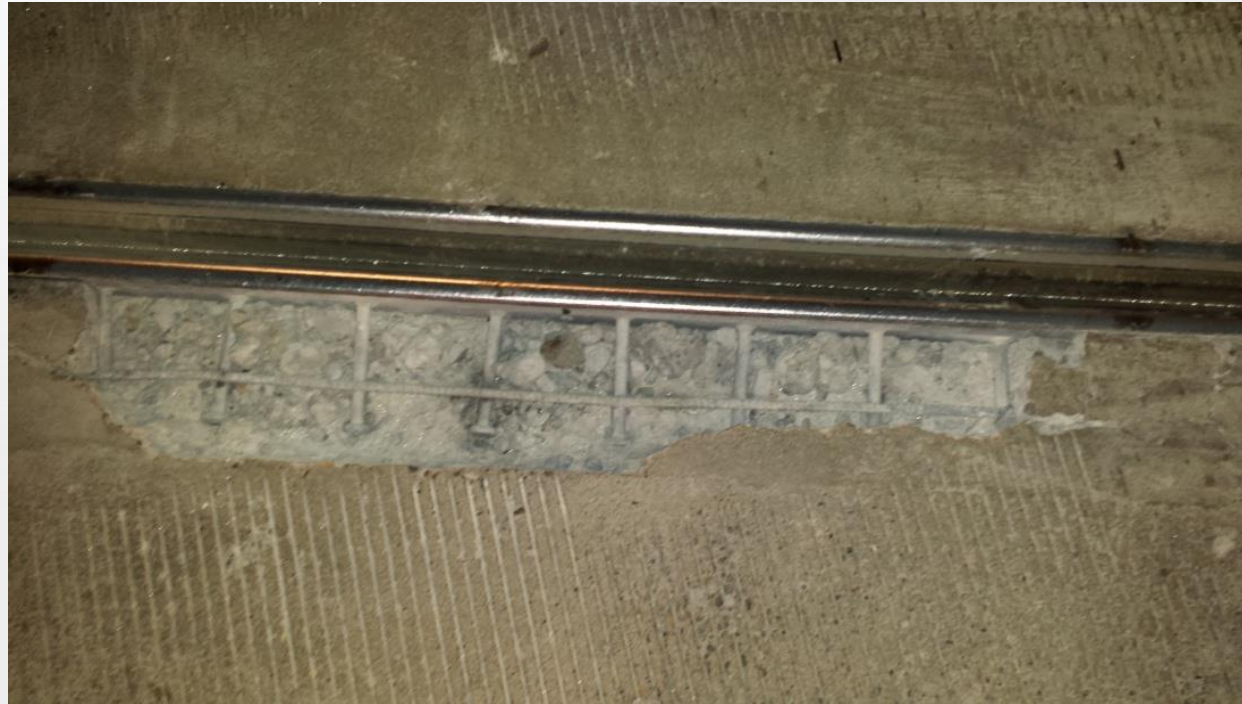
# Armored Strip Seal Expansion Joint Failure (I-5 SB Blakeslee Junction Bridge)

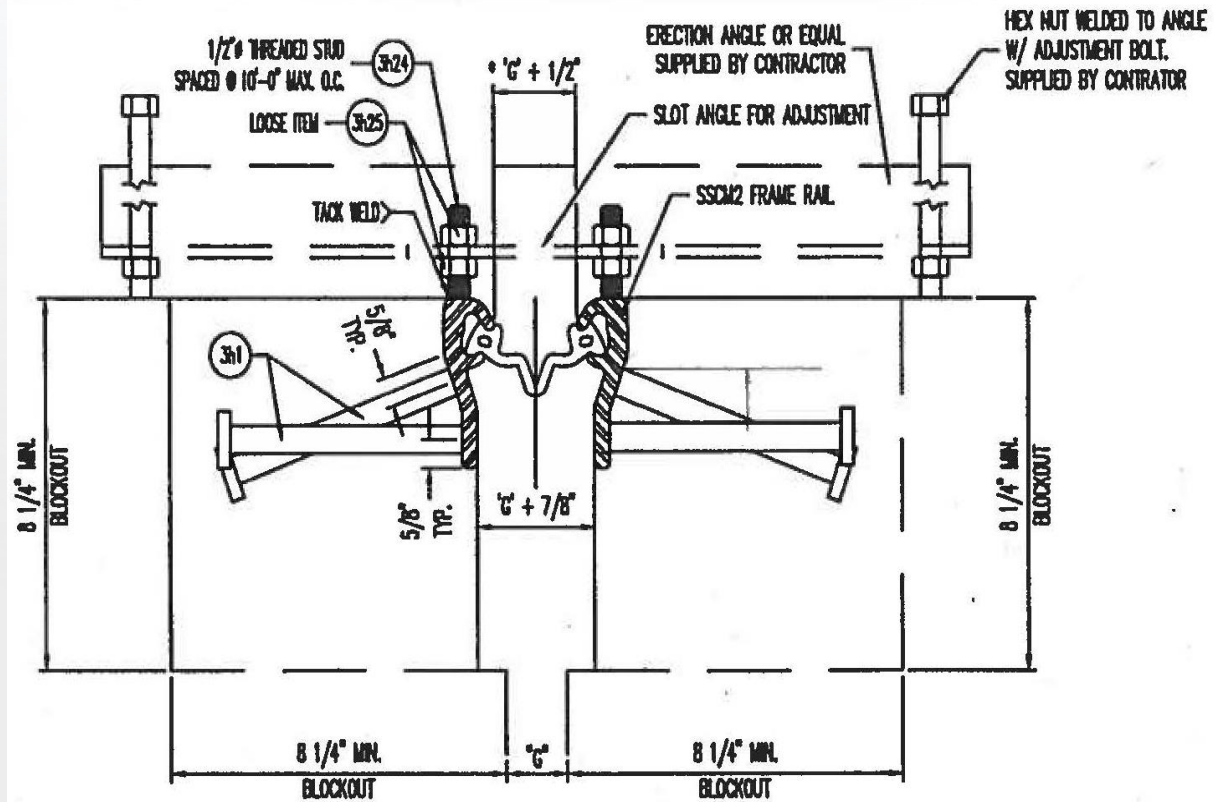
# Support and Setting Details

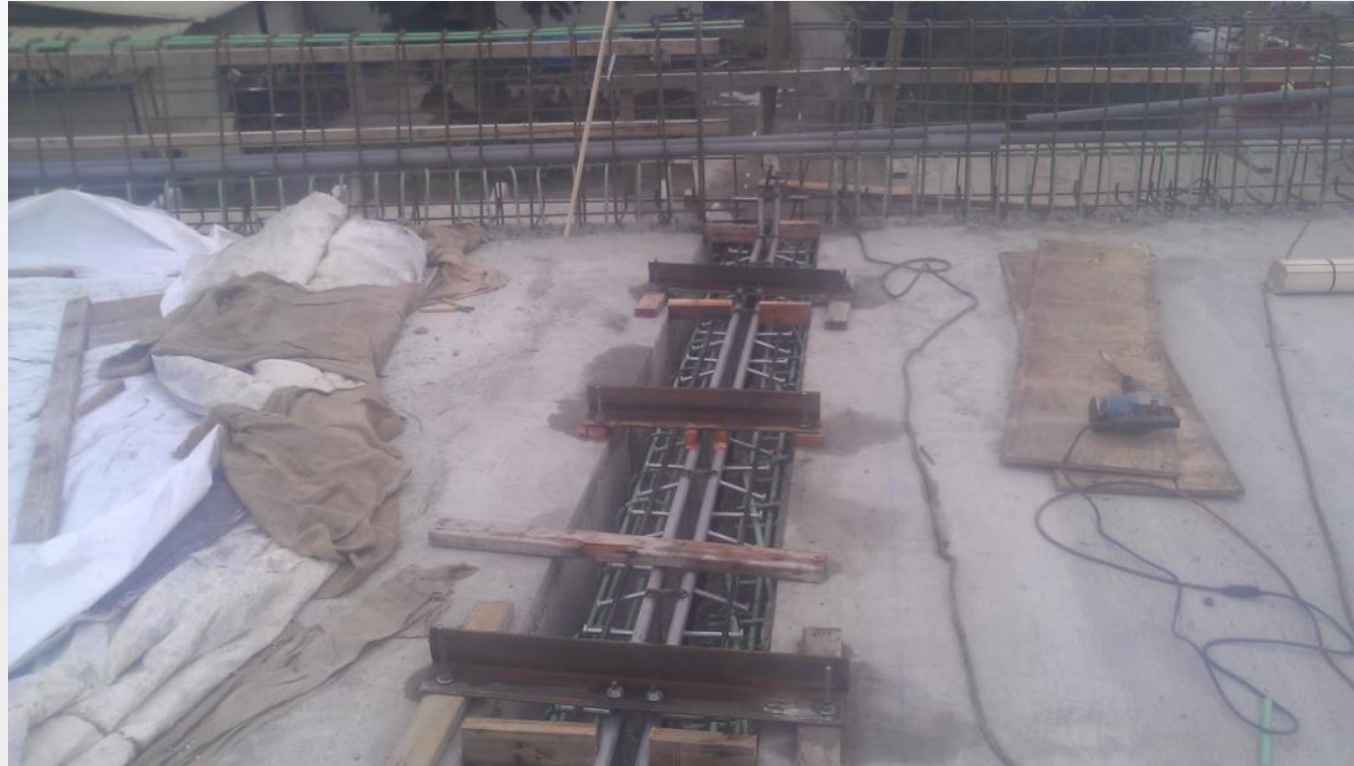
# Installation Hardware

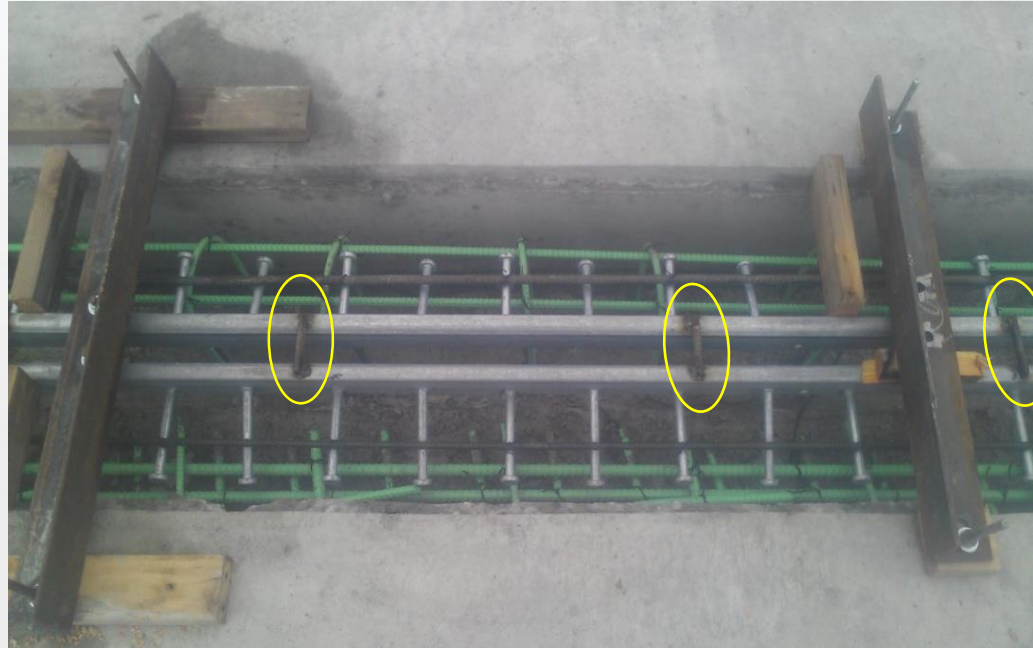
# Installation Hardware – Close-up

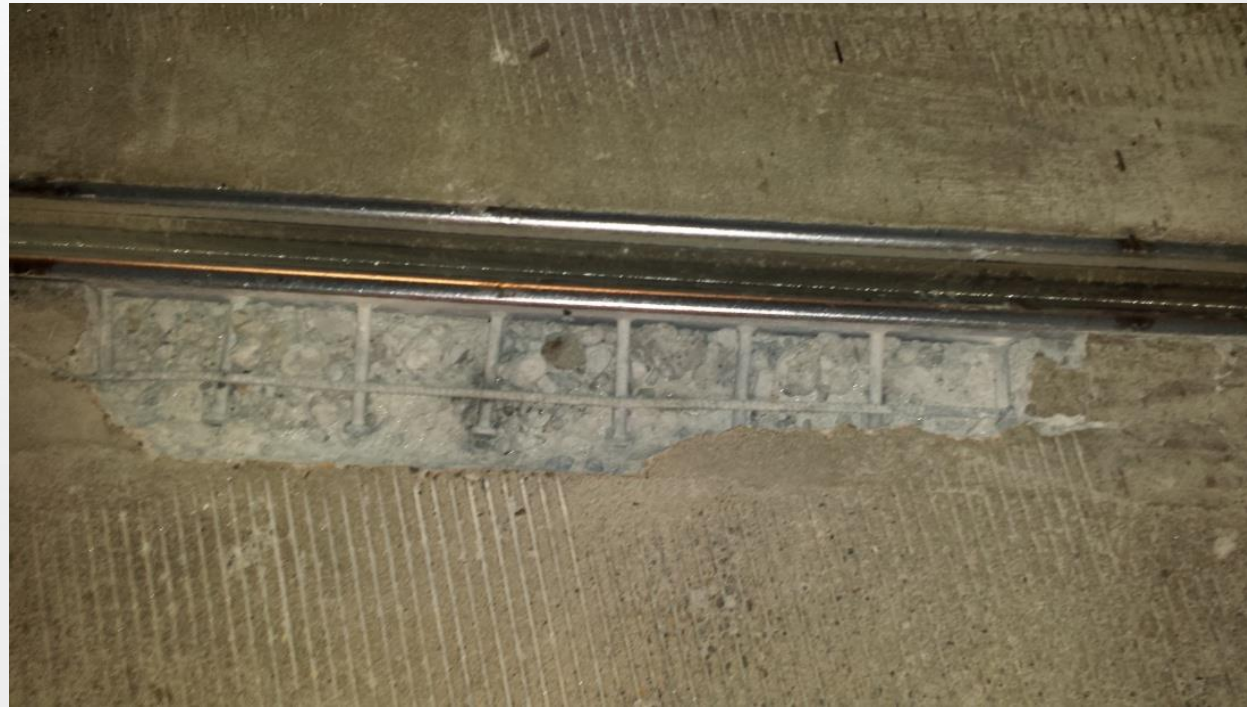
# Armored Strip Seal Anchorage Failure

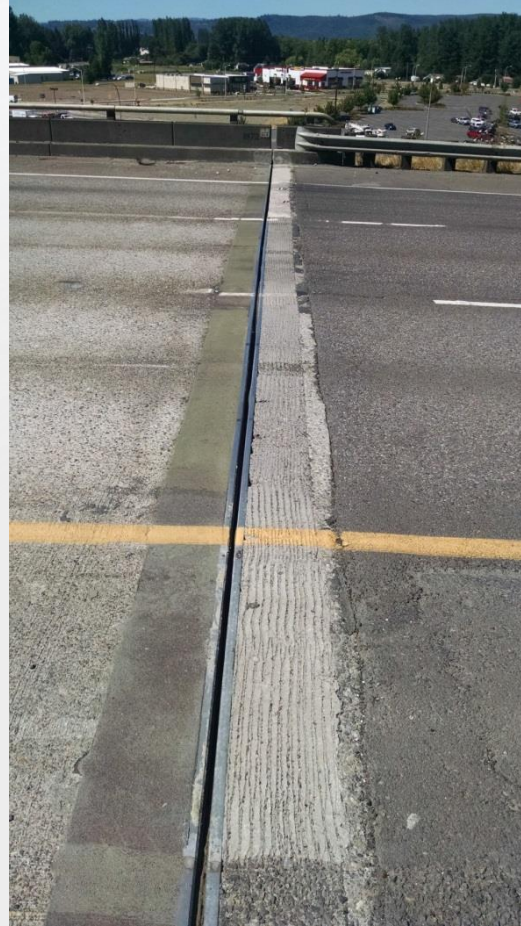
# Armored Strip Seal Expansion Joint Failure

## (I-5 BNSF / Dike Road O/C Bridge)

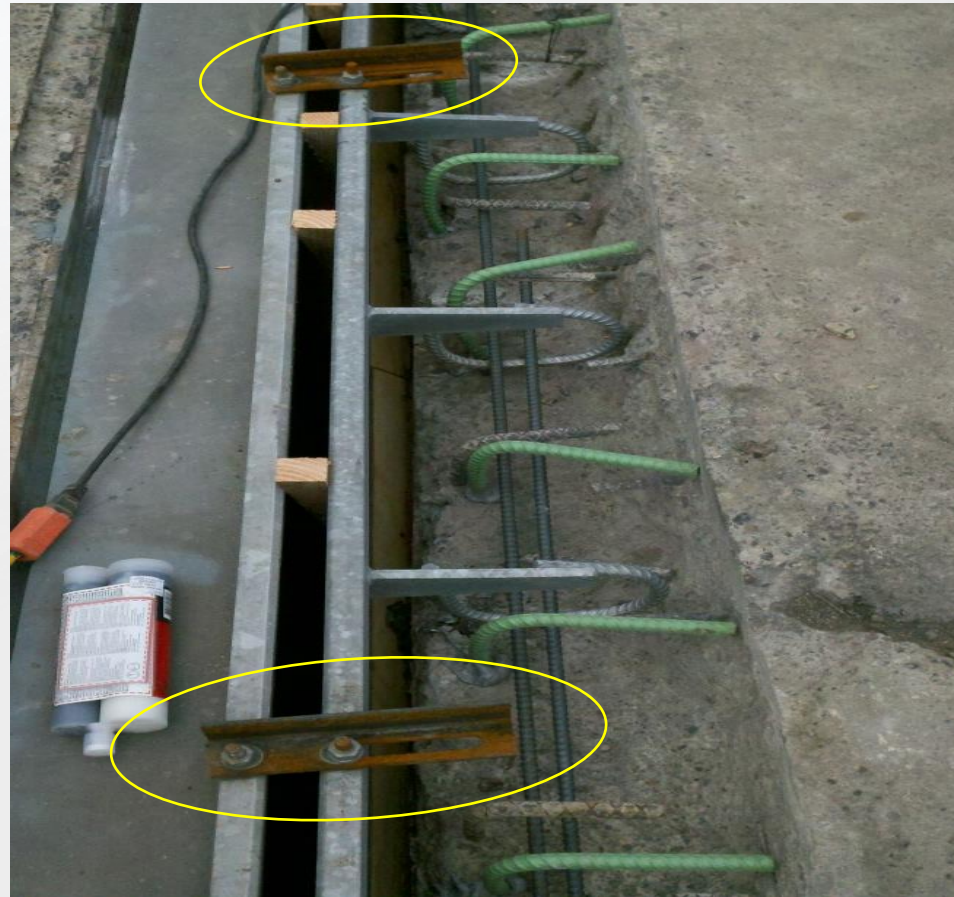
# Installation Hardware

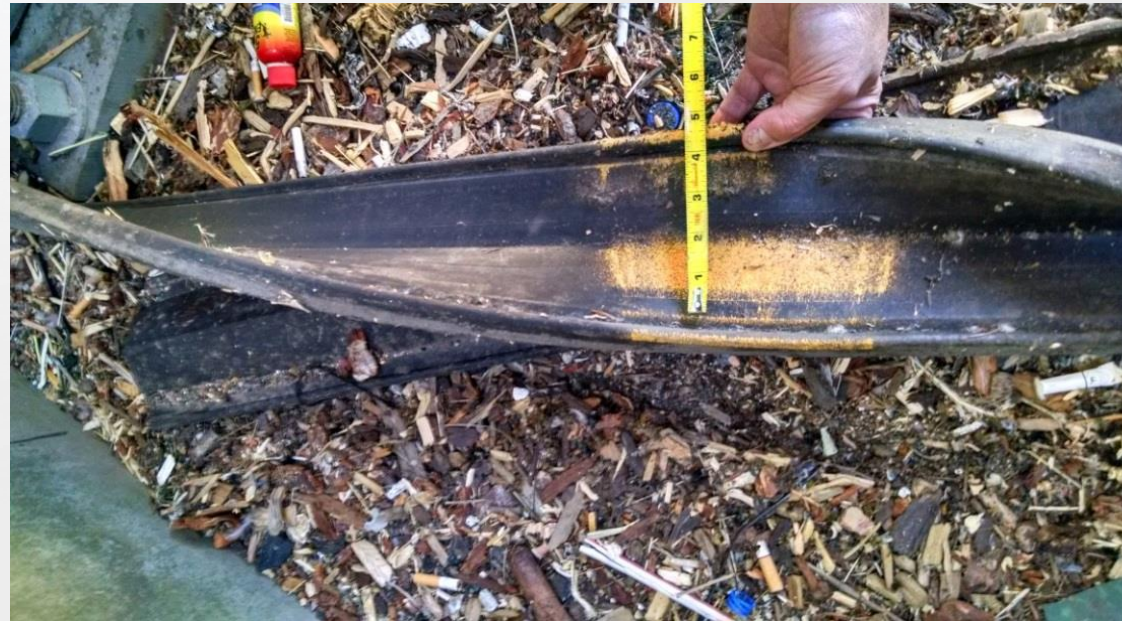
# Detached Elastomeric Seal

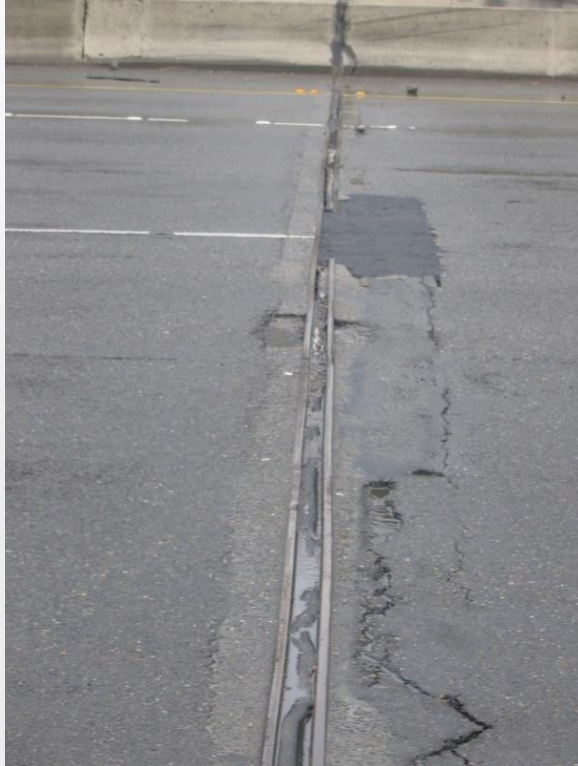
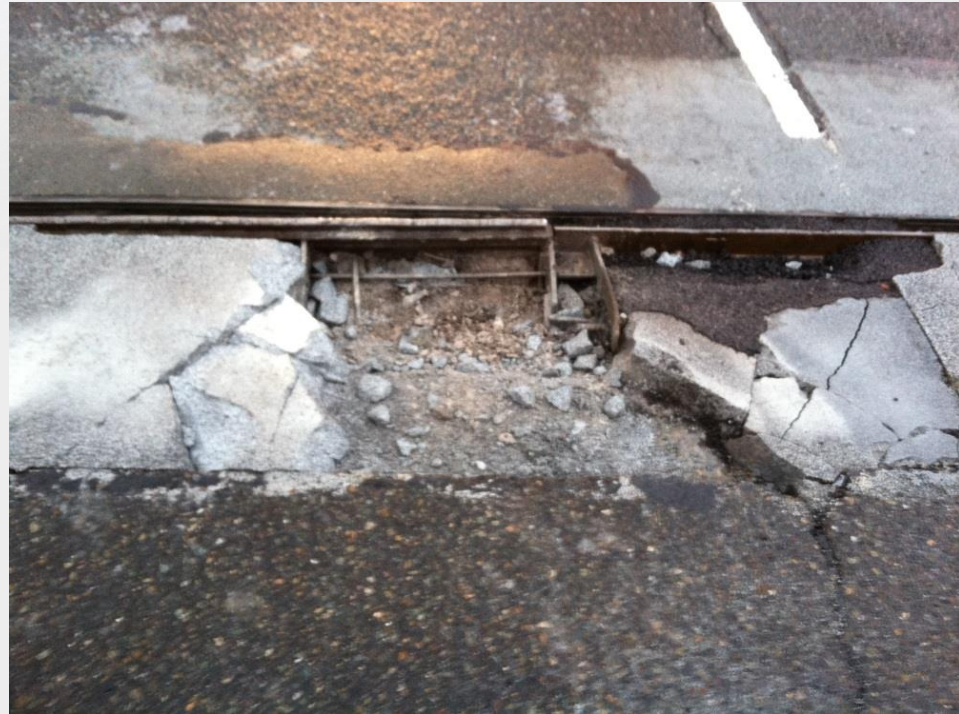
# Preformed Silicone Seal Joint Failure

## (I-5 Capitol Lake O/C Bridge)

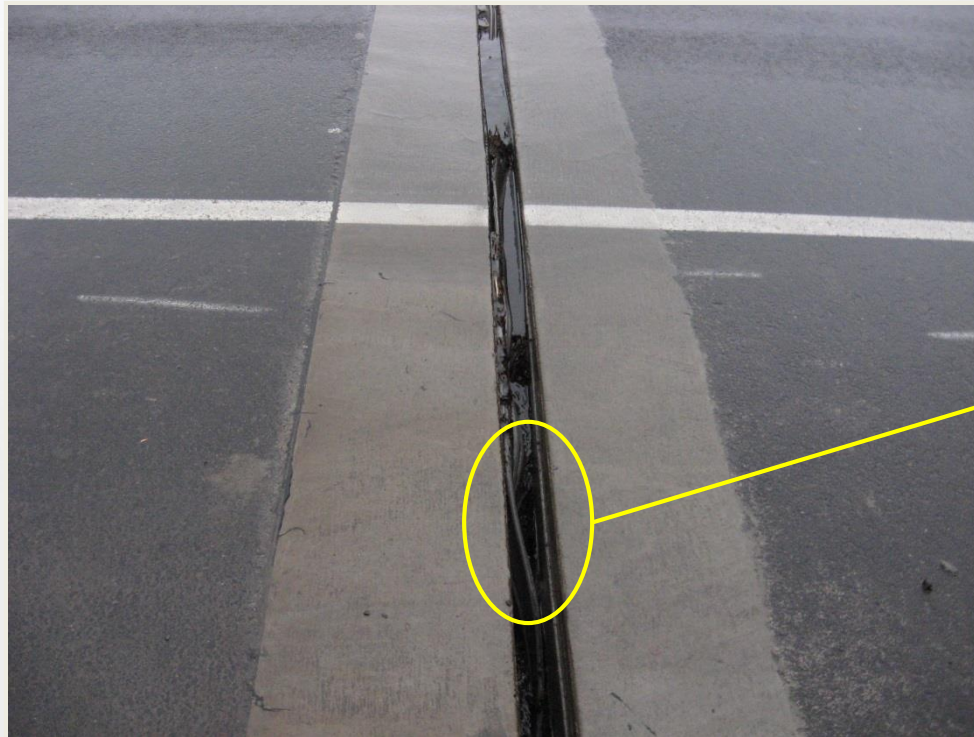
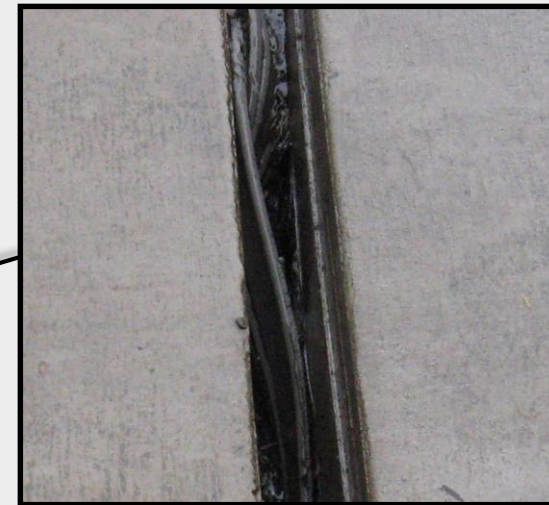
# Preformed Silicone Seal Replacement and Failure

**Seal debonding**

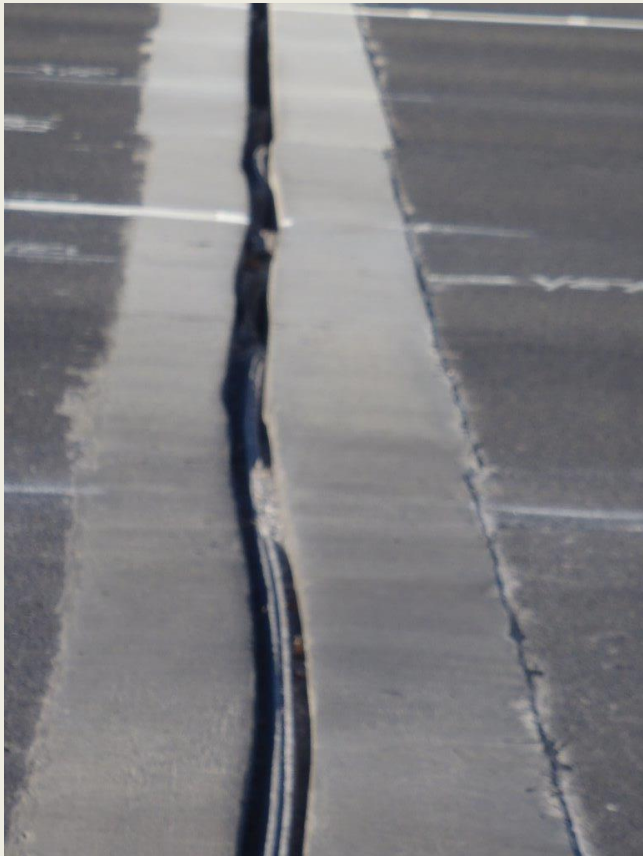
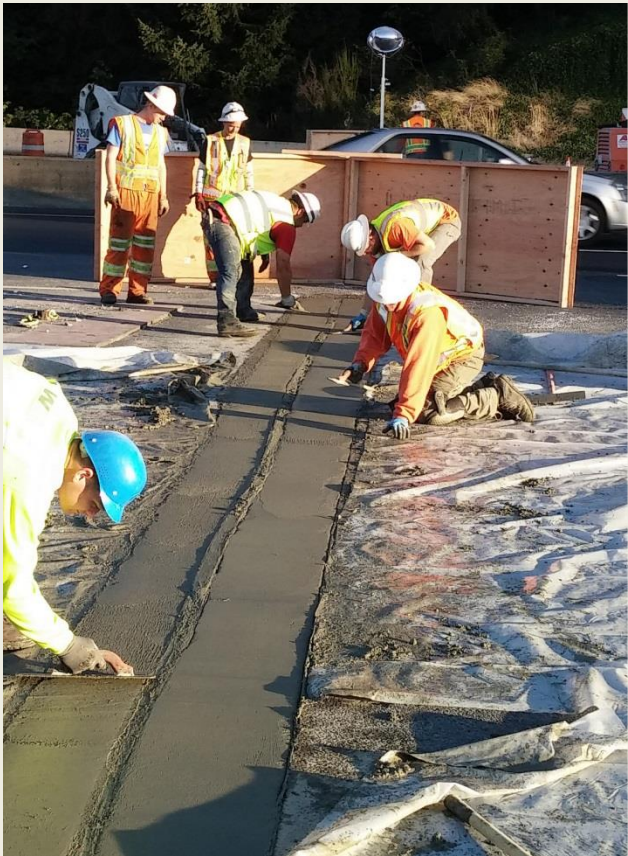
# Unarmored Silicone Strip Seal Installation Deficiencies

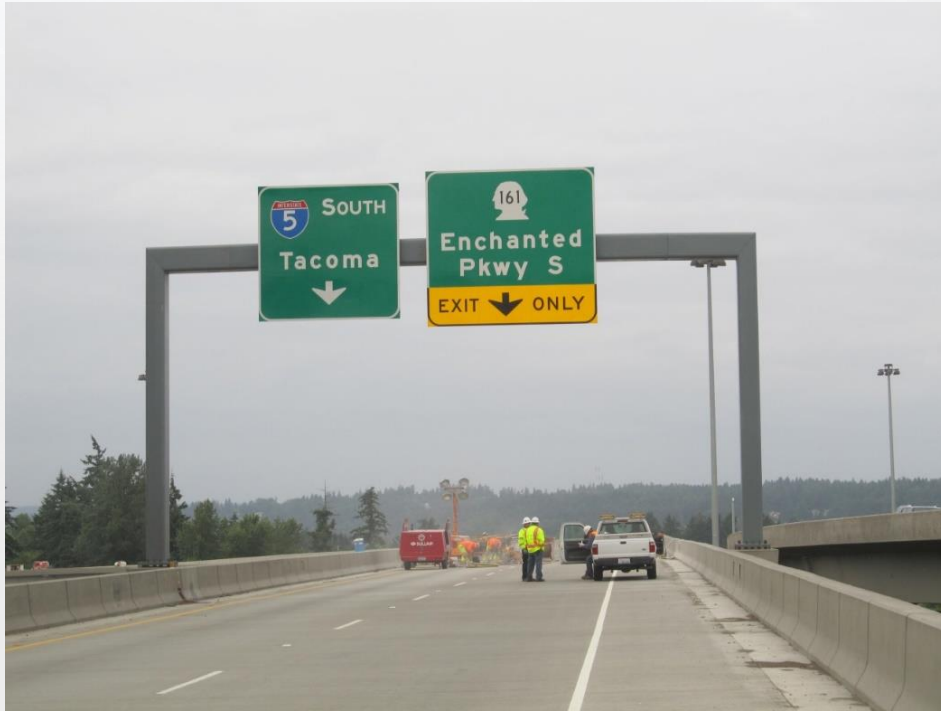
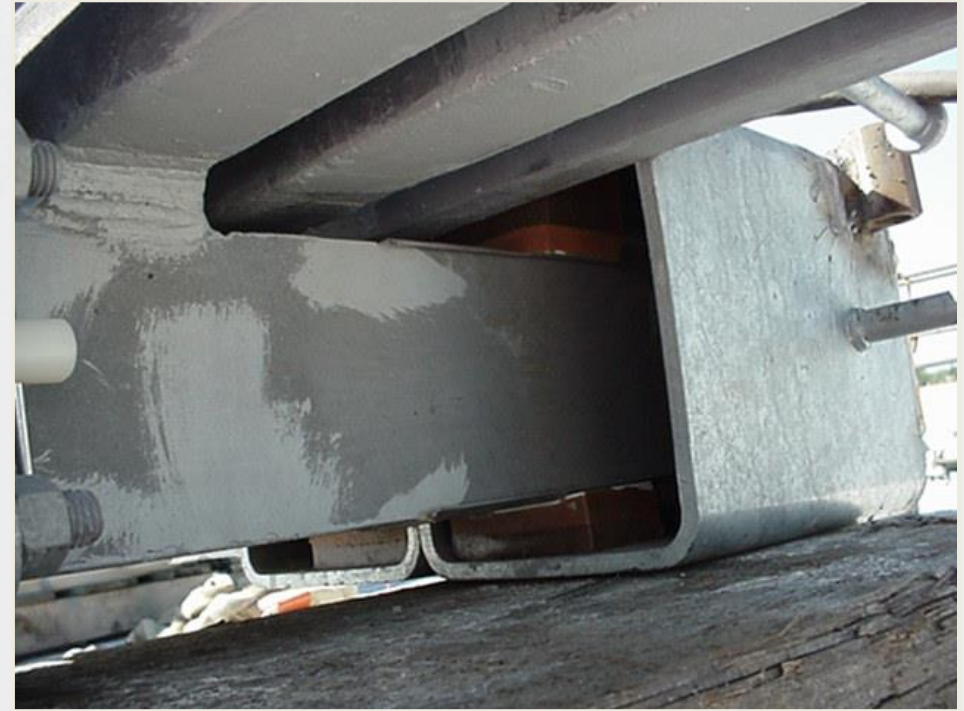
# I-Modular Expansion Joint Failure (I-5 / SR 18 Triangle Project Ramp Bridge)

Pre-installation photo underneath modular expansion joint

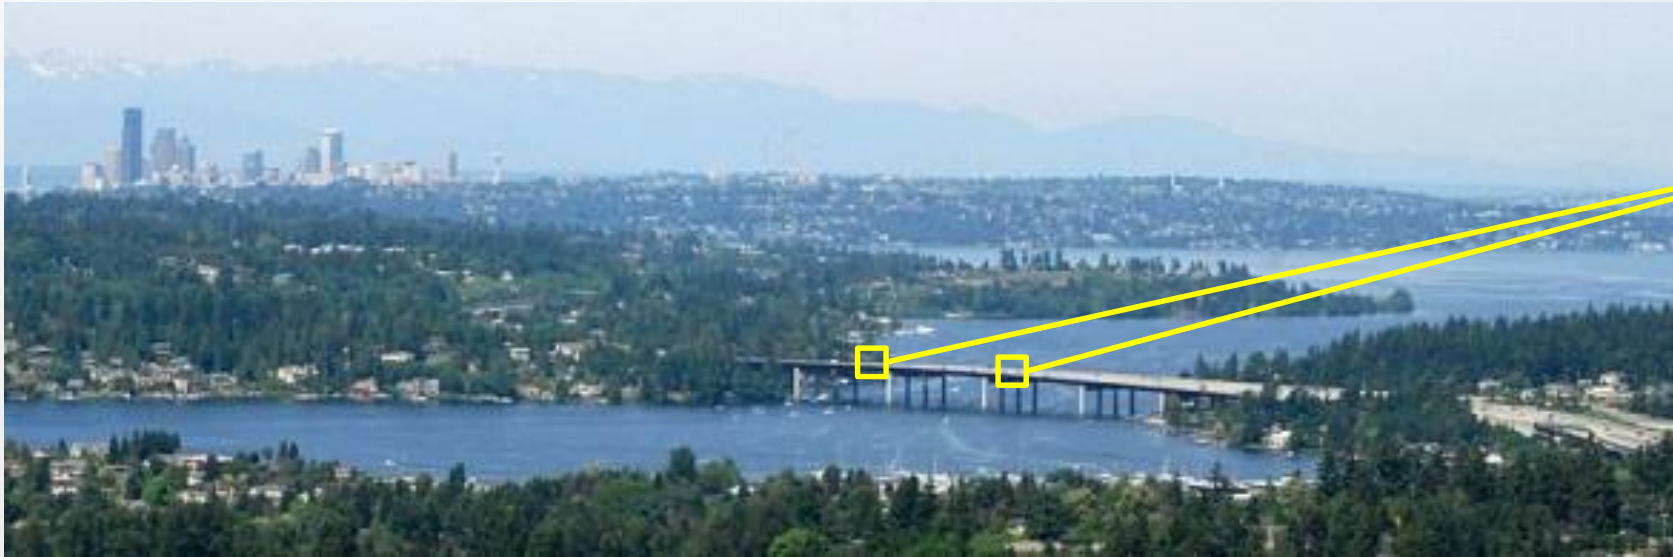
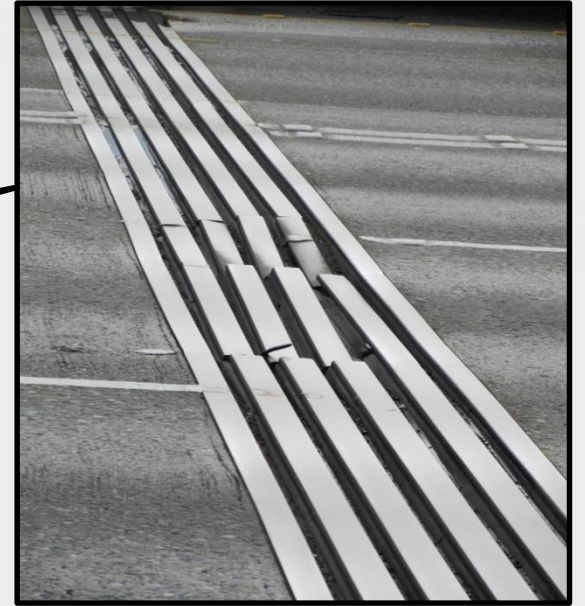
# Modular Expansion Joint Handling Issues

## (I-90 WB East Channel Bridge)

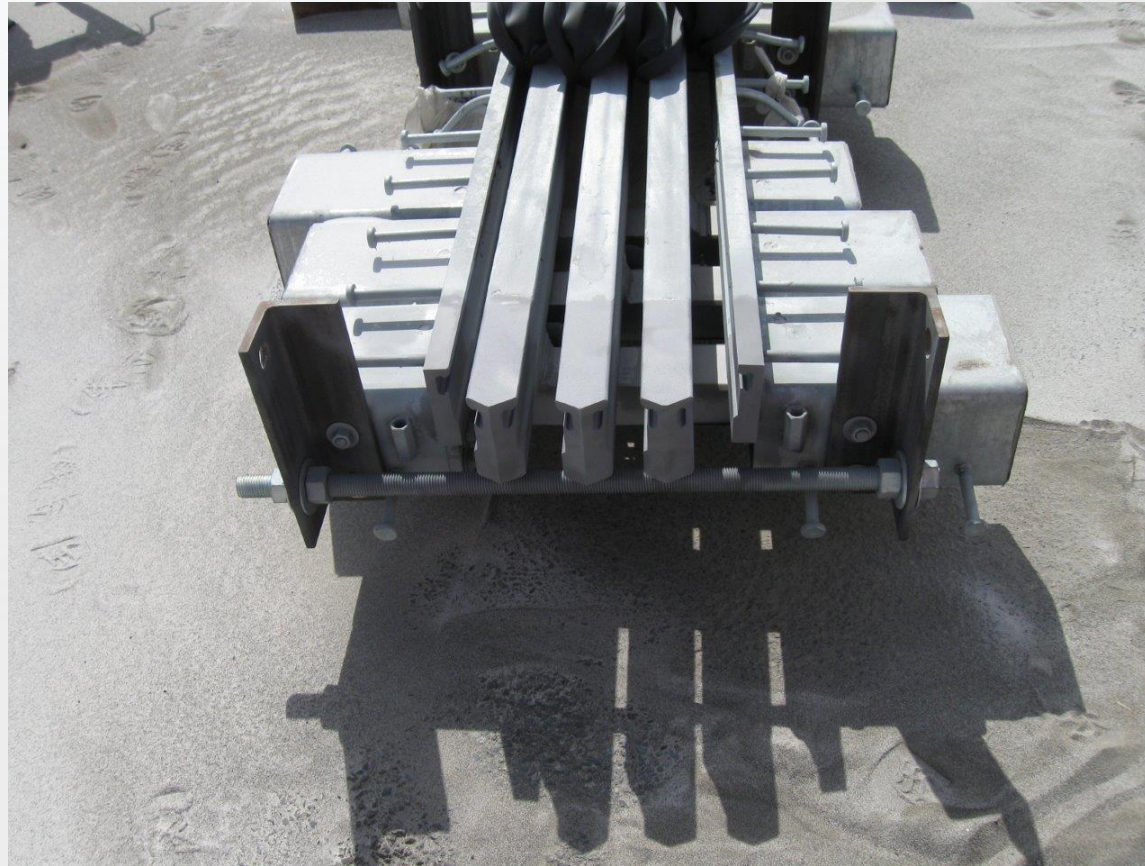
# Modular Expansion Joint - Field Splice Location

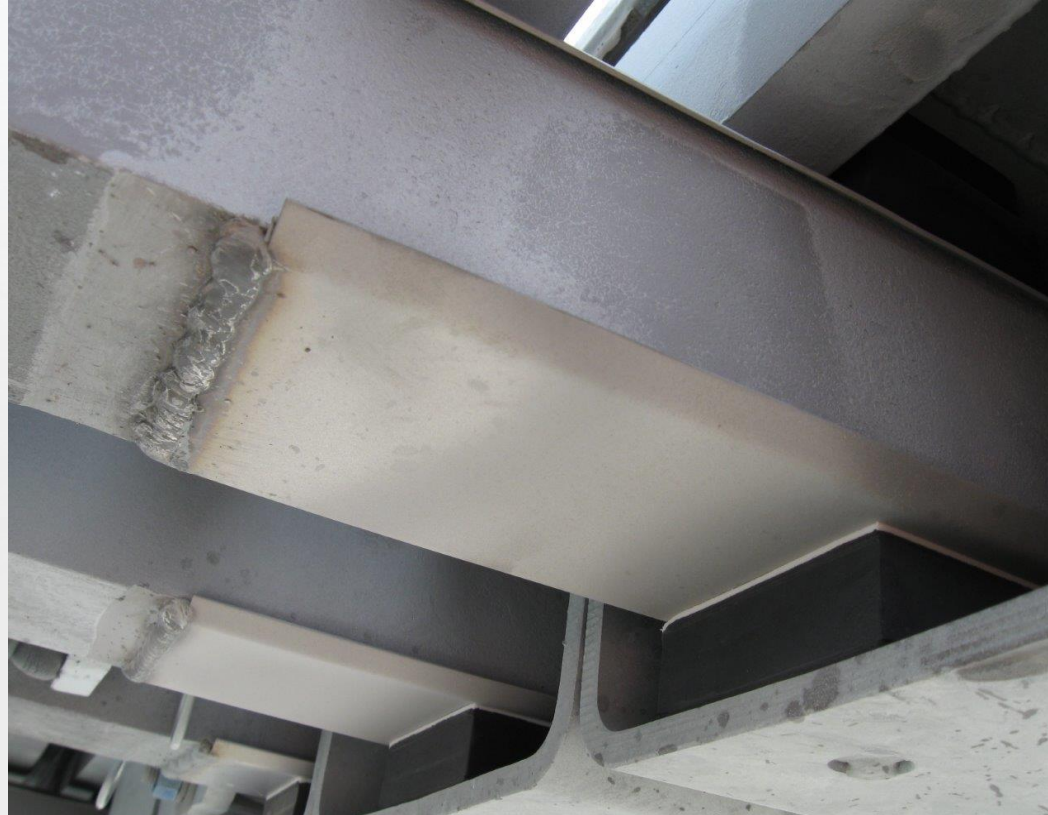
# Damaged Stainless Steel Slide Plate

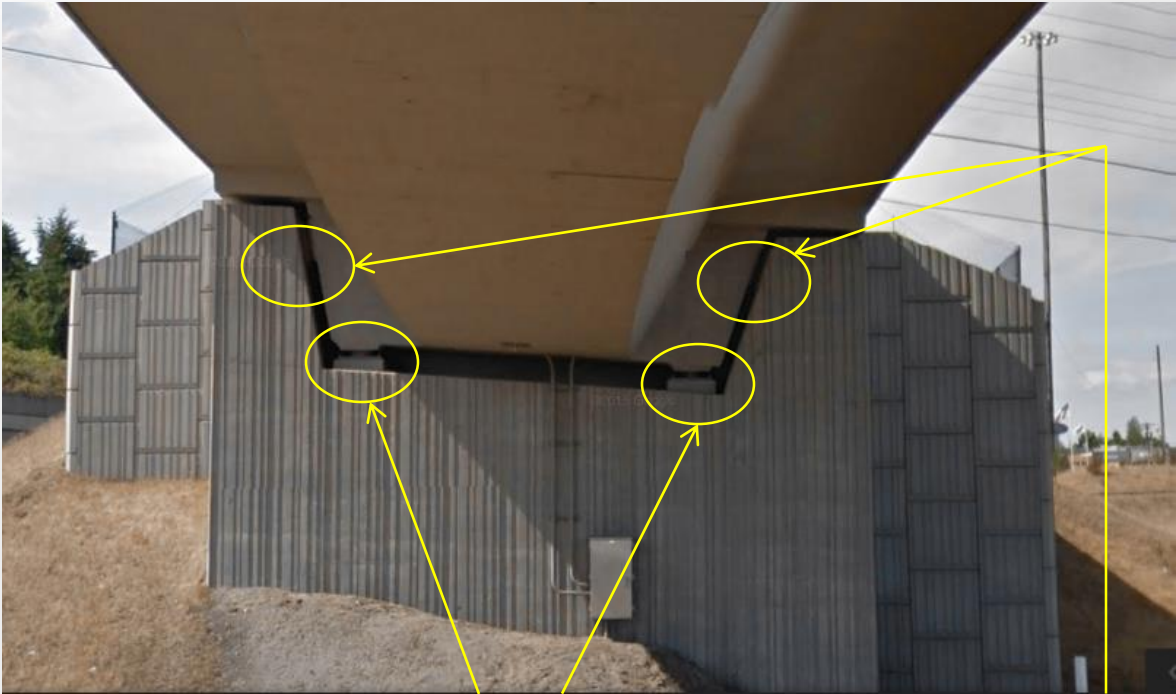
# Misoriented Disk Bearings (Nalley Valley SW-Line Bridge)

Sliding Disk Bearing

Transverse Stop Bearing

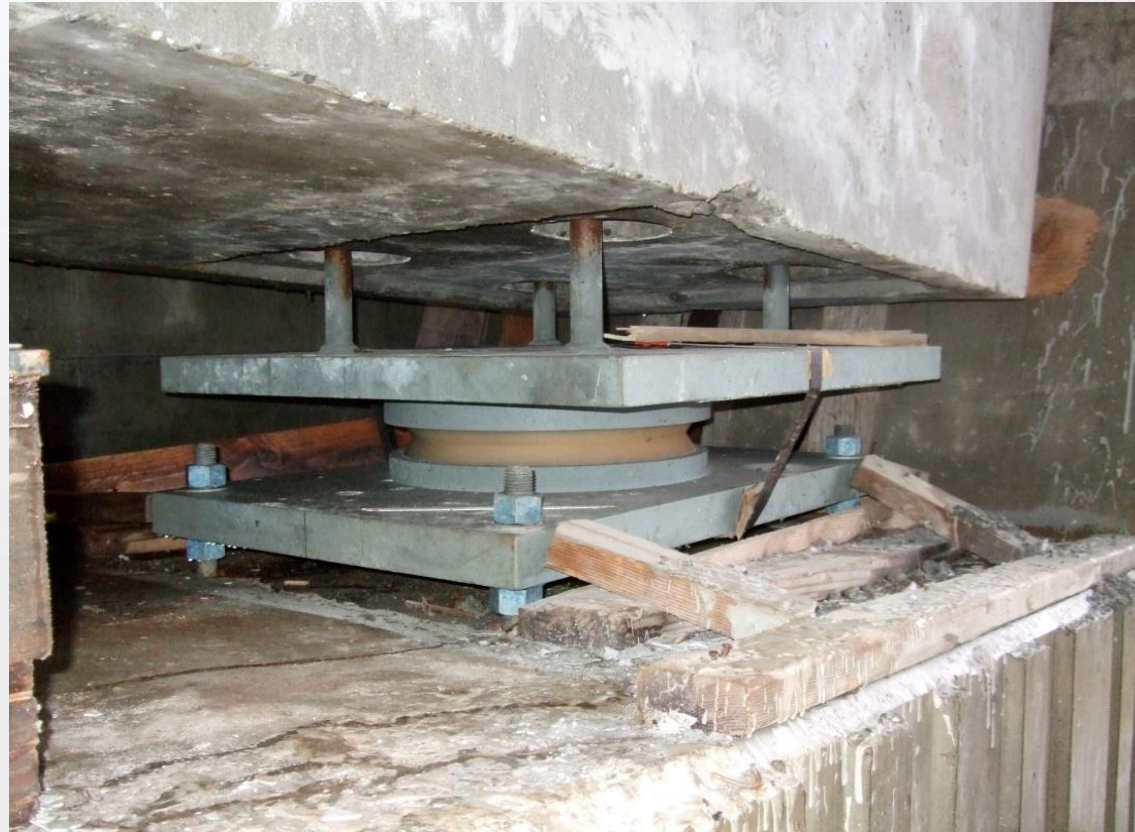
# Disk Bearing Installation

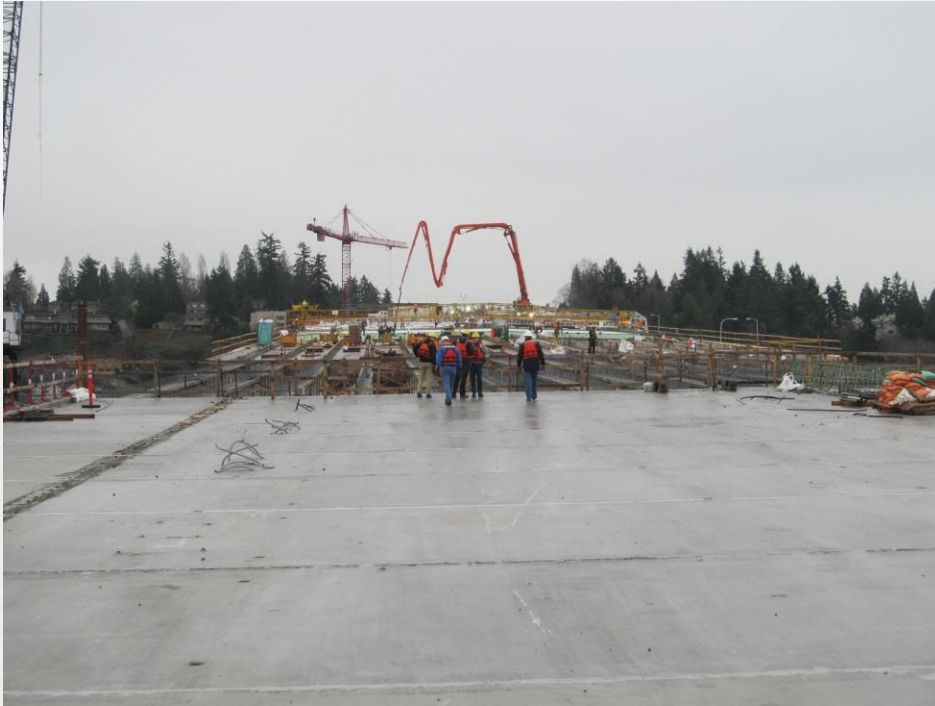
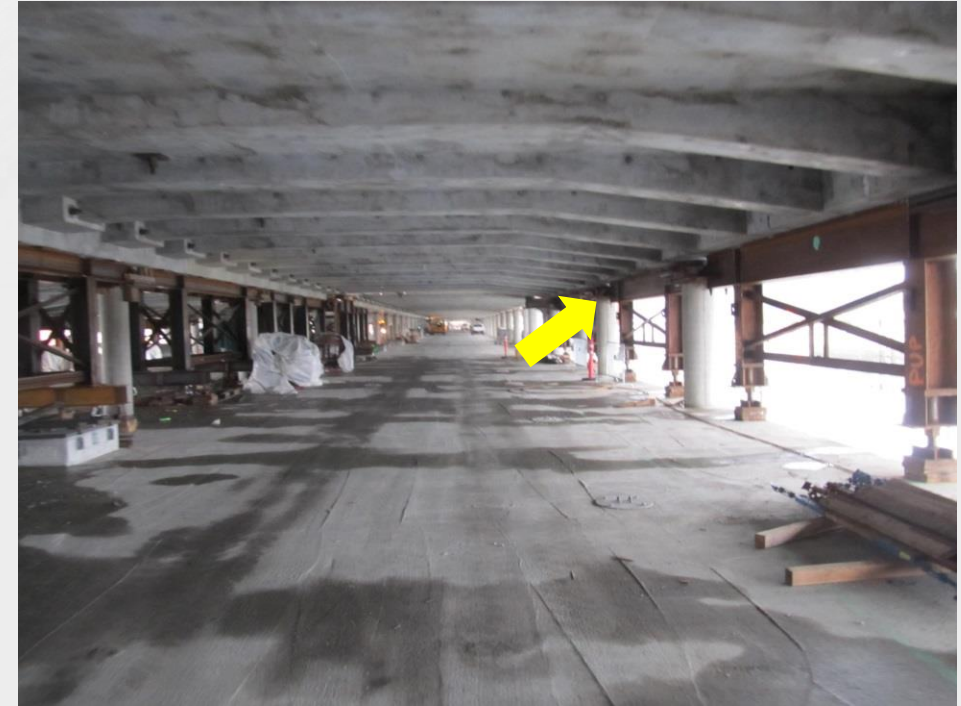
# Mishandled Elastomeric Bearings

## (SR 520 Replacement Floating Bridge)

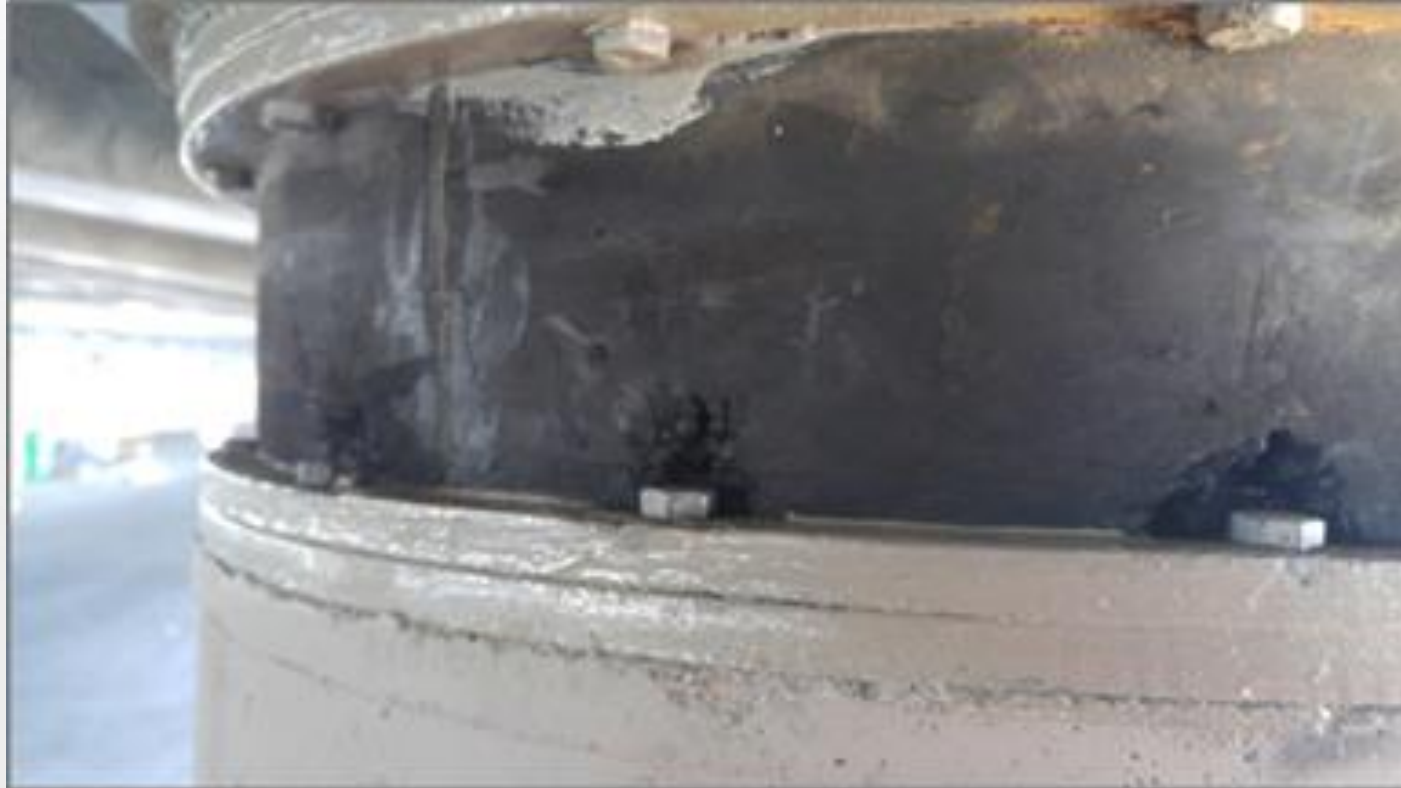
# Elastomeric Bearings Installation Damage

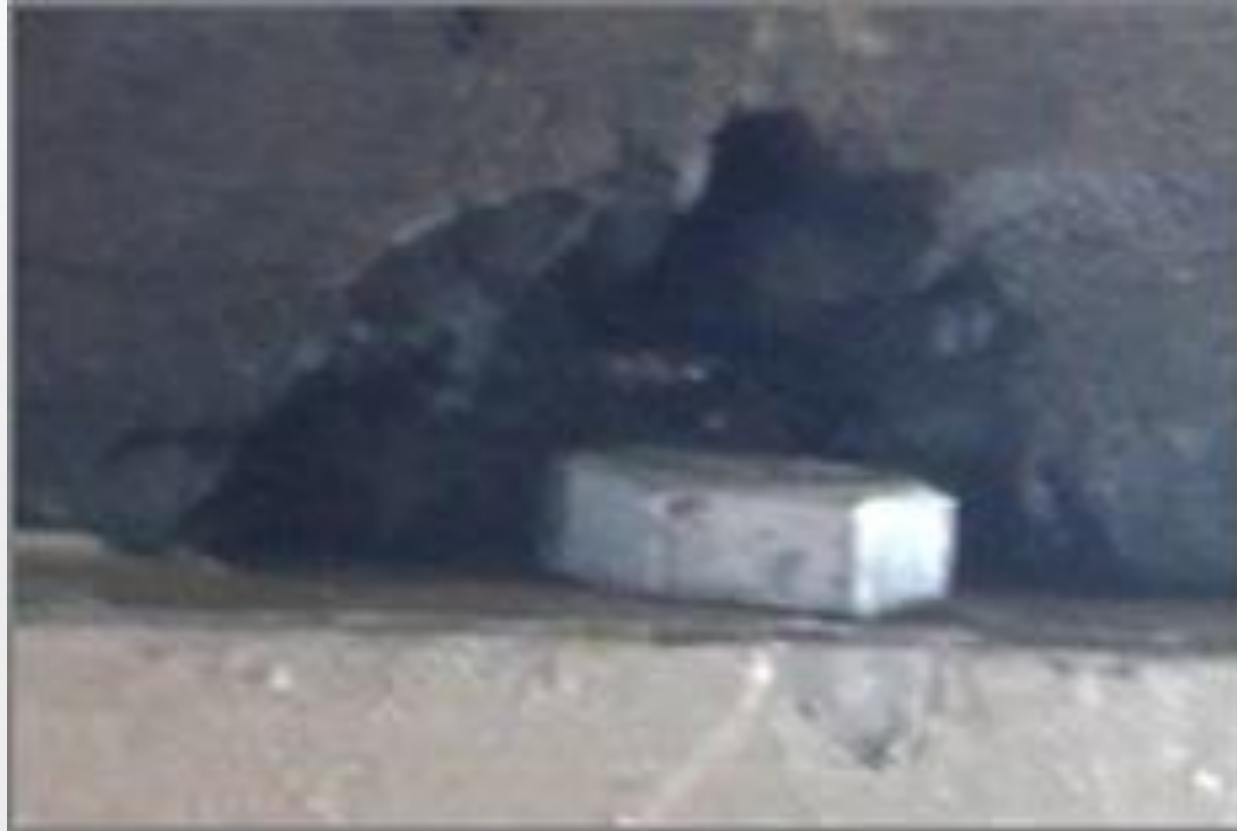
# Gouged Elastomer with Exposed Steel Shims

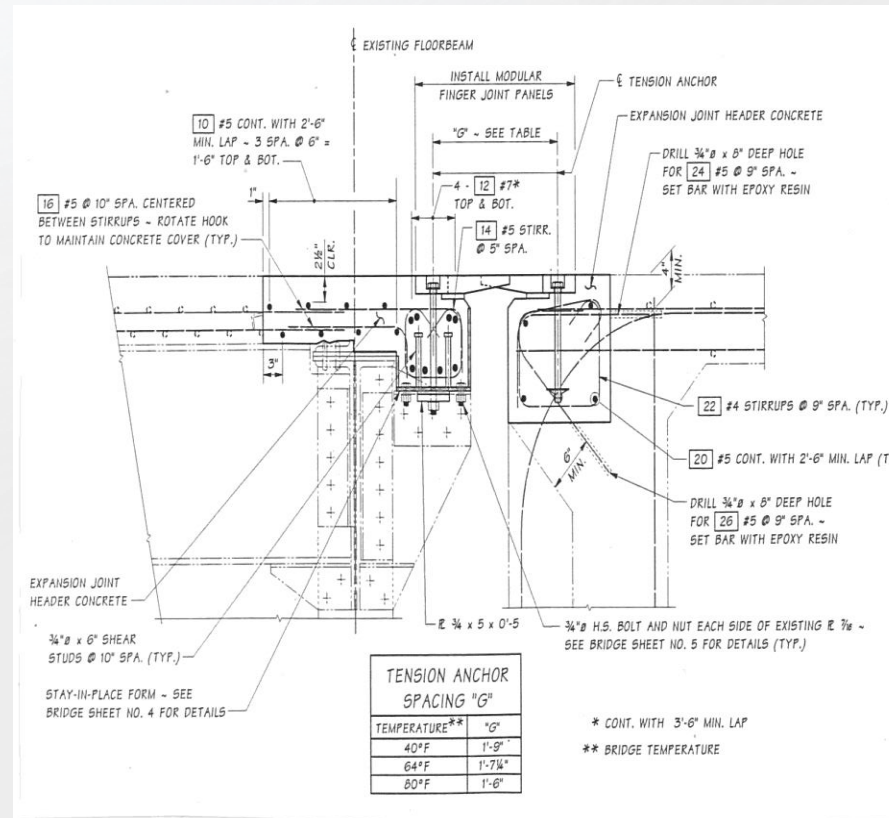
# Modular Finger Joint System (I-5 North Fork Lewis River Bridge)

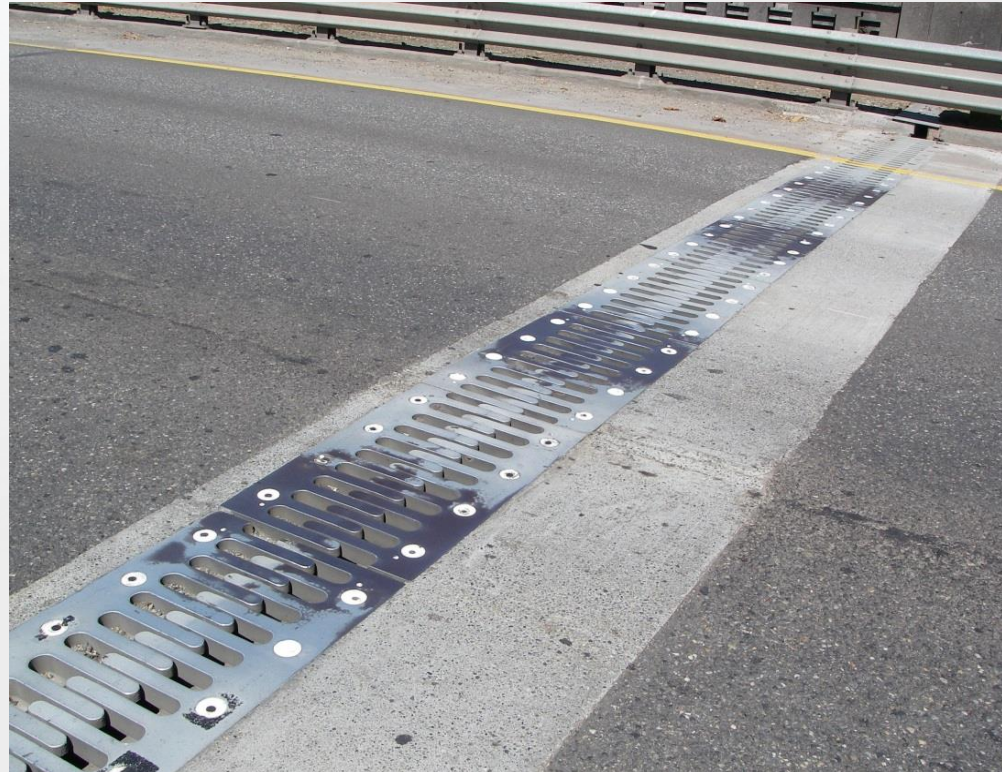
# Installed Finger Joint System
