Continuous Galvanized Rebar

Proven protection – Innovative Process

NBPP - Orlando, FL

Mike Stroia – National Marketing Specialist

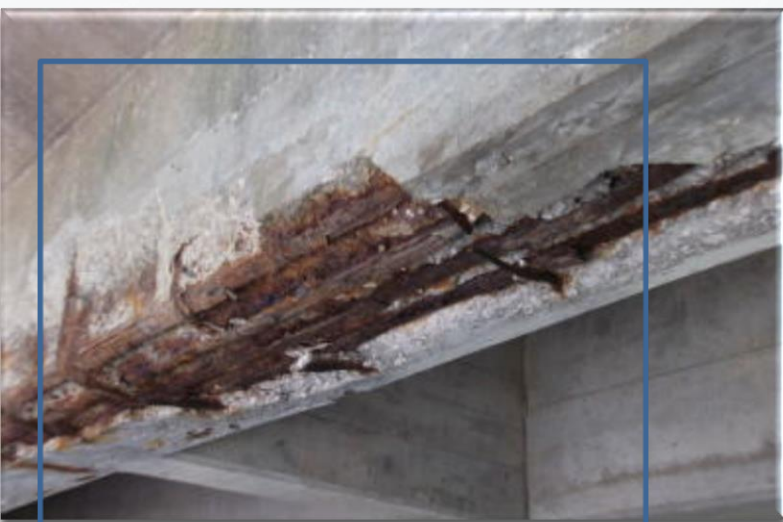
Severe Spalling

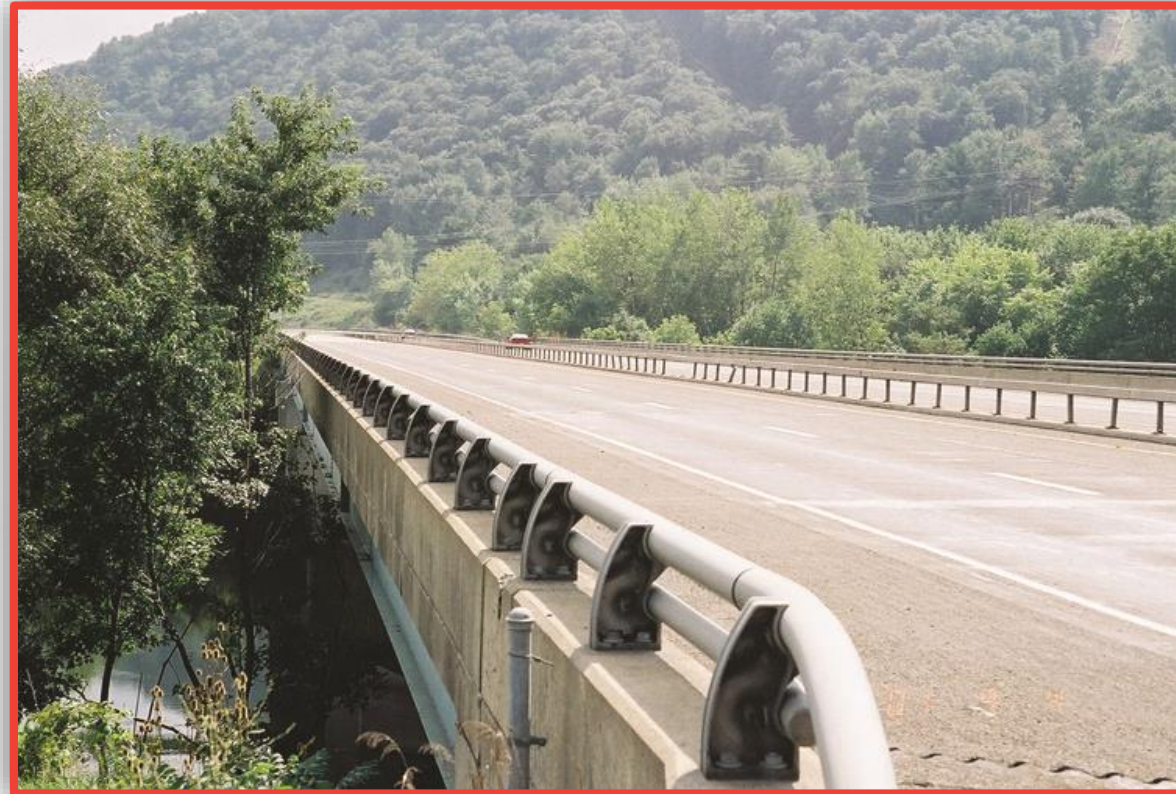
Athens Bridge

ATHENS, PA

- 1973

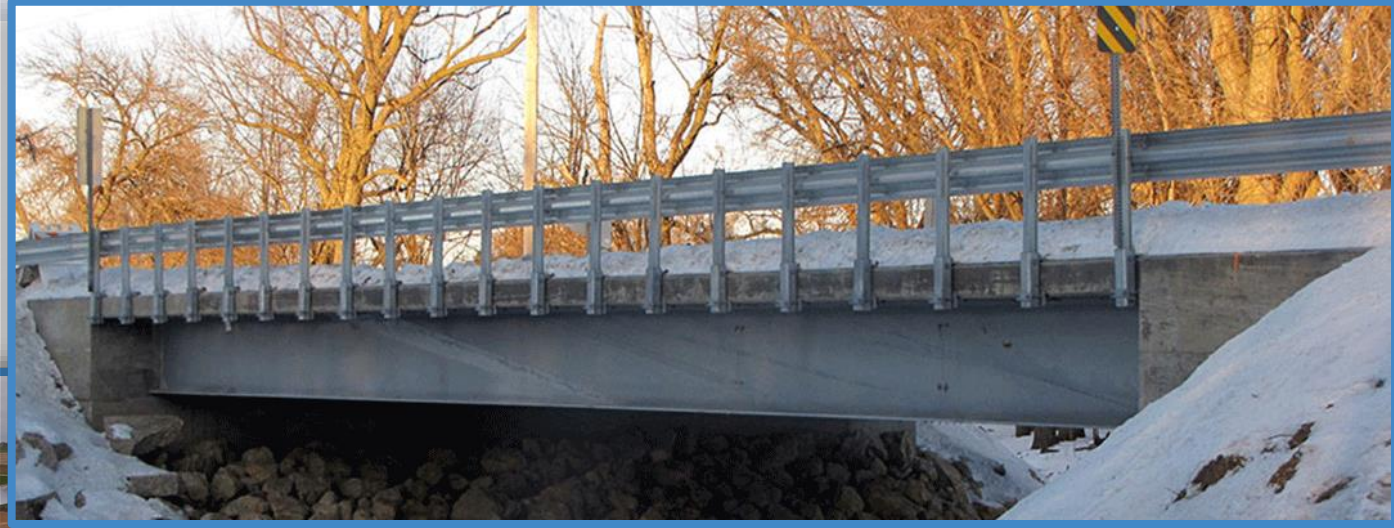
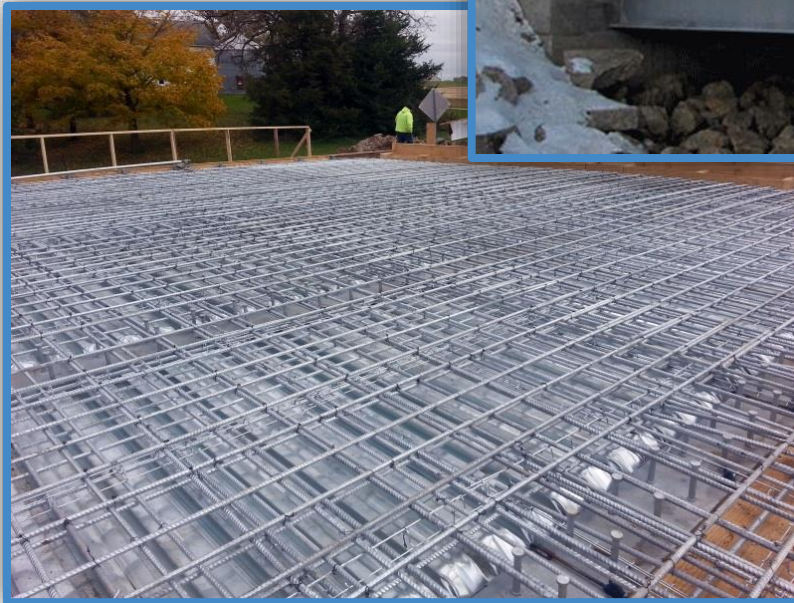
Jesup Bridge

Jesup County, Iowa • 2013

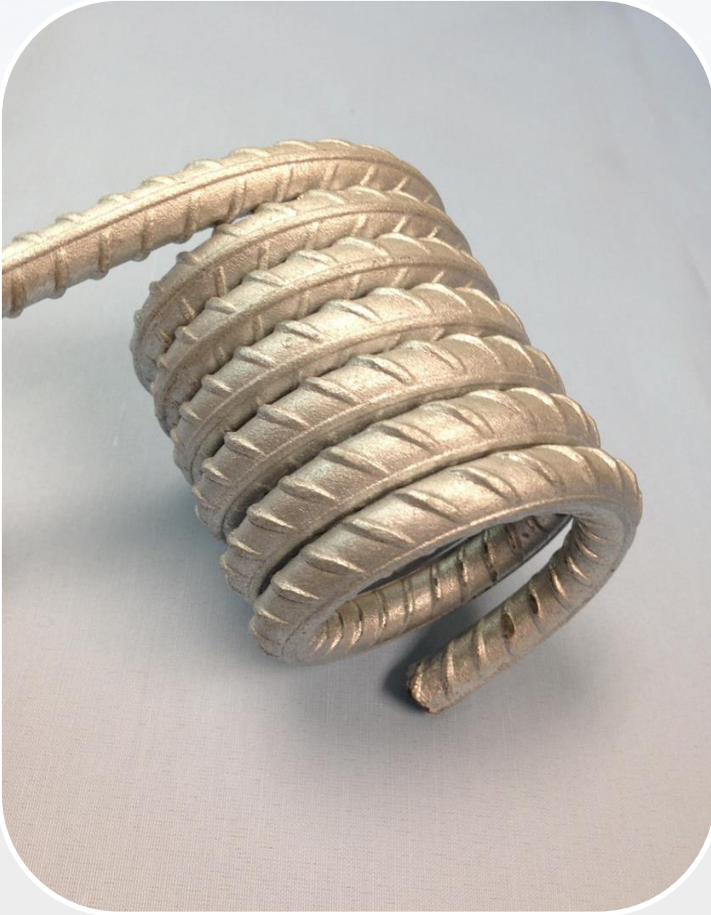
What is Continuous Galvanized Rebar

Durable, Flexible Zinc Coating

Fabricate after coating
(bending, forming)

Pure Zinc Layer increases
corrosion initiation threshold

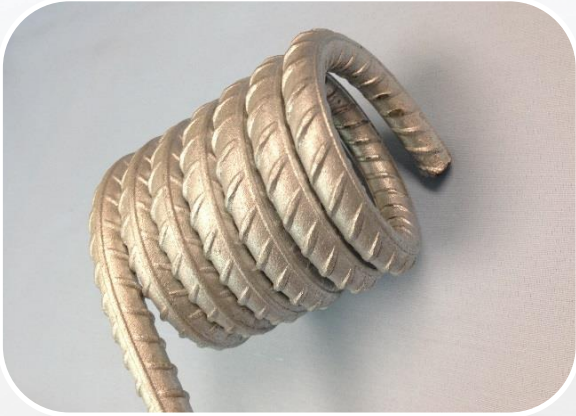
Utilization of current supply chains. Steel Mills, Independent Fabricators, Distributors

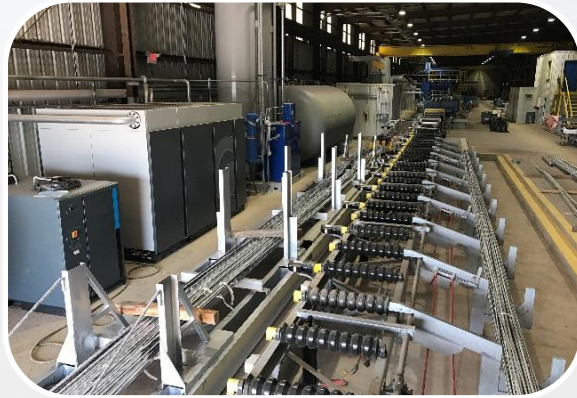
Rebar can be staged in stock lengths prior to being released by fabrication creating a consistent flow of product and allowing for field changes to be addressed on the fly

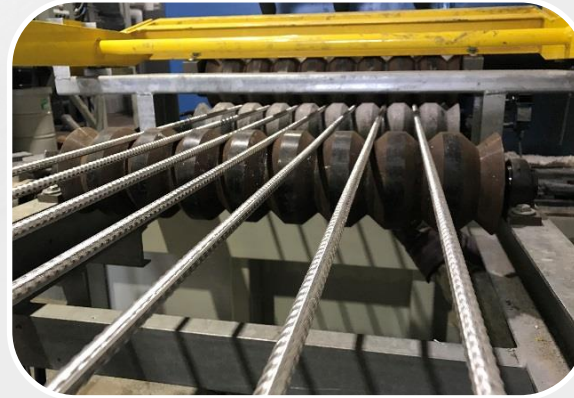
No special equipment or special handling. Utilize the most efficient machinery in lengths up to 60'+

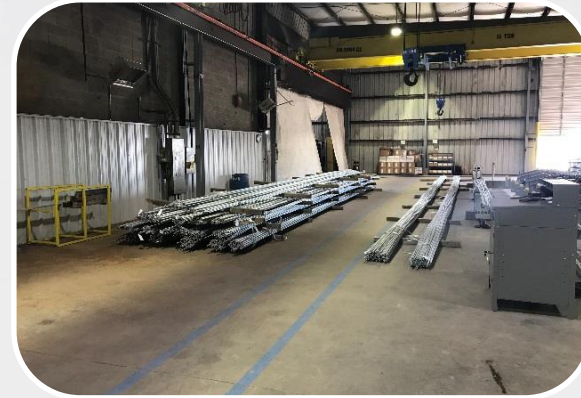
Seamless supply of CGR to projects through current supply chain without double handling resulting in better product flow and customer satisfaction.

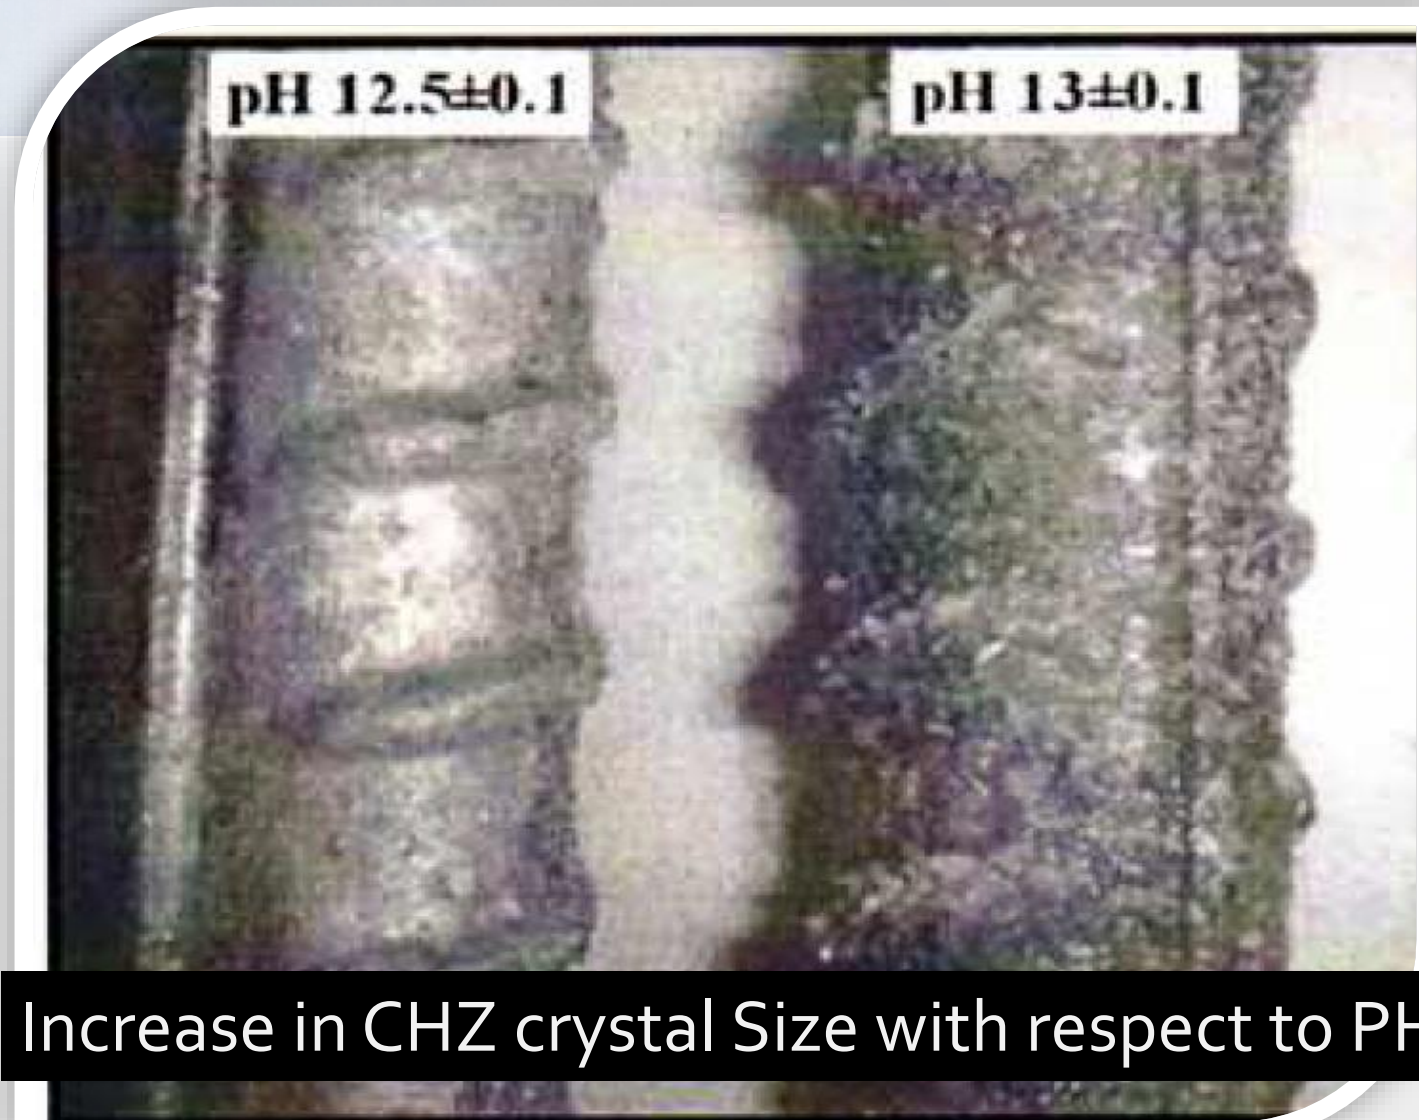
Increase in CHZ crystal Size with respect to PH

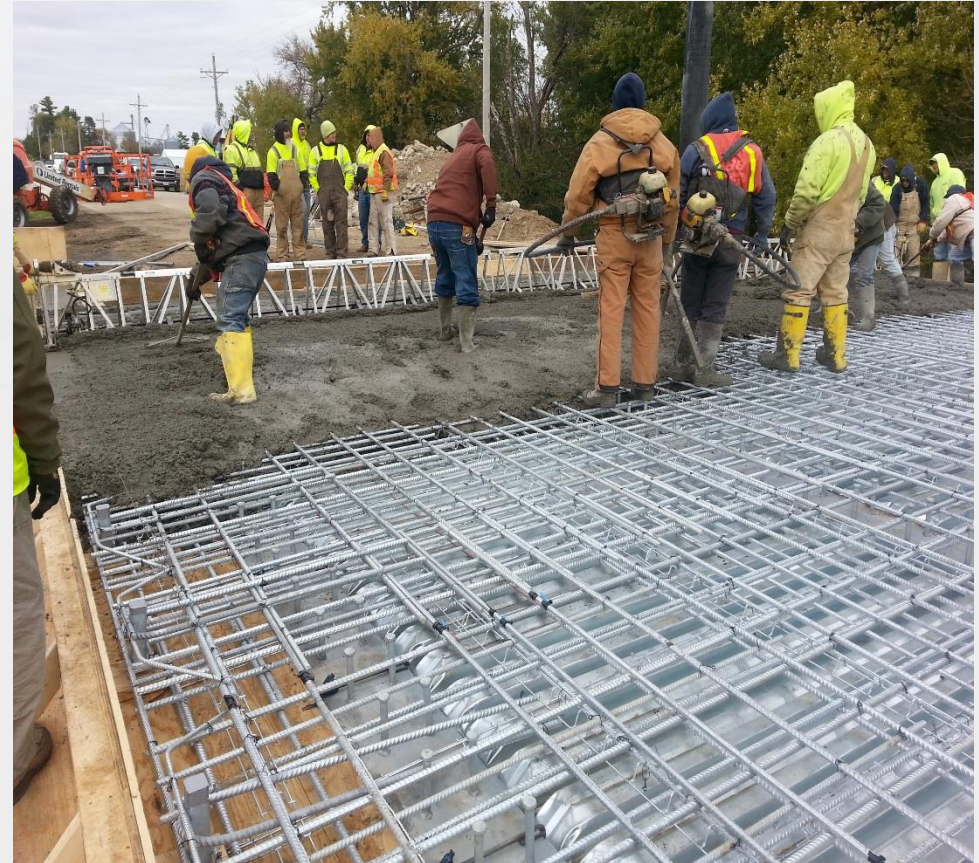
- Same as Black rebar:
- Same overlap links
- Same handling procedures
- No weather restrictions
- No sensitivity to UV light
- No touchup (except field-cut ends)
- Use galvanized or plastic connectors (where permissible)

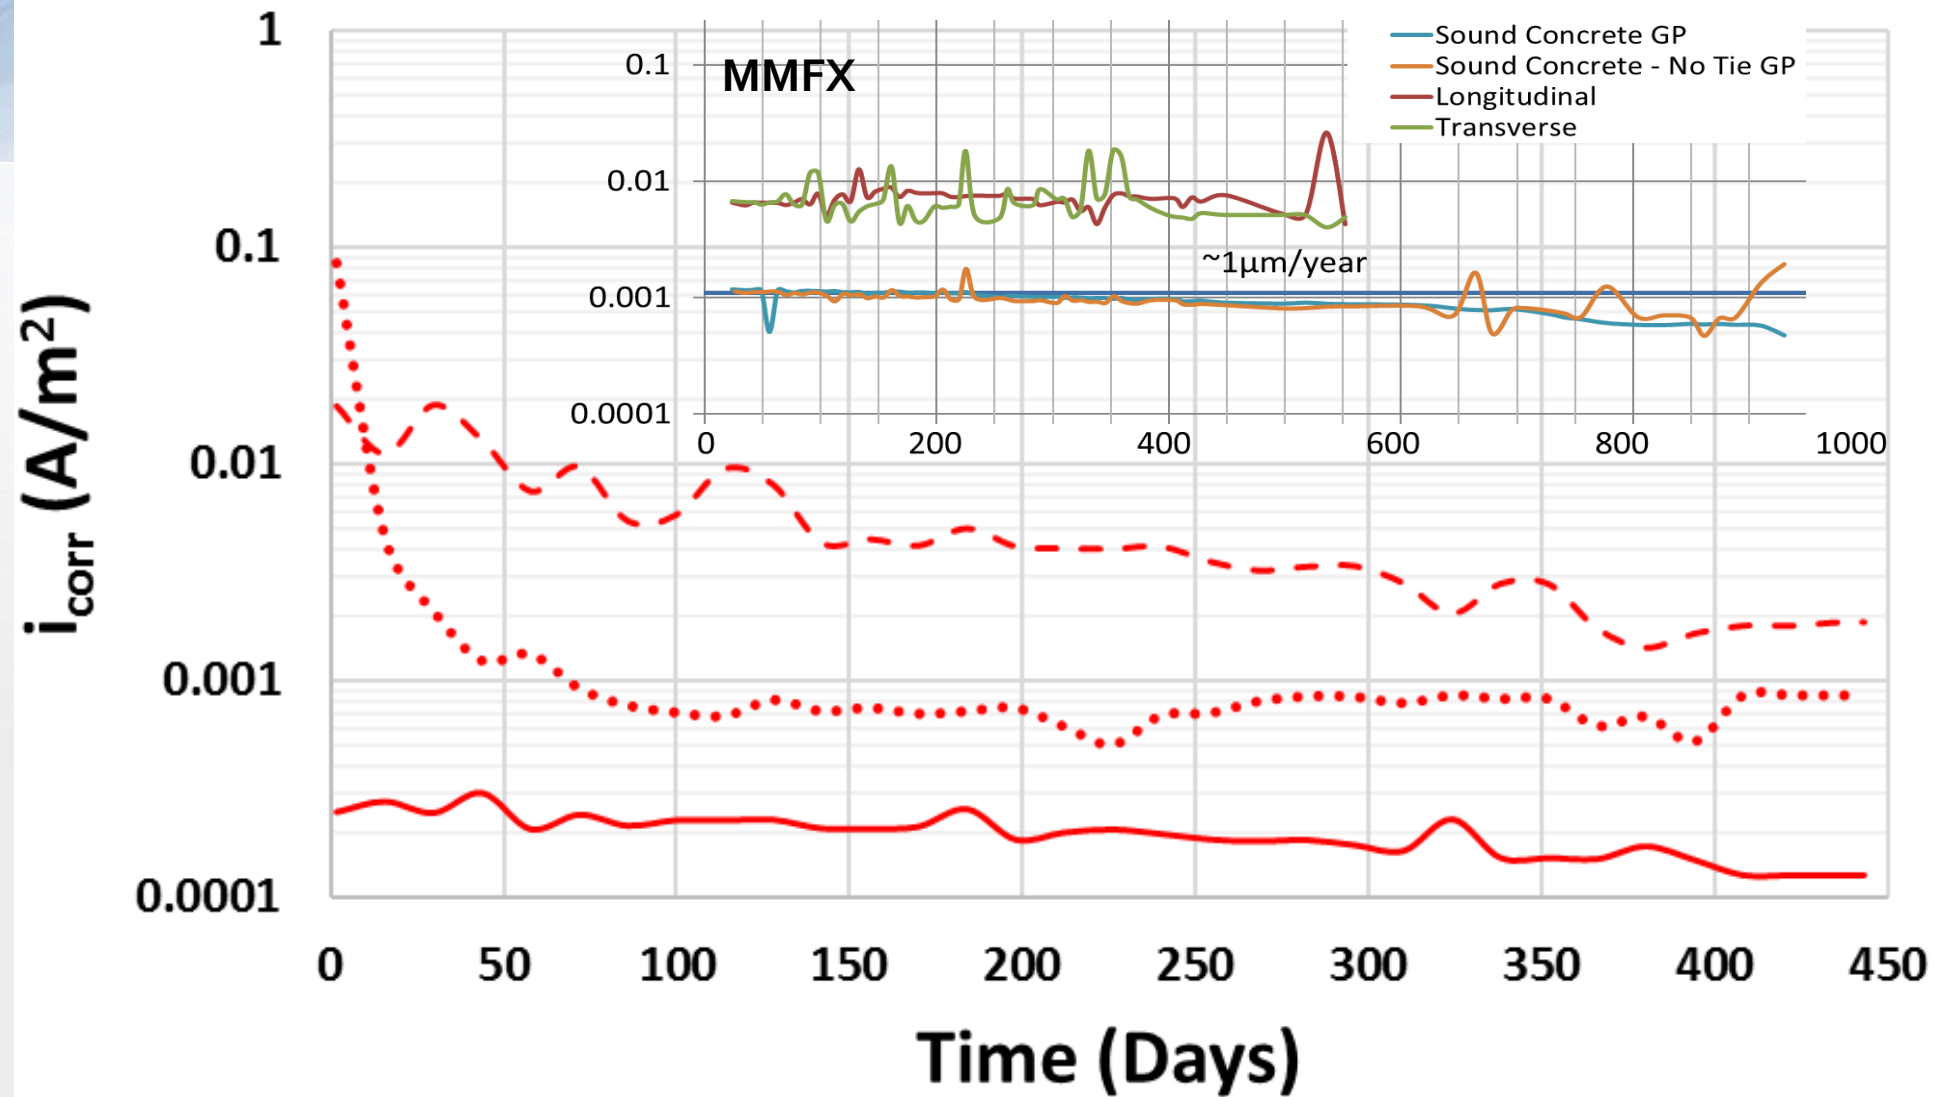
HDG i_{corr}

- Tombstone samples
 - Hot-dip, Continuous coated rebar
 - C1&C2, 30-40um thick continuous coatings
 - C3 experimental Zn-Al coating
 - Sound, longitudinal and transverse cracks
- Cyclic Ponding
 - 21% Brine solution
- Comparable Performance
 - Equivalent corrosion rate in sound concrete

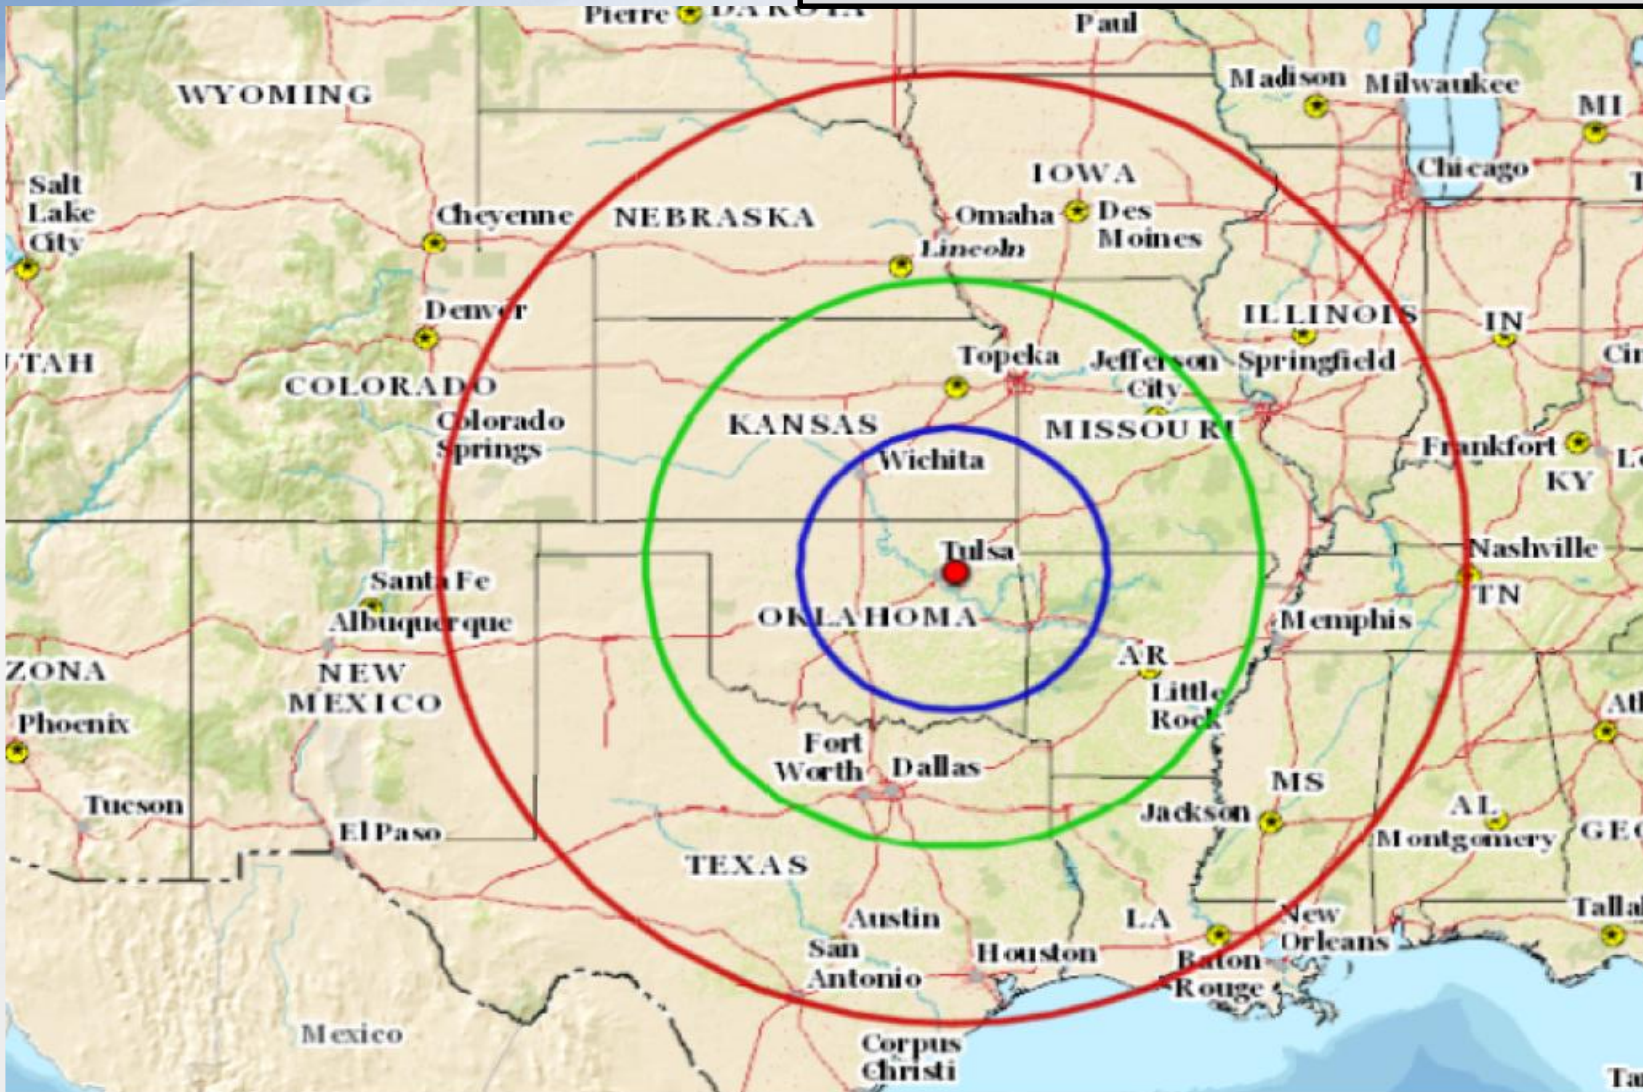
CGR Location #1

Plant: Port of Catoosa, OK
