# BUREAU of BRIDGES

## Post Tensioning Timber Bridges

# US-2 Roadside Park in Naubinway

**B05 of 49022**

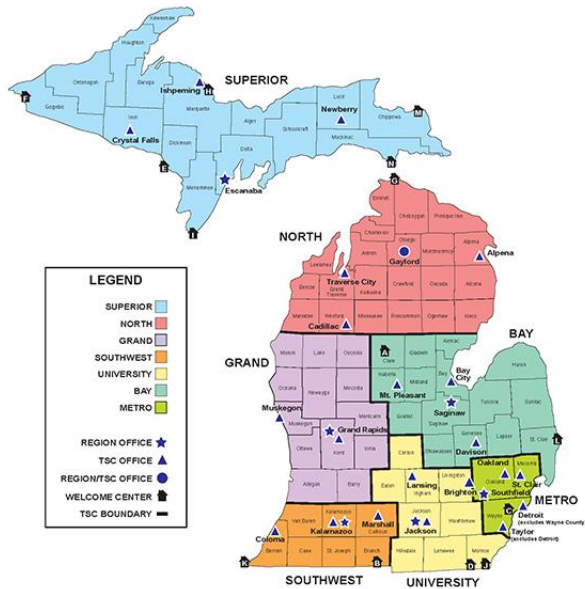
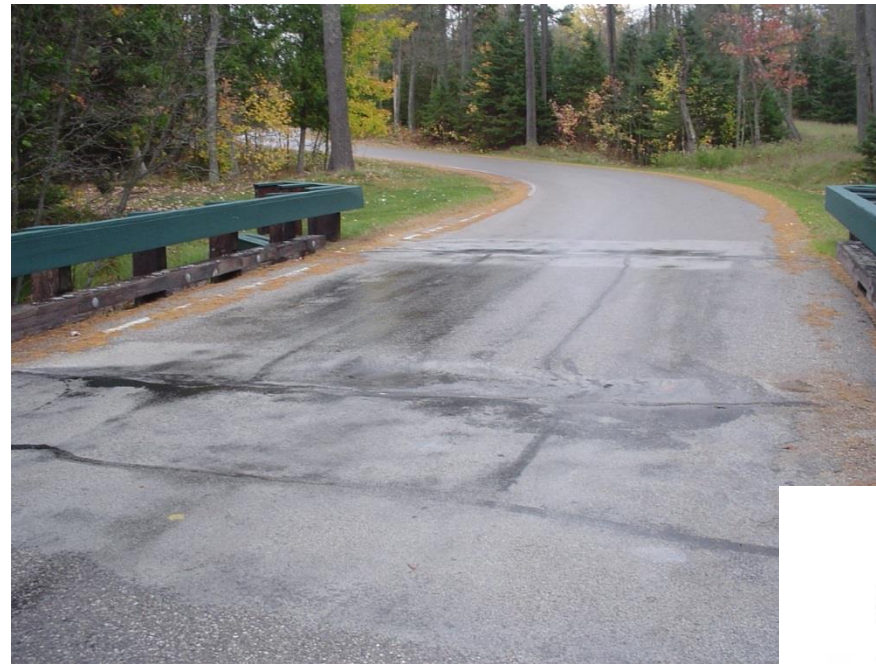
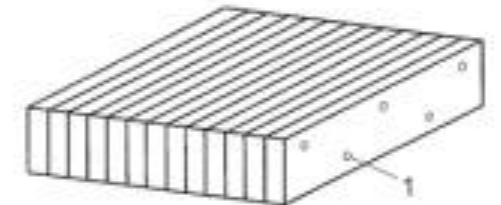
- **Constructed in 1990**
- **Timber Superstructure comprised of 2 x 12 timbers spanning 24 feet nailed together.**

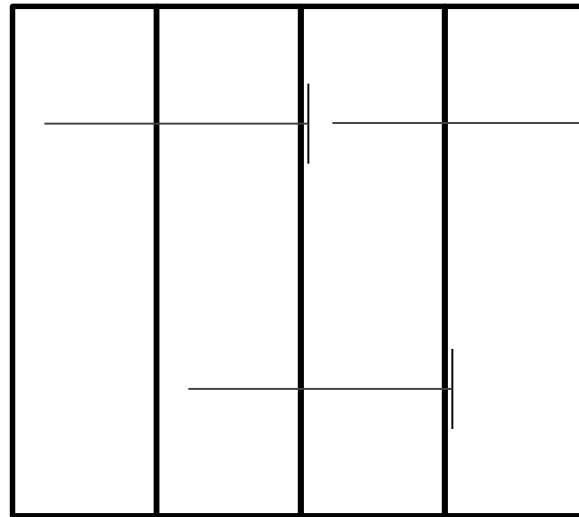
**Initial Laminates**

- Pressure between timbers due to nailing initially allows for composite action

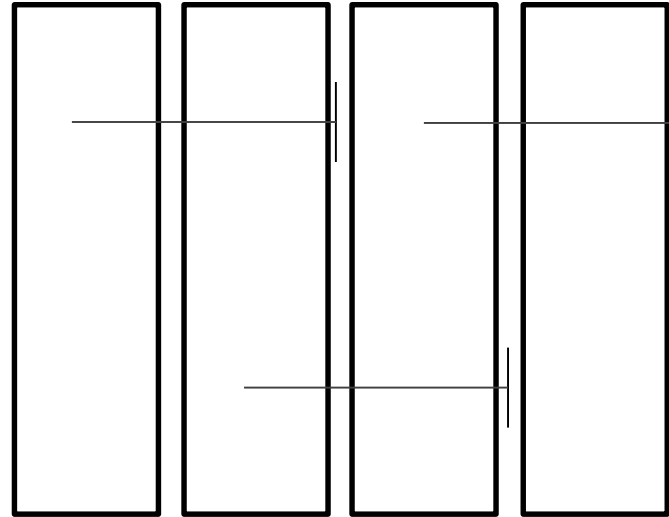
Spread Laminates

- Over time nails back out and timbers spread

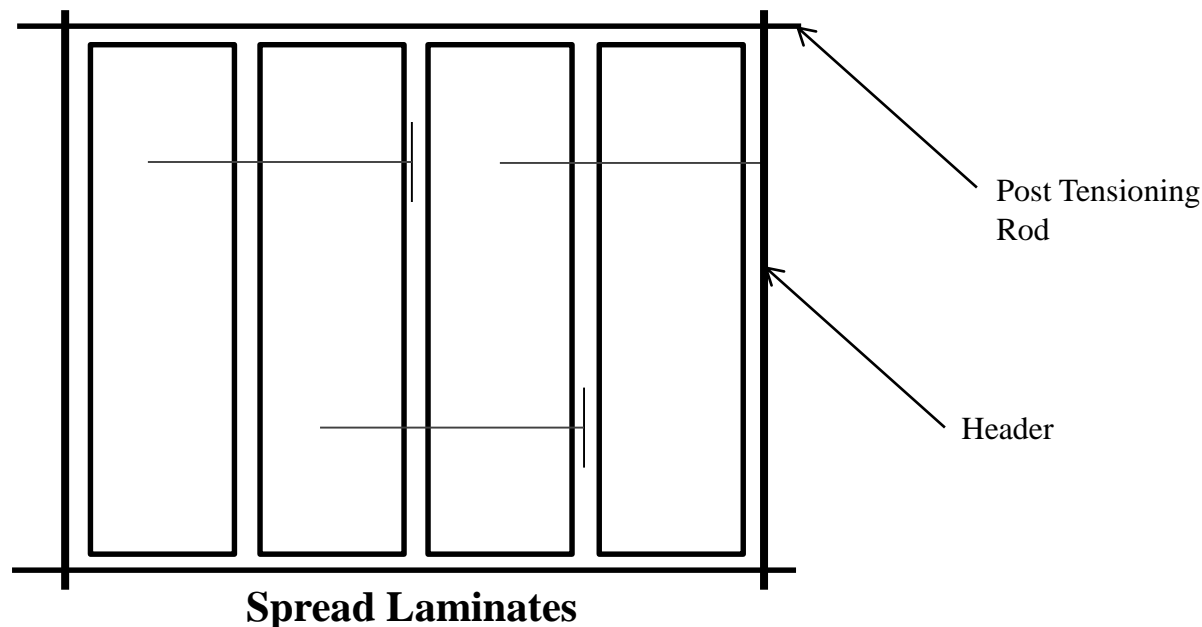
- Ontario Ministry of Transportation Post Tensioned the Hebert Creek Bridge to 150 psi

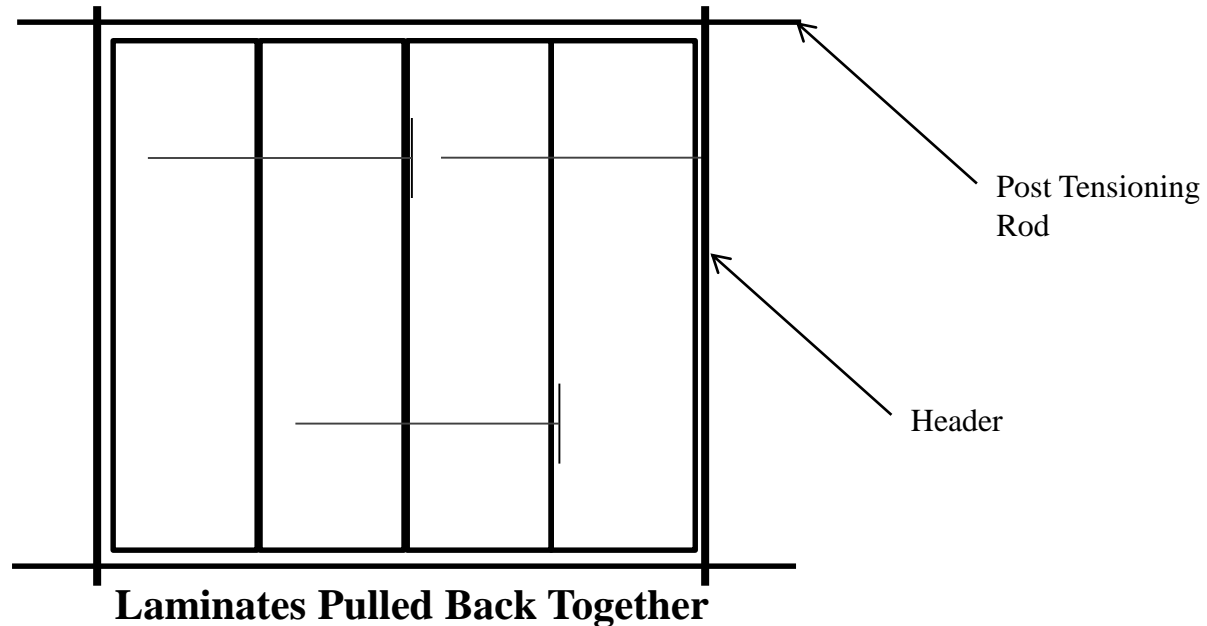
- Post Tensioning Force shrunk the bridge 6 to 18 inches

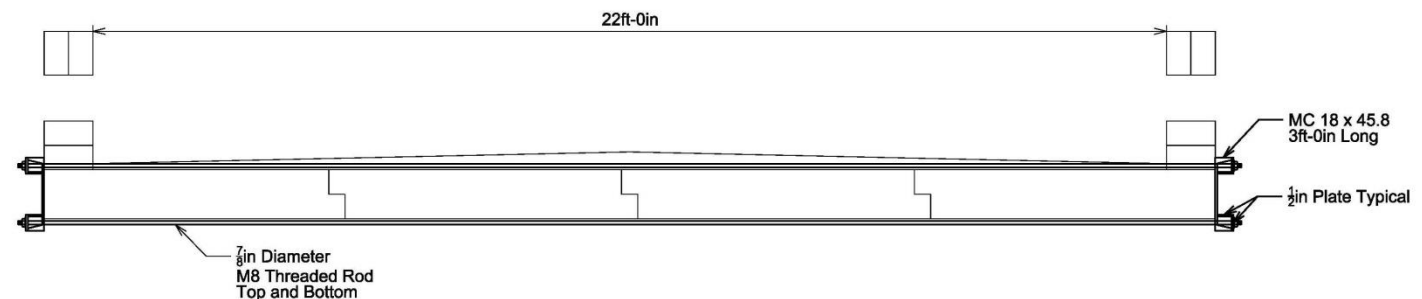
### SECTION A-A

- Hebert Creek Bridge shrunk 6 to 18 inches when post tensioned to 150 psi
- Ontario Ministry determined later that only 40 psi was needed to achieve composite action.
- Naubinway Bridge Measured 24'-2" Wide (Only 2" wider than As-Built)
- Tighten to between 40 psi and 150 psi, with goal of squeezing bridge back to 24'-0" Width

Section at  
MC 18x45.8 and  
M8 Threaded Rod

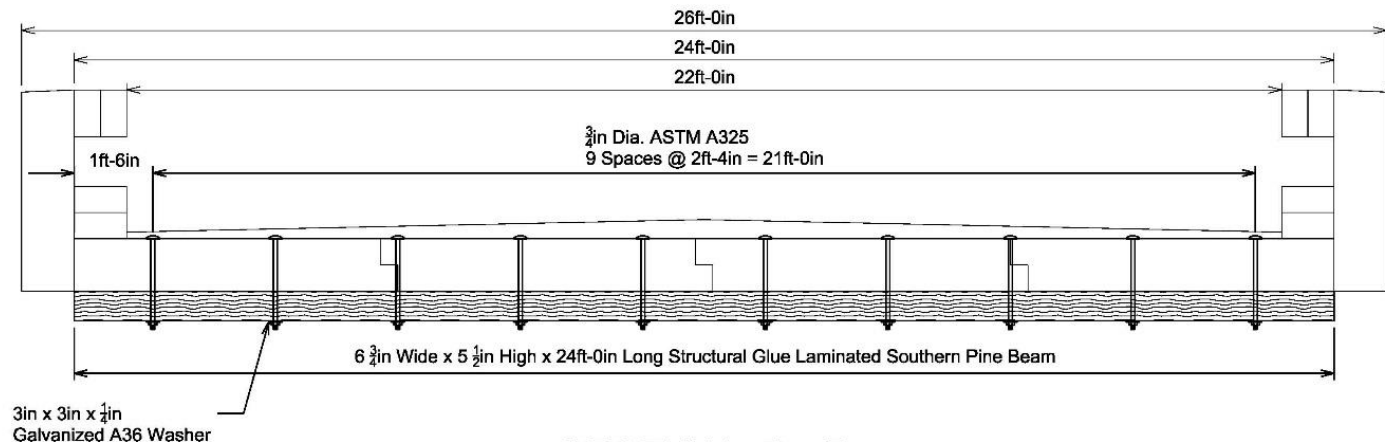
### SECTION B-B

- Belt and Suspenders

Section at  
Glue Laminated Timber

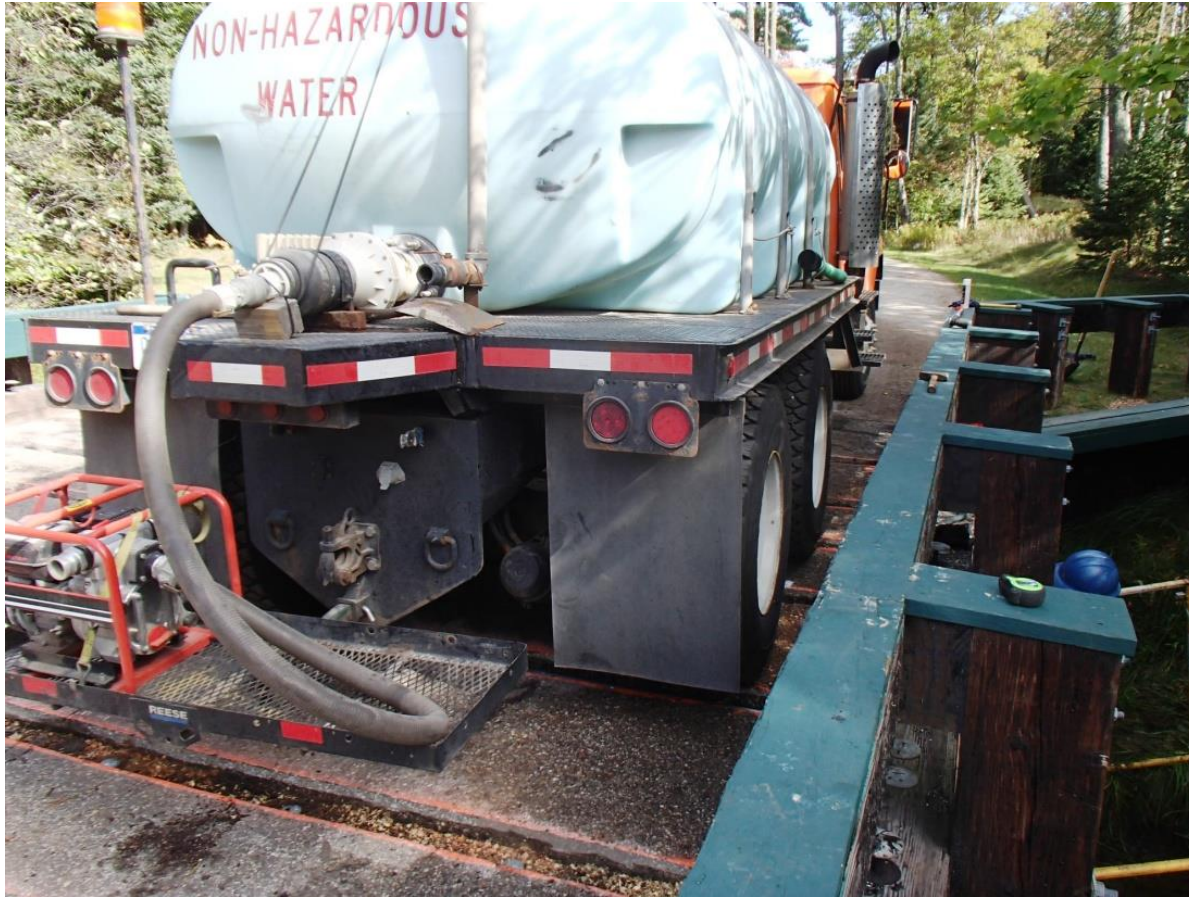
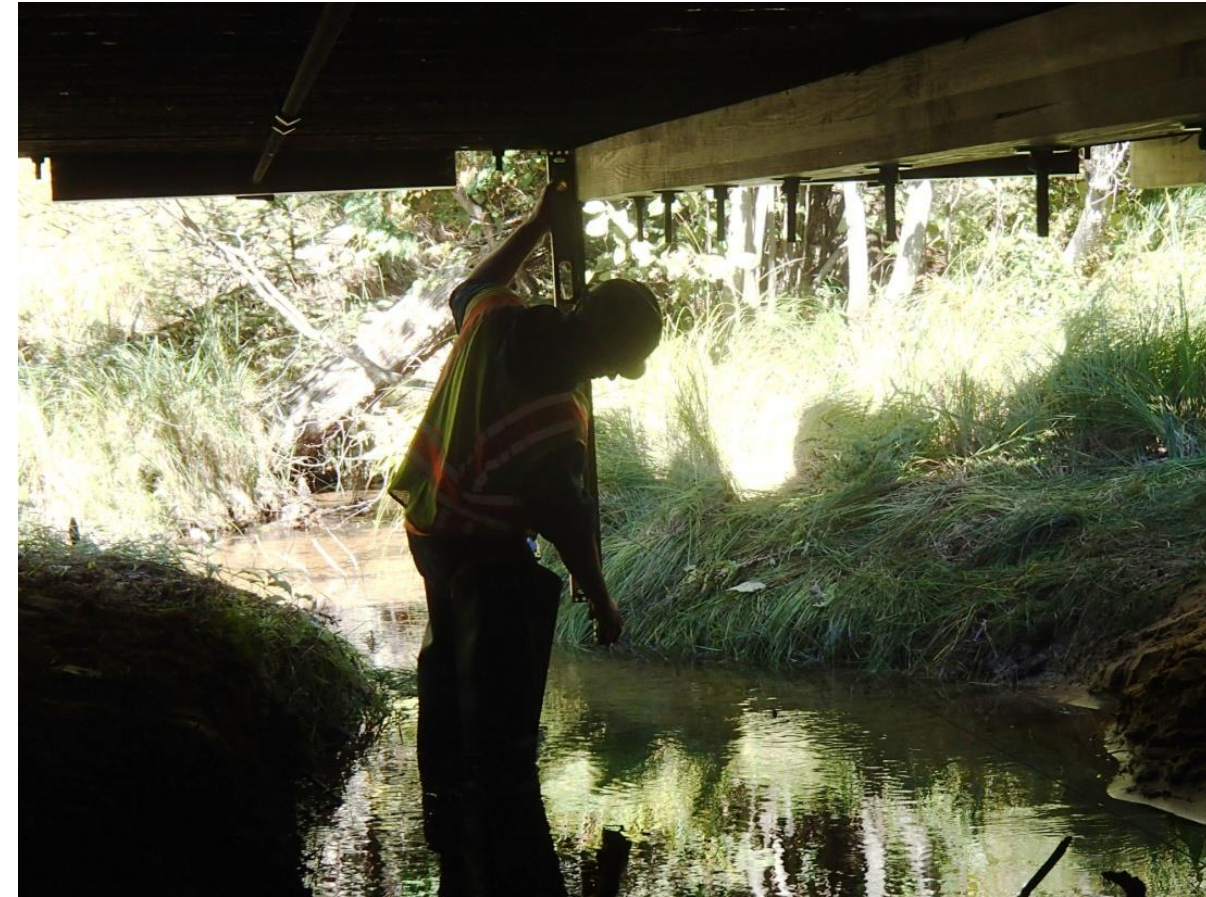
# Load Test

West Fascia	4' West	8' West	Centerli ne	8' East	4' East	East Fascia
Basel ine	34 1/4	33 5/8	32 3/4	32 1/8	31 5/8	31 1/4	30 5/8
Test 1	34 1/8	33 5/8	32 3/4	32 1/8	31 1/2	31	30 1/2
Test 2	34 1/8	33 5/8	32 1/2	31 7/8	31 3/8	31 1/4	30 5/8
Test 3	34	33 3/8	32 1/2	32 1/8	31 1/2	31 3/8	30 5/8

**1/4" Max Deflection (Greater than 50% Reduction)**

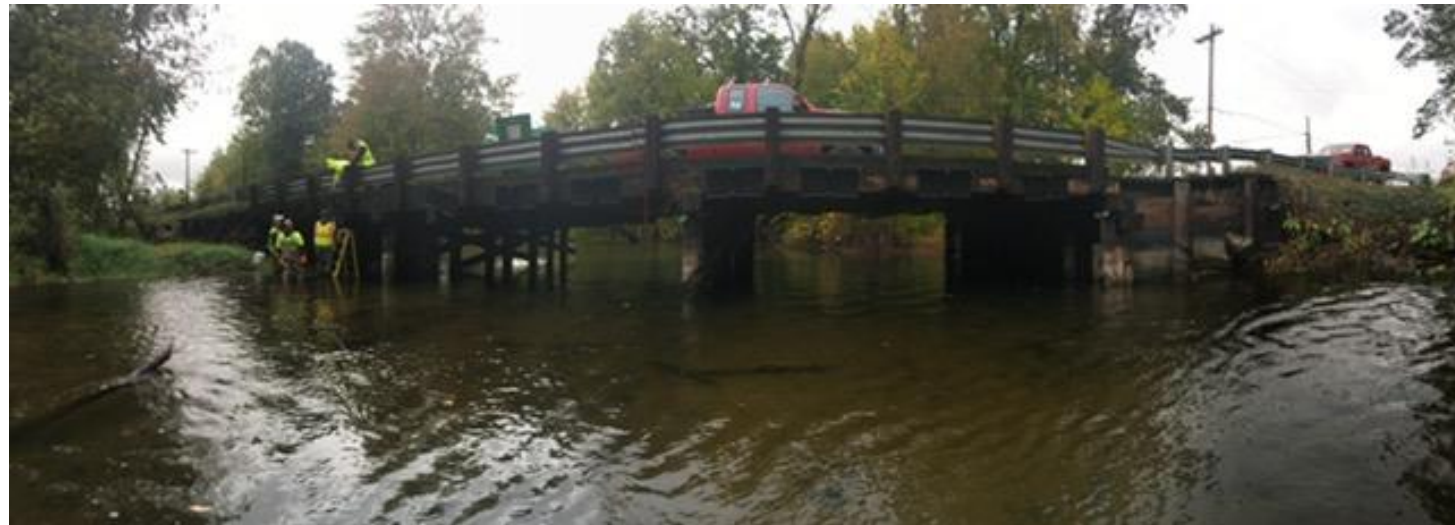
- St Joe County Road Commission
  - Attended Michigan LTAP Bridge Conference
  - Reached out to Region Support
  - 55 Nail Laminated Timber Bridges

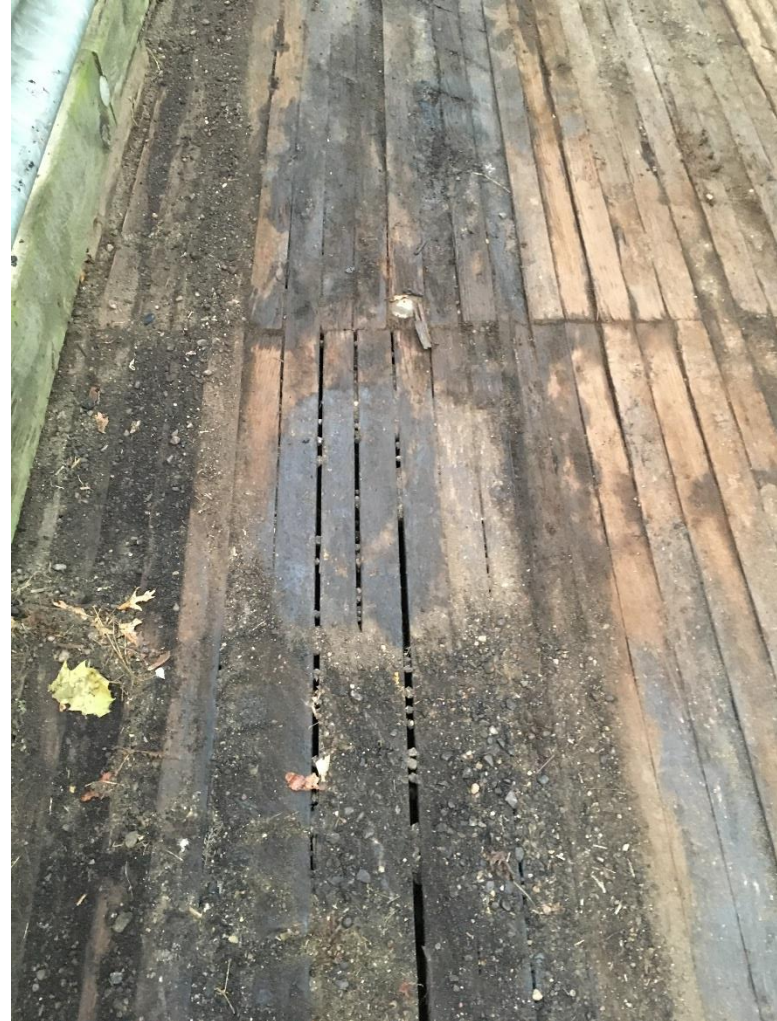
- St Joe County Road Commission
  - Heimbach Road Load Test
    - $\frac{3}{4}$ " Deflection
    - Lamination Separation developing cracking in spreader beams

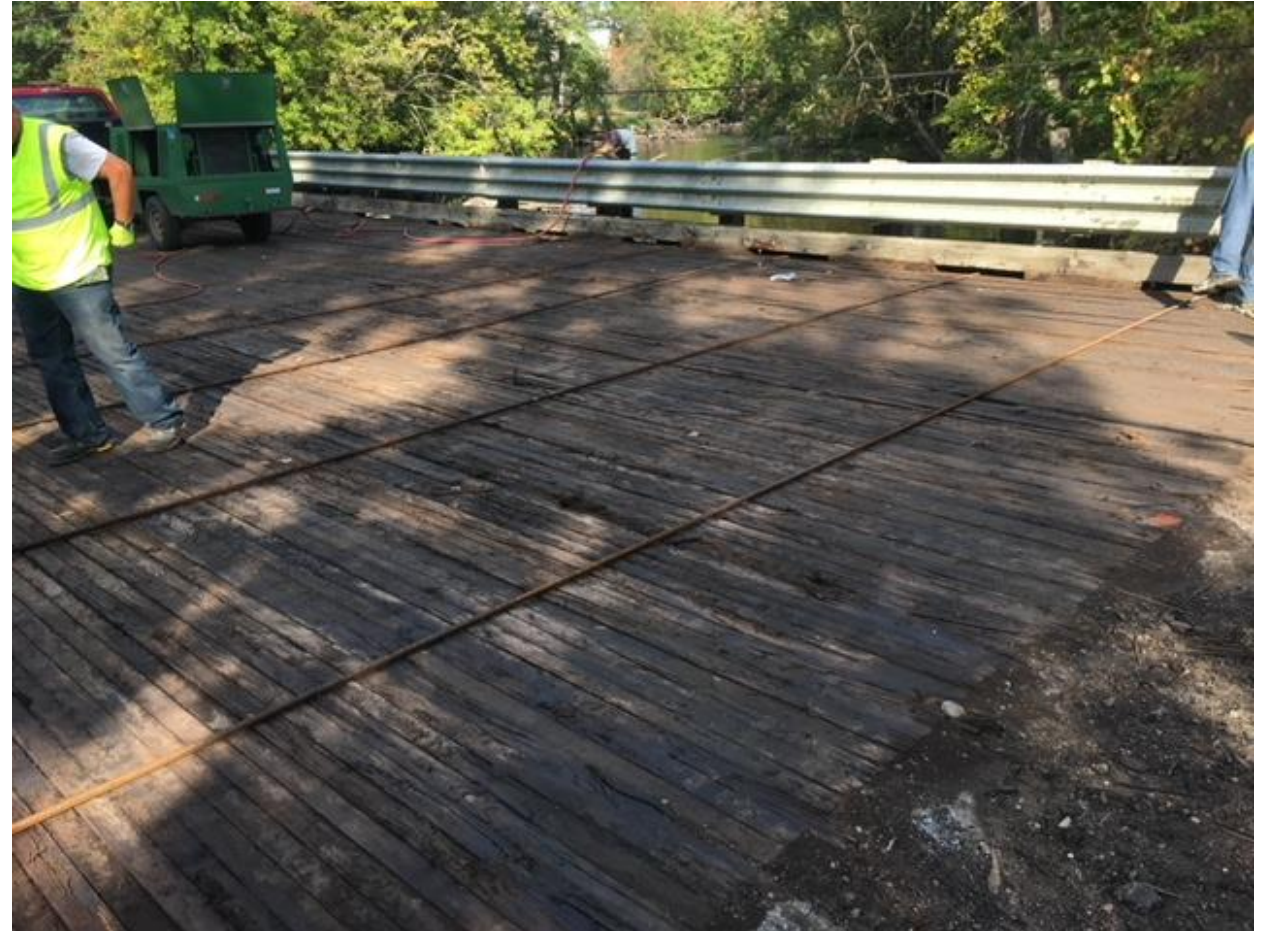
- Design Change
  - Naubinway used Short M7 Bars coupled together
  - Heimbach Rd used Continuous Grade 36 Threaded Reinforcing Bars
  - Remove Asphalt overlay up front.

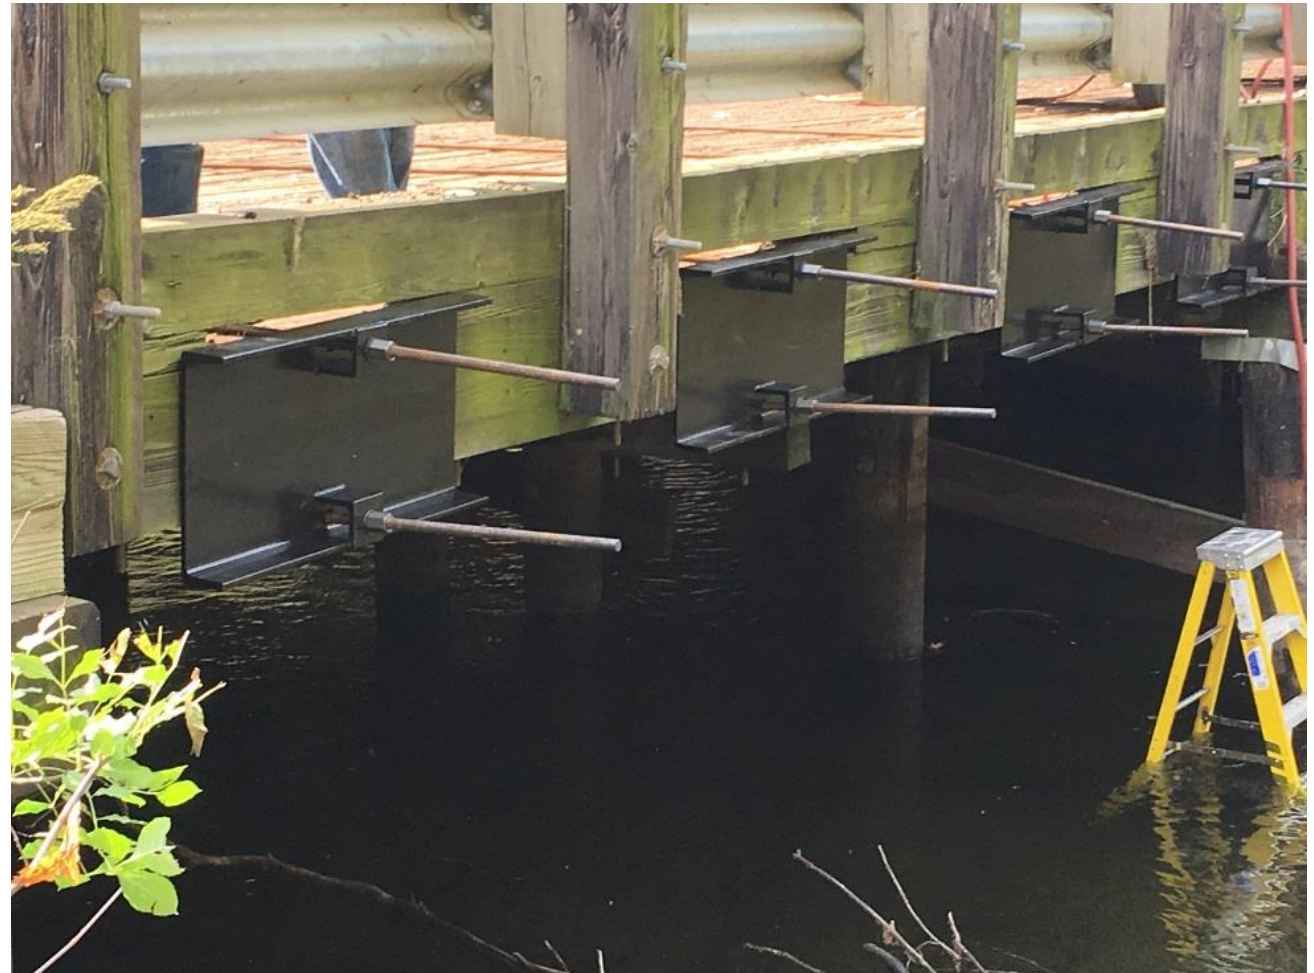
- Results
  - Heimbach Road Load Test
    - $\frac{3}{4}$ " Deflection - Before
    - Bridge Width Shrunk 6"
    - $\frac{1}{8}$ " Deflection - After
