## New Jersey Turnpike Authority Bridge Coating Assessment and Repainting Capital Program

Presented by: Mark Nyerges, PE

#### New Jersey Turnpike Authority

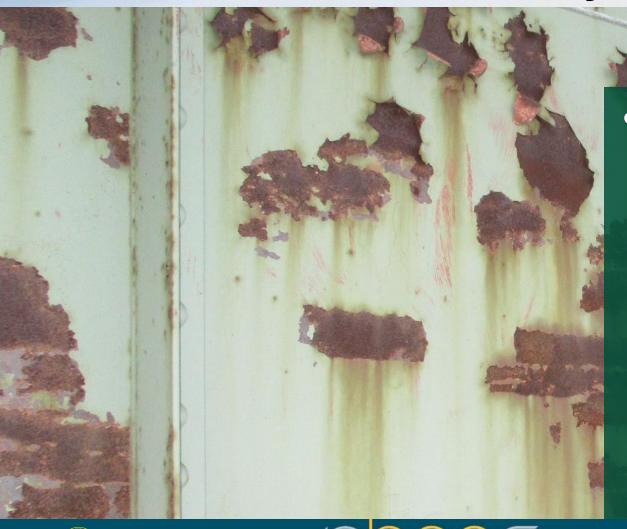
#### • Results indicated:

- All had original coatings; latest overcoat>20 years old
- DFT was 15-30 mils with 6-8 coats of paint
- Generally poor condition
- Failing, brittle, poor adhesion (mill scale)
- Tested positive for heavy metals
- Areas of laminar corrosion present
- All WS members had laminar corrosion at ends (not painted)

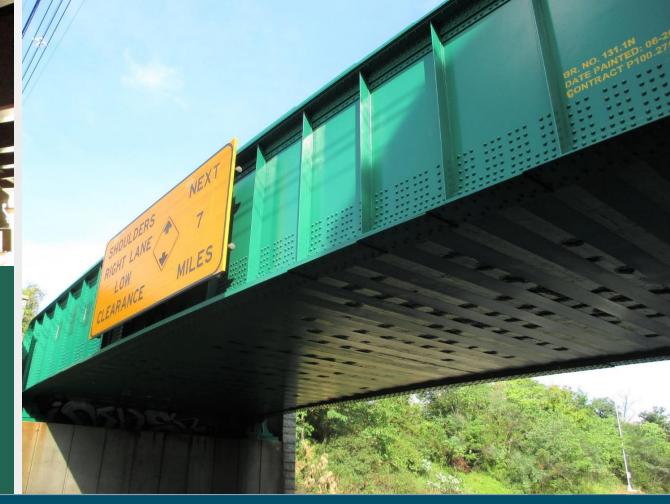
- Fracture Critical Members (FCMs)
  - Queried Authority's BMS to identify potential bridges
  - Predominantly WS box girder pier caps
  - One (1) previously painted G/F/S bridge

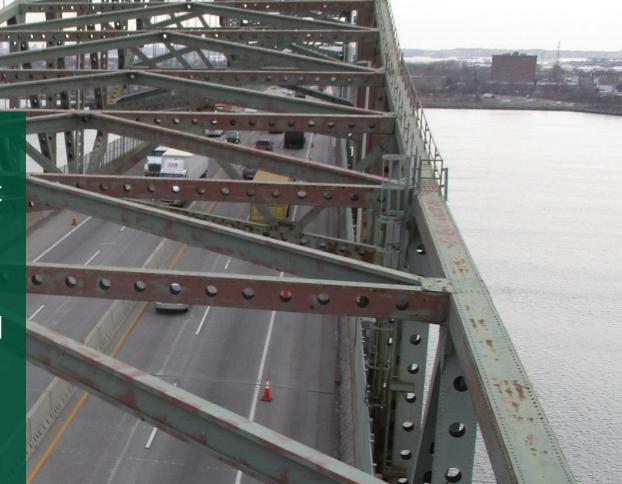
- Complete Removal and Replacement
  - Best for failed coatings / corrosion present
  - Not applicable to weathering steel
- Spot Repairs with a Full Overcoat
  - Common "Maintenance Painting" method
  - Can extend life of existing system
  - Lowest initial cost (relies on integrity)
  - Not applicable to weathering steel

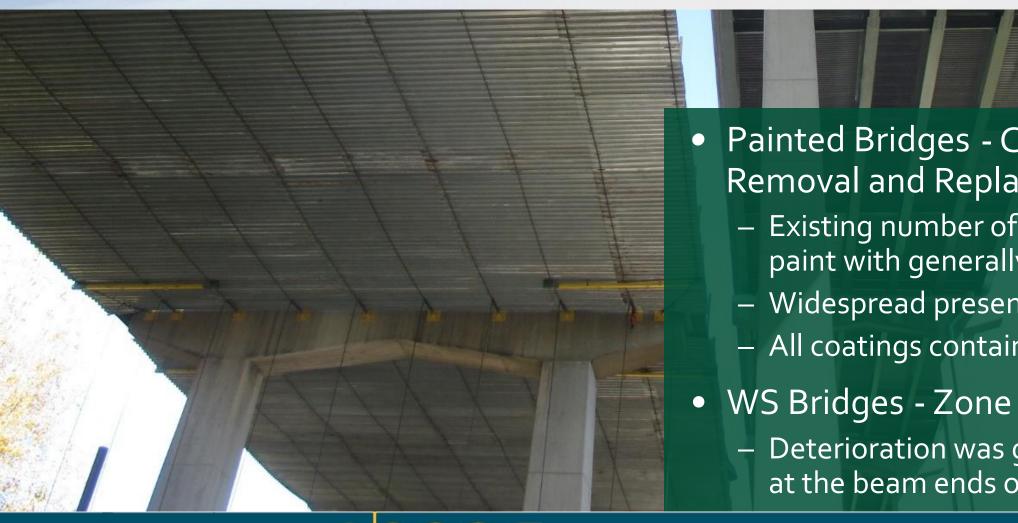
- Painted Bridges Complete Removal and Replacement
  - Existing number of coats / layers of paint with generally poor adhesion
  - Widespread presence of mill scale
  - All coatings contained heavy metals
- WS Bridges Zone Painting
  - Deterioration was generally localized at the beam ends only

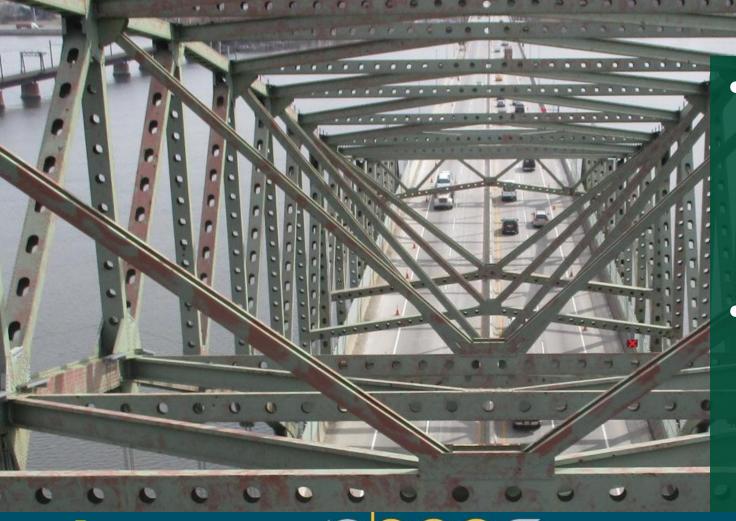
- Painted and WS Traditional 3-Coat Z/E/U System
  - NEPCOAT approved
  - Proven track record in Greater
    Northeast Region
- Special Provisions:
  - Penetrating sealer after prime
  - Stripe Coat after prime and seal
  - Caulking before finish
  - Two full intermediate coats on WS

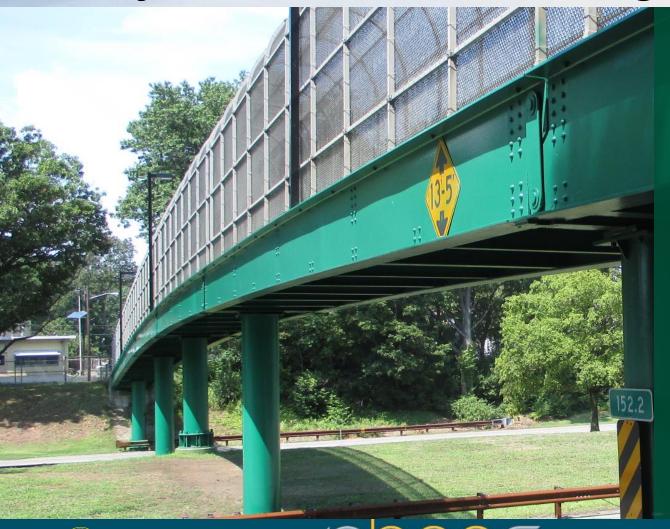
- All with FCMs repainted under a single Contract
  - Predominantly Zone Painting at box girder pier caps (17 bridges)
  - One (1) fully painted G/F/S bridge
- 18 highest priority Parkway bridges repainted by a single Contract
- Six (6) prioritized Contracts are planned (≈2 per year; 120 bridges)
- Total Painting-Related Construction Value >\$100M
