Preventing Crevice Corrosion in New and Existing Steel Structures

Eric Shoyer – Elzly Technology
Pete Ault – Elzly Technology

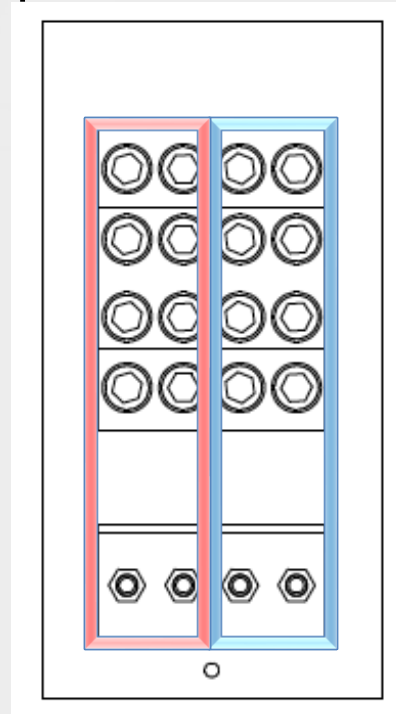
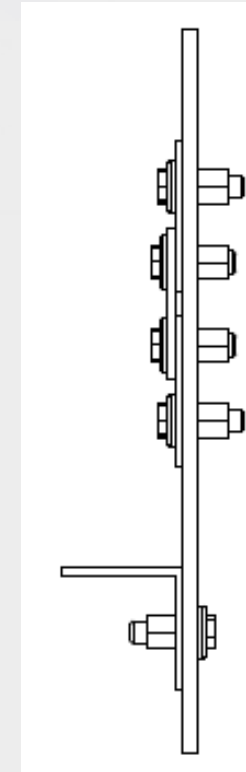
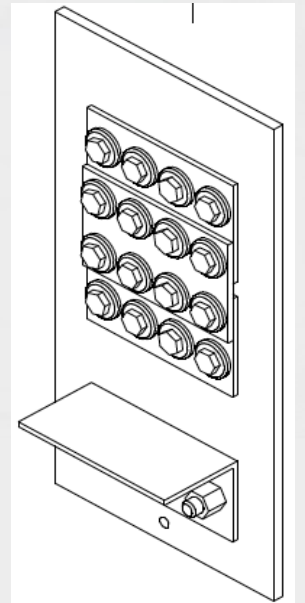
Test Panel Design

- 6" by 12" by 1/8" steel
 - Three 2.5" by 4" steel coupons
 - Assembled to create crevices for water penetration
 - One 4-inch long 2.5-inch Angle
 - 10 Black Oxide bolts
(highlighted in blue box)
 - 10 Galvanized bolts
(highlighted in red box)

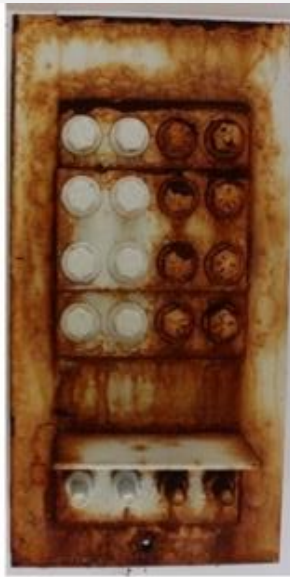
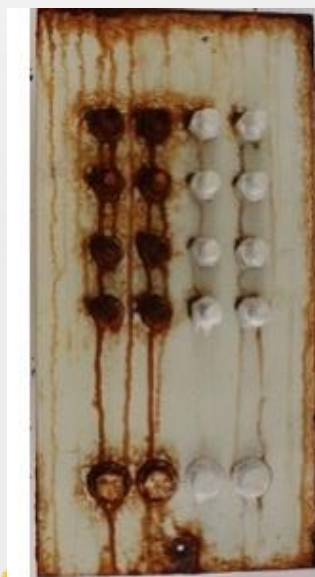
Preparation of “Aged” Steel

- 10 panels were assembled/ coated/ pre-weathered
 - Coated with 3 mils of Epoxy
 - ~150 hours ASTM B117 Corrosion Exposure
 - 9 months of Outdoor Exposure (Vineland, NJ)

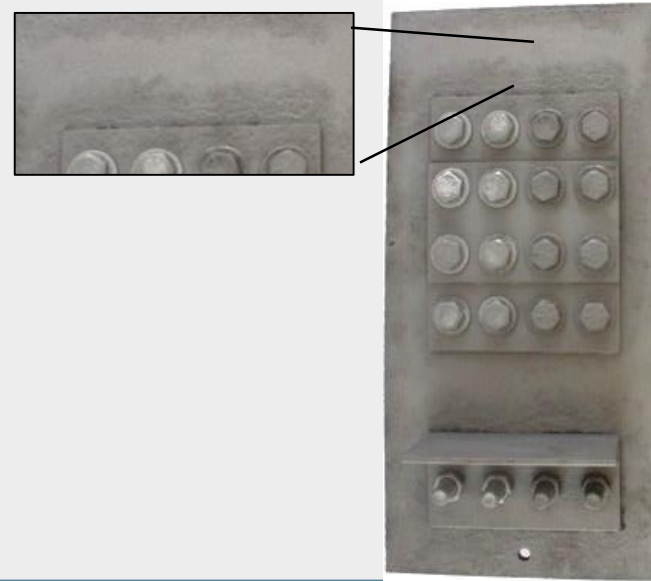
SP-10 Near-White
Metal Blast

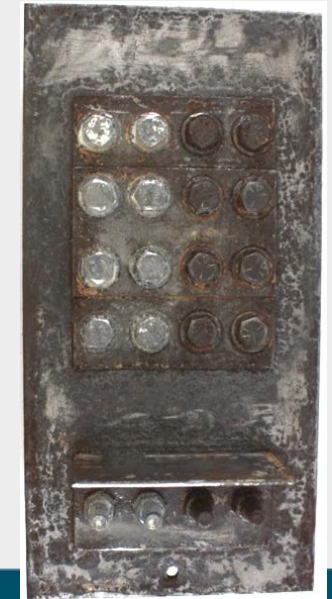
SP-11 Power Tool
Cleaning to Bare Metal
using a Needle Gun &
Grinding Wheel

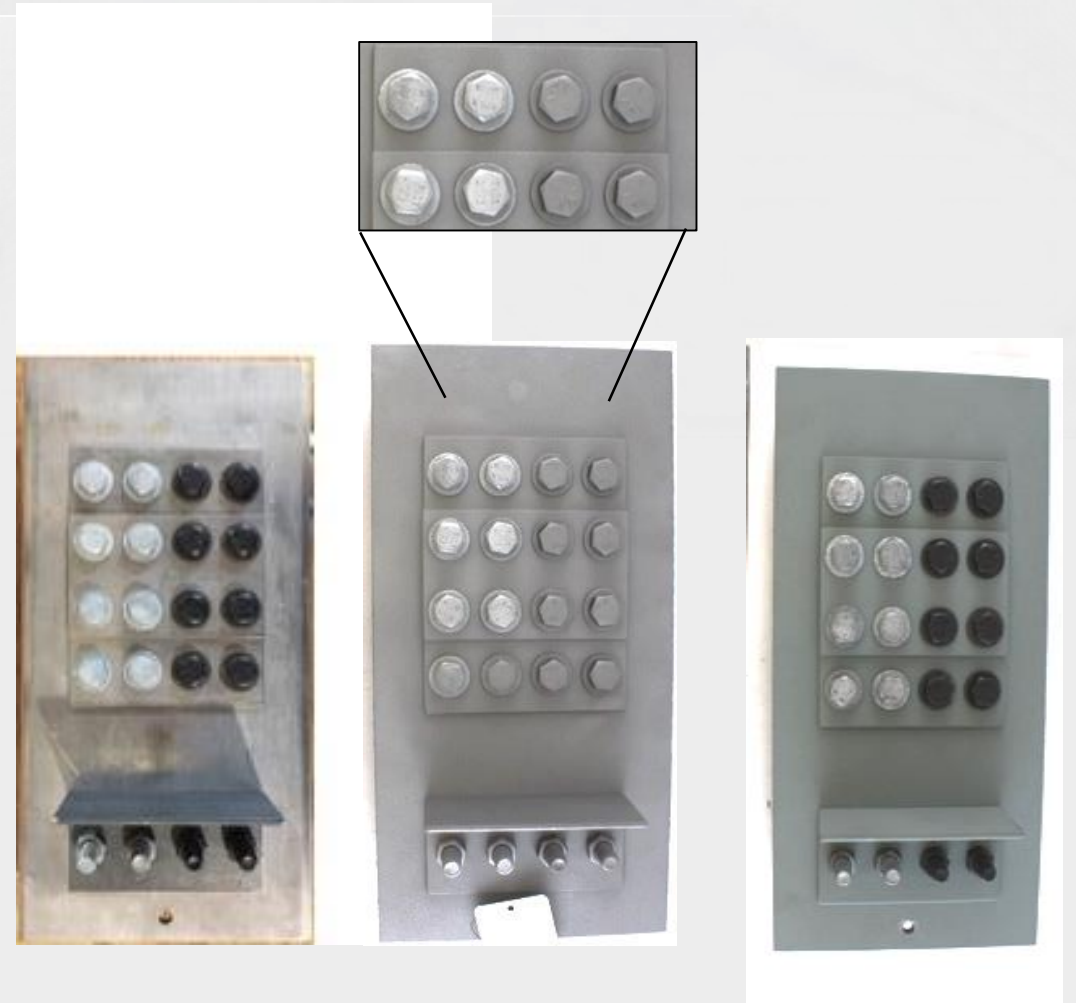
New Steel Panels

- Two fabrication sequences :
 - Assembled, abrasive blasted (SP-10), and coated with a OZ/E/URE System
 - Abrasive blasted (SP-10), OZ primed, assembled, and then finish coated (EP/URE)
 - All bolts where scuff sanded prior to intermediate coating

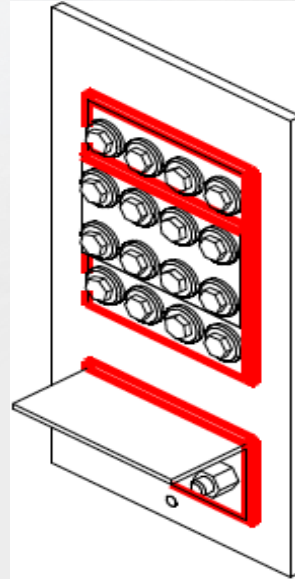
Full Method
Caulking applied to
all crevices

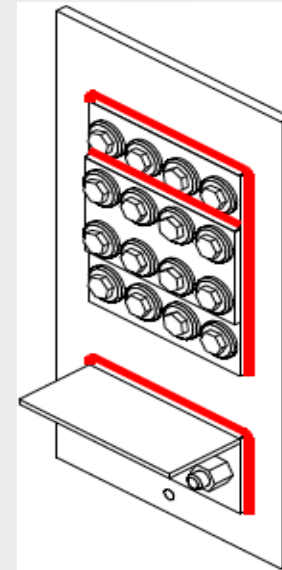
$\frac{3}{4}$ Method
Caulking applied
to all except
bottom crevices

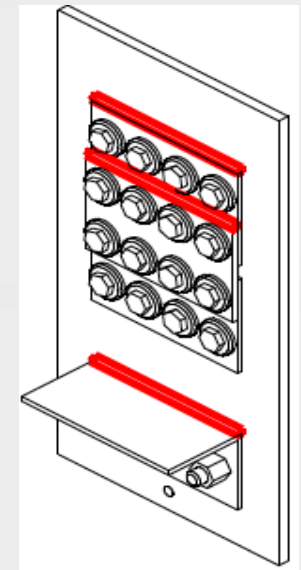
Top Method
Caulking only
applied to top
crevices

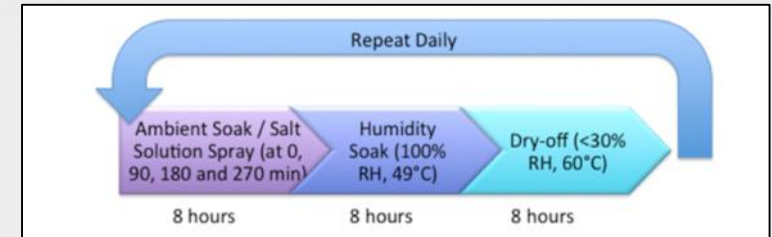
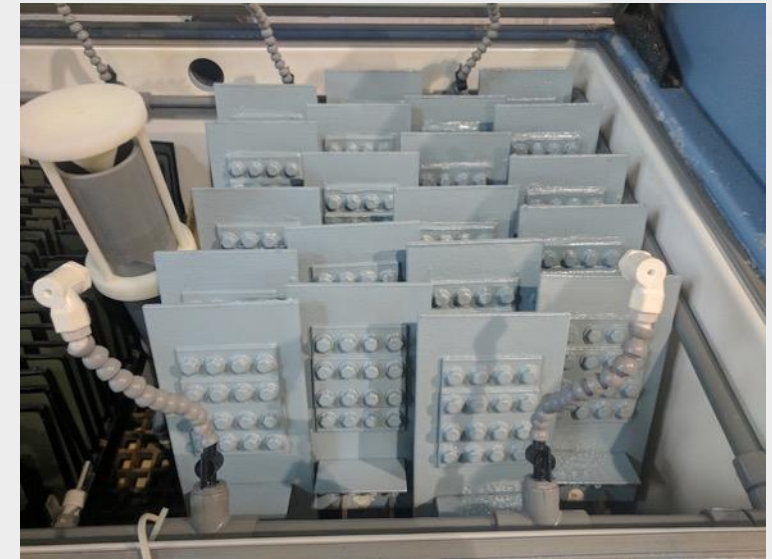
Performance Testing

- Corrosion (GMW14872)
 - 120 cycles – Underbody method C
 - Inspections 20/40/80/120 cycles
 - ASTM D-610 (rusting)
 - ASTM D-714 (blistering)
 - Crevice corrosion locations
 - Rusting bolt count
 - Note: panels are rotated positions every 20 cycles
 - At end of test, panels were disassembled for pitting analysis within crevices

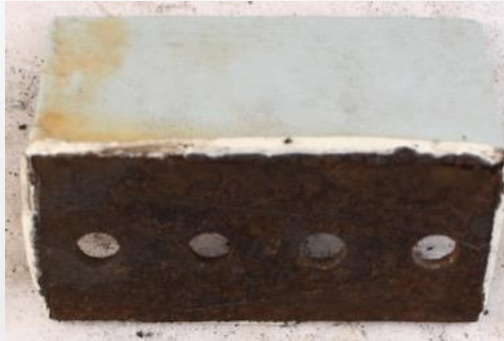
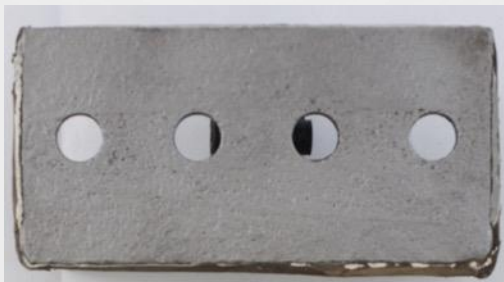
- L - Bracket

- In an attempt to better quantify the crevice corrosion, pit depths were measured on two different surfaces.
- After disassembling the panels, all corrosion products were removed from the crevice surface of the angle using abrasive glass bead blasting.
- Ten measurements were made to find the highest pits for each surface
