# EARTHQUAKE PREPAREDNESS AND RESPONSE

Oklahoma DOT's Proactive Approach for Bridges

April 10, 2018

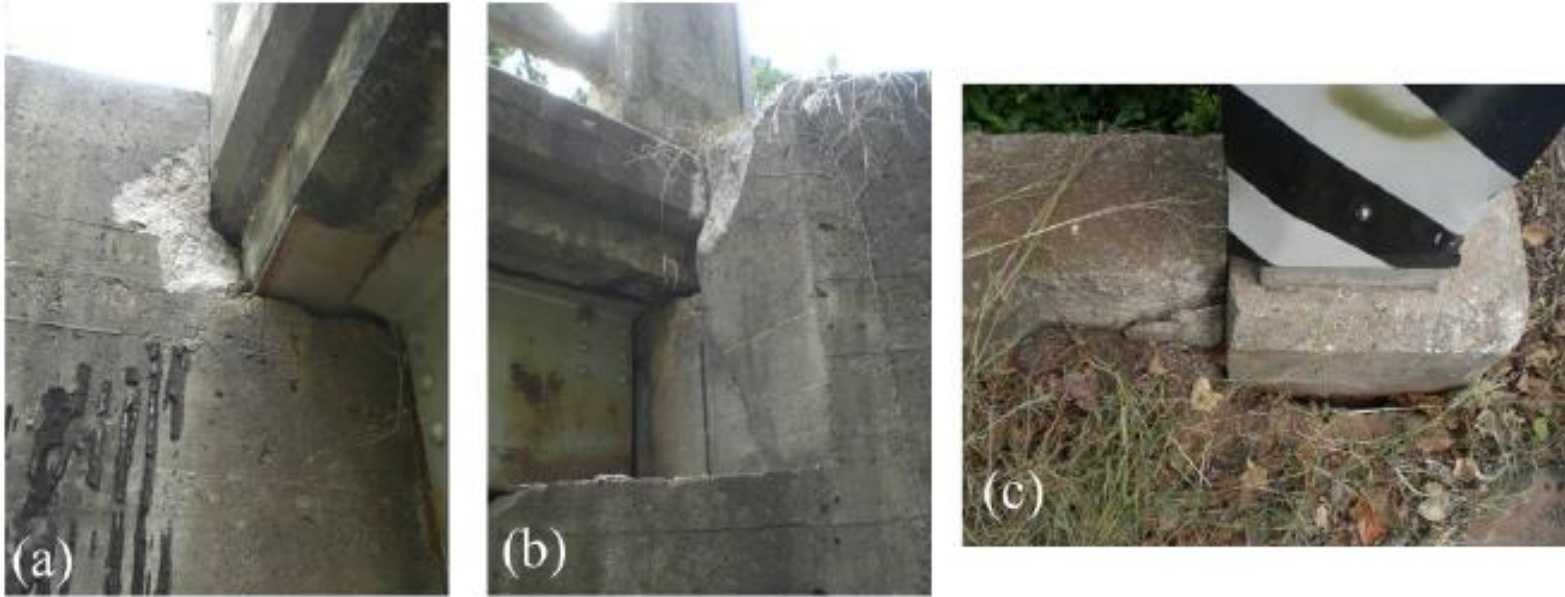
M5.8 - Pawnee, OK (September 3, 2016)  
Largest Quake in Oklahoma History  
Cosmetic Bridge Damage

Figure 14: Observations of damage at the West Abutment of Belford Bridge (Latitude/Longitude: (36.505°, -96.8493°)): a,b) concrete spalling of abutment; c) approx. 4 cm wide gap between backfill soil and abutment

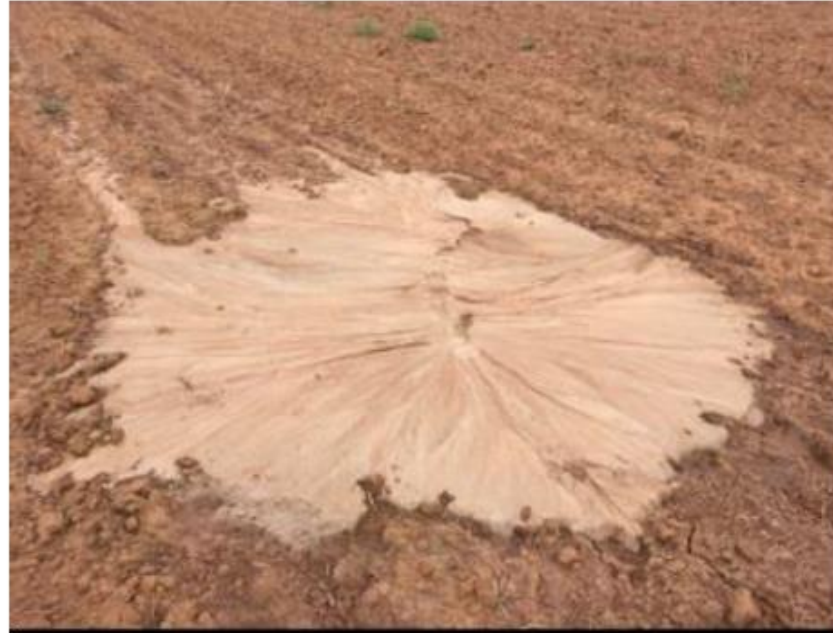
M5.8 - Pawnee, OK  
(Sept 3, 2016) –  
Sand Boil

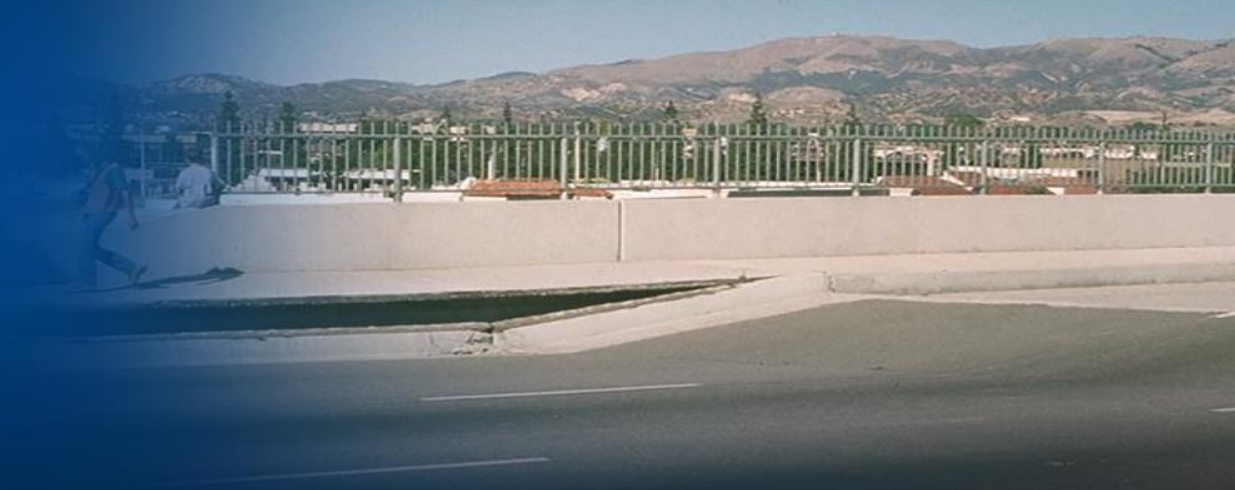
## Stage 1 Inspection

- Completed immediately after an earthquake for assigned bridges
- Quick, accurate ground level safety evaluation
- Categorize bridges as:
  - Green – Safe
  - Yellow – Minor damage
  - Red – Bridge Closed

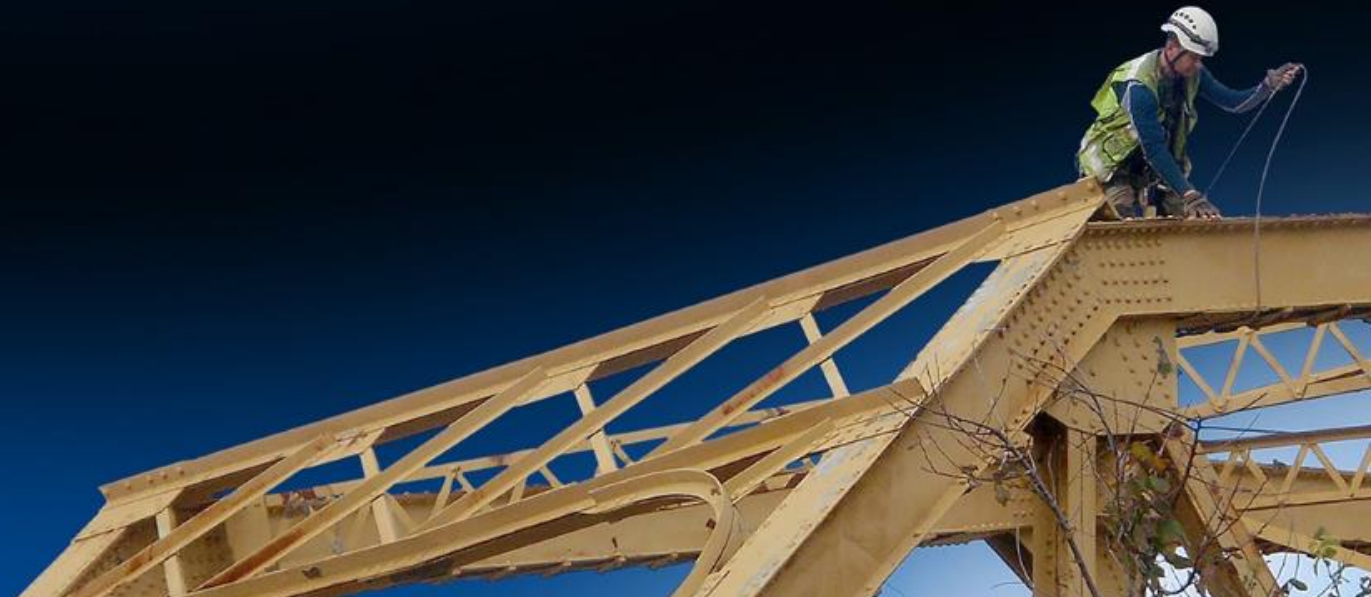
### Stage 3 Inspection

- Specialized assessment
- Focus is restoring service to closed or otherwise restricted bridge
- “Hands-on” assessment, requiring specialized access
- Team comprised of:
  - Structural Engineer
  - Geotechnical Engineer
  - Certified Bridge Inspector

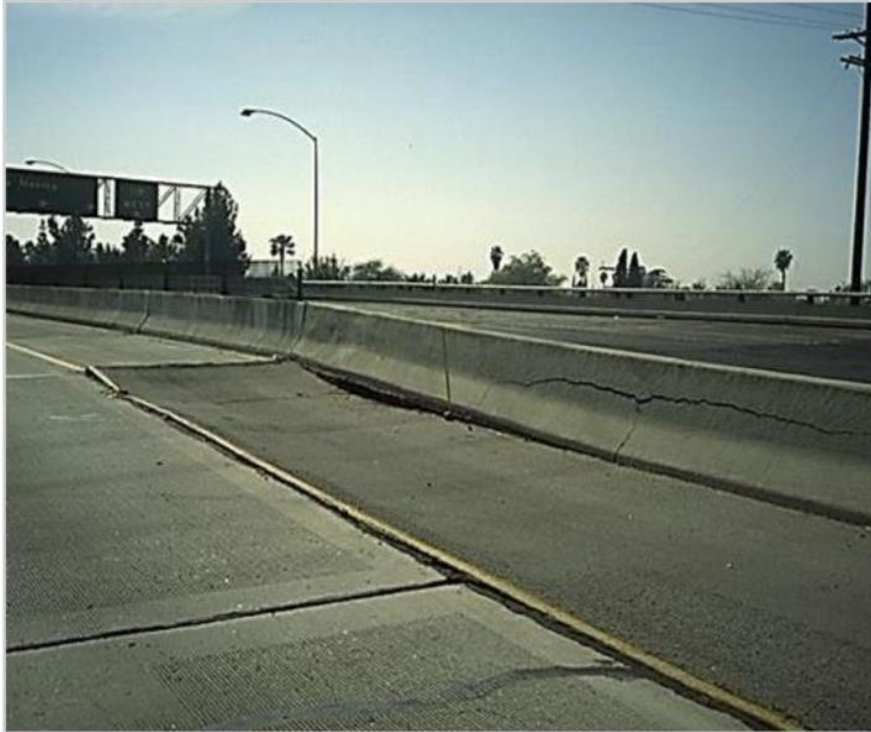
**Figure 62:** Approach slab settlement and cracking of the concrete barrier (*NISEE*)

**ACTION:** May require closure. Inspect for settlement and superstructure or substructure damage. Further evaluation is required.

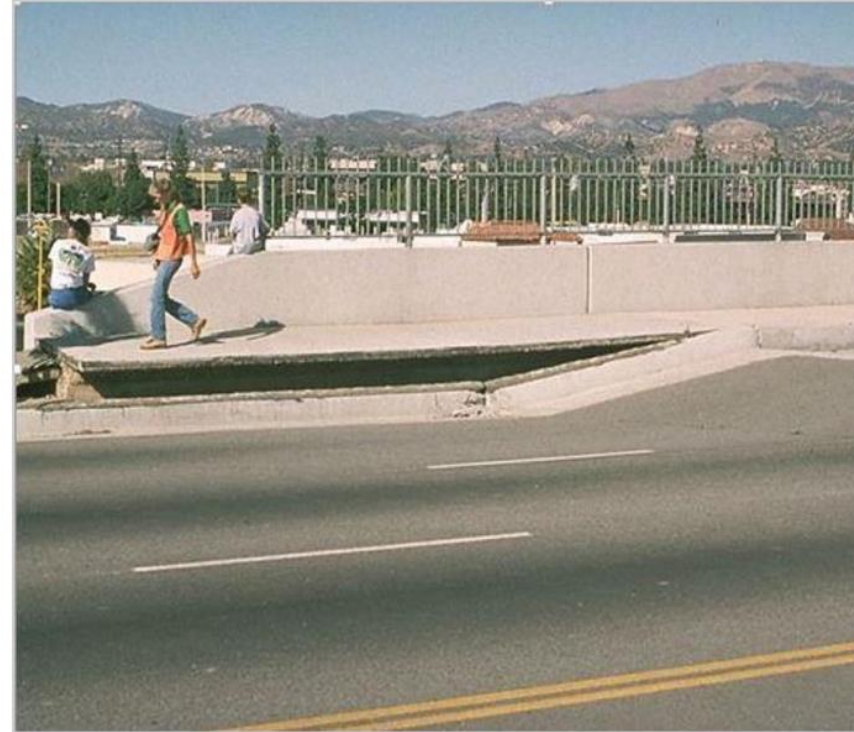
**Figure 63:** Settlement of the approach slab (*NYSDOT*)

**ACTION:** Close bridge. Report findings immediately.

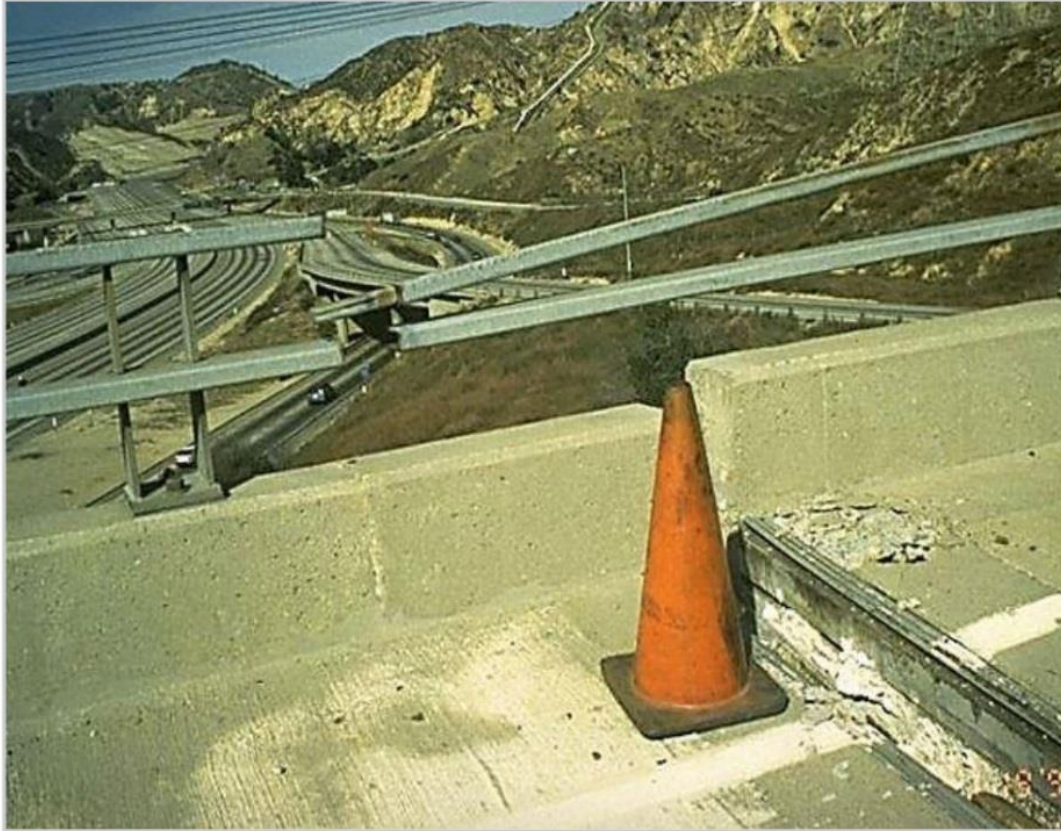
**Figure 68:** Vertical displacement observed in expansion joint (*NISEE*)

**ACTION:** Close bridge. Report findings immediately and request Stage 2 Inspection.

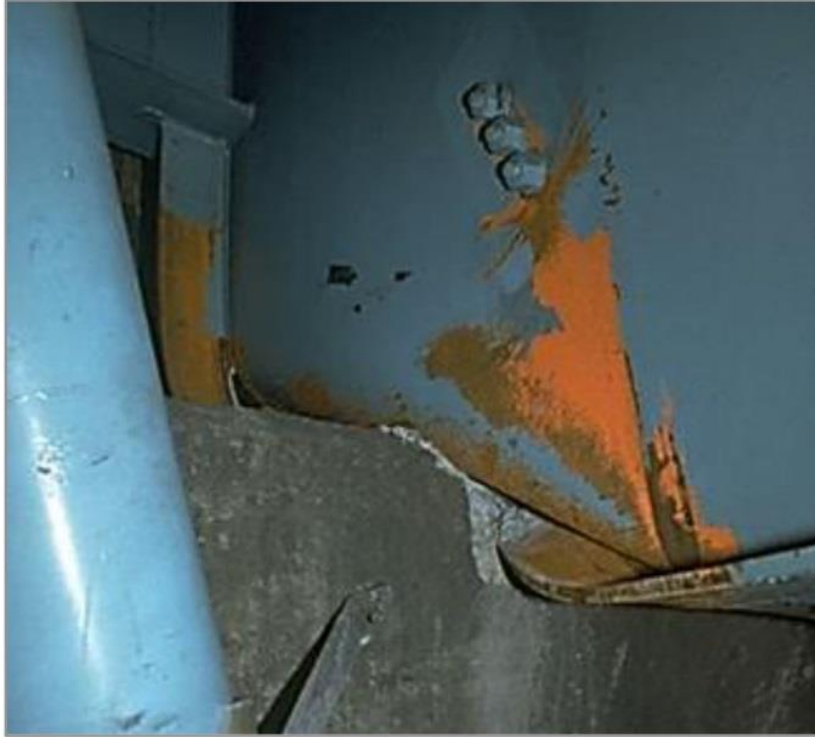
**Figure 76:** Damage to beam caused by movement of the structure (*NISEE*)

**ACTION: Close bridge. Report findings immediately and request Stage 2 Inspection.**

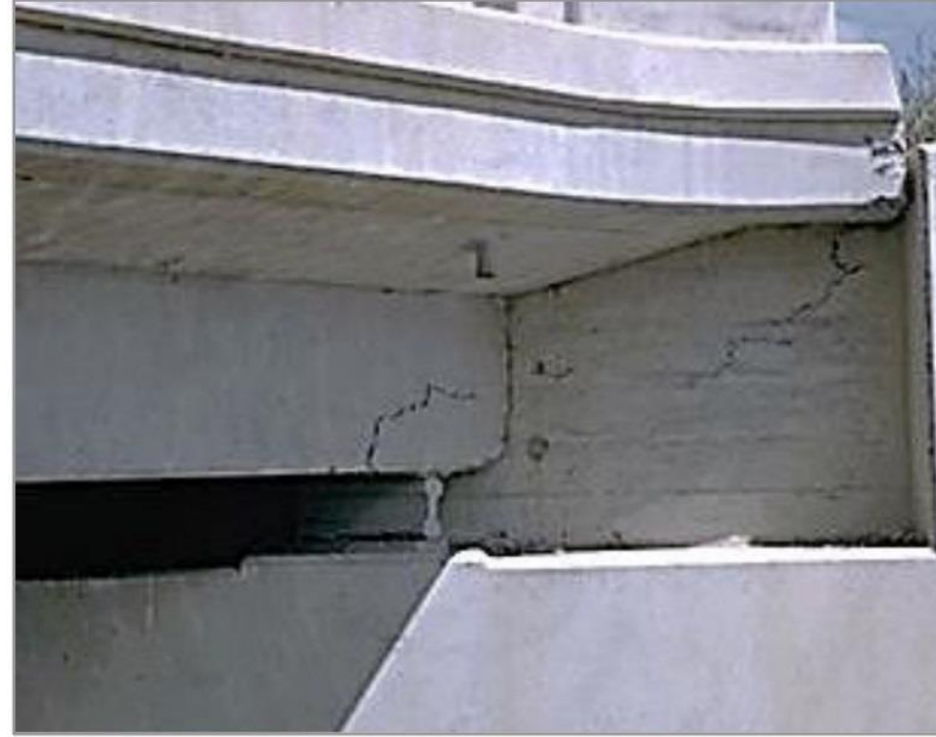
**Figure 77:** Superstructure spalled at bearing location (*NISEE*)

**ACTION: Report findings and recommend Stage 2 Inspection.**

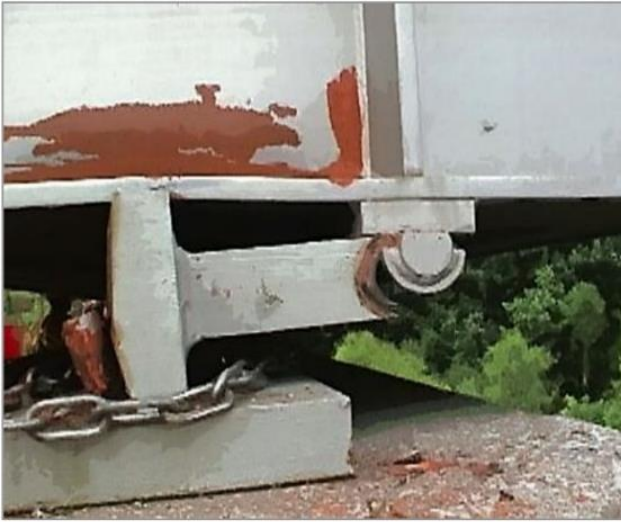
**Figure 78:** Rocker bearing failure (*NISEE*)

**ACTION:** Close bridge. Report findings immediately and request Stage 2 Inspection.

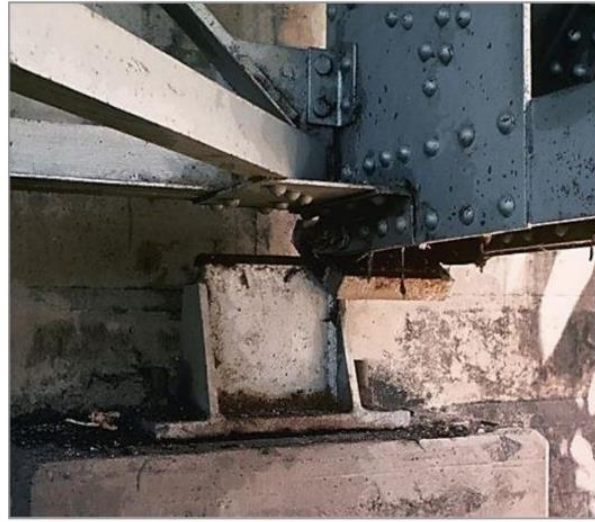
**Figure 79:** Failure of bearing, complete lateral displacement (*NISEE*)

**ACTION:** Close bridge. Report findings immediately and request Stage 2 Inspection.

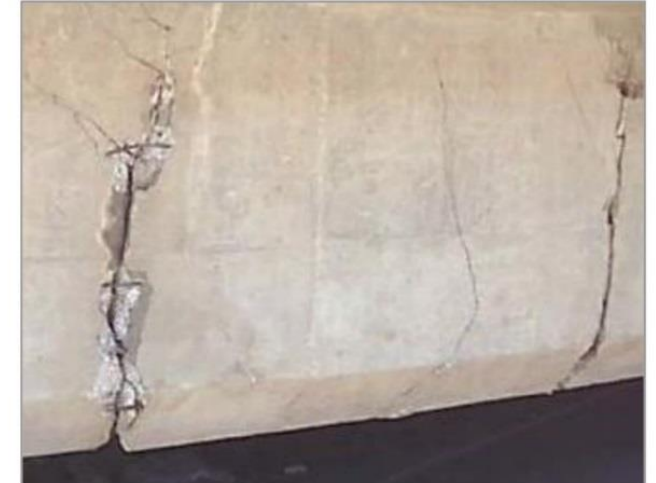
**Figure 74:** Cracking in web of concrete beams (*NYSDOT*)

**ACTION:** Close bridge. Report findings immediately and request Stage 2 Inspection.

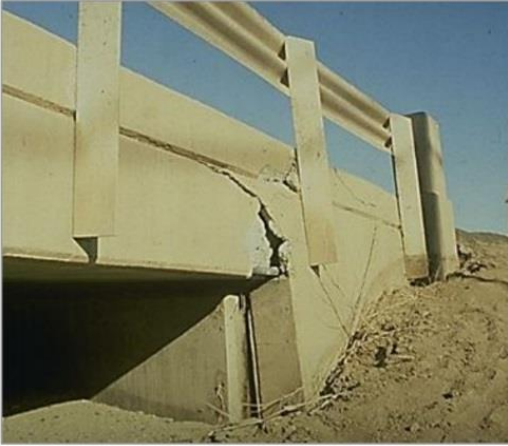
**Figure 86:** Cracking and rotation of wingwall (NISEE)

**ACTION:** Close bridge. Report findings and immediately request Stage 2 Inspection.

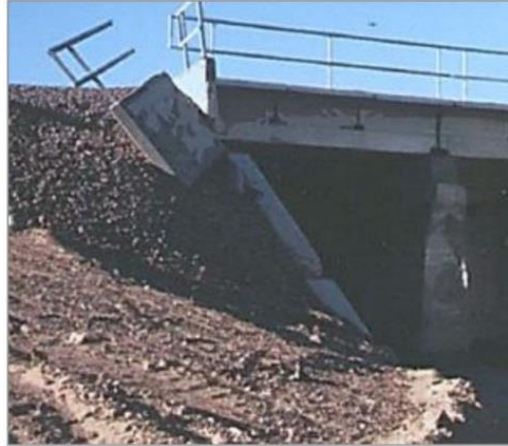
**Figure 87:** Wingwall released from superstructure after earthquake tremors (NISEE)

**ACTION:** Close bridge. Report findings immediately and request Stage 2 Inspection.

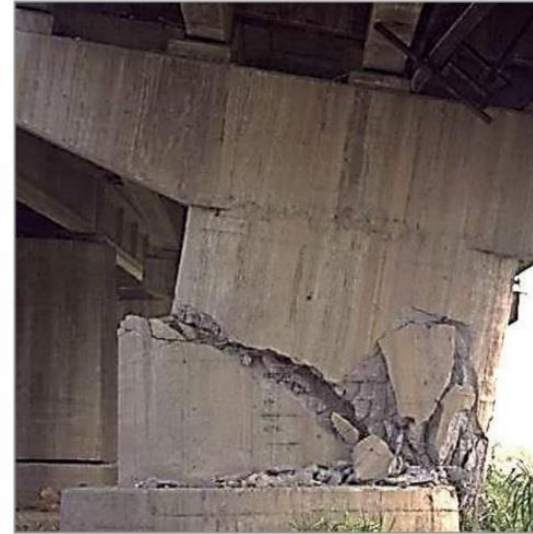
**Figure 92:** Full collapse of pier (NISEE)

**ACTION:** Close bridge. Report findings immediately and request Stage 2 Inspection.

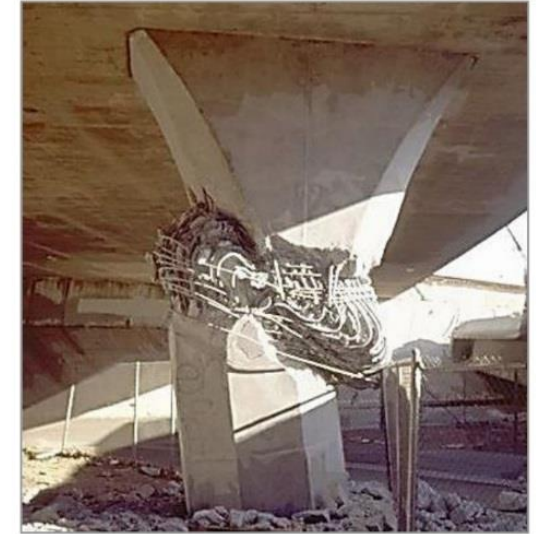
**Figure 93:** Failure of column (NISEE)

**ACTION:** Close bridge. Report findings immediately and request Stage 2 Inspection.

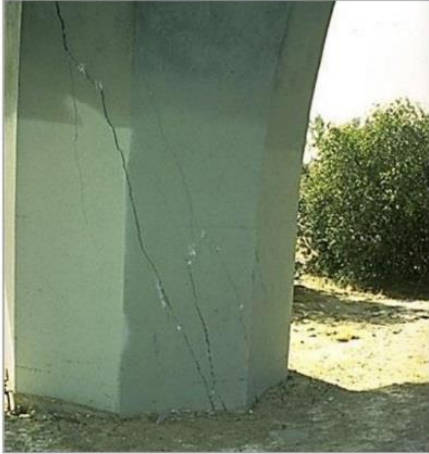
**Figure 94:** Shear cracks in column (*NISEE*)

**ACTION:** Bridge remains open. Report findings immediately and request Stage 2 Inspection.

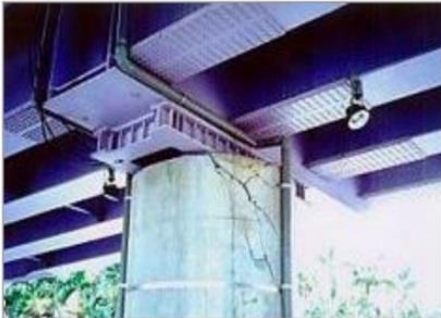
**Figure 95:** Compression failure on the top of concrete bridge pier (*INDOT*)

**ACTION:** Report findings immediately and request Stage 2 Inspection.

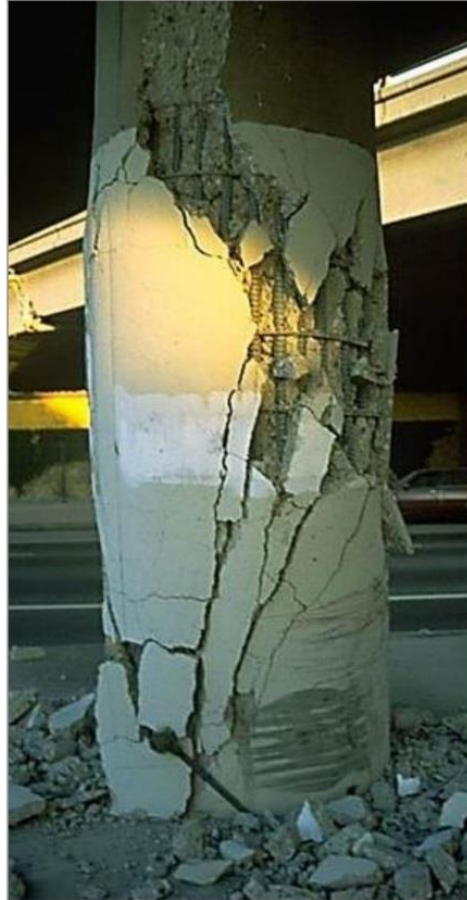
**Figure 96:** Confinement failure in single column (*NISEE*)

**ACTION:** Close bridge. Report findings immediately and request Stage 2 Inspection.

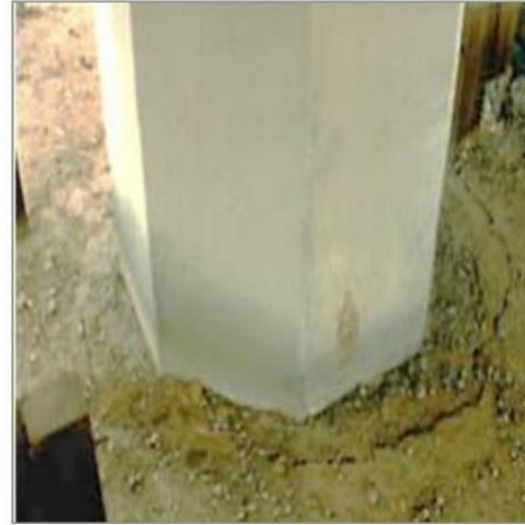
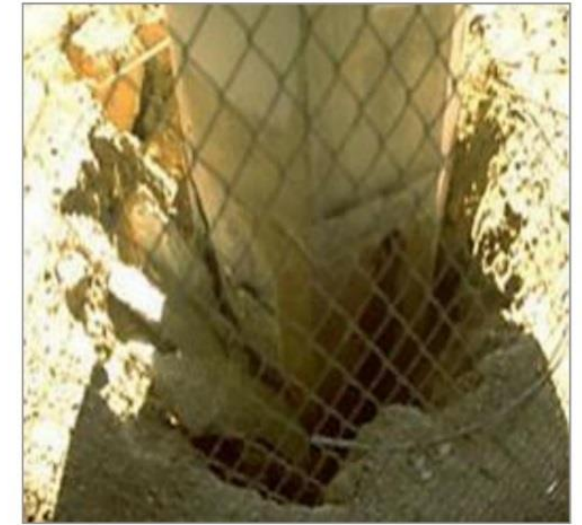
**Figure 100:** Ground movement indicating possible foundation problems (*INDOT*)

**ACTION:** Report findings immediately and request Stage 2 Inspection.

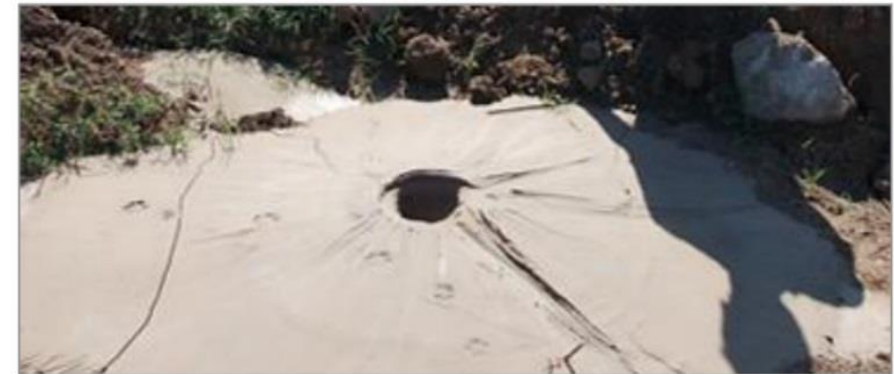
**Figure 102:** Liquefaction sand boil

**ACTION:** Report findings immediately and request Stage 2 Inspection. Close bridge when sand boils are present near substructure.

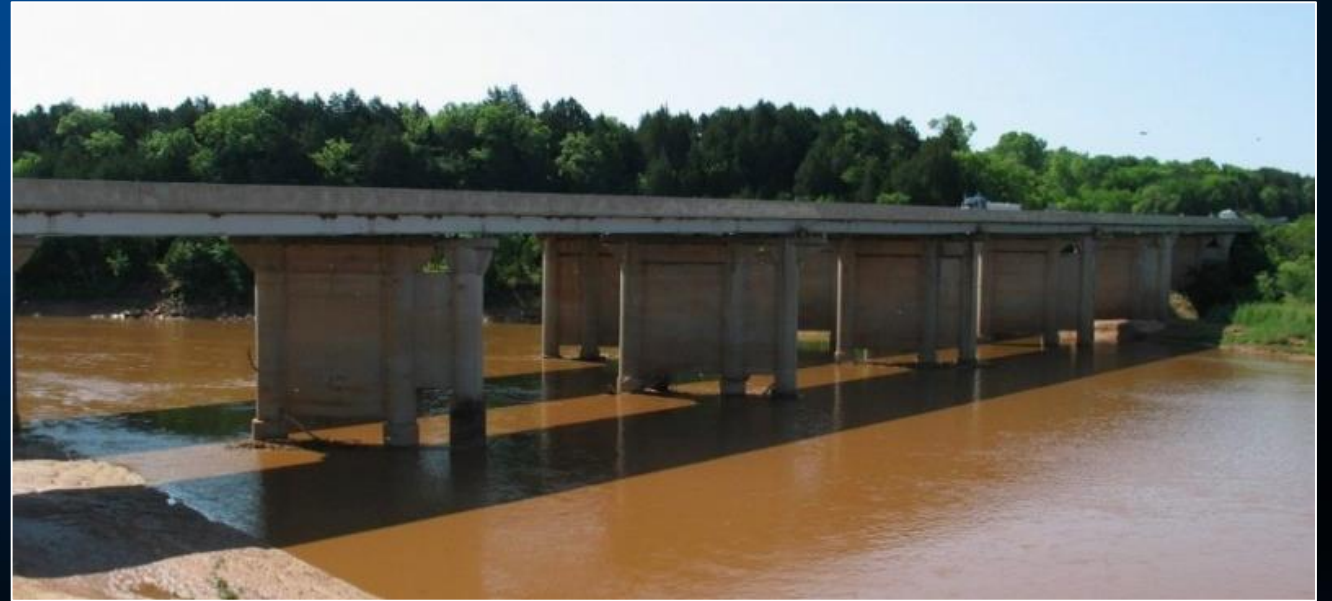
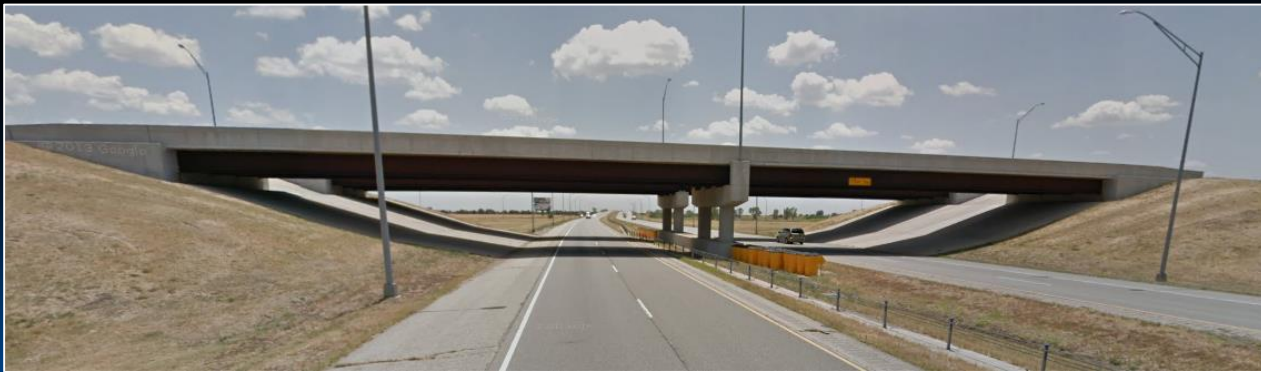
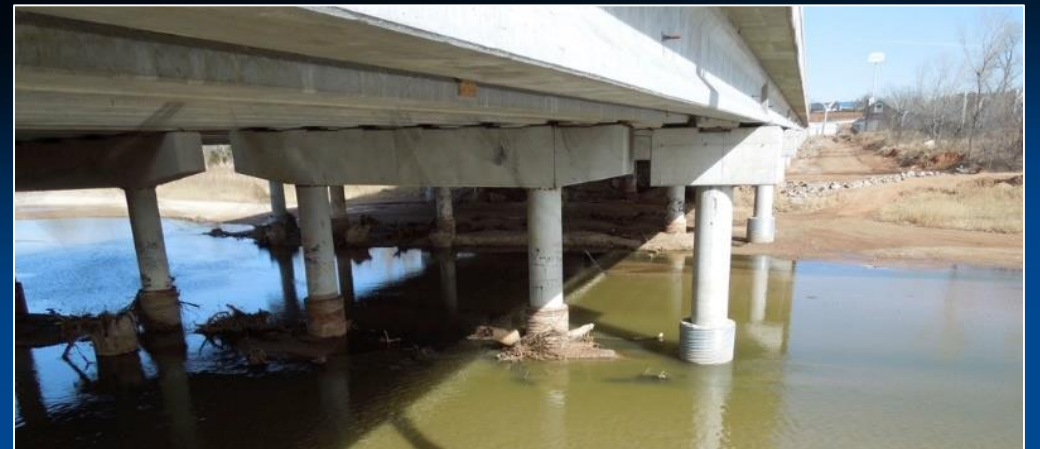
- I-35 over Canadian River (top)
- I-35 over Cimarron River (bottom right)
- SH-11 over I-35 (bottom left)

### Key findings:

- Validation of  $S_1$  trigger values
- Very low potential for liquefaction
- Bearings are most vulnerable to damage
- Transverse loading most critical
- Cost per bridge for site specific analysis:
  - \$21k for geotechnical
  - \$15k for structural
