# Fire Damage Inspection and Analysis for a Prestressed Concrete Girder Bridge

Matthew Harlan, PE  
David Evans and Associates, Inc.

- N. Vancouver Ave. over Columbia Slough
- Portland, OR
- 3-Span Prestressed BT72 girders with CIP Concrete Deck
- Built in 2011
- Large transient camps were present at both abutments
- Current bridge replaced an existing 14-span timber bridge
- The original bridge was severely damaged by a transient fire

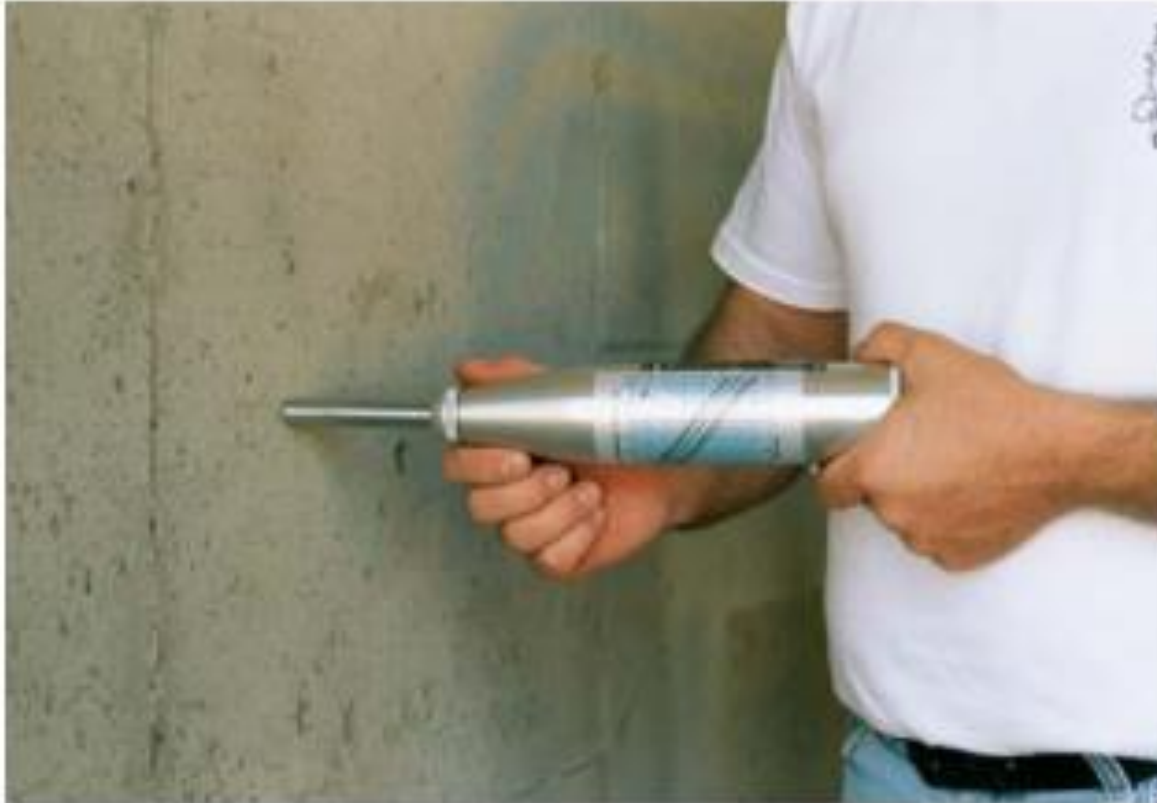
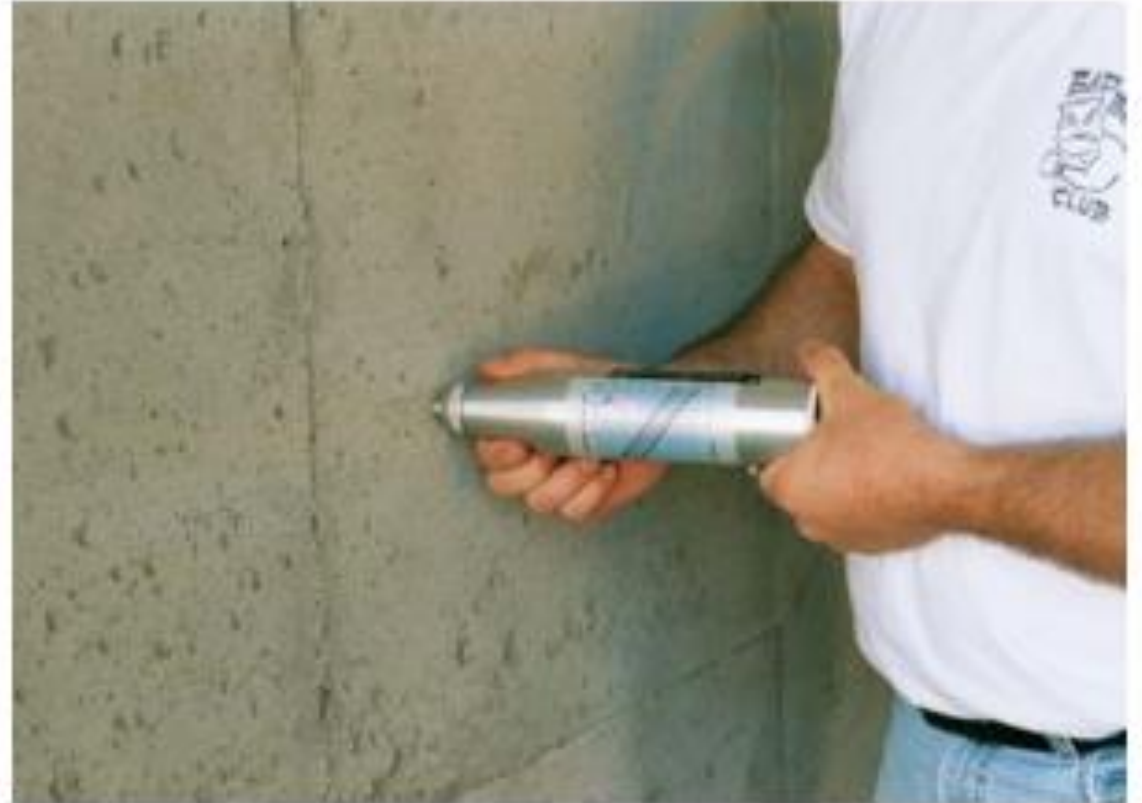
The tests can be performed in horizontal, vertically upward, vertically downward or any intermediate angled positions in relation to the surface (Figs 1 and 2). The devices are furnished with correlation curves by the manufacturer. ASTM C805 now states that these references to the relationship between the rebound number and compressive strength provided by the manufacturer "shall be used only to provide indications of relative concrete strength at different locations in a structure." To obtain greater accuracy of test results, it is

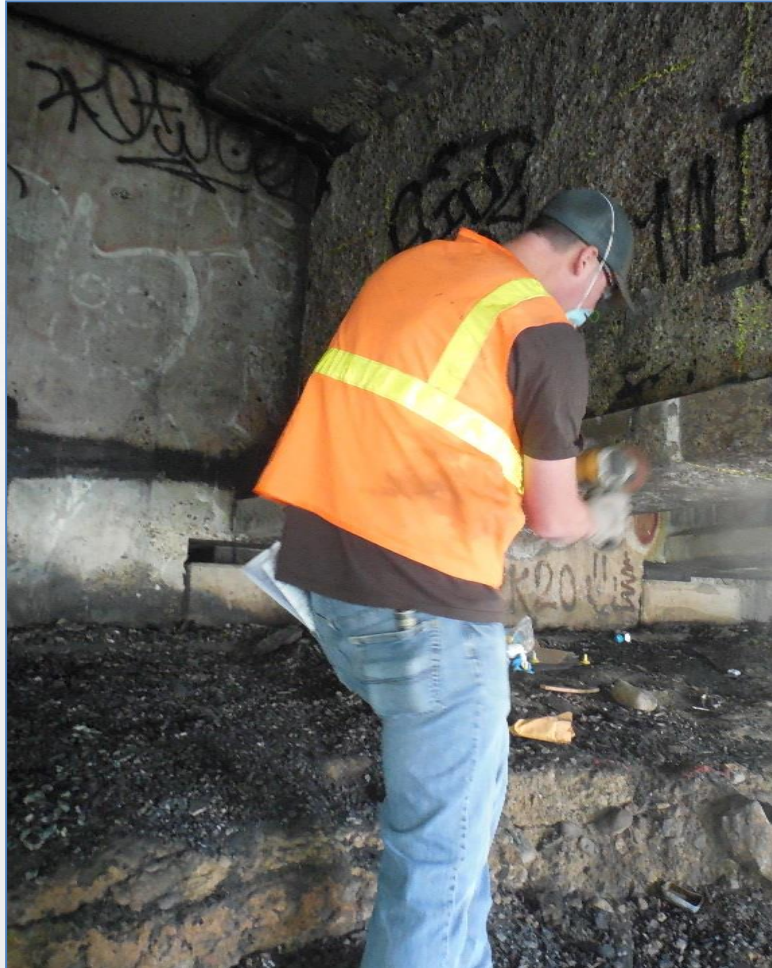
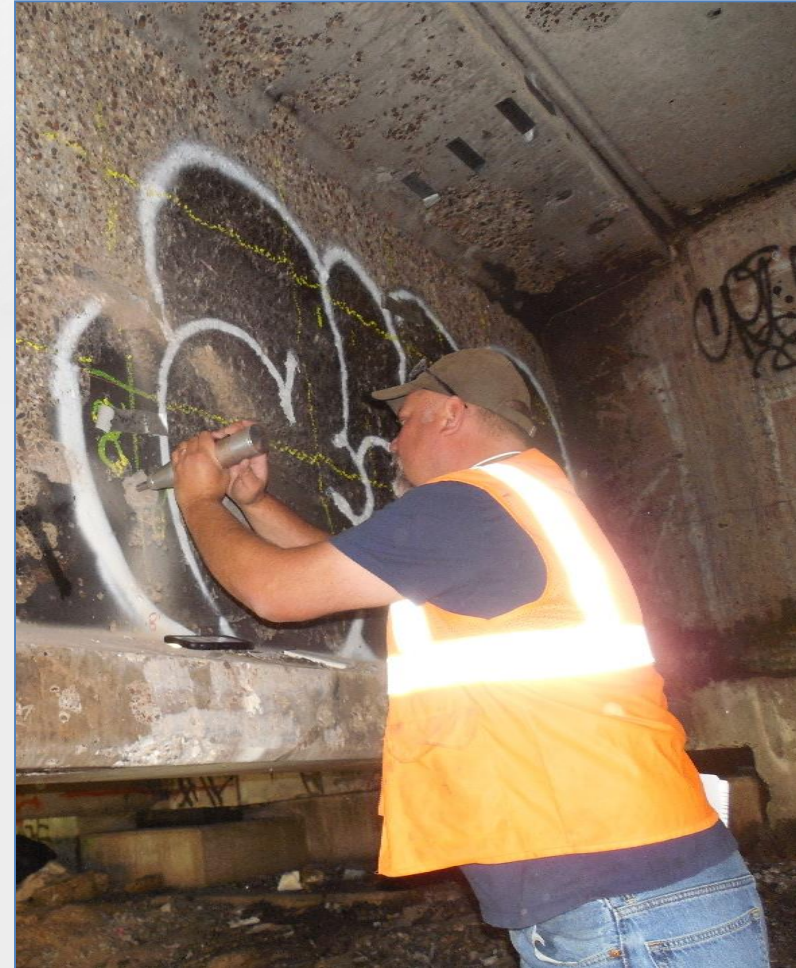
- Northwest Geotech, Inc. / Northwest Testing, Inc.
- Bottom flange, web, top flange, and deck
  - Damaged girders and a non-damaged girder
- Results were used to investigate any loss of concrete compressive strength of the fire damaged areas

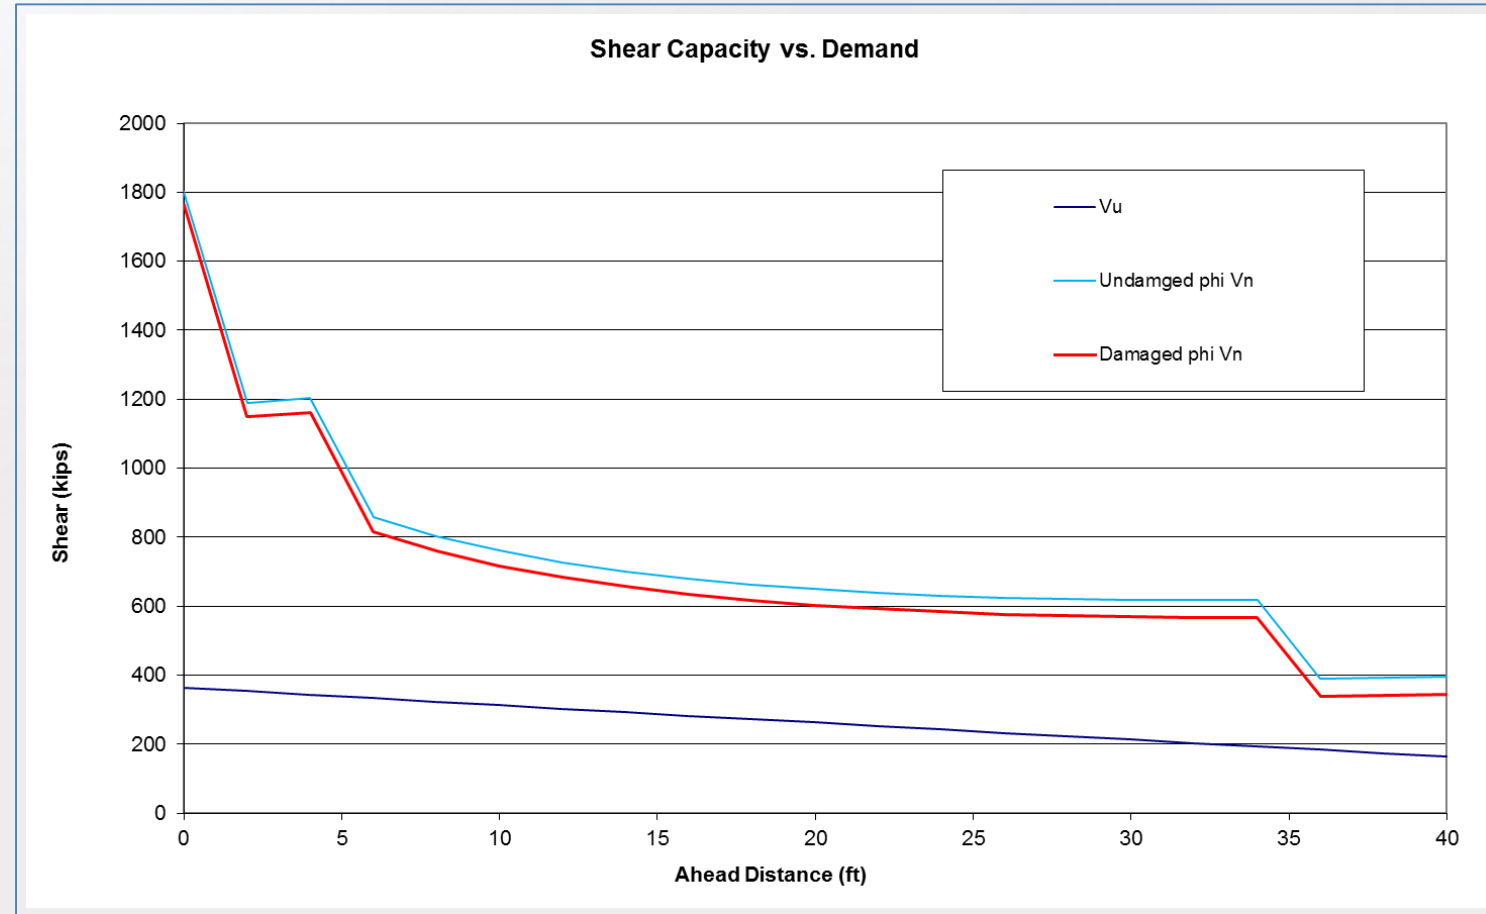
- Shear Strength – ***Adequate Reserve Capacity***
