Evaluation Methods for Preservation of Bridge Decks

Brian Pailes and J. Chris Ball

Vector Corrosion Services

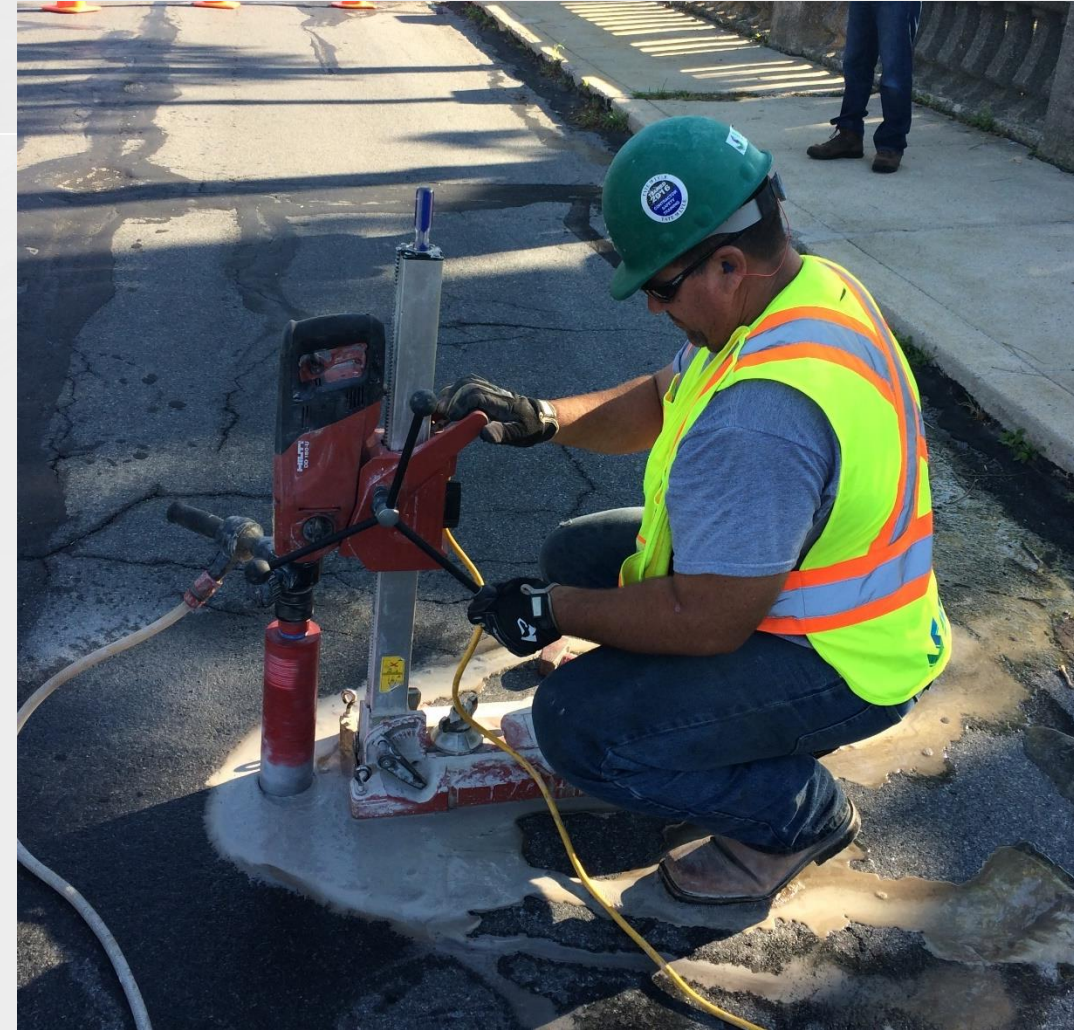
Typical Concrete Coring

- Compressive strength
 - ASTM C43 – Proper collection of the cores
 - ASTM C39 – Compressive strength test
- Chloride concentration
- Carbonation depth
- Petrographic analysis

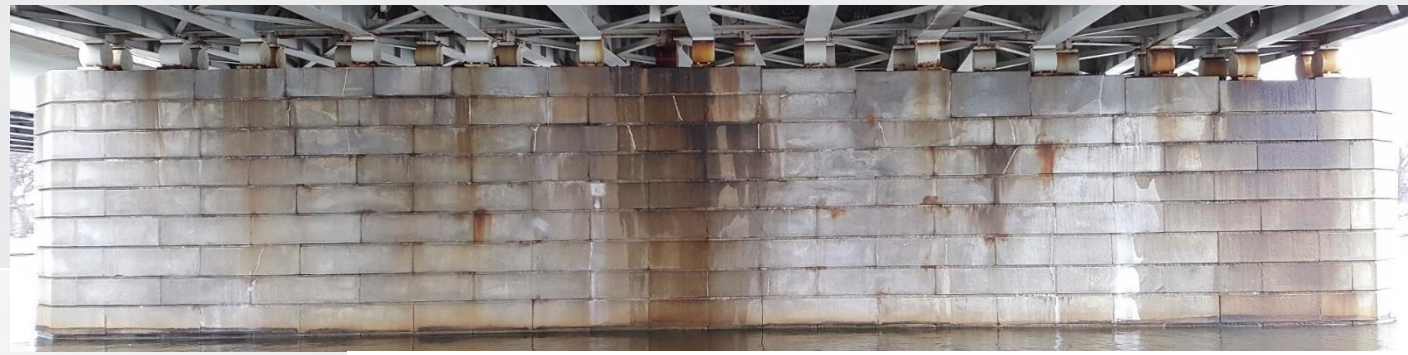
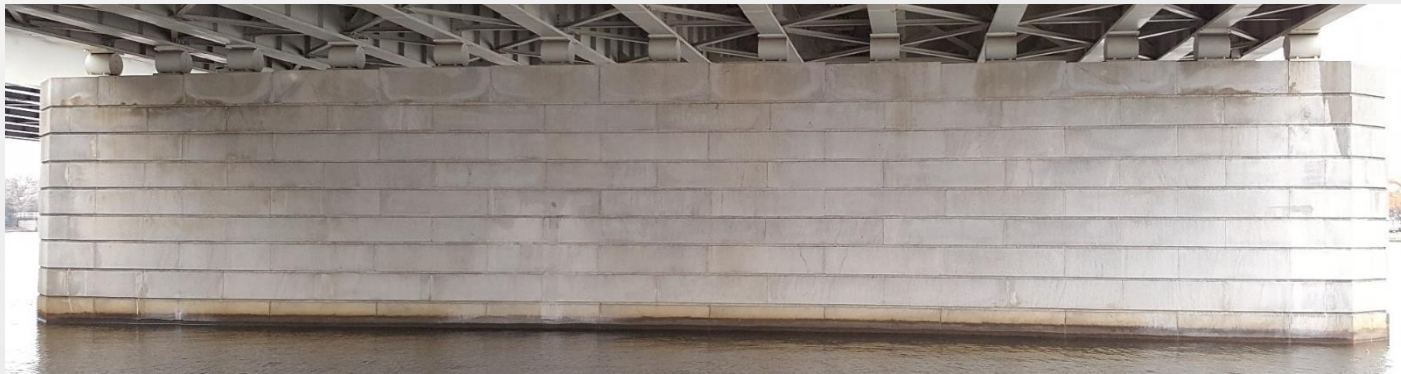
Deck Joint

- Location and condition of deck joints have a profound affect on substructure elements

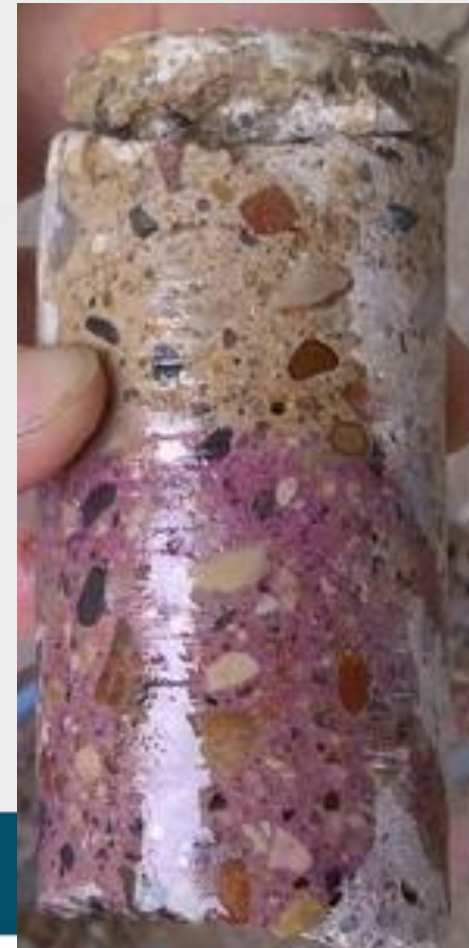
Carbonation Depth

- Carbon dioxide permeates into concrete
- Reduces pH of concrete
 - CO₂ reacts with free lime, Ca(OH)₂, resulting in CaCO₃ and H₂O
- Reduced pH de-passivates steel
- Often seen when
 - Concrete permeability is high
 - Industrial sites
 - Very old structures – carbonation is a result of time and exposure

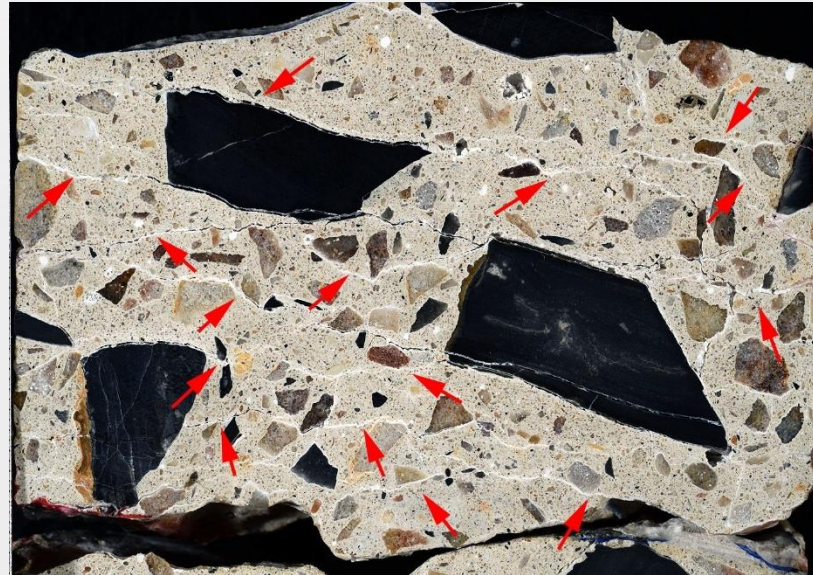
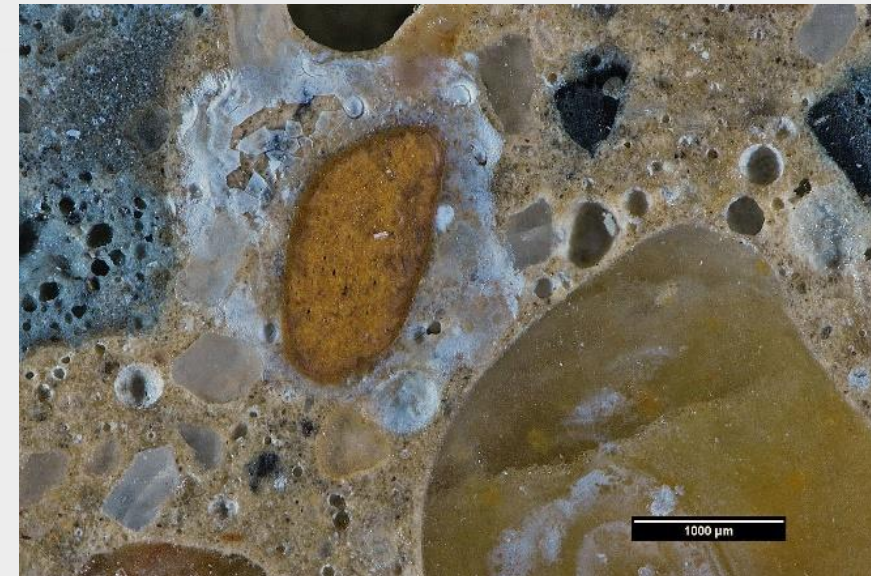
Petrography

- ASTM C856
- Identify chemical characteristics of concrete
 - Air entrainment
 - Supplemental cementitious materials
 - Reactive aggregate

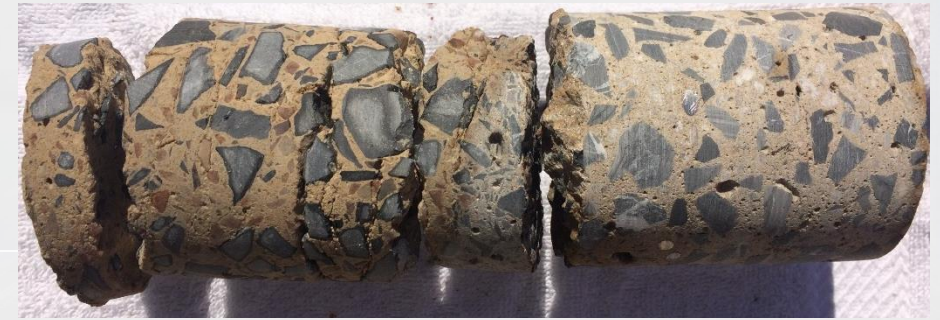
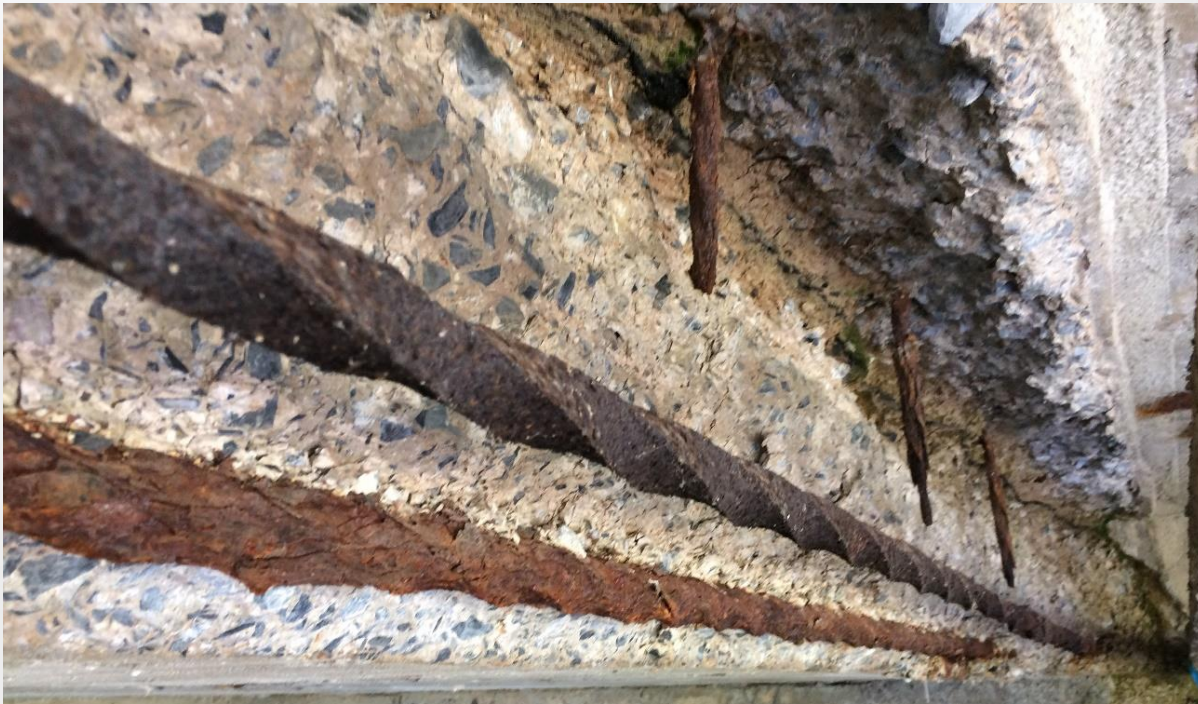
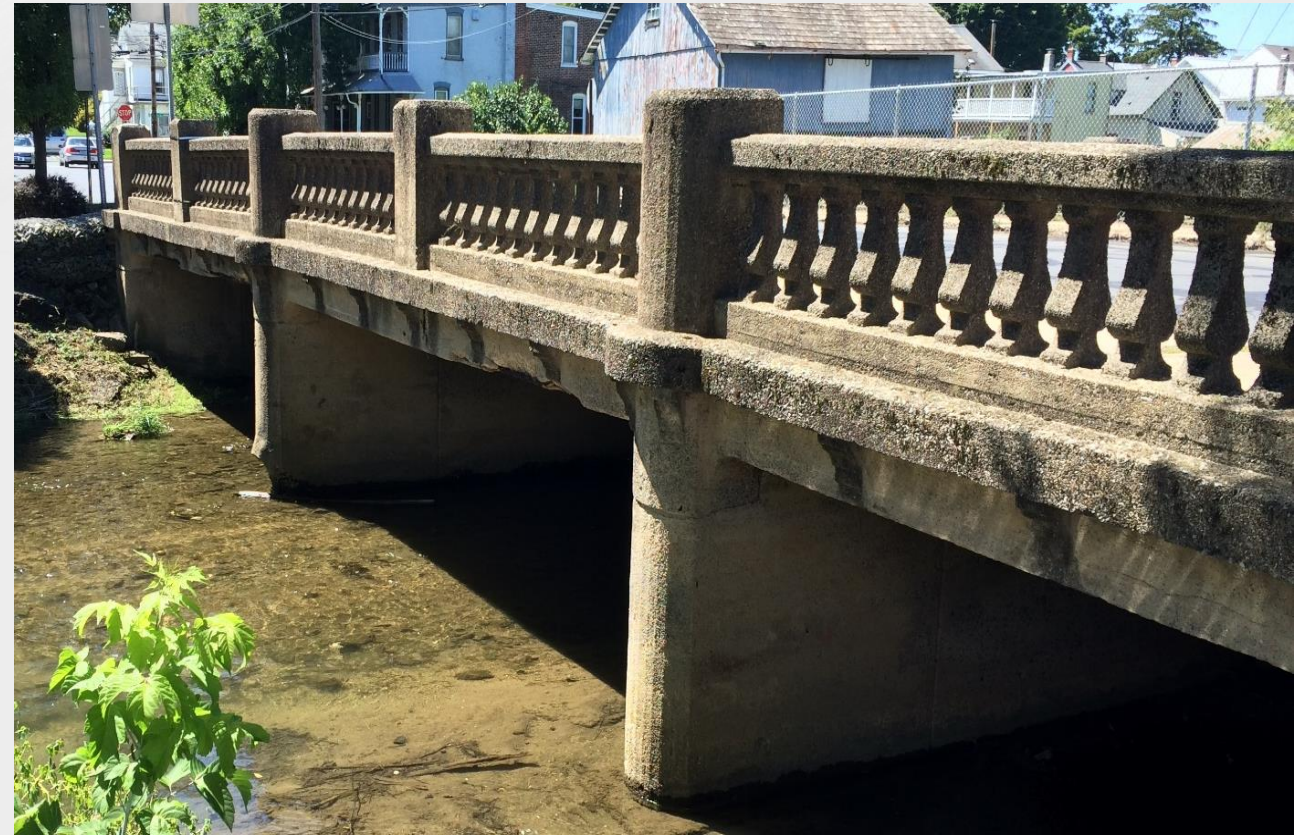
Peach St Bridge

- Freeze thaw damage lead to major deterioration and extensive corrosion activity

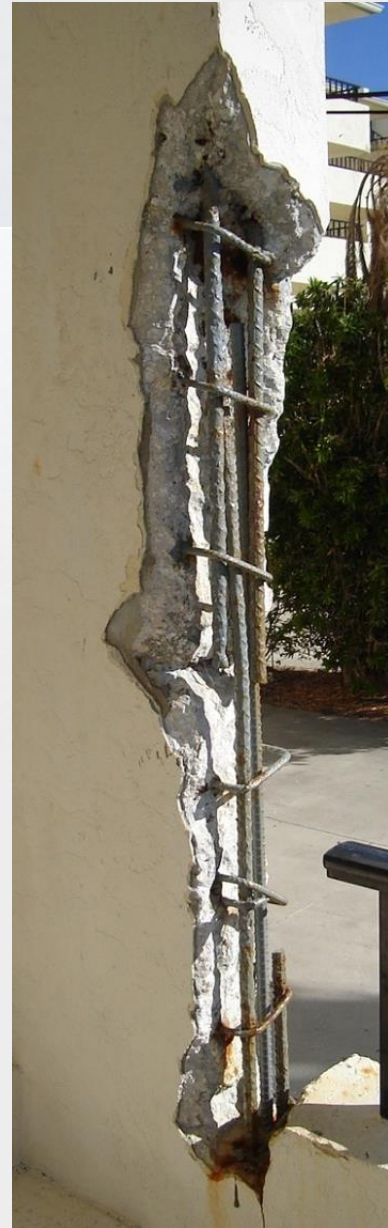
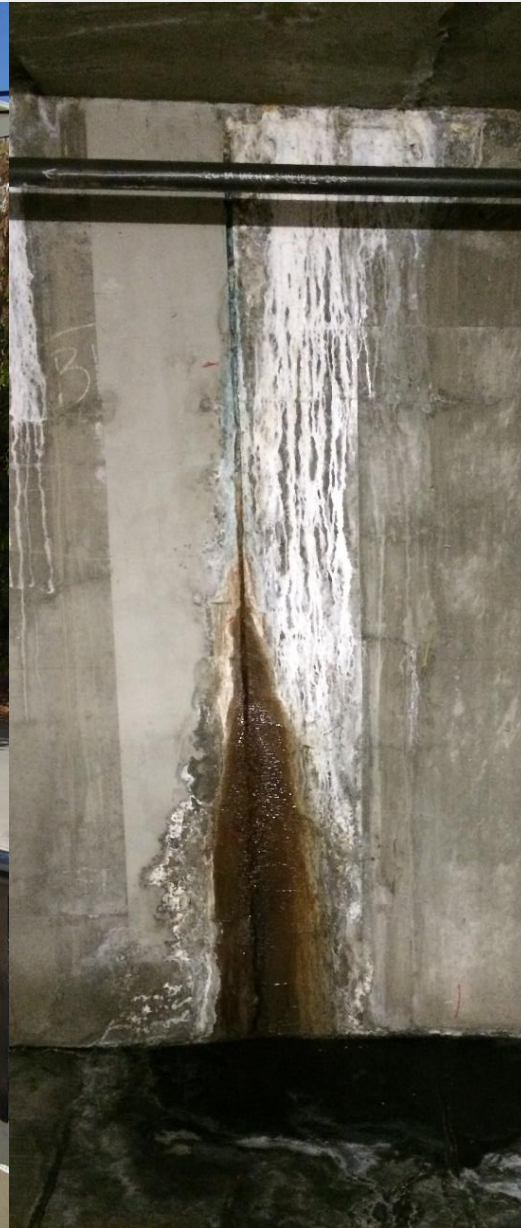
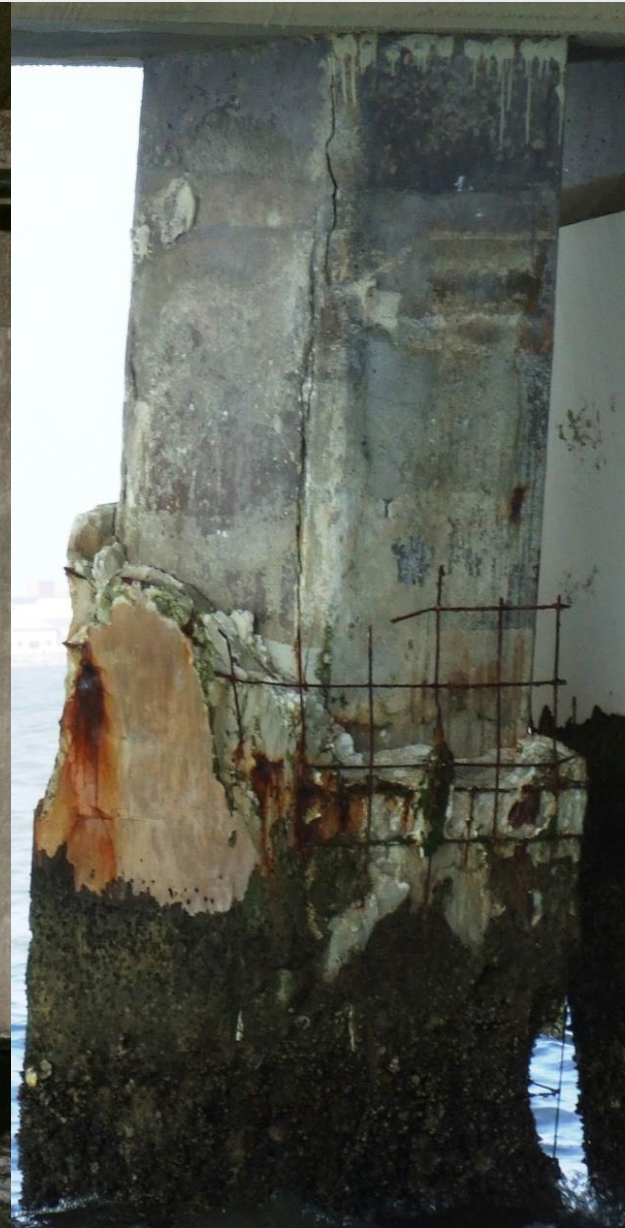
Visual Inspection

- Identify areas of visual damage
 - Rust staining
 - Cracking
 - Spalls
 - Exposed steel
 - Water infiltration
 - Efflorescence
- Note exposure conditions and other observations

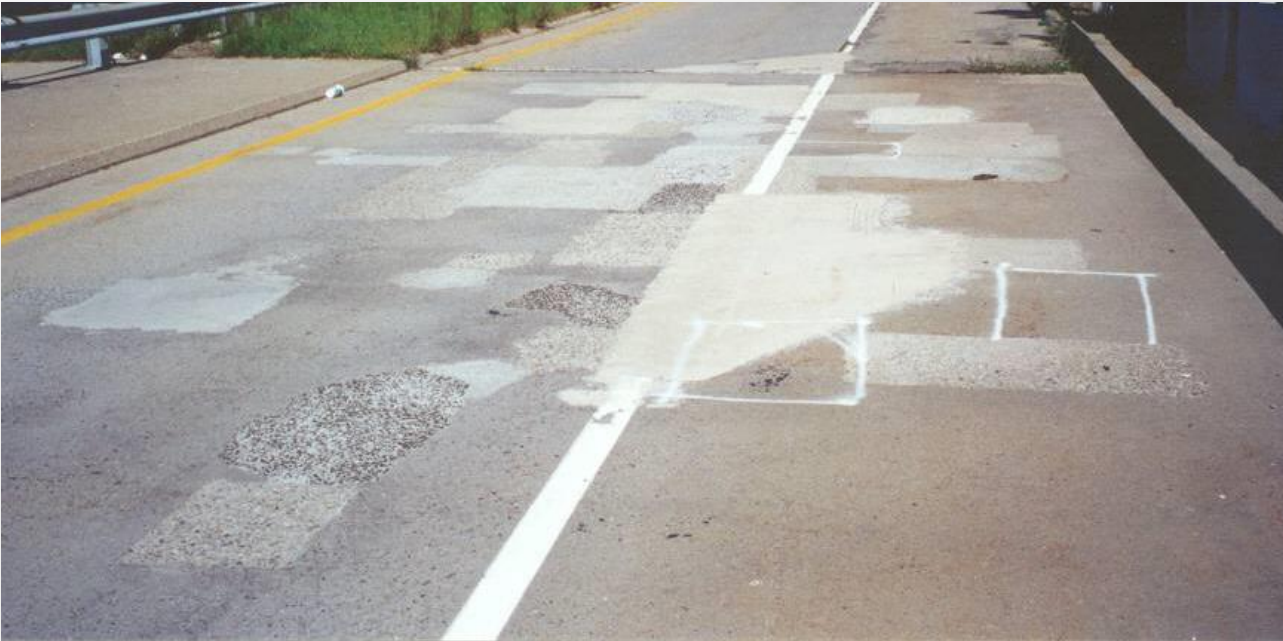
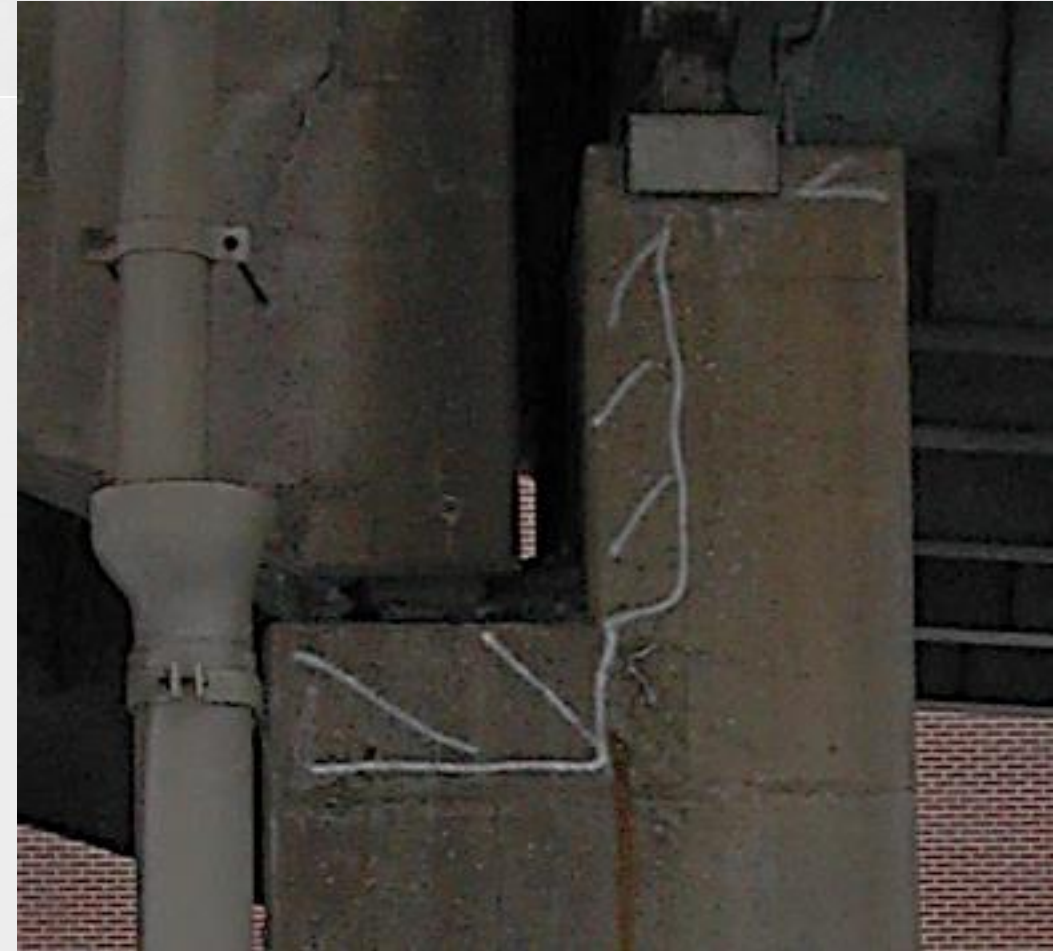
Chain Drag/Hammer Sounding

- Identifies delaminations
 - Late stage, large, near surface delaminations

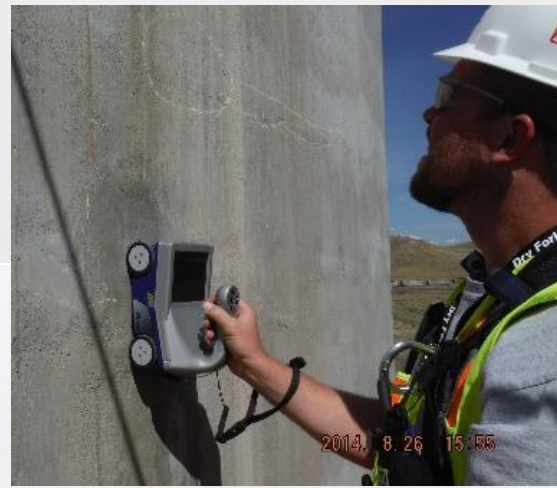
Ground Penetrating Radar

- Electromagnetic evaluation of concrete
 - Reinforcement layout
 - Location of embedded metals
 - Cover-depth
 - Qualitative condition of reinforced concrete
 - Chlorides, moisture, and concrete deterioration attenuate GPR signal

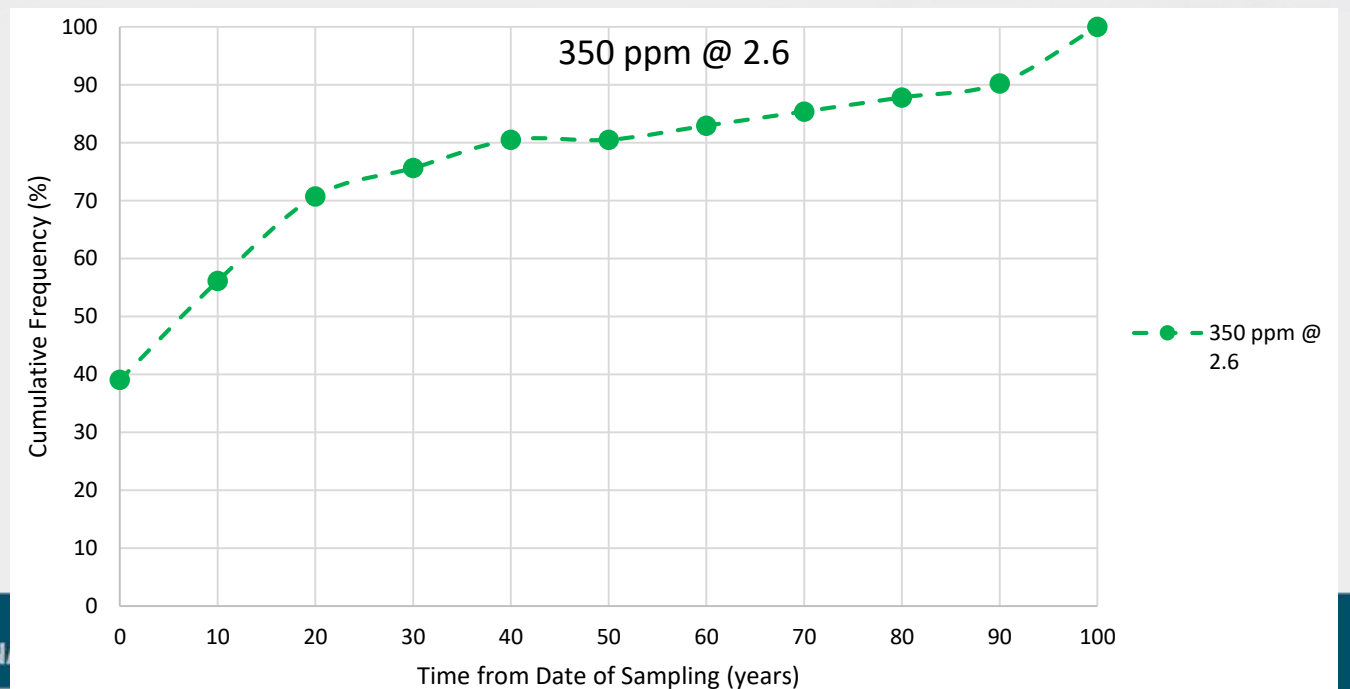
Service Life Analysis

- Cover-depth and chloride concentration are critical inputs regarding service life analysis
 - Calculate diffusion coefficient
- How much of the steel has reached chloride threshold?
- How will that increase over time?

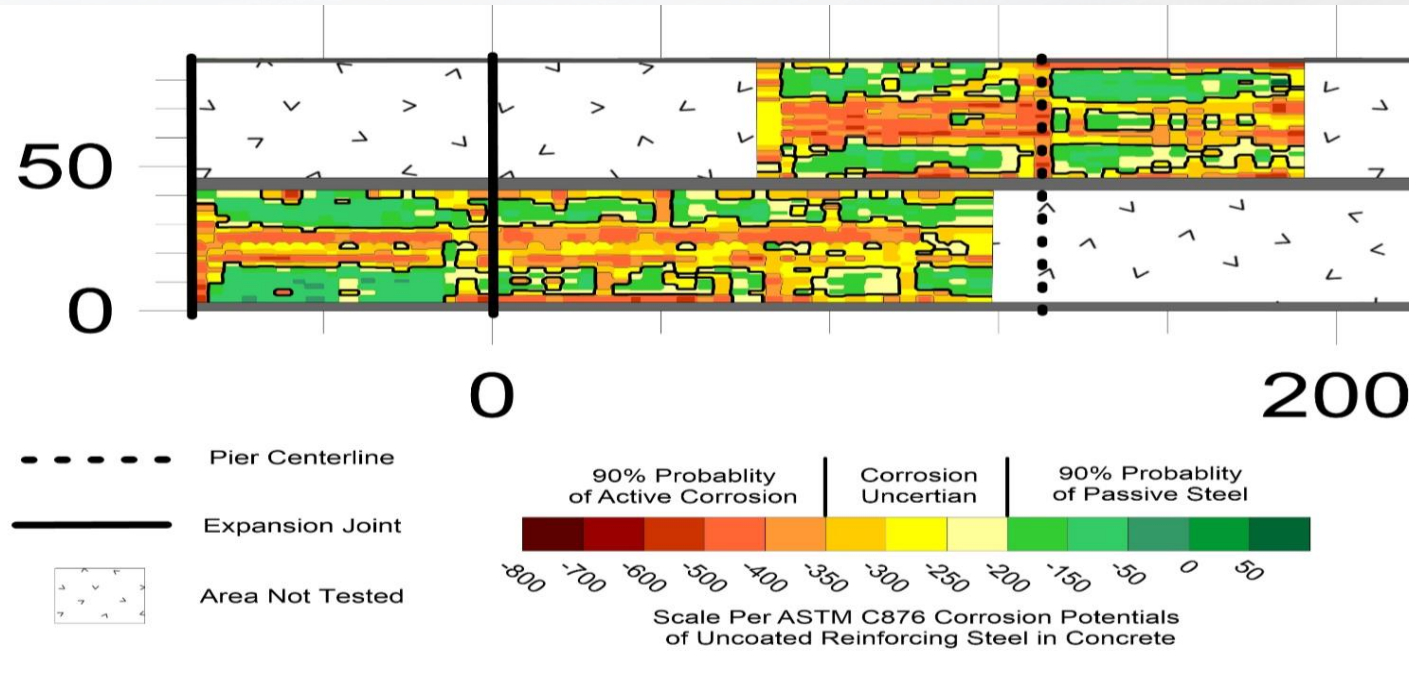
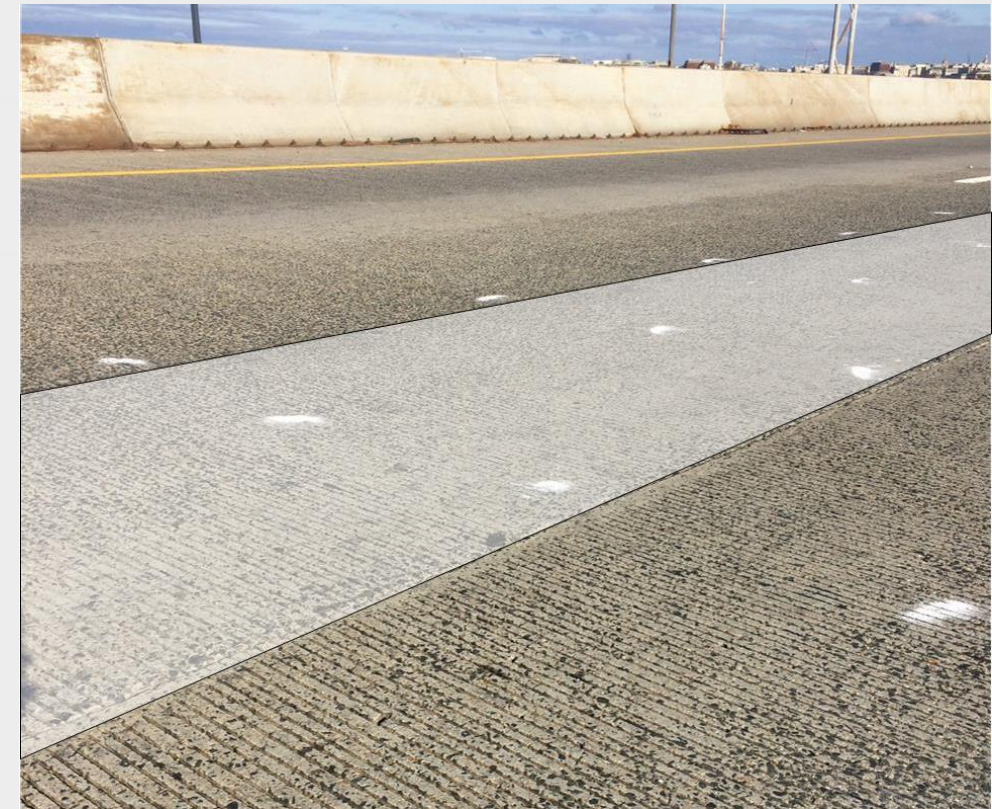
Corrosion Potential Survey

- Corrosion survey of a bridge in Washington DC

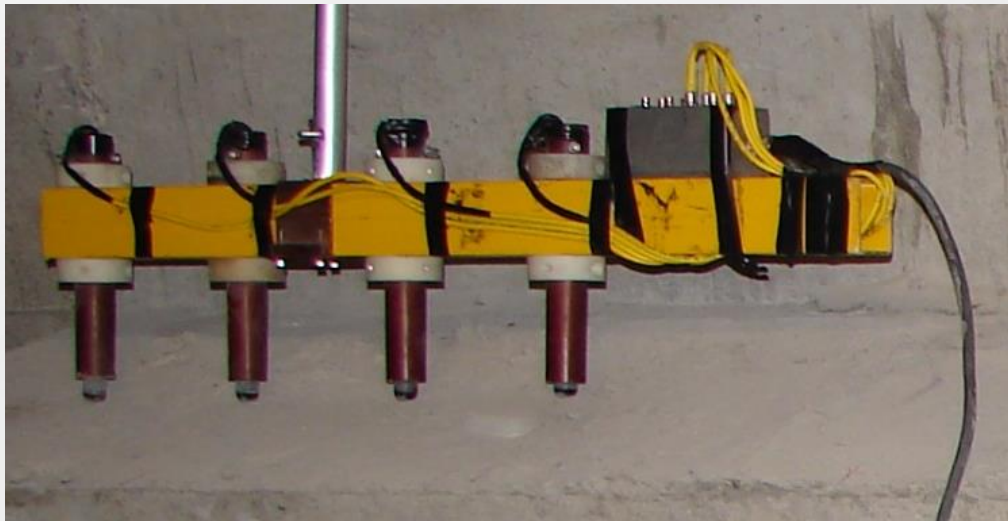
Impact Echo

- Identify thickness of a slab
- Defects will affect the apparent thickness

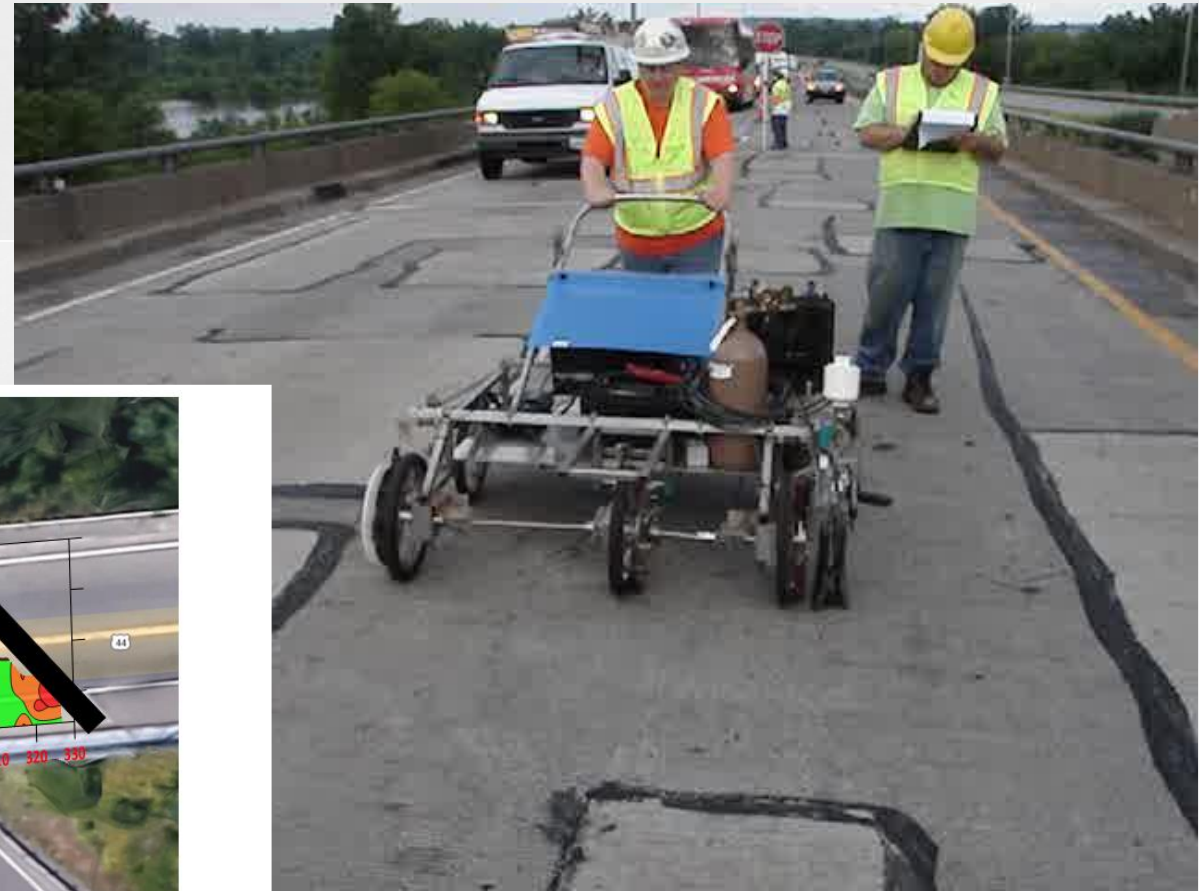
IE Deck Testing

- DELAMINATION AREA

- EXPANSION JOINT

NONDESTRUCTIVE TESTING
HARDING STREET ROUTE 44
BRIDGE OVER I-495

CONTOUR PLOT OF RESULTS

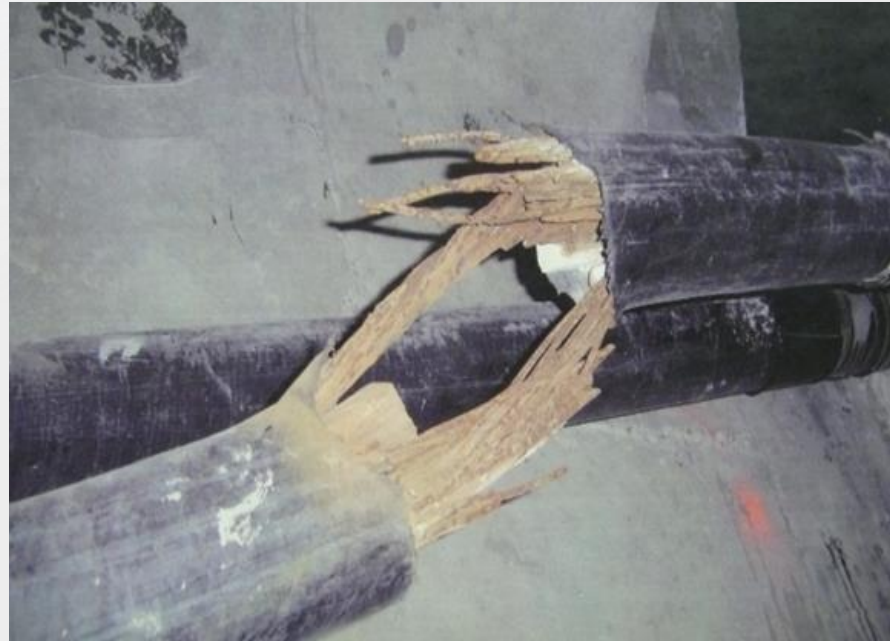
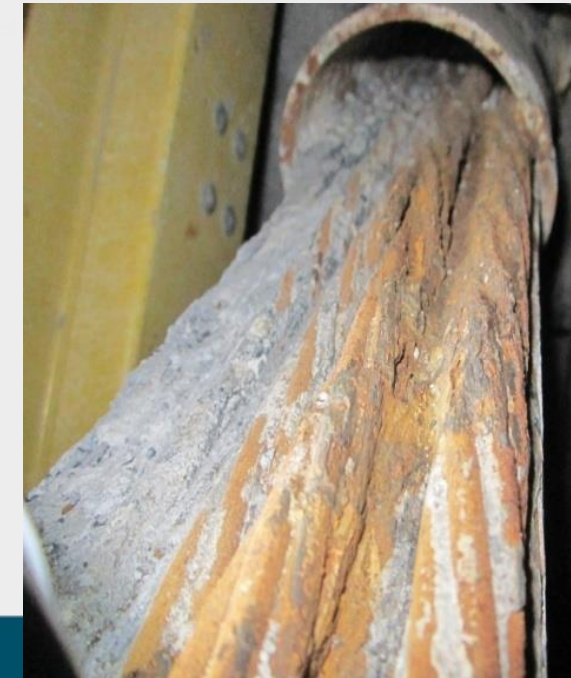
Post Tension Grout Inspection with Impact Echo

- Identify issues like soft grout
- Water or air voids

Fully Grouted Duct
Resonant Frequency = 8,500 Hz

Soft Grout or Voided Duct
Resonant Frequency = 7,000 Hz

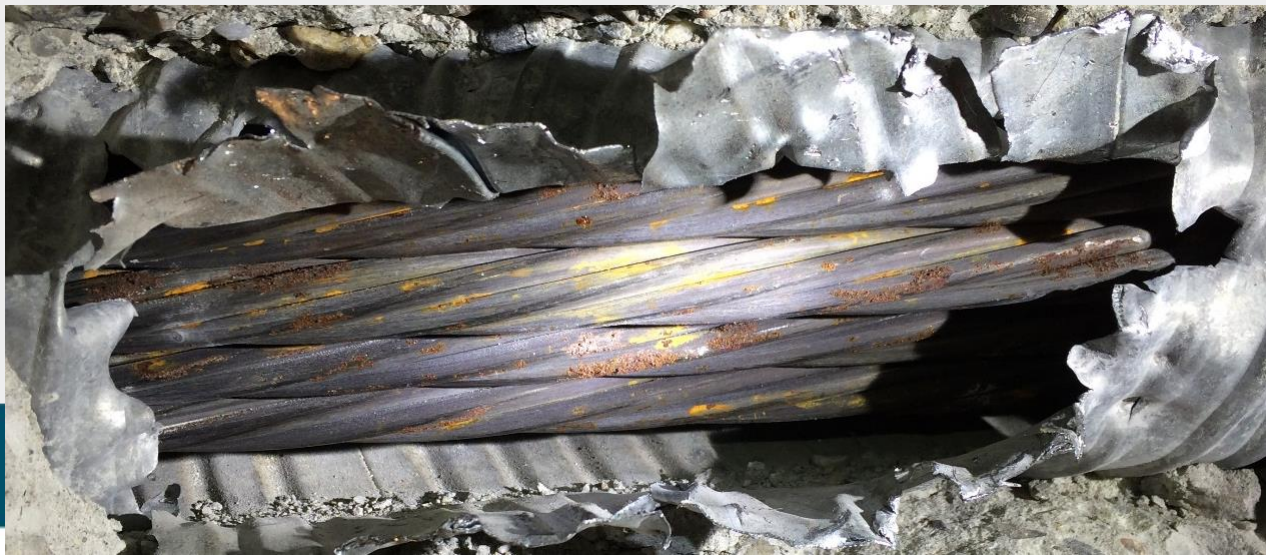
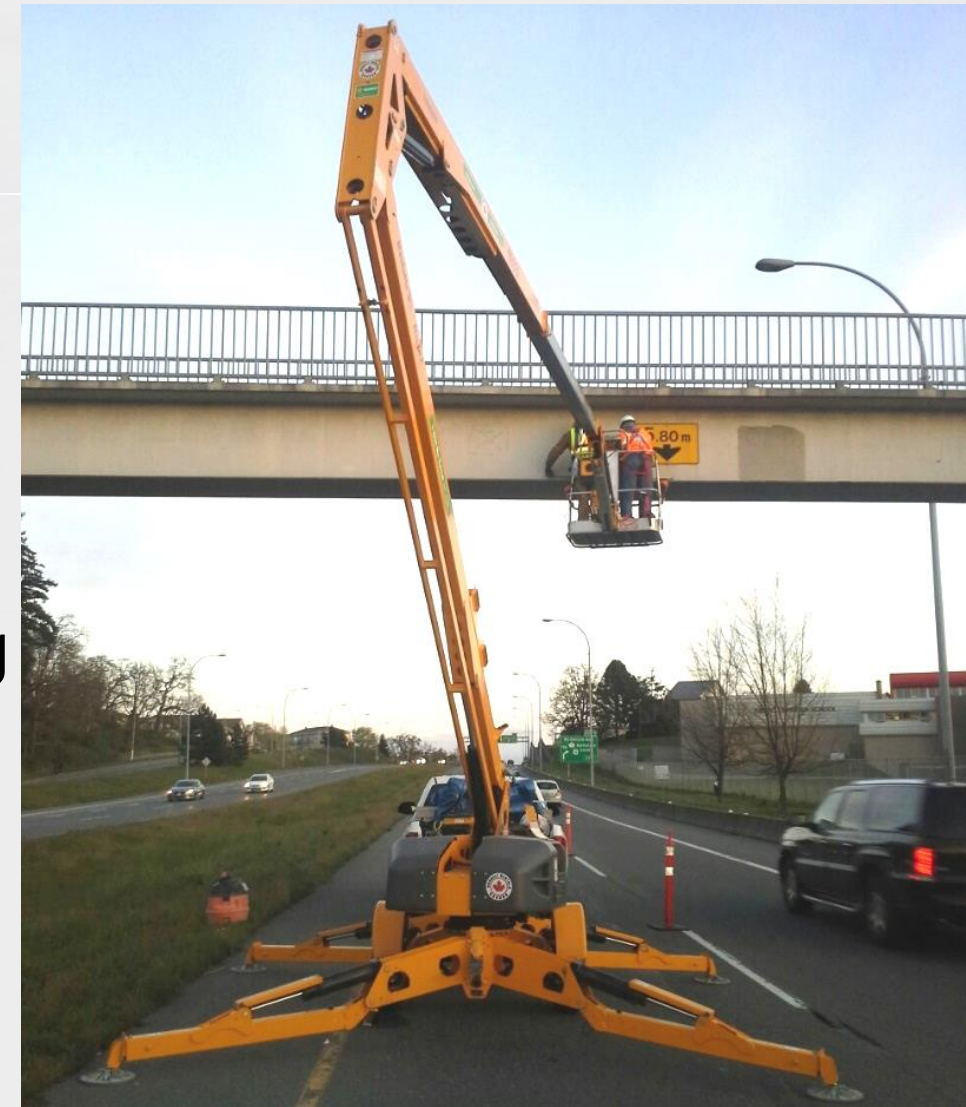
Rogers Overpass

- Pedestrian overpass in Victoria British Columbia
 - 4 PT tendons
- Construction inspector noted that contractor may have made a mistake during PT grouting
