Retaining Walls

Preservation Discussion

NATIONAL BRIDGE PRESERVATION PARTNERSHIP CONFERENCE 2018

PRACTICES WE CAN NOT AFFORD TO DEFER

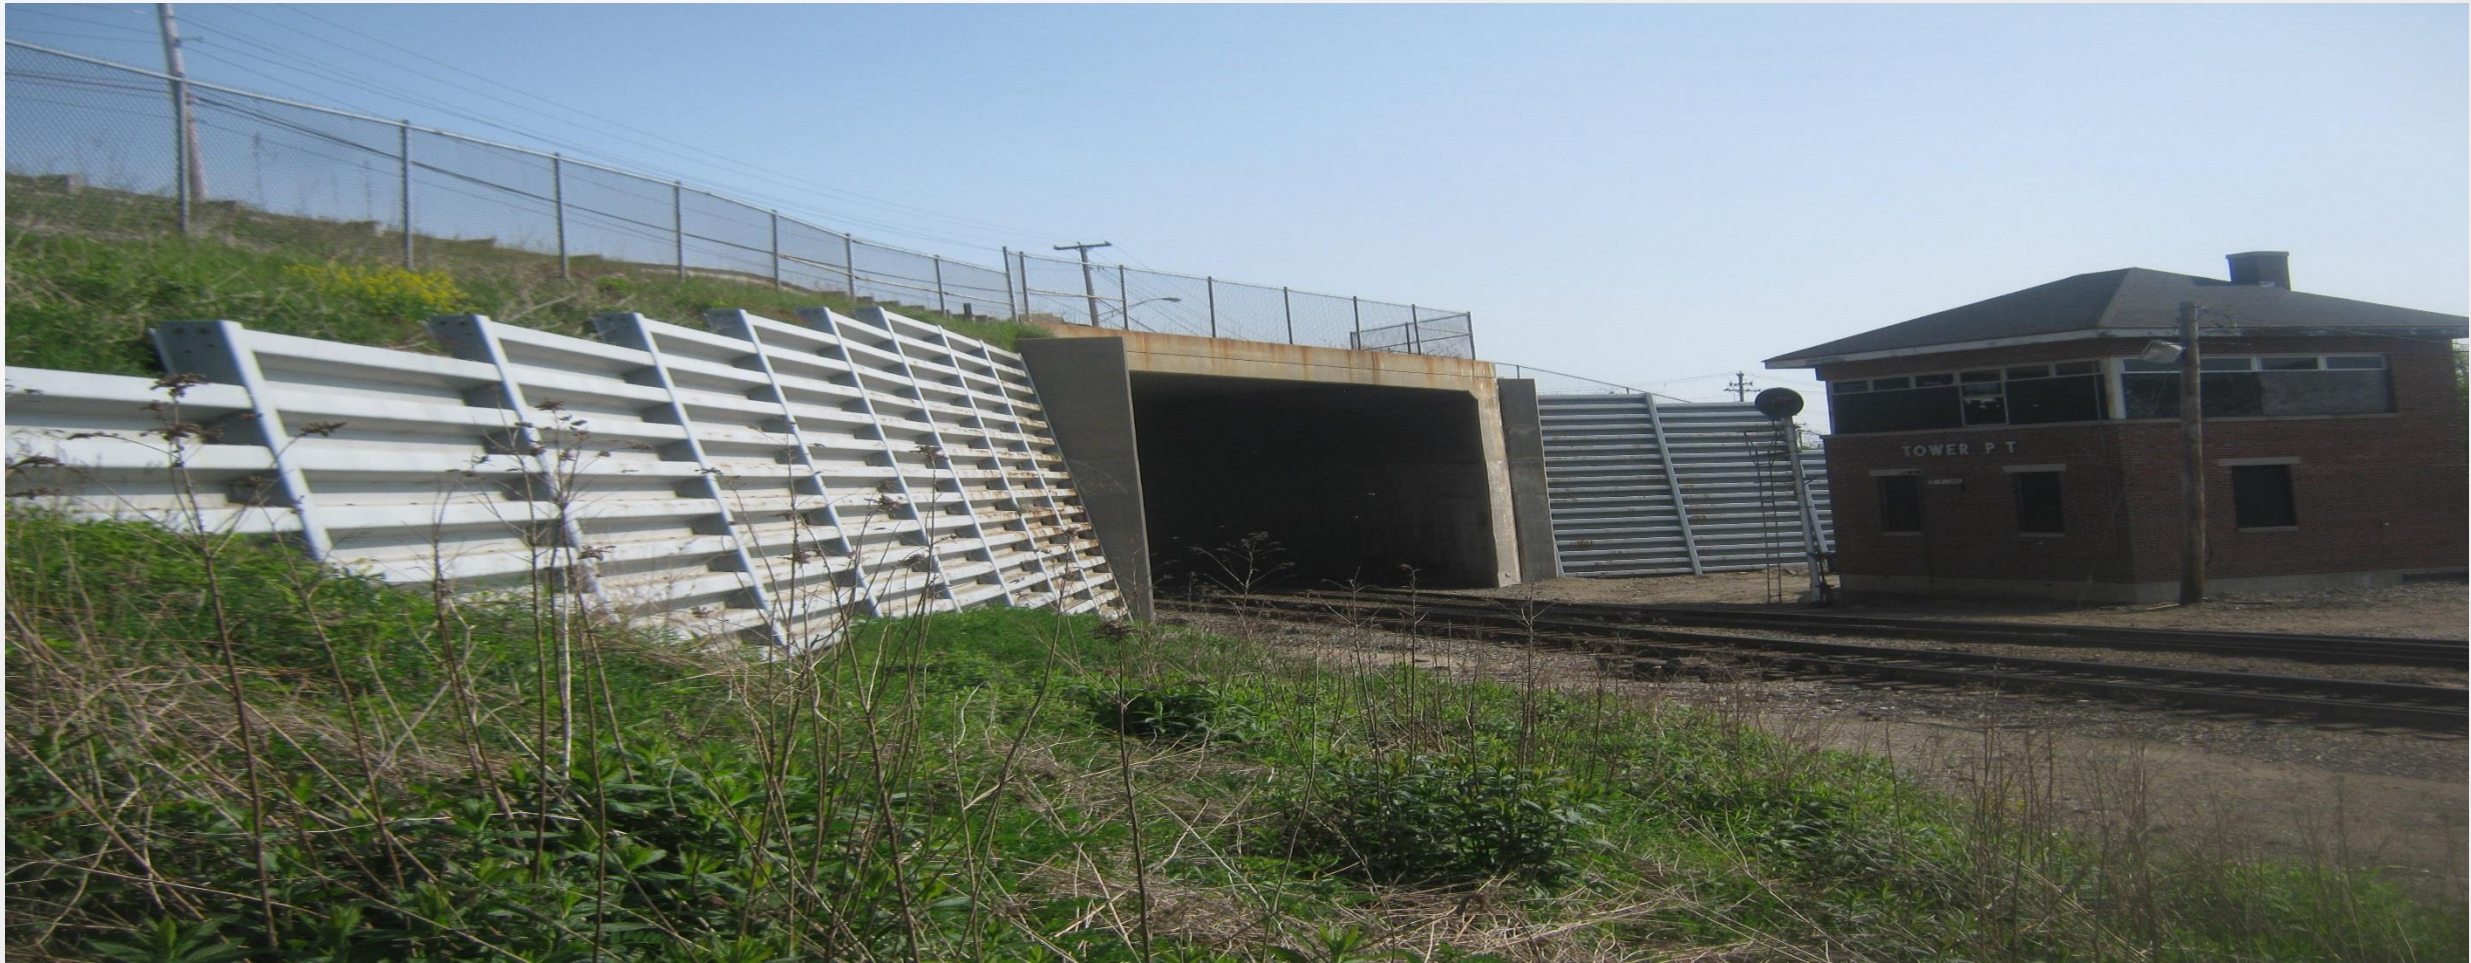
Metal Bin Walls

- Several were built in 70's and 80's
- Cellular construction
- Deteriorates from back forward

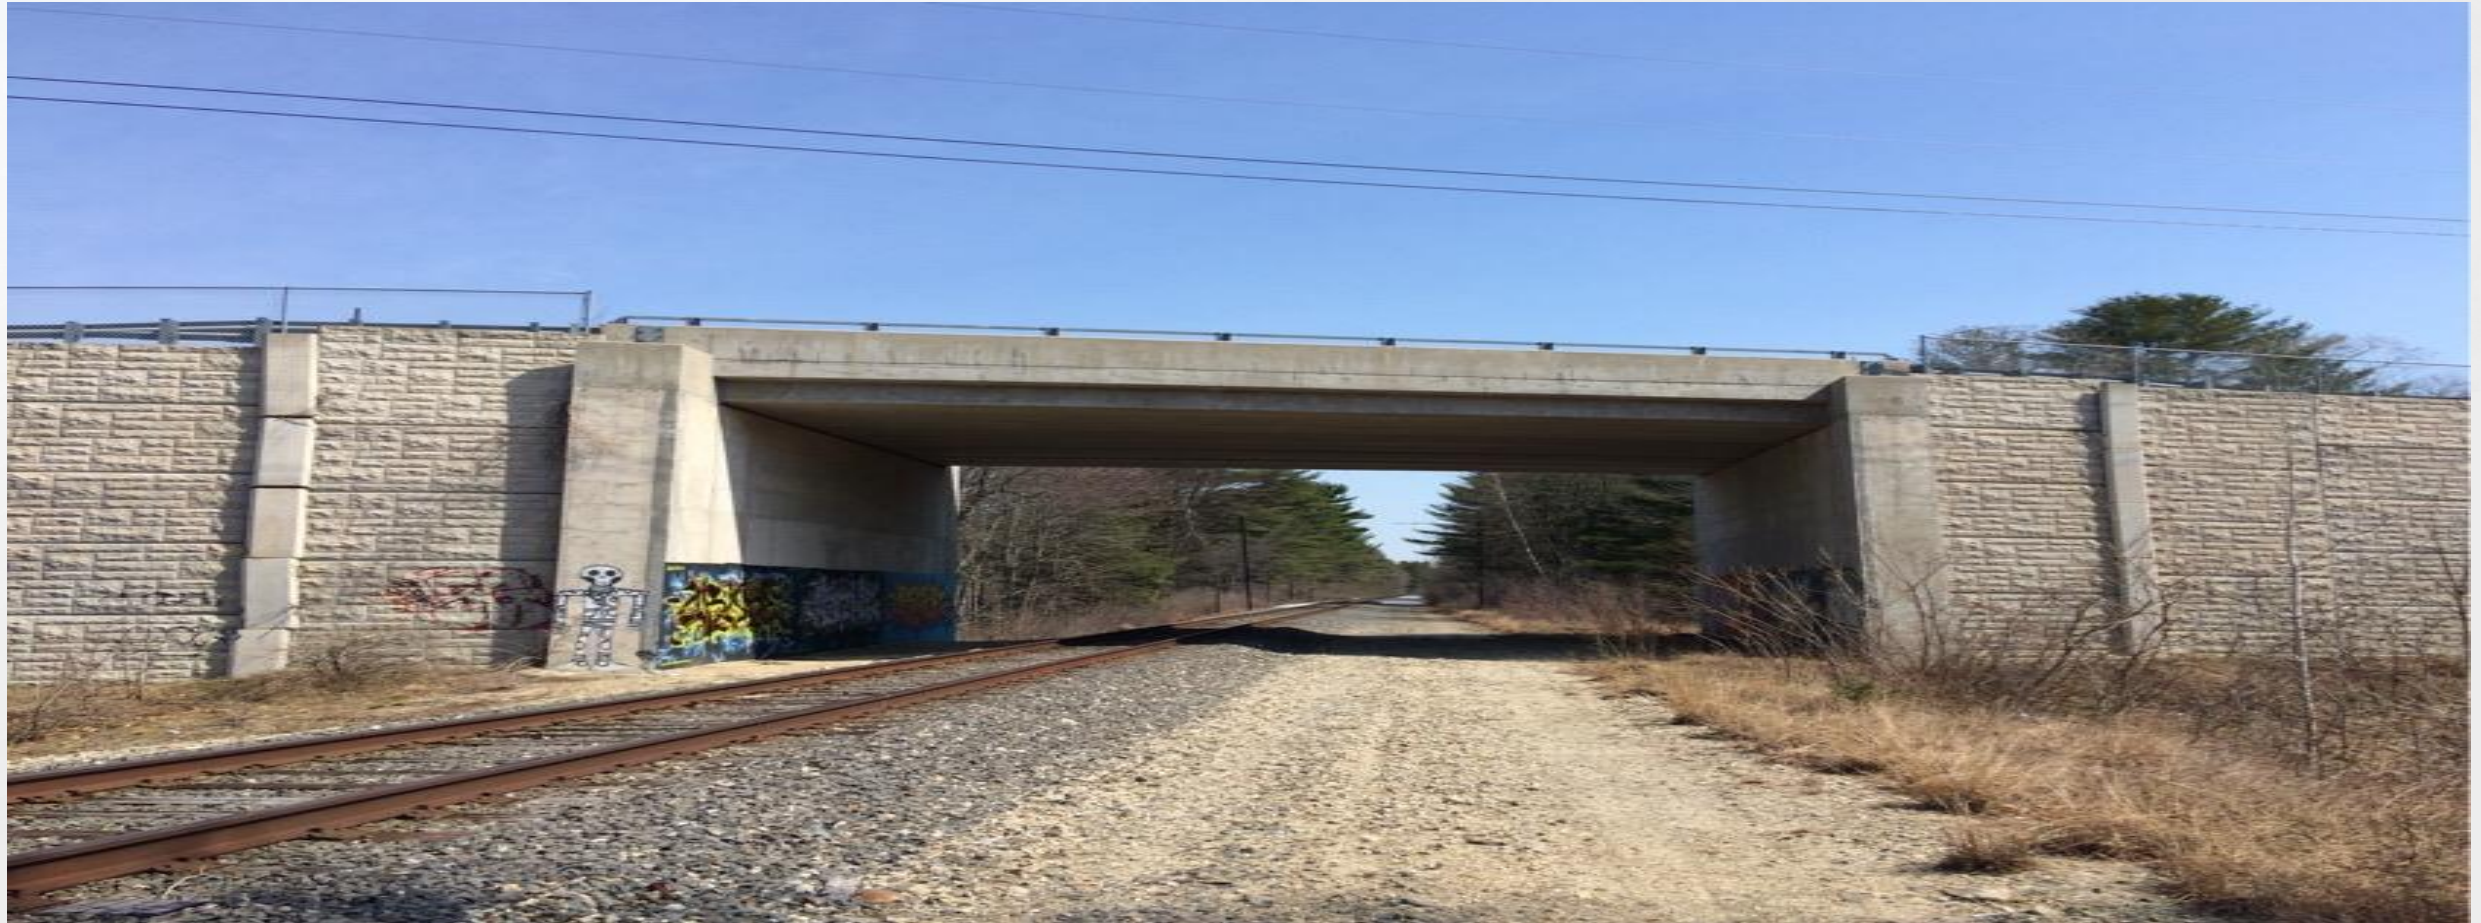
MSE Walls

- Precast Concrete Panels
- Metal Straps or Plastic Mesh

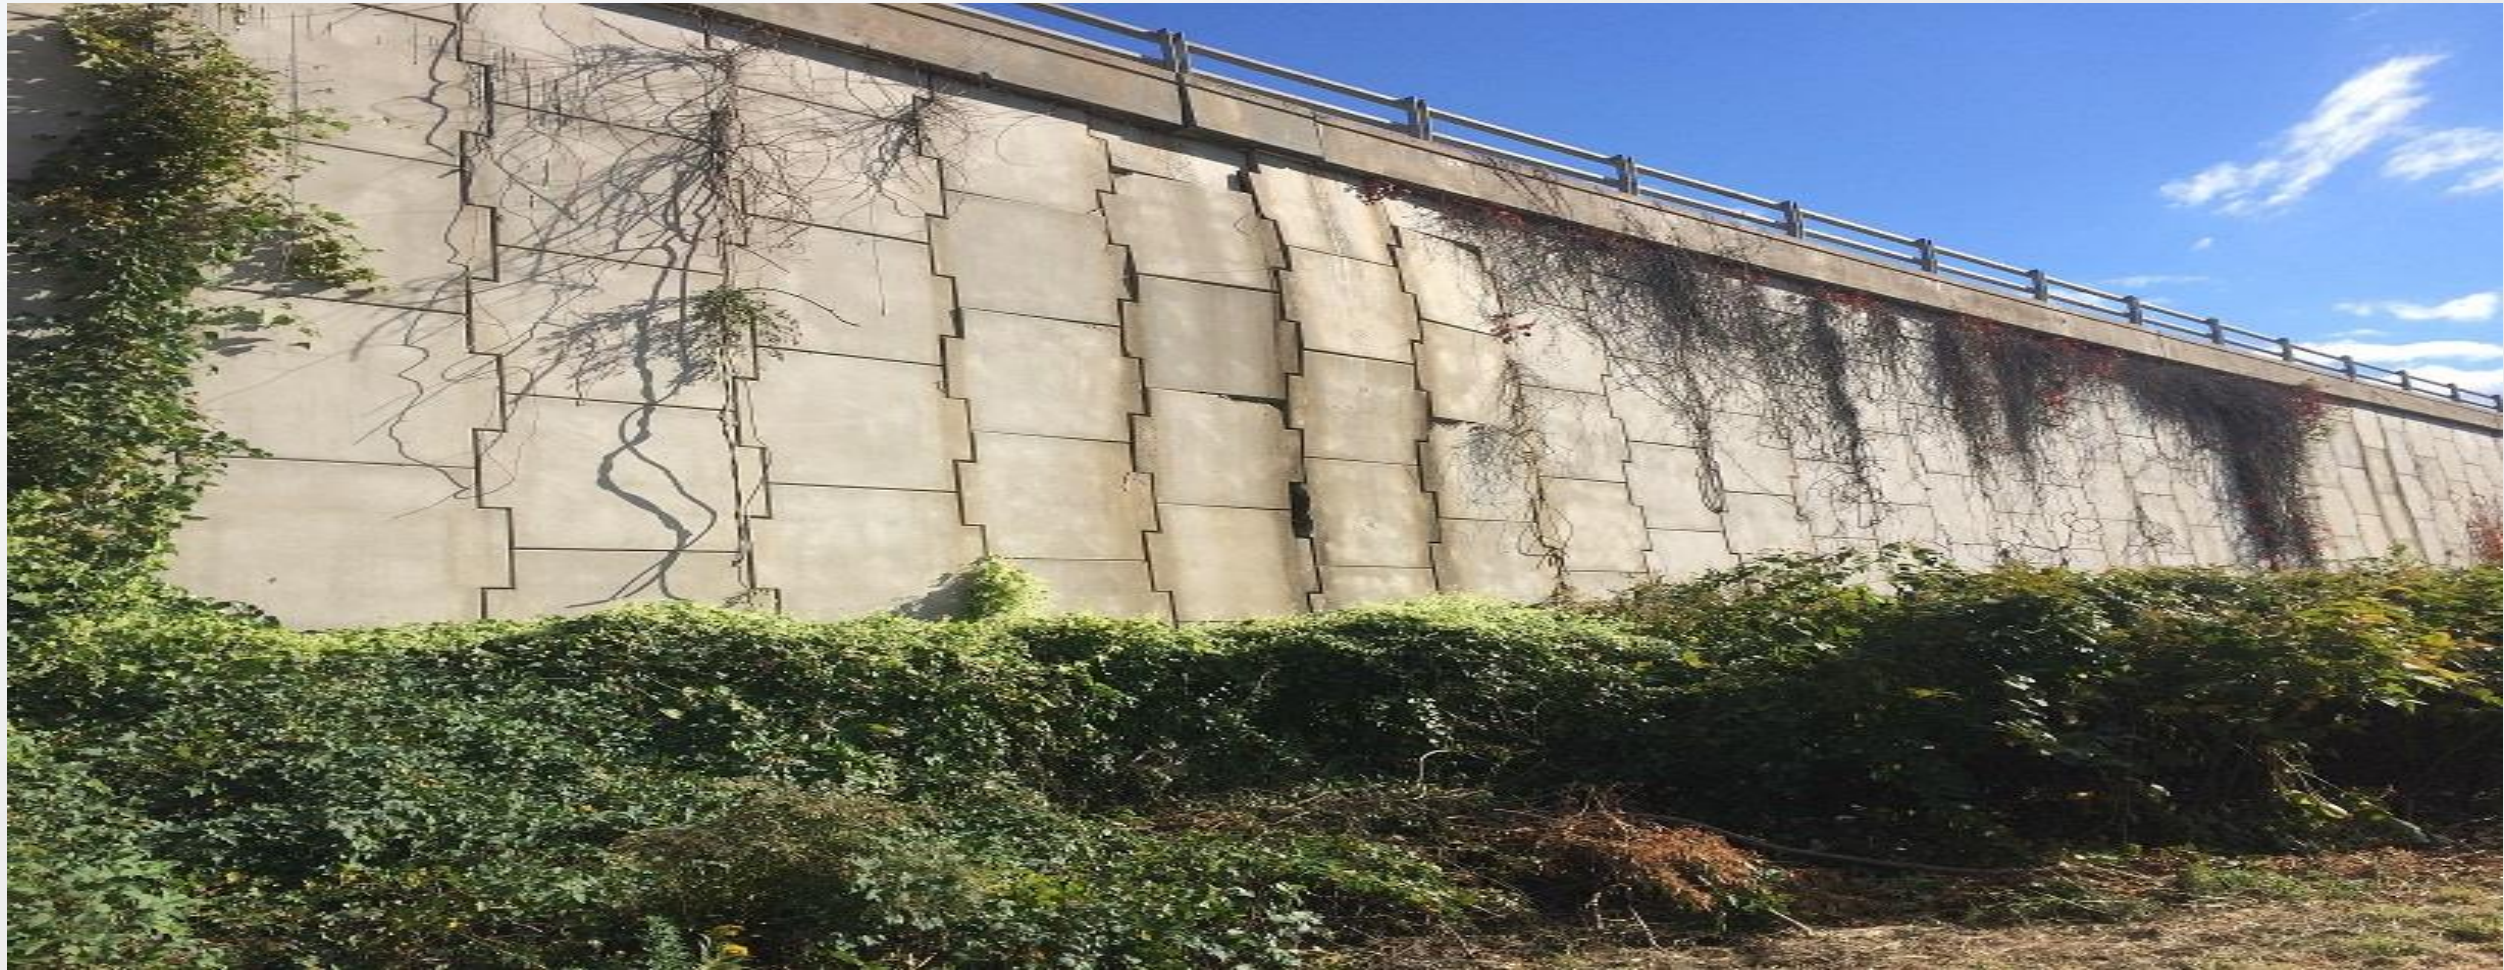
Starting to Bulge

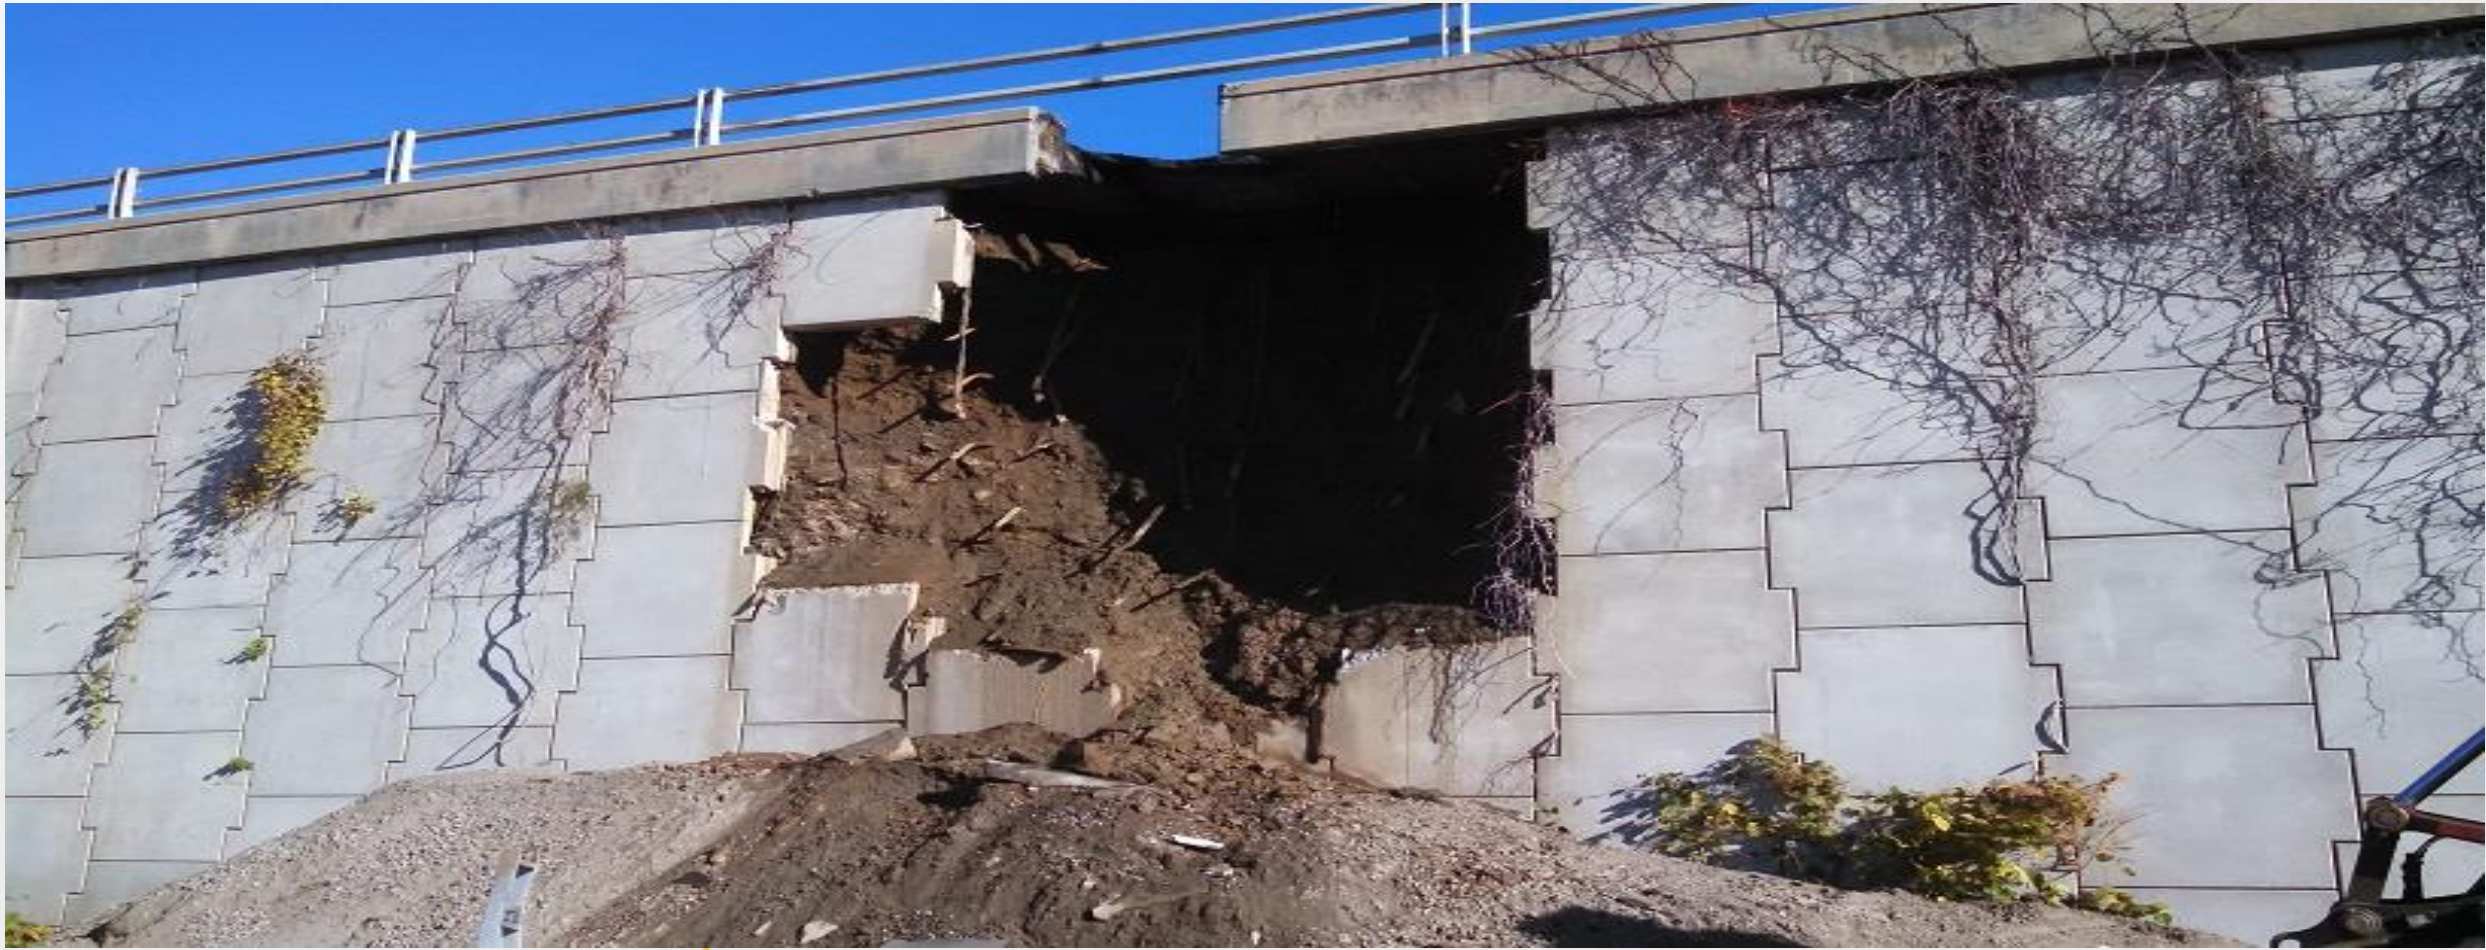
Failure

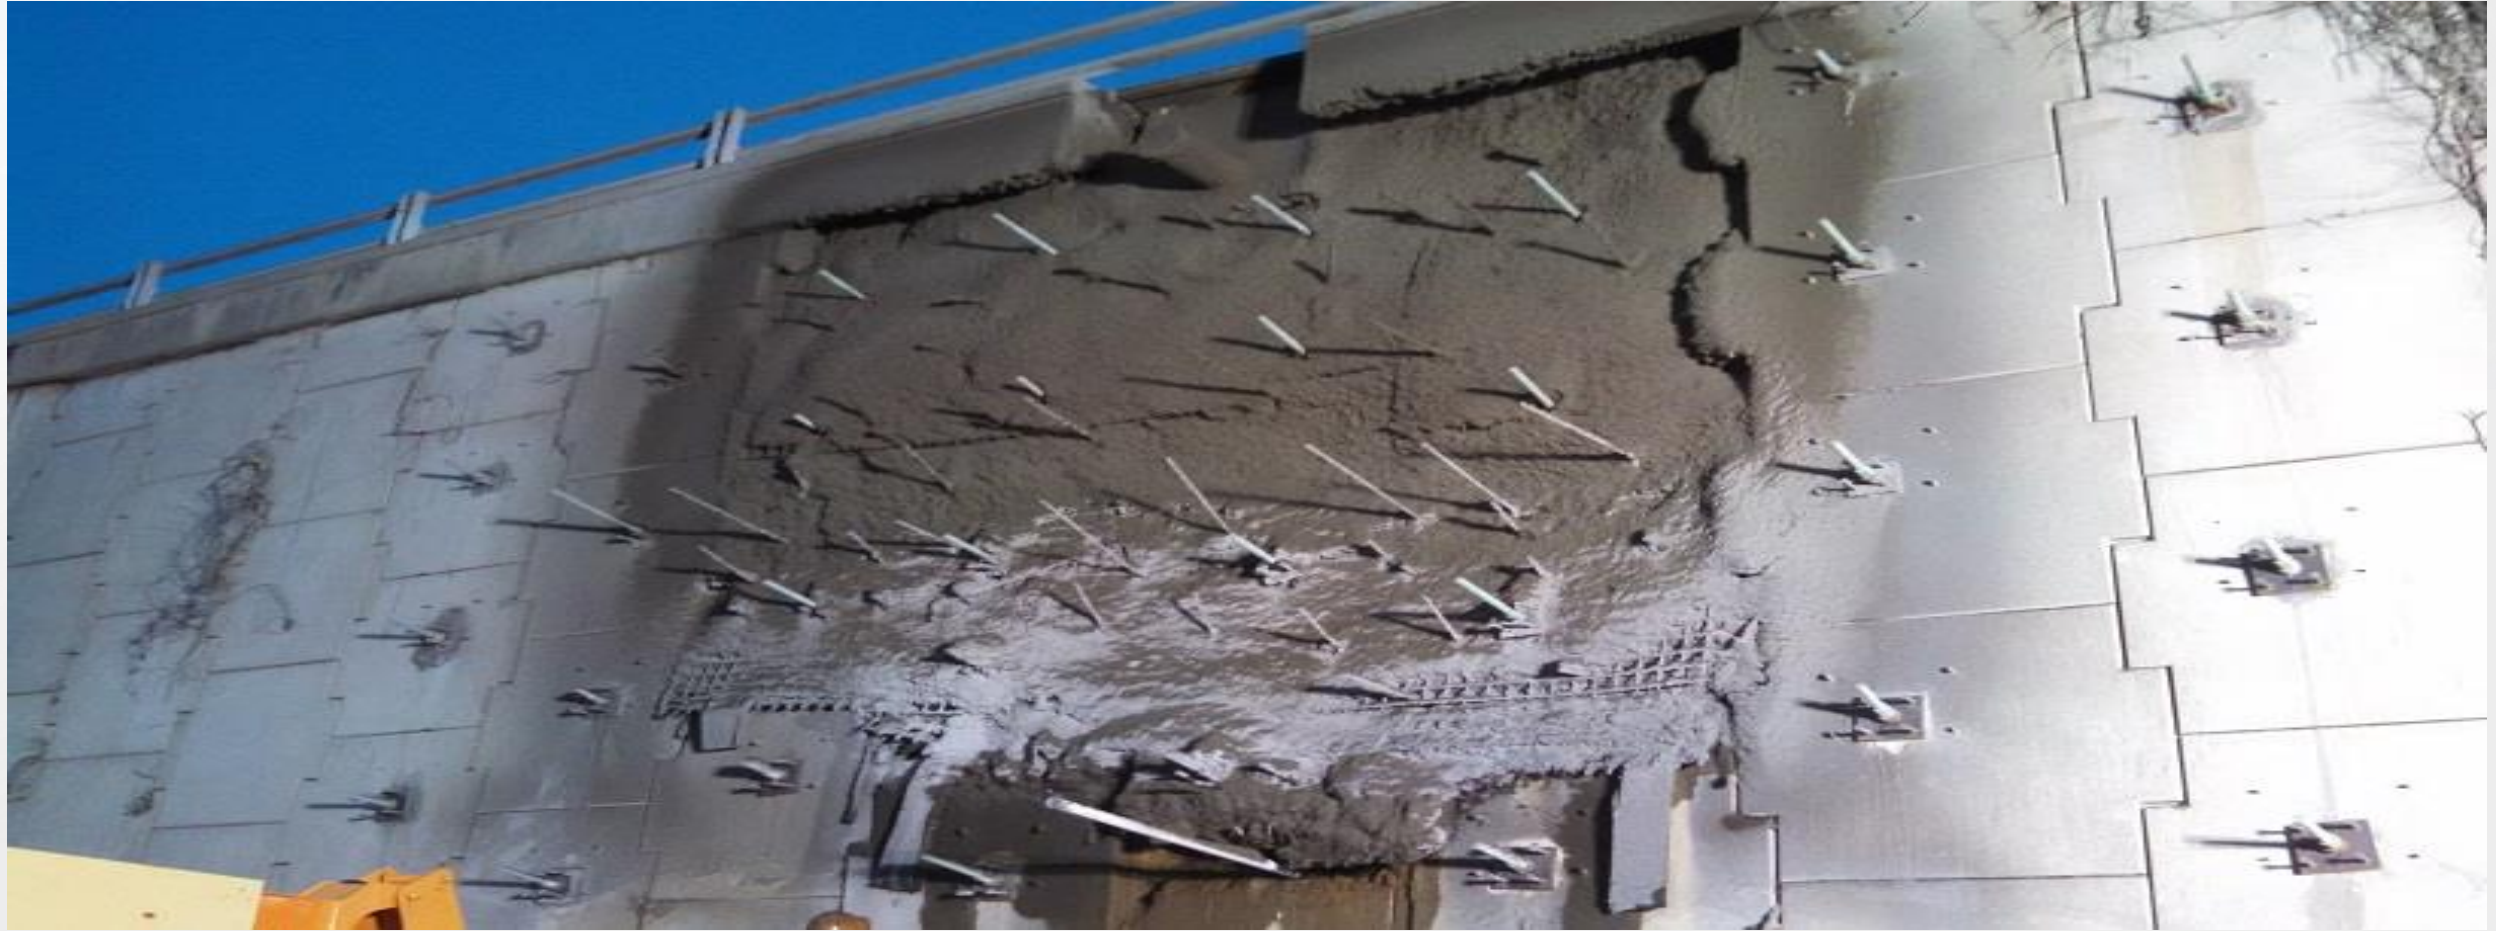
- Soil Nail
- Sheet Piles in Front
- MSE Walls

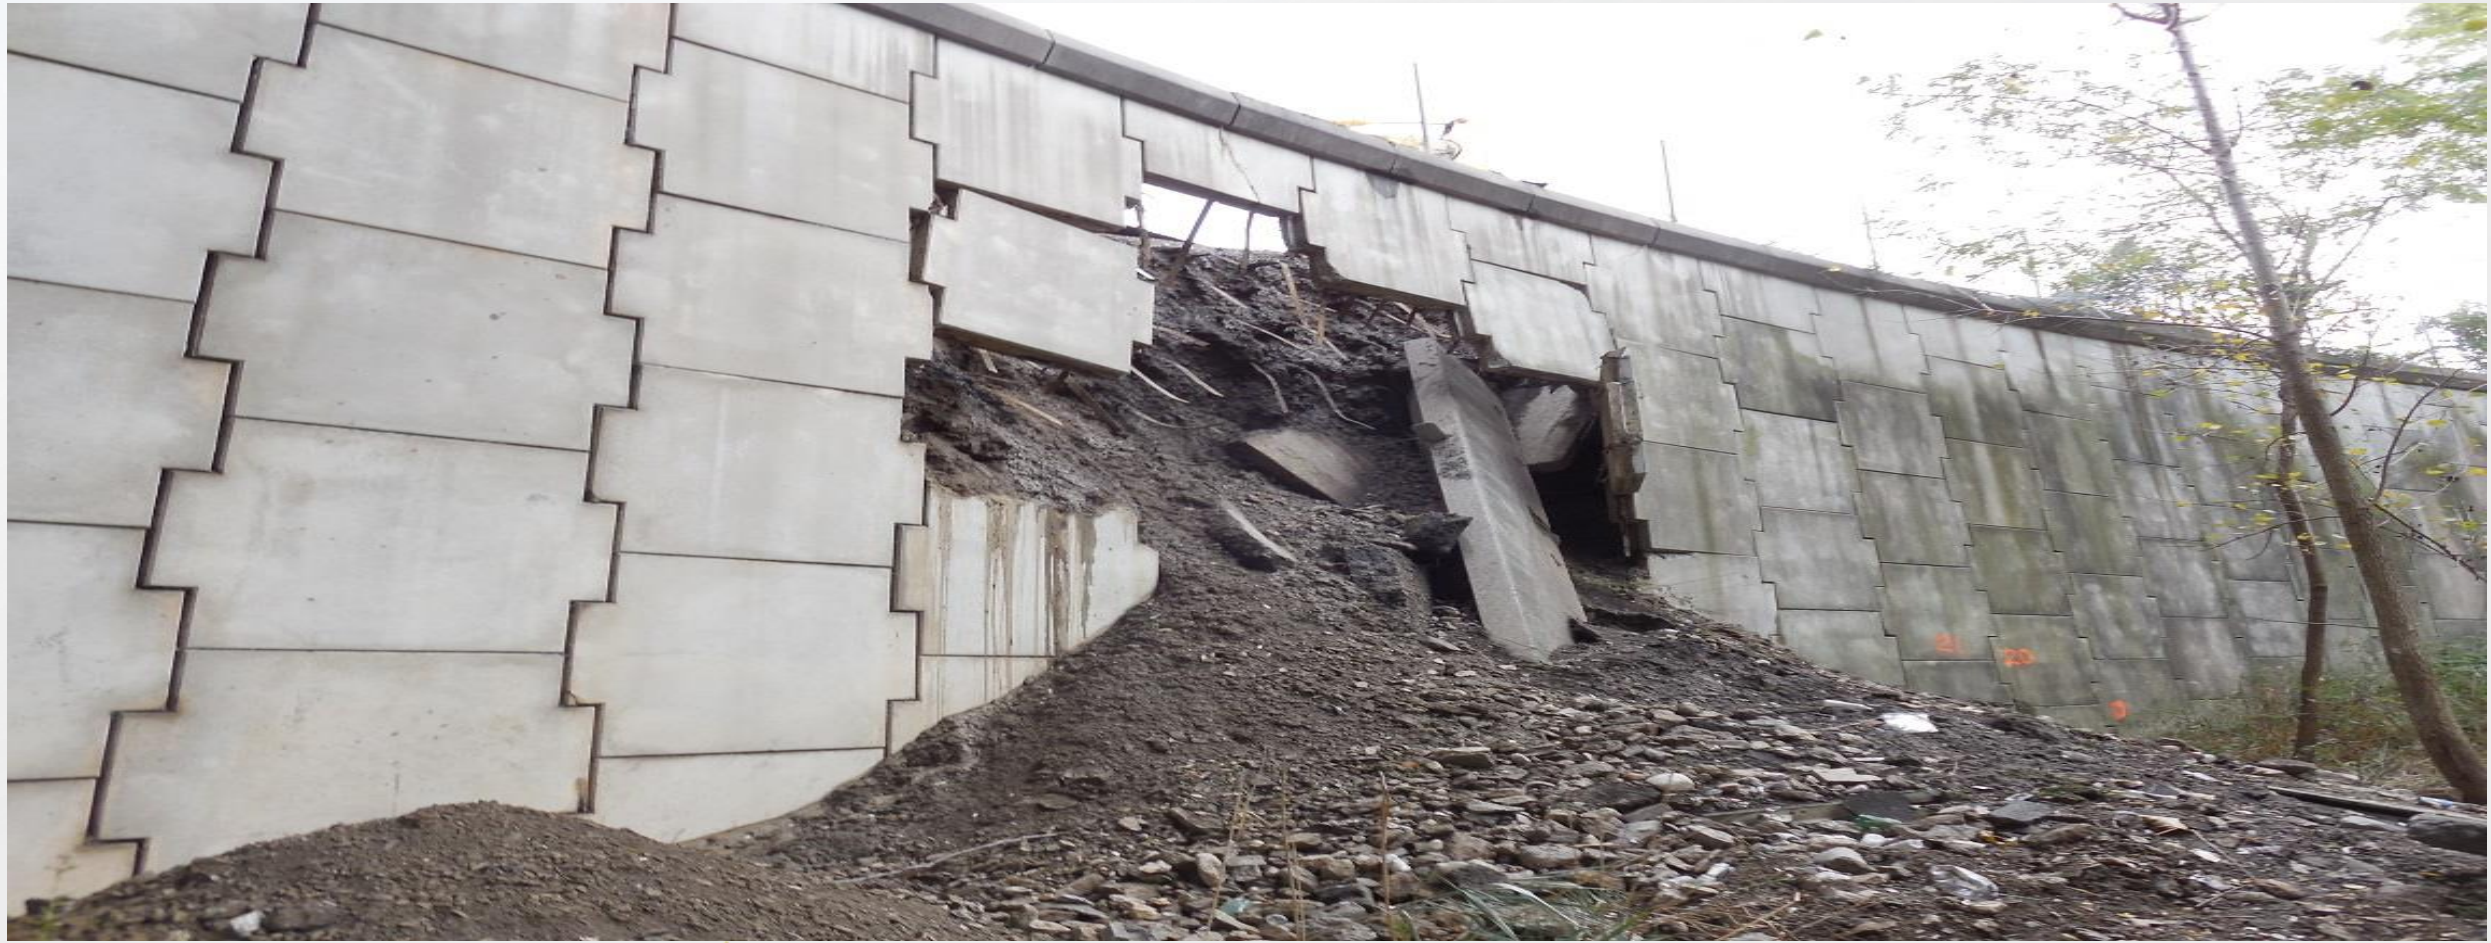
Another Failure

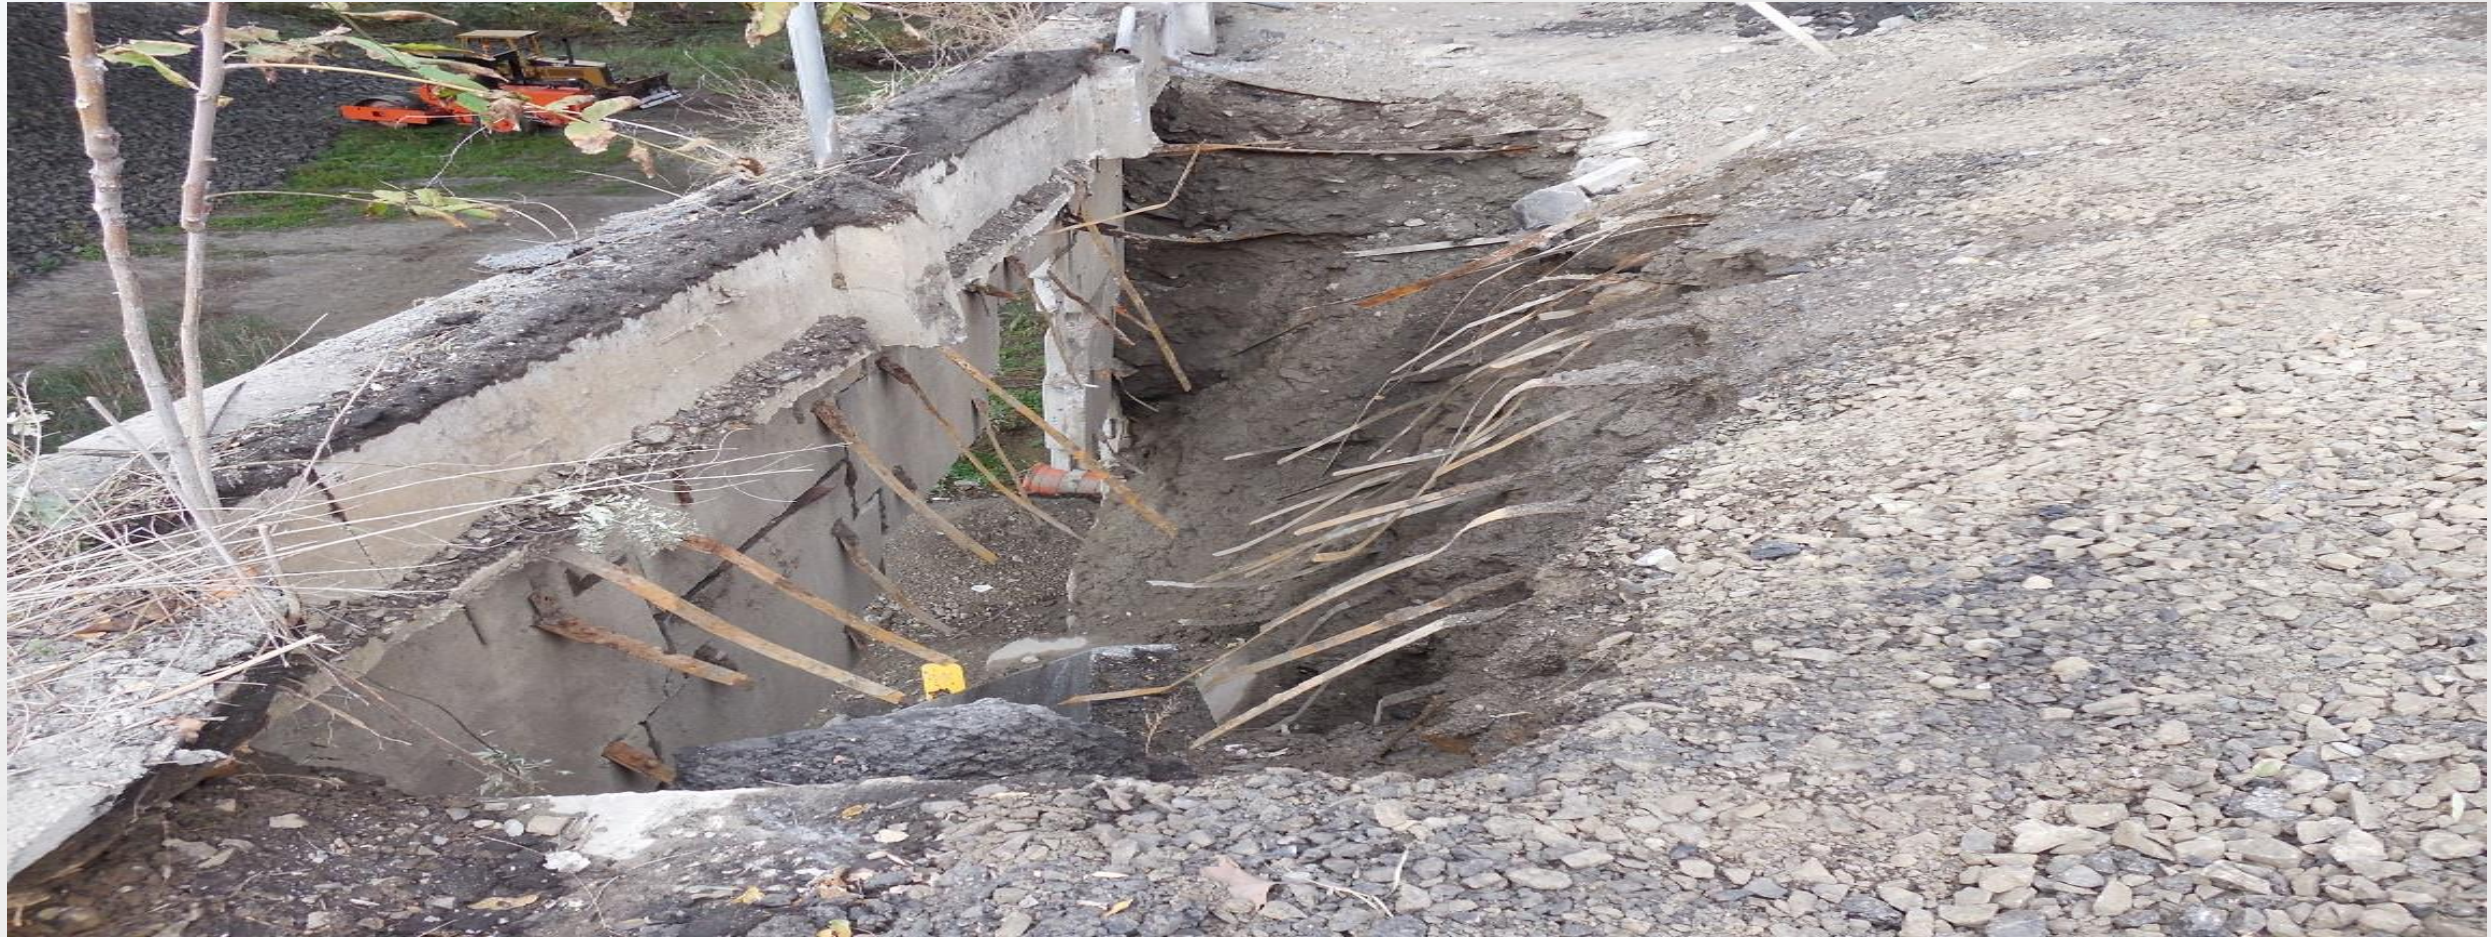
Failed Straps

- What are some potential problems / concerns?
- Projected life span?
- What steps are taken to protect steel straps?
- Differential Settlement?

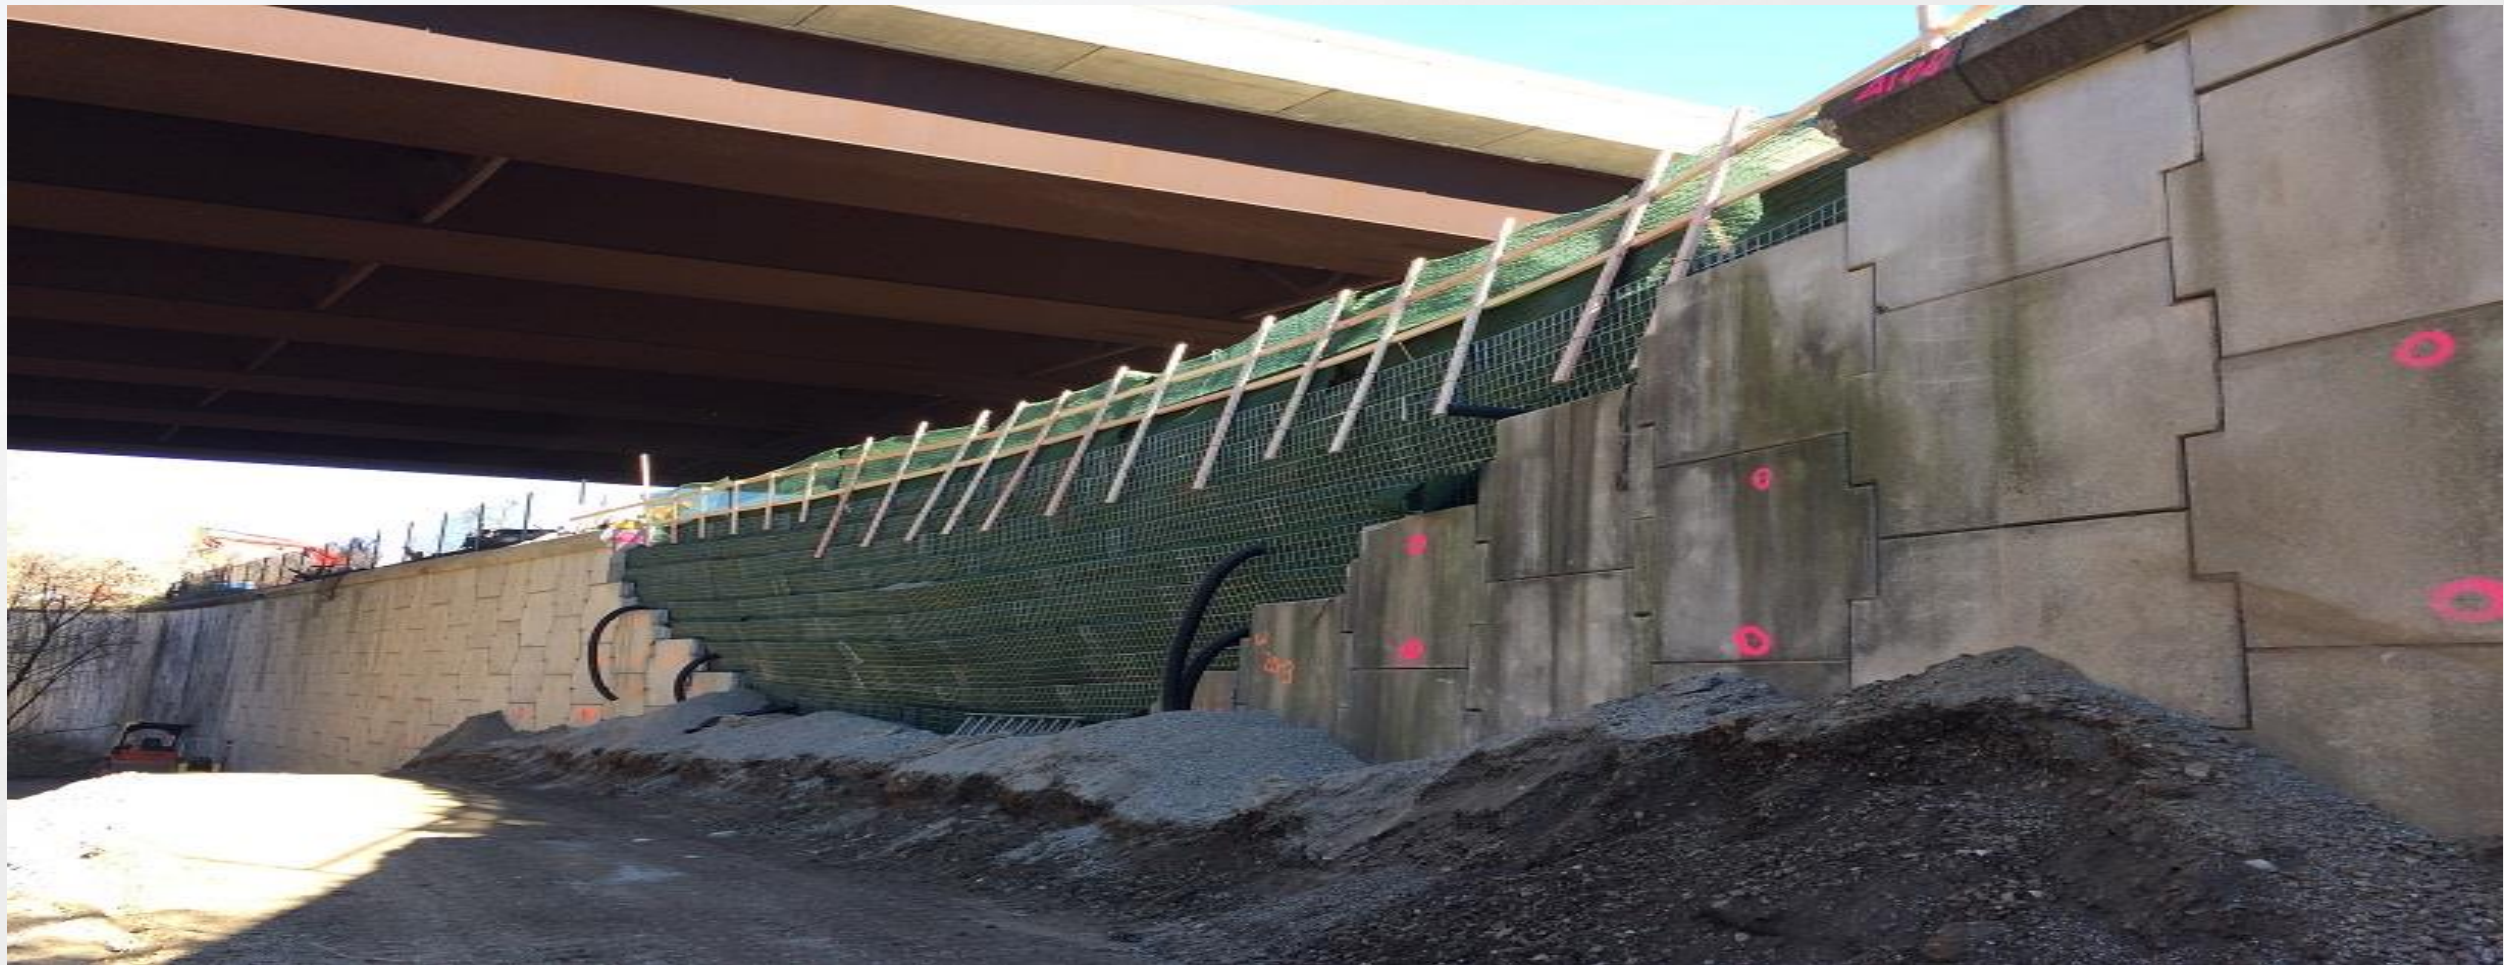
The Fix
