Bridge Maintenance and Repair with Ultra-High Performance Concrete (UHPC)

2019 Northeast Bridge Preservation Partnership Meeting | Burlington VT

Session 7 – Bridge Joints & Concrete Bridges | September 10th 2019

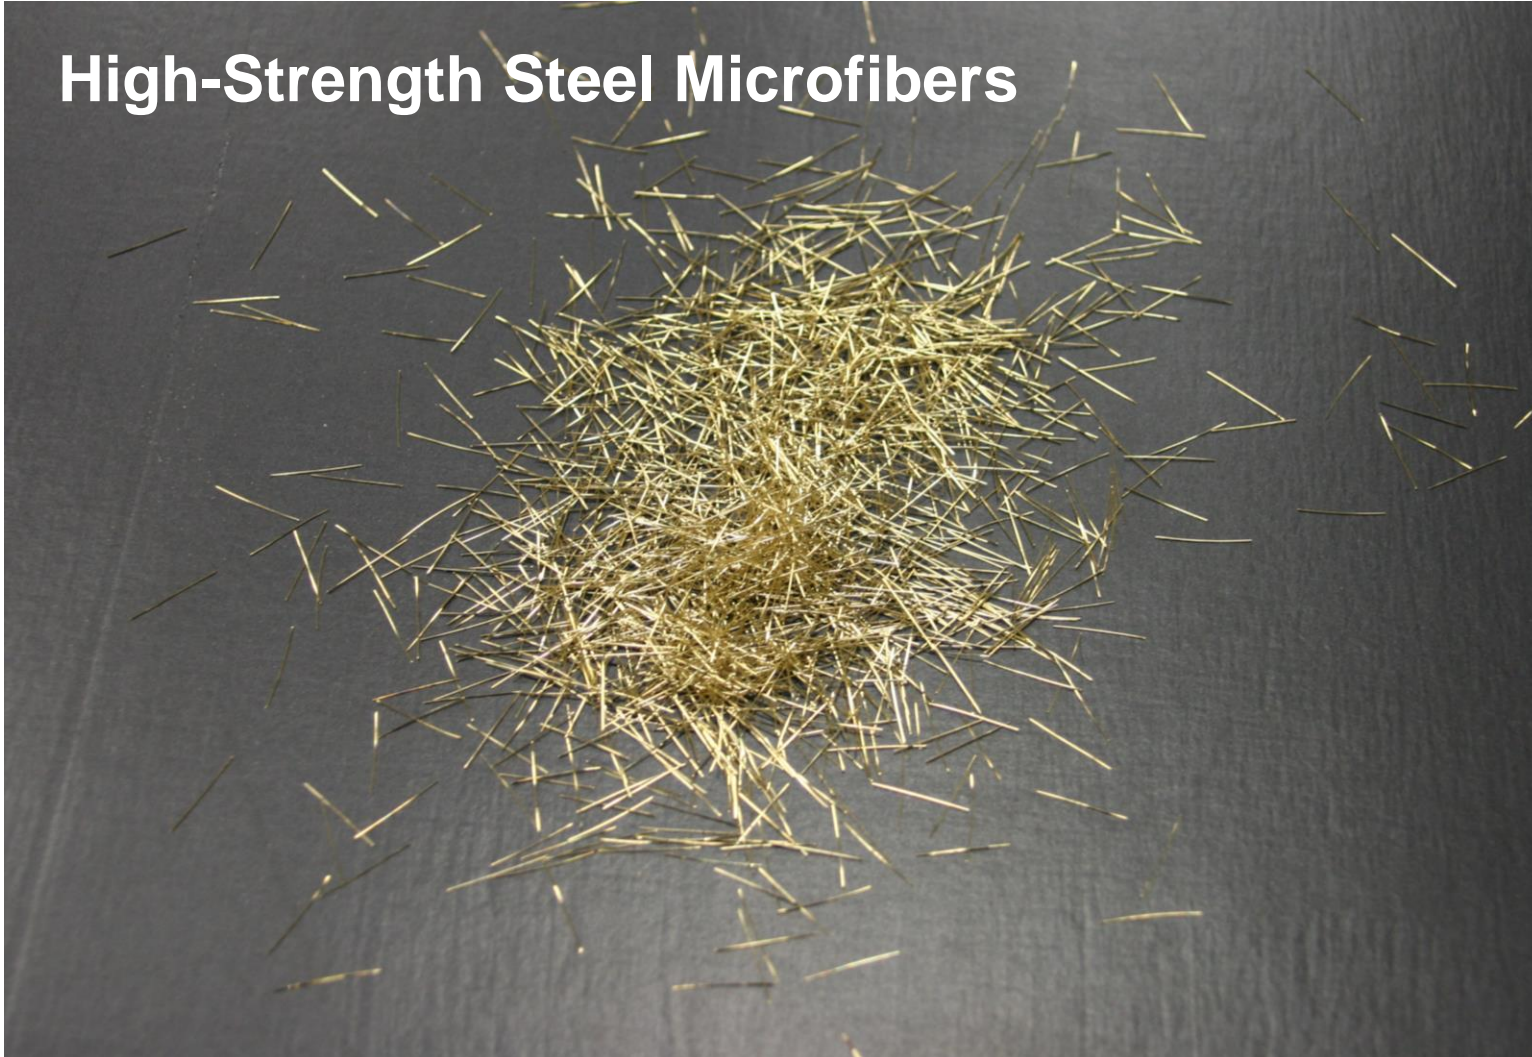
High-Strength Steel Microfibers

Tensile Strength ≈ 300 ksi

Fiber Length $\approx 0.5''$

Fiber Diameter $\approx 0.01''$

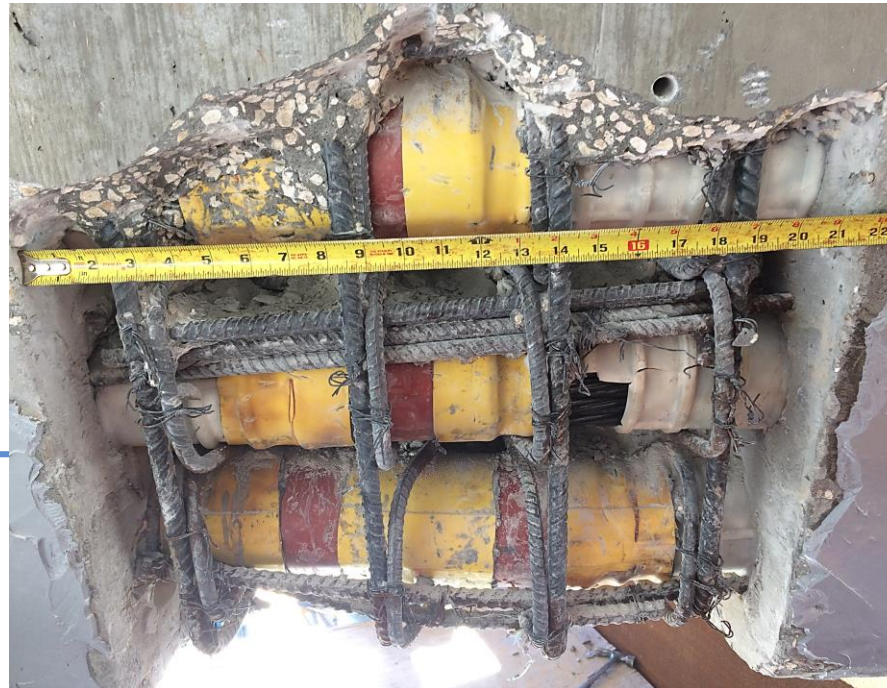
Repaired with UHPC

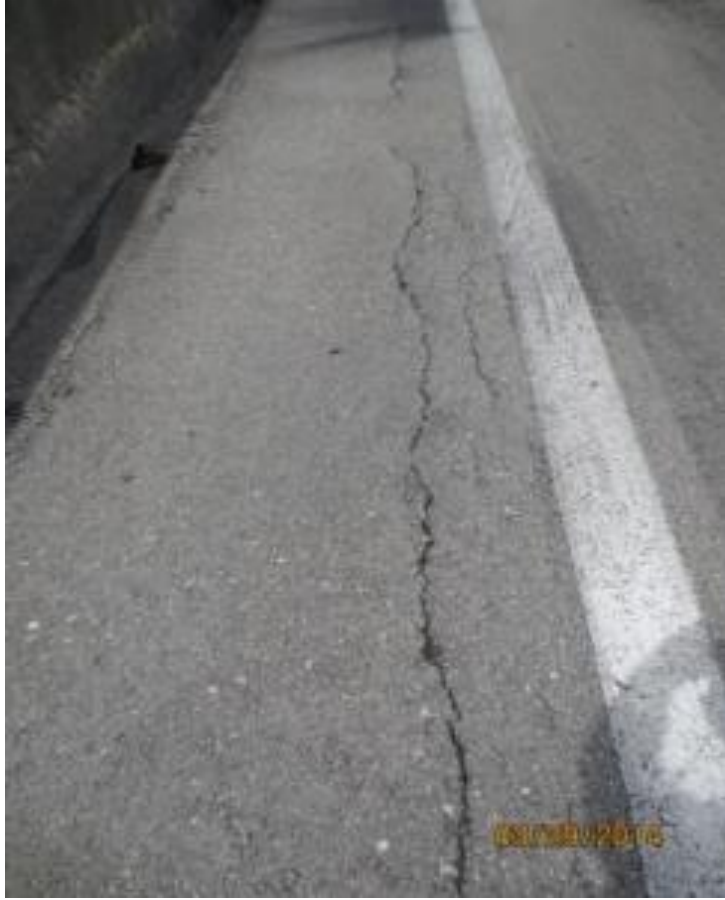
Reflective Cracking in Asphalt

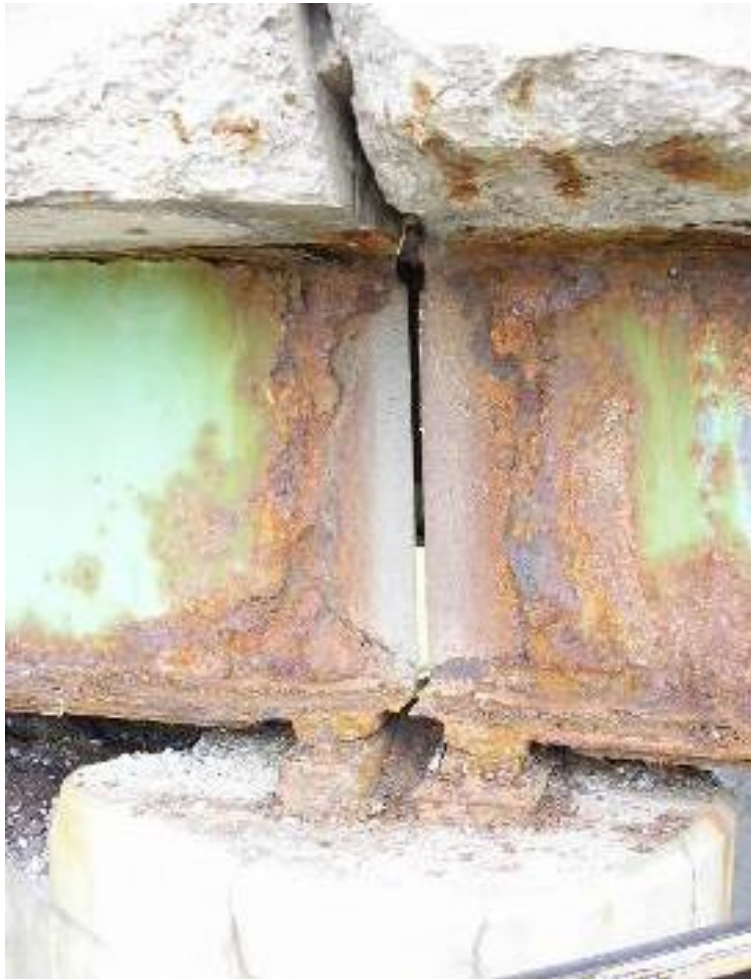
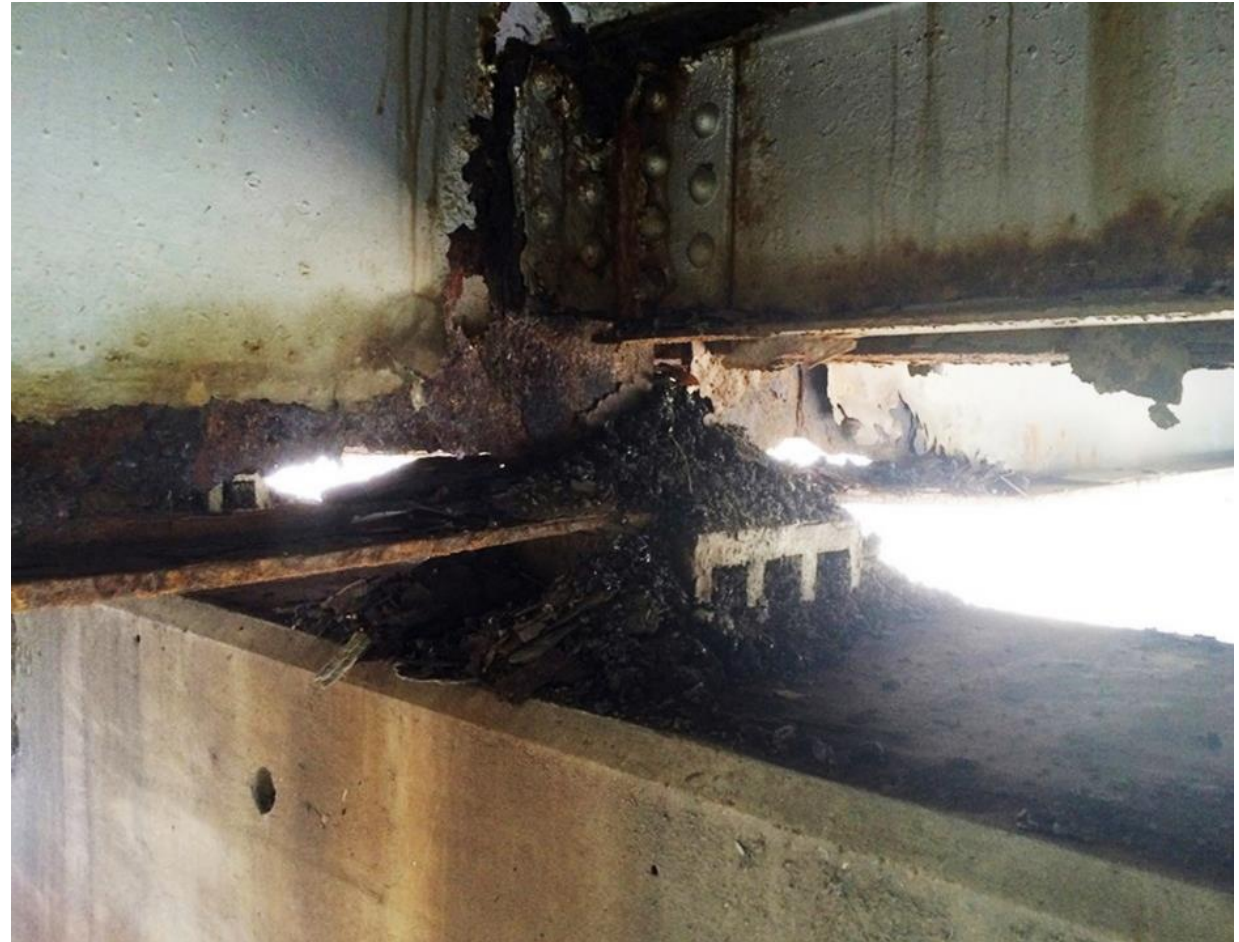
UHPC for Steel Girder Rehabilitation

Leaky or unsealed expansion joints...

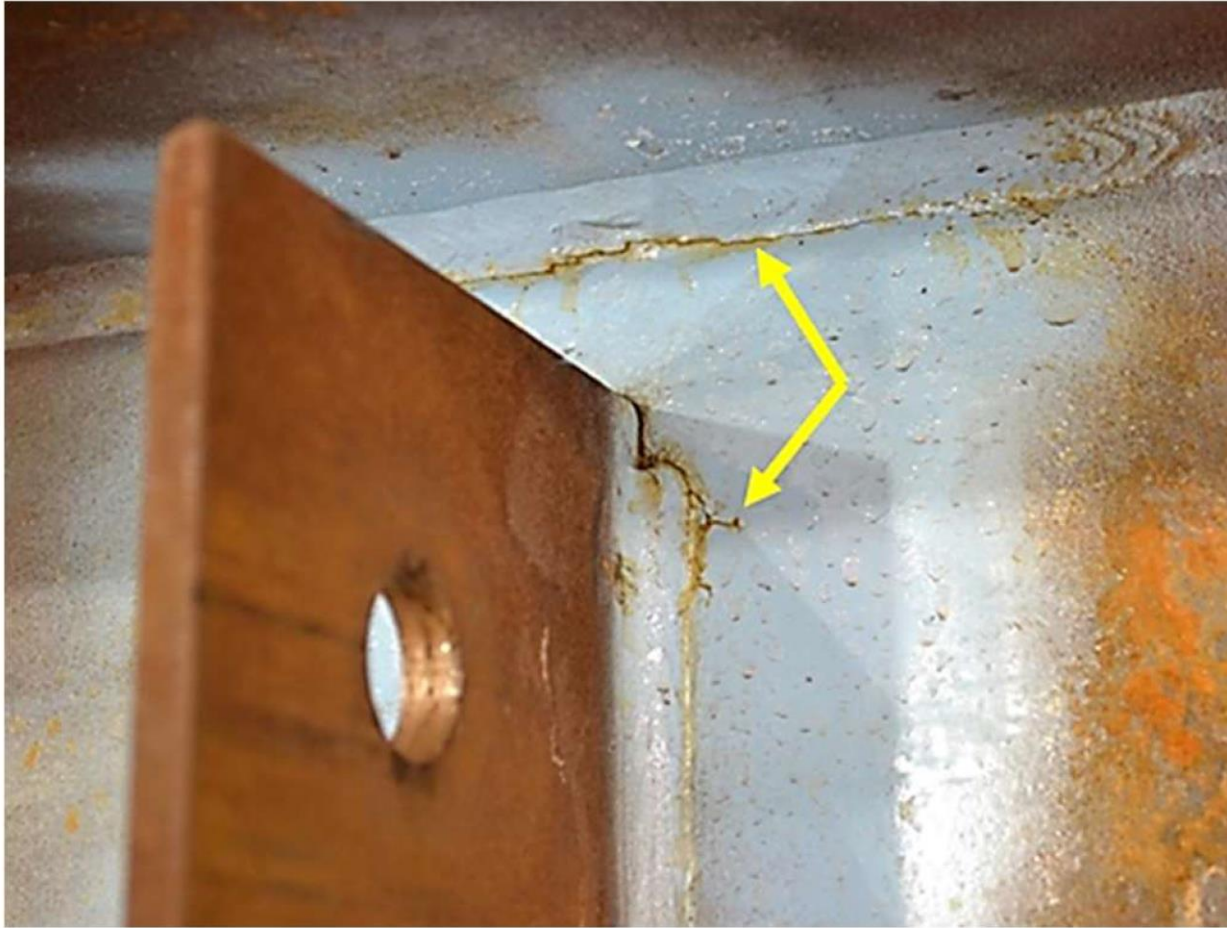
Web-Gap Fatigue Crack Repair

Distortion Induced Cracking
