Virginia's SHRP2 R06A Project Report to Southeast Bridge Preservation Partnership April 2019

Jeff Milton - Bridge Preservation Specialist Virginia Department of Transportation Structure and Bridge Division April 2019

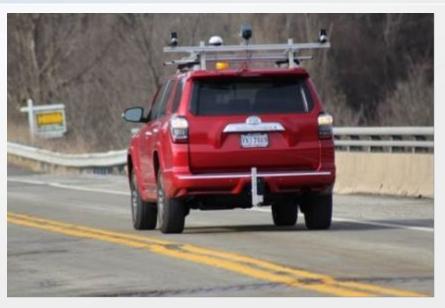
The technology used was the Deck Top Scanning System (DTSS) which is a mobile platform that can be loaded/mounted onto a vehicle. It consists of an infrared thermography (IR) camera, two line-scanning cameras, a GPS unit, and a speedometer unit that, combined, locate surface and sub-surface defects in bridge decks or roadways.

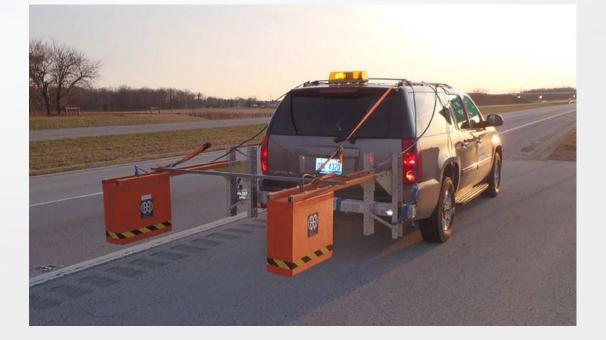
The technology used was a dual 2 GHz horn antenna system manufactured by GSSI, Inc. of Nashua, NH, The survey vehicle was equipped with an electronic distance-measuring instrument (DMI) mounted to the rear wheel of the survey van, providing continuous distance data as the GPR data was collected. The data collection and recording was controlled by the SIR-30 GPR system operated from within the survey vehicle.
