# Kentucky Pavement Preservation

2019 SEPPP MEETING

# US 127 MERCER COUTY MP 12.75 - MP 17.1

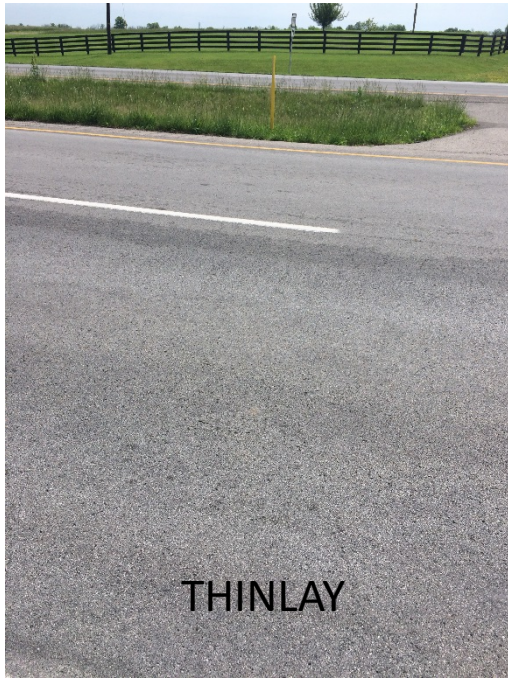
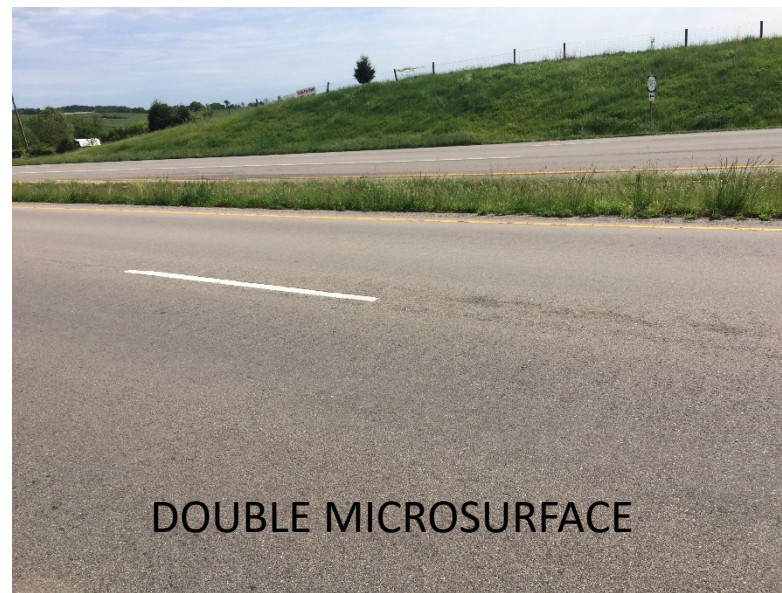
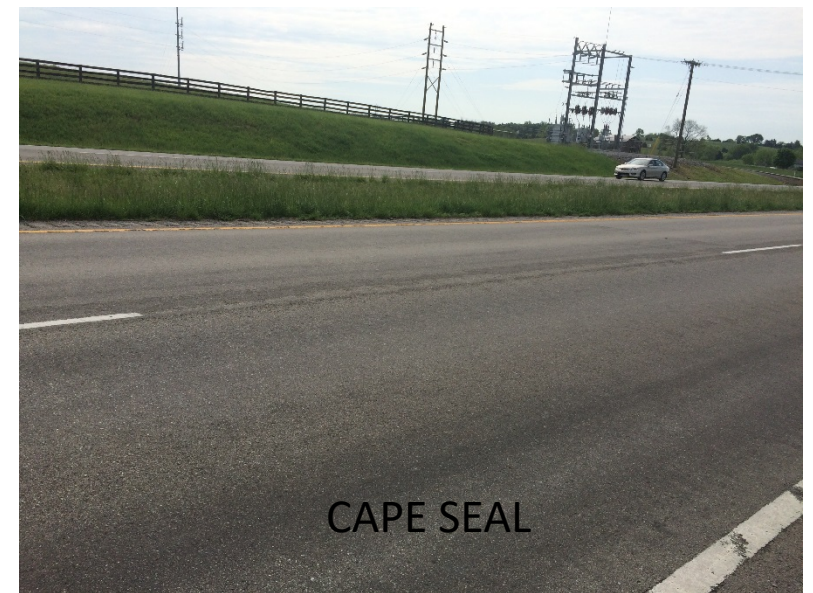
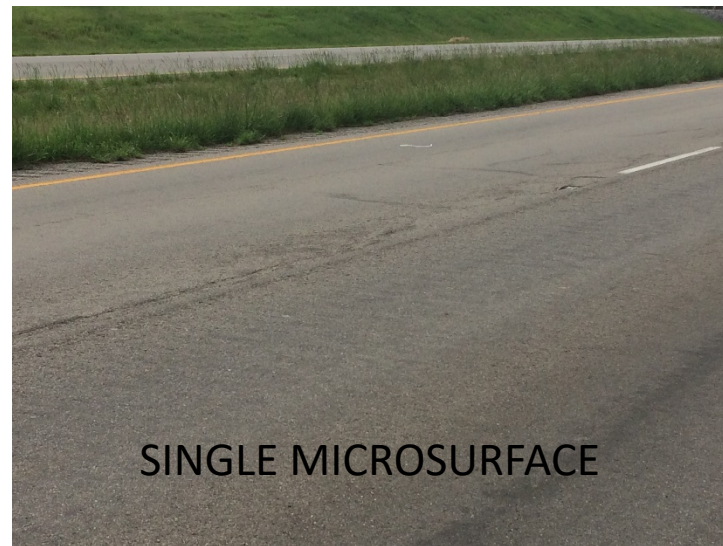
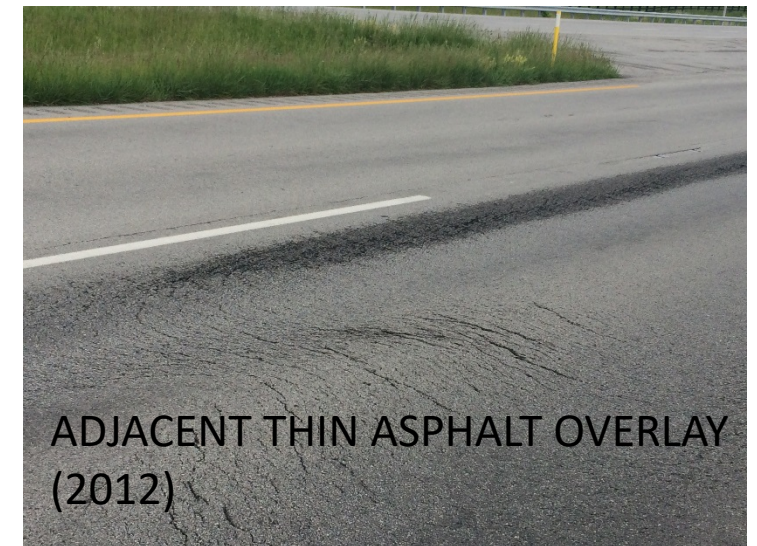
- 2012 HMA overlay from 14.4 to 17.15
- 2003 HMA overlay from 11.0 to 14.4
- 1500' sections
- Installed August 2014
- Monitoring plan with KTC
  - Cracking
  - Raveling
  - Rutting
  - Friction
  - Permeability
  - Smoothness
  - Pavement marking reflectivity

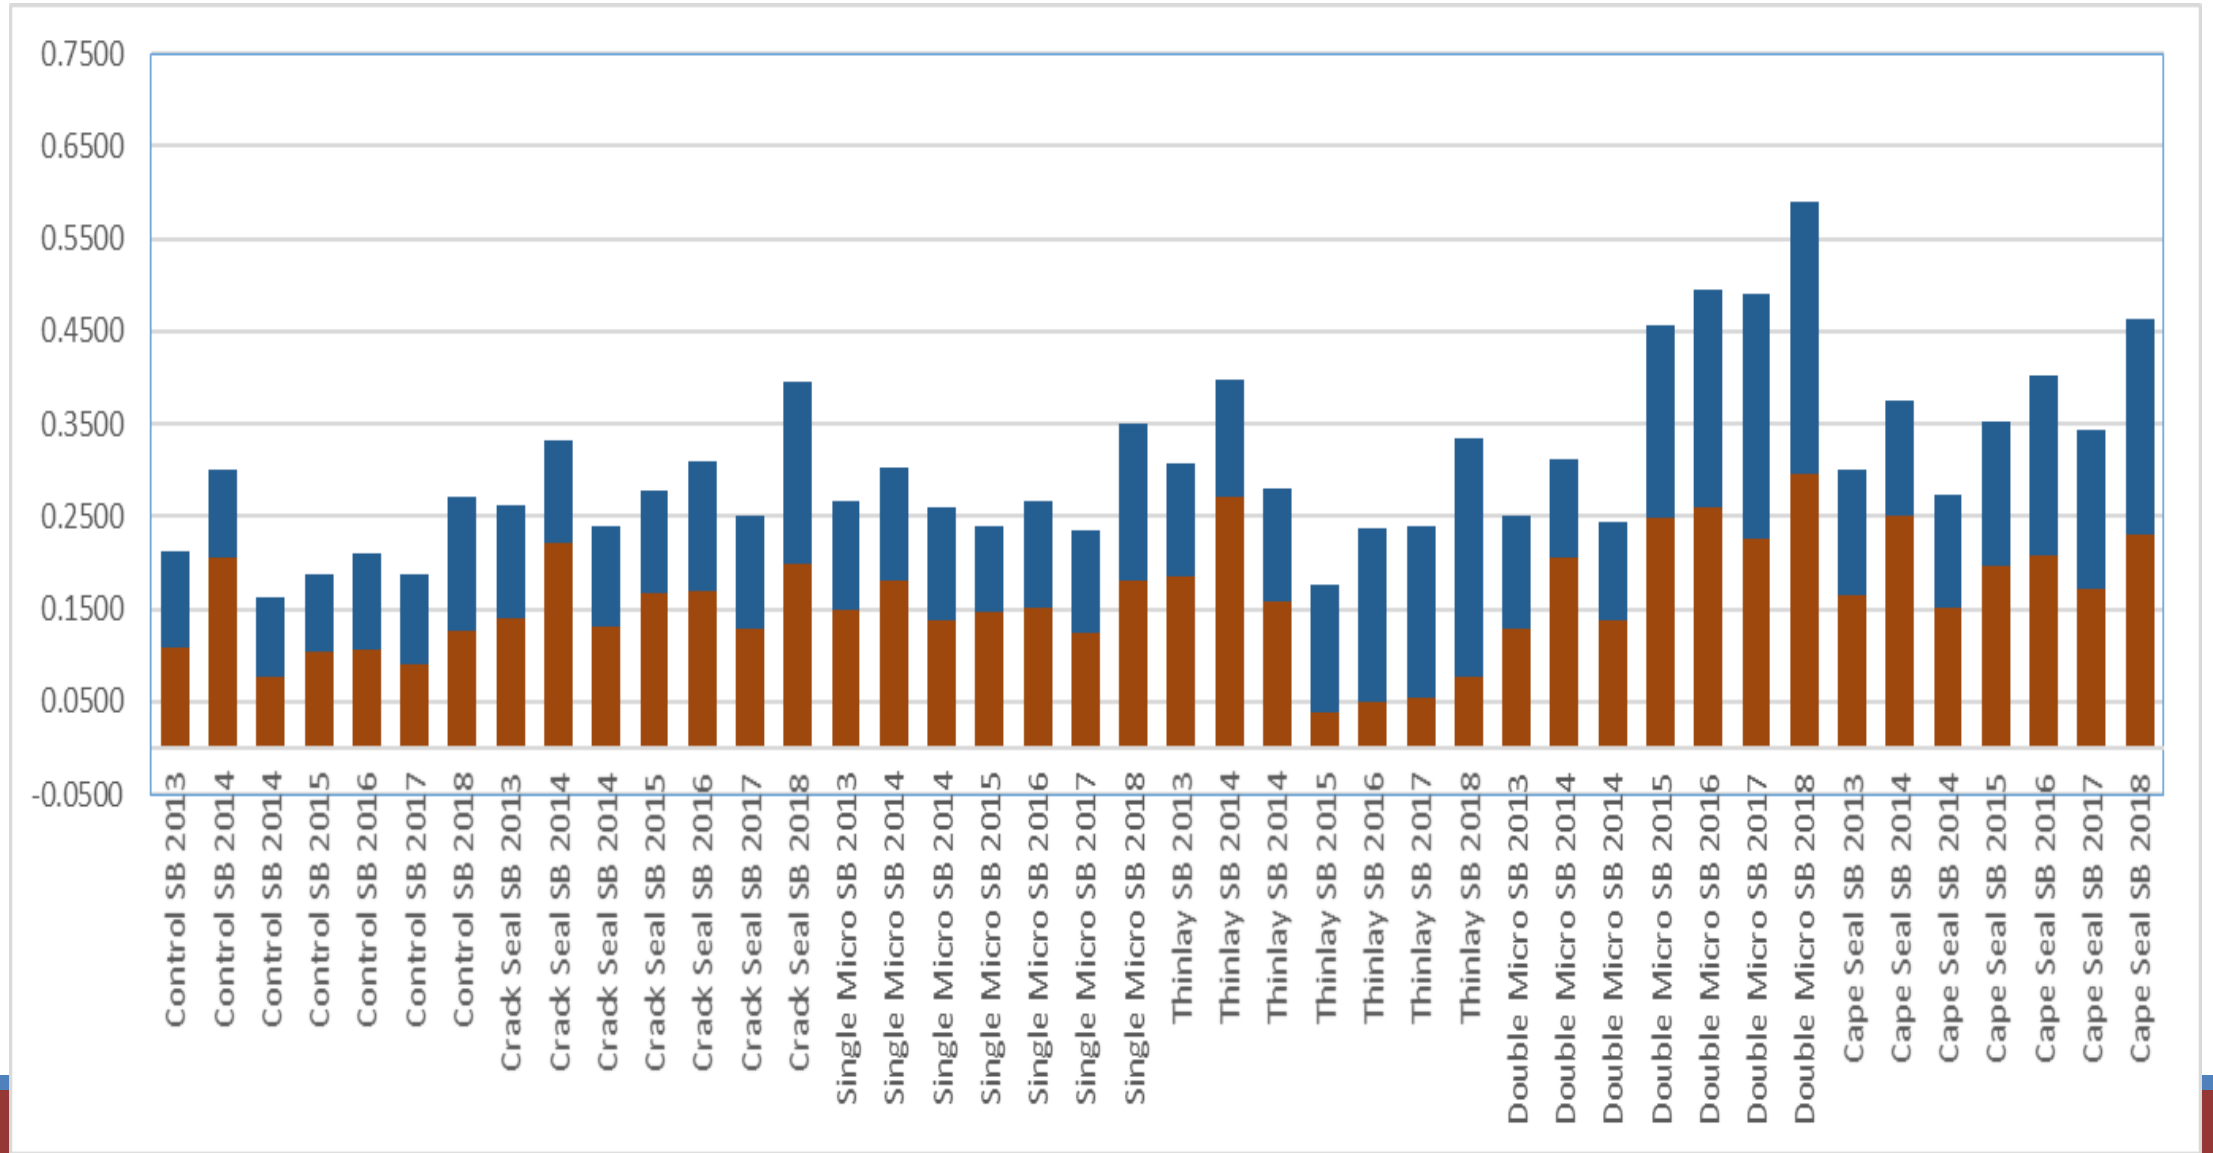
# RUTTING RIGHT AND LEFT

Mostly consistent rutting in right WP

Left WP picking up centerline overlaps

Thinlay showing early rut resistance
