*Technologies to manage risk
for infrastructure*

I-91 Springfield Viaduct Structural Life Extension

**2019 Western Bridge Preservation Partnership
Annual Meeting, May 14, 2019**

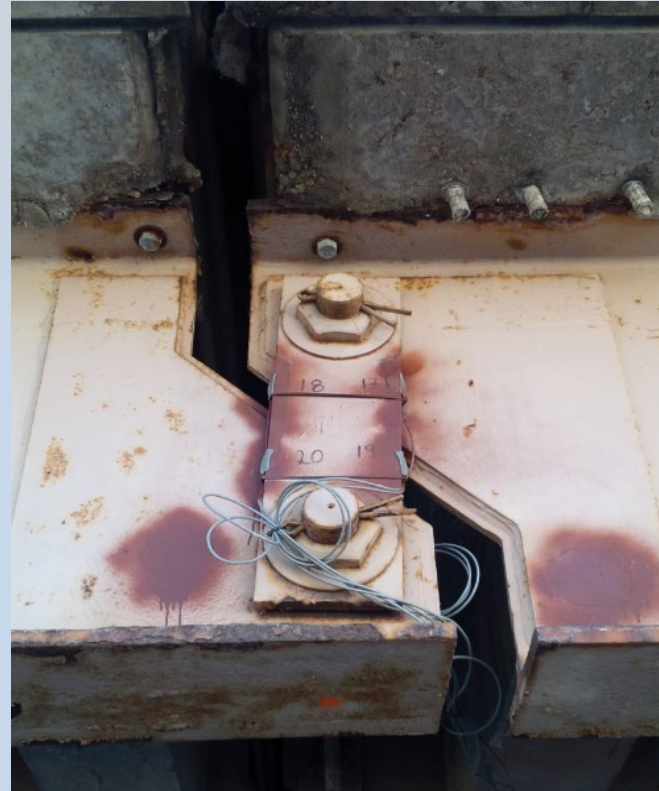
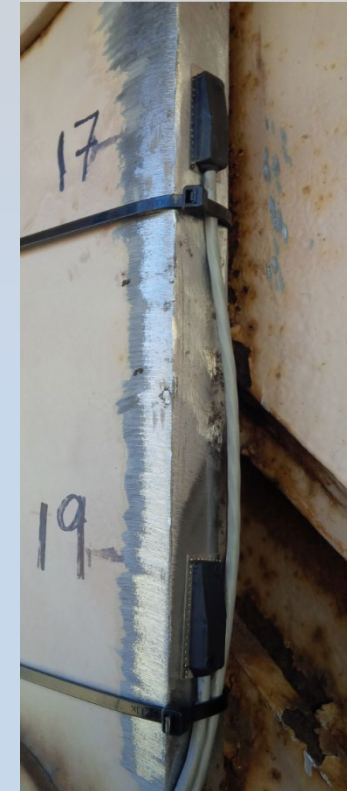
Installation of Strain Gages Hanger Plates

Spot weldable strain gages on Hanger Plates to measure stresses induced by frozen or corroded pins.

48 SG total on
6 hanger sets

- 24 on NB
- 24 on SB

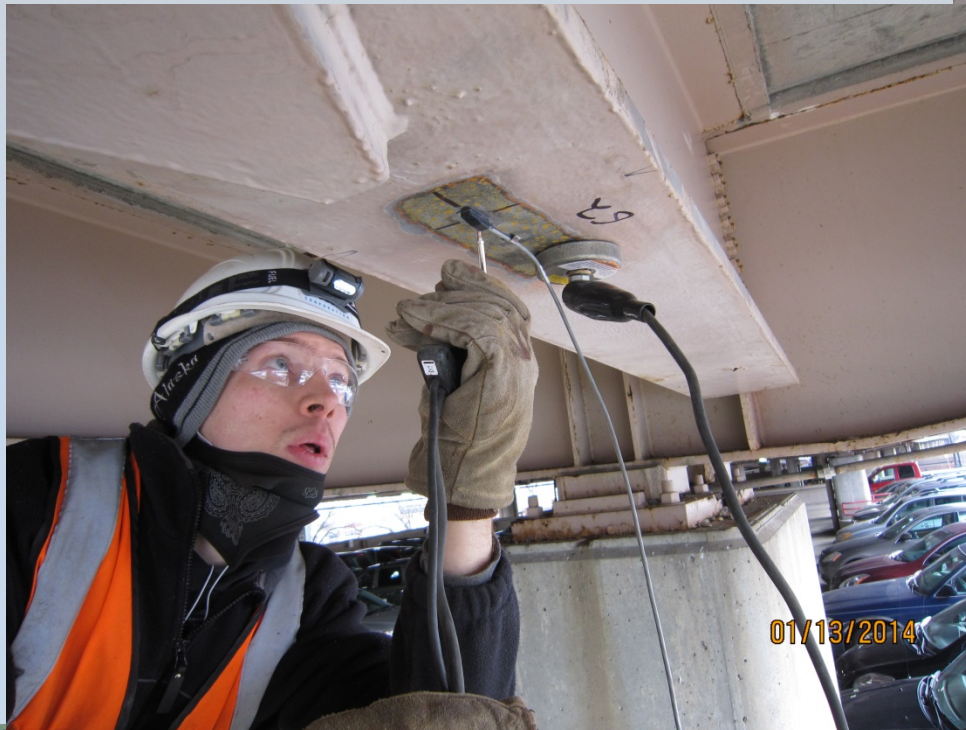
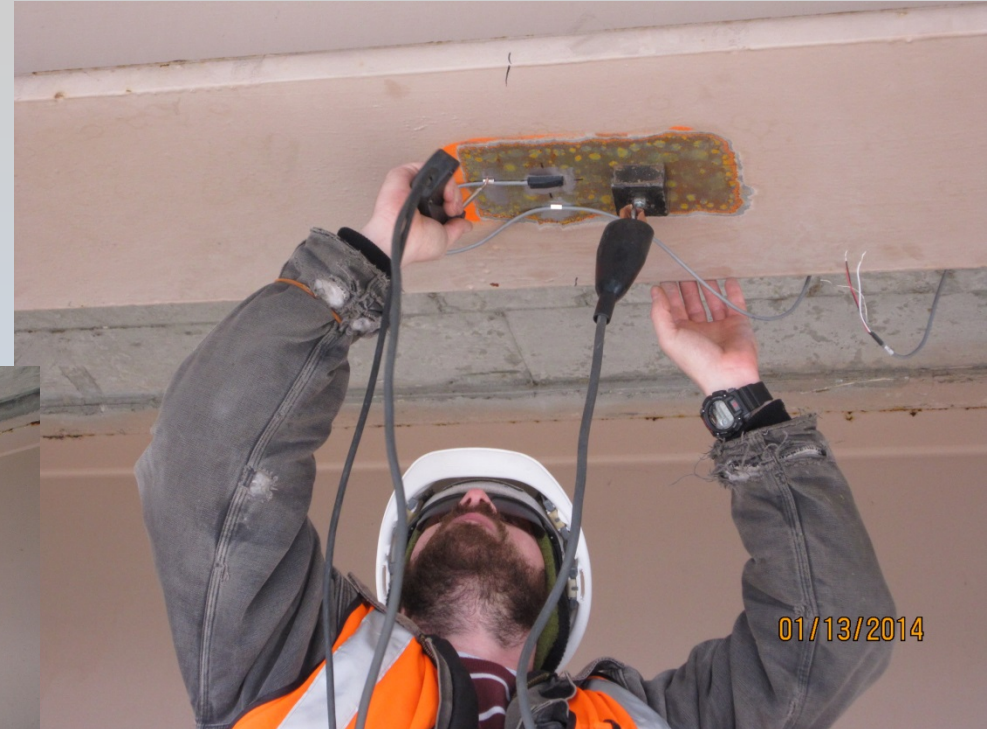
Installation of Strain Gages Girders

Spot weldable SG on girders
with partial length cover plates
to determine remaining fatigue
life of girders

32 SG total on 16 girders

- 16 on girder mid span
- 16 at cover plate end
