Steel Bridge Painting Program

2019 WBPP

DeWayne Wilson
Bridge Asset Management Engineer

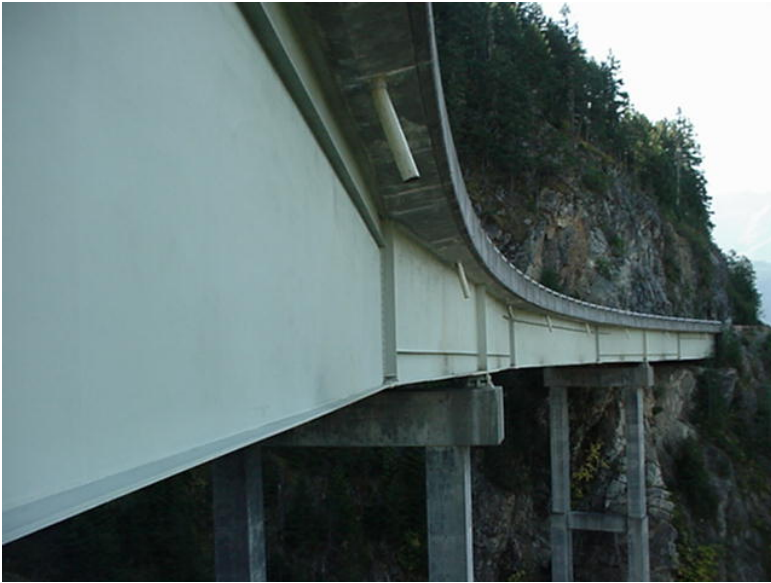
Paint Cond State 1:

The paint system is sound and functioning as intended.

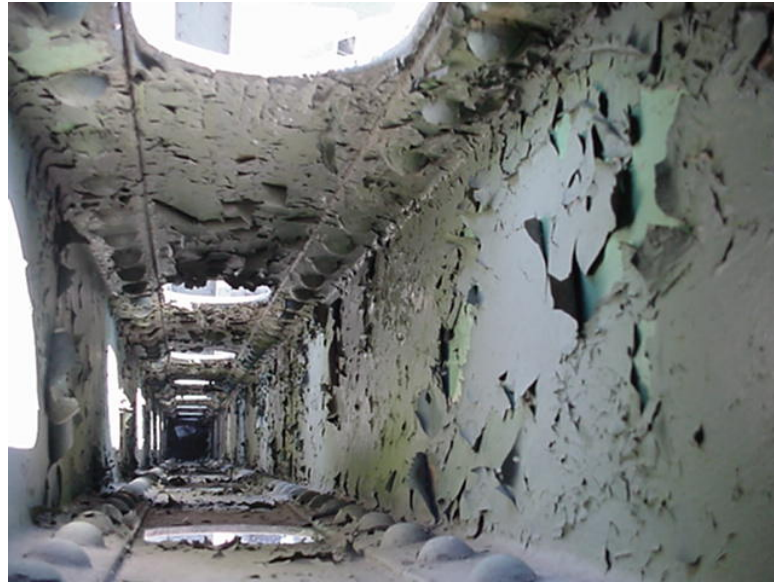
Paint Cond State 2:

The paint system may be chalking, peeling, curling, or showing distress with no exposure of metal.

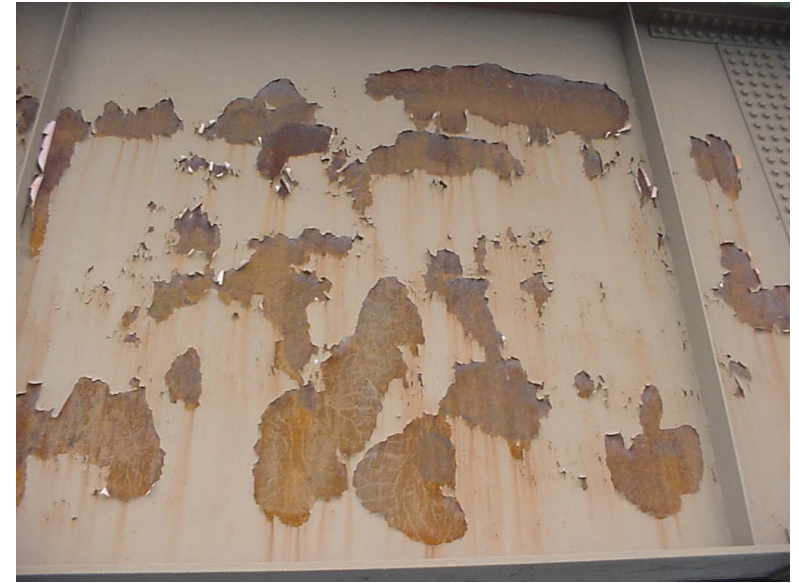
Paint Cond State 3:

The paint system is no longer effective. The metal substrate is exposed.

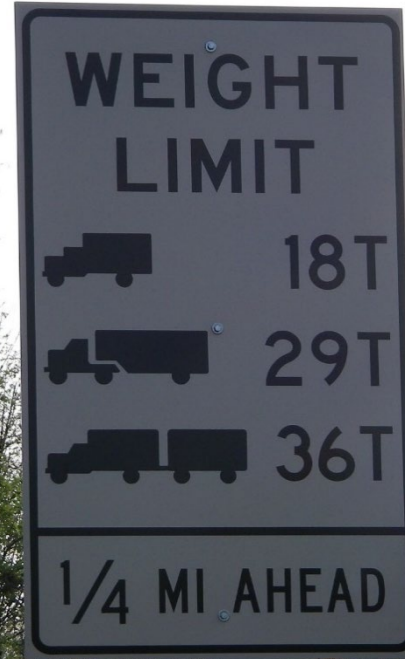
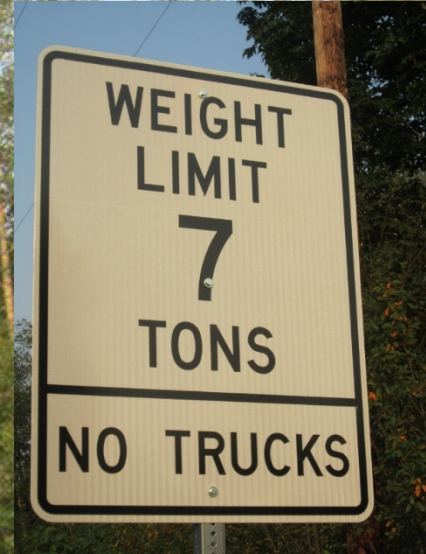
Year Built – 1930
Year Last Painted – 1978
Poor Condition - 2008
Load Posted - 2010/12

2010

2012

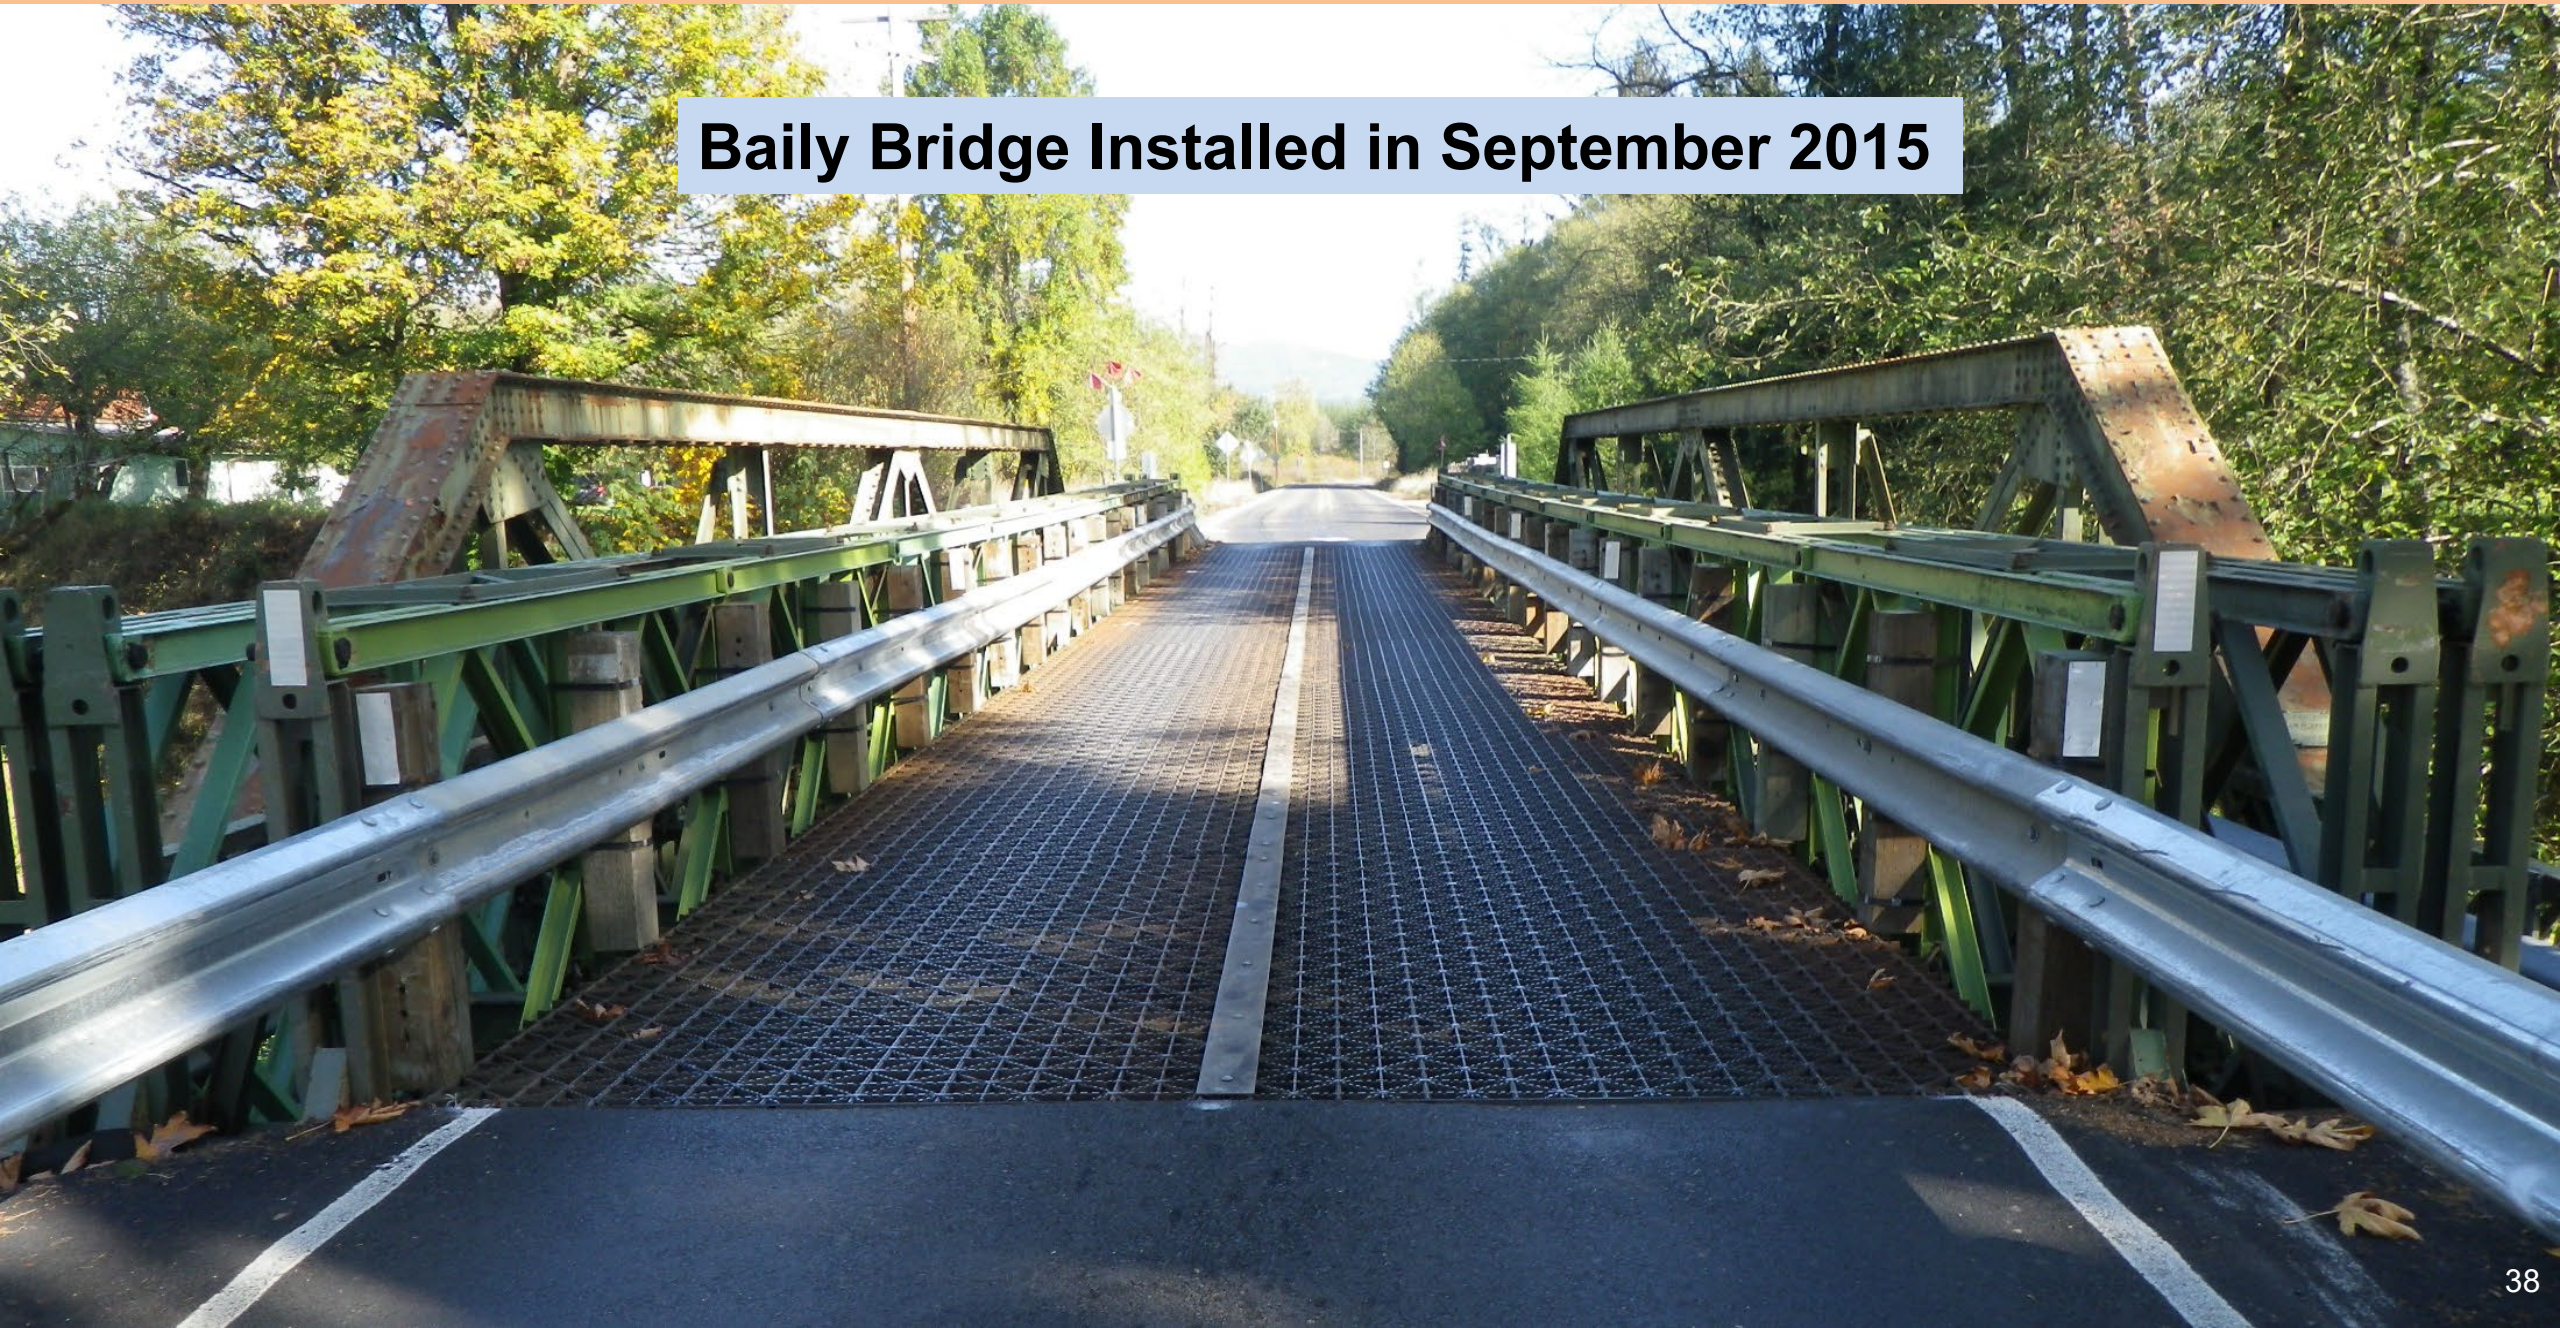
Baily Bridge Installed in September 2015

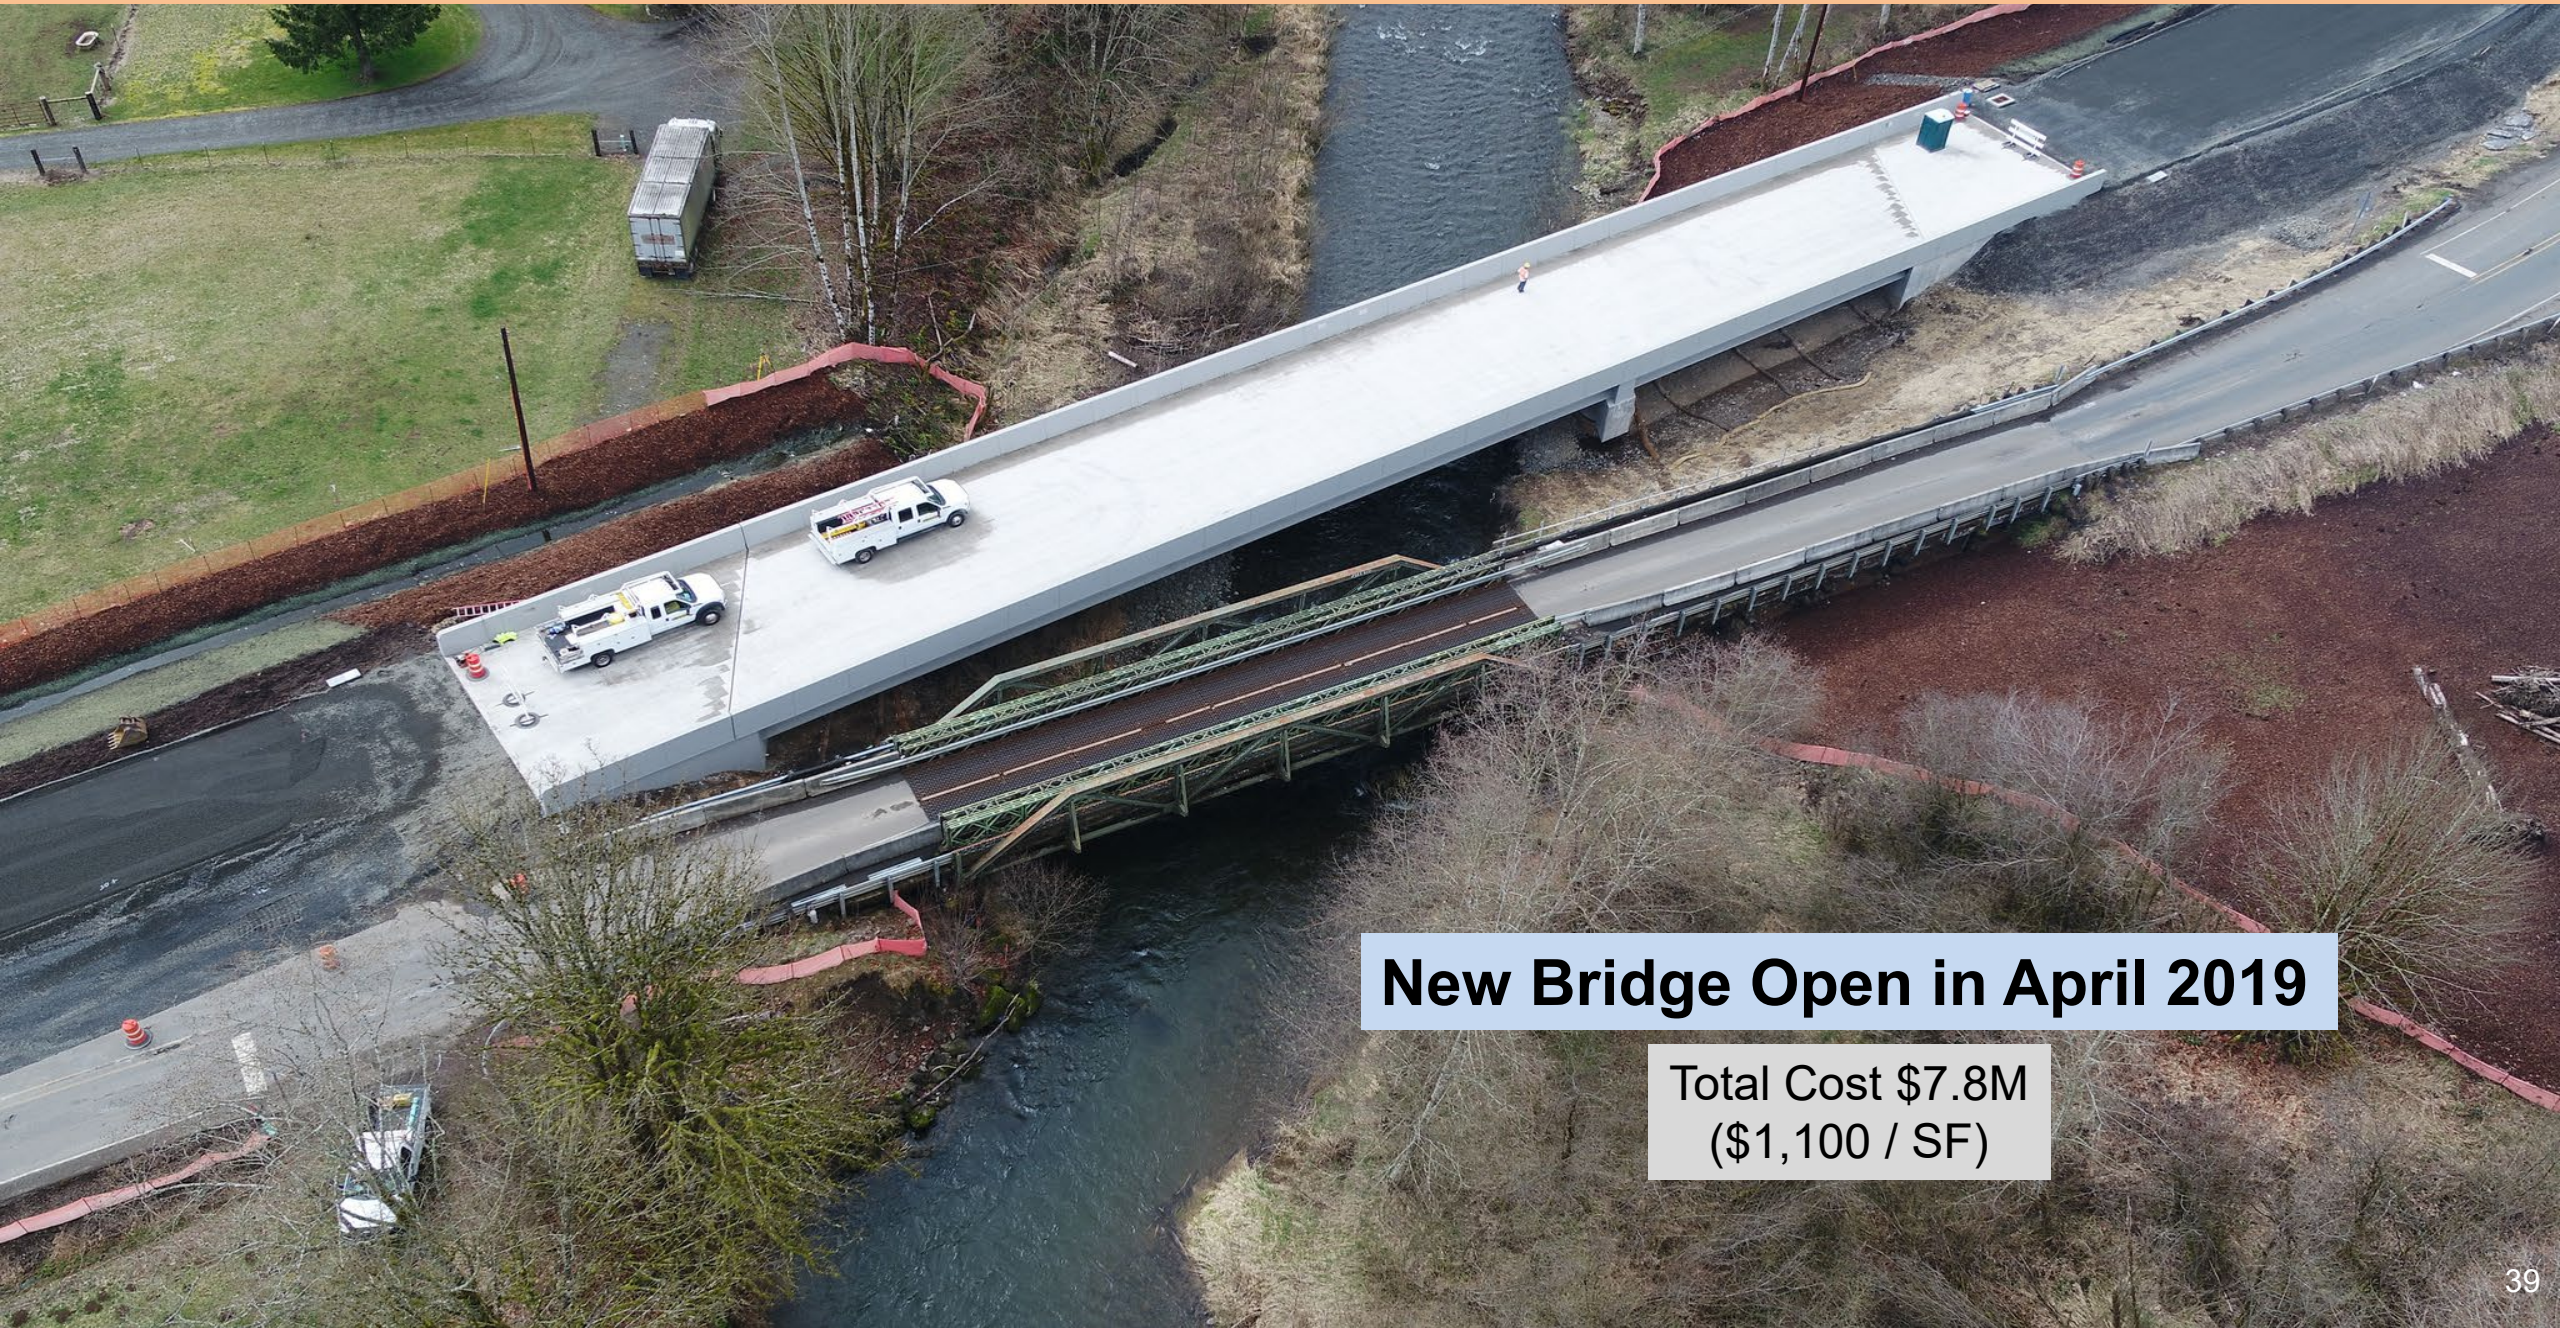
New Bridge Open in April 2019

**Total Cost \$7.8M
(\$1,100 / SF)**

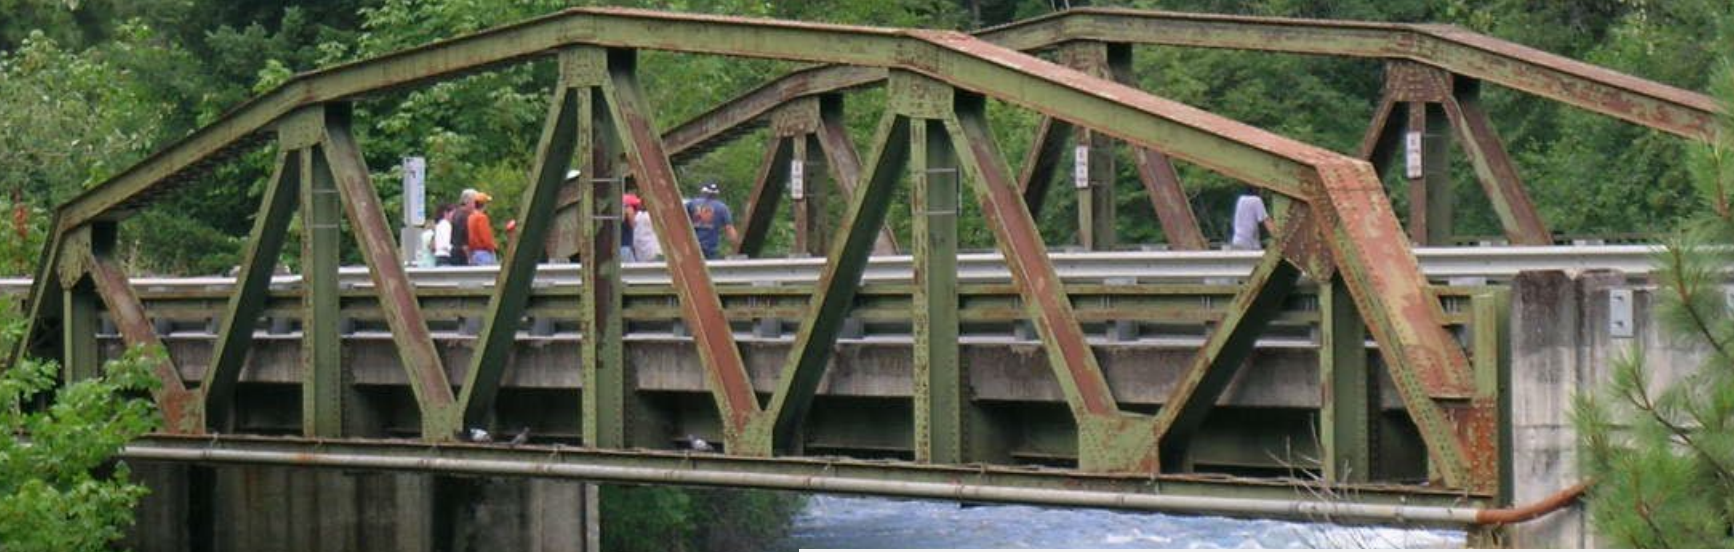
Year Built – 1940
Year Last Painted – 1988

2014 Age of Paint = 26 years

Action	Year	Cost \$
Planned Paint Year –	2014	\$1.0 M
<i>Do Nothing – Year “Poor” –</i>	<i>2020</i>	
Do Nothing Rehab Year -	2025	\$3.0 M
Do Nothing Replace Year –	2035	\$6.0 M

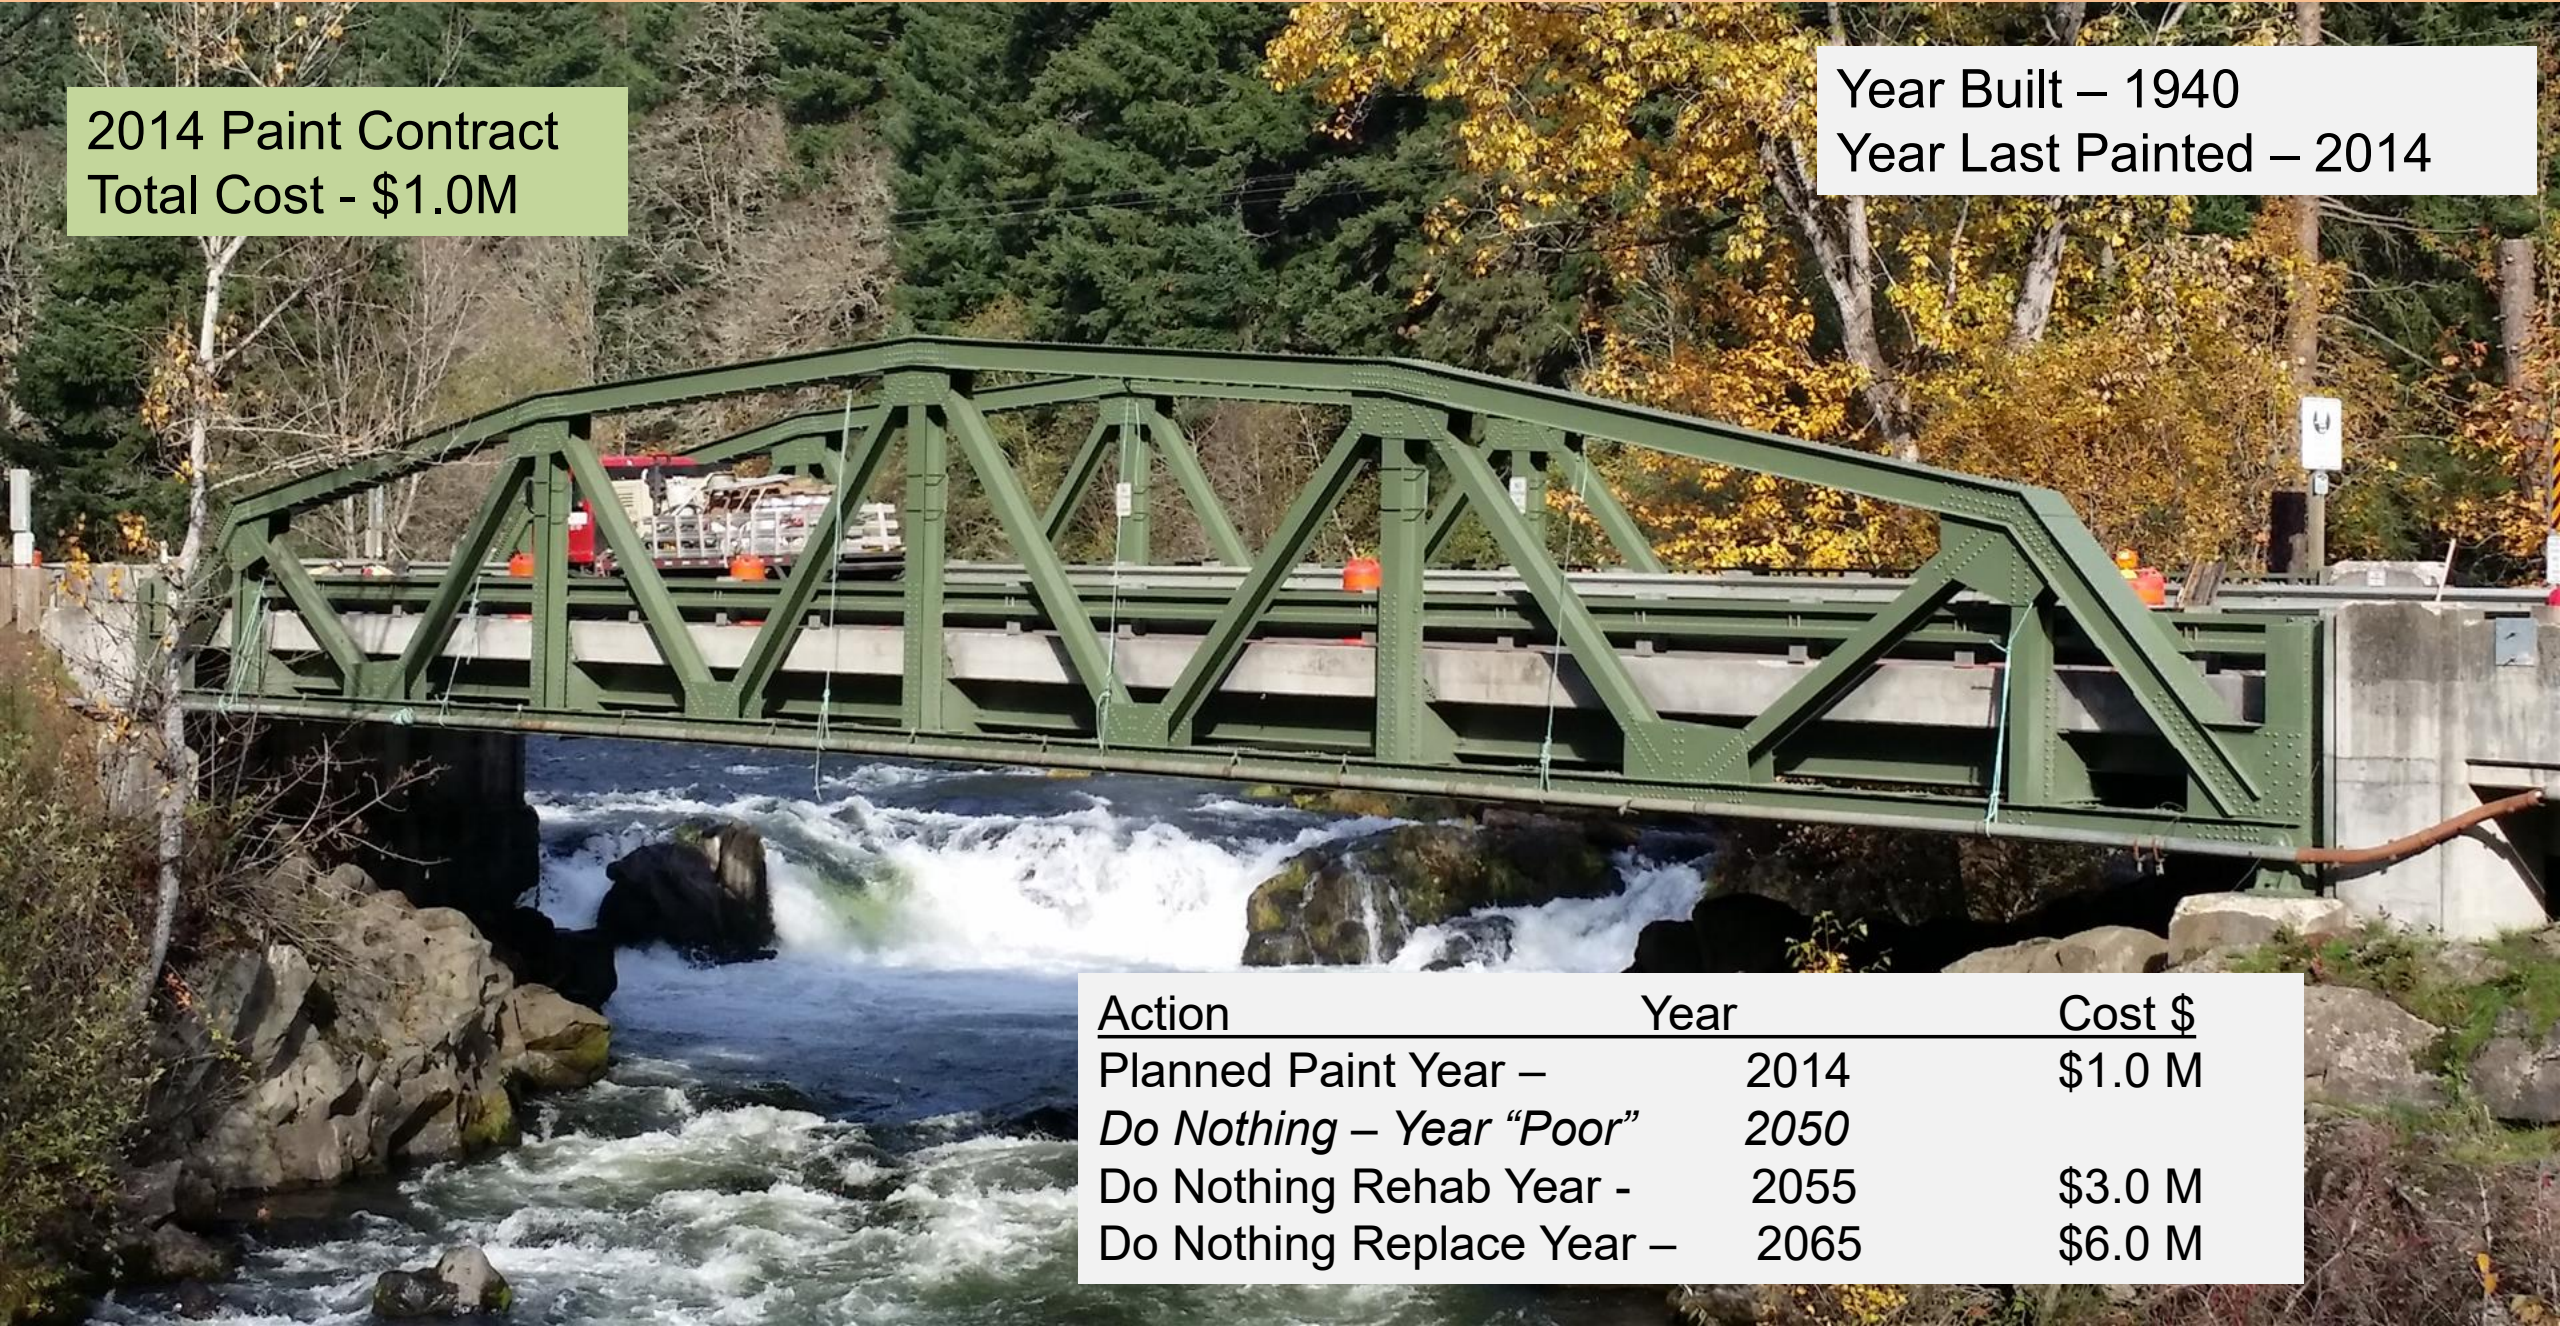
2014 Paint Contract
Total Cost - \$1.0M

Year Built – 1940
Year Last Painted – 2014

Action	Year	Cost \$
Planned Paint Year –	2014	\$1.0 M
<i>Do Nothing – Year “Poor”</i>	2050	
Do Nothing Rehab Year -	2055	\$3.0 M
Do Nothing Replace Year –	2065	\$6.0 M

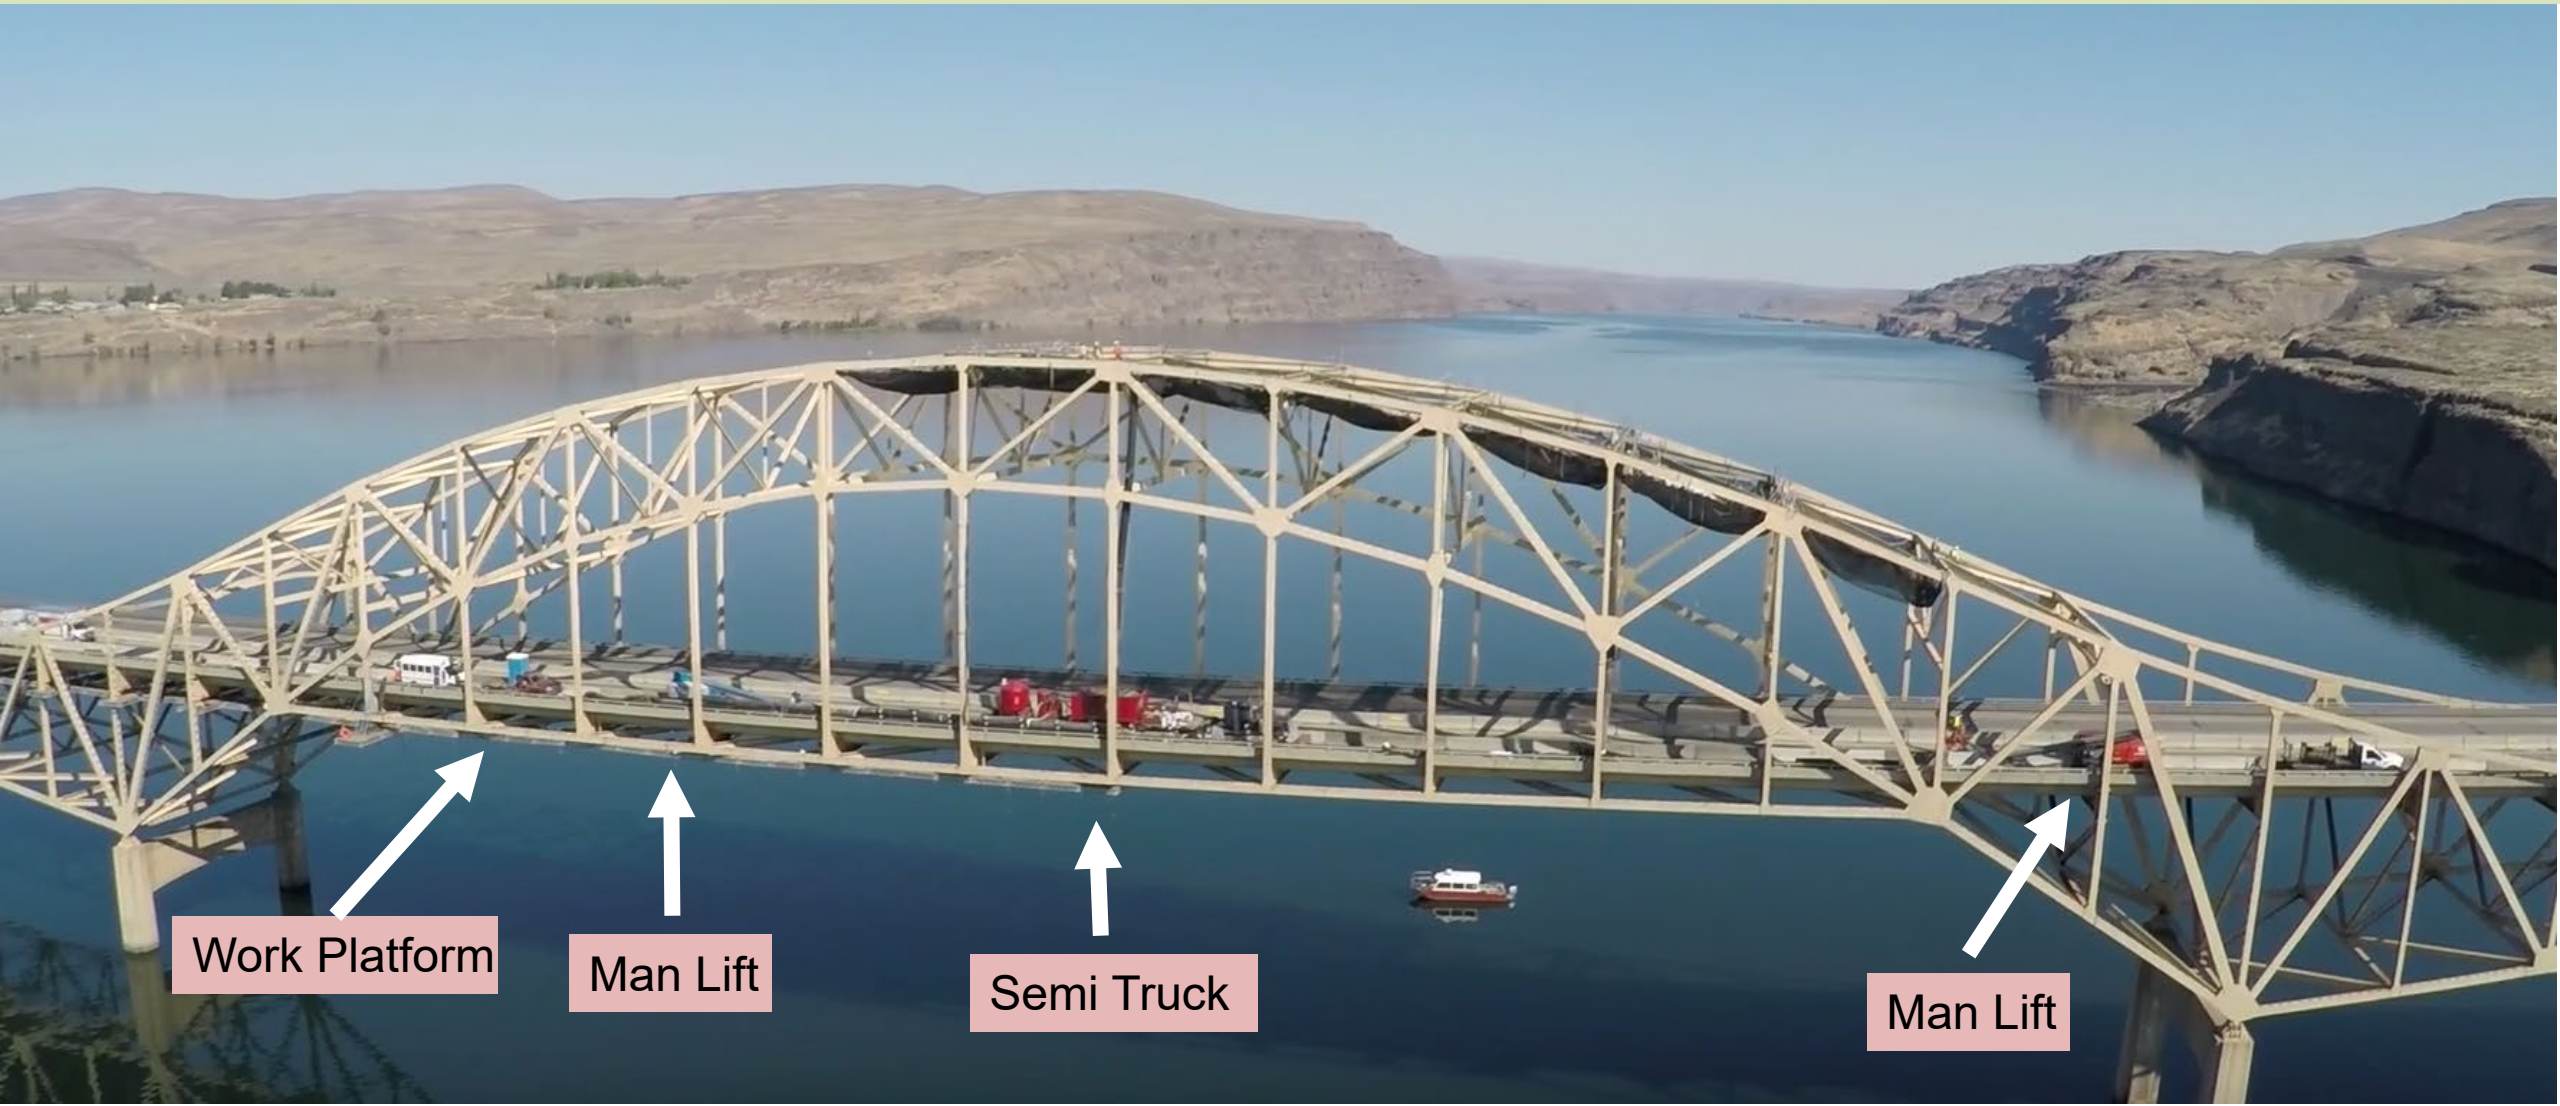
Work Platform

Man Lift

Semi Truck

I-90 Columbia River bridge @ Vantage (Drone video Aug 2016)
