Washington State Polyester Concrete Activity

**Andre' La Foe
Bridge Deck Program Manager**

Polyester Concrete Overlays

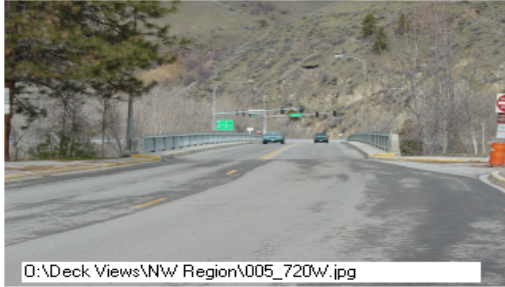
Bridge Number: 0007141B 5 / 720W	Bridge Name: SAMISH RIVER	Milepost: 234.04	County: Skaqit Region: Northwest
Year Built / YR Widened: 1963	Bridge Type: CS	Number of Main/Appr span: 5 / 0	Overall Bridge Condition: Poor
Bridge Width (curb-curb): 33.5 ft.	Bridge Length: 187 ft.	Max Span: 48 ft.	Bridge Deck View

Cure	Deck Repair and Overlay		
Status	Prioritized for Bridge Rehabilitation		
Preservation Cost\$:	\$1,500,000		
<p>This bridge is classified in "POOR" condition due to the NBI DECK CODE.</p> <p>The 2014 bridge inspection noted 187 SF of deck patching (3.3%). The NBI deck code is a "4" based on the deck patching exceeding 2%.</p> <p>The original concrete slab thickness is 18.5 inches with 1.5 inches of concrete cover over the top mat of deck reinforcing.</p> <p>A future bridge deck rehabilitation project will shotblast 1/2 inch from the existing slab, perform deck repair and apply a 3/4" polyester overlay.</p>

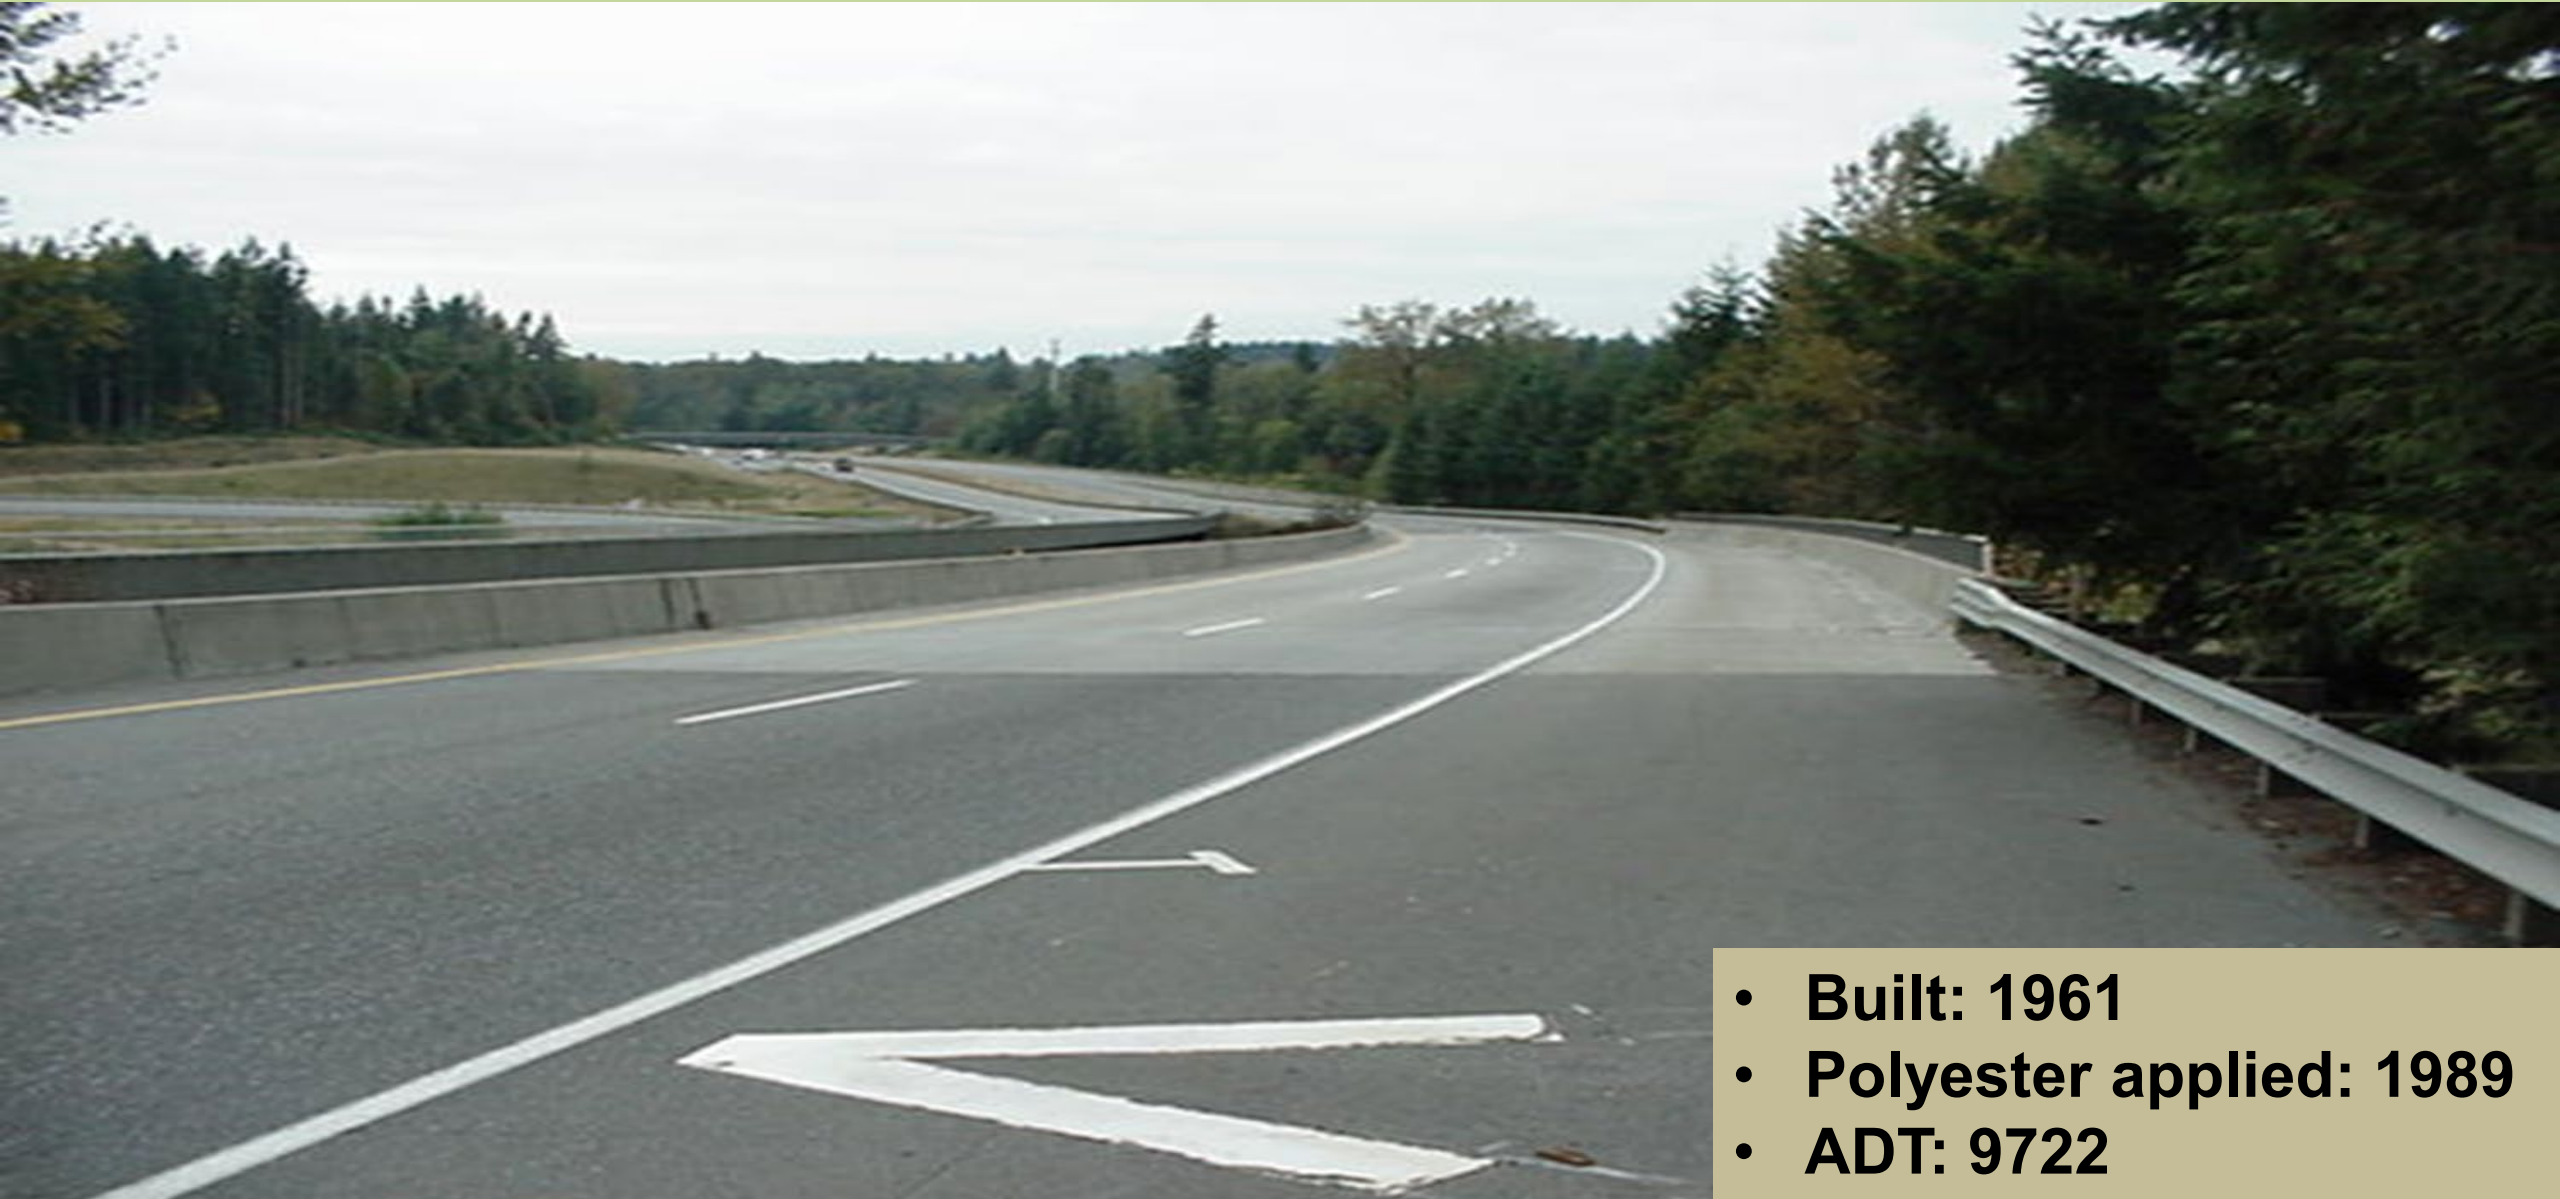
SR-18 Holder Creek Bridge

- **Built: 1961**
- **Polyester applied: 1989**
- **ADT: 9722**

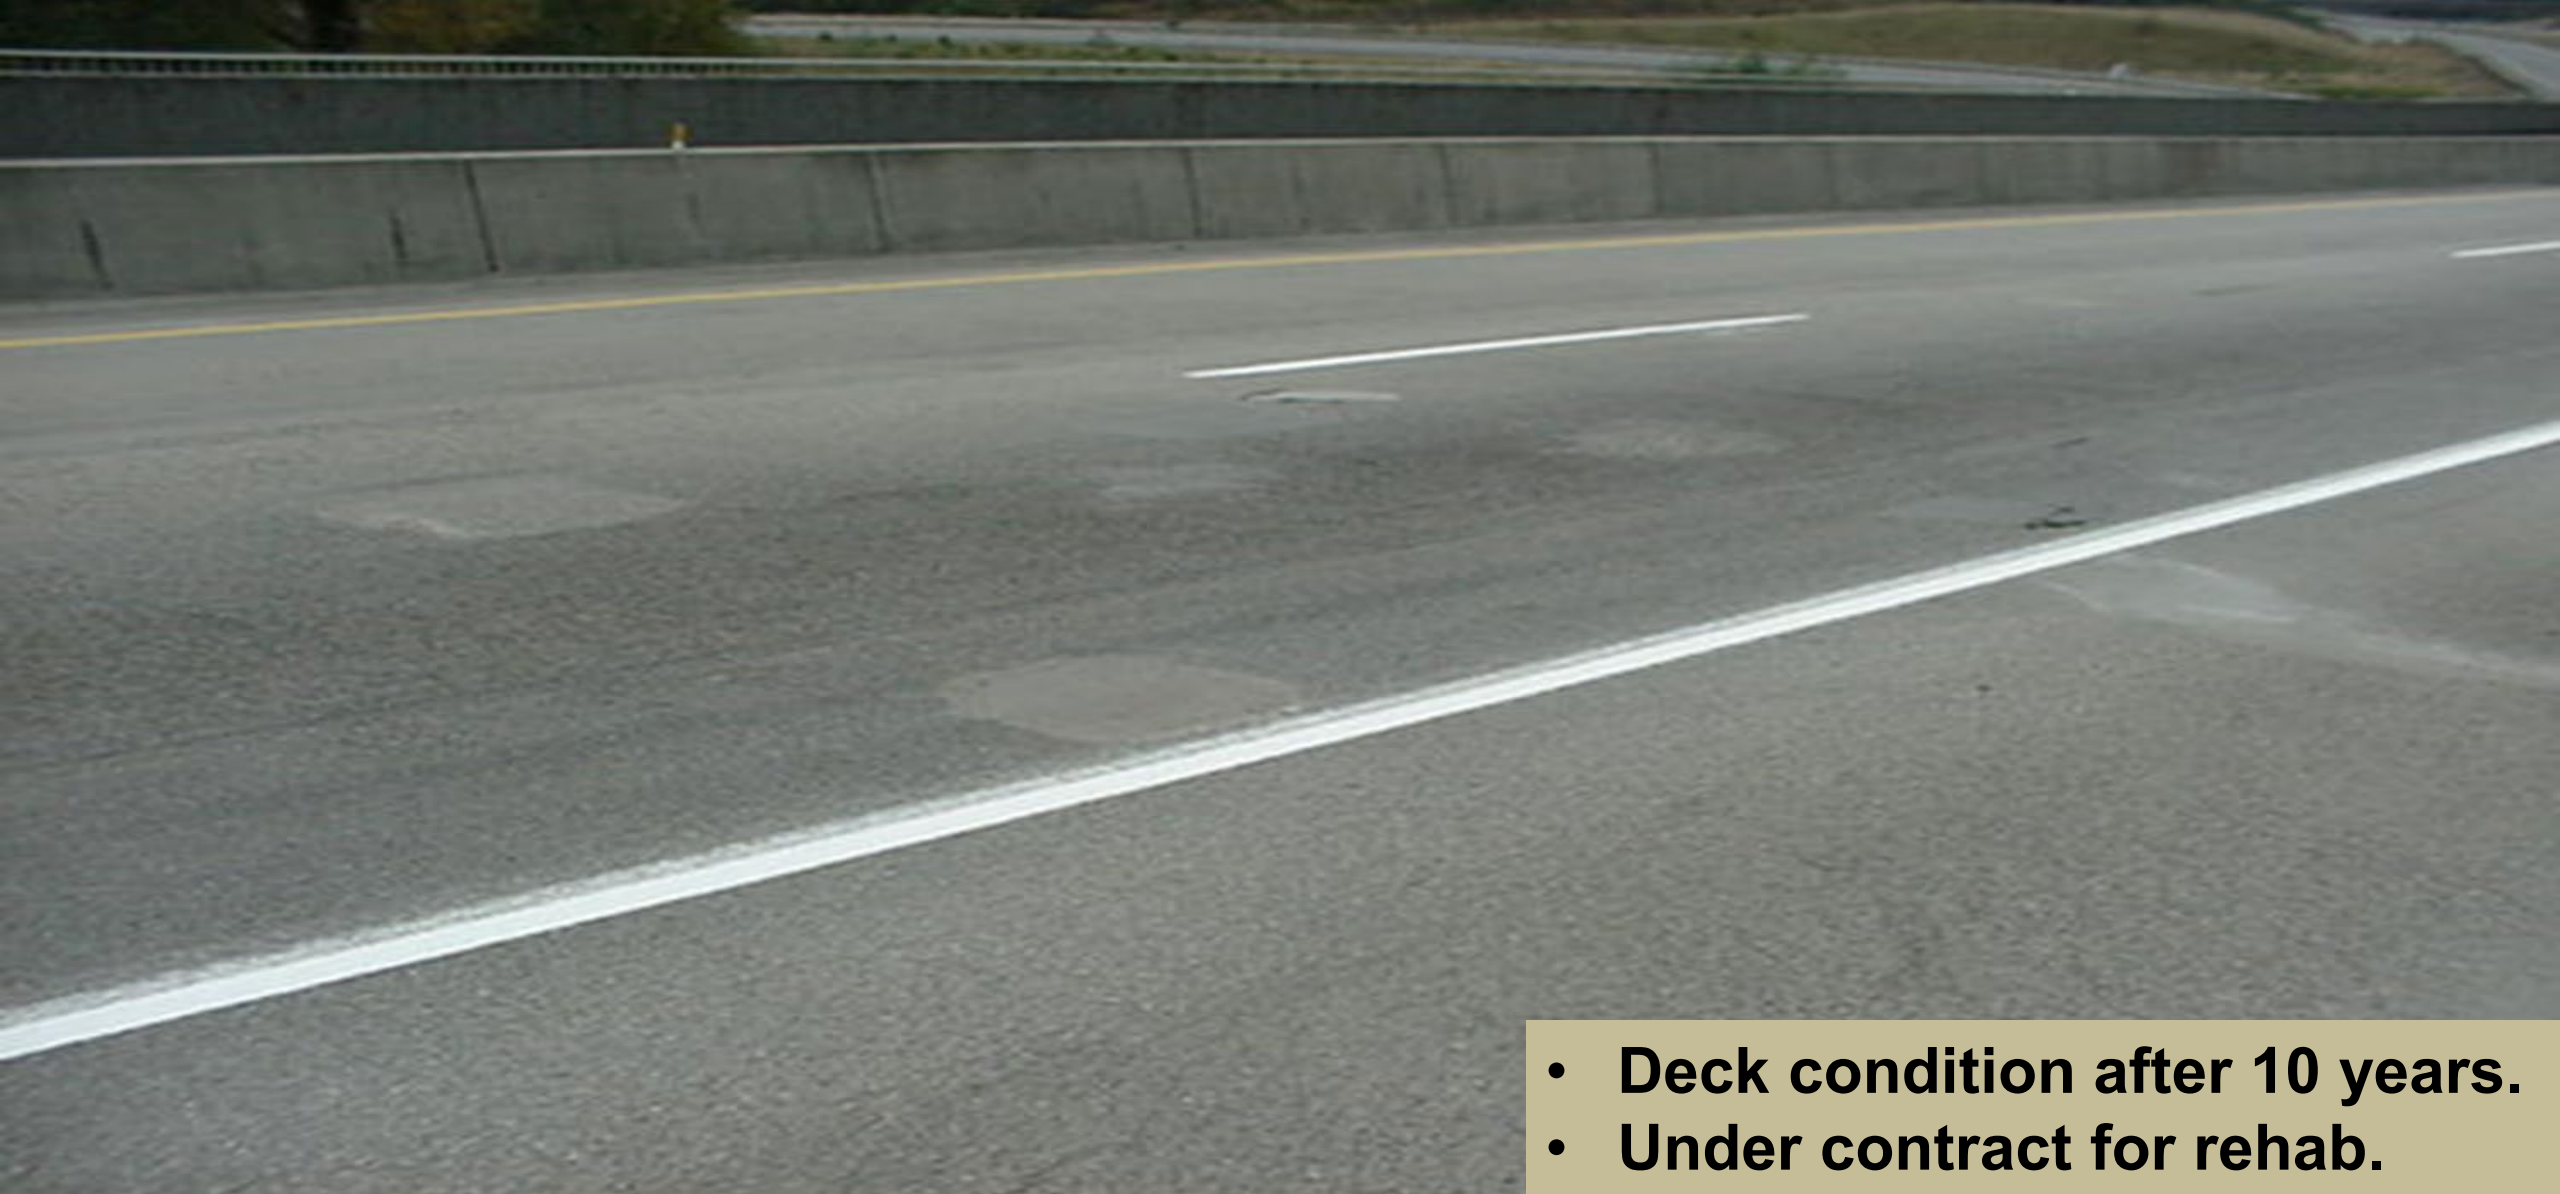
SR-18 Holder Creek Bridge

- Deck condition after 10 years.
- Under contract for rehab.

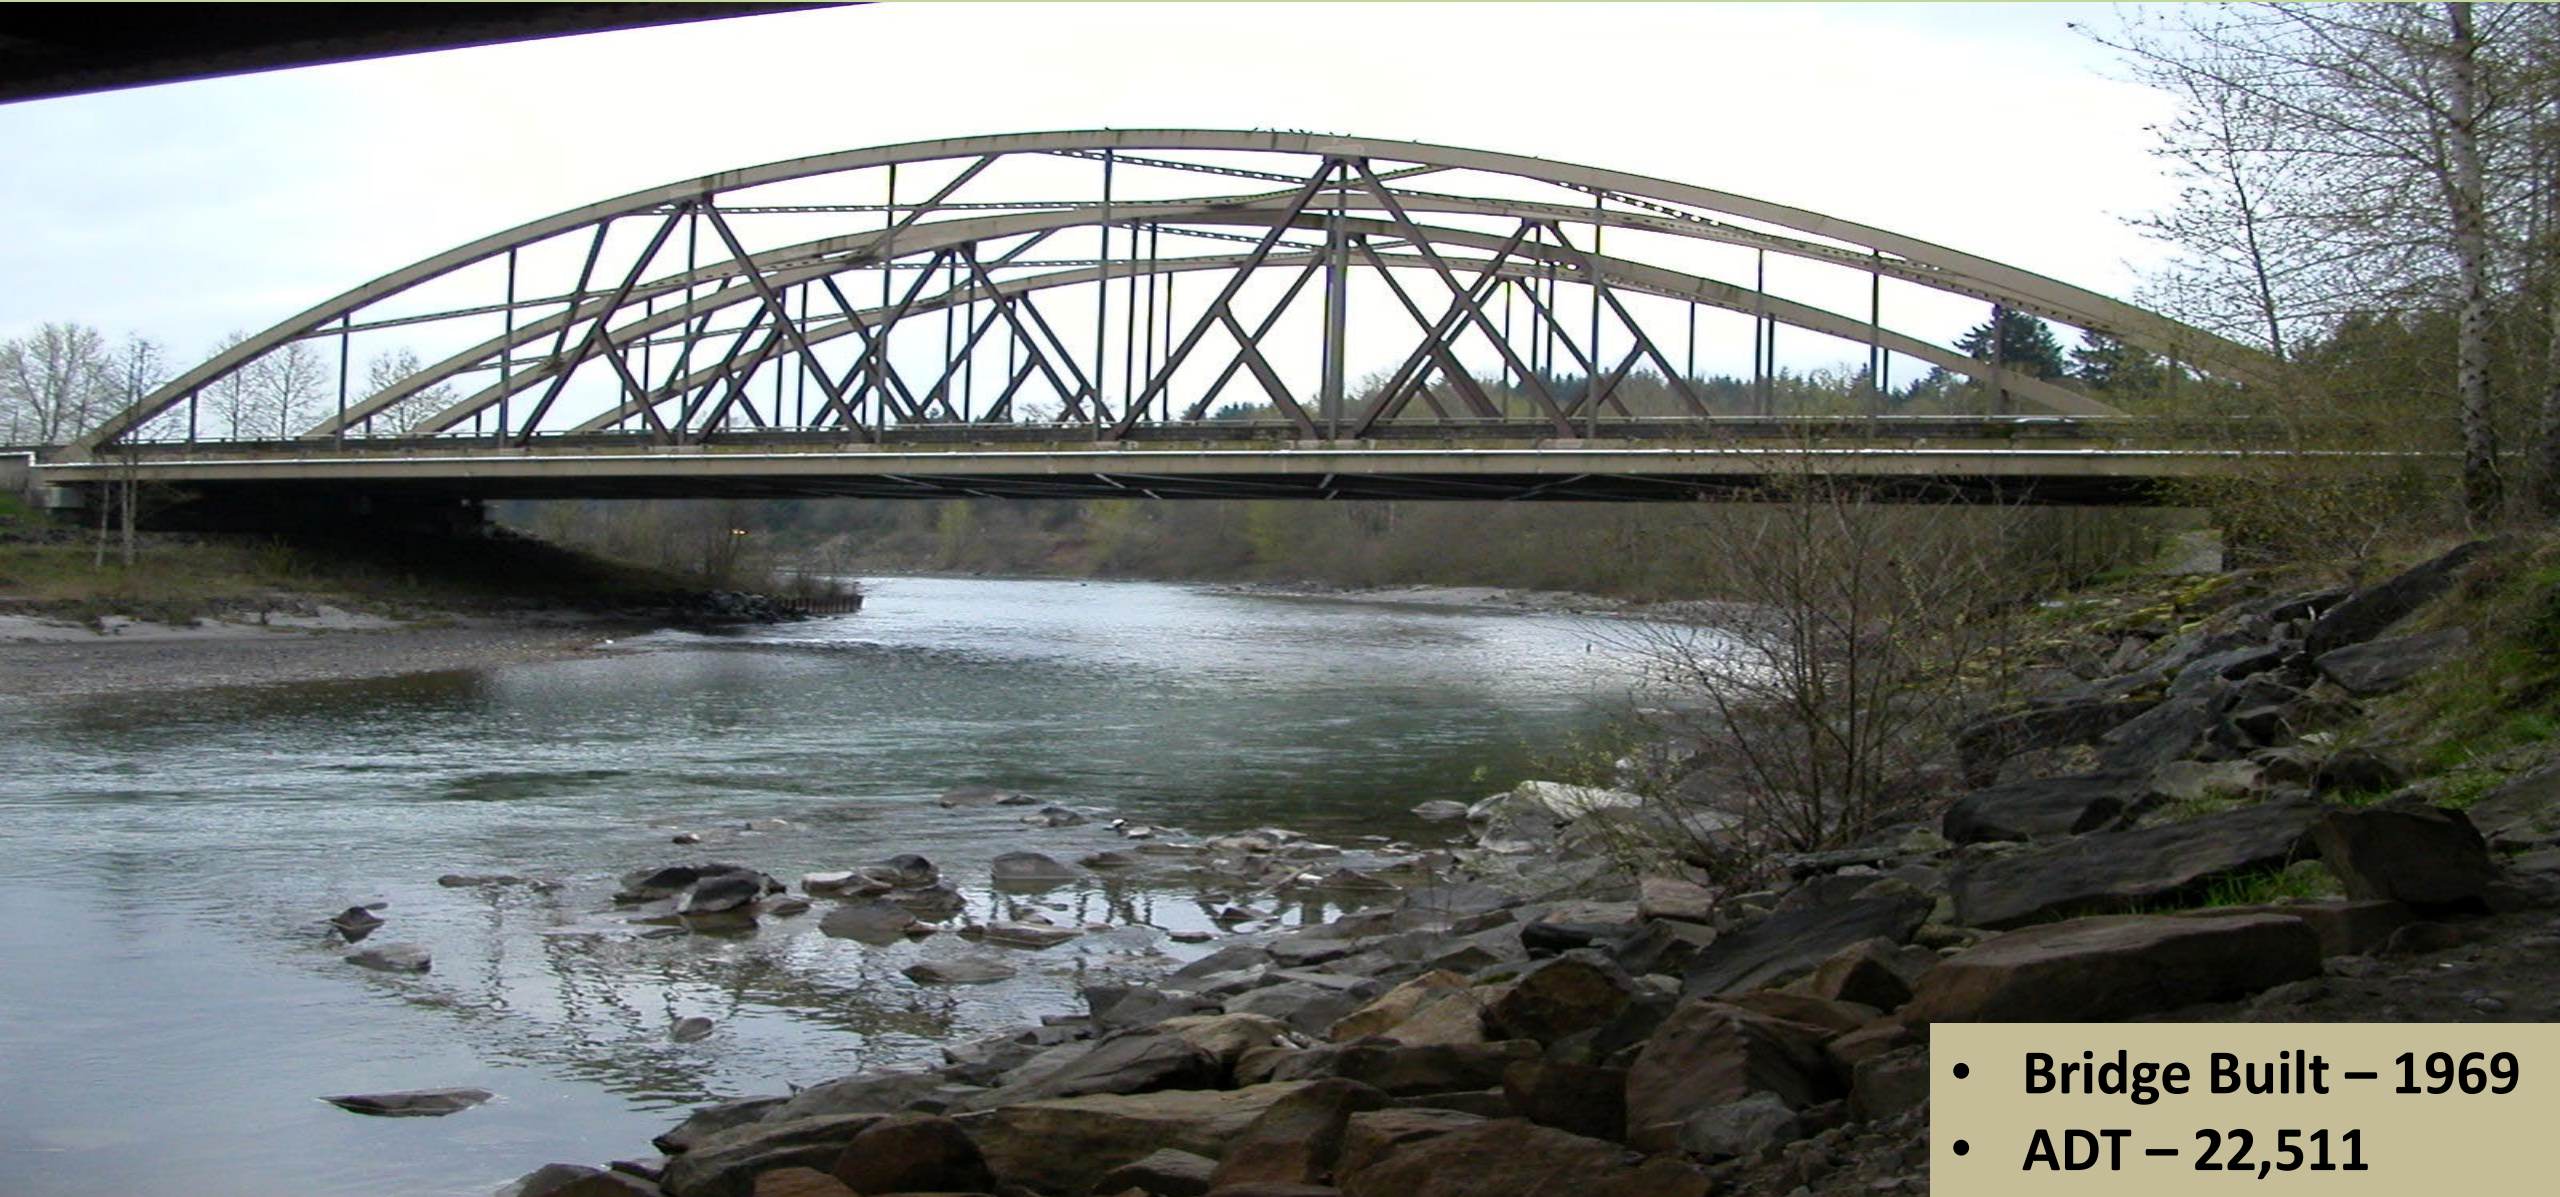
SB I-5 Toutle River Bridge – Deck Rehab

- Bridge Built – 1969
- ADT – 22,511

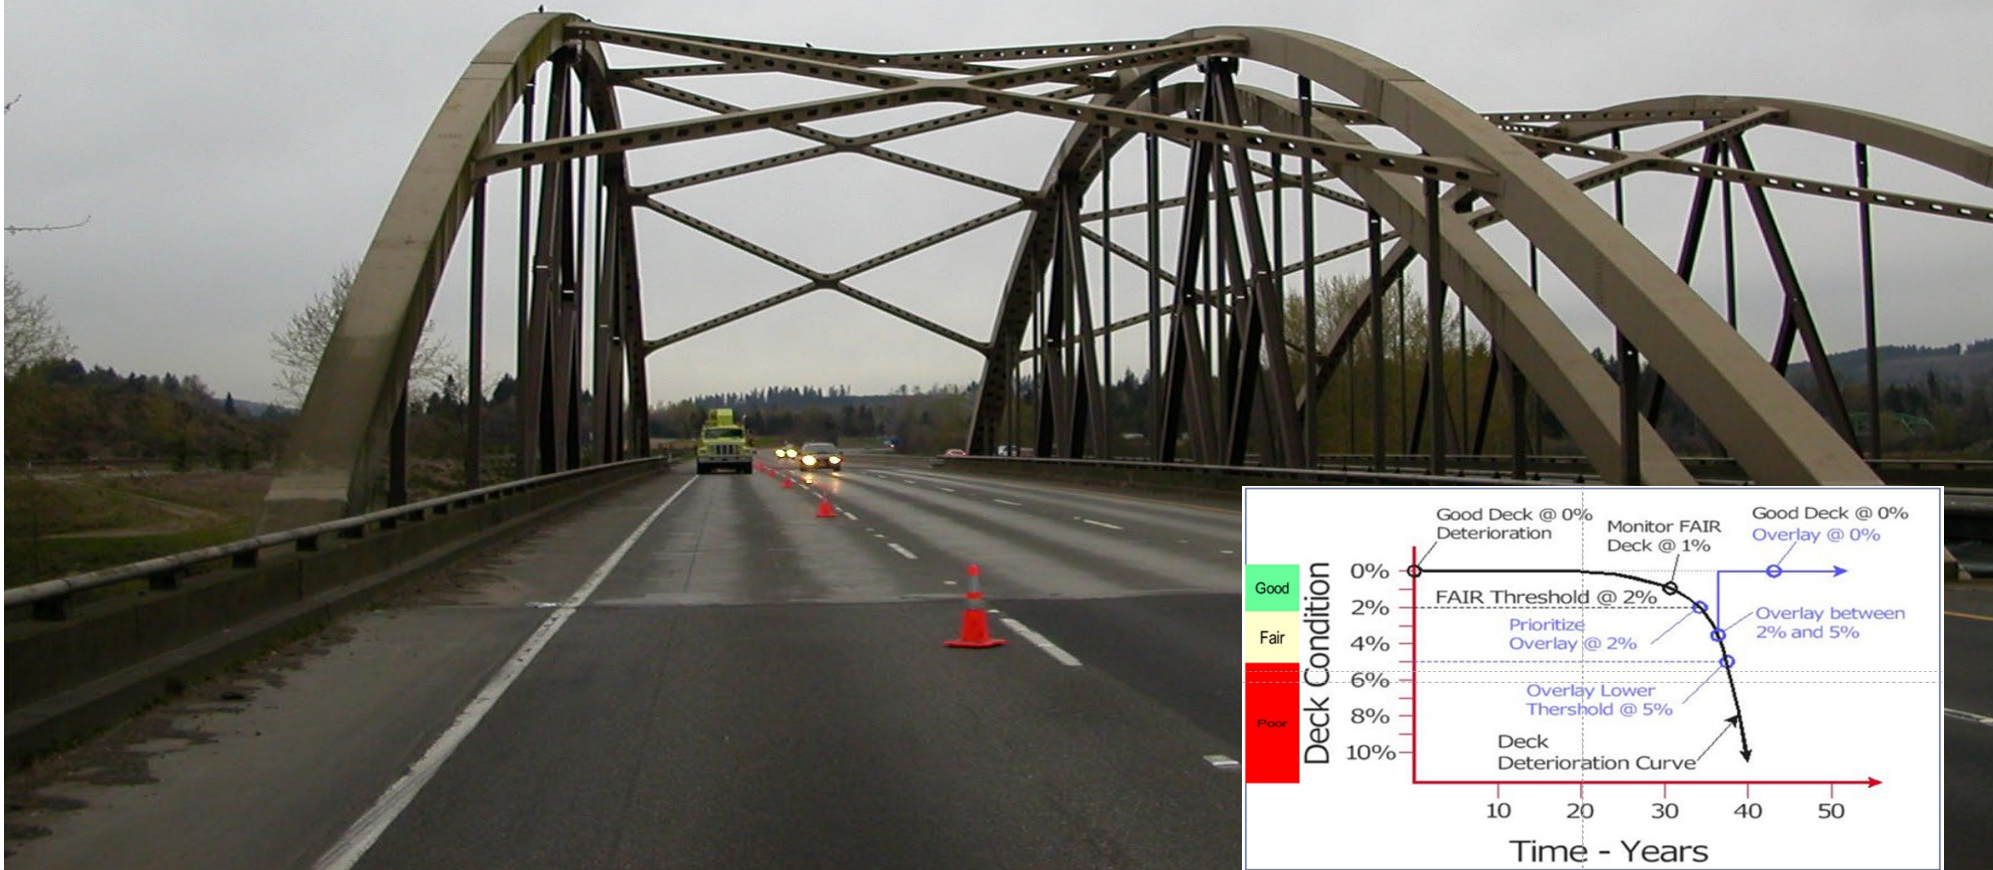
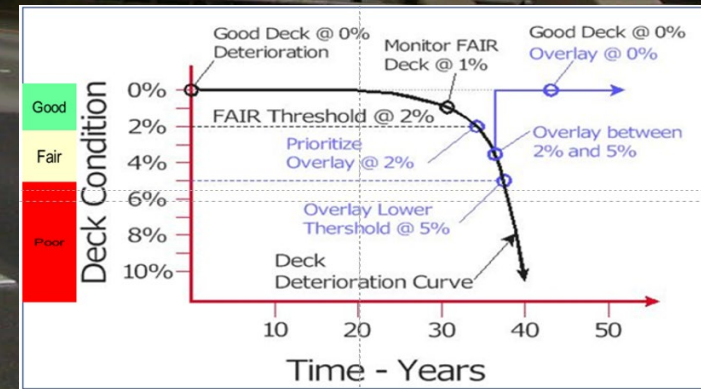
Deck – Looking North

BMS Elements							
Element	Element Description	Total	Units	CS 1	CS 2	CS 3	CS 4
12	Concrete Deck	14,832	SF	14,373	450	9	0
35	Concrete Deck Soffit	14,832	SF	14,702	126	4	0

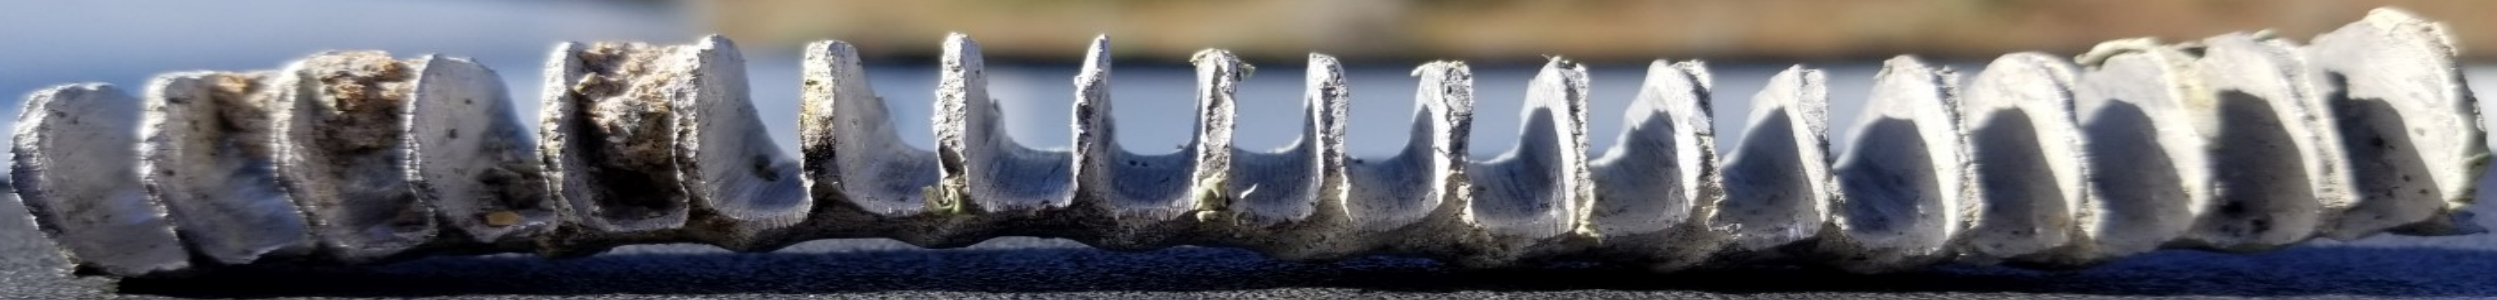
Verify the Clearcover Prior to Surface Removal

- **Damaged reinforcing from milling**

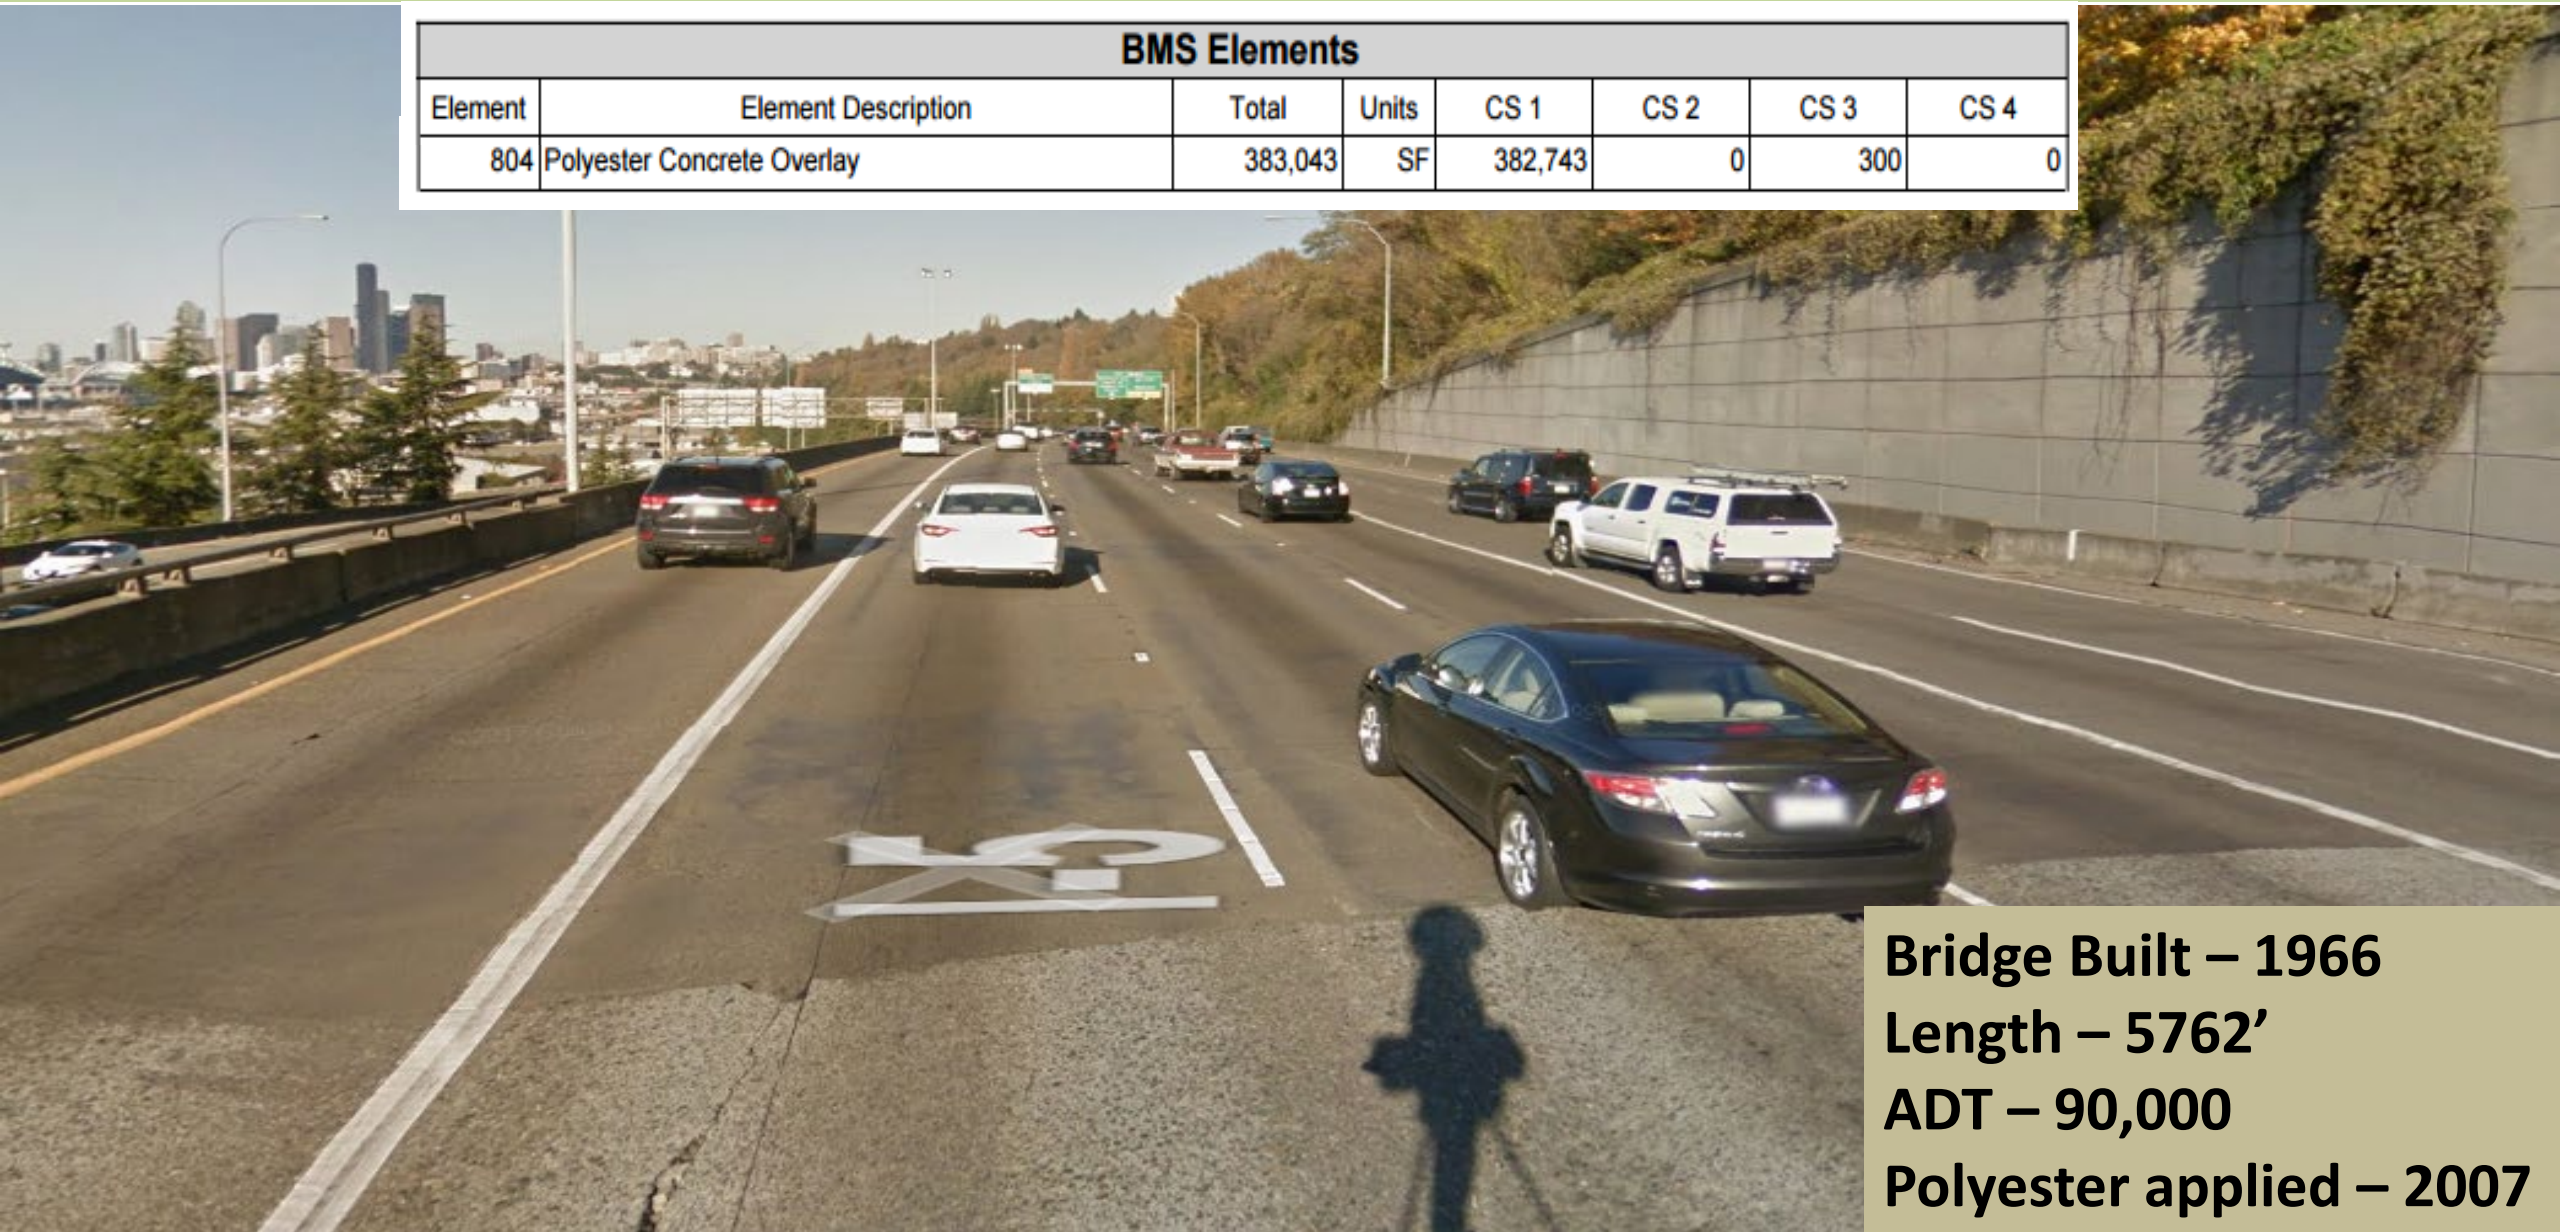
NB I-5 Seattle Viaduct

BMS Elements							
Element	Element Description	Total	Units	CS 1	CS 2	CS 3	CS 4
804	Polyester Concrete Overlay	383,043	SF	382,743	0	300	0

Bridge Built – 1966
Length – 5762'
ADT – 90,000
Polyester applied – 2007

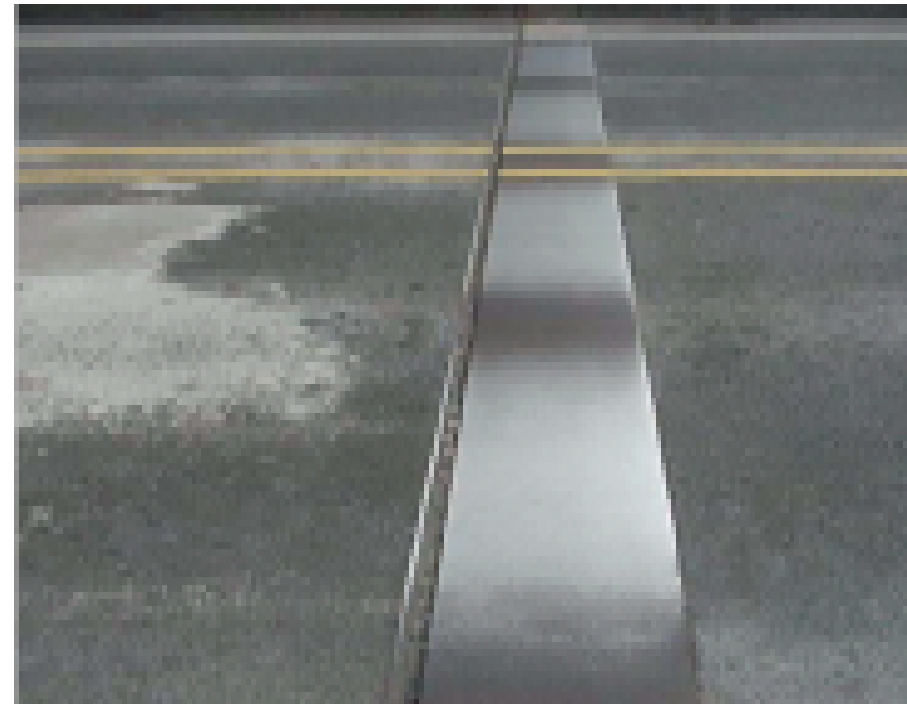
NB I-5 Seattle Viaduct – Original Joint Detail

This element defines a joint with steel sliding plates. The quantity should equal the length measured along the expansion joint.

> 1,800 LF of sliding plate joints

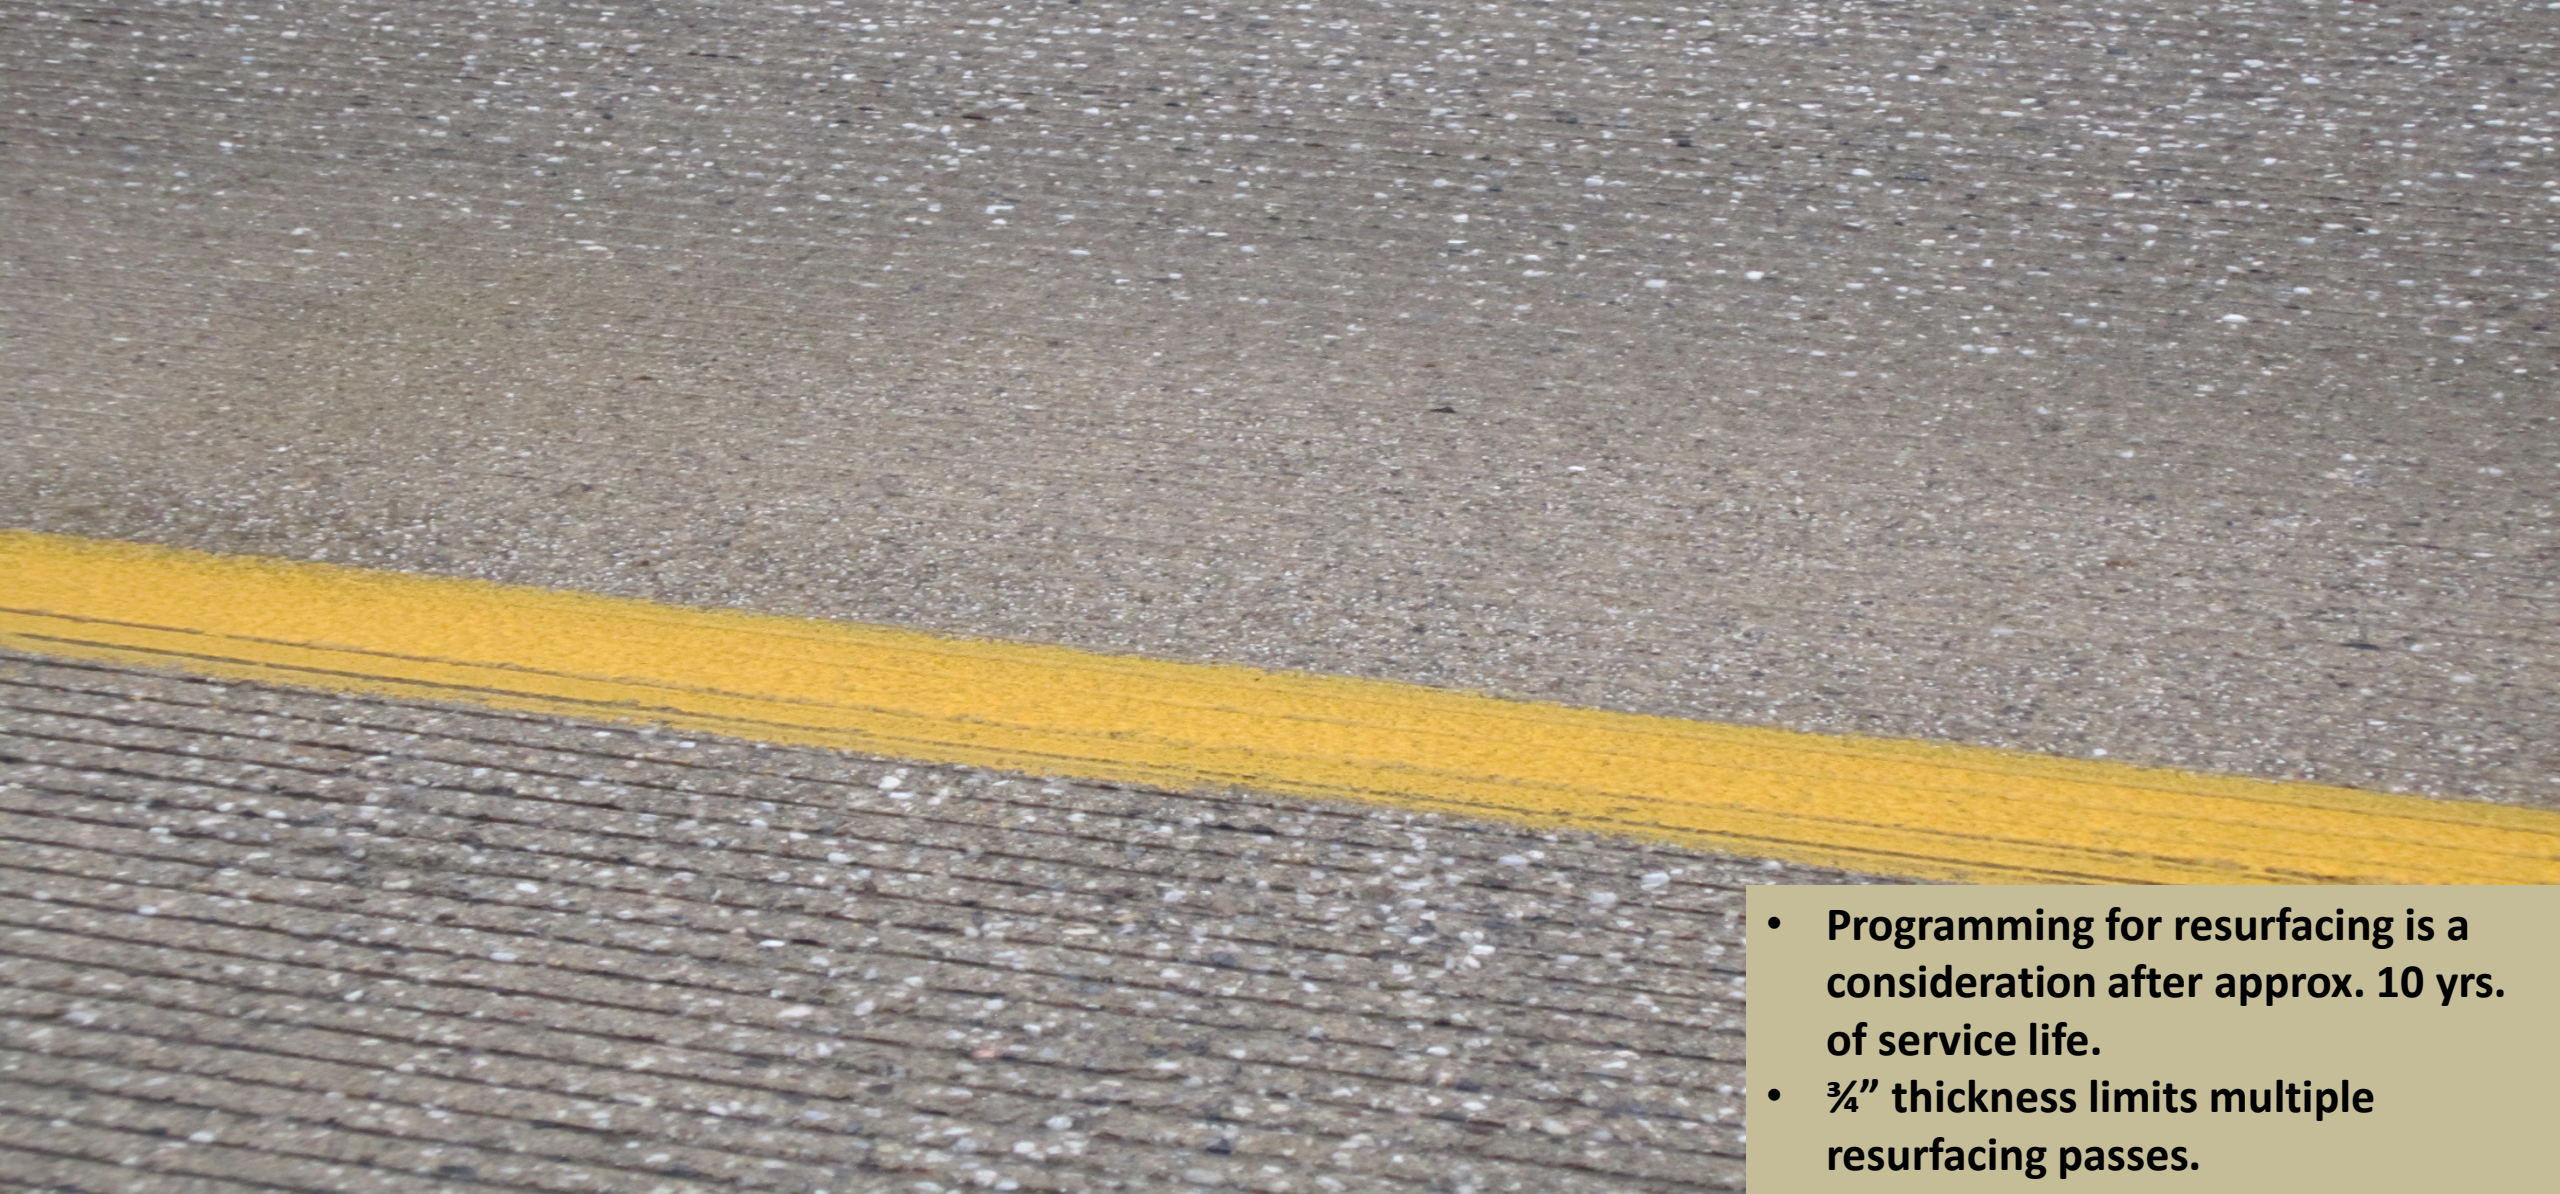
Program - Periodic Resurfacing of Polyester Overlays

- Programming for resurfacing is a consideration after approx. 10 yrs. of service life.
- $\frac{3}{4}$ " thickness limits multiple resurfacing passes.

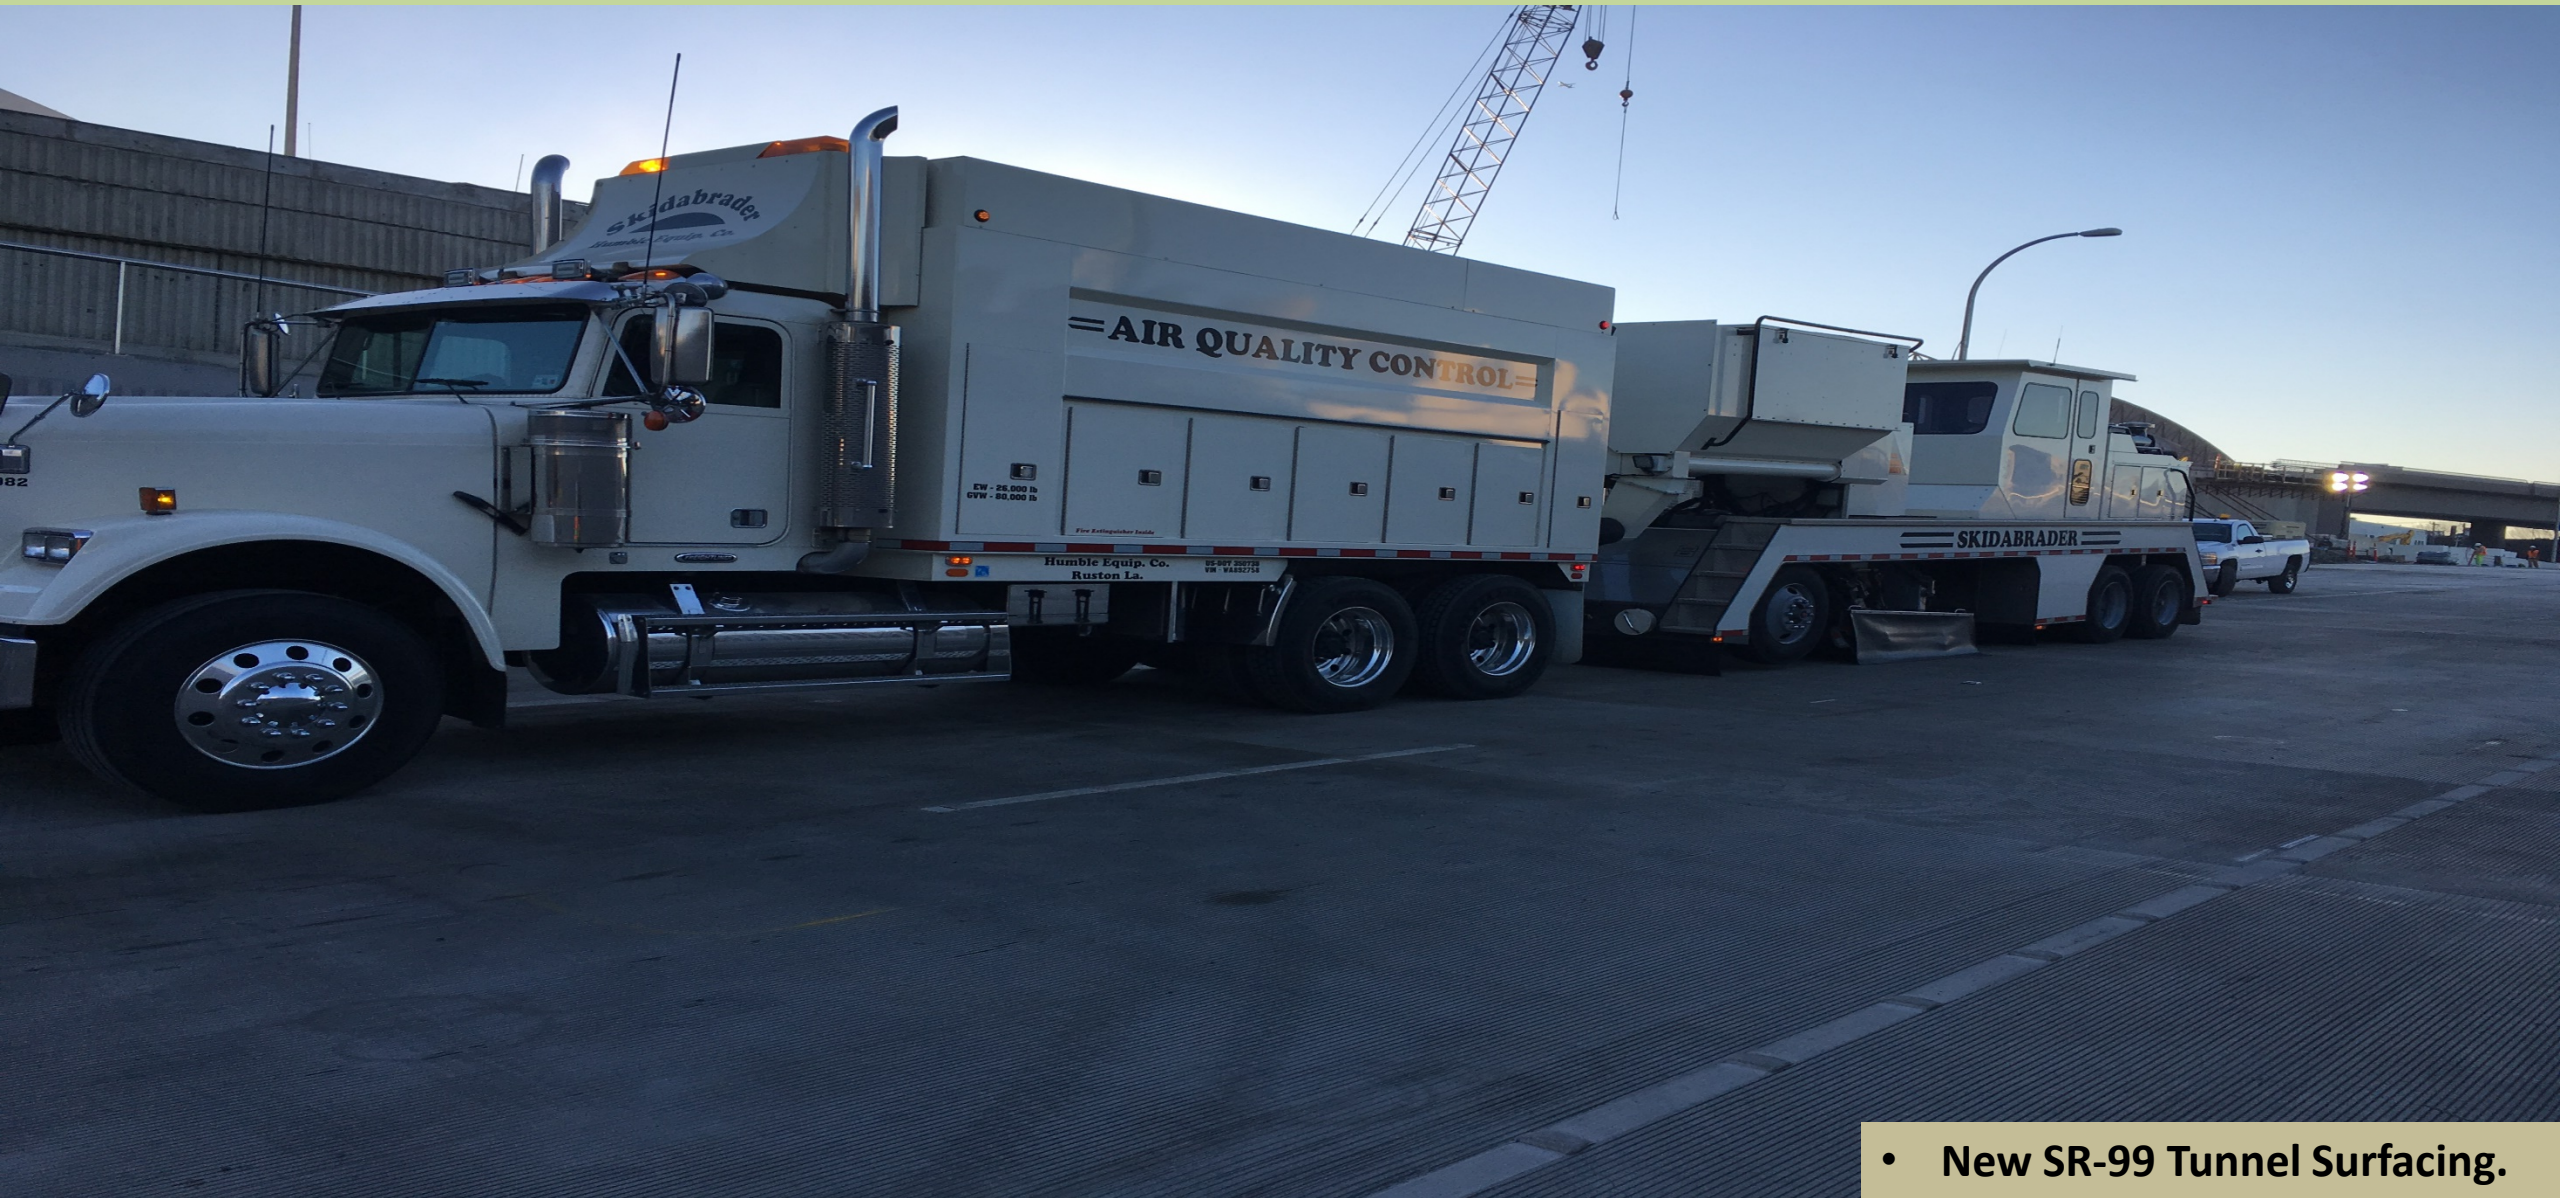
Periodic Resurfacing of Polyester Overlays

- New SR-99 Tunnel Surfacing.
