Washington State Polyester Concrete Activity

**Andre' La Foe
Bridge Deck Program Manager**

Polyester Concrete Overlays

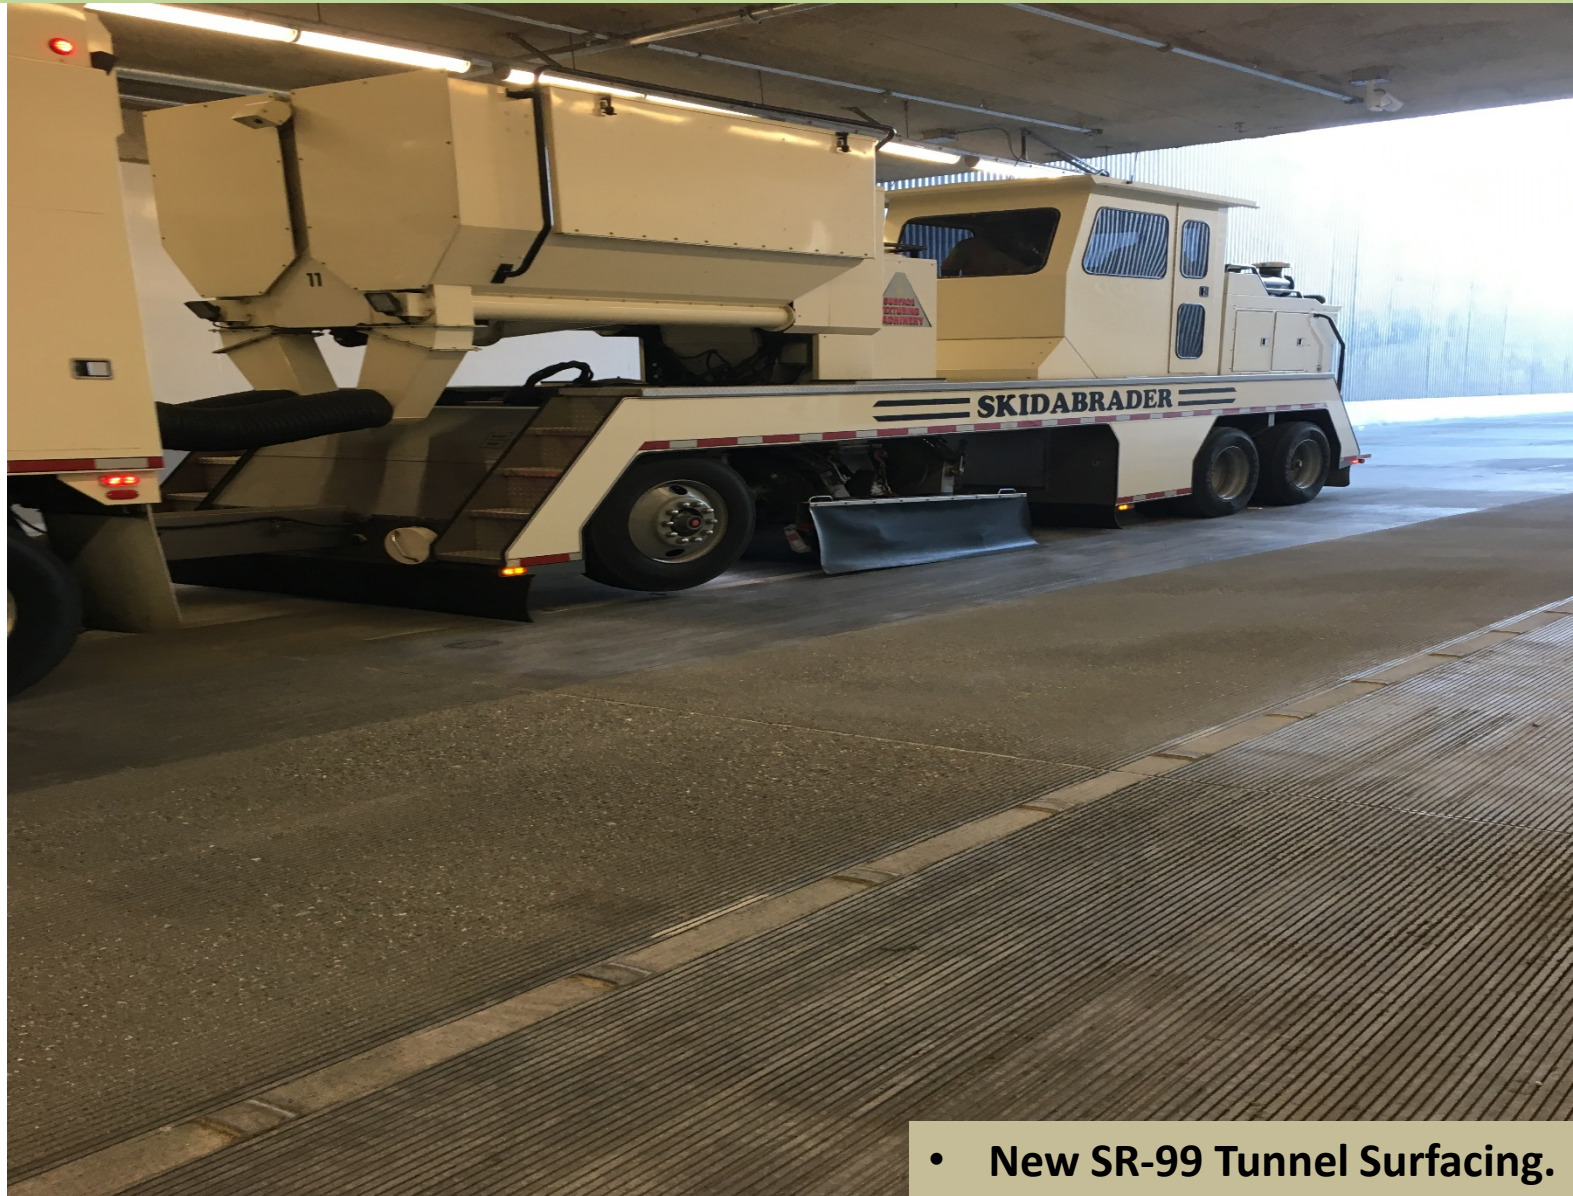
Periodic Resurfacing of Polyester Overlays

- New SR-99 Tunnel Surfacing.
