Michigan Department of Transportation Emerging Technology

Polyurethane Stabilization as a Preventive Maintenance Strategy

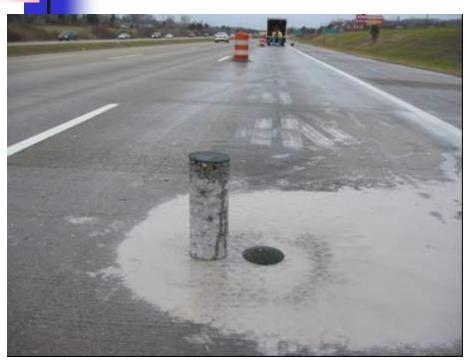
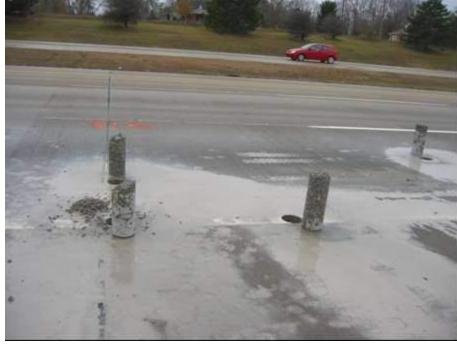
WB I-94, CS 82021, Belleville, 27 Ft JRCP; 11 inch Concrete; 4 inches CTB

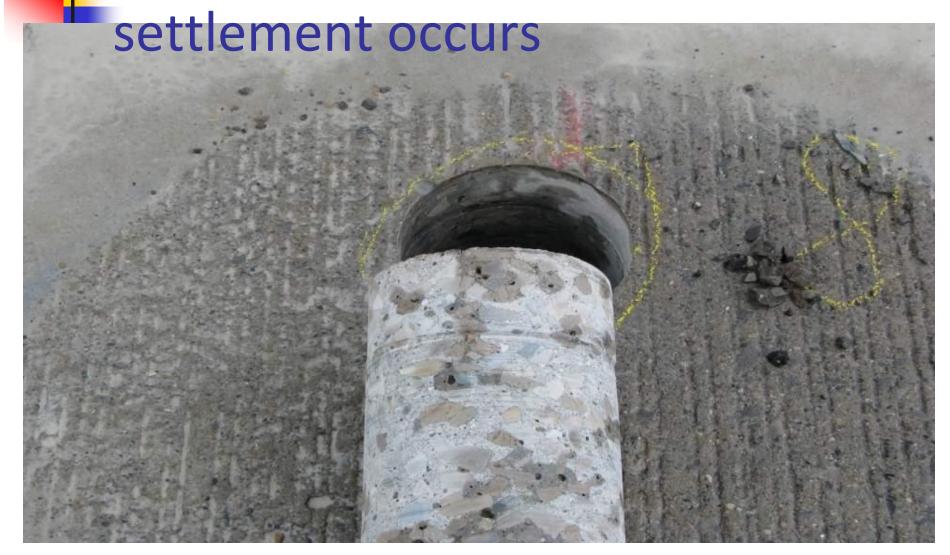
Mid-panel top down cracking starts after a level of joint

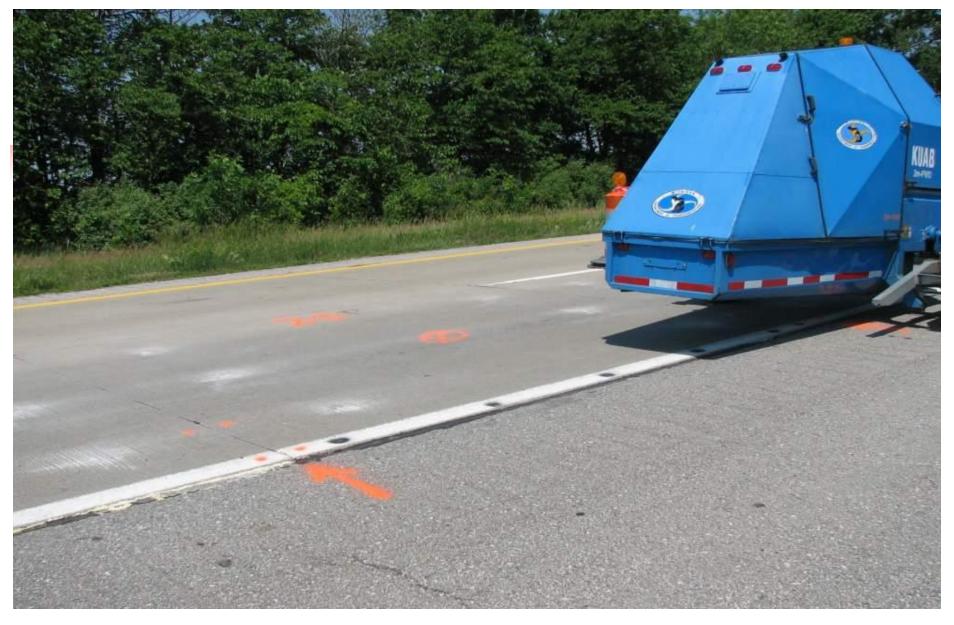
FWD testing will be done annually to monitor changes in deflections for US-23 NB Asphalt Stabilized OGDC Polyurethane Joint Treatment

FWD results before and after stabilization

- Experimental polyurethane joint stabilization was done by MDOT at a few joints in 2007
- More experimental stabilization techniques were completed in 2009 to refine the process
- FWD tests were run prior to joint stabilization and shortly after work was completed
- Lower deflections and higher load transfer effectiveness was recorded along the outside edge of pavement after the joint stabilization

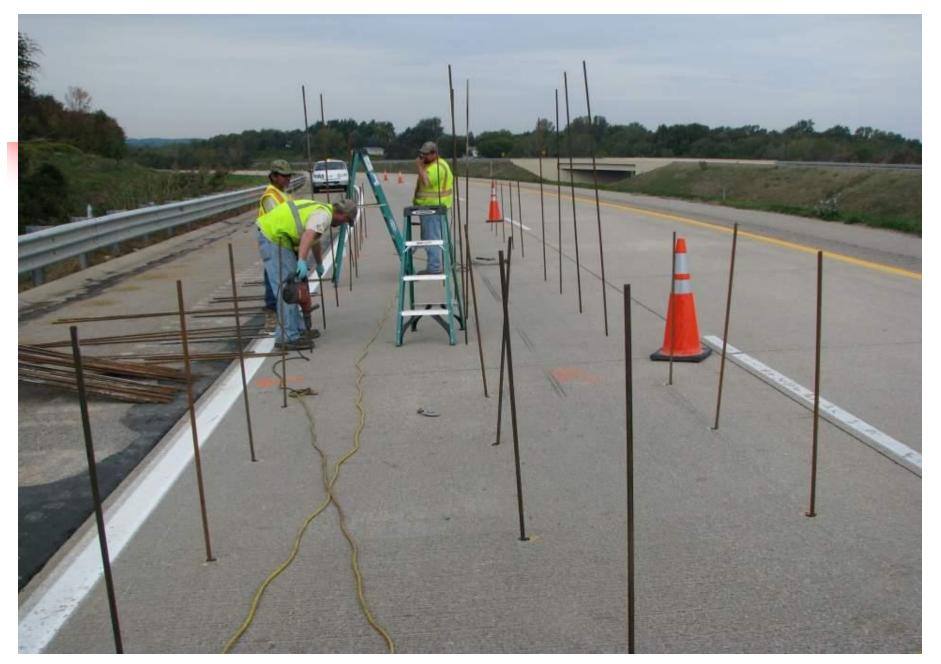
Slab jacking on M-6 near Grand Rapids
