# Corrosion Mitigation Systems for Existing Concrete Structures

Erik Thorp  
Vector Corrosion Technologies  
[www.vector-corrosion.com](http://www.vector-corrosion.com)

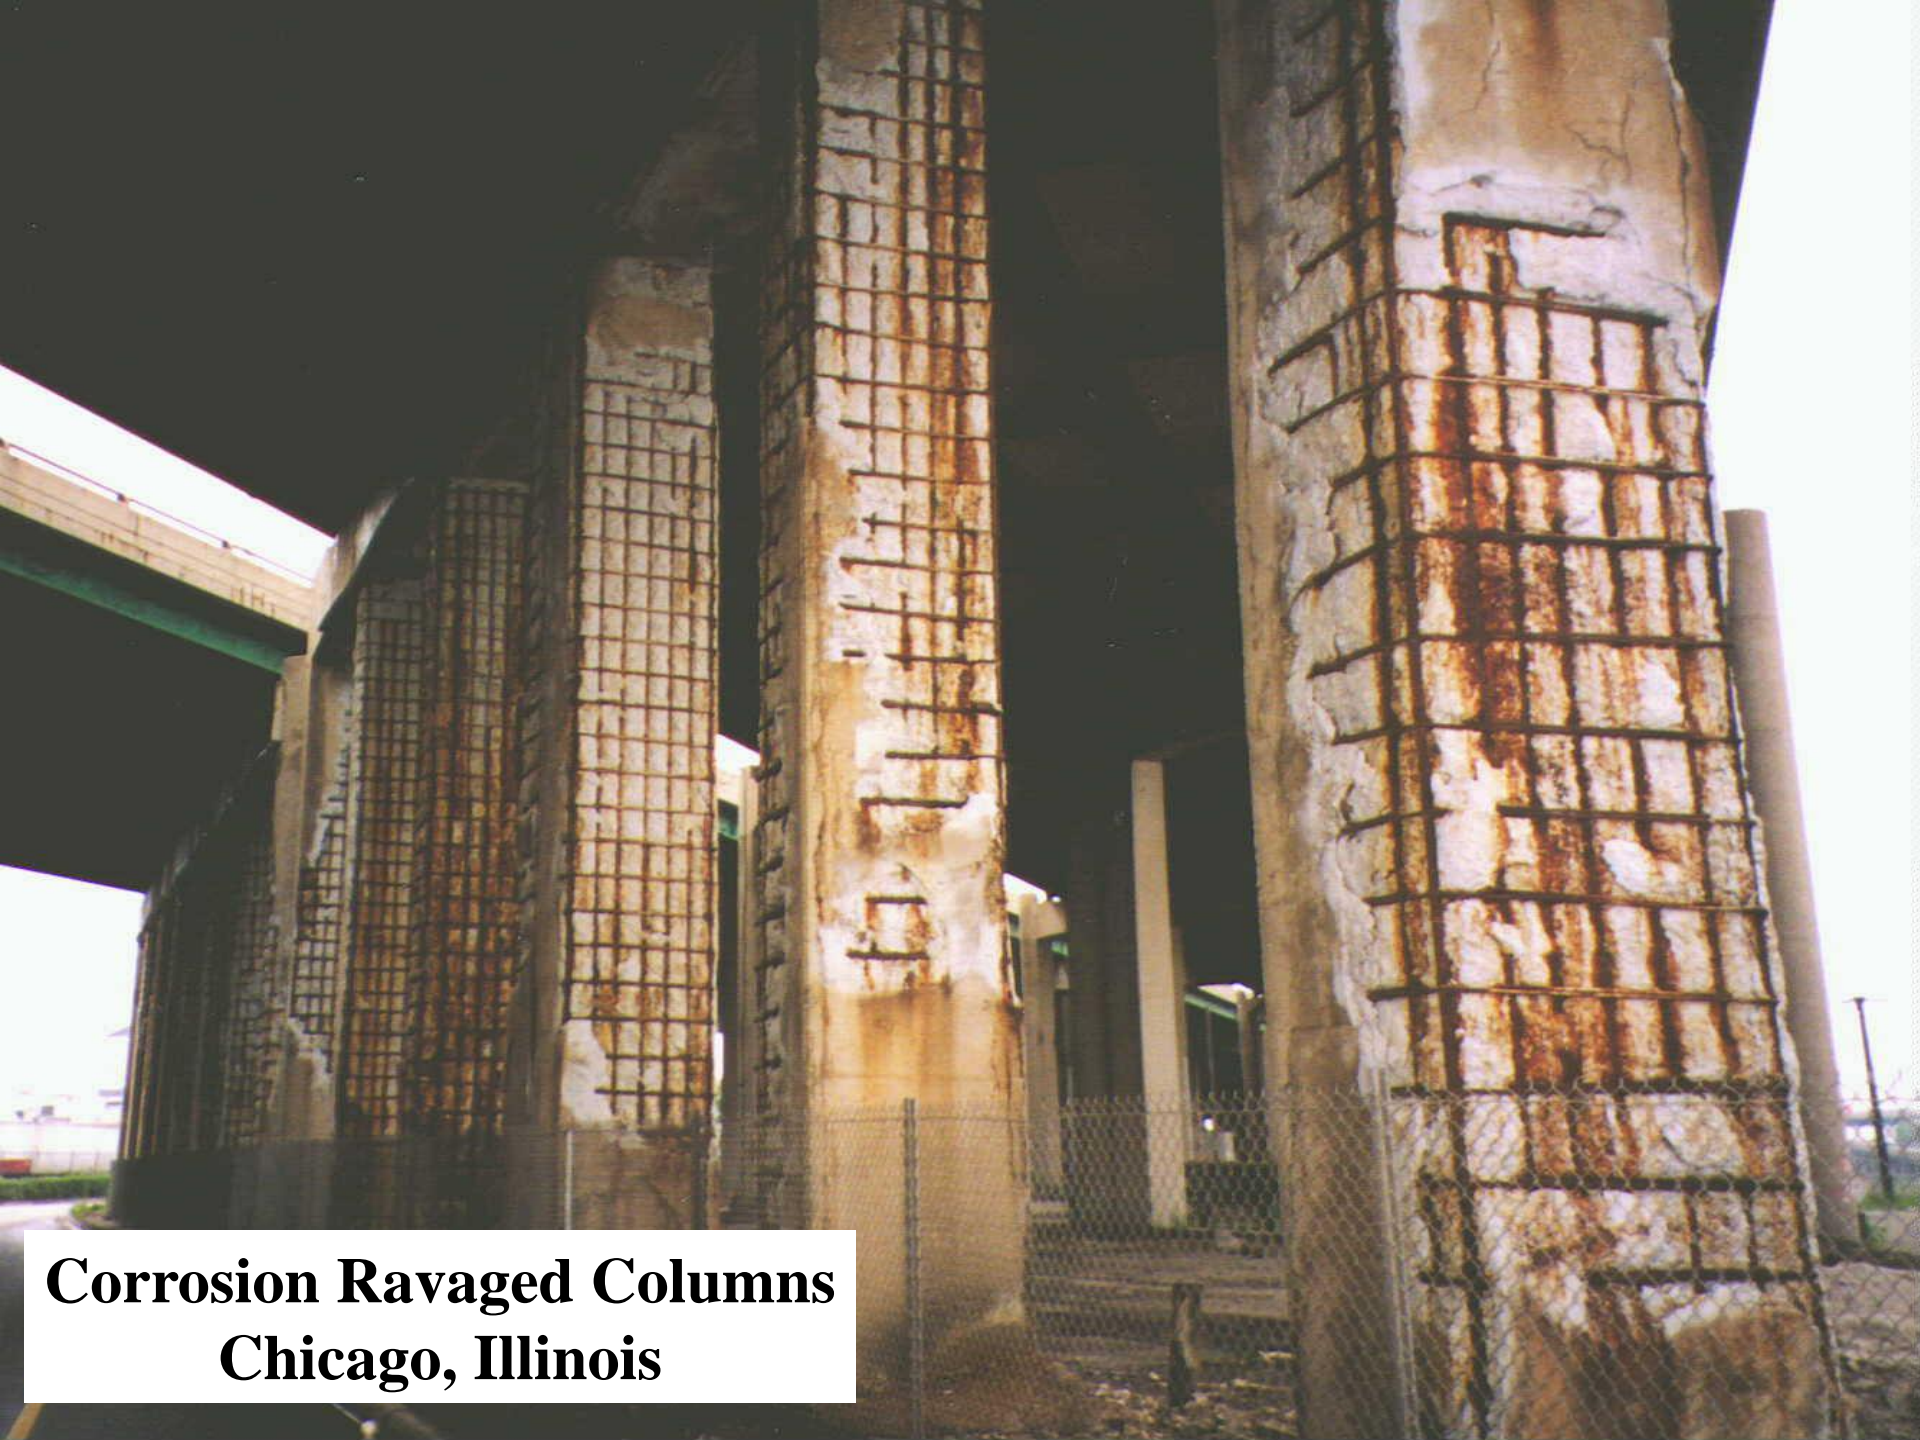
**Corrosion Ravaged Columns  
Chicago, Illinois**

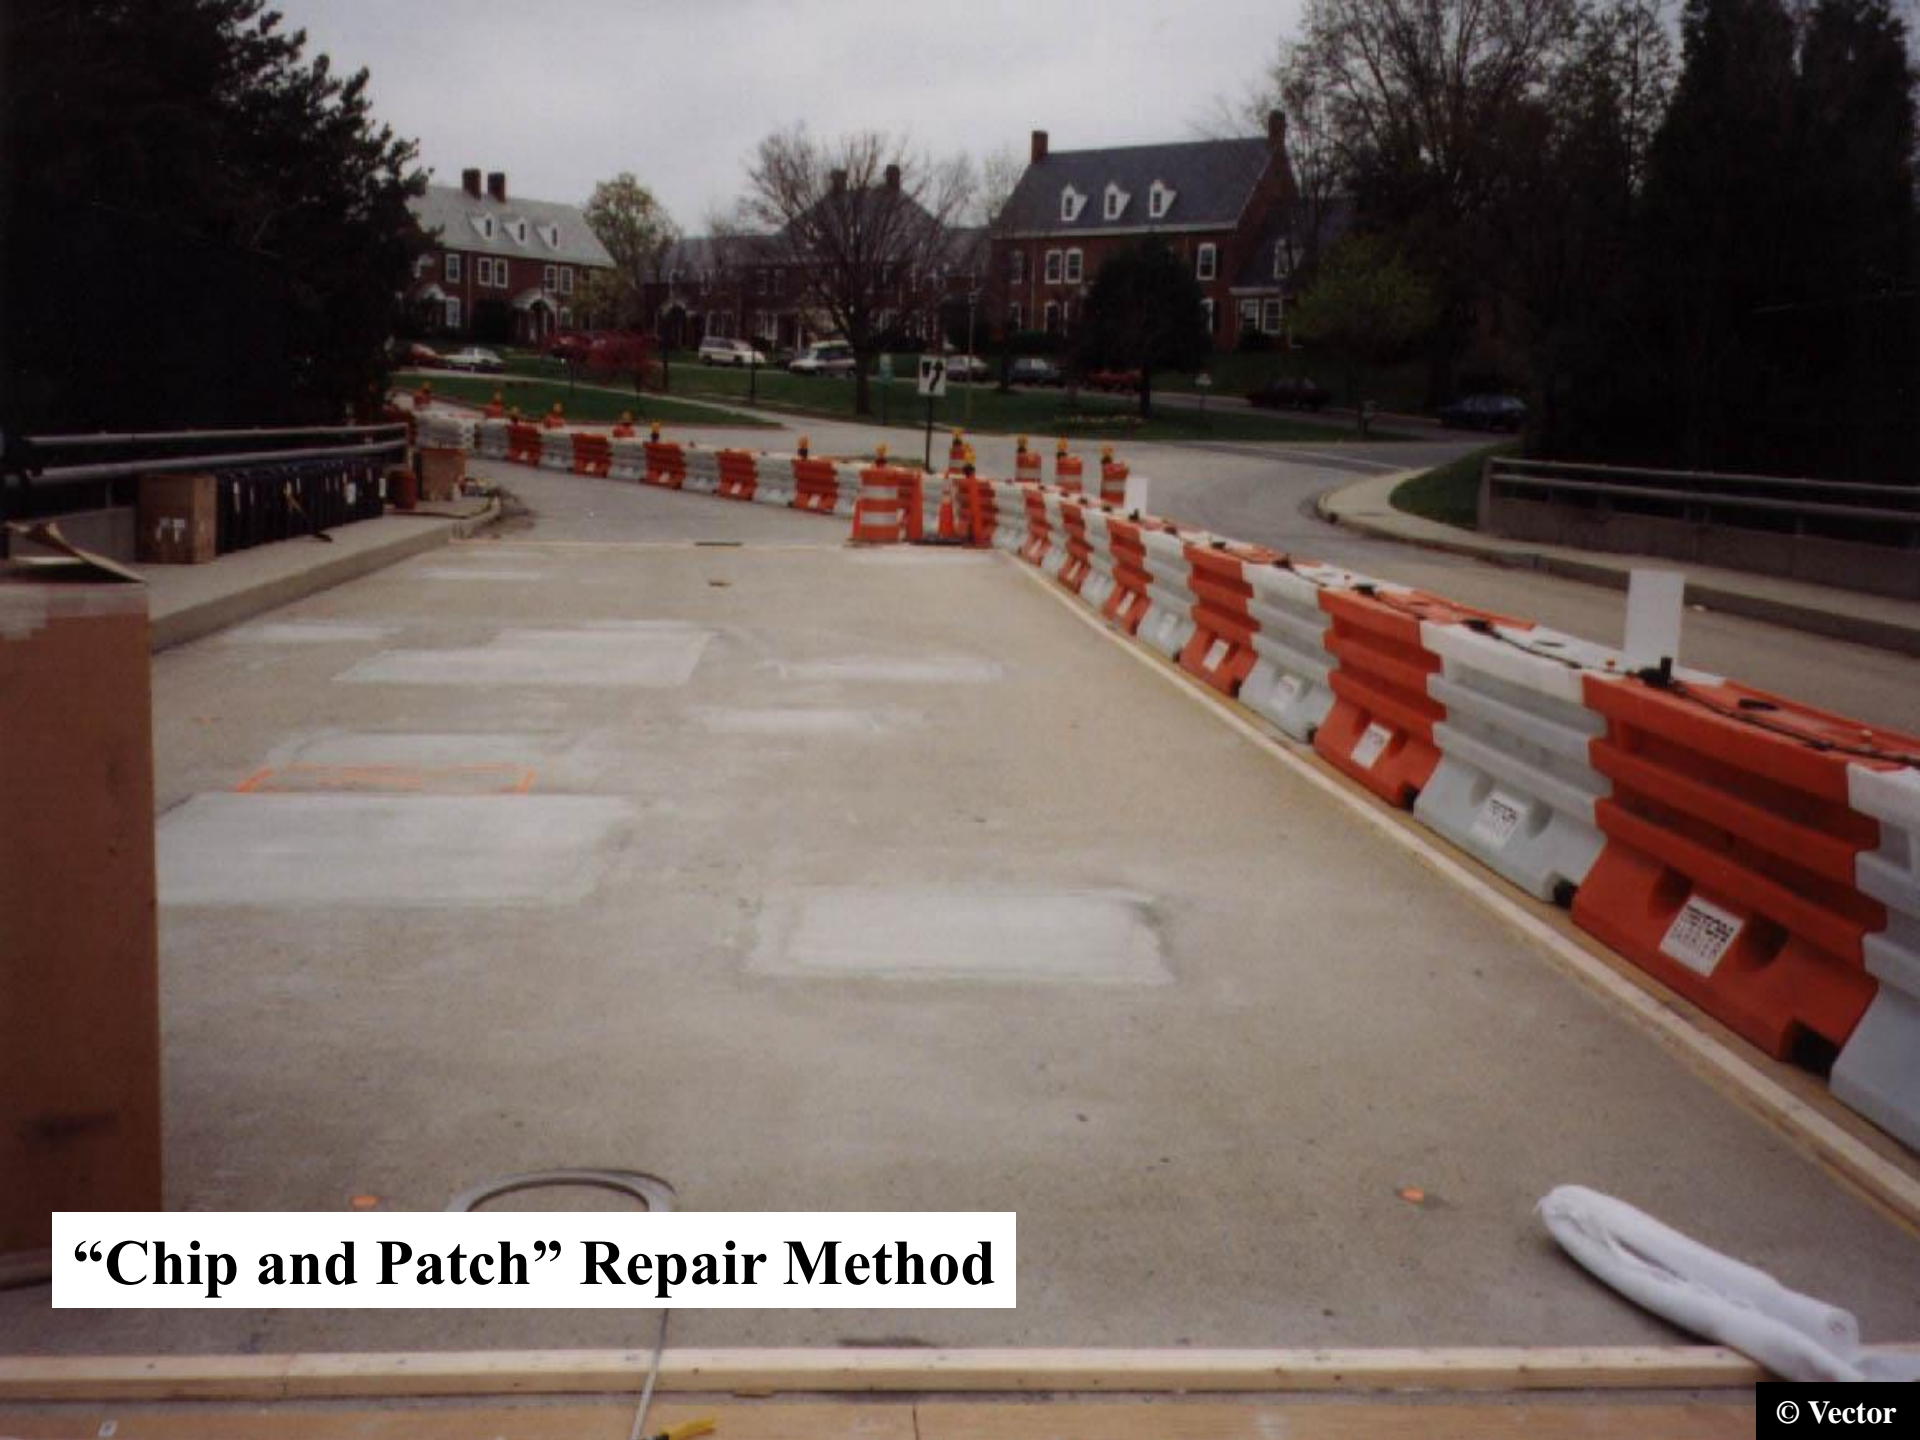
**“Chip and Patch” Repair Method**

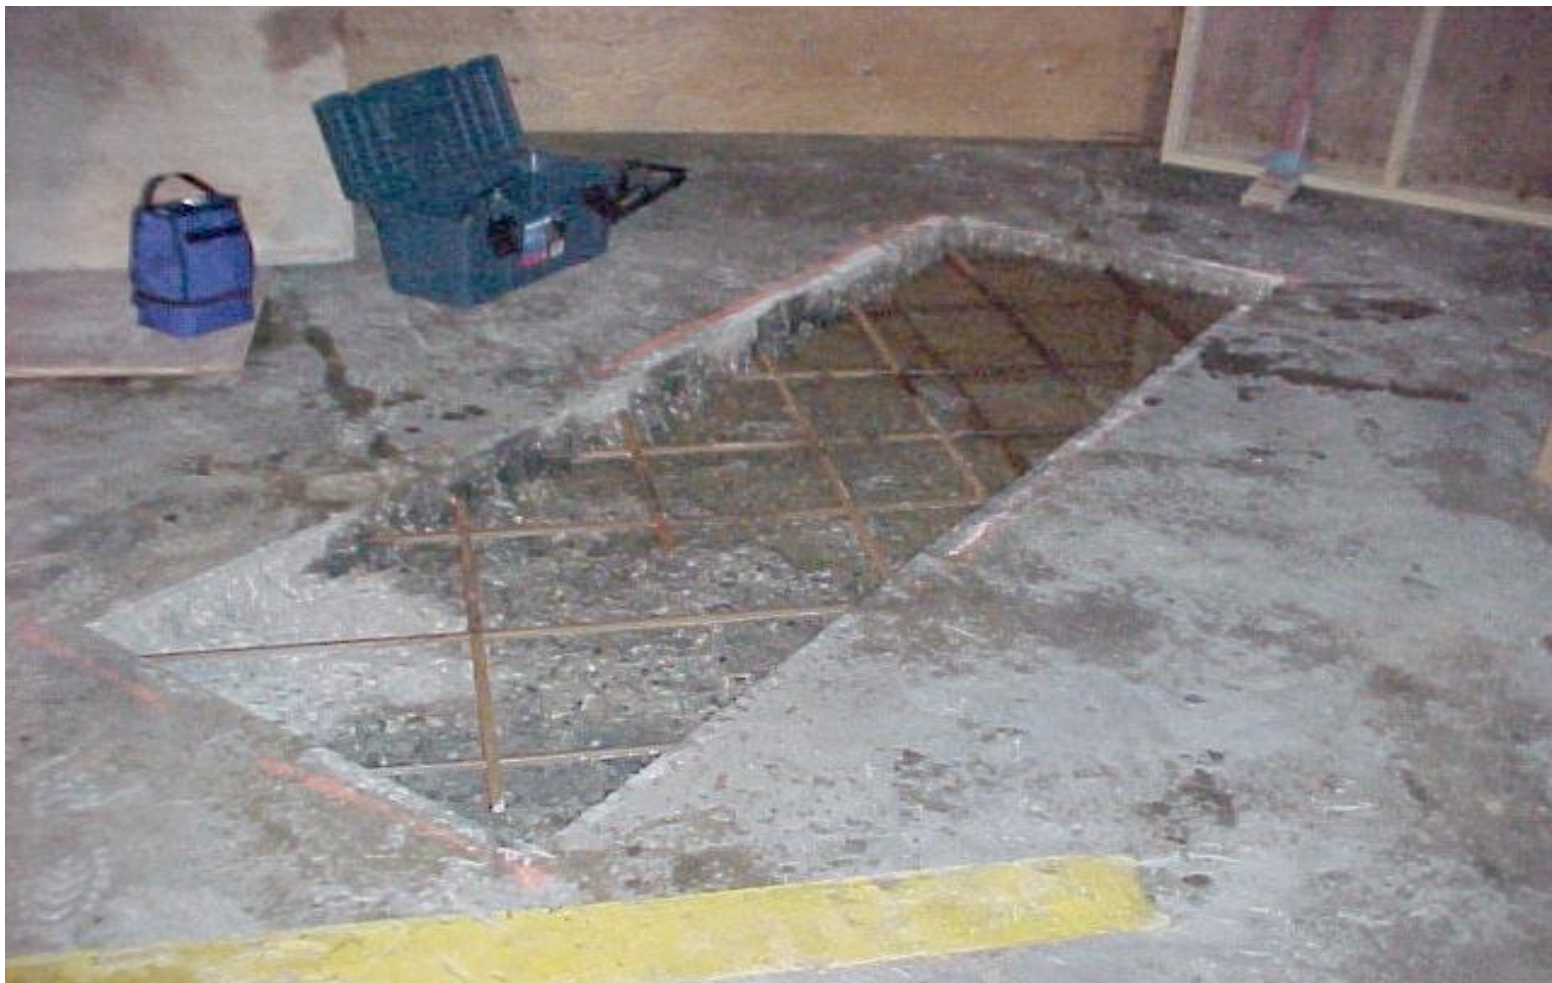
**Saw cut and cleaned repair area.**

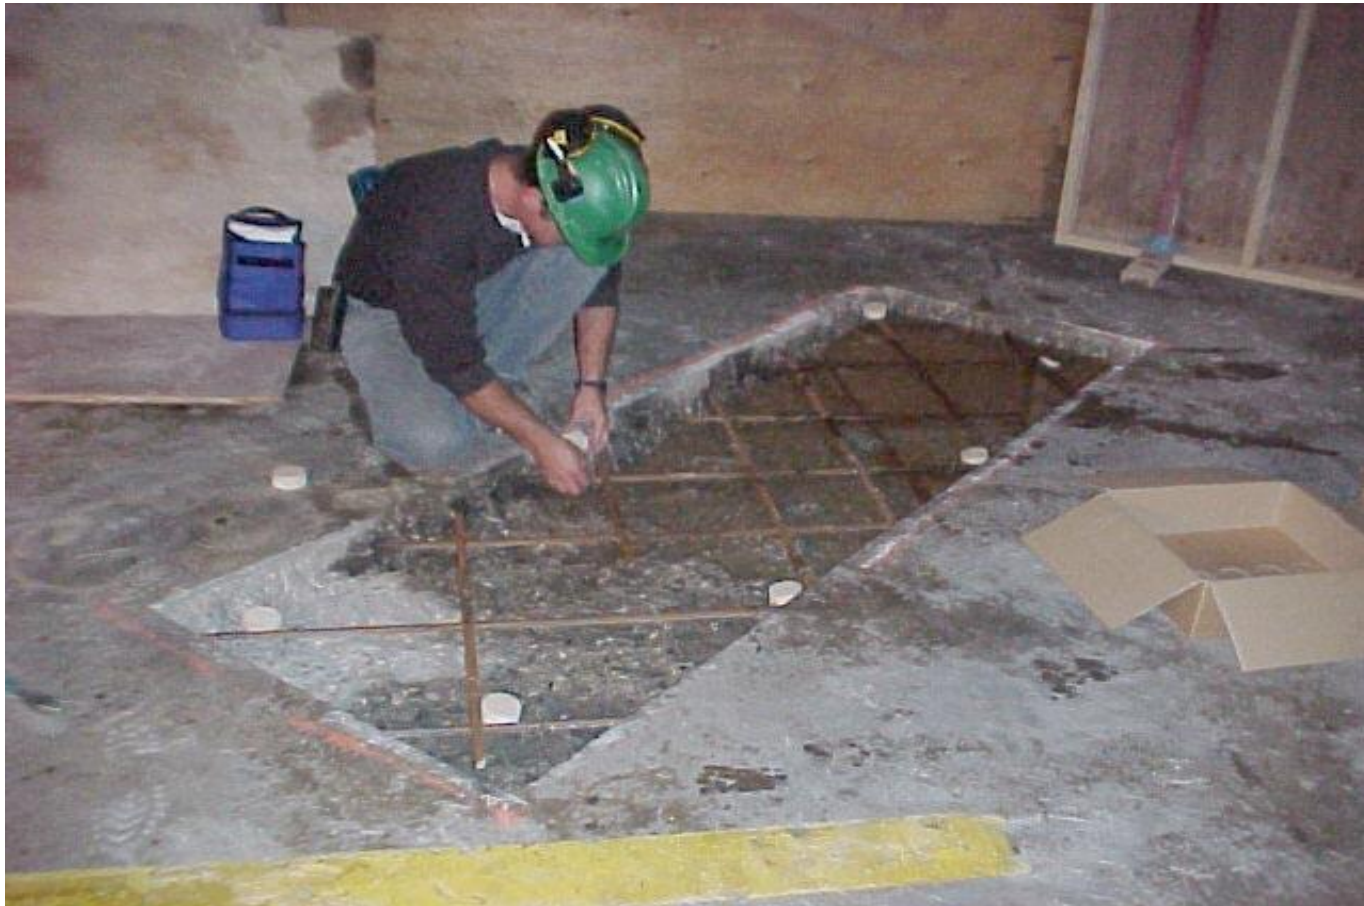
**Installing anodes around the perimeter of the repair.**

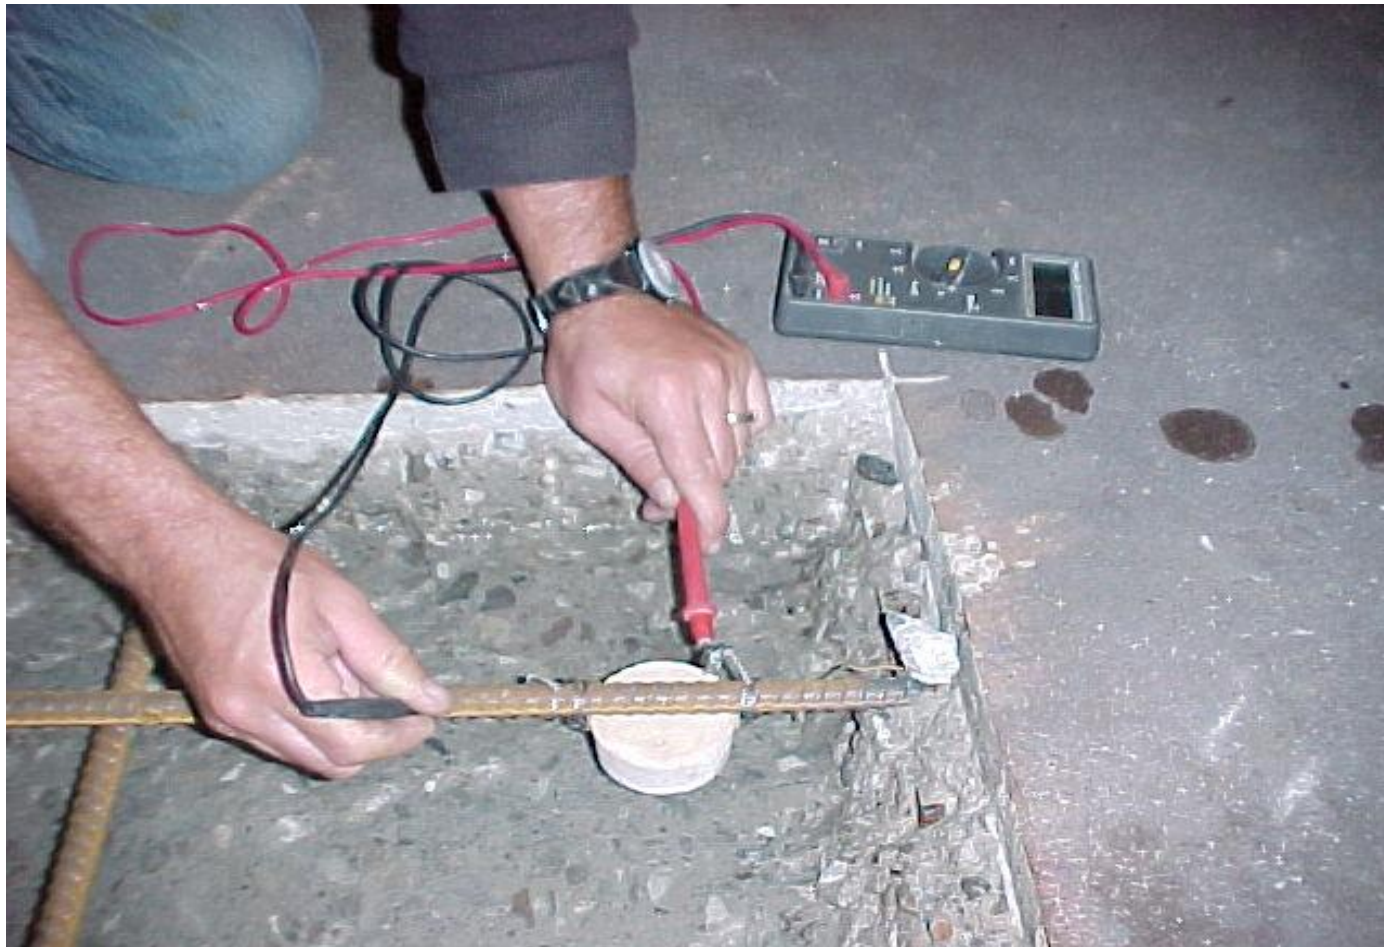
**Testing anode connection to reinforcing steel.**

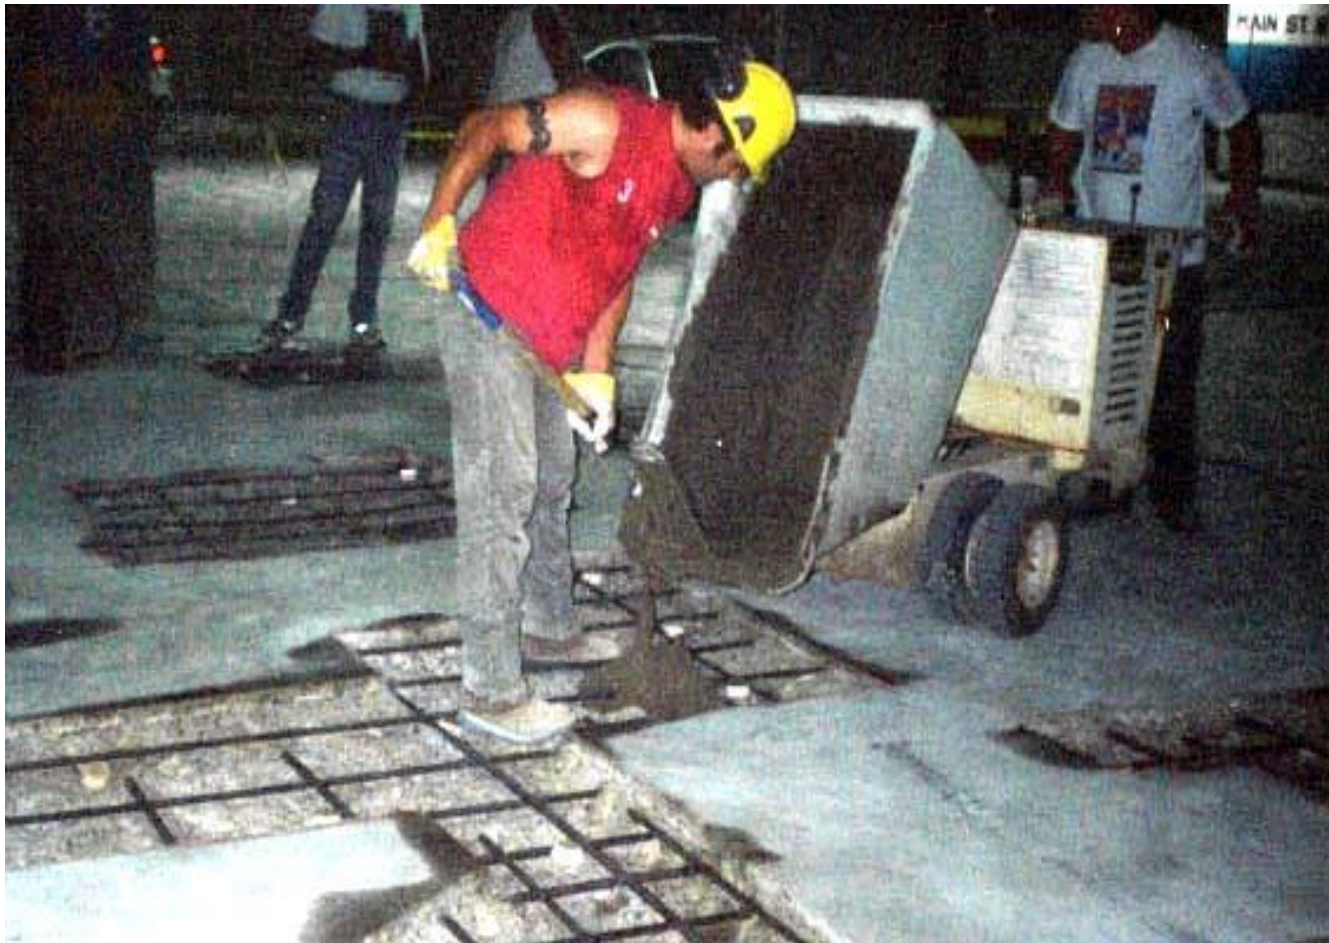
**Embedding anodes with repair material.**

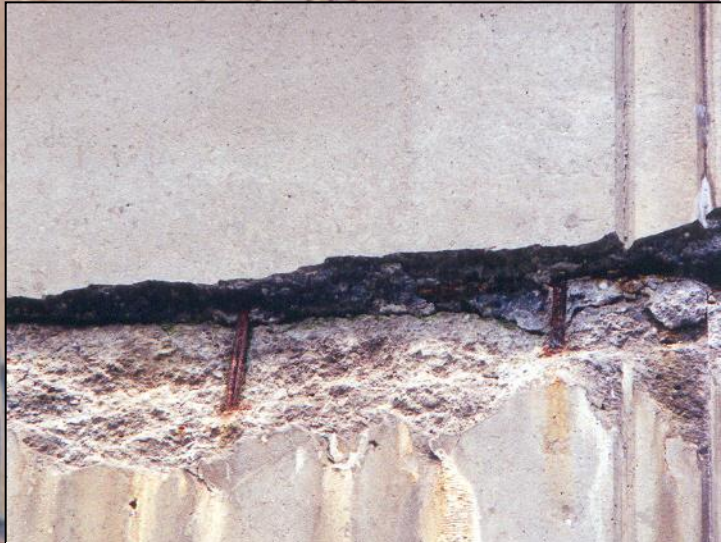
# Corroded Joint Pittsburgh, Pennsylvania

**Failed Concrete Next to Joint  
Due to Corrosion**

**Old Chloride  
Contaminated Concrete**

**New Chloride-Free  
Concrete Extension**

**Surrounding  
Rebar is Protected**

**Anode Galvanically Protects  
Adjacent Rebar**

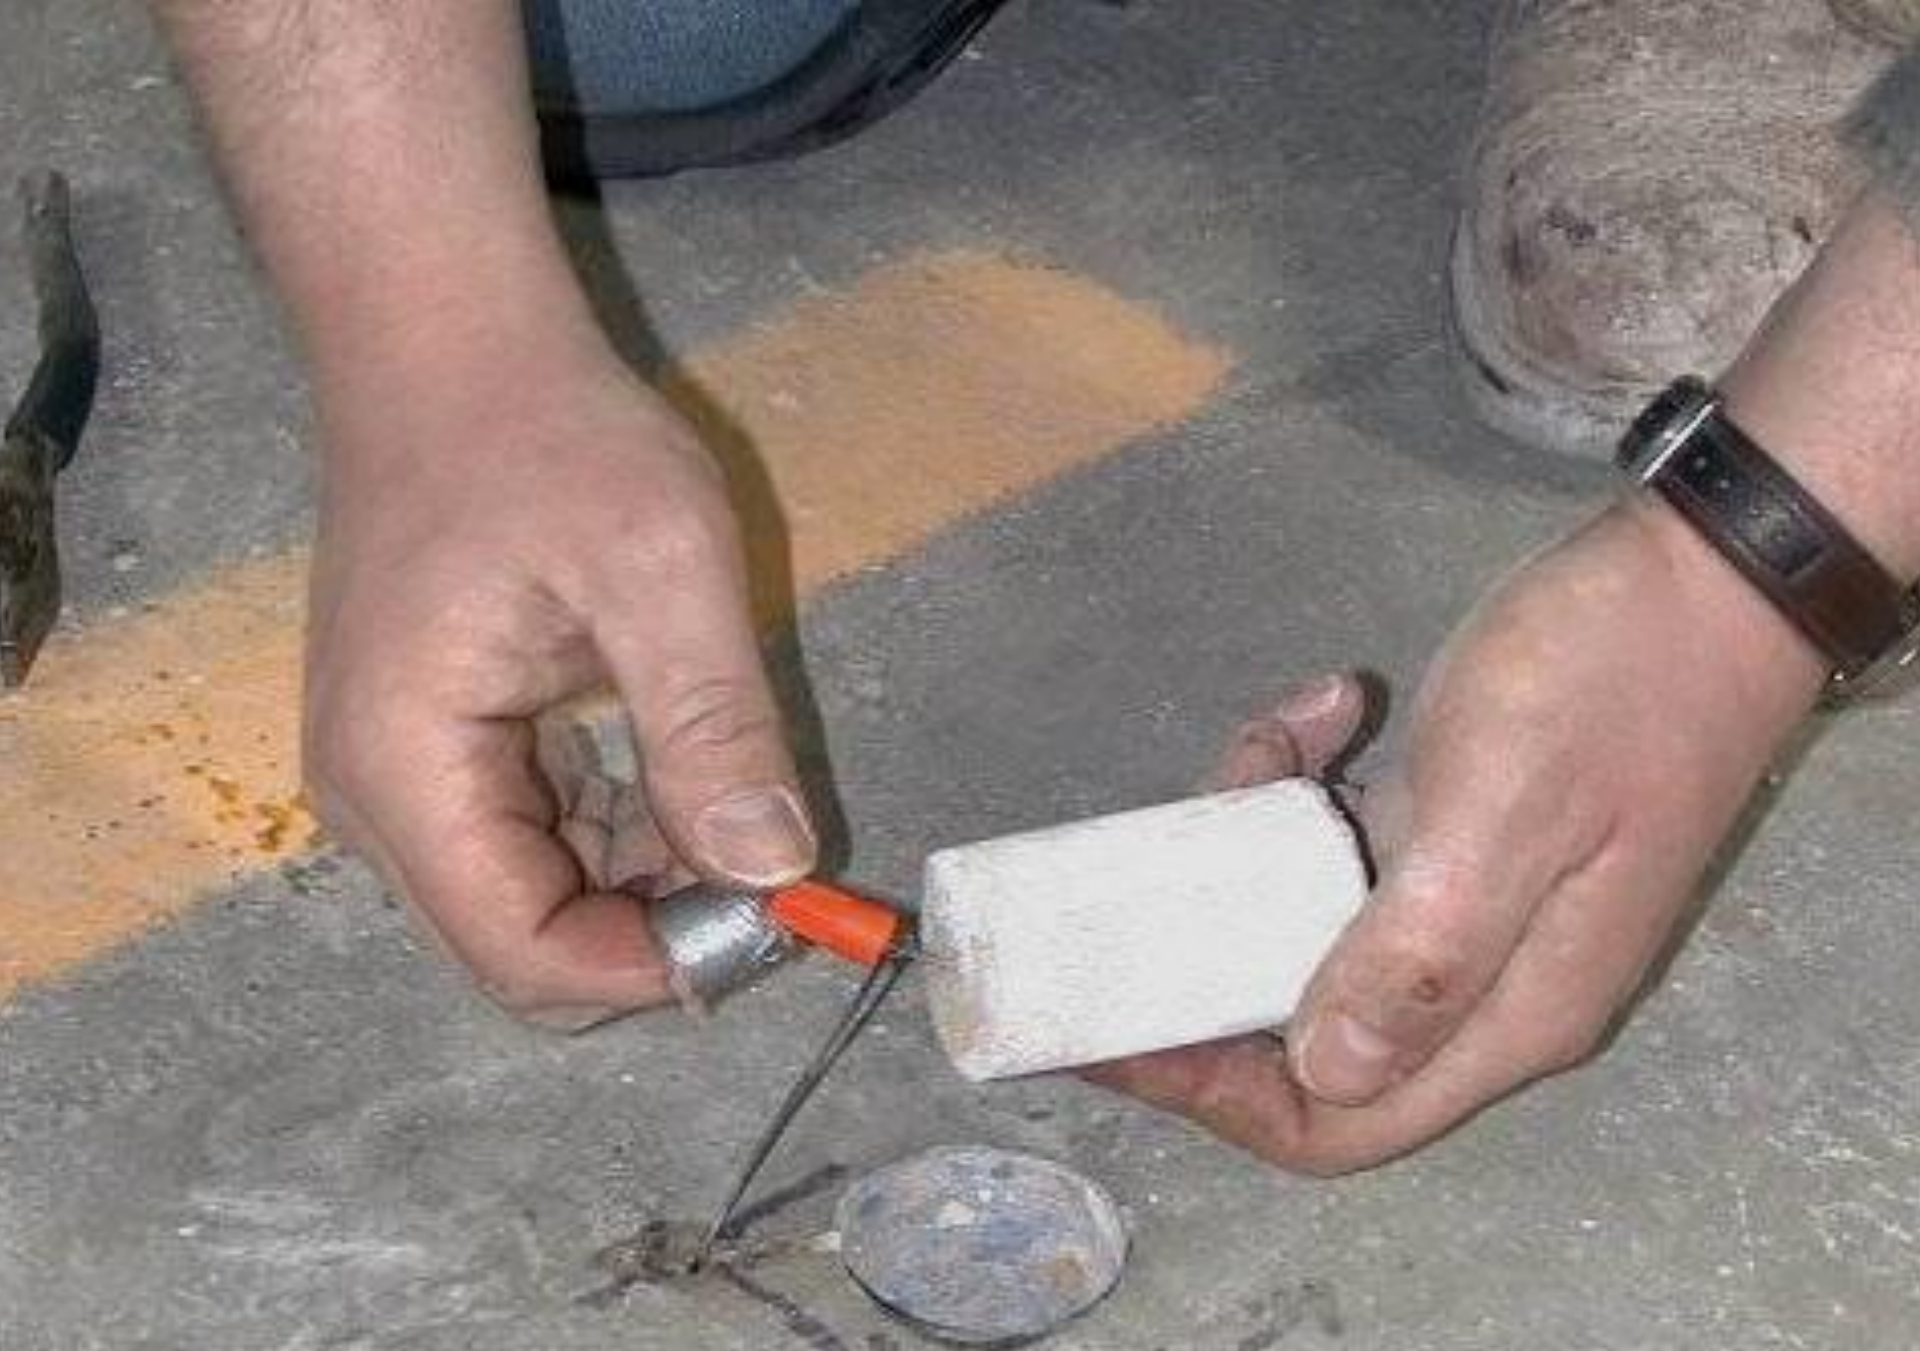
*Anode Connection to Reinforcing Steel*

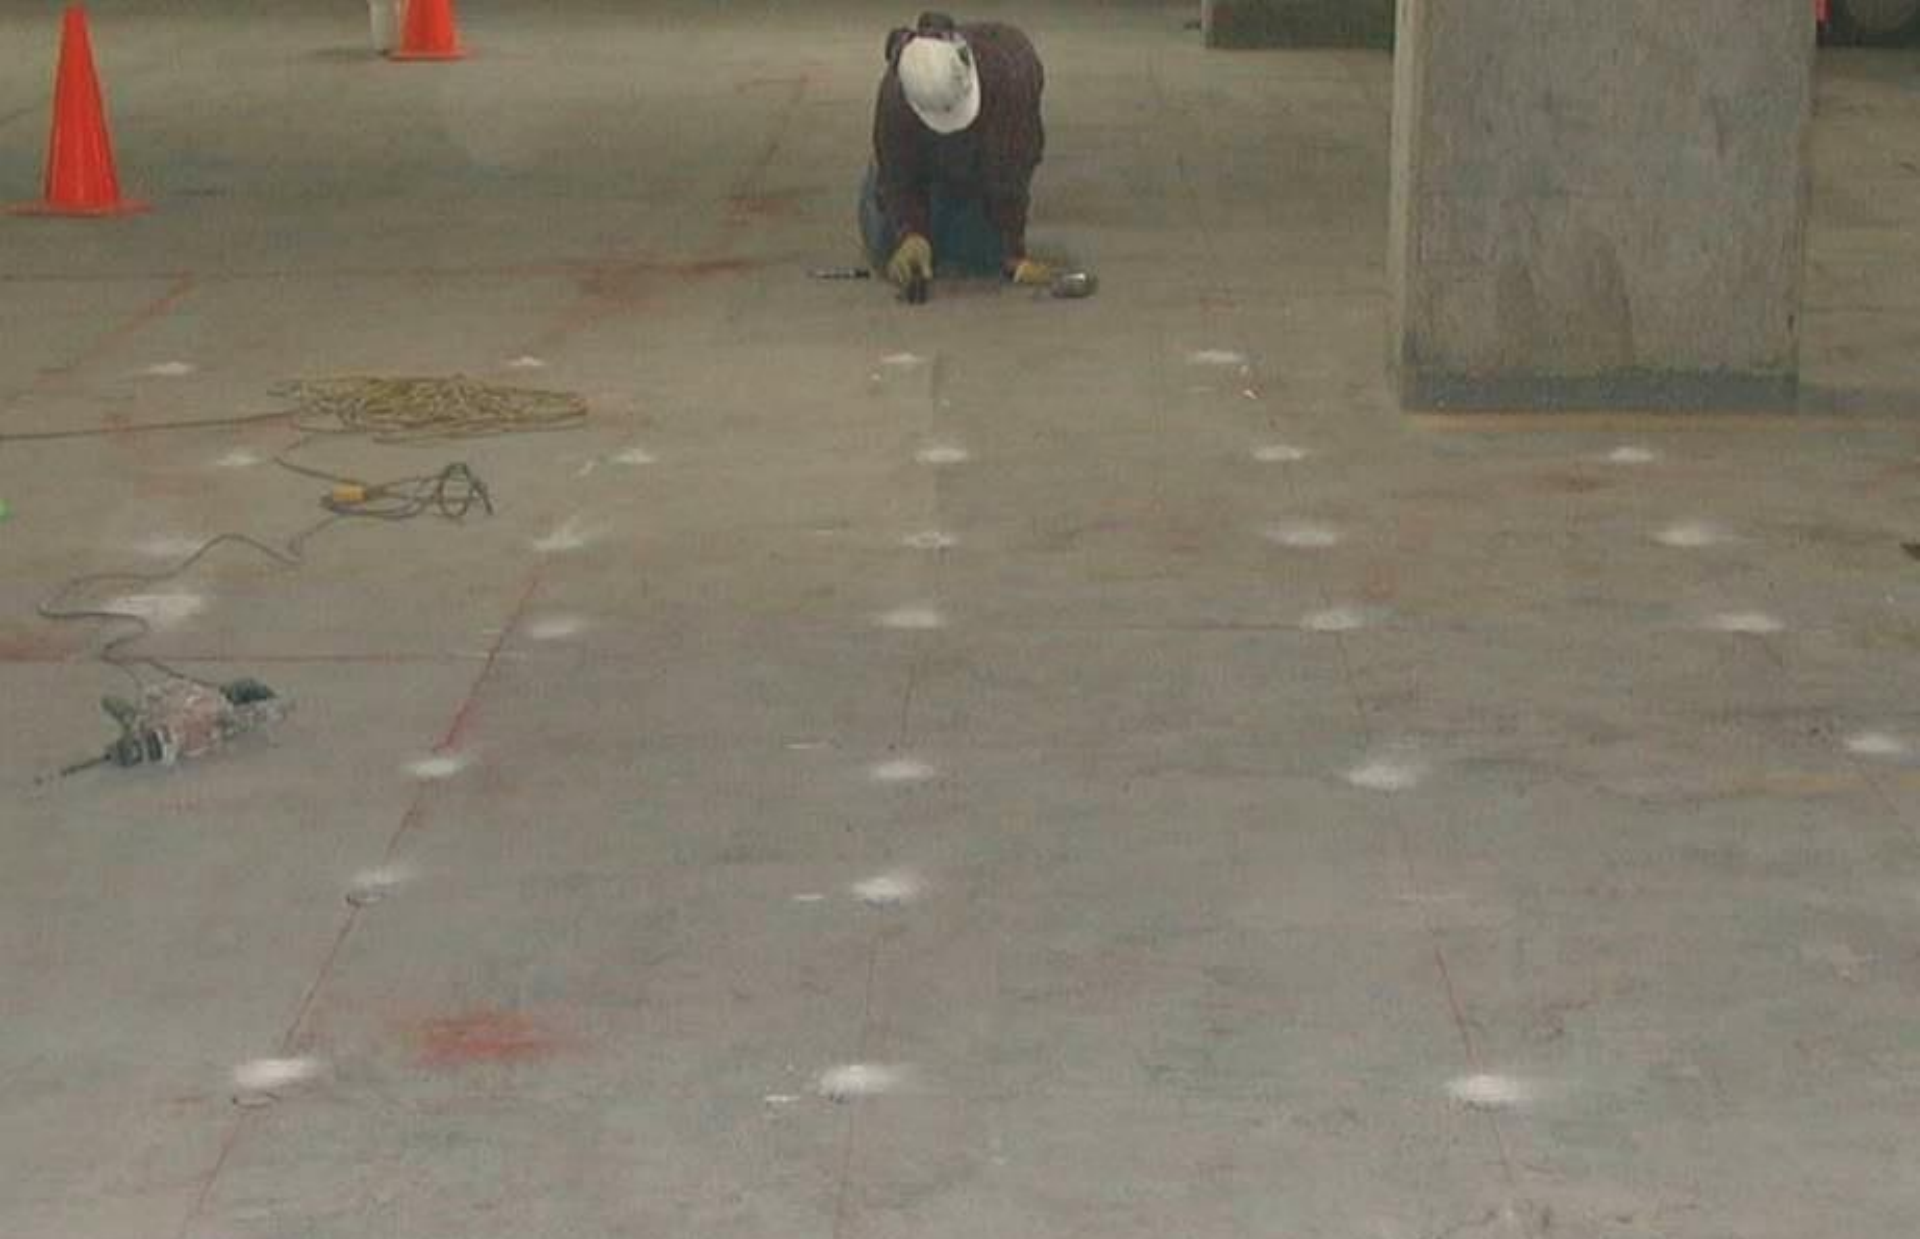
**Predrilled Holes for CC Installation  
Parking Garage Deck**

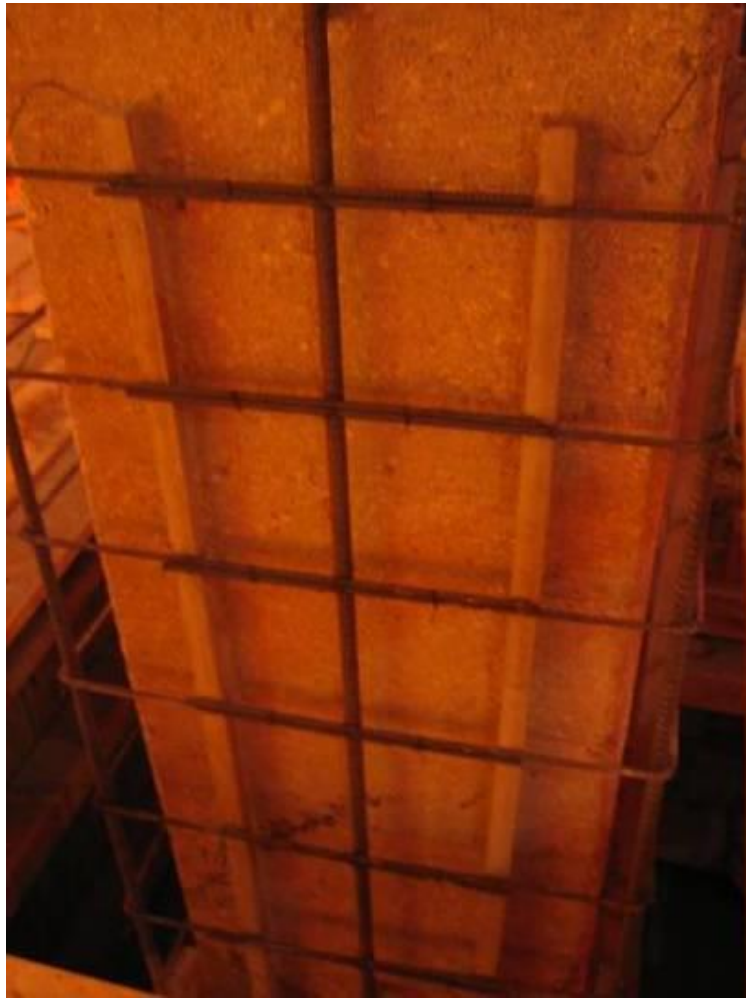
**Bridge Column Repair  
with Reinforced Concrete  
Jacket**

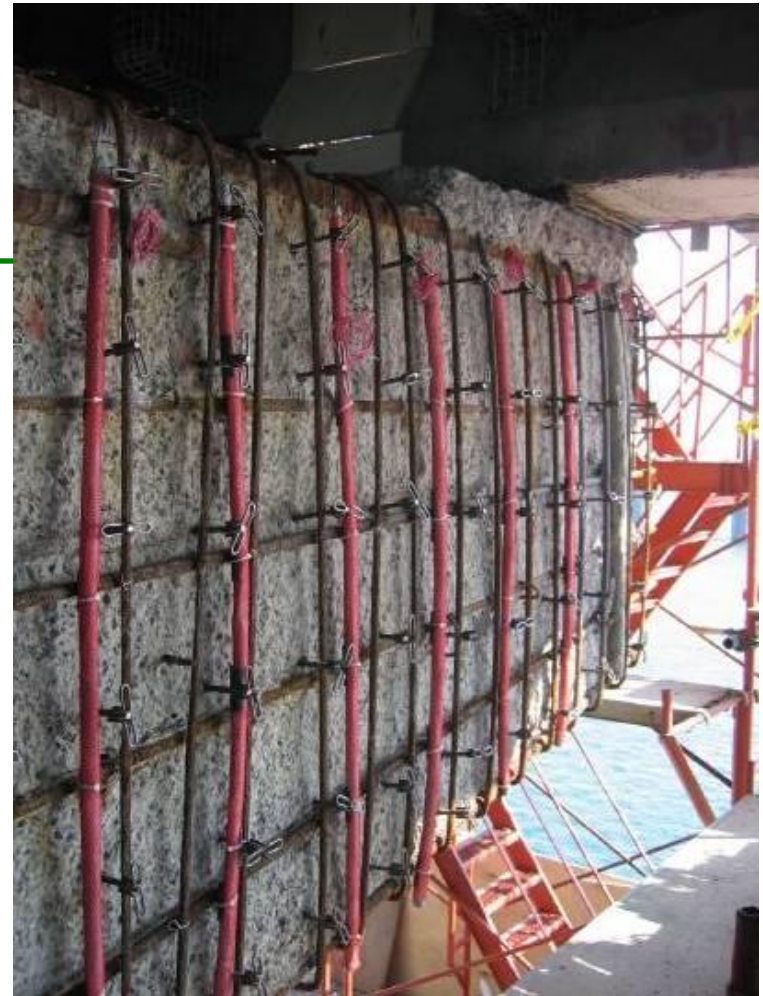
**Bridge Pier Cap Repair with  
Galvanic Anode Strips**

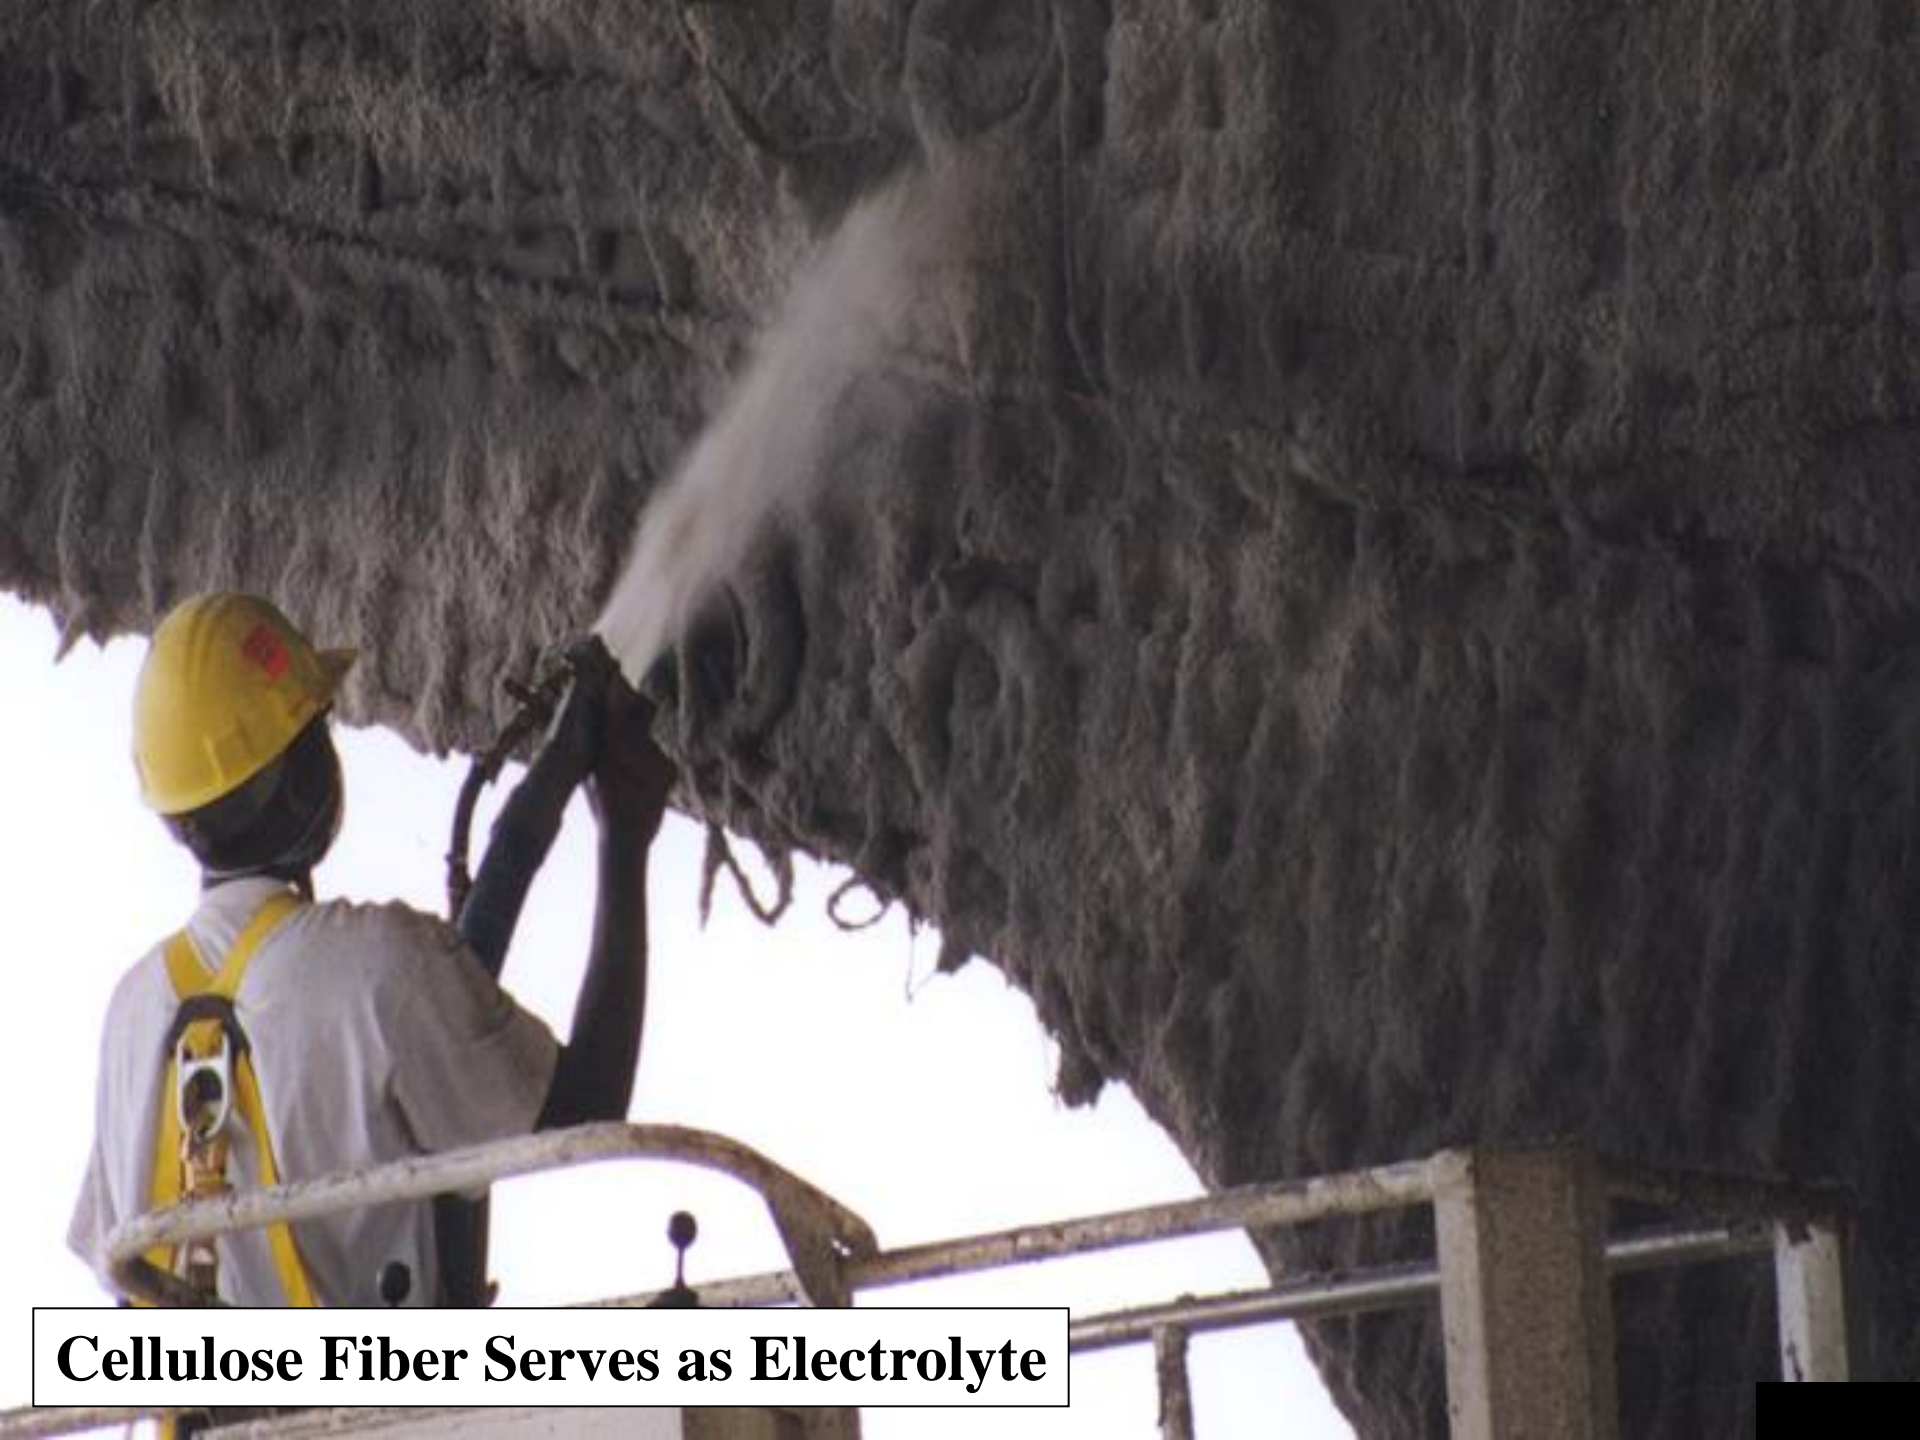
**Cellulose Fiber Serves as Electrolyte**
