# Corrosion Mitigation Systems for Existing Concrete Structures

Erik Thorp  
Vector Corrosion Technologies  
[www.vector-corrosion.com](http://www.vector-corrosion.com)

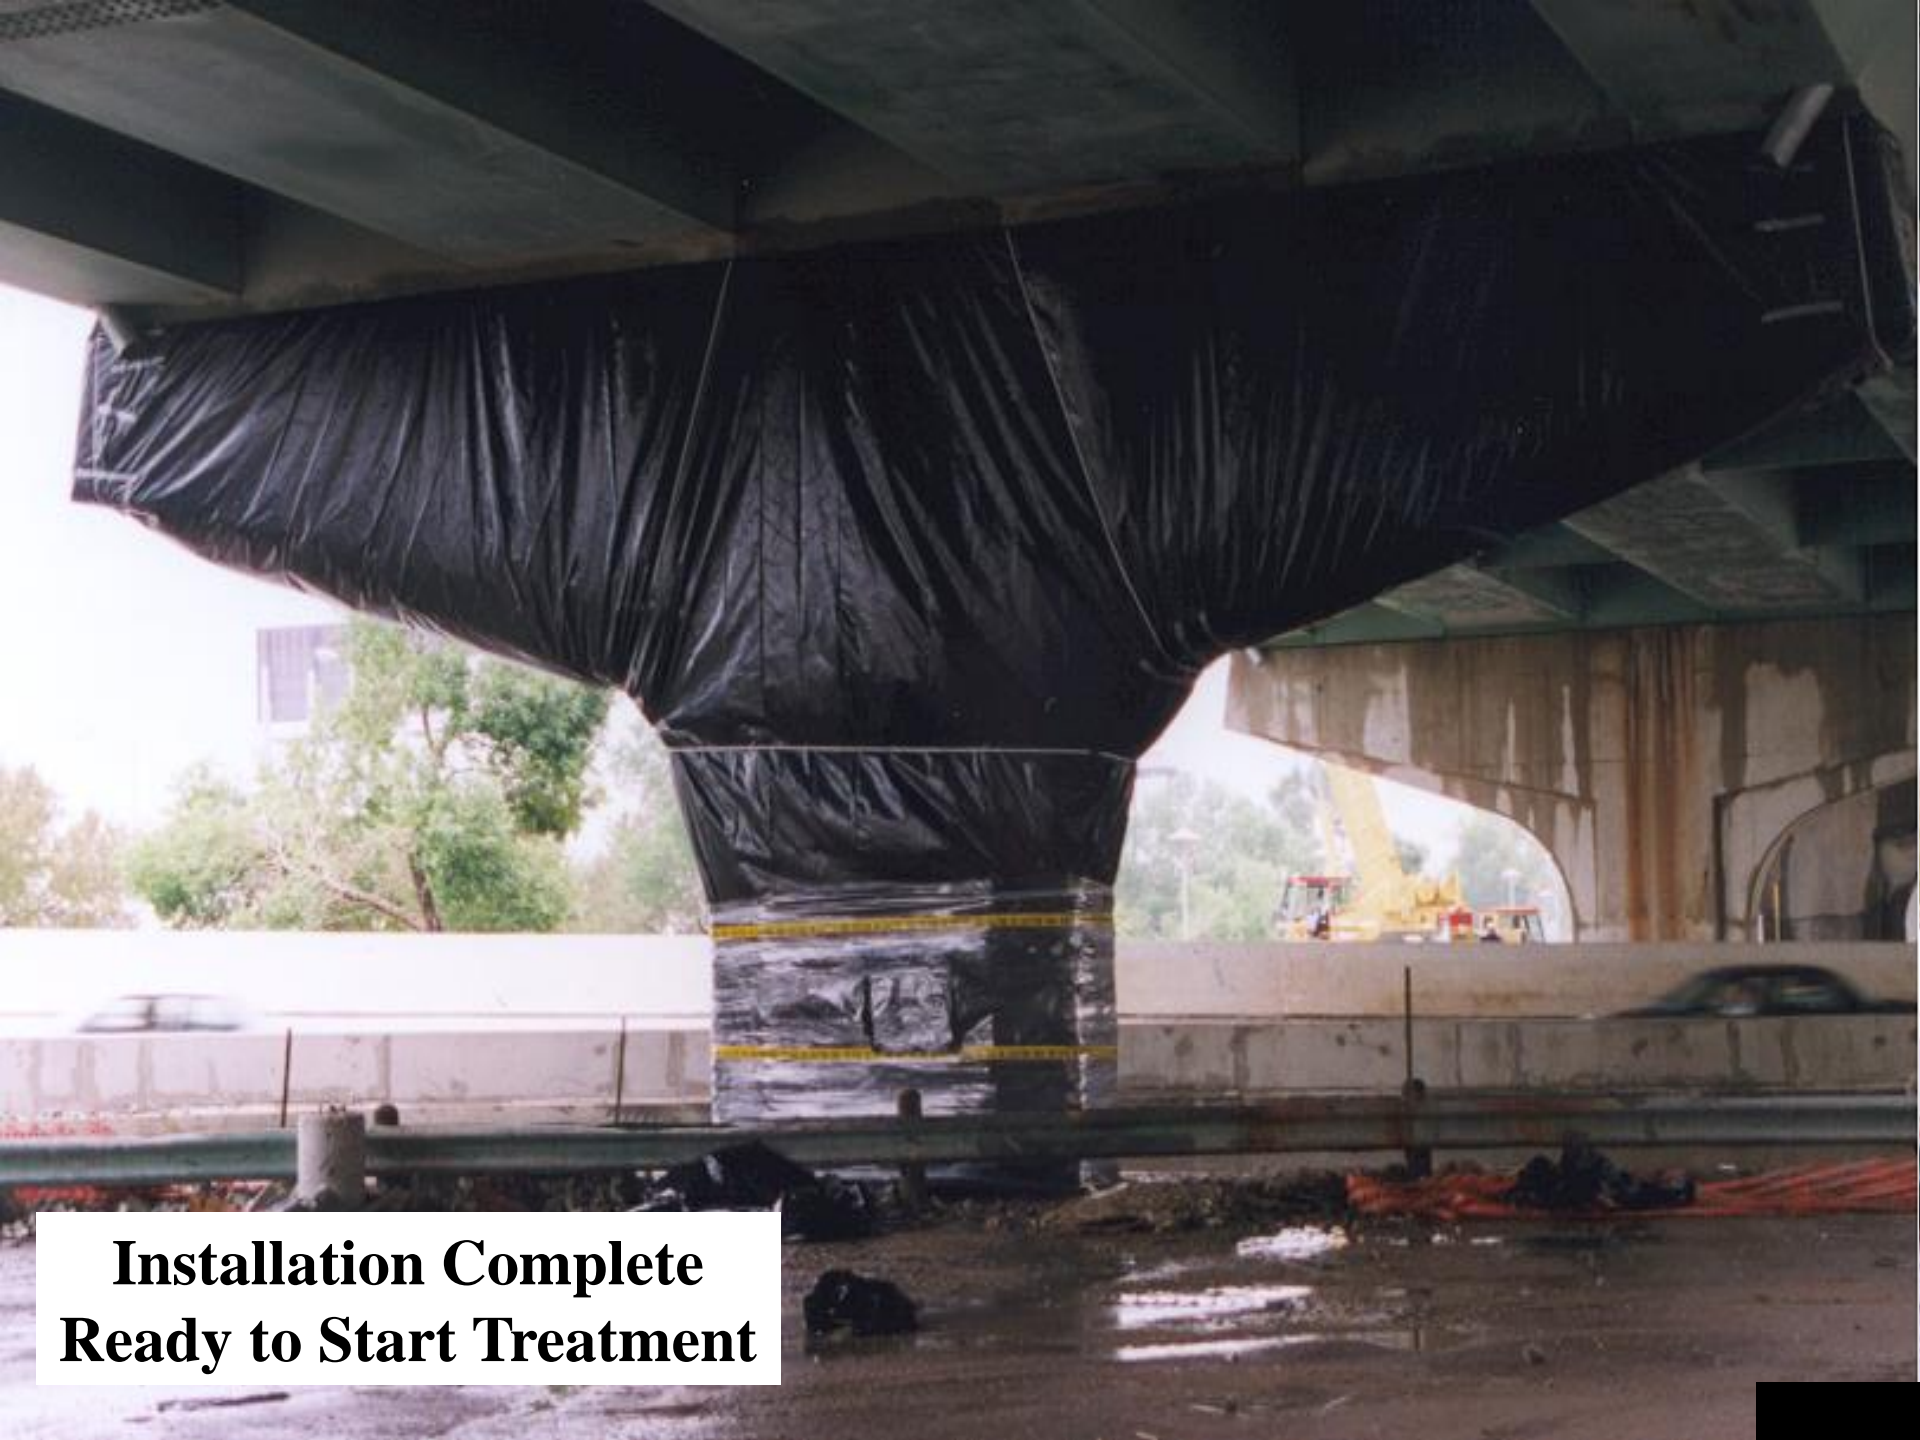
**Installation Complete  
Ready to Start Treatment**

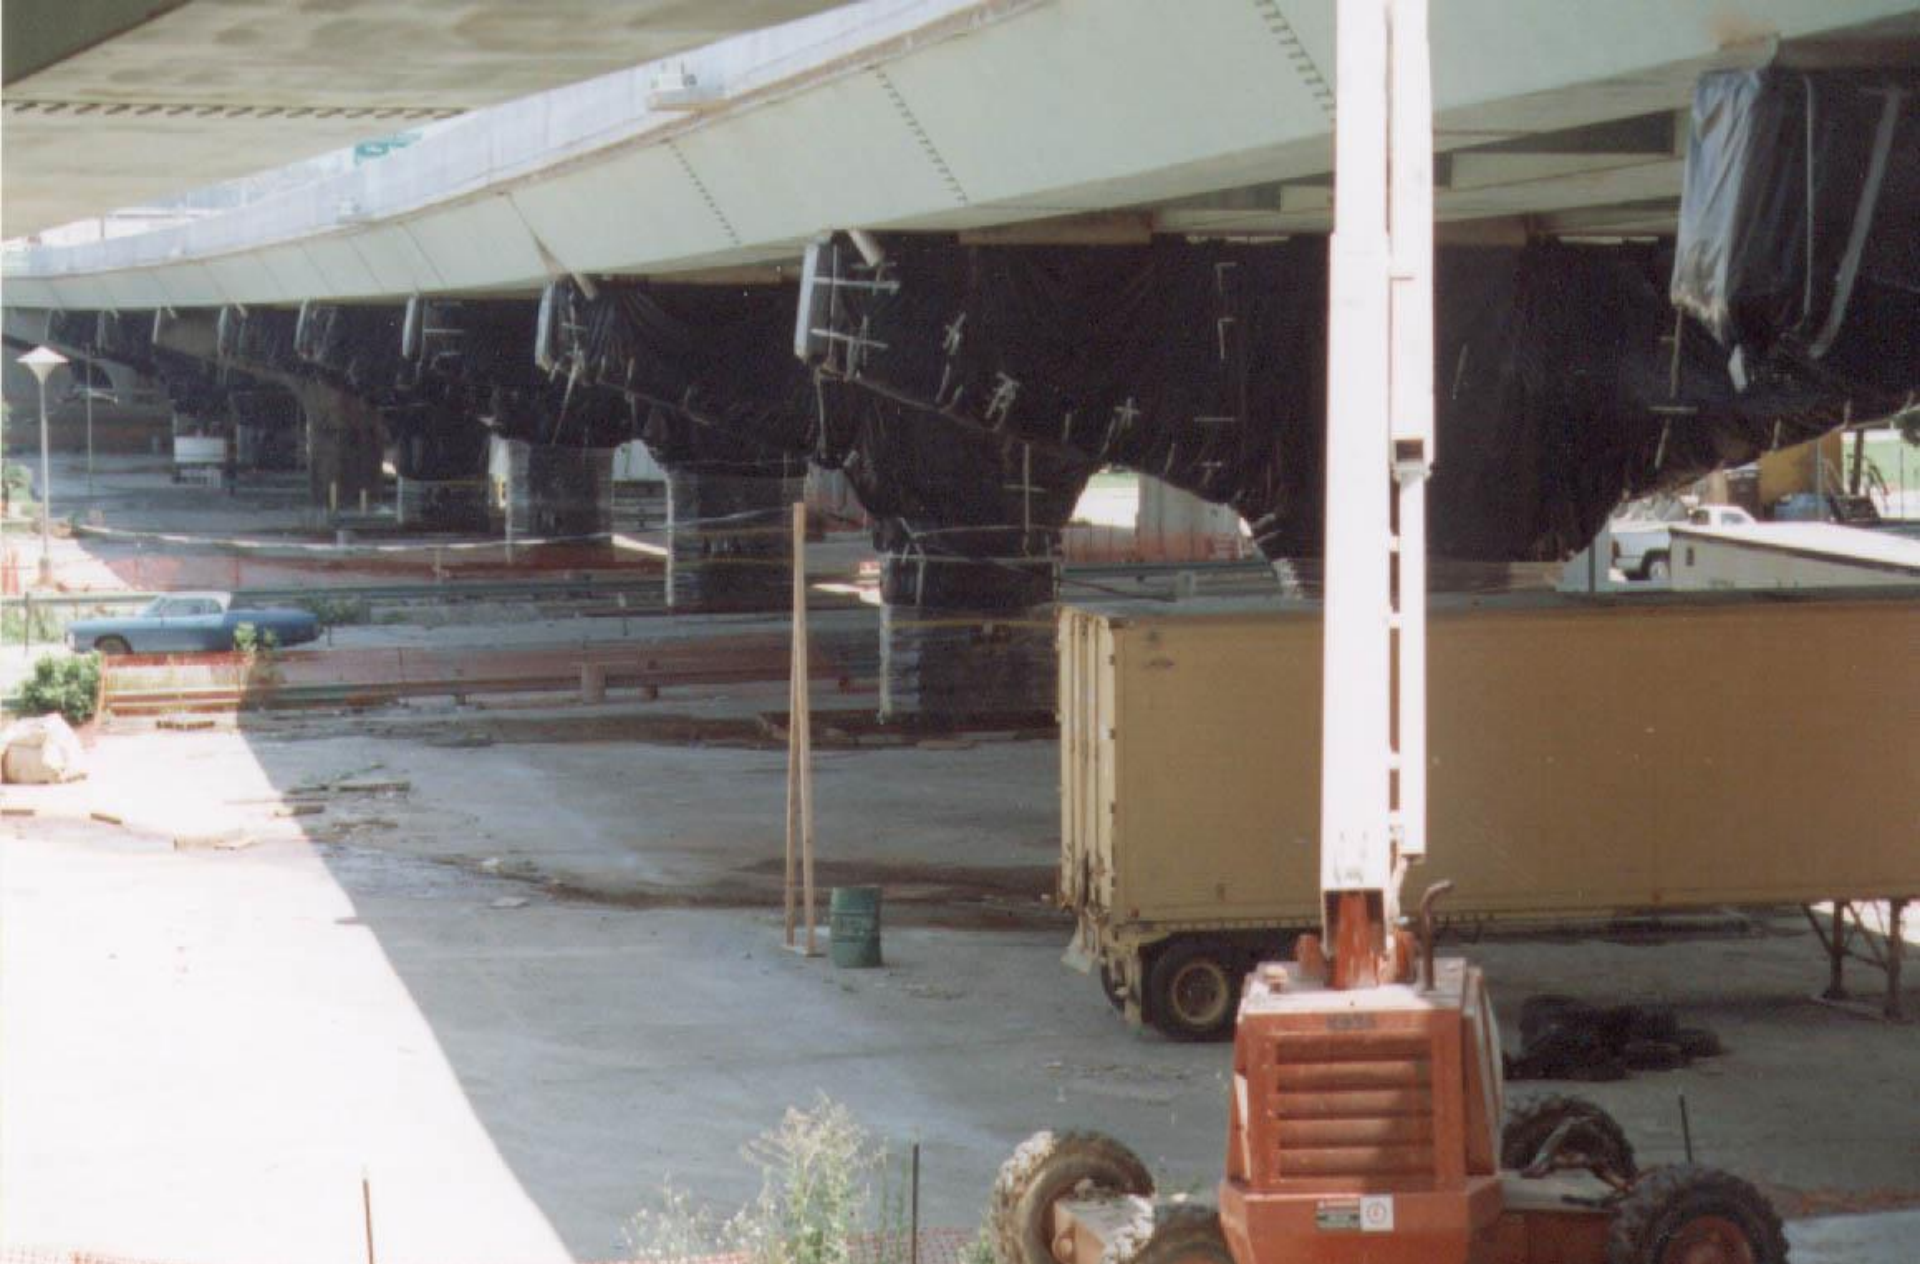
**Several Piers Wrapped and Undergoing ECE Treatment  
Omaha, Nebraska**

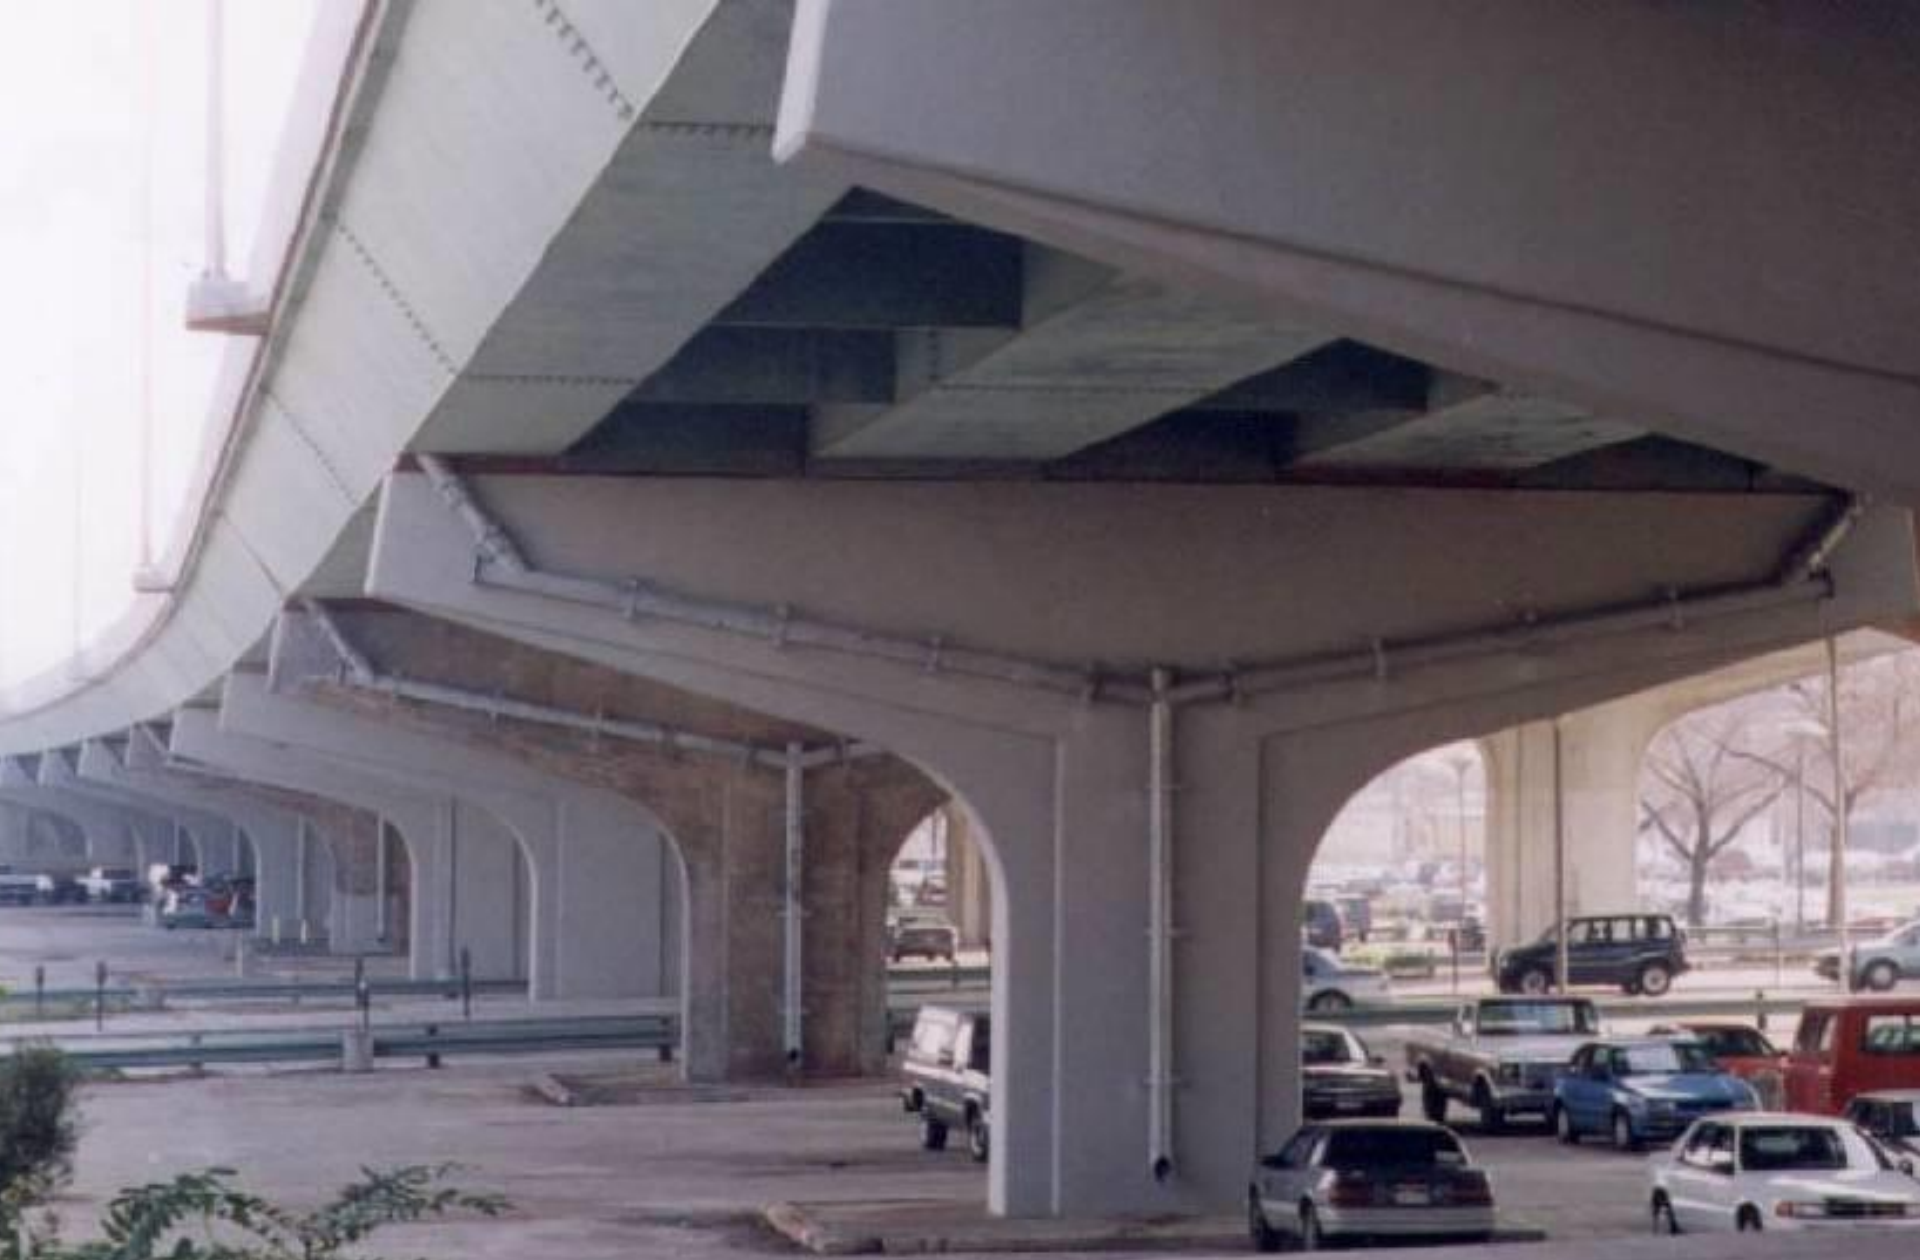
**Piers after ECE Treatment  
Cleaned and Sealed**

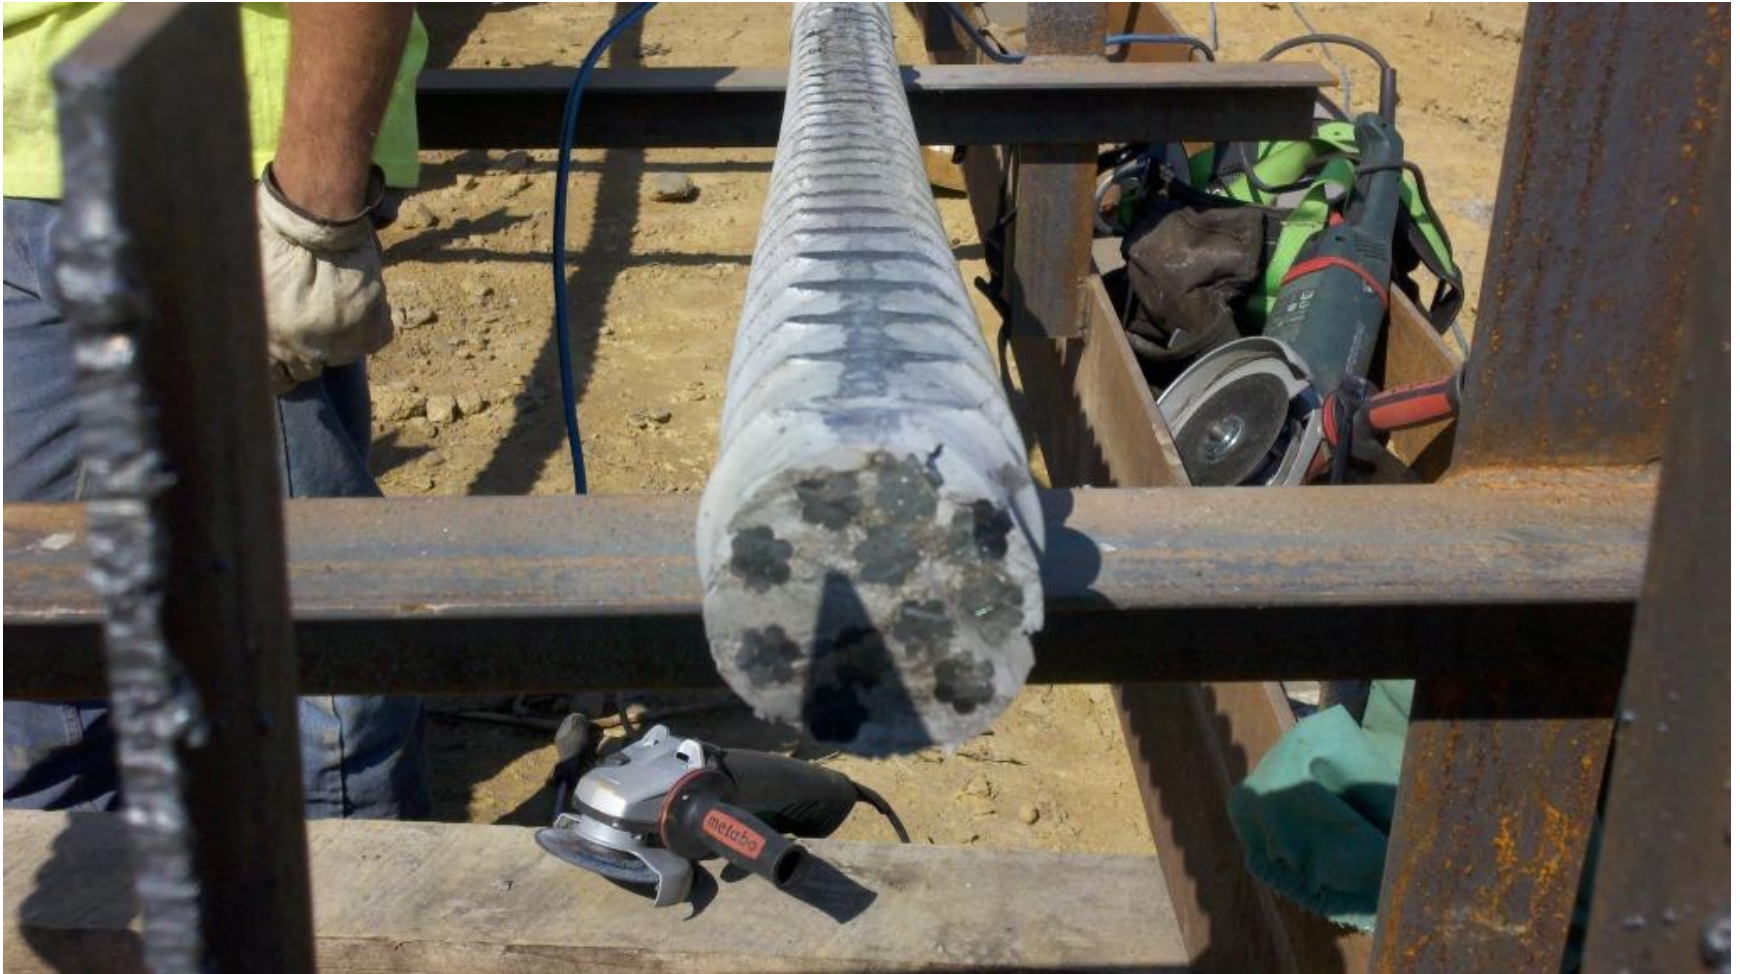
# Problem: Corrosion or Grout related issues

## Example: Bleed water issues within duct
