Two New and Proven

Pavement Preservation Processes

for State DOT's

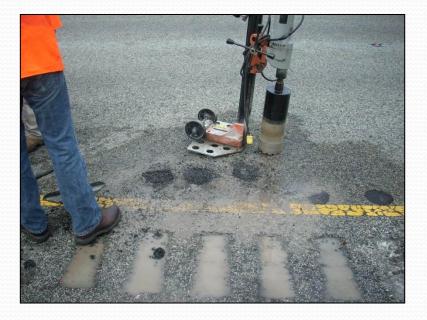
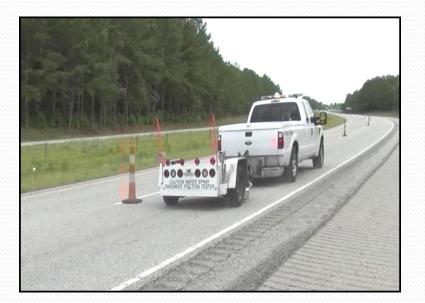
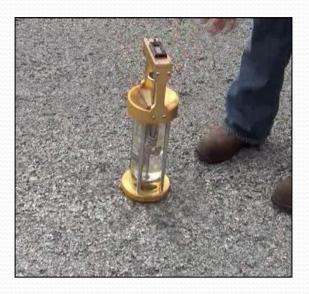
- Cores pulled to determine AC viscosity before
- Skid tests conducted to determine existing skid numbers
- Hydro-timer outflow tests to determine surface macro and micro texture

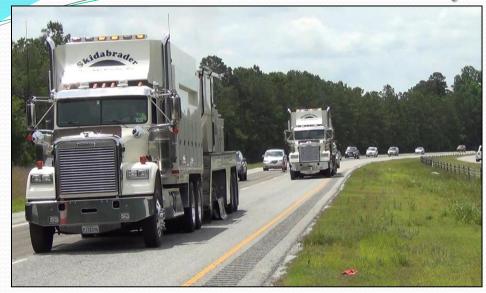
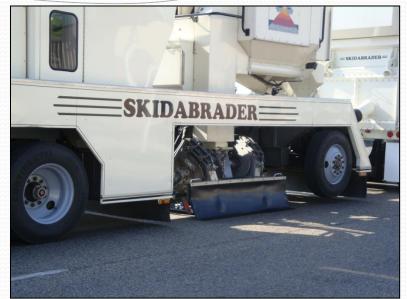
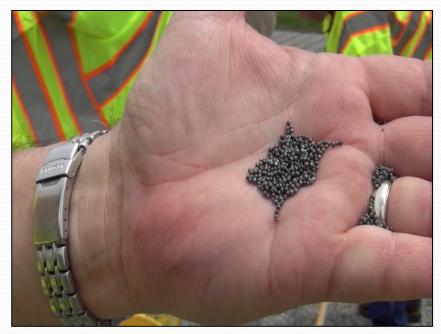
Surface Abrasion conducted by Skidabrader

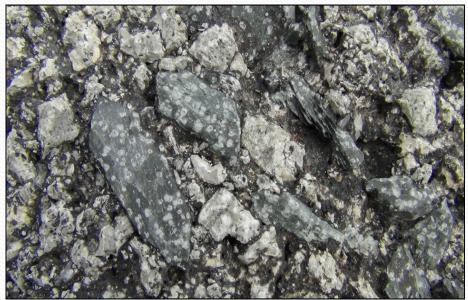
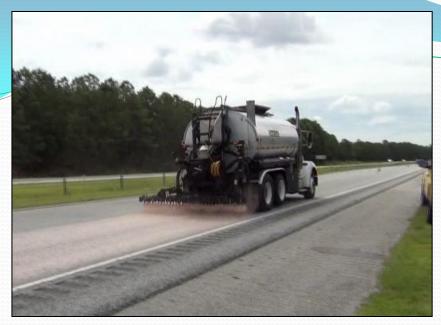
Light water mist applied to aid in allowing the Reclamite to quickly penetrate into the OGFC surface.

Reclamite maltene based **asphalt rejuvenator** is applied to the abraded

surface.

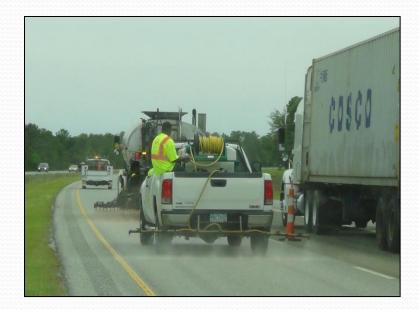
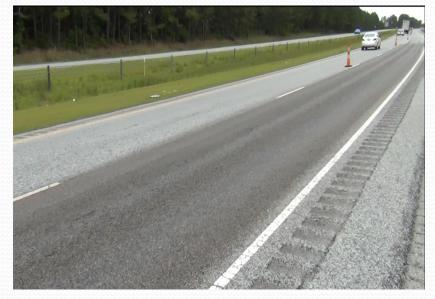
The Reclamite completely penetrated down into the pavement within 15 minutes of its application

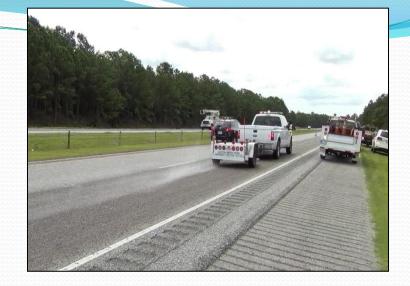
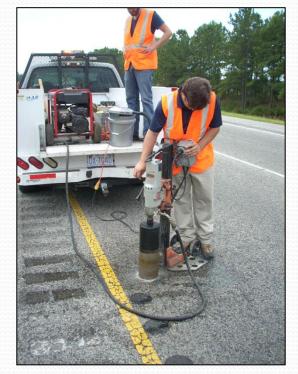
Skid tests conducted 30 minutes after application.

Skid tests conducted 48 hours after application.

Cores removed and tested 2 weeks after application.

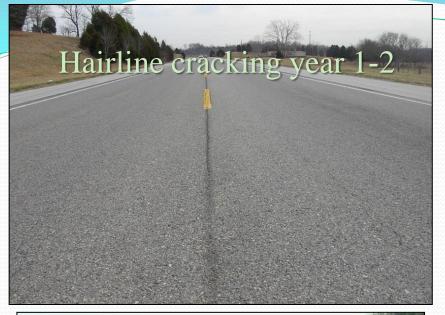
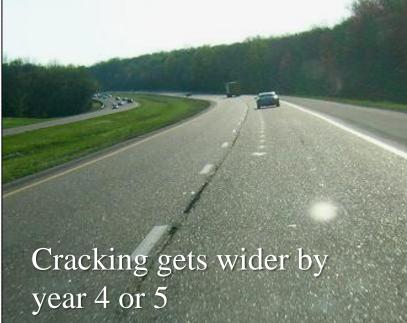
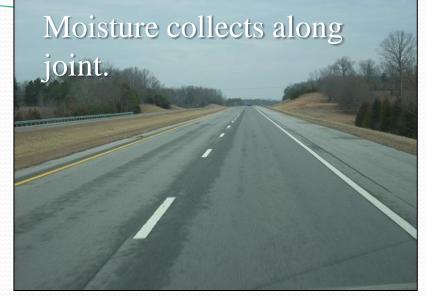
General Deterioration Process

Moisture migrates under wearing surface.

Freezing causes pop-outs

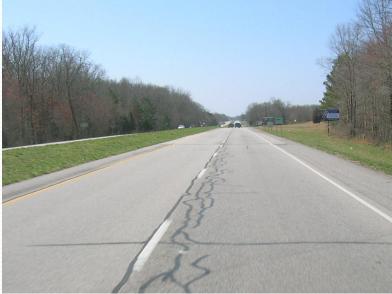
Crack filling/ sealing

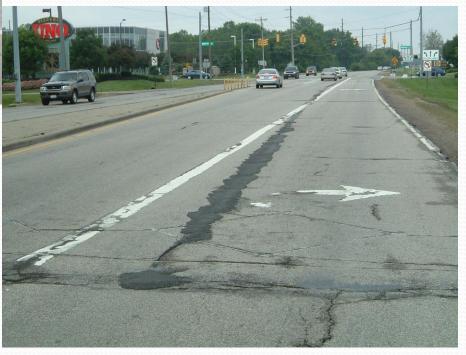
Joint patching

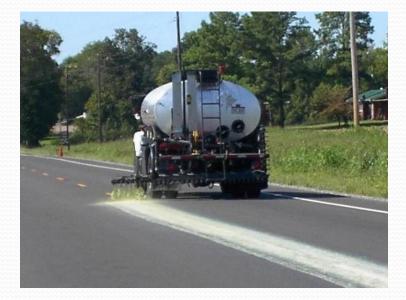
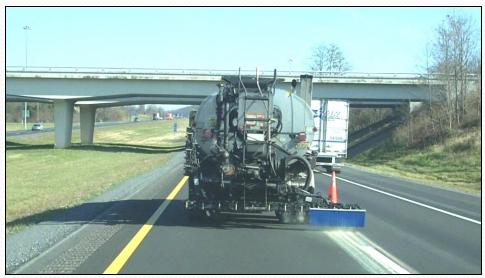
JOINTBOND[®] Longitudinal Joint Stabilizer

JOINTBOND® can prevent the failures as it penetrates into the pavement carrying the maltenes along with its unique polymers down into the upper 1/2" - 3/4" of the pavement where it restores flexibility and cohesive property of the AC while also reinforcing the treated area.
