Crack Resistance with Thin Overlays

Northeast Pavement Preservation Partnership

Innovative Research in Asphalt Pavements

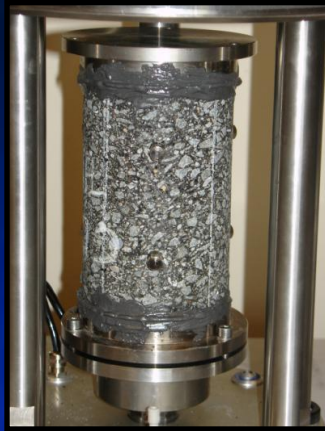
Uniaxial Fatigue in the AMPT

- Specimens fabricated at a target air void level of $7.0 \pm 1.0\%$
- A proposed standard practice for continuum damage fatigue analysis was developed by the Asphalt Research Consortium (ARC)
- Number of cycles to failure (N_f) based on 50% reduction in $|E^*|$ criterion

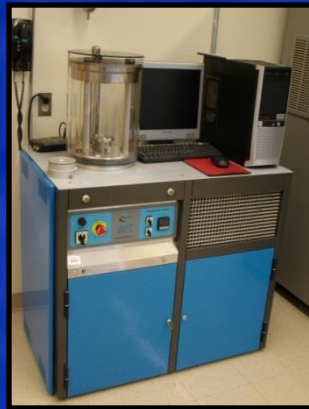
Uniaxial Fatigue (Push-Pull)

AMPT

Specimen #	Temperature	Strain
1	10°C	200 μ s
2	10°C	260 μ s
3	20°C	200 μ s
4	20°C	260 μ s

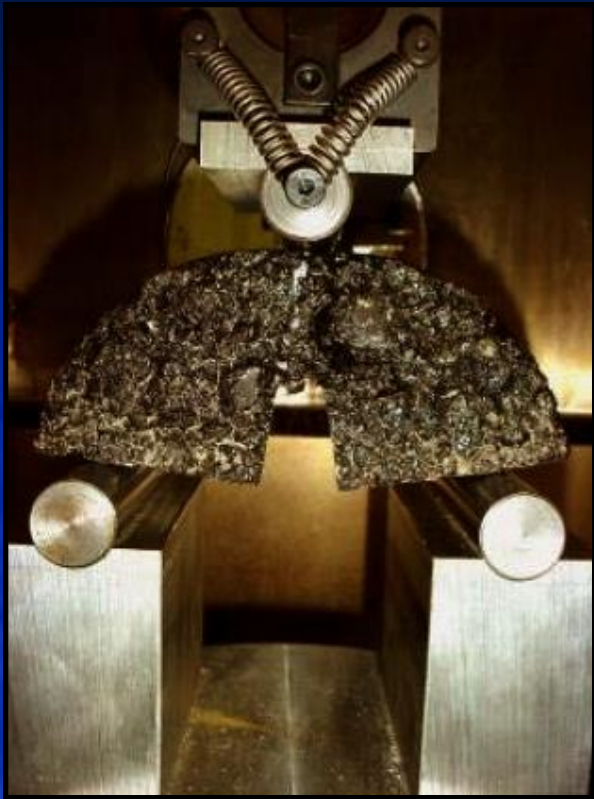
SCB Test Setup

- Three notch depths utilized (25.4 mm, 31.8 mm & 38.0 mm)
- Test temperature = Intermediate
- Loading rate = 0.5mm/min
- Calculating the critical strain energy release rate, J_c

$$J_c = \left(\frac{U_1}{b_1} - \frac{U_2}{b_2} \right) \frac{1}{a_2 - a_1}$$

a = the notch depth

b = sample thickness

U = the strain energy to failure

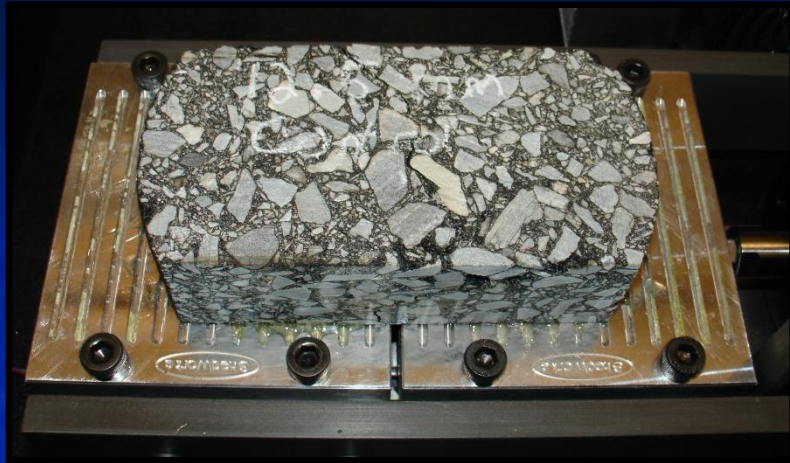
Reflective Cracking - Overlay Tester

- Test Temperature = Intermediate
- Test Termination at 1,200 cycles or 93% Load reduction
- Testing in accordance with Tex-248-F

Diagram from: Zhou et al. "Overlay Tester: Simple Performance Test for Fatigue Cracking" Transportation Research Record: Journal of the Transportation Research Board, No. 2001, Transportation Research Board of the National Academies, Washington, D.C., 2007, pp. 1-8.

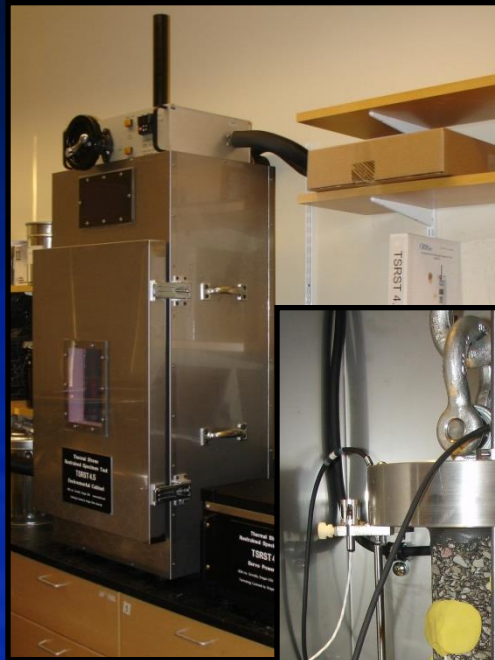
Mixture Low Temperature Cracking - TSRST

- Cooling Rate of $-10^{\circ}\text{C}/\text{hour}$
- Testing in accordance with AASHTO TP10-93

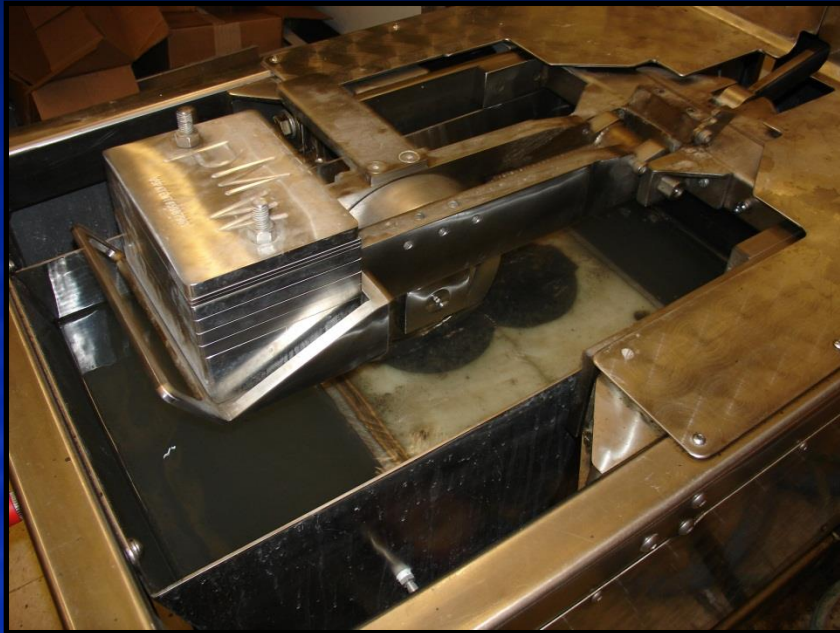
Hamburg Wheel Tracking Device

- Compact two HWTD and two OT specimens at OAC, OAC+0.5%, and OAC+1.0% at $93 \pm 1.0\%$ density
- Run HWTD to evaluate rutting resistance
- Run OT to evaluate cracking resistance

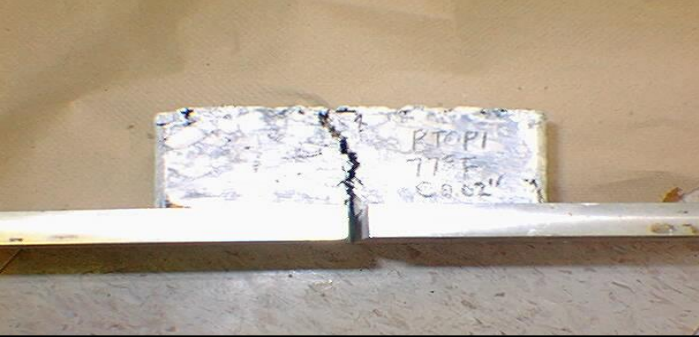
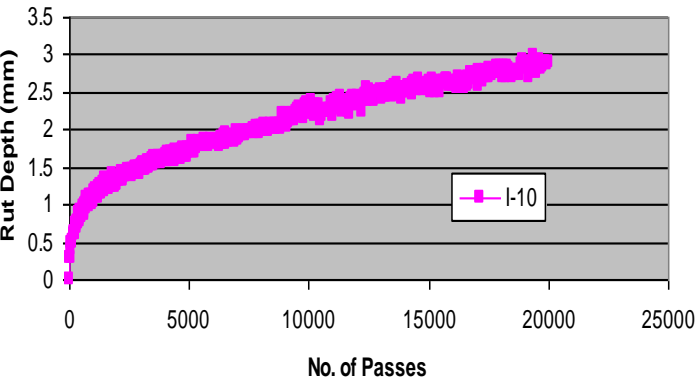
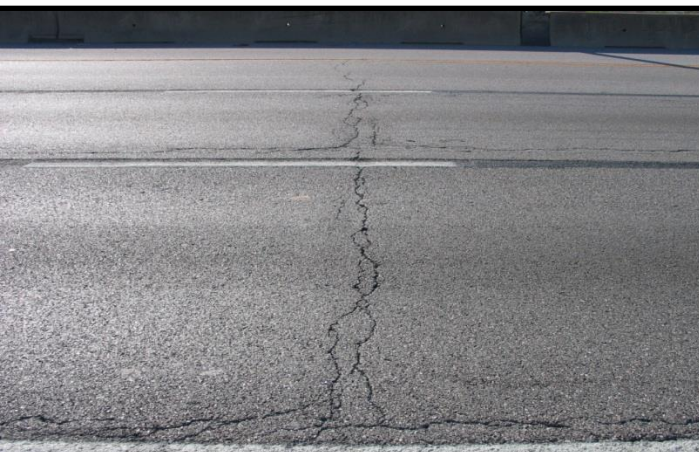
IH-10 Type C (PG76-22), 4.4% AC

Reflection Cracking on IH 10 in Houston
Had to be replaced after 3 years

Hamburg Test@50C

Properties	Result	Target
Cracking (overlay tester cycles to failure)	2	>300
Rutting (Hamburg cycles to 12.5mm rut)	2.9 mm at 20K	>20K

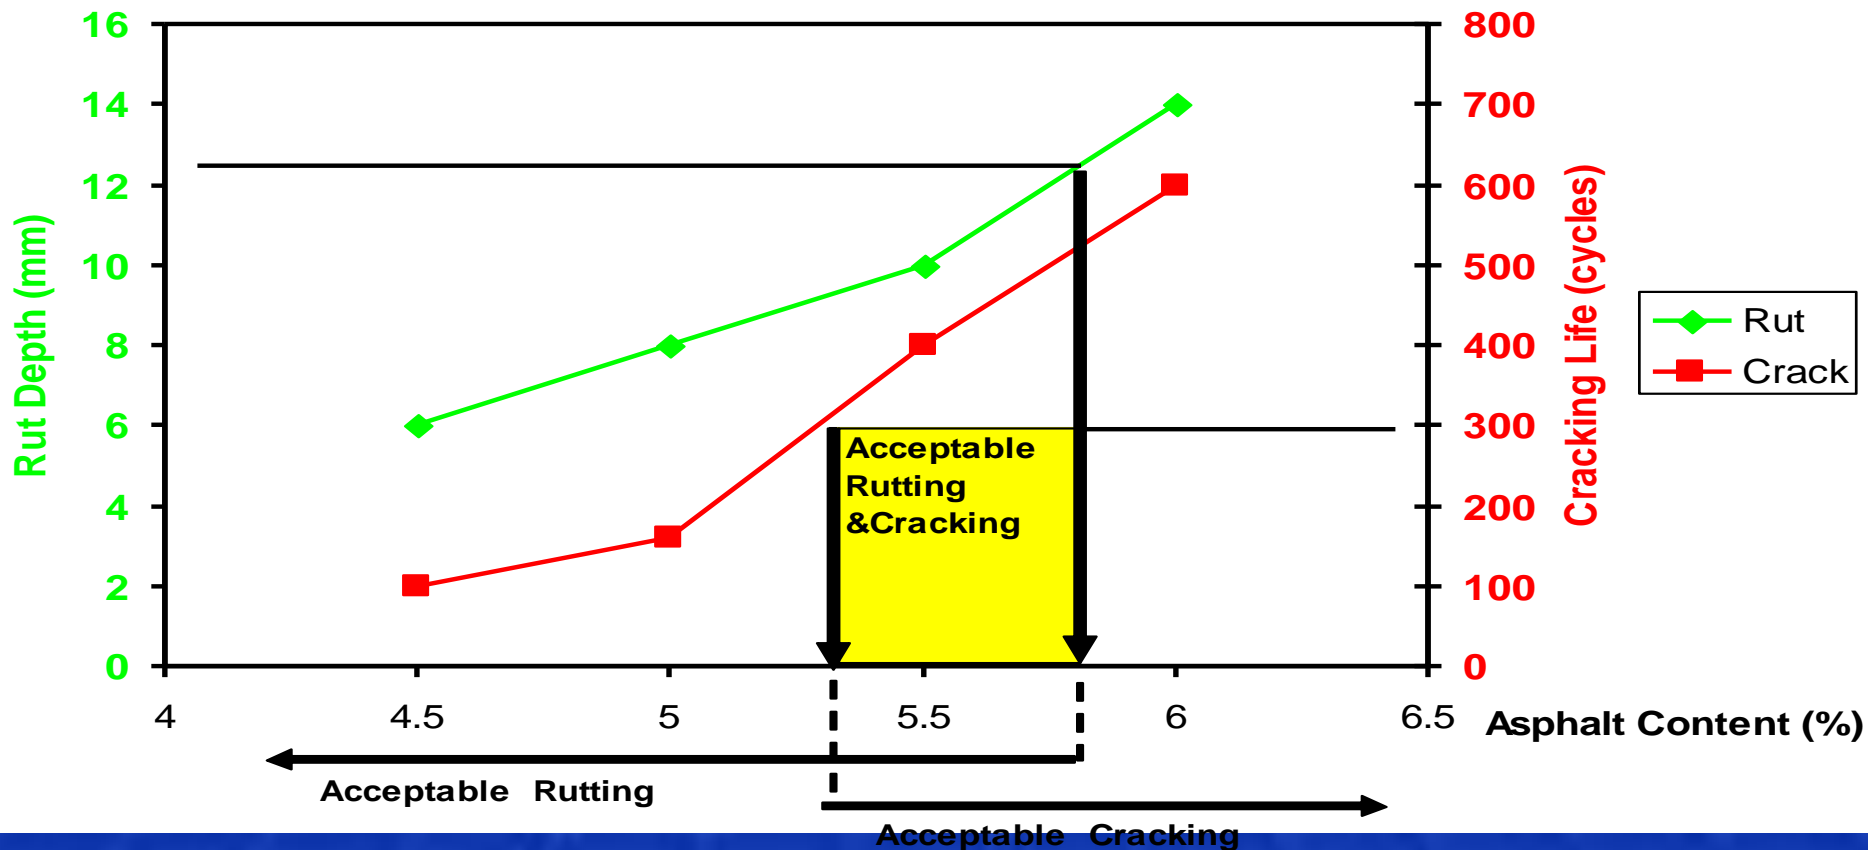
Balancing Rutting and Cracking

3. Select a balanced asphalt content based on HWTD and OT requirements

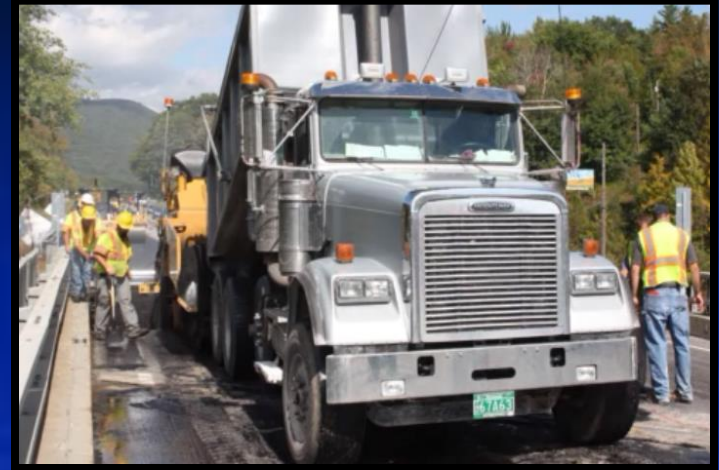
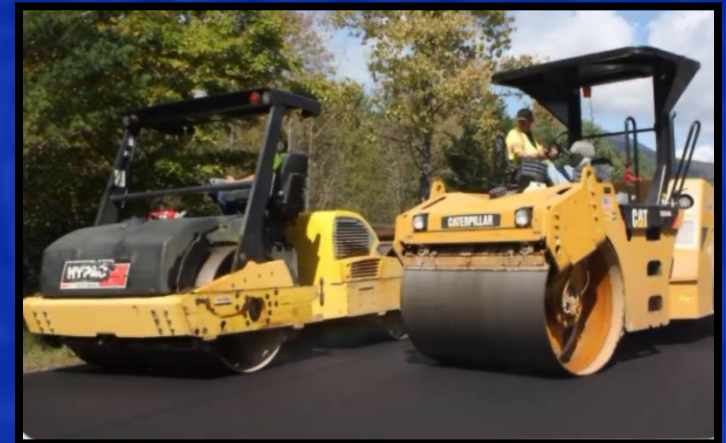
Vermont US Route 7 - Danby, VT

- AADT = 4,500 vehicles
- Existing pavement surface was 14 years old with isolated areas of permanent deformation, some transverse cracking and some shrinkage cracking.
- Surface preparations included spot shimming of permanent deformation areas, crack sealing, patching of cracks wider than 1 inch and patching of all potholes.
- After one year in service there is no apparent distress in either test section or in the control as of mid to late spring 2012.

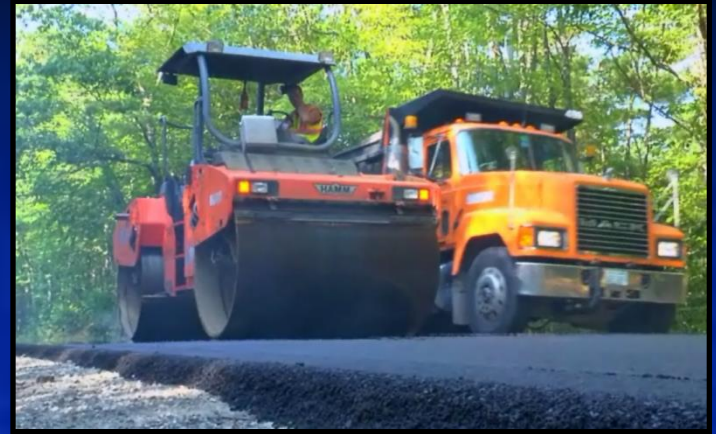
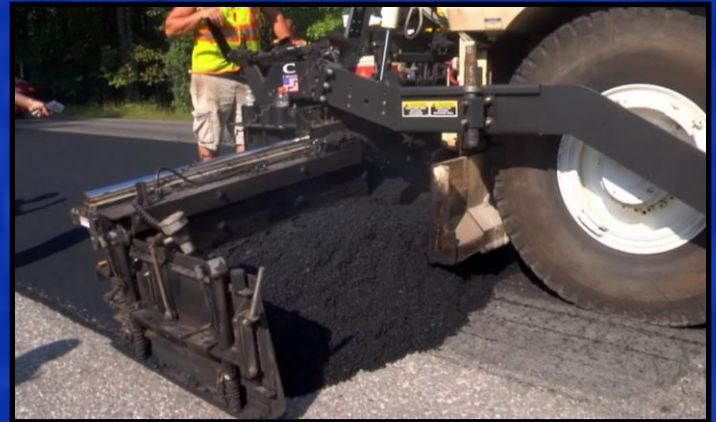
New Hampshire Route 202 - Rochester, NH

- 1,500 tons of the HiPO mixture incorporating 25% RAP placed.
- AADT = 4,600 vehicles
- Existing pavement was in poor condition and no milling was done prior to the placement of the HiPO.
- After one year in service, the HiPO mixture has minimal cracking returned.
