Pavement Preservation Update

Derek Nener-Plante
Pavement Design/Quality
Highway Program
MaineDOT

Pavement Preservation Program

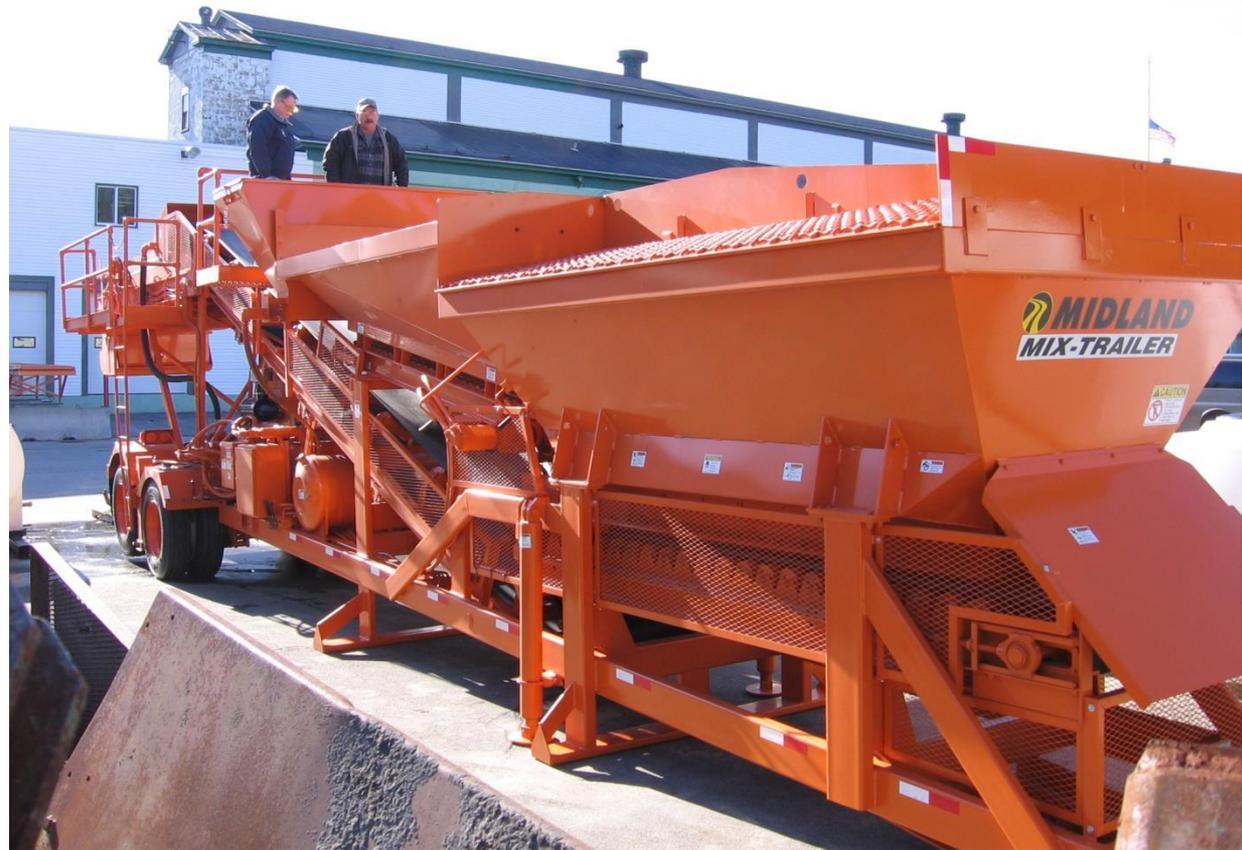
PMRAP Program

- Plant-mixed recycled asphalt pavement is used on many lower priority roads in the state
- Variable depth course placed by crew (in multiple lifts), then covered by thin overlay
- Over 50,000 T placed last year

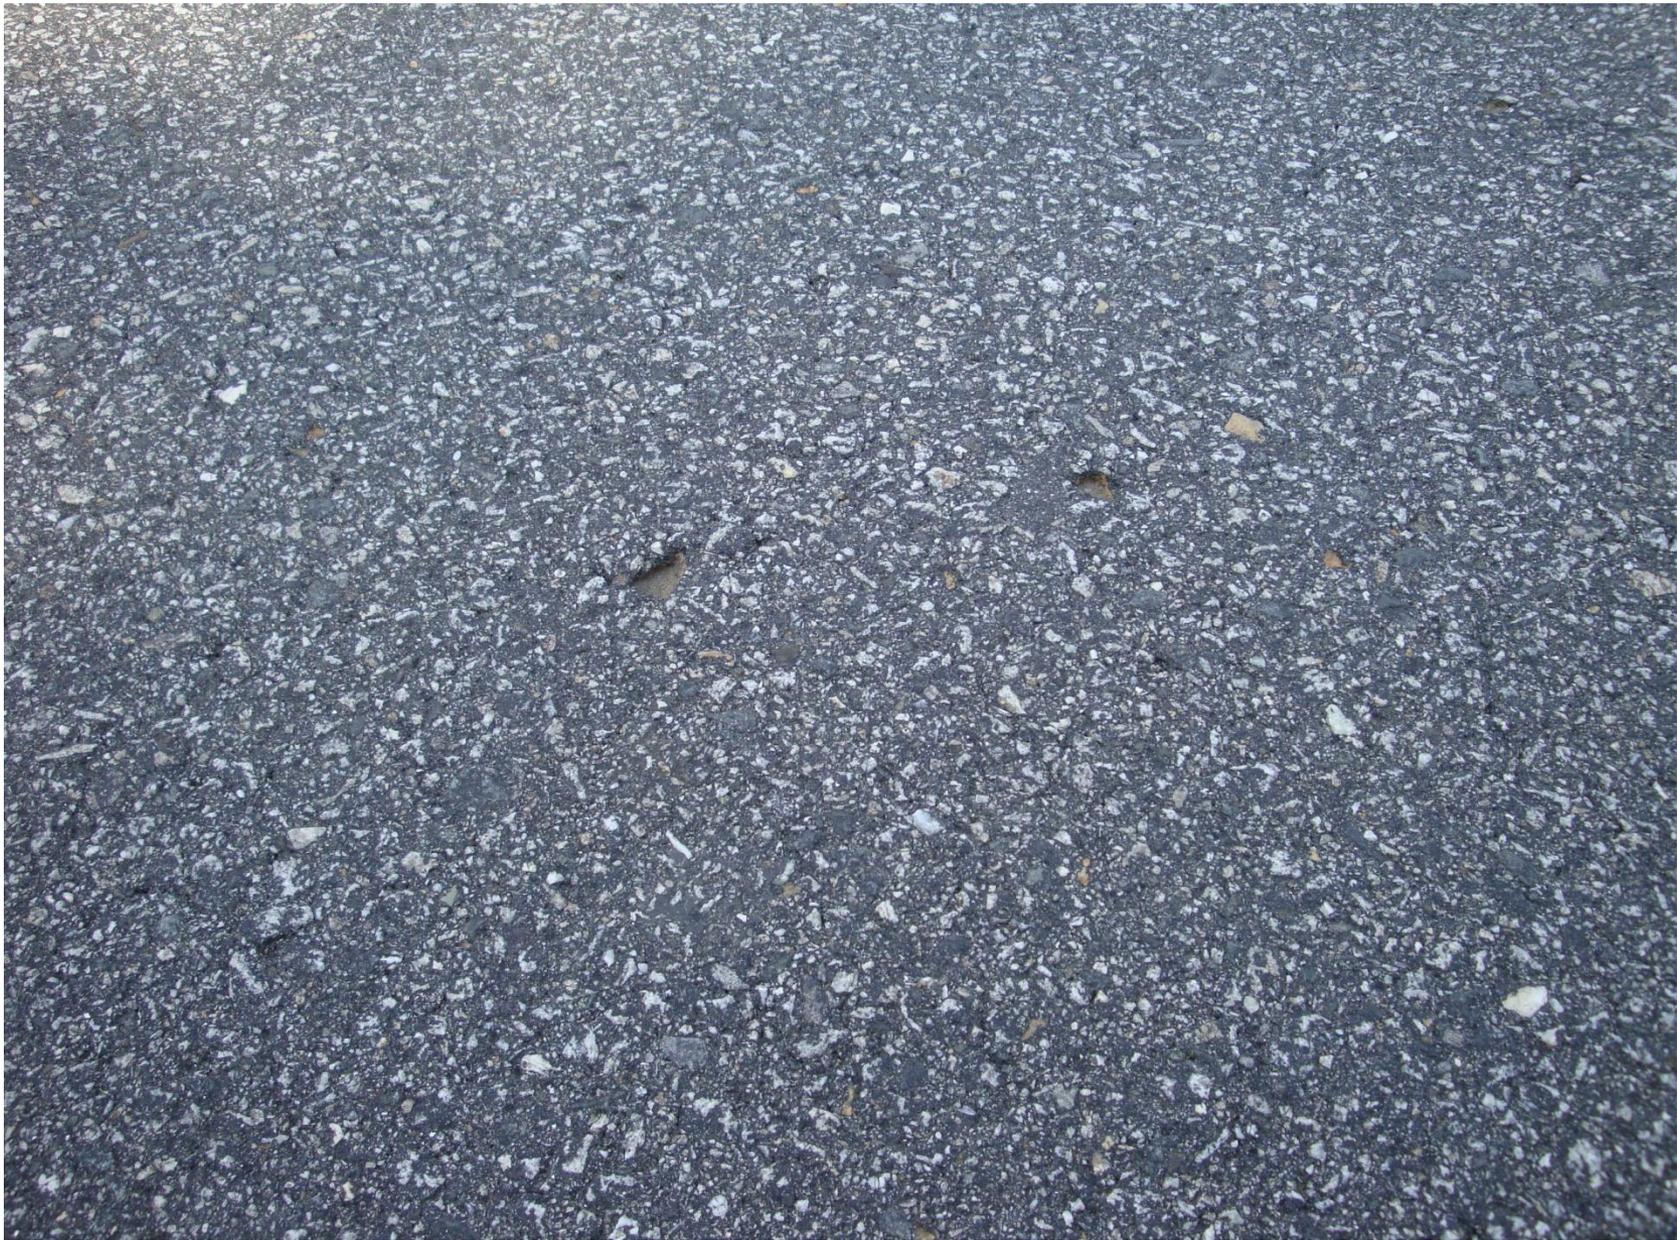
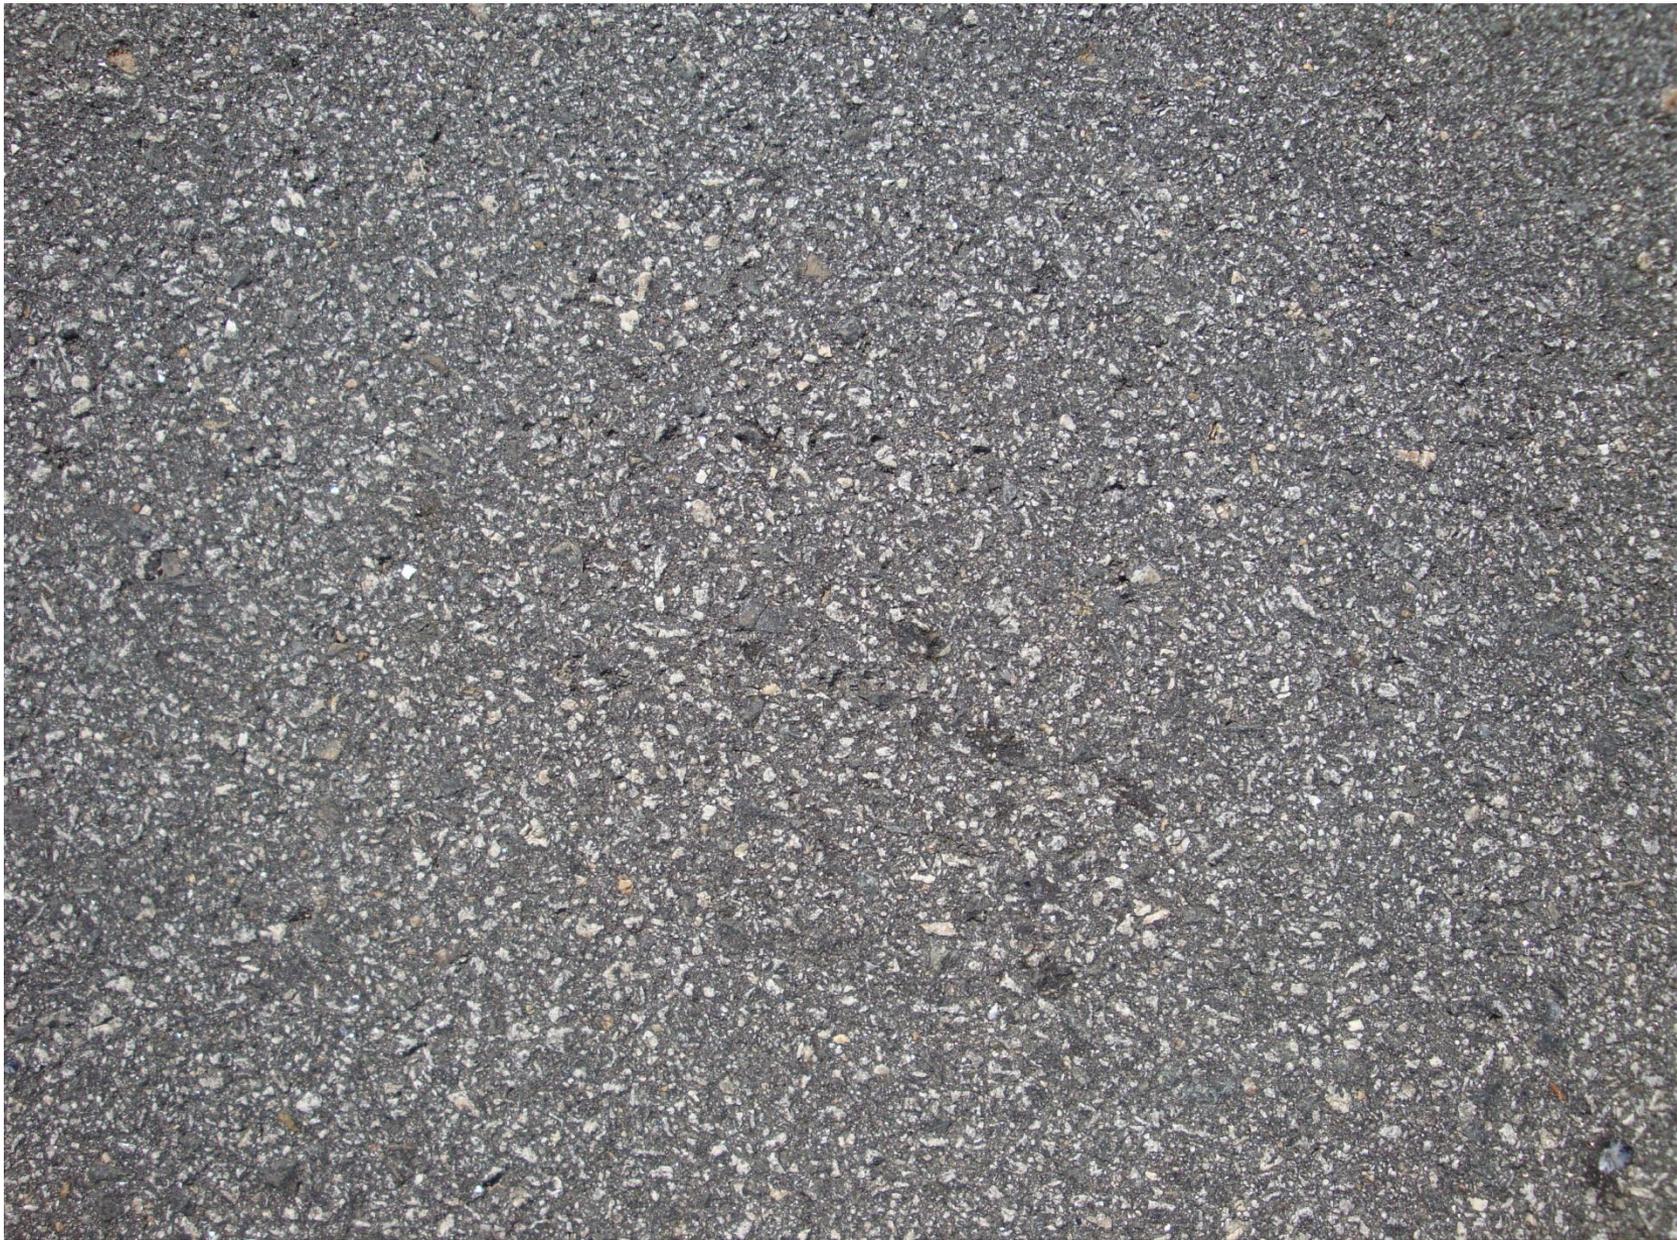
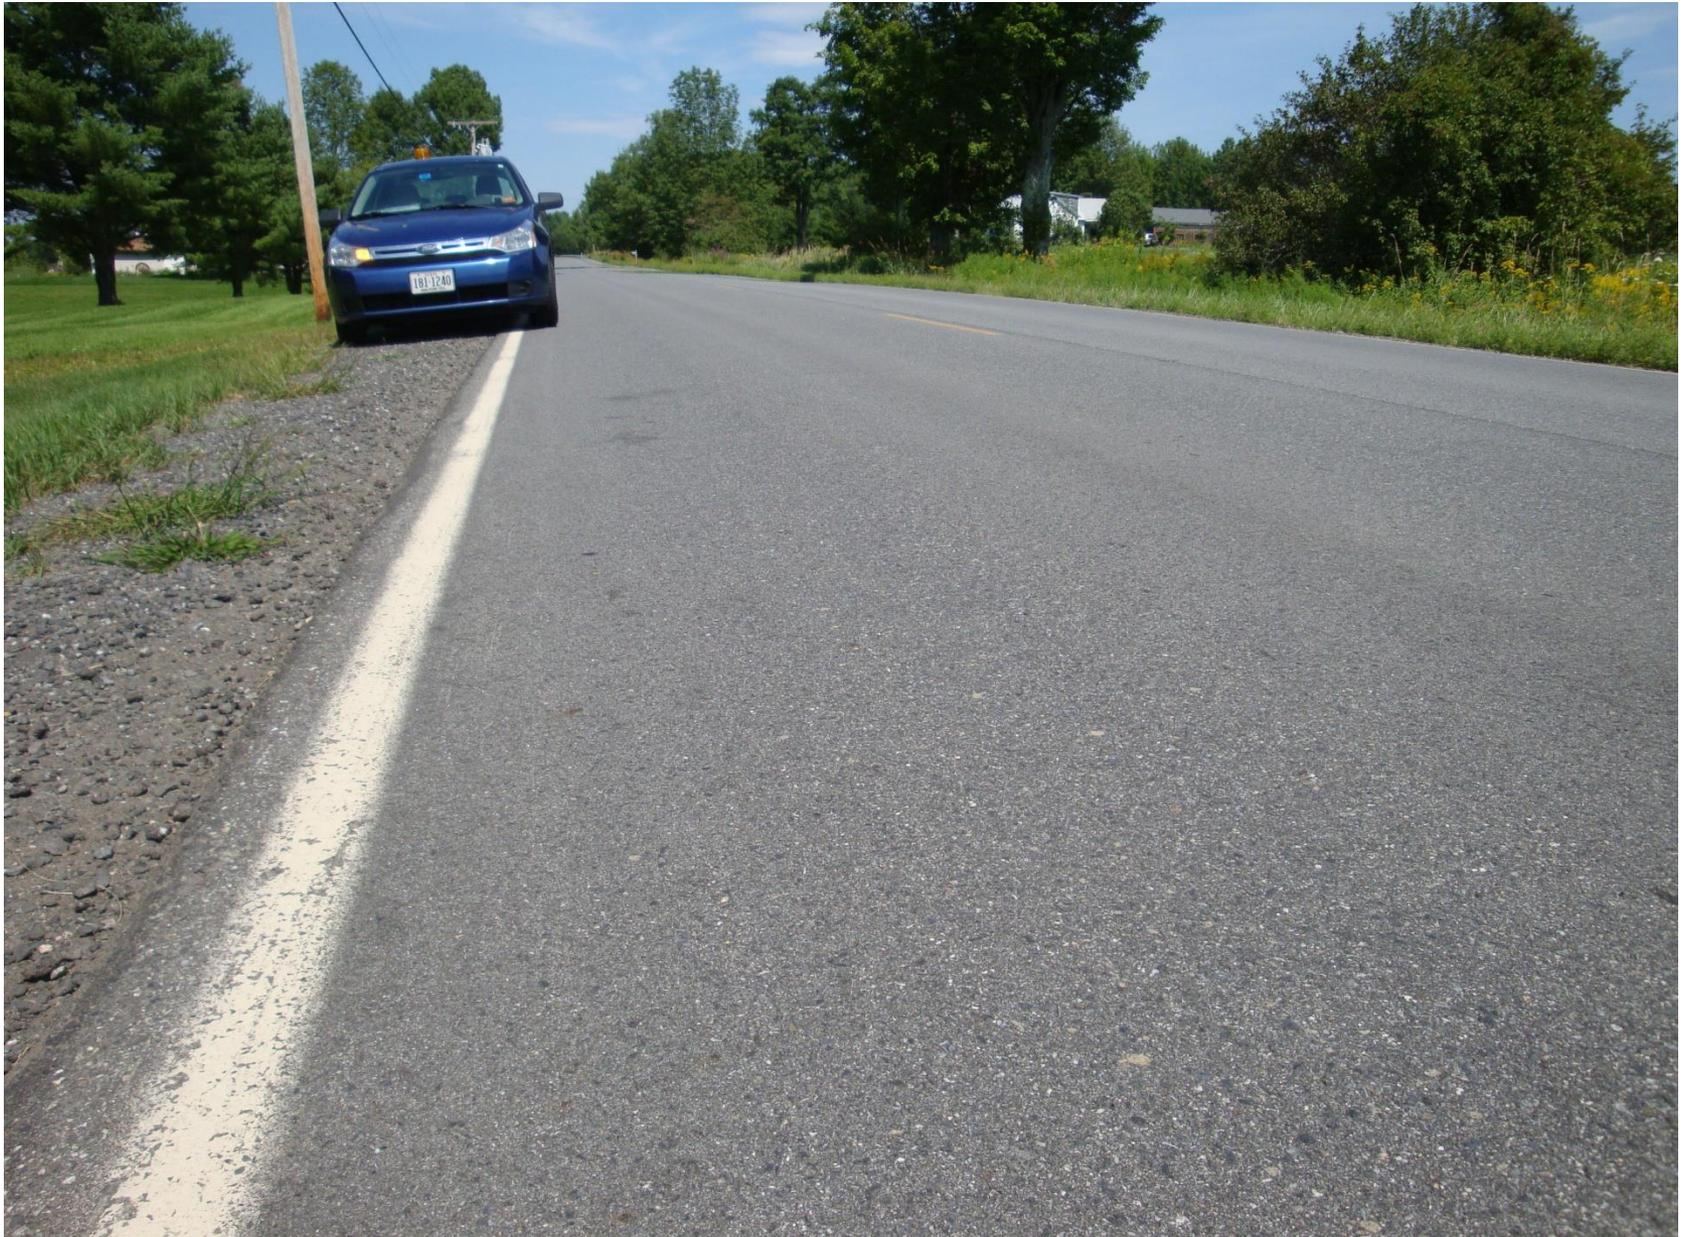
Aggregate Loss / Erosion

- Distress increasingly identified in new HMA pavements in recent years
- Loss of matrix and or coarse aggregate stone from the mat within 6 months to 1 year
- Results in a very open textured mat
- Mat eventually wears away to underlying base layer
