2012 NCAT Pavement Test Track Pavement Preservation Study

NE Pavement Preservation Partnership Meeting

2012 Preservation Group (PG) Study

- Quantify life extending benefit of study treatments
 - Time/traffic to return to pretreatment condition(s)
 - Test sections on the Track and Lee Road 159
- Sampling/testing for construction quality

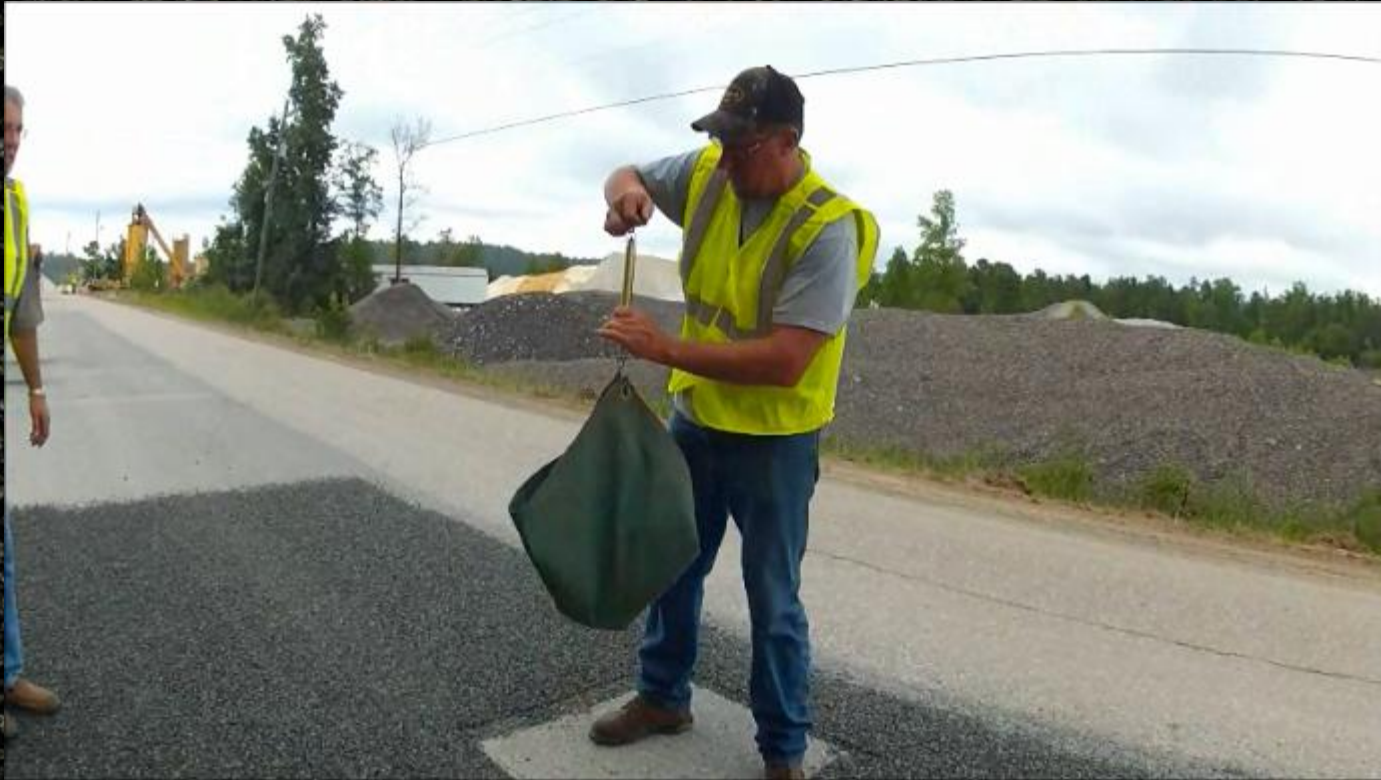
Rates Checked Prior to Placement

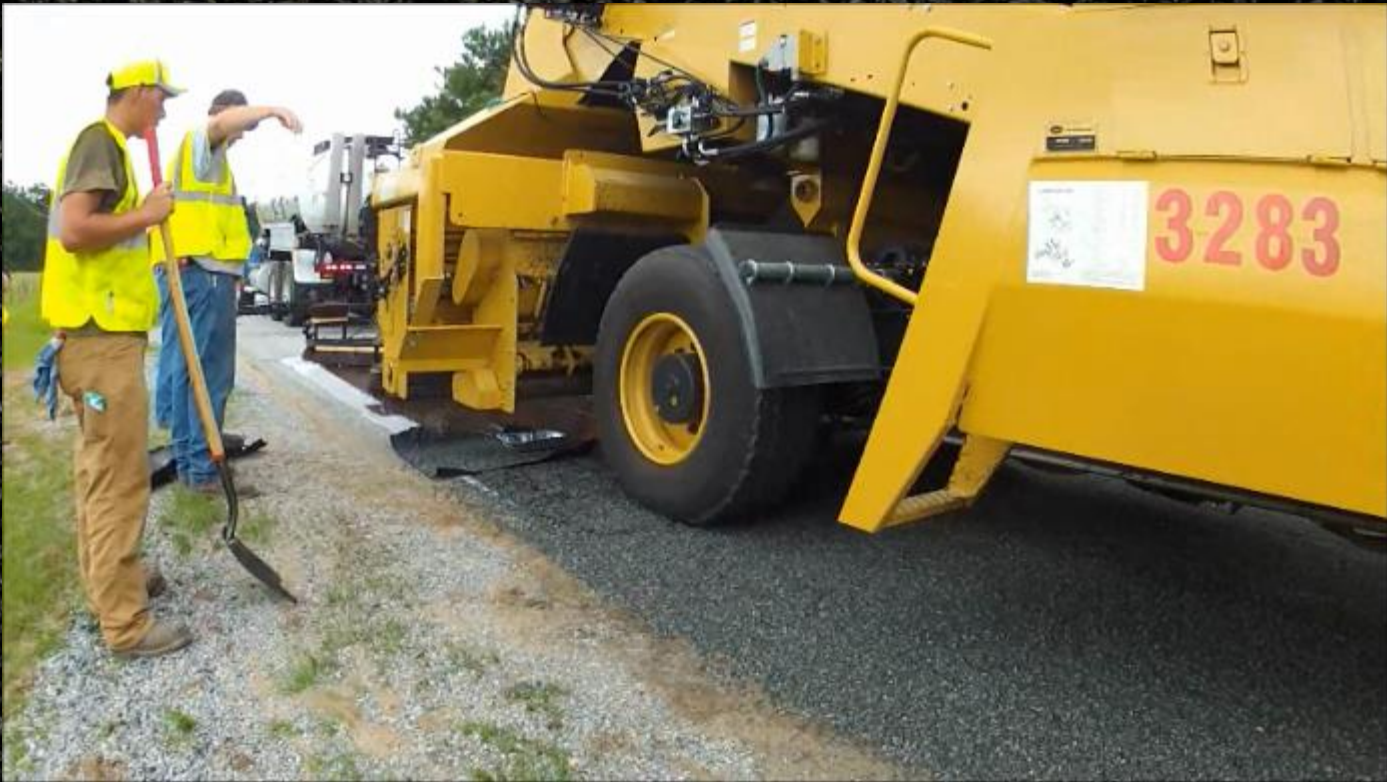
Actual Rates Verified During Placement

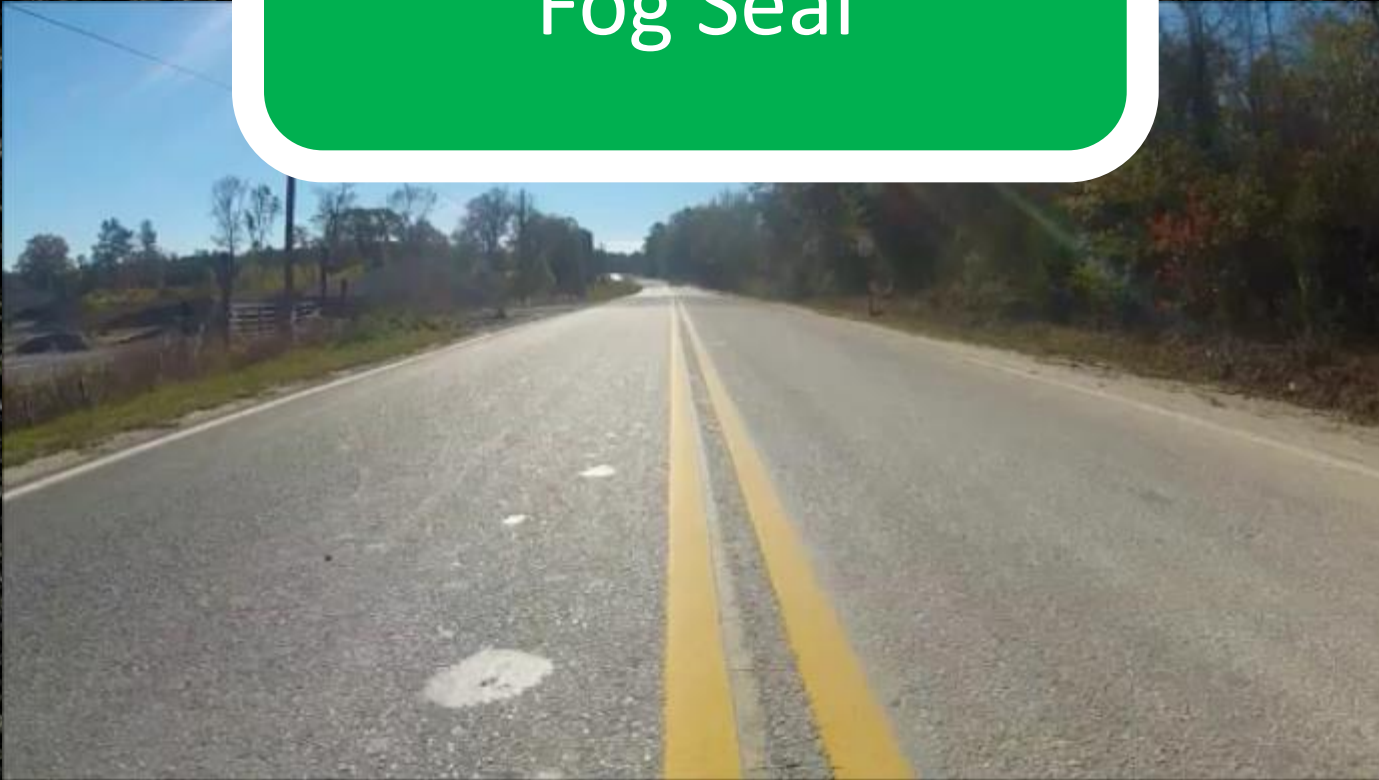
L1 – Rejuvenating Fog Seal

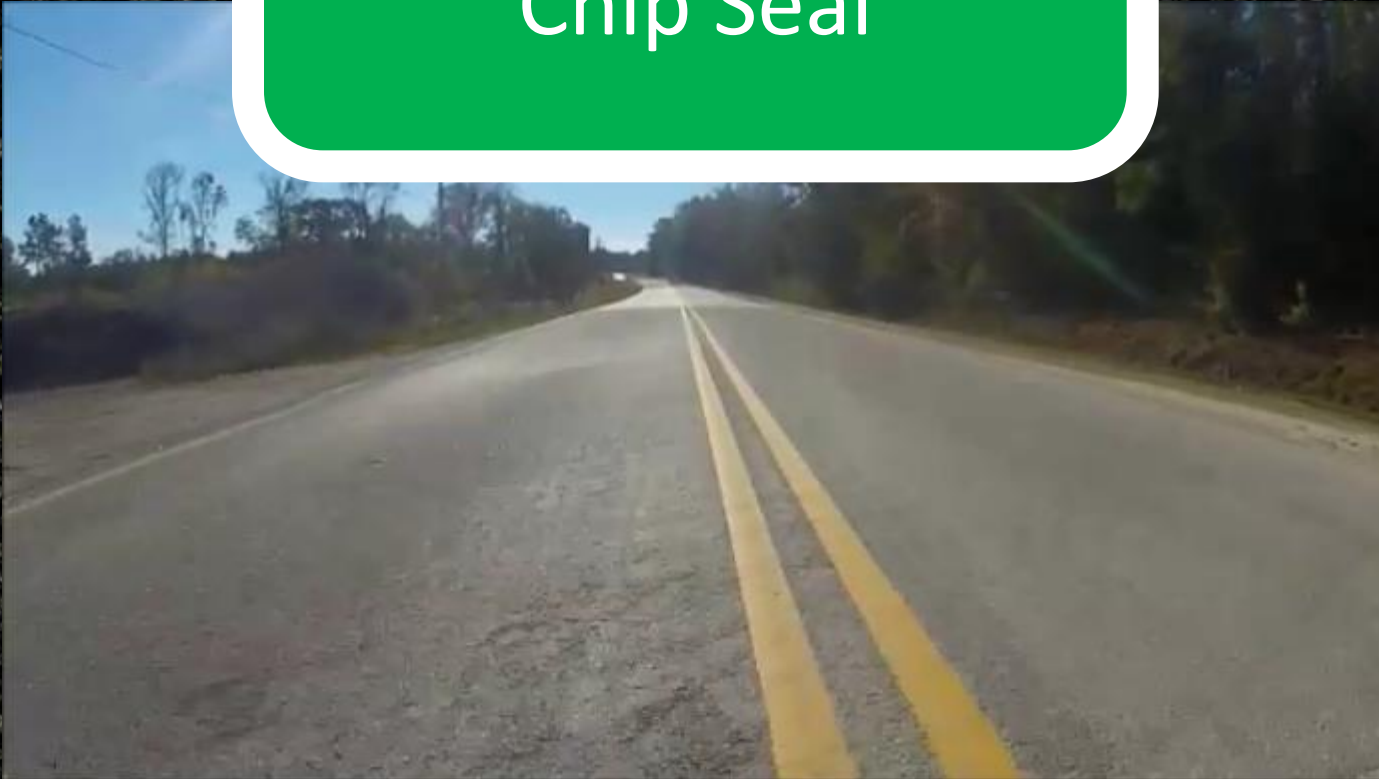
L2 – FiberMat Chip Seal

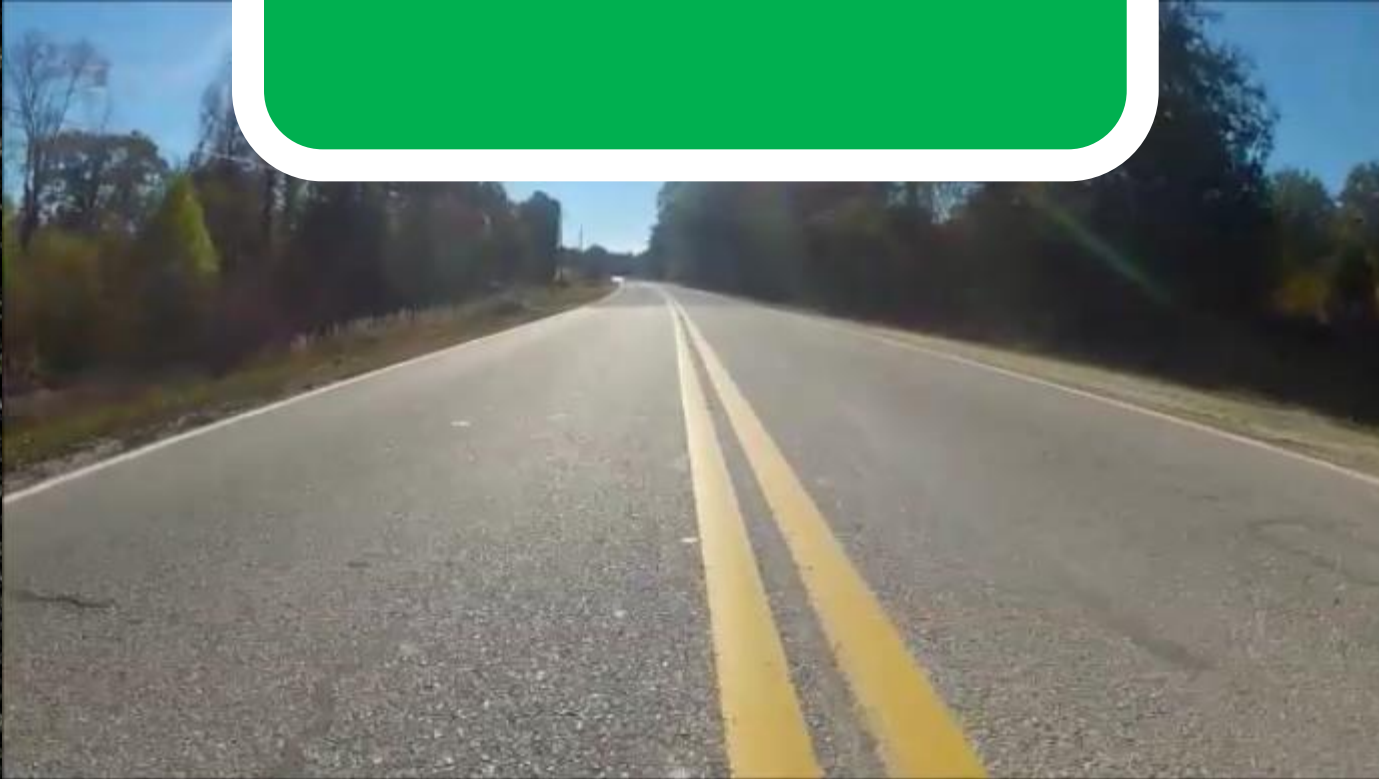
L5 – Crack Sealing

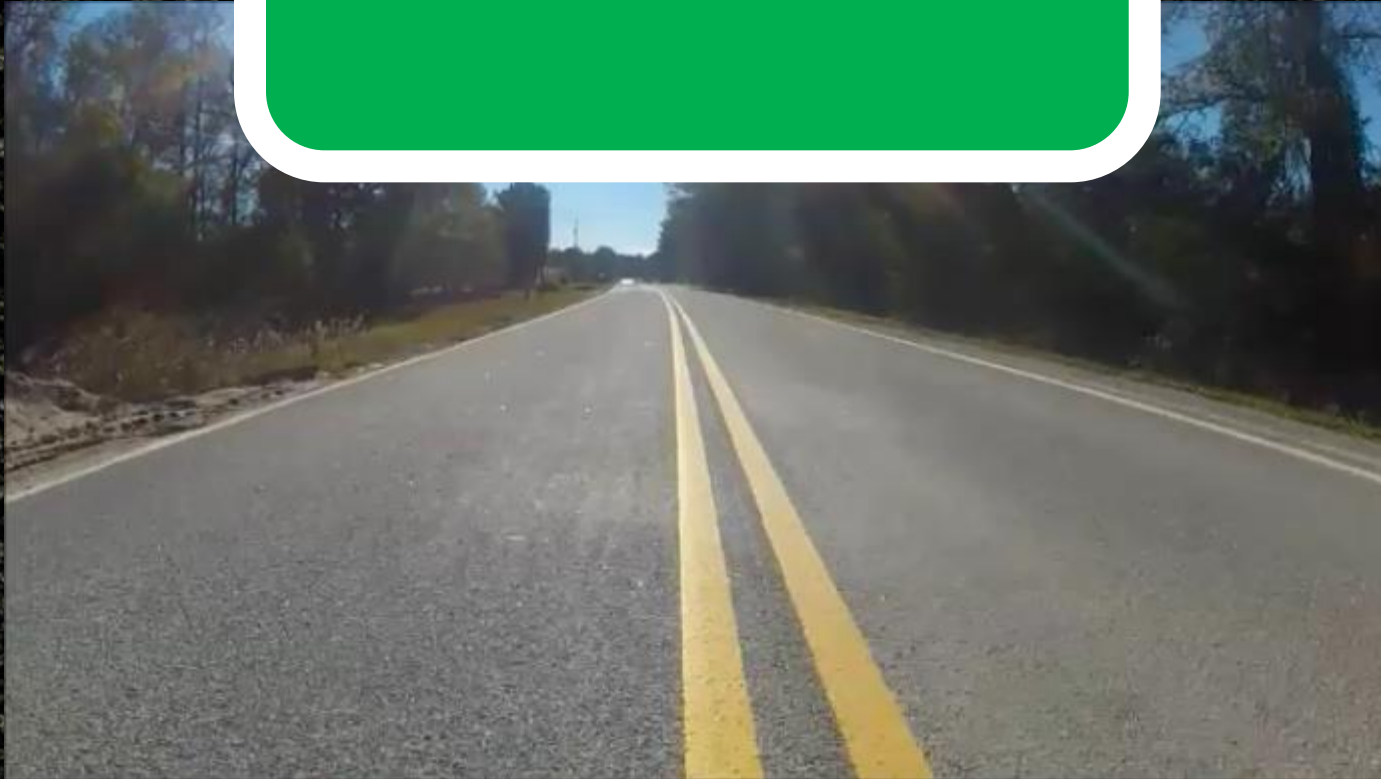
L6 – Chip Seal

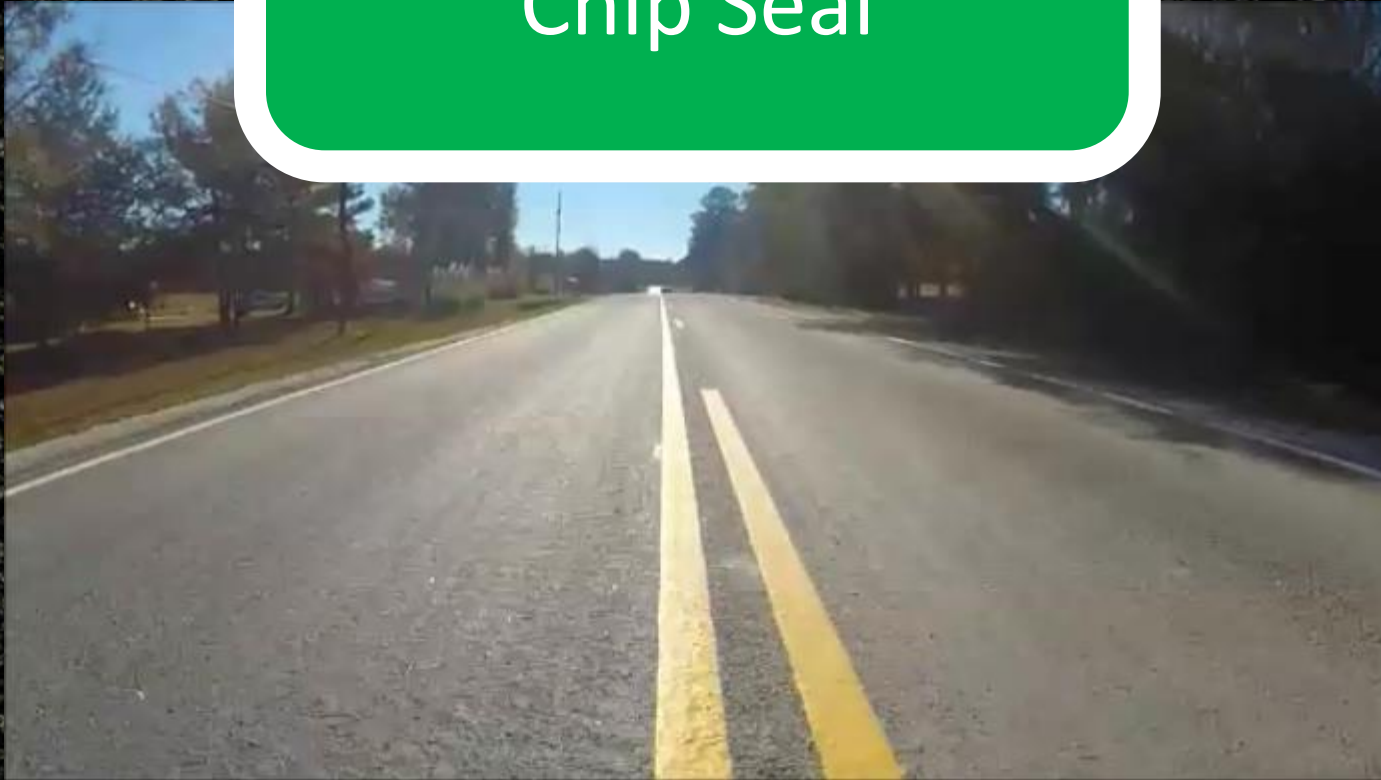
L8 – Triple Layer Chip Seal

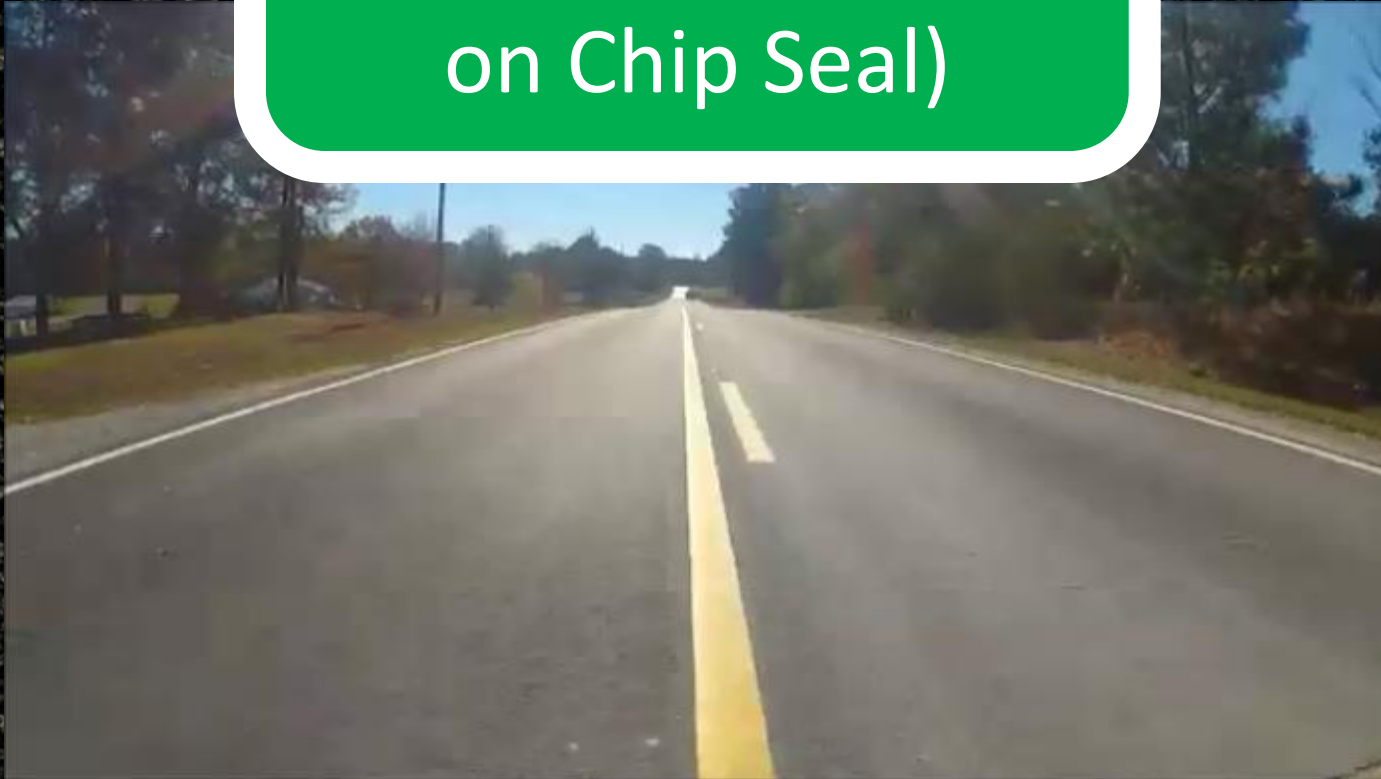
L10 – Cape Seal
(Micro Surface
on Chip Seal)

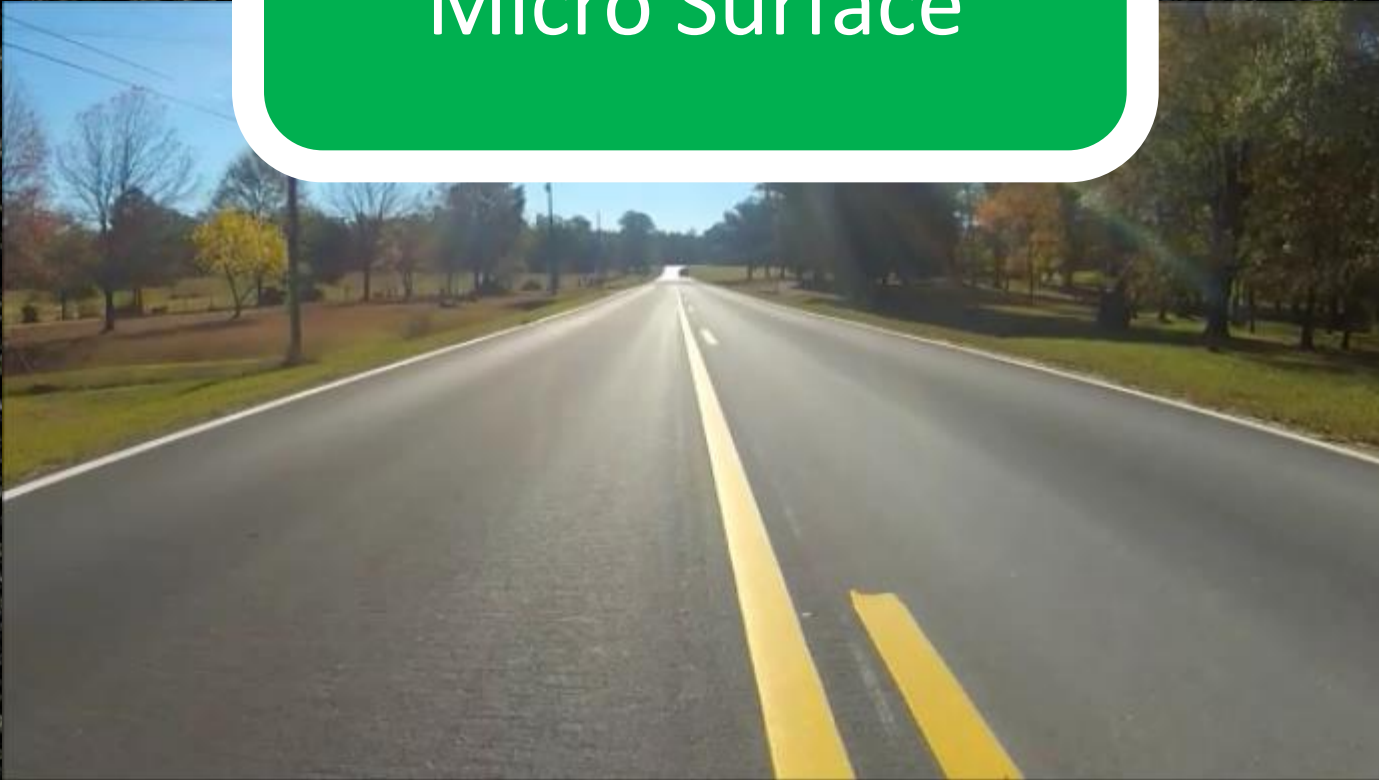
L13 – Double Layer Micro Surface

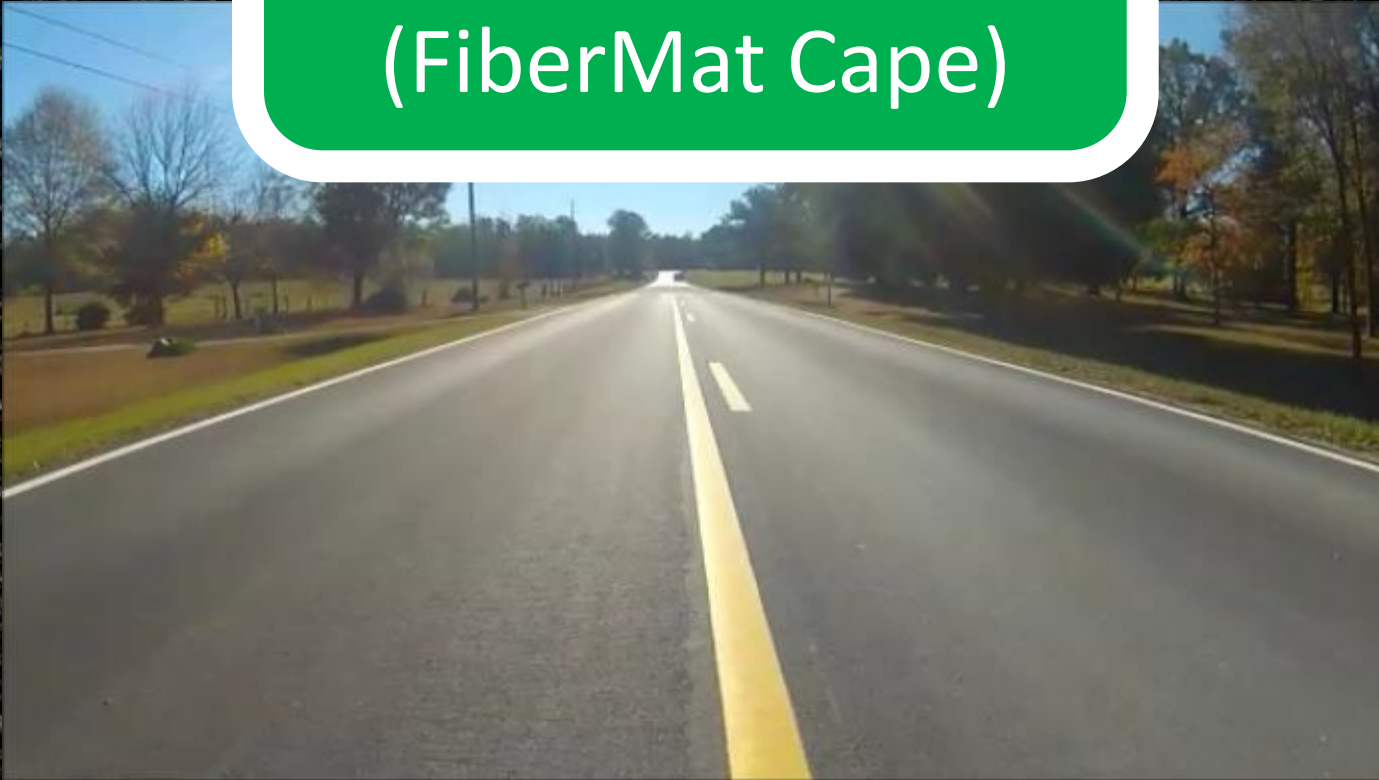
L14 – Micro Surface on FiberMat (FiberMat Cape)

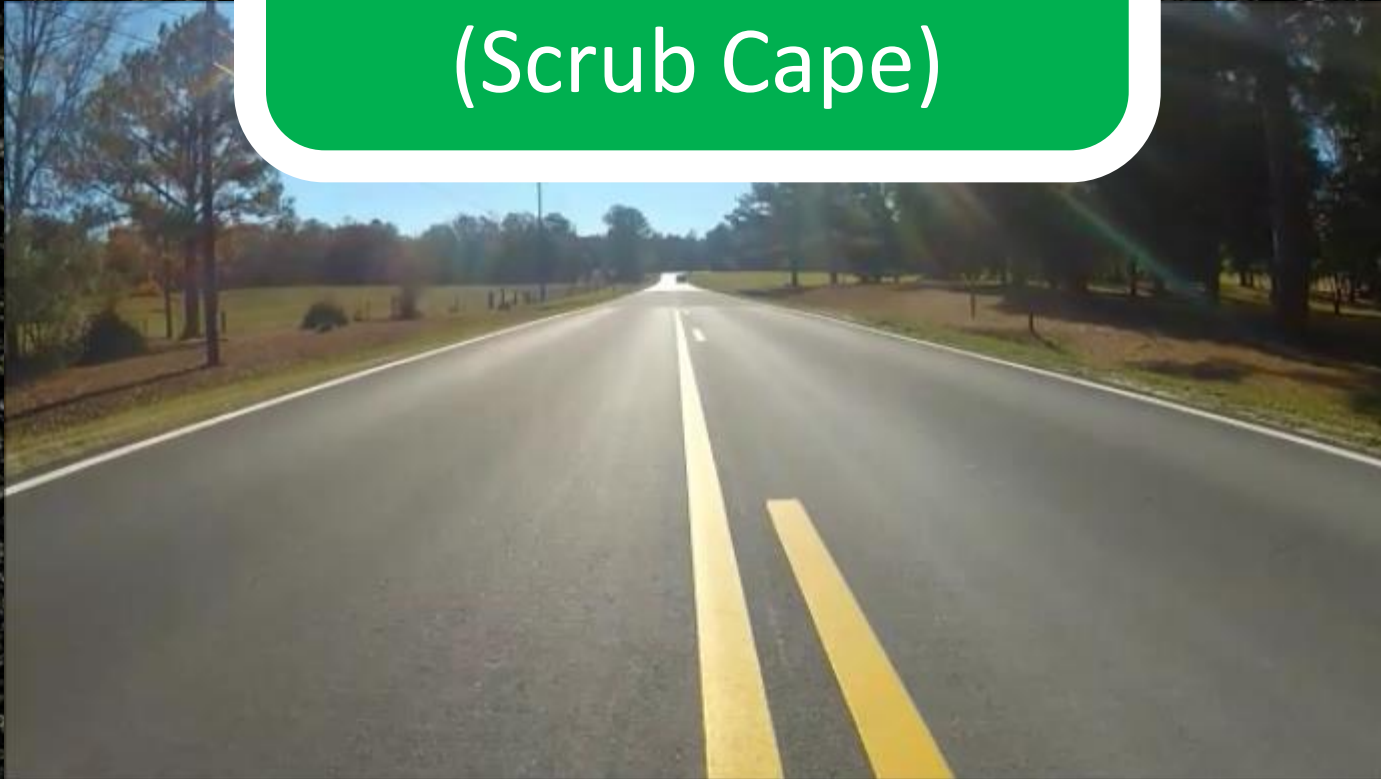
L15 – Micro Surface on Scrub Seal (Scrub Cape)

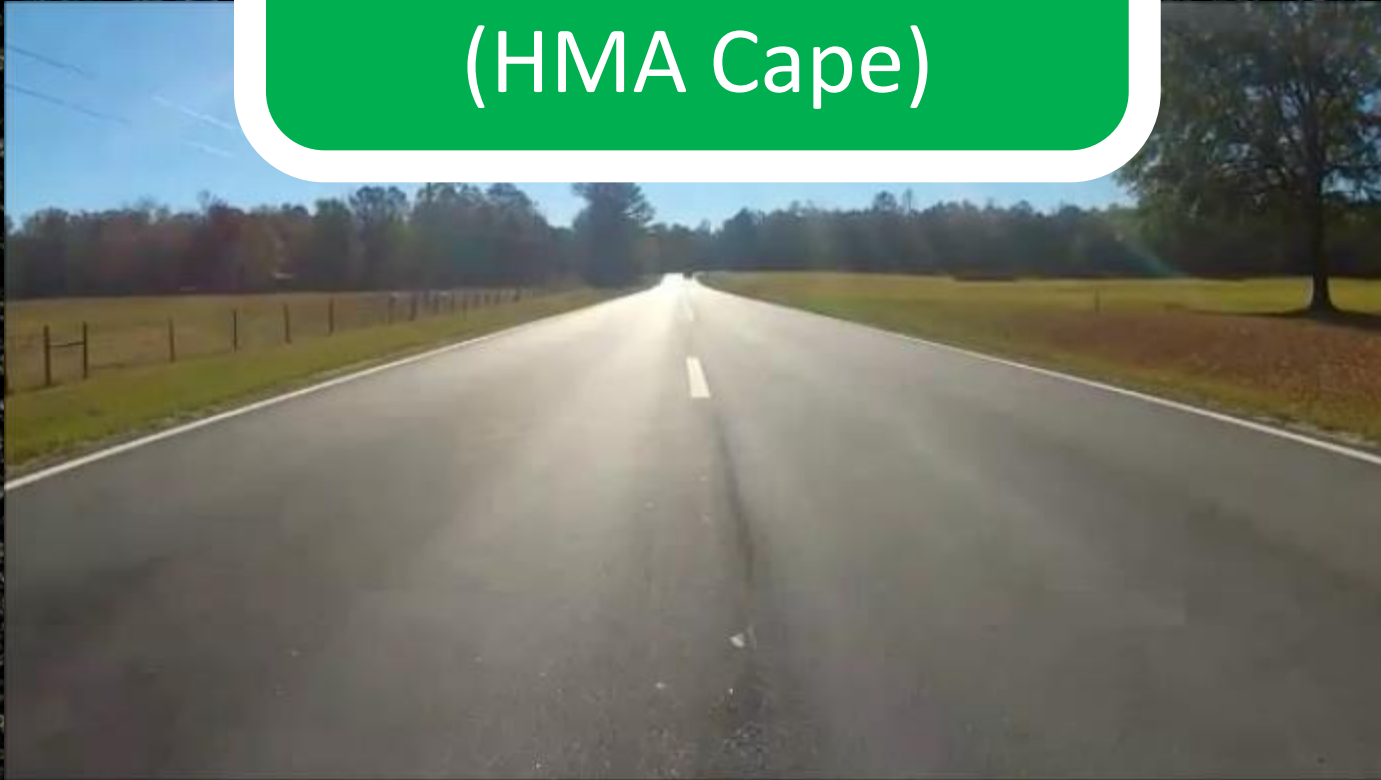
L18 – Thin HMA Overlay on FiberMat (HMA Cape)

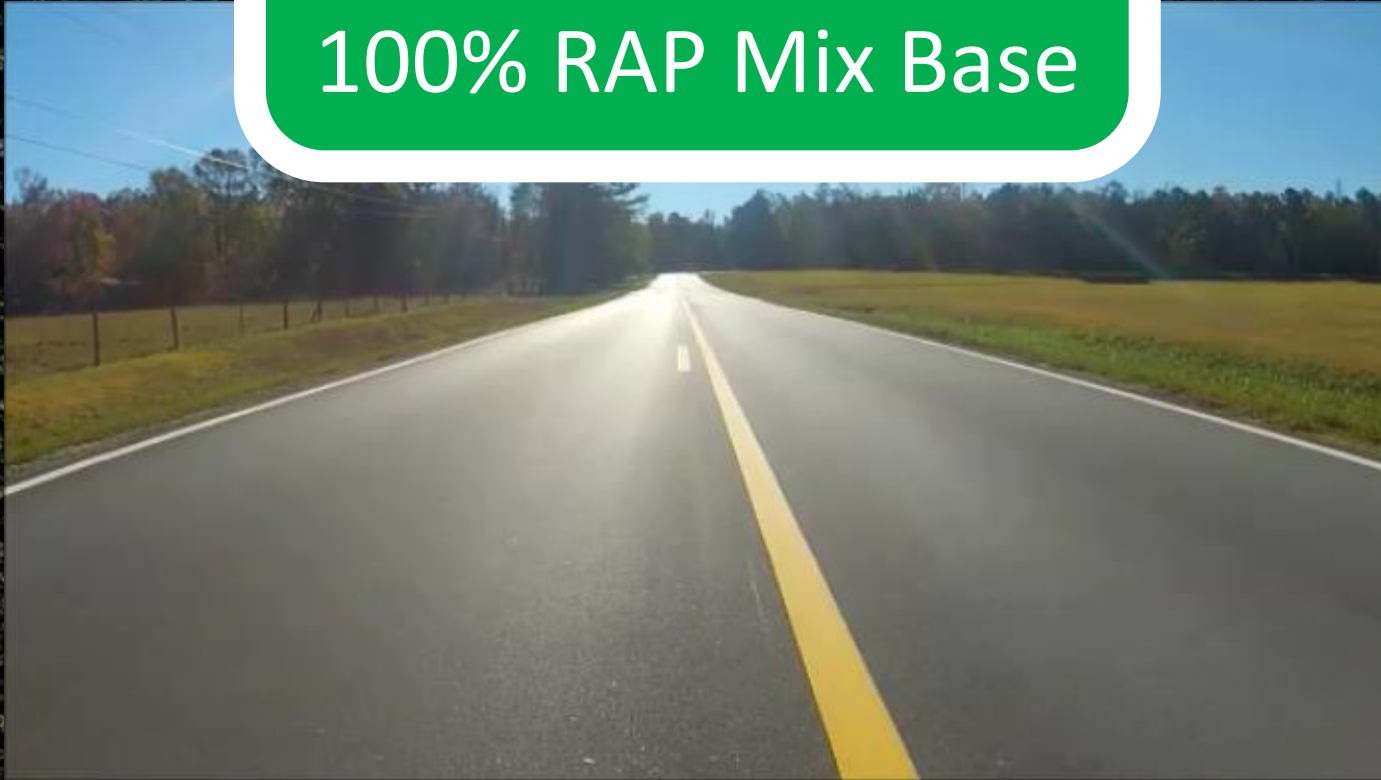
L20 – Thin HMA
Overlay on
100% RAP Mix Base

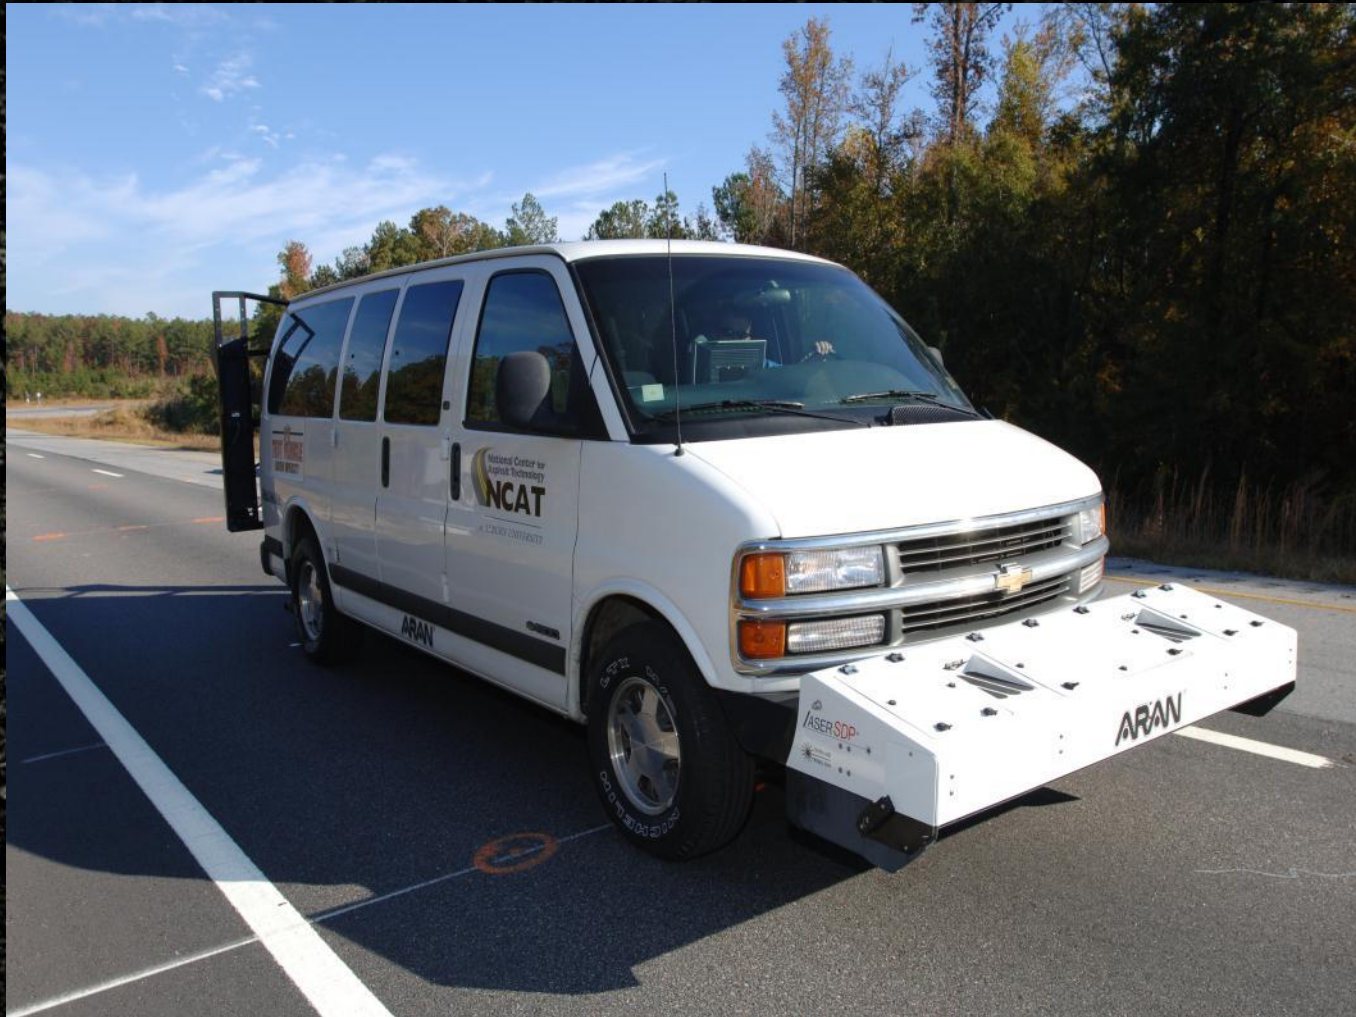
ARAN Van for Roughness/Texture

- Weekly
 - ARAN Van (rutting, roughness, texture)
 - Video for crack mapping
 - Visual inspections with notes/pictures
- Monthly
 - Wet ribbed surface friction
 - Subgrade moisture readings
 - Falling weight deflectometer (FWD)
- Other
 - Ground penetration radar (GPR)

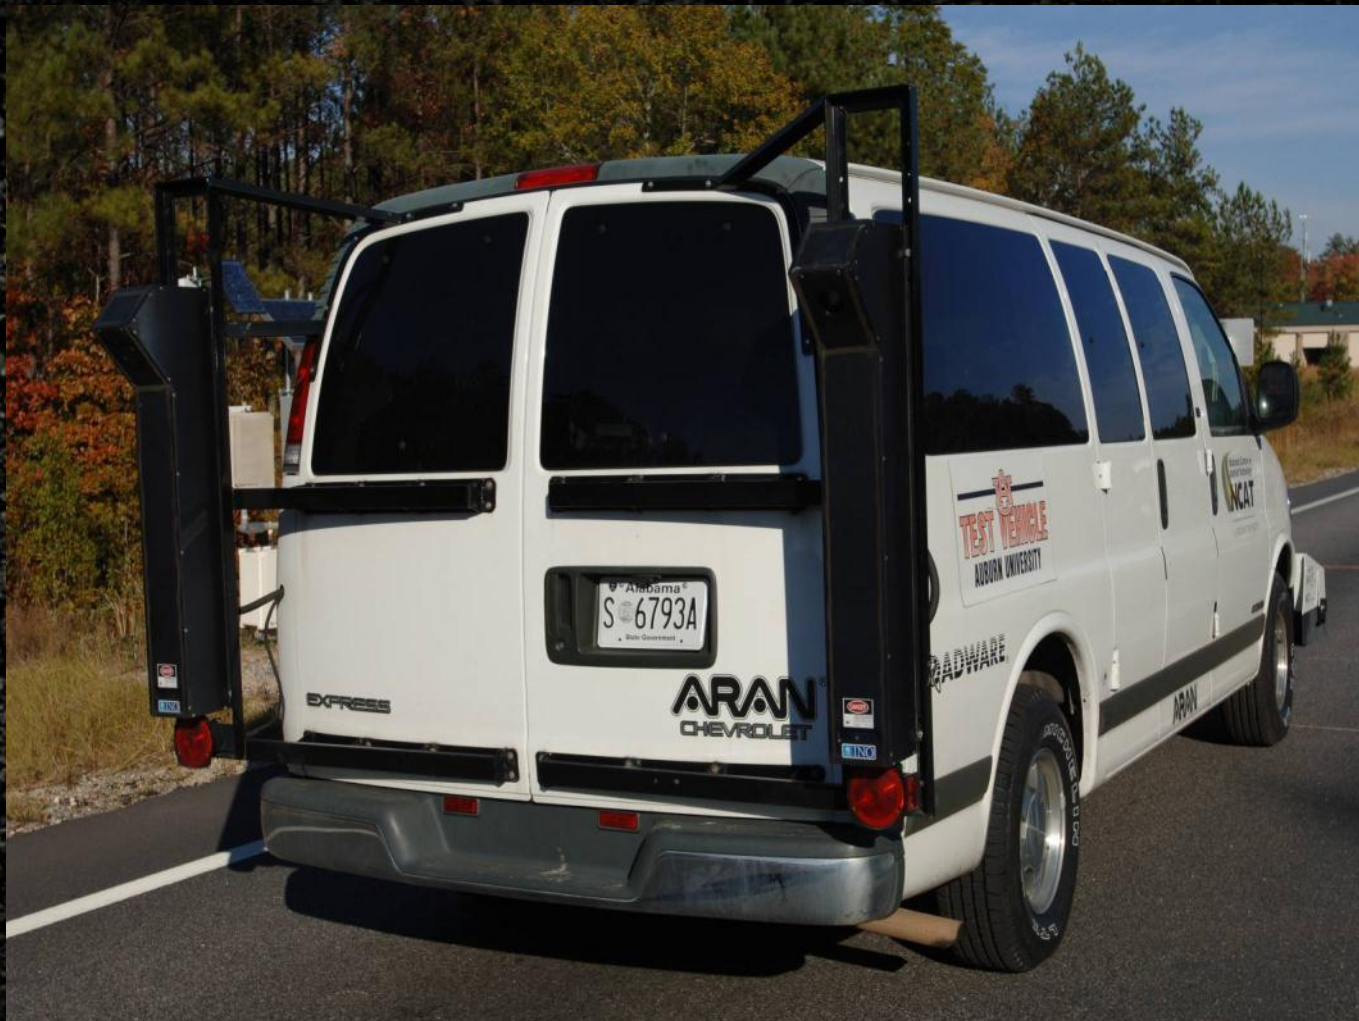
ARAN Van for Rut Depths

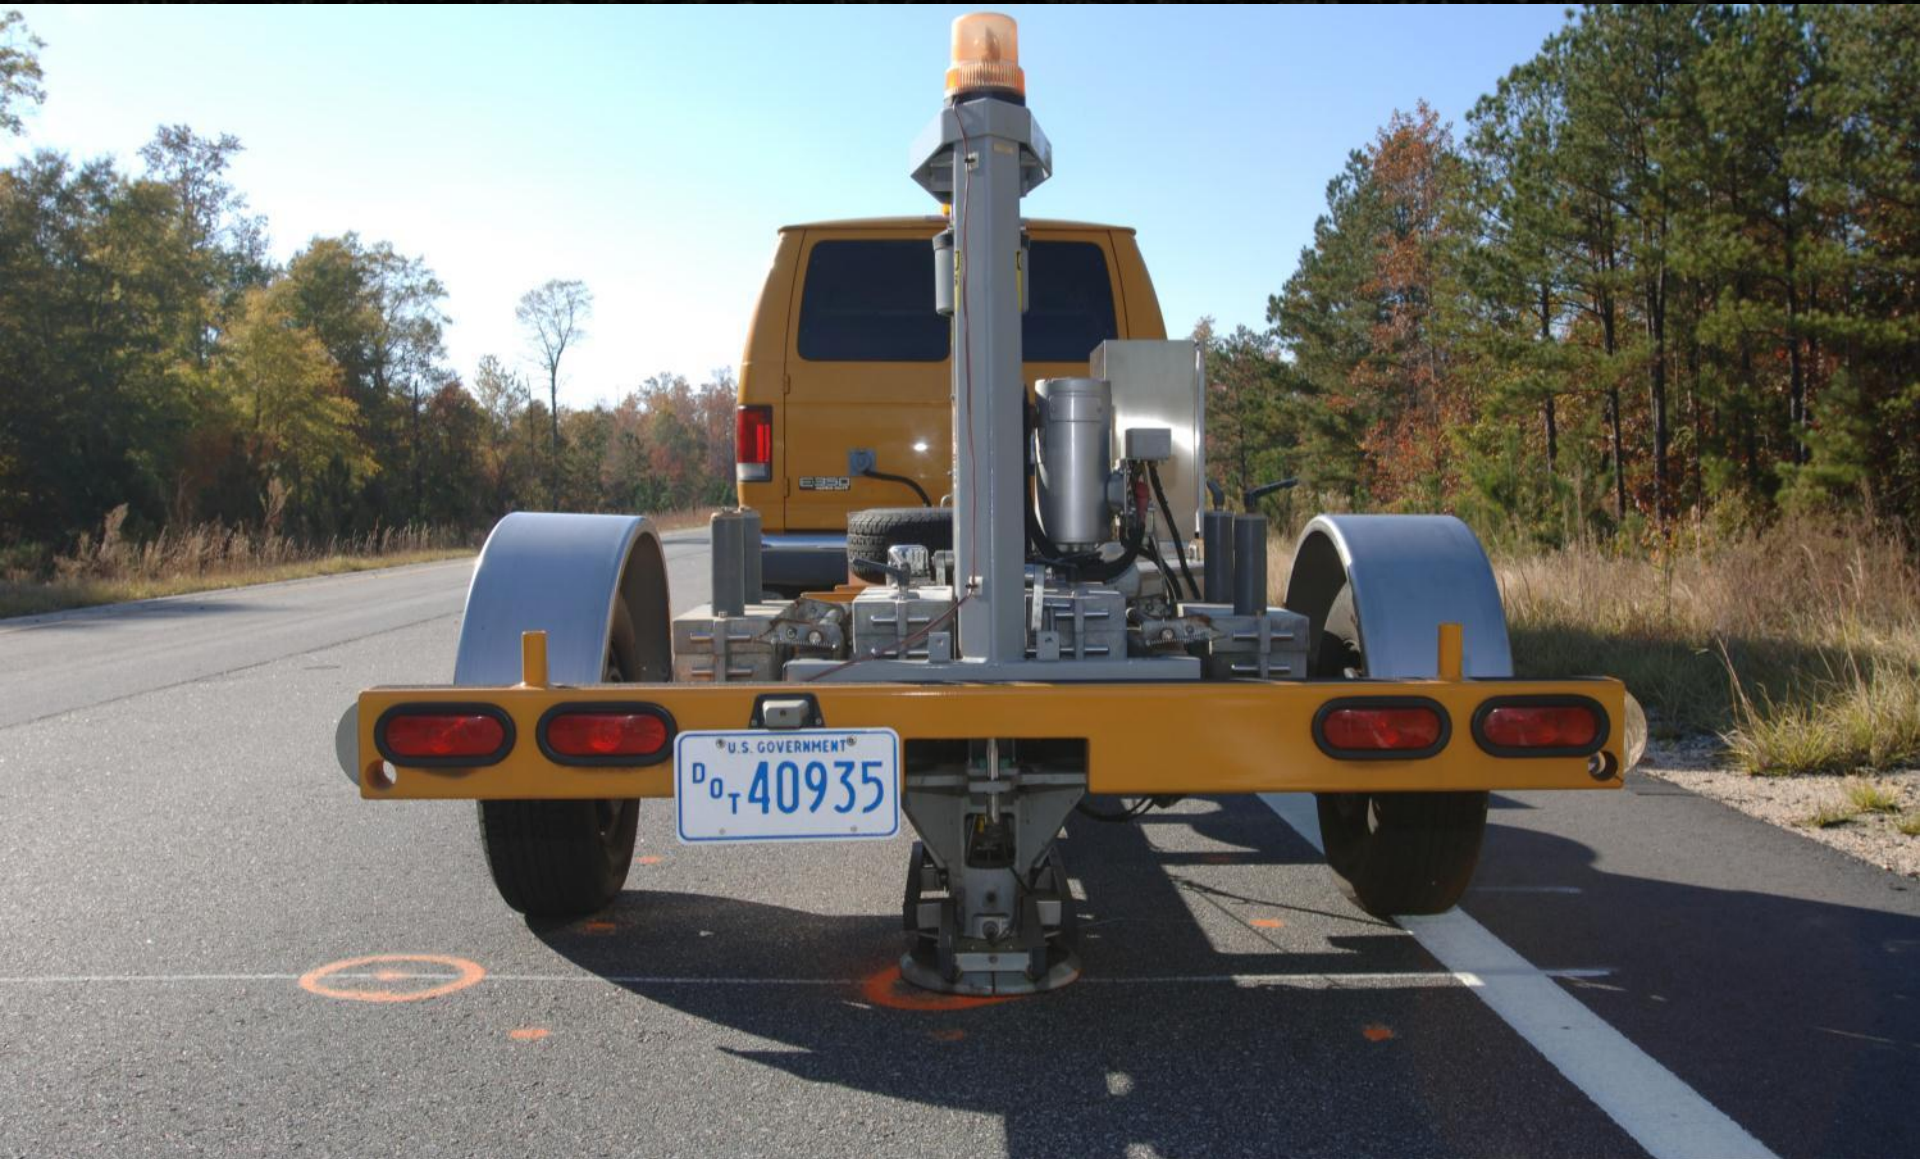
Falling Weight Deflectometer

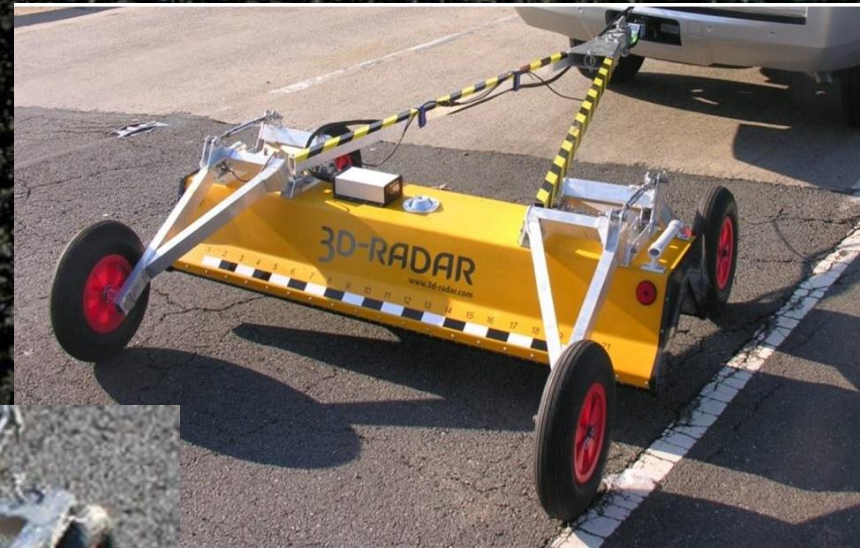
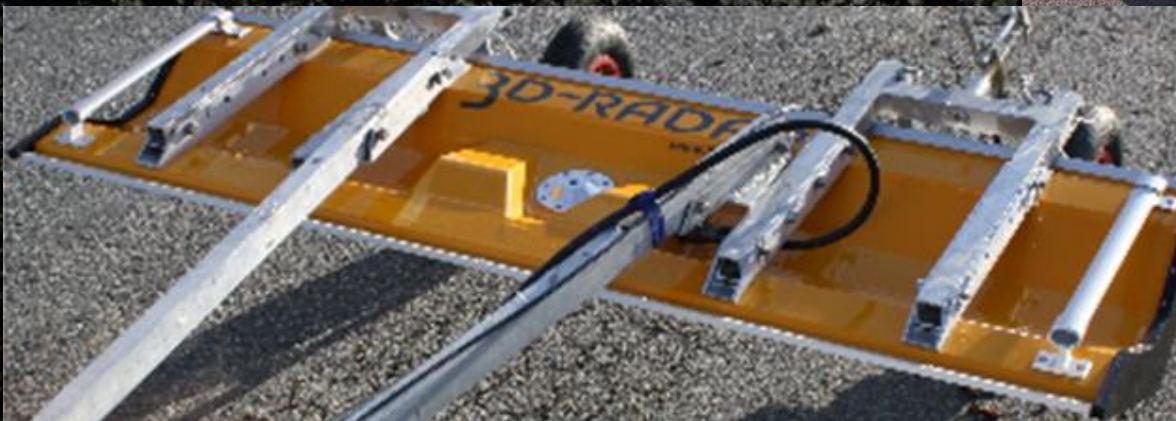
- Ground Penetrating Radar
 - By 3d-Radar
 - Dec. 3, 2012

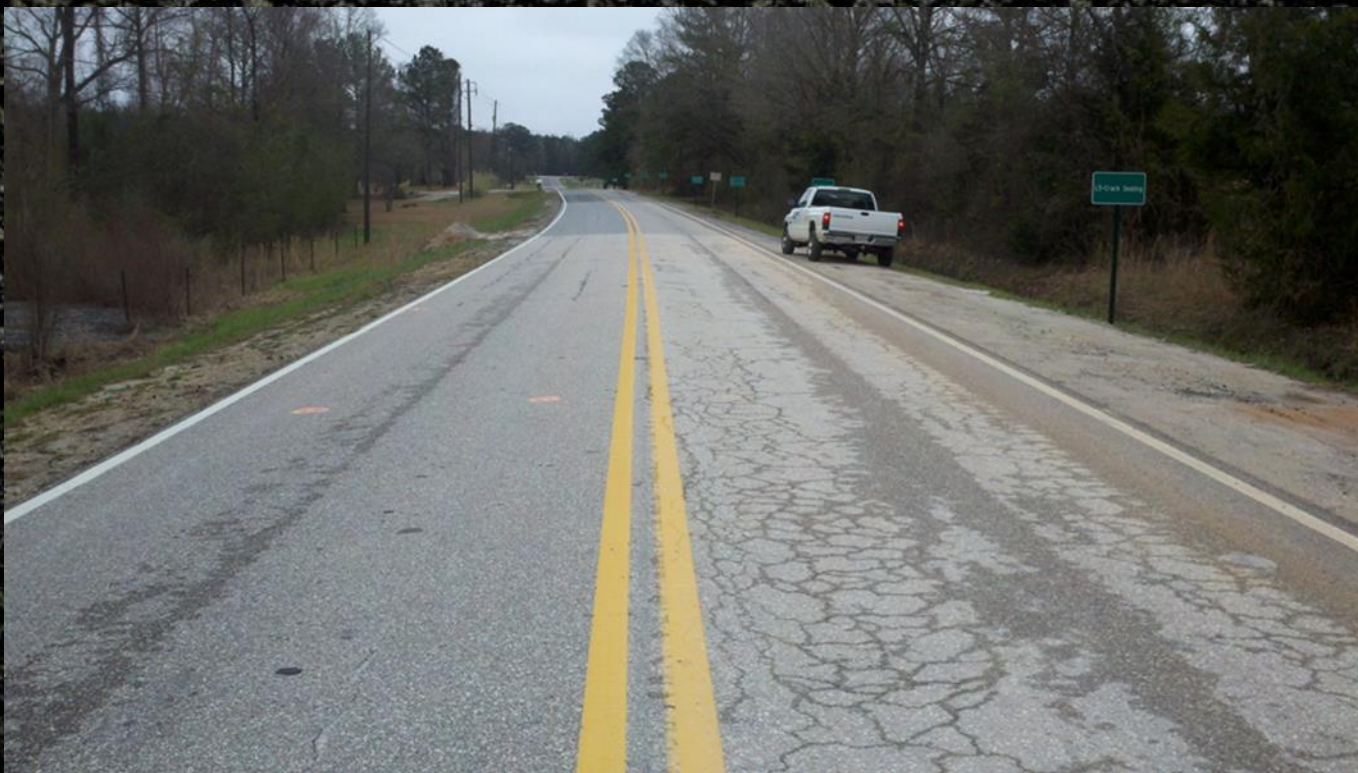
- Progression of cracking in control
