Alaska Department of Transportation & Public Facilities

RMWPPP Anchorage, AK

Jim Horn, PE

October 8, 2013

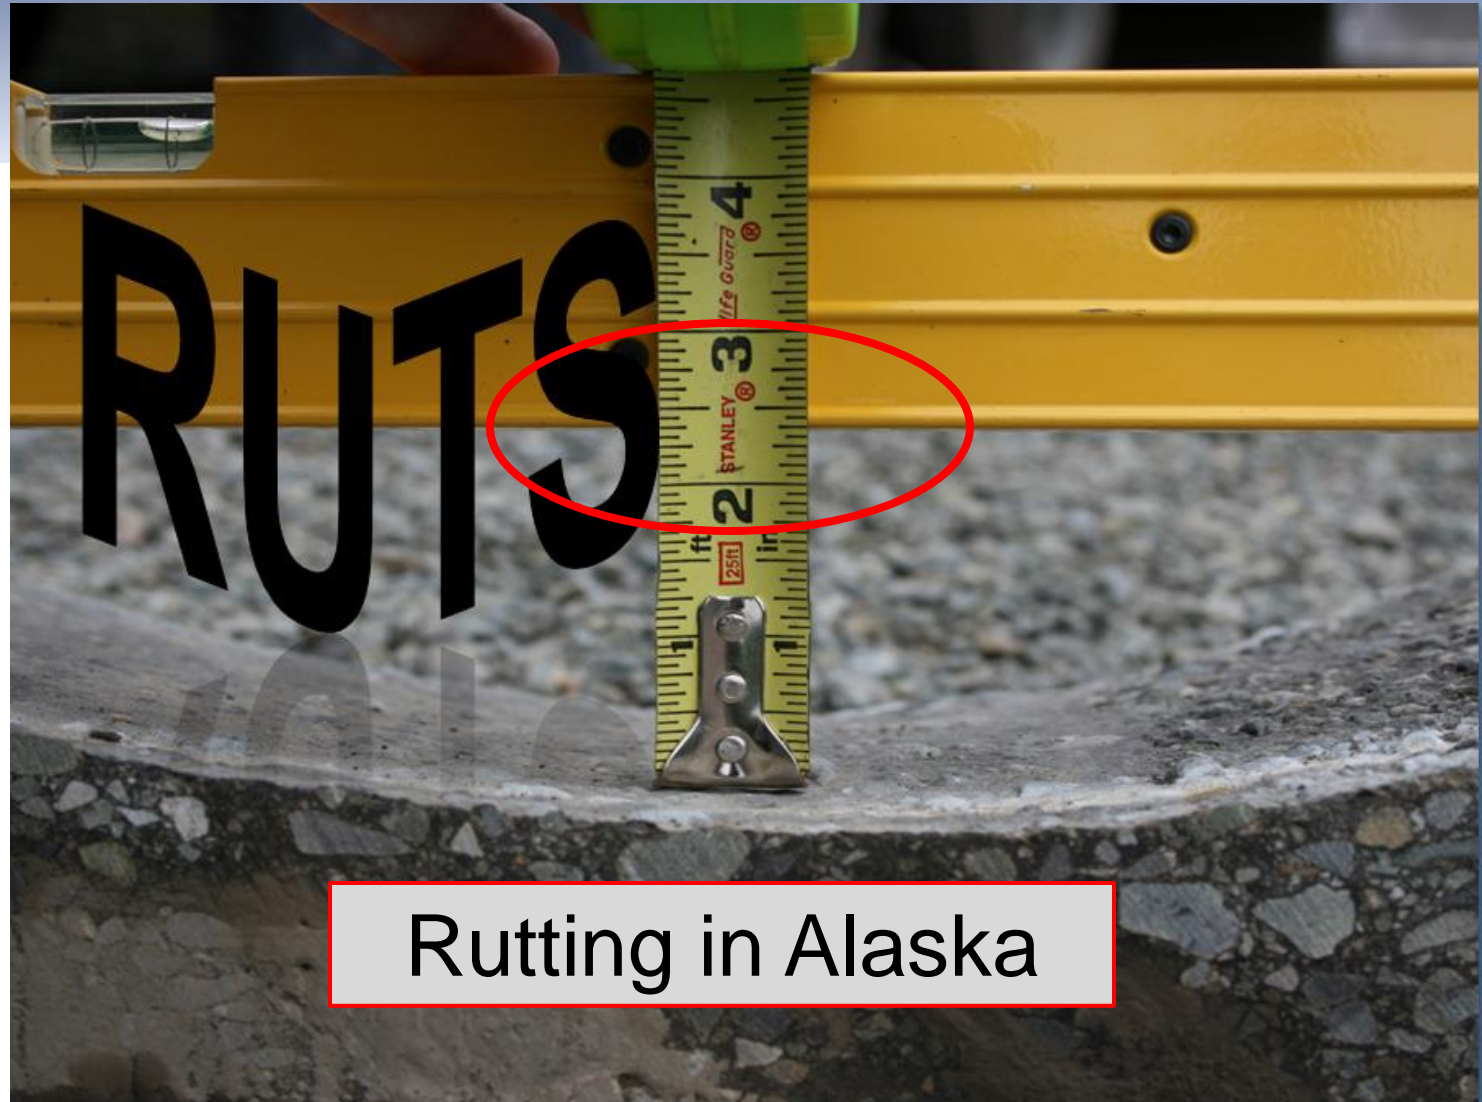
Rutting in Alaska

- Ruts
 - **Plastic deformation** during hot days in summer months (June & July)
 - **Studded tire wear**: Alaska runs studded tires 7.5+ months causing mechanical removal (as much as ¼ inch per year)
- Treatments: Primarily Mill and Fill
- Better Treatments?
