American Traffic Safety Services Association (ATSSA)

High Friction Surfacing

Robert N. Dingess Chair, ATSSA High Friction Surface Working Group

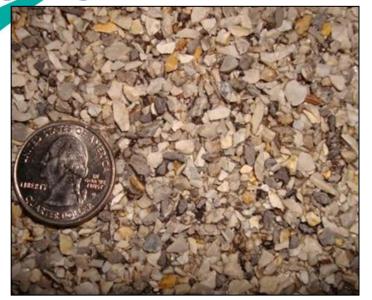
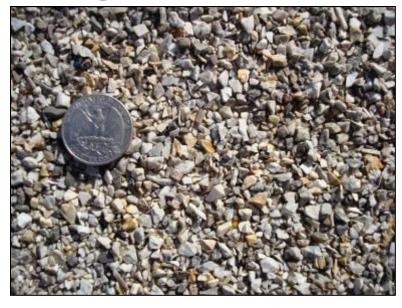
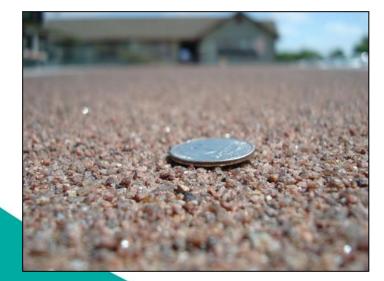
Aggregates That Meet High Friction

Calcined Bauxite

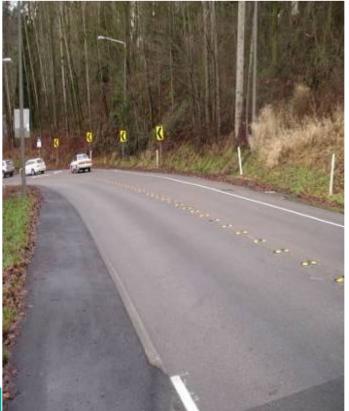
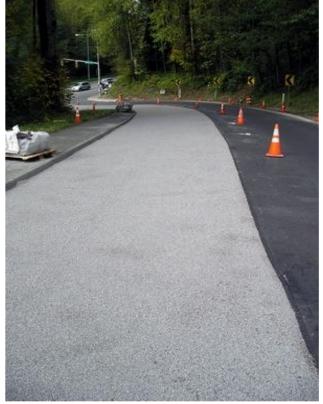
Intersection/Curve: Bellevue, Wash.

Installation of a Microtexture surface on a horizontal curve. Prior to the installation, this location had 45 accidents.

Bellevue, Wash: 45 crashes, four rollovers

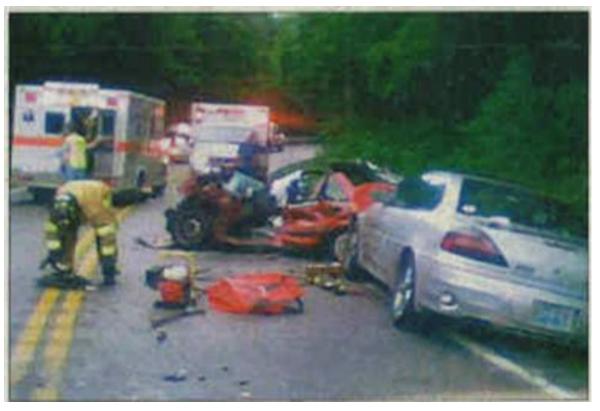
Crews work to clear the roadway after a head-on collision during rush hour Friday on KY- 22 at Bridge Hill. The crash left four people injured. Another crash took place Sunday afternoon.
