Bridge Preservation / Management

Better Assessment in the use of
Bridge Deck Preservation Treatments

By Gregg Freeman
Kwik Bond Polymers
Director of Business Development
May 2013

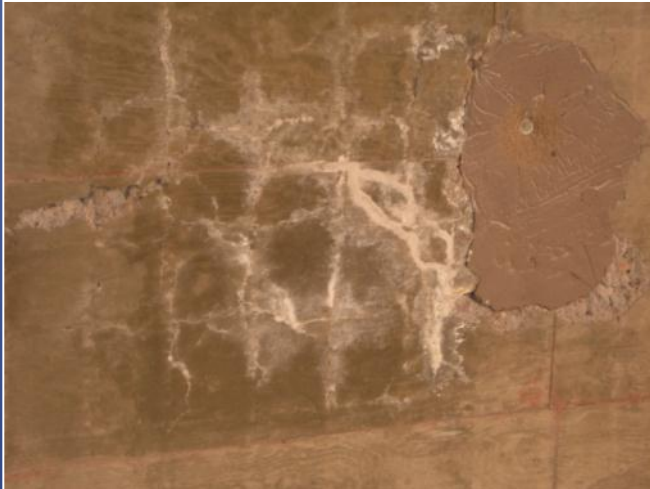
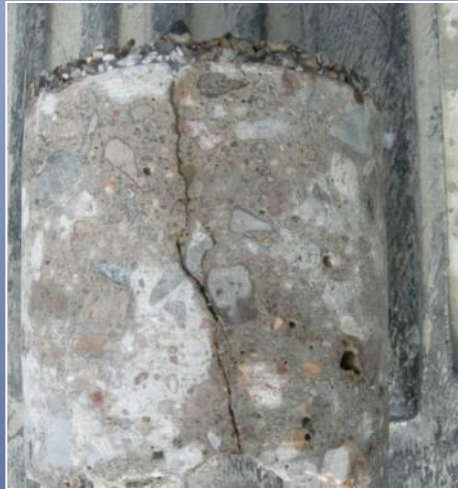
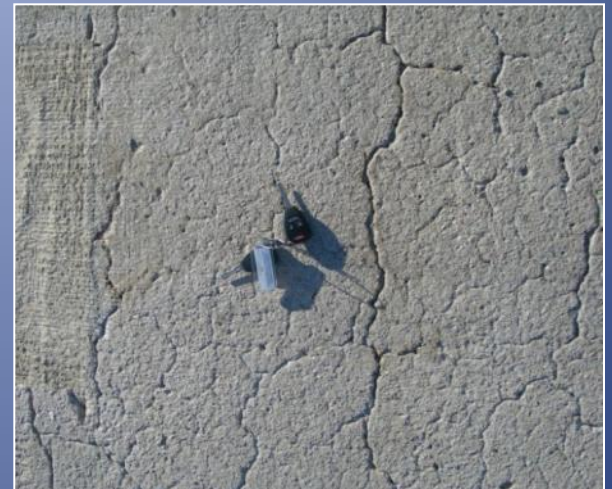
EARLY TRIGGER: Plastic shrinkage, thermal cracking, drying shrinkage etc...

Water, penetrating through these cracks, is the most important substance that is involved in virtually every form of concrete deterioration-freezing-thawing damage, reinforcement corrosion, alkali-aggregate reactions, dissolution, sulfate attack and carbonation (Cody, 1994).

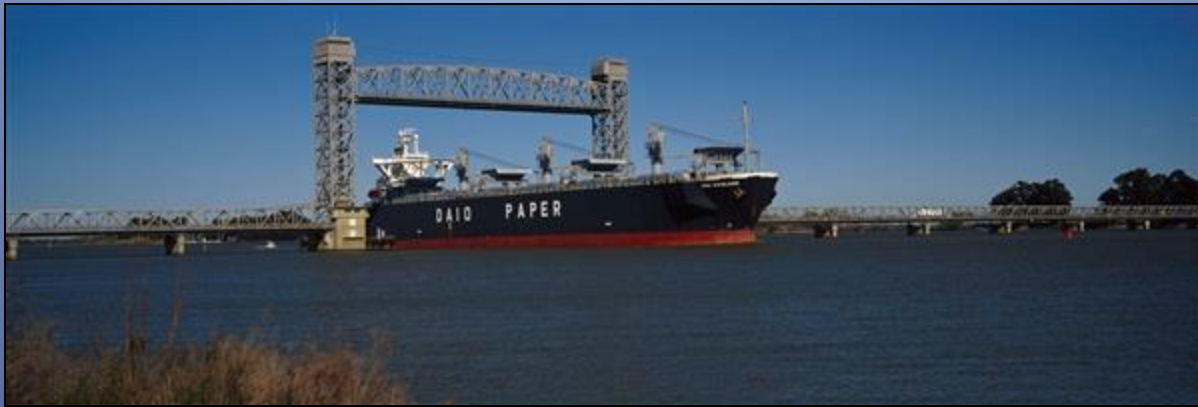
A concrete bridge deck can retain a lot of water?

Early Use of Low Viscosity Healer / Sealer on a Concrete Bridge Deck

1981 – The Rio Vista lift span would gain so much weight when it rained that Caltrans had to adjust the counterweights every rainy season. The cracks in the deck were sealed with a HMWM Monomer, the counterweights have not had to be adjusted since.

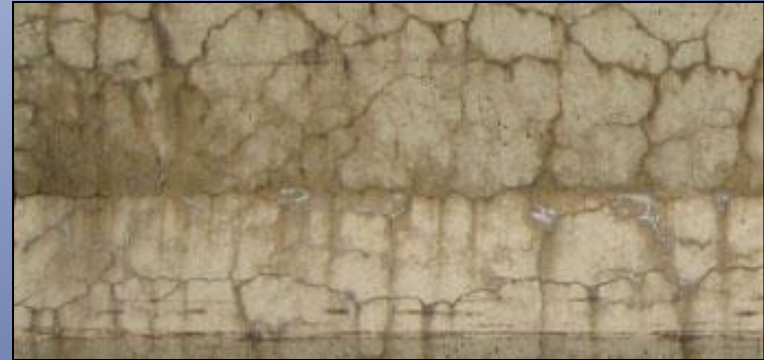
Cracking - caused by Alkali–Silica Reactivity (ASR)
This reaction causes a gel which expands when water is available

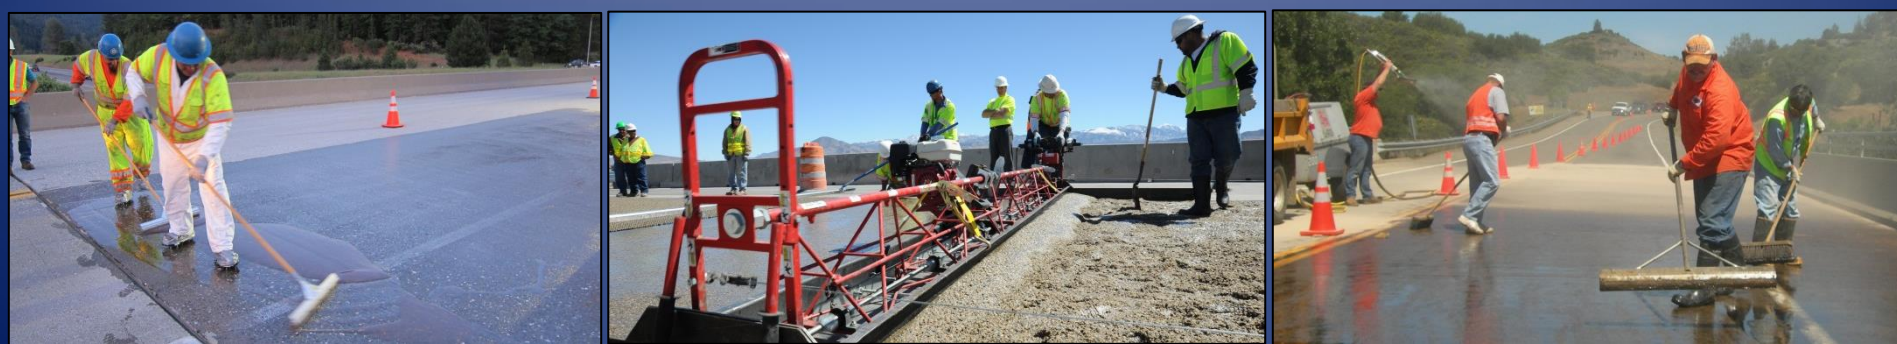
Common Treatments for Bridge Deck Preservation

- Crack Sealing by Flood Coat – Healer/Sealer
 - HMWM, LV Epoxy, MMA, Urethane, etc.
- Thin-Bonded, Multi-Layer, Polymer Overlay
 - Modified Polyester, LM Epoxy, MMA, Urethane, etc.
- Polyester Polymer Concrete – PPC
- Low Slump Concrete, Latex Modified Concrete, Microsilica Concrete

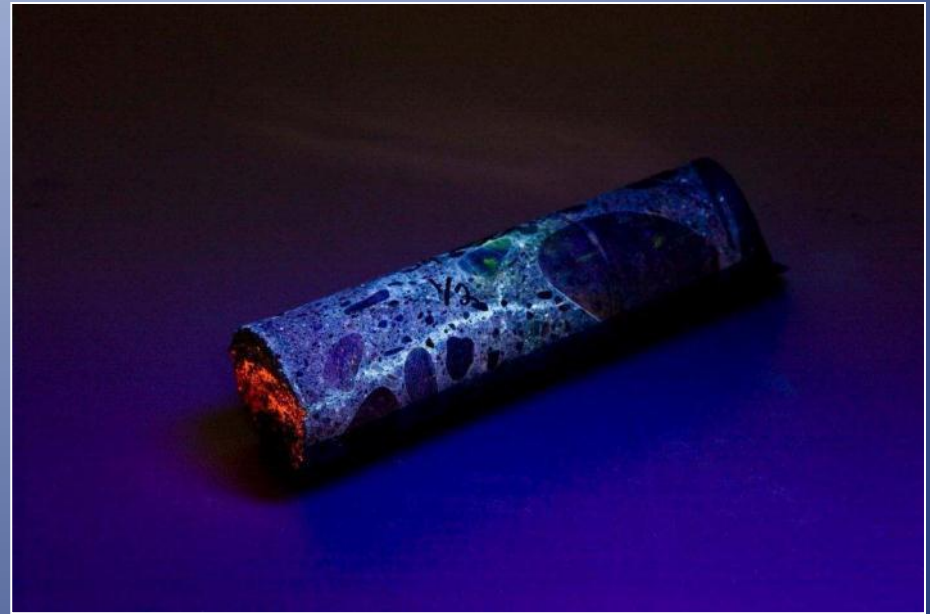
HMWM - Caltrans Concrete Core

American Concrete Institute ACI recommended tolerable crack width for structures exposed to deicing chemicals is 0.007 in. - (ACI) 204 as a trigger for planned maintenance activities.

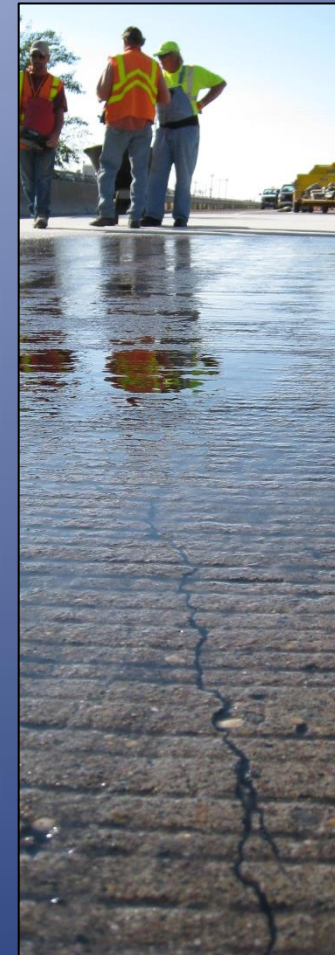
SHRP-S-344

New bridge decks with a 1.75in avg. cover should show signs of chloride-induced corrosion (chloride ion content equals 1lb/yd³ [0.63 kg/m³]) as follows when the average chloride application rate is moderate:

- 13 years when no protection treatment is used
- 25 years when a polymer sealer is maintained
- 77 years when a polymer overlay is maintained

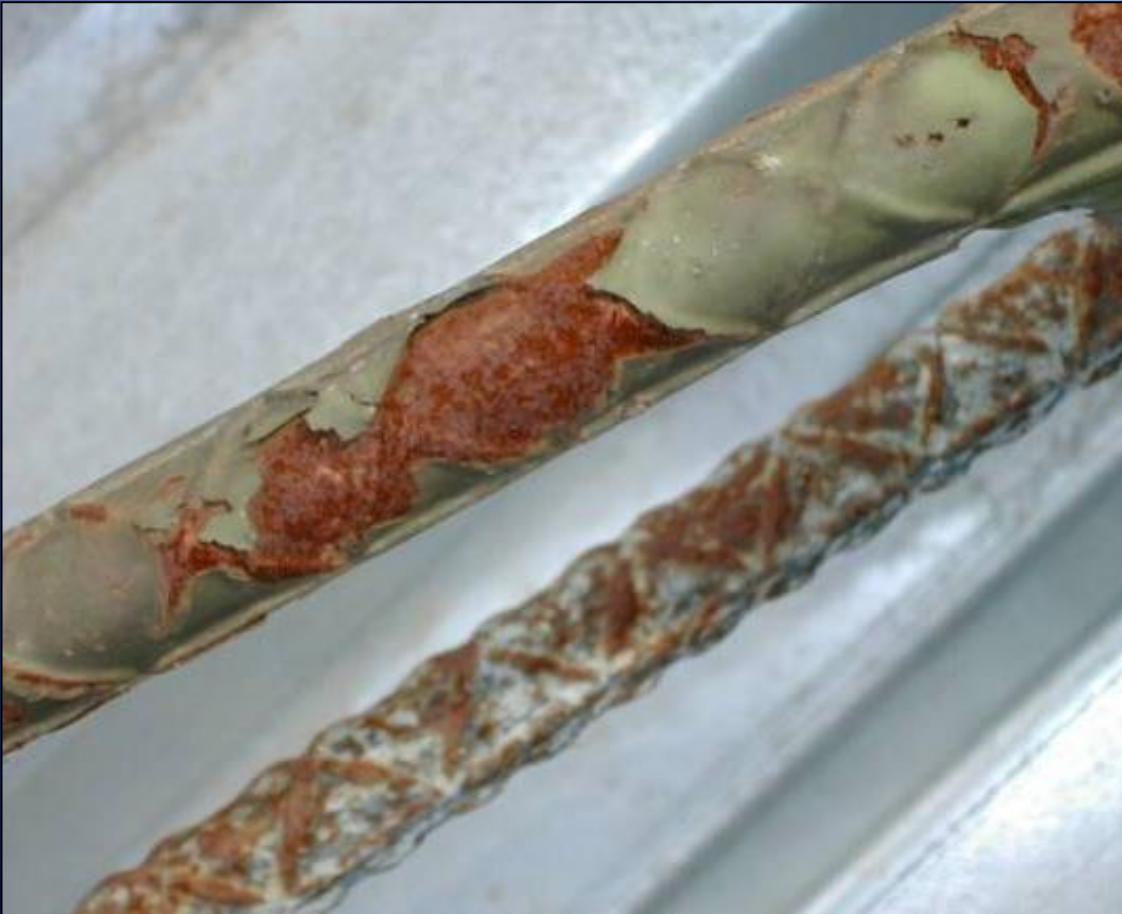
Evaluations of ECR in approximately 250 concrete samples from 18 bridge decks across Virginia indicate that the epoxy coating debonds from the reinforcement in as little as 4 years and long before chlorides arrive at the level of the reinforcement. Assuming a debonded coating will provide for little additional service life, ECR should not be used to extend the service life of bridges in Virginia.

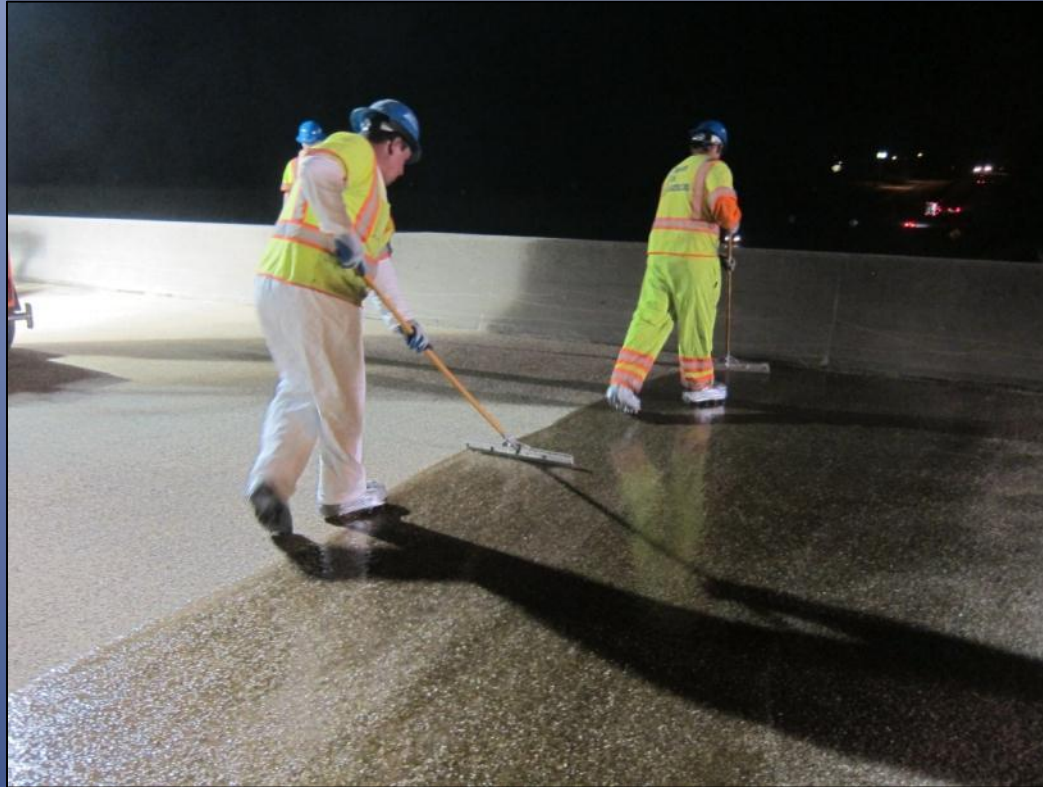
Thin-Bonded, Multi-Layer, Polymer Overlay

Trigger for use: Deck is still in good-excellent condition with <5% spalled, de-bonded or patched, minimal chloride contamination & > 250 psi strength of substrate (deck concrete)

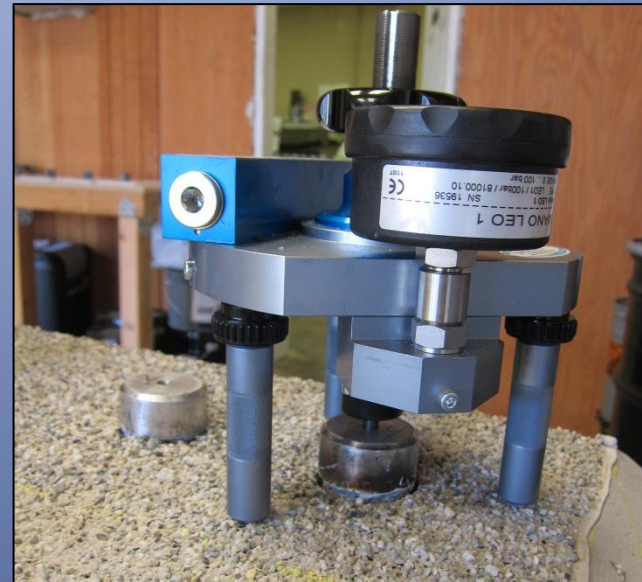
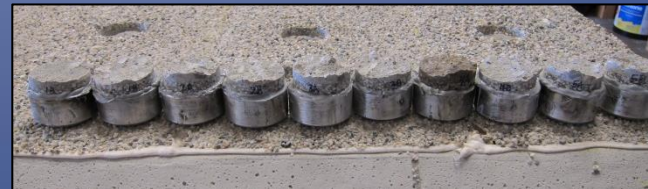
Condition Assessment

Criteria for Thin Bonded Polymer Overlay

- >250psi tensile strength of deck concrete
- <5% of the concrete deck de-bonding from corrosion of steel reinforcing
- Exposure to moisture, de-icing chemicals and freeze/thaw conditions.
- Mild to moderate cracking
- A new bridge deck should have a minimum hydration period of 28 days

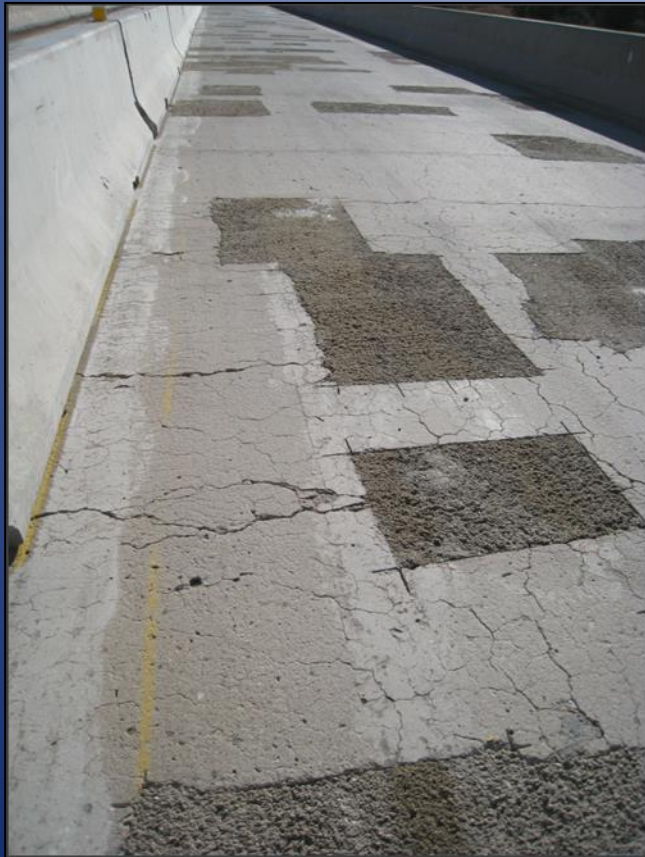
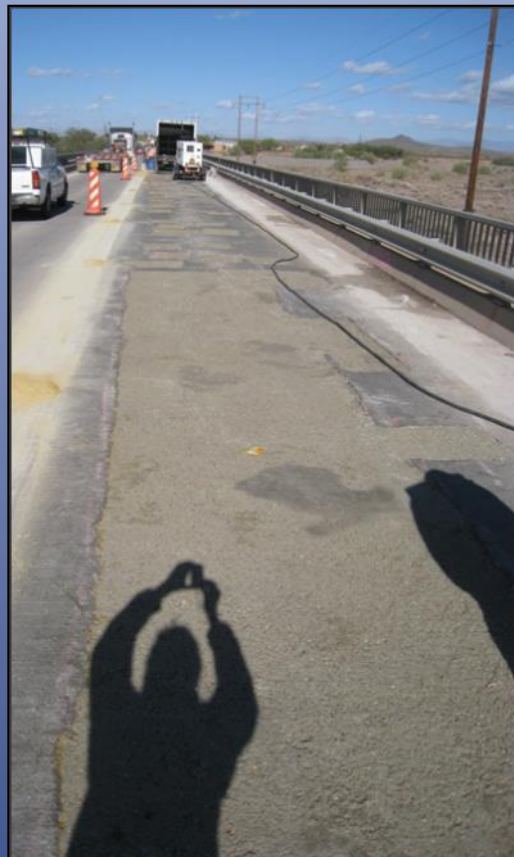
Poor Condition for Thin Polymer (MLS)

Concrete with low tensile strength is a poor substrate for a Thin Polymer MLS.

Shear stresses within a compromised substrate will likely lead to the de-bonding of the thin-bonded overlay system.

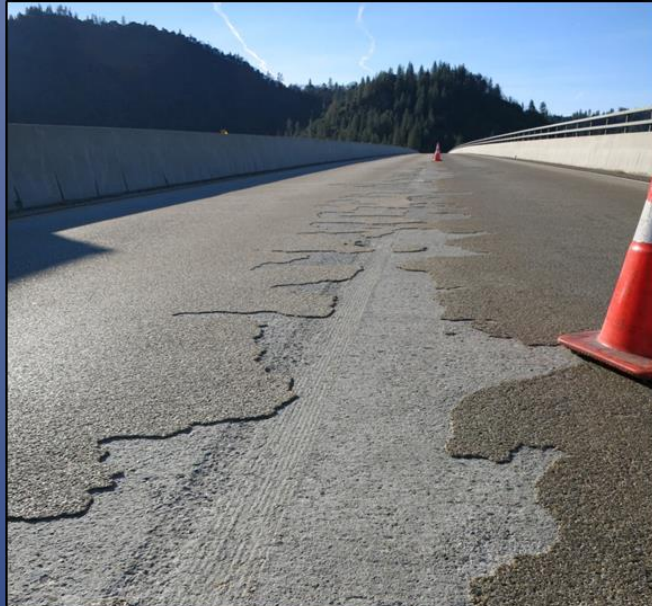
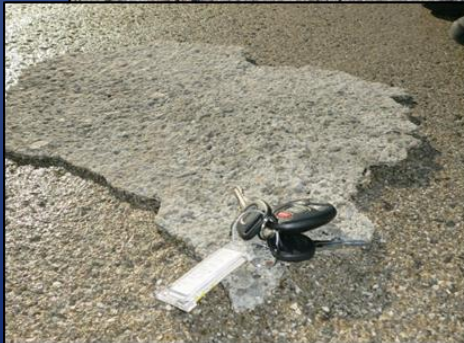
- Thermal incompatibility with deck substrate – de-bonding with concrete attached
- Poor surface preparation-de-bonding without concrete attached
- Poor deck condition – de-bonding with concrete attached (spalling affect)
- Improper mix ratio – tacky material that doesn't reach designed properties

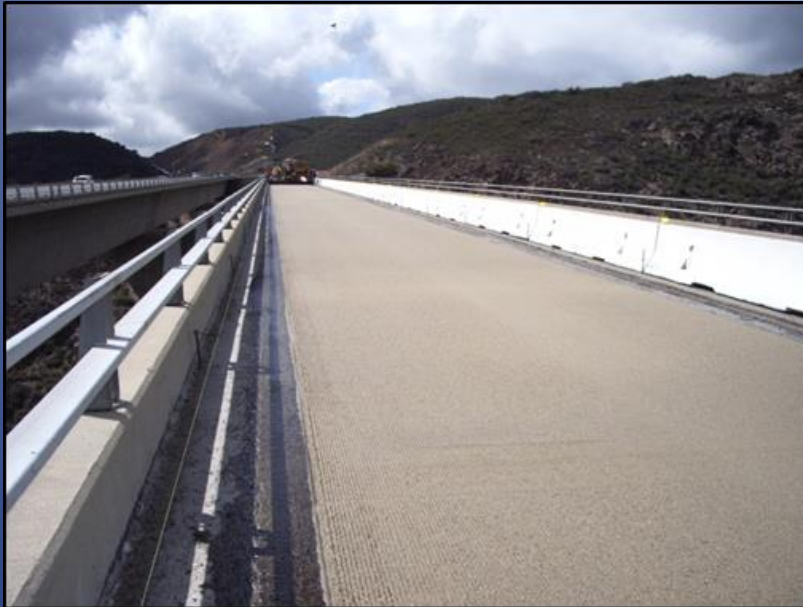
Overlay or Deck Replacement

TRIGGER: PPC, LMC, MSC, Low Slump, Rapid Set Overlay

Overlay General Guidelines

- 2%-35% Visual Deck Distress
- Consider critically chloride-contaminated concrete [chloride ion content at the reinforcing bar of 1 lb./yd.³ (0.6 kg/m²) or more, or more half-cell potential of -0.250 V (CSE) or less] should be removed prior to placing a bridge deck treatment”
- Sound substrate under repairs
- Mild to moderate cracking
- Deck surface / ride problems
- Highly permeable concrete deck concrete
