Middle Aged Deck Preservation

When to overlay or replace?

By Bruce Thill

Washington State DOT (WSDOT)

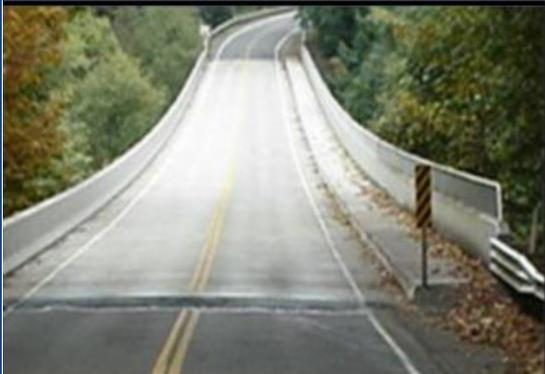
Condition State 1
Good

Deck & Overlay

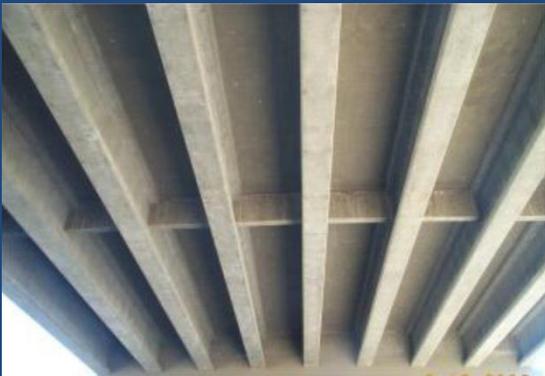
Condition State 1
Good

Soffit

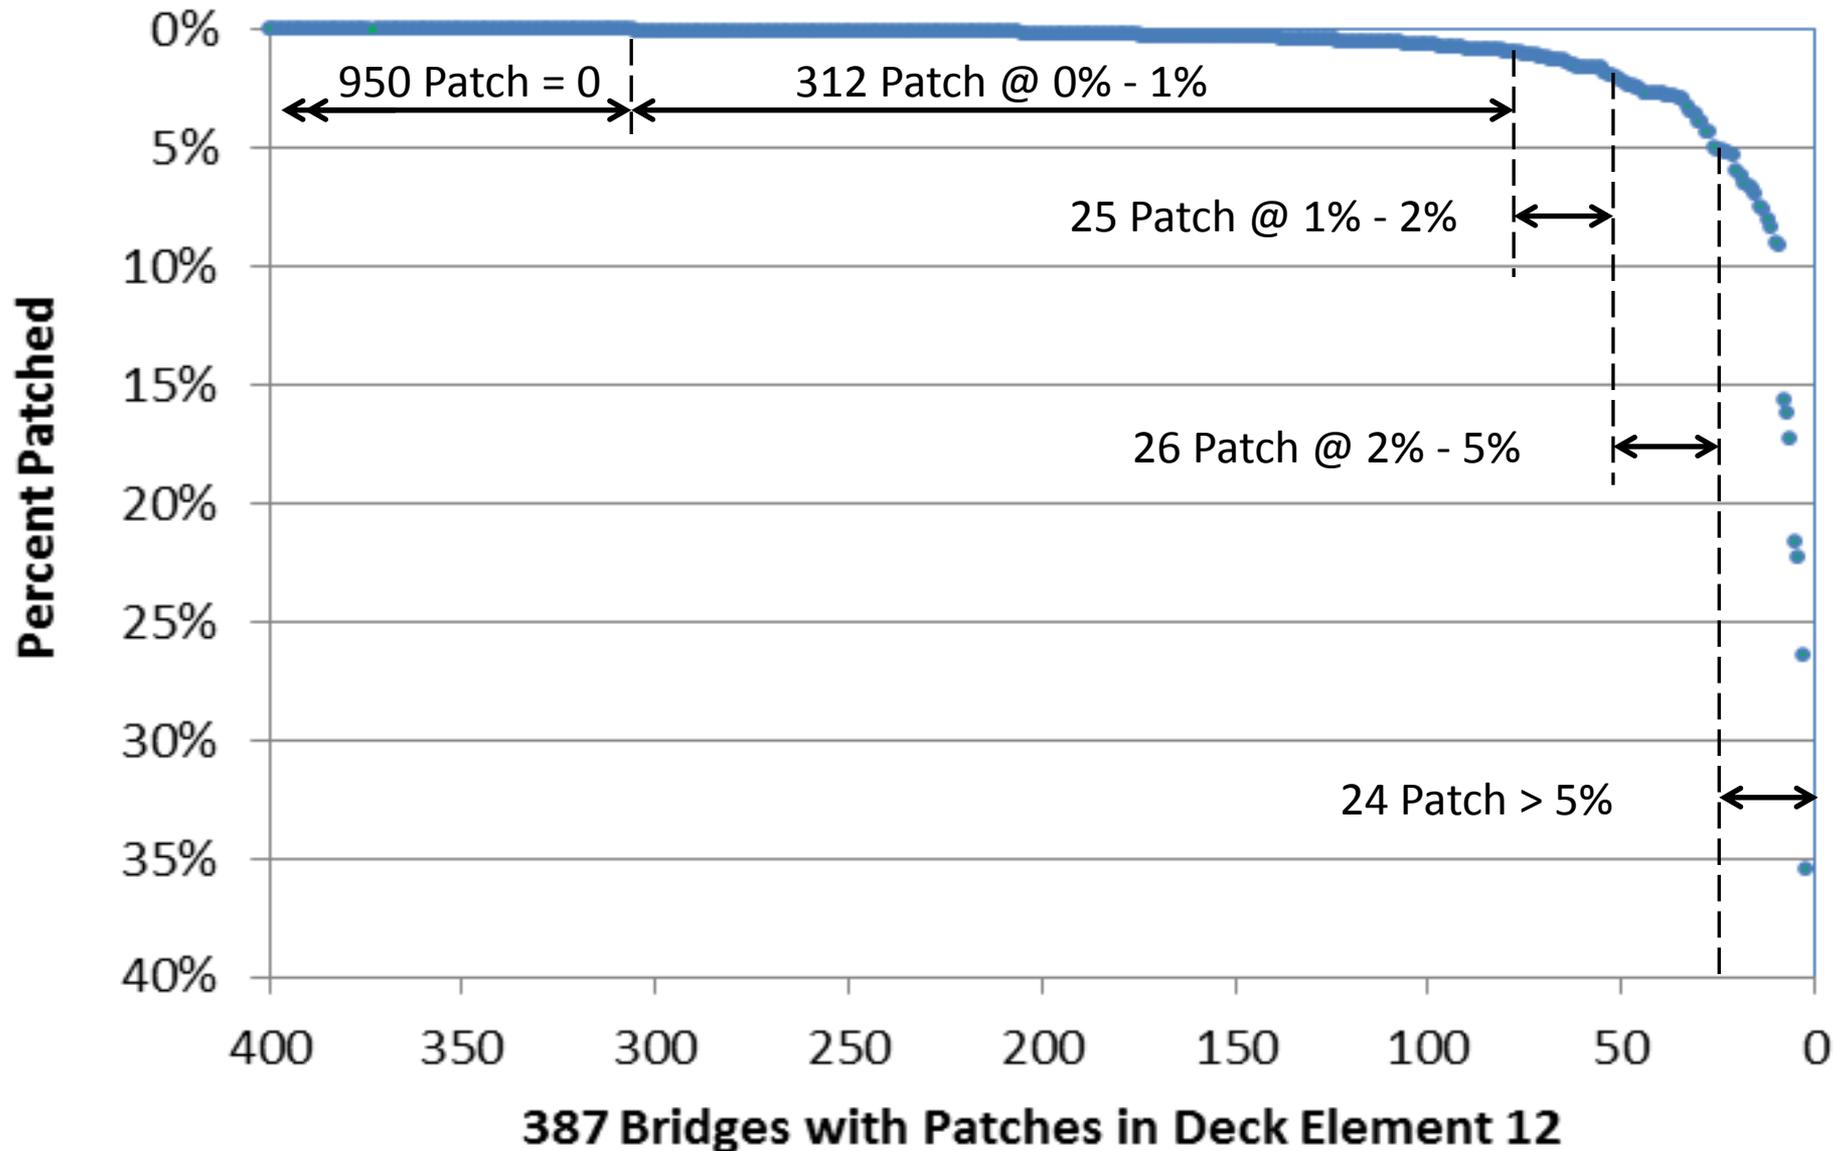
Distribution of CS2 -Top 400

Deck Condition Summary

312 brgs @ 0% - 1%

25 brgs @ 1% - 2%

26 brgs @ 2% - 5%

24 brgs > 5%

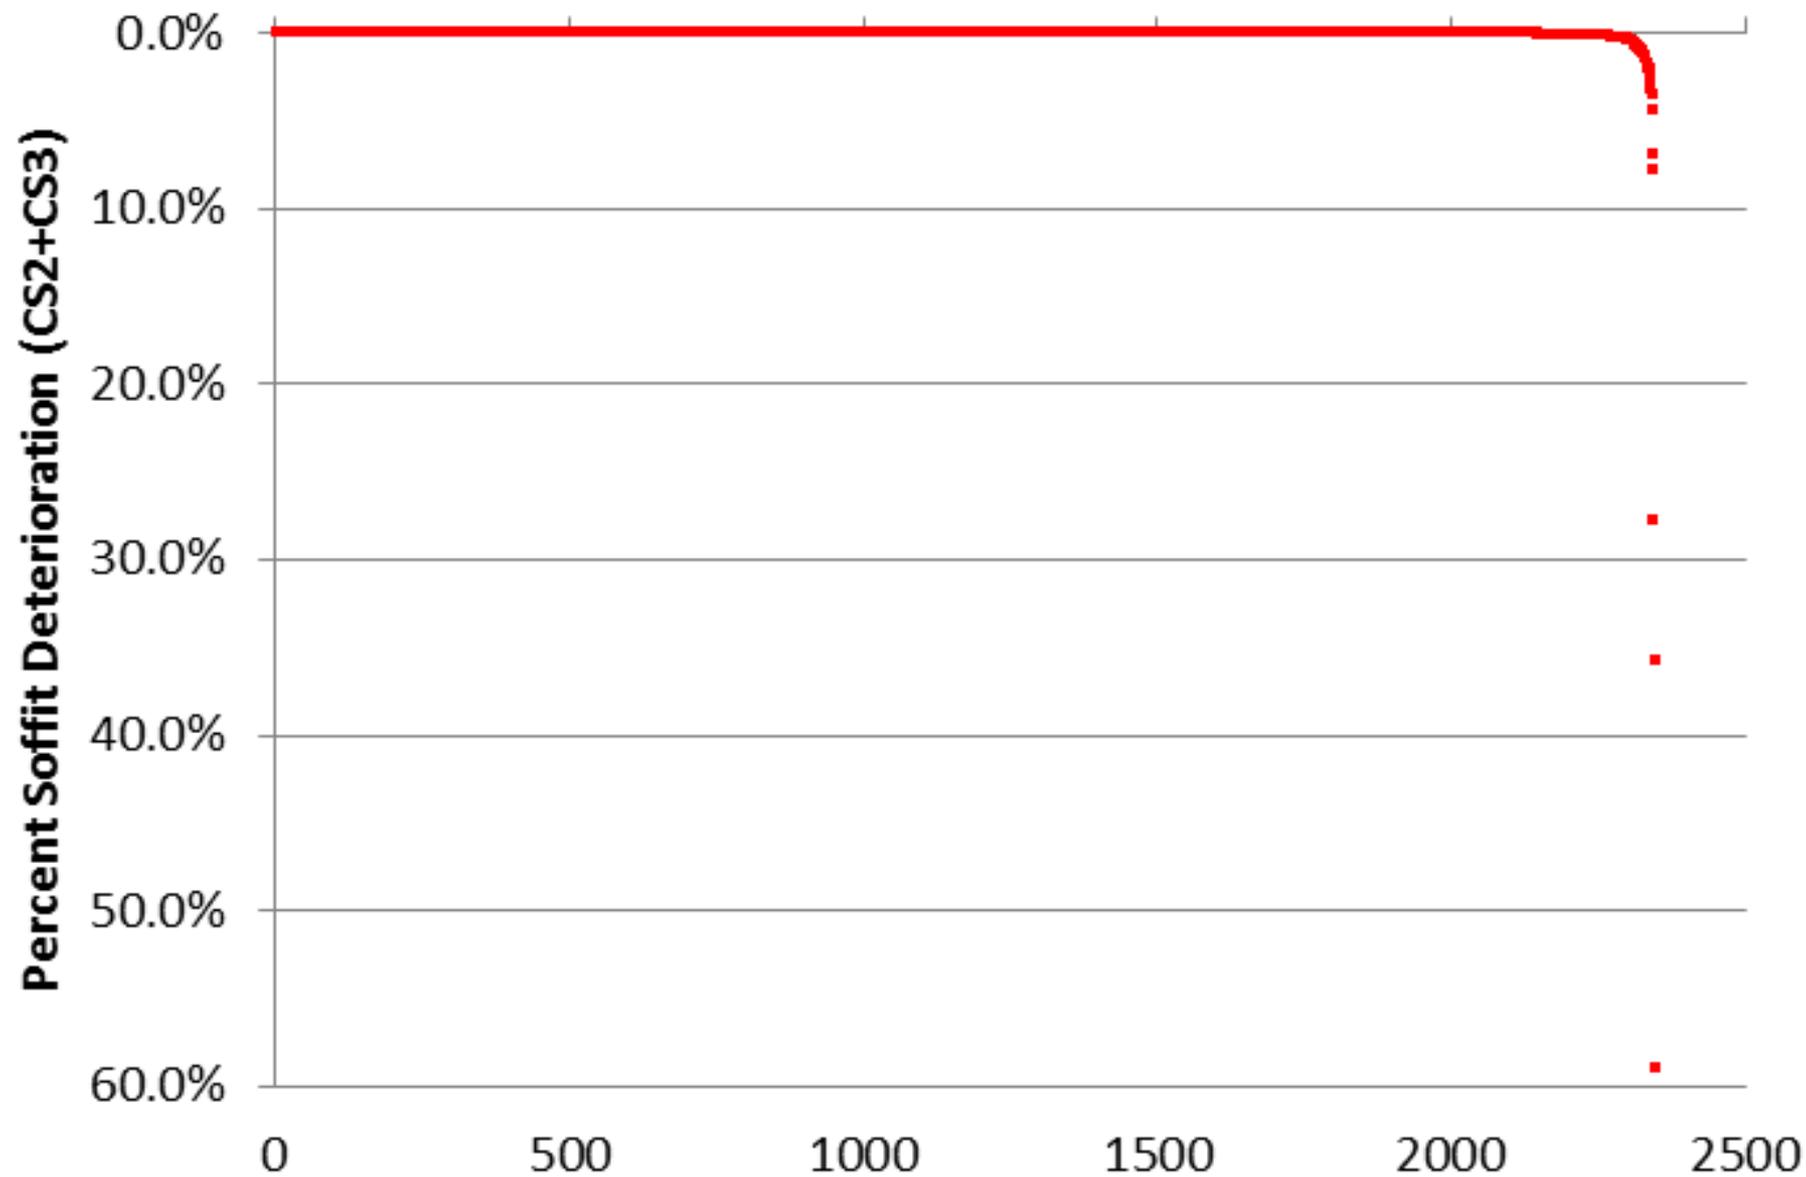
Distribution of Soffit - 2349 brgs

WSDOT Soffit Element Summaries

39.9 MSF
(99.94%)
1705 brgs
73%

10,362 SF
(0.03%)
16 brgs > 2%

12,464 SF
(0.03%)
13 brgs >2%

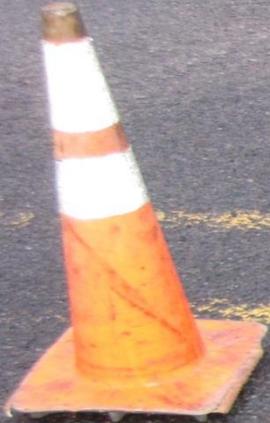
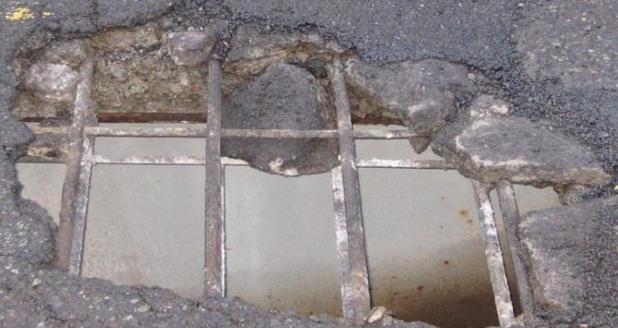
12/309 Deck Repair – 5 SF?

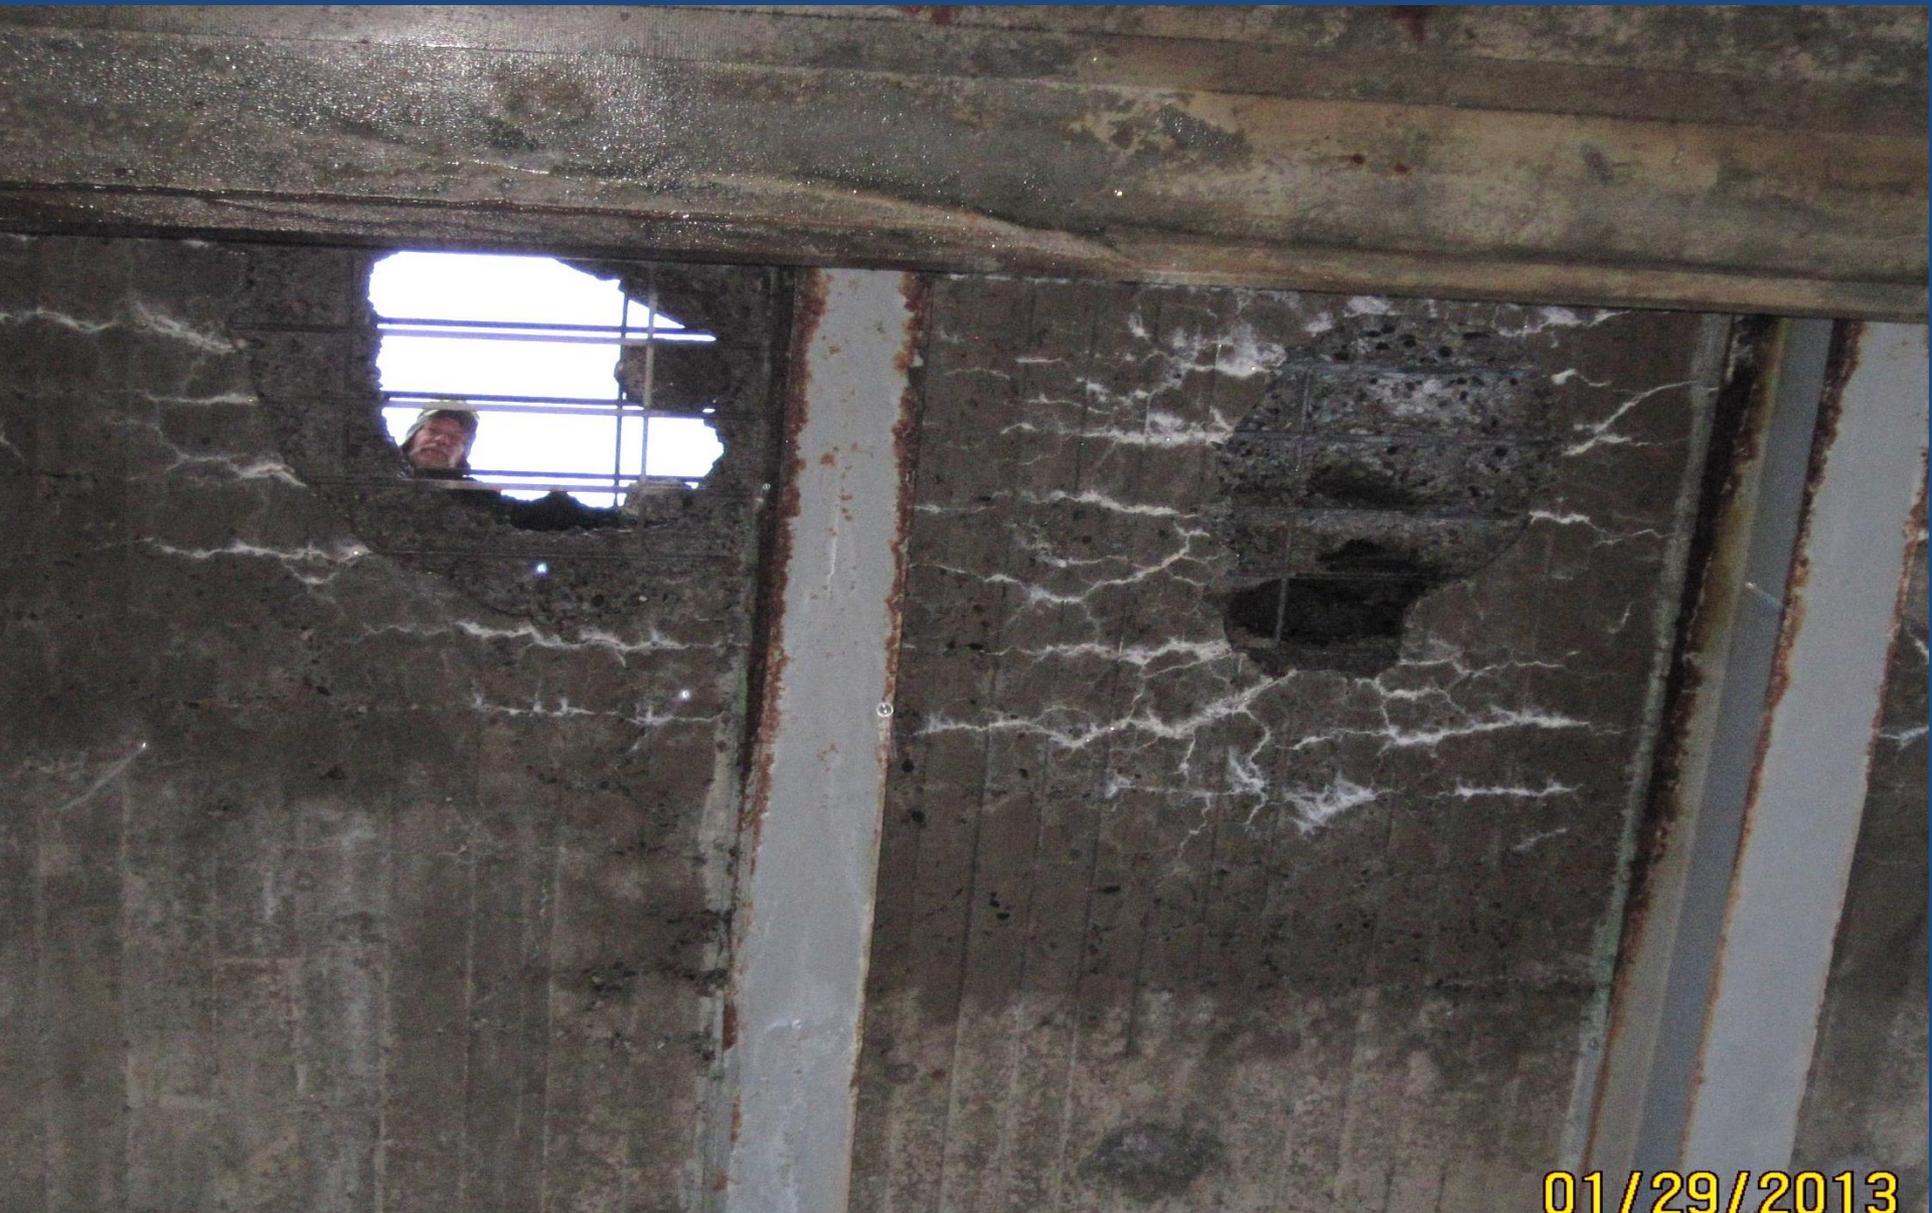
Soffit – CS2=10 SF, CS3=70 SF

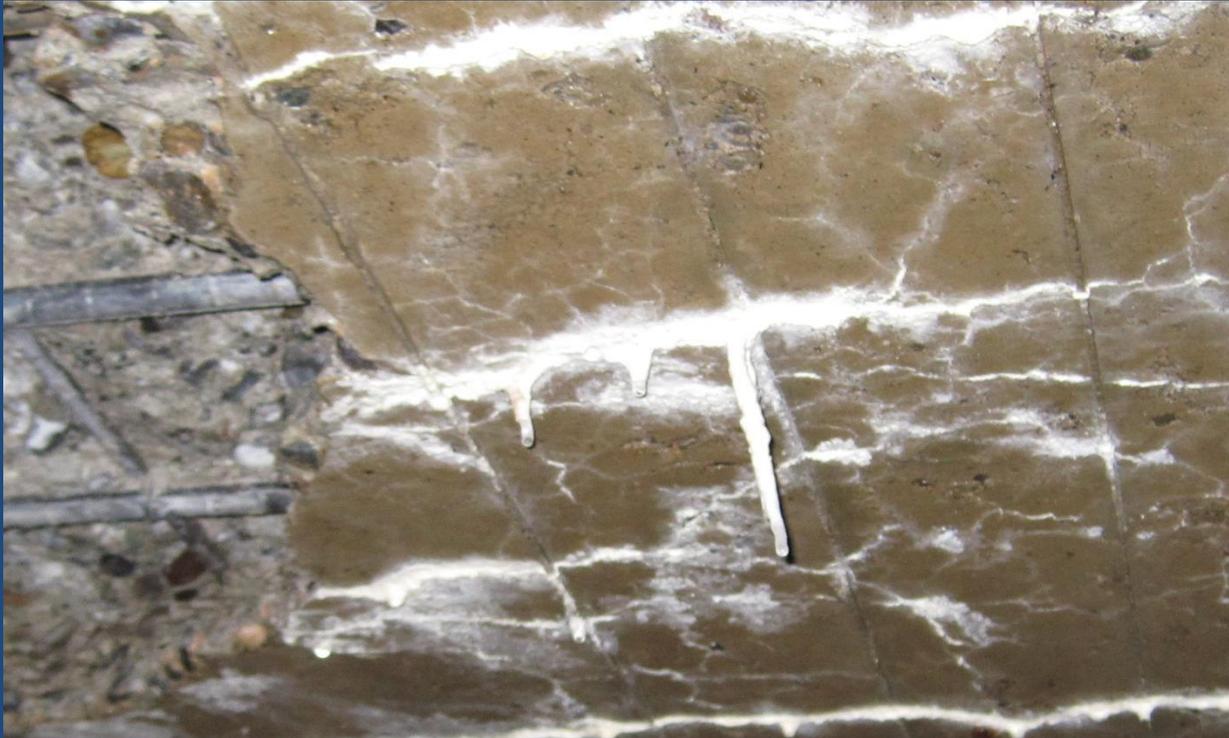
Soffit Stalactites & Rebar

- White stalactites are salts from the top.
- Not calcium from the concrete matrix.
- Brown = rust, asphalt or dirt.

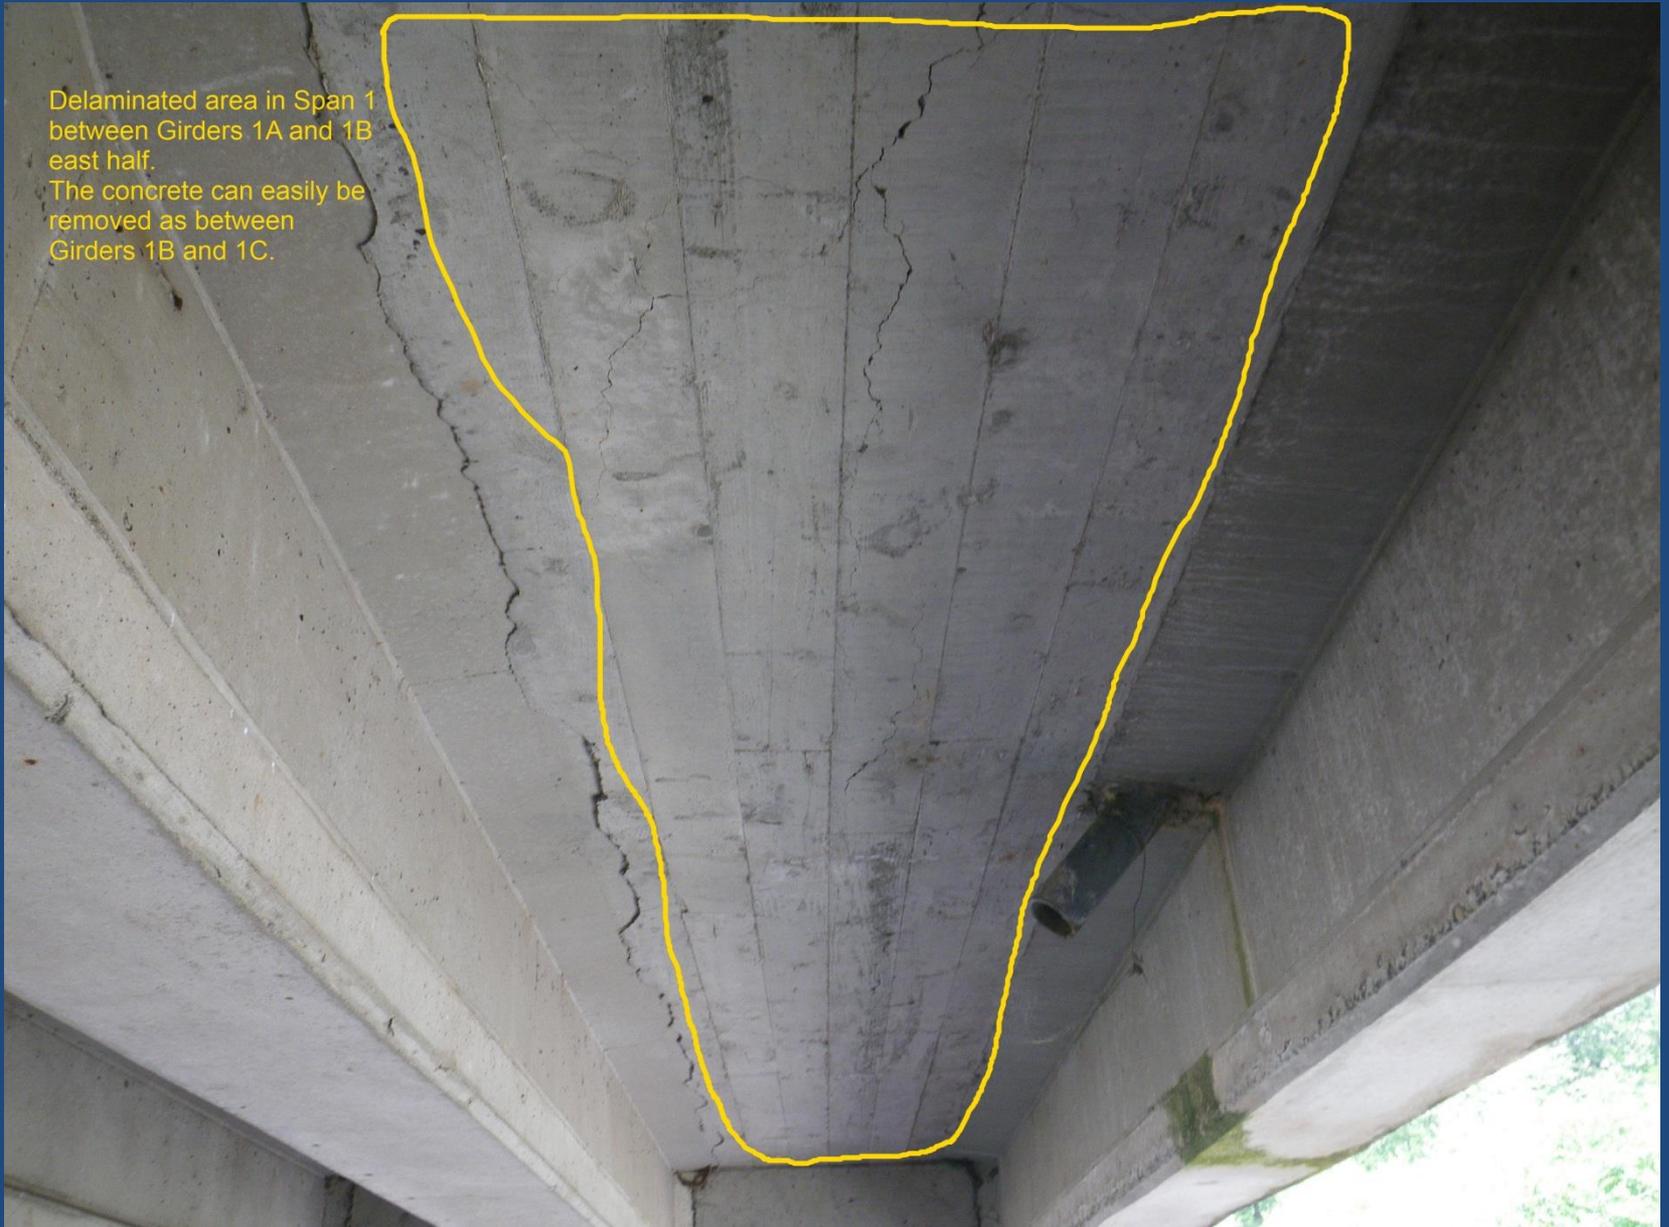
Structural Problem in Soffit?

Delaminated area in Span 1
between Girders 1A and 1B
east half.
The concrete can easily be
removed as between
Girders 1B and 1C.

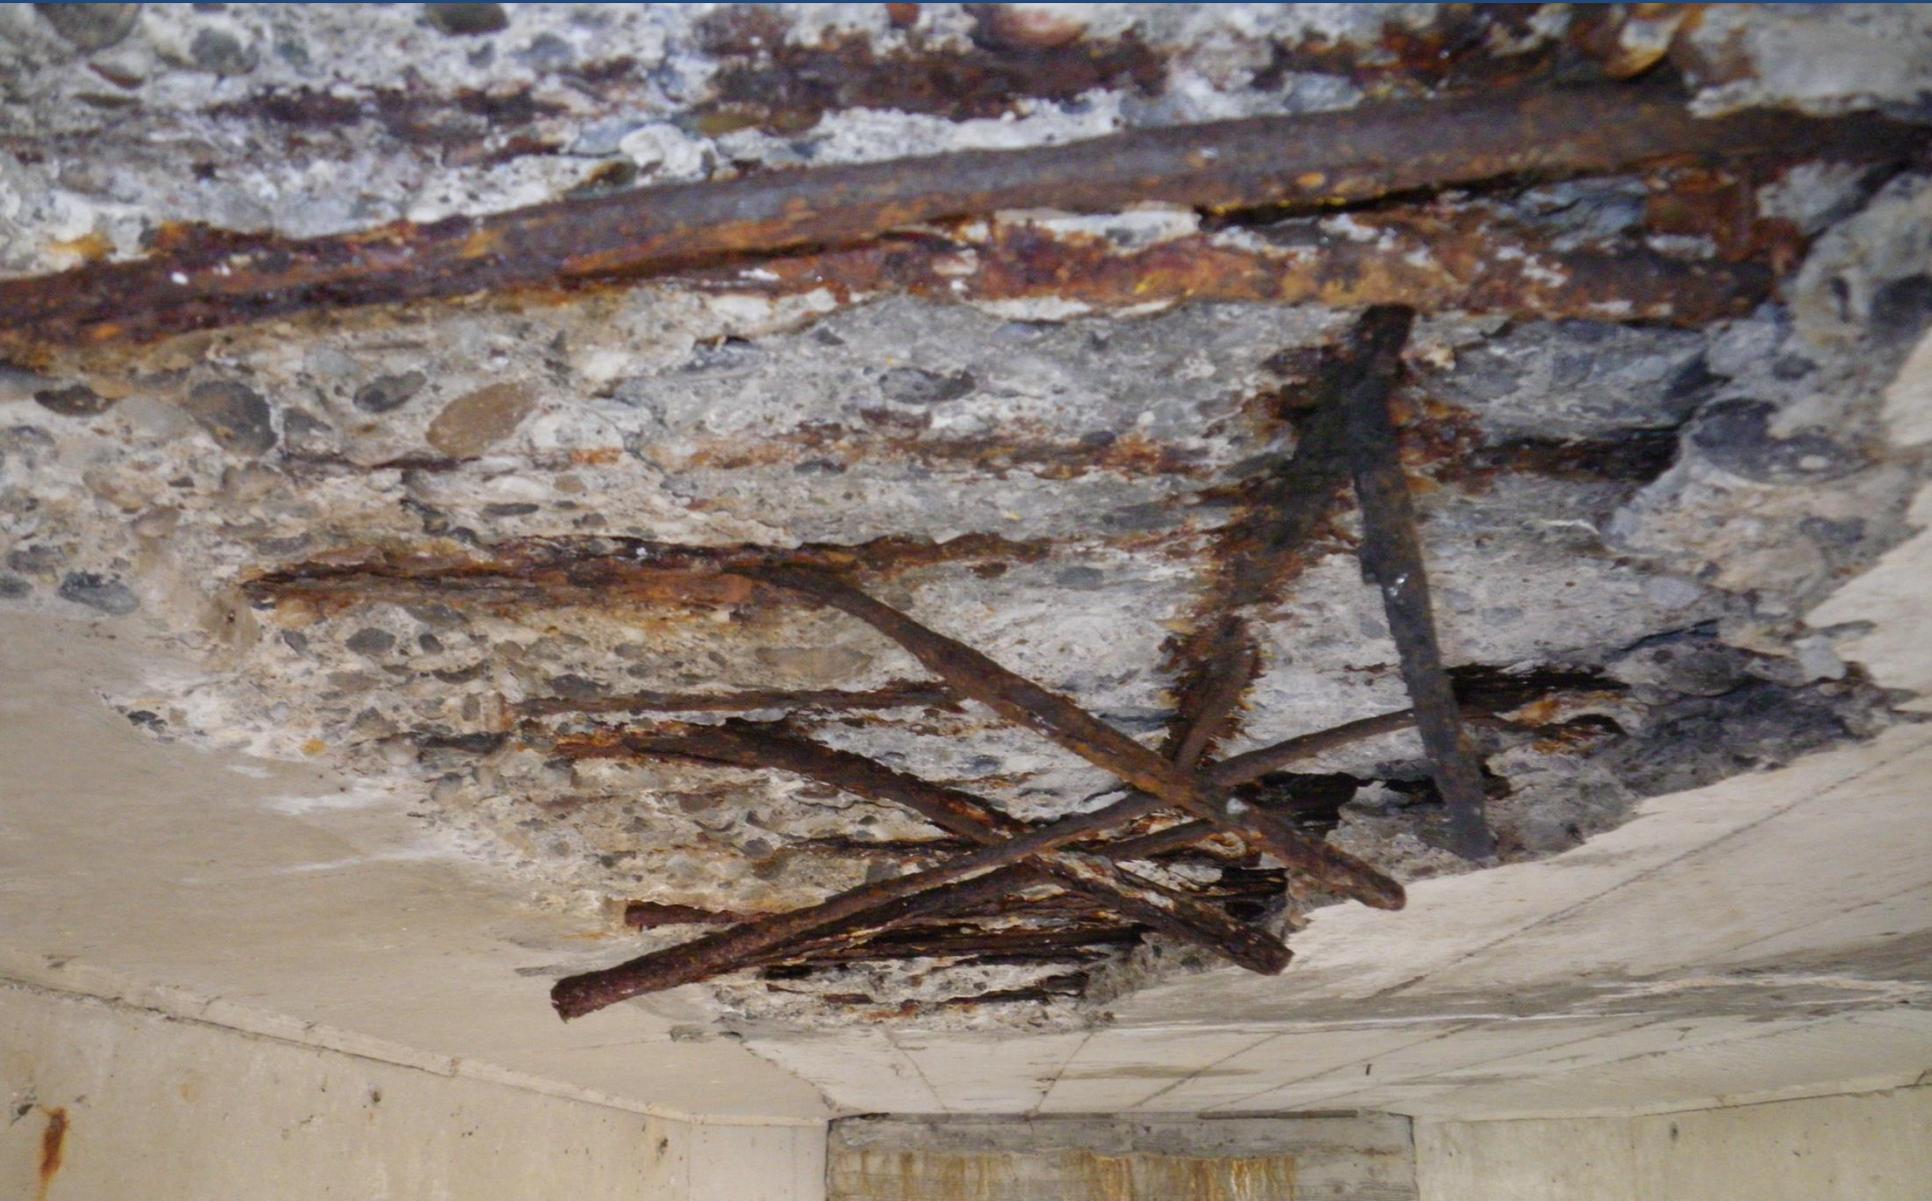
Exposed with little effort

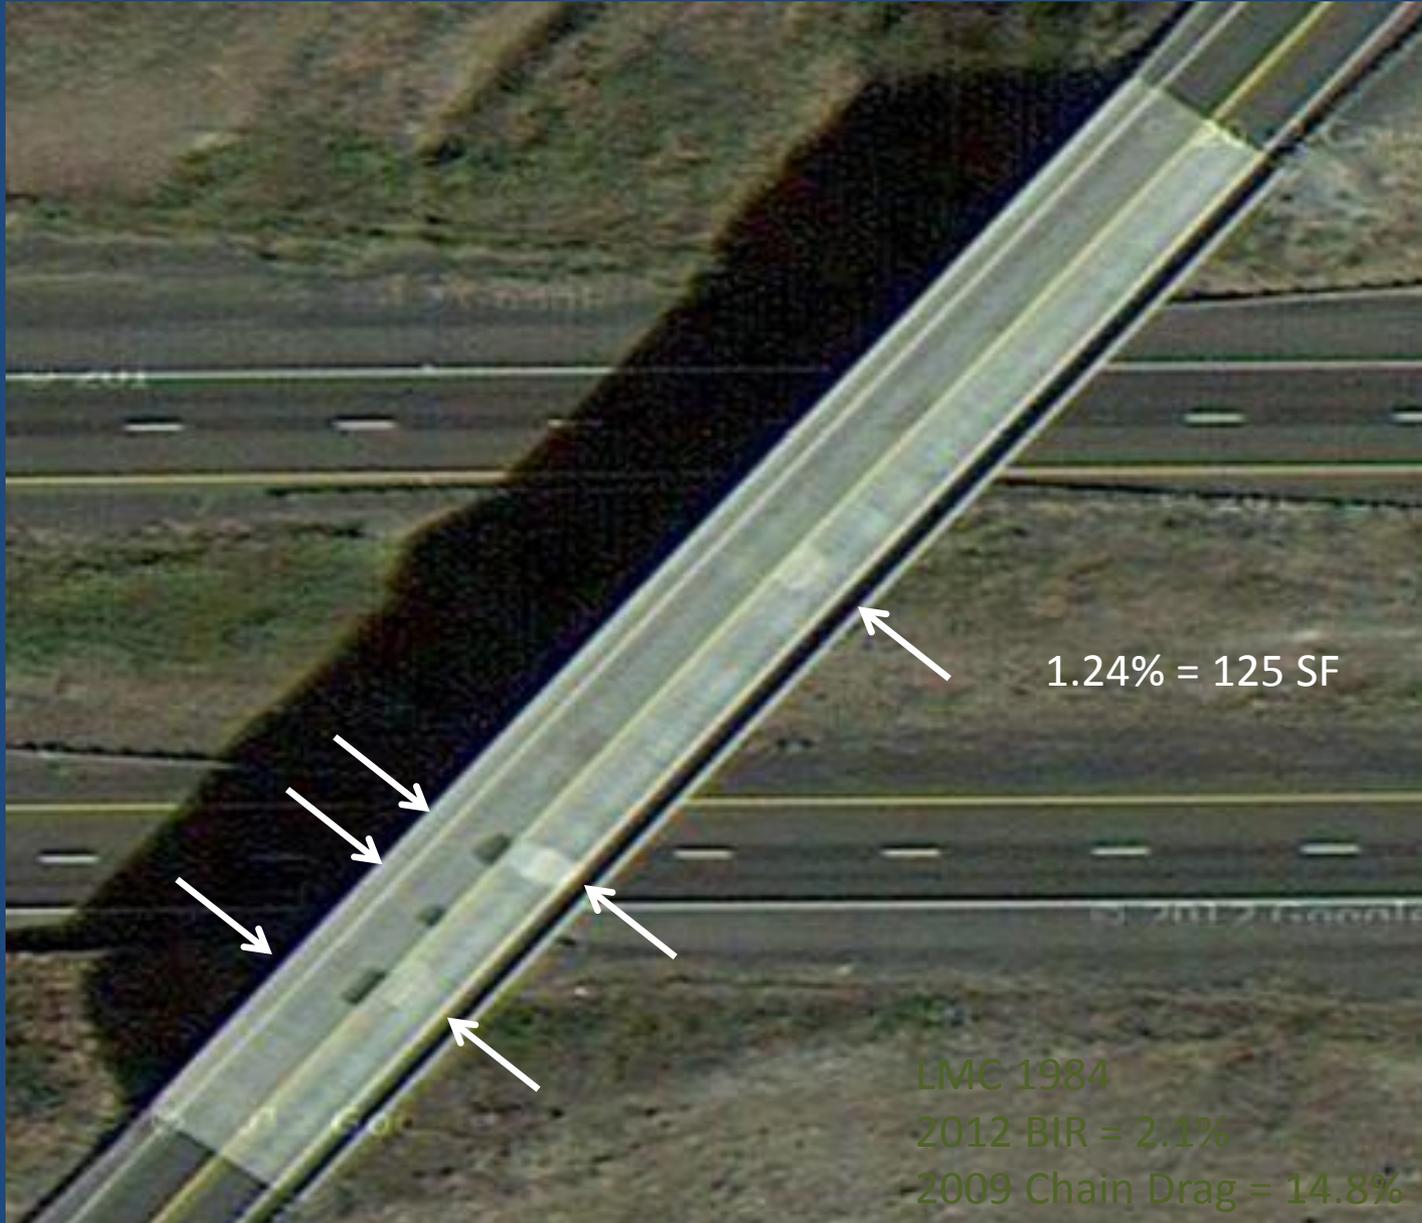
395/212N-W Monitor @ 1.24%

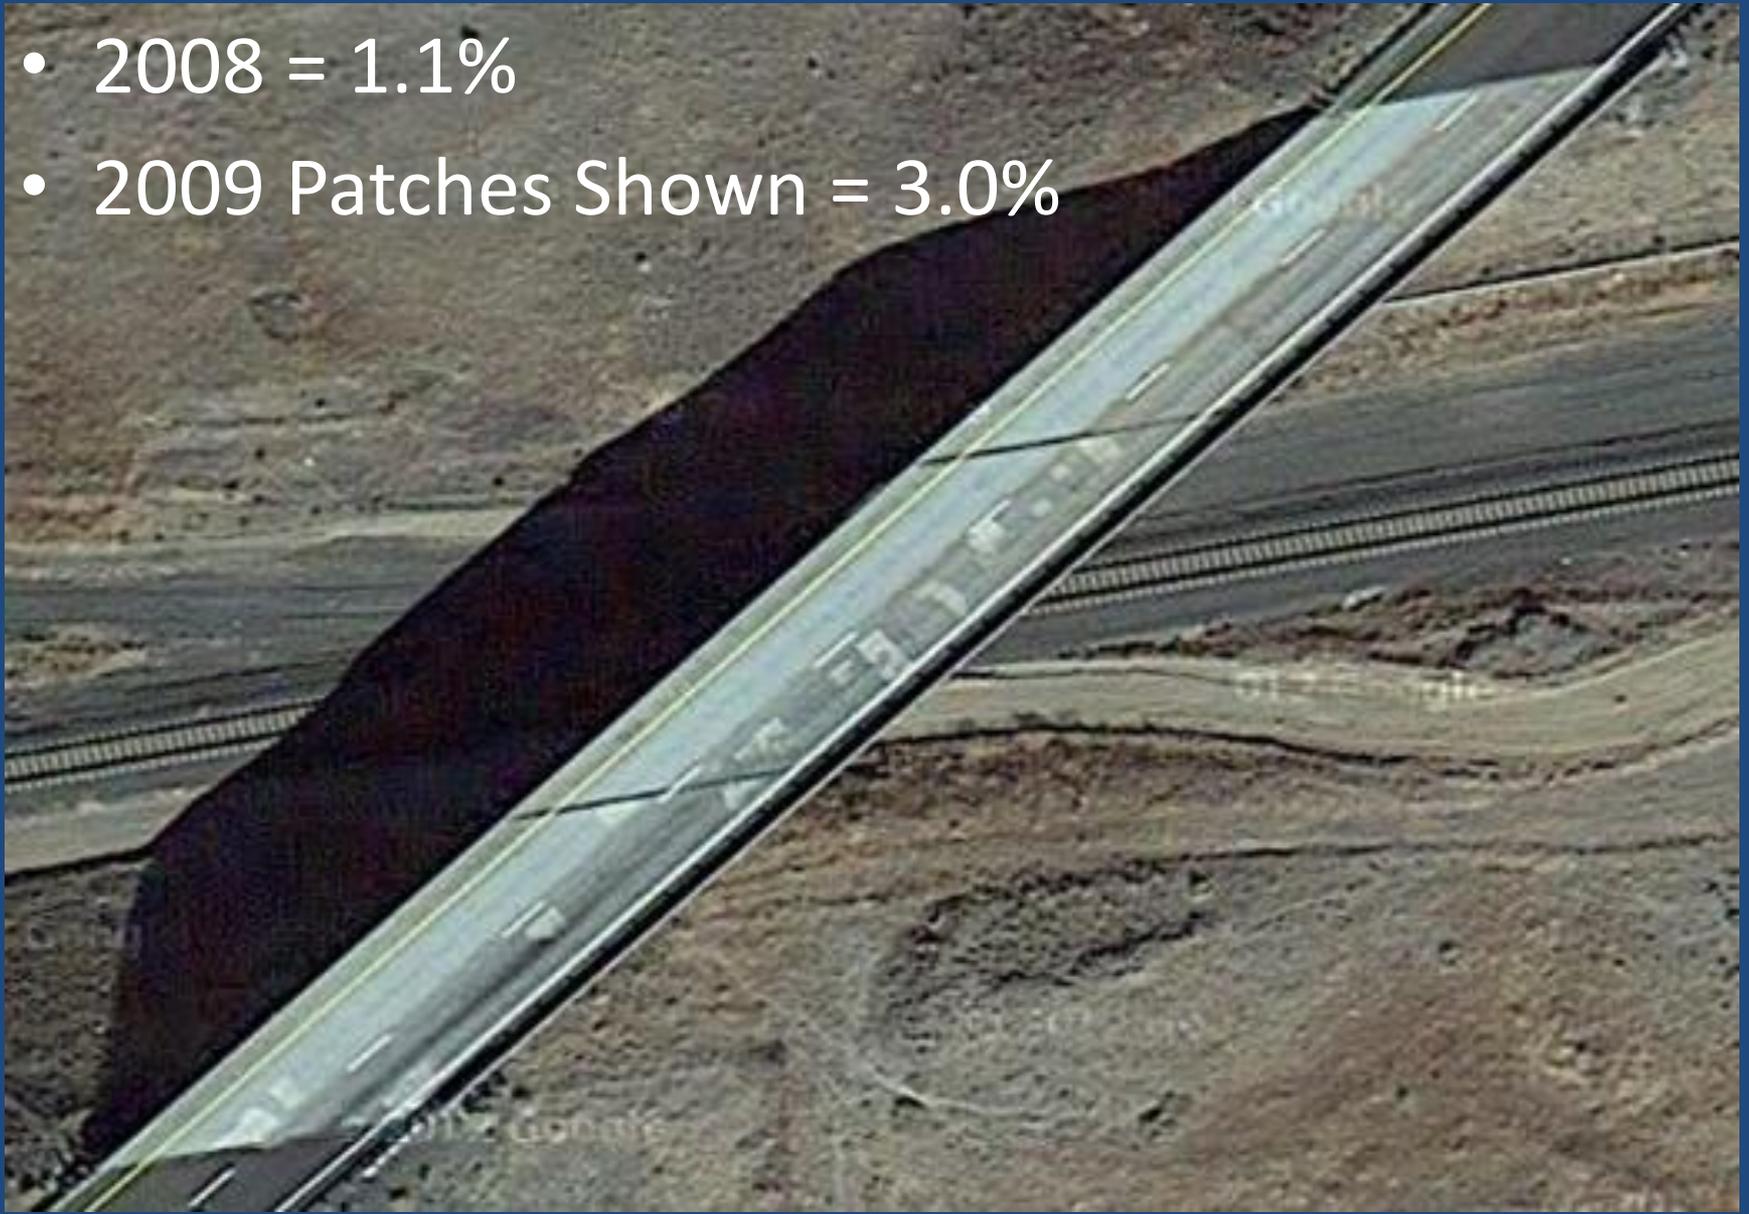
90/336S – Prioritize @ 2%

- 2008 = 1.1%
- 2009 Patches Shown = 3.0%

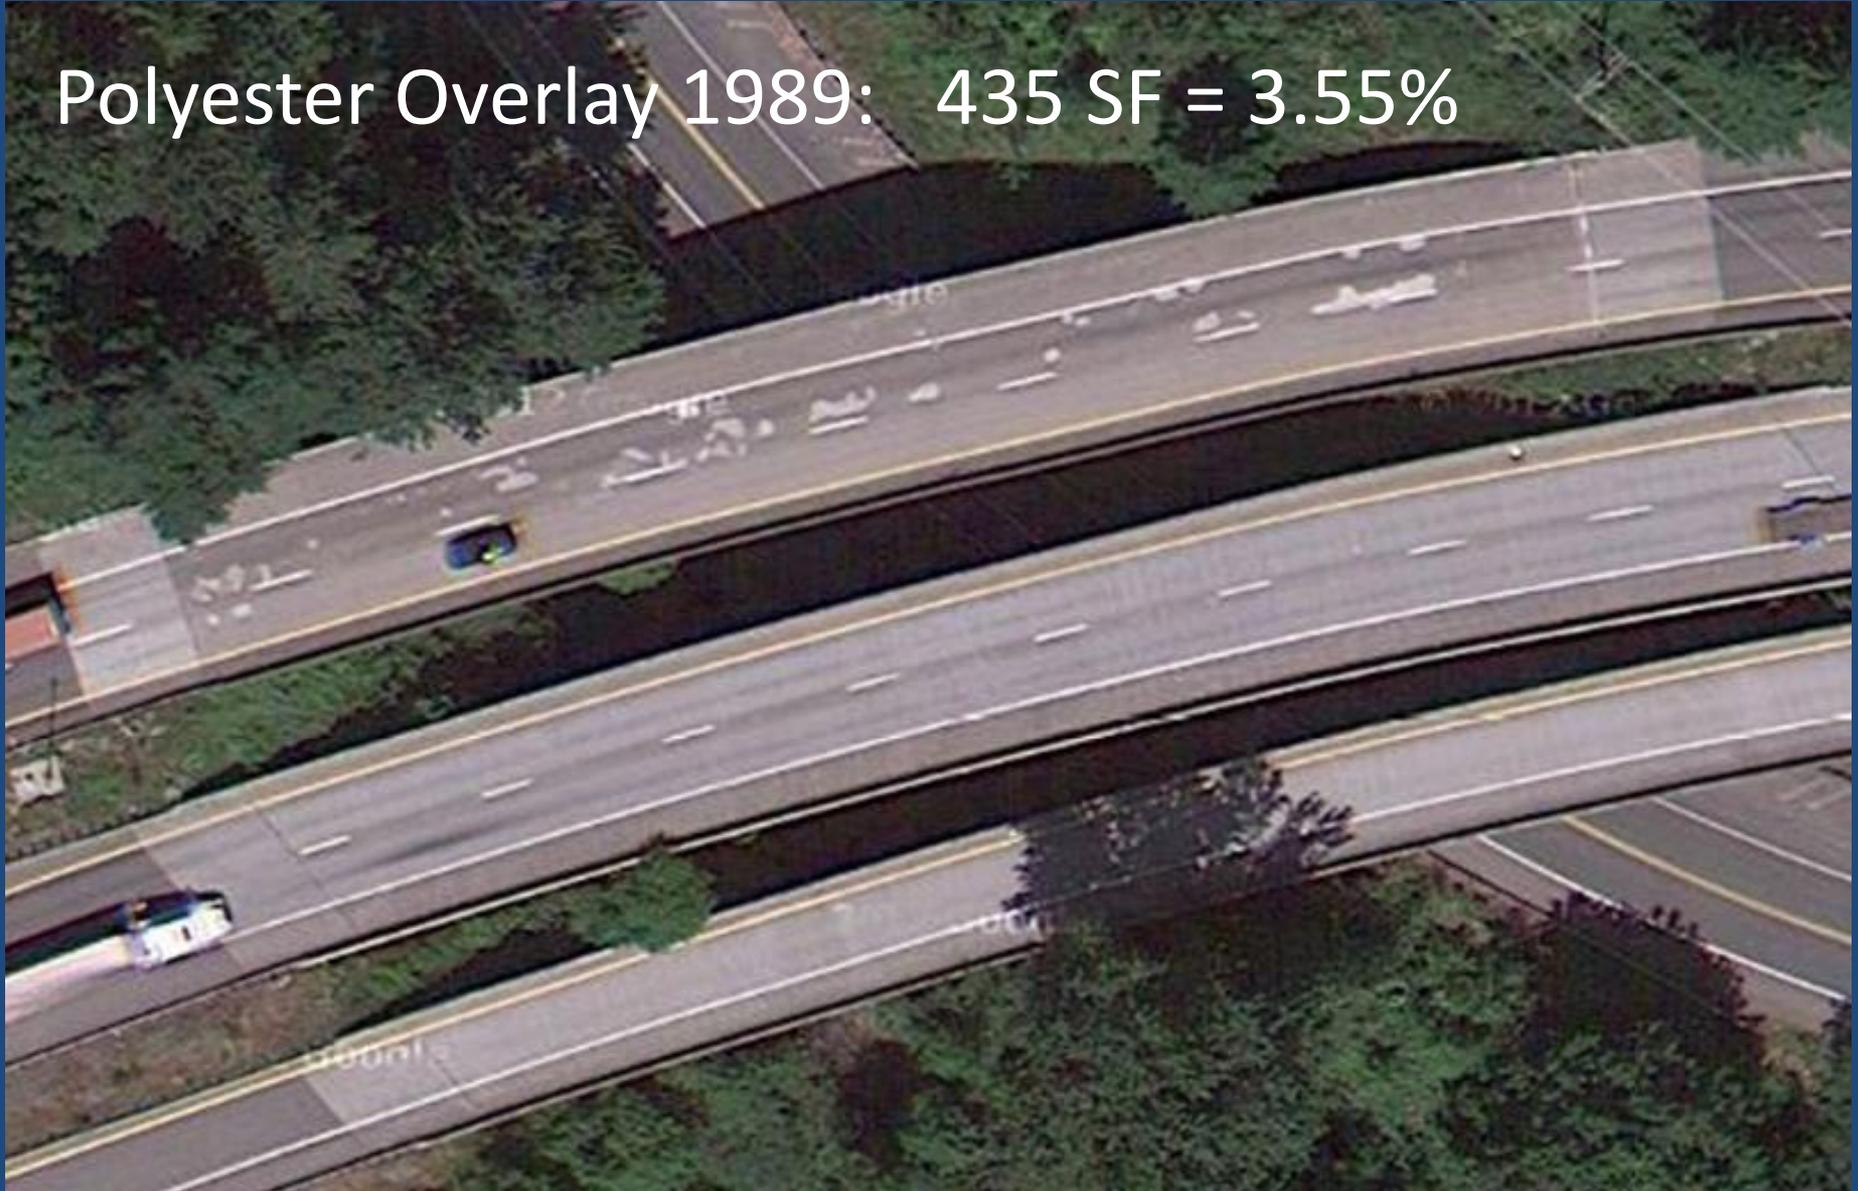
18/31N Prioritized @ 2%

Polyester Overlay 1989: 435 SF = 3.55%

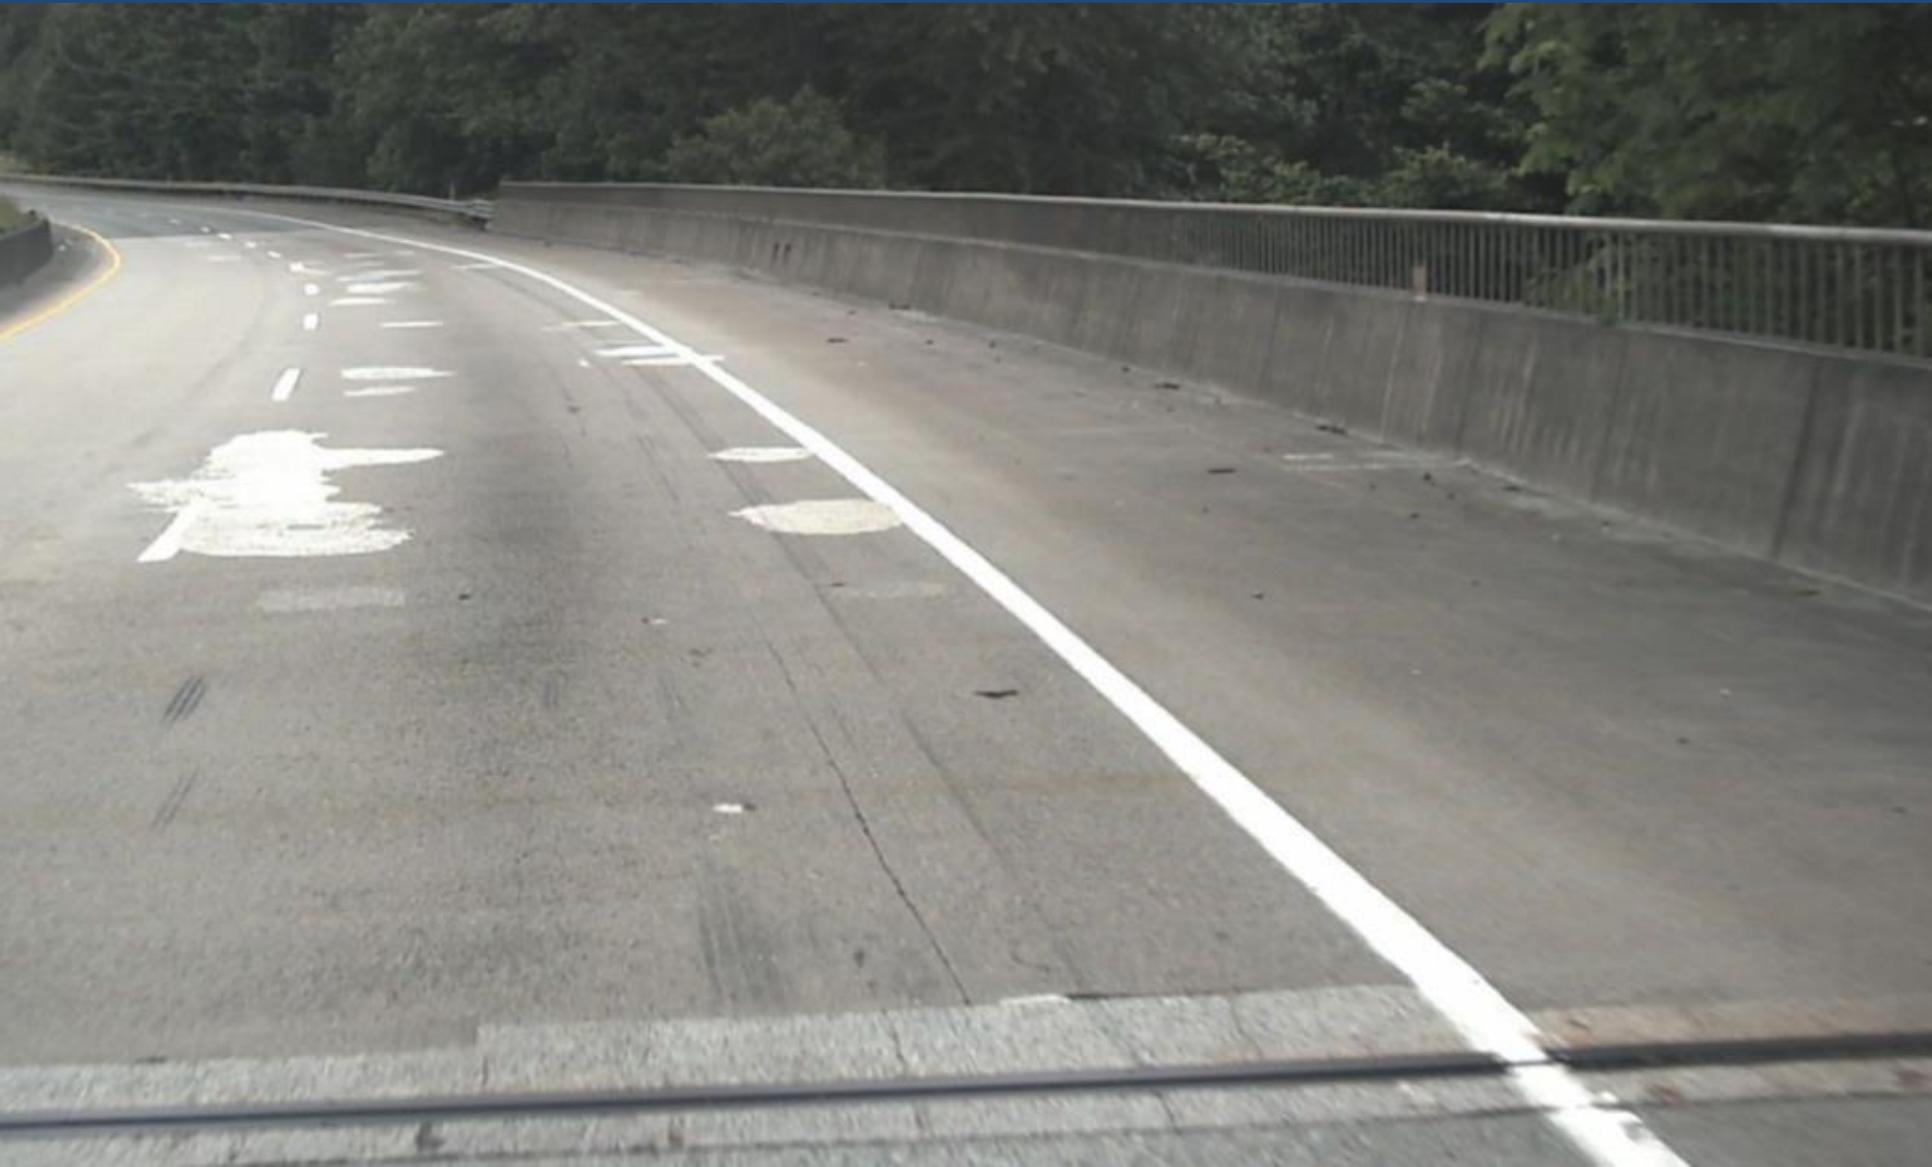
18/31N Deck View @ 3.55%
