Middle Aged Deck Preservation

When to overlay or replace?

By Bruce Thill

Washington State DOT (WSDOT)

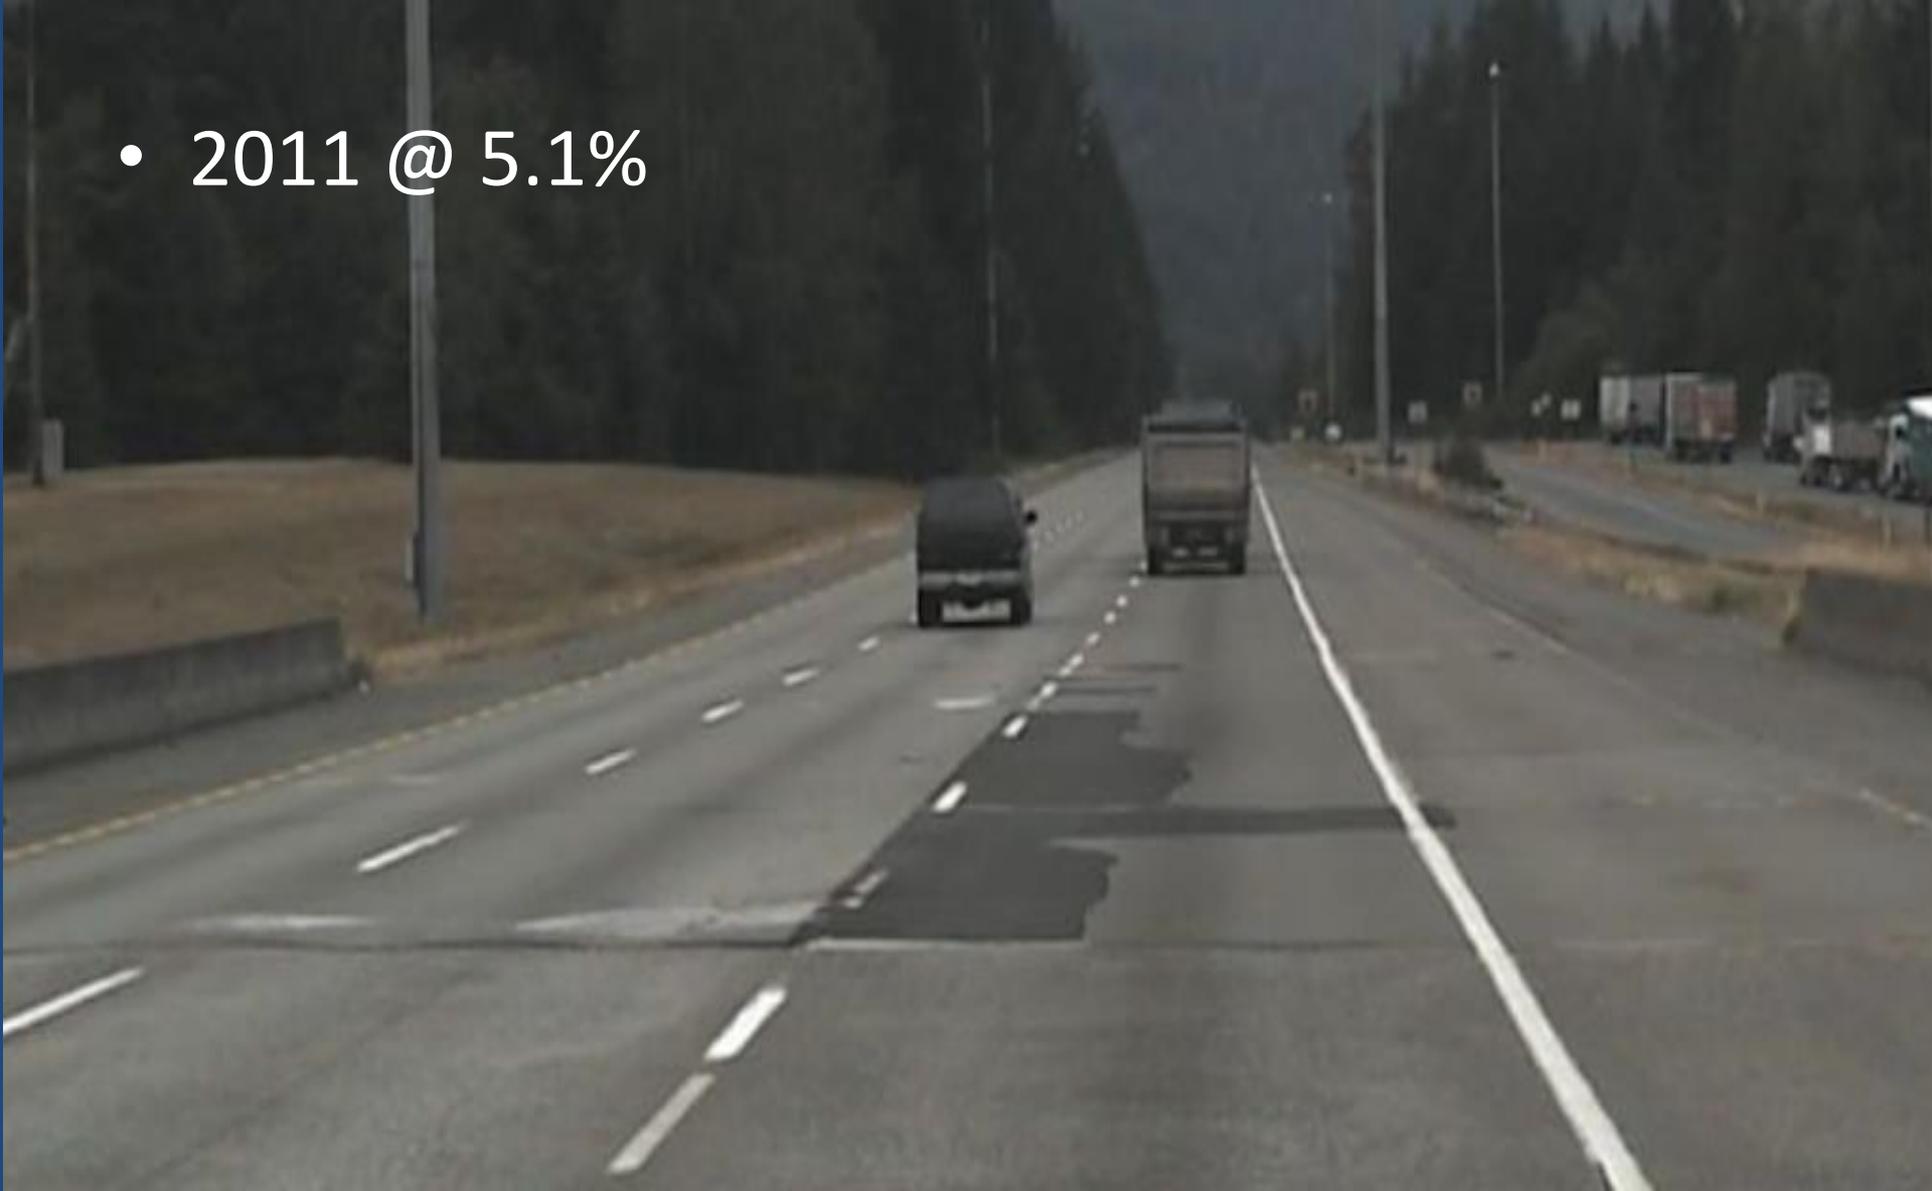
90/78N Contract @ 5%

- 2011 @ 5.1%

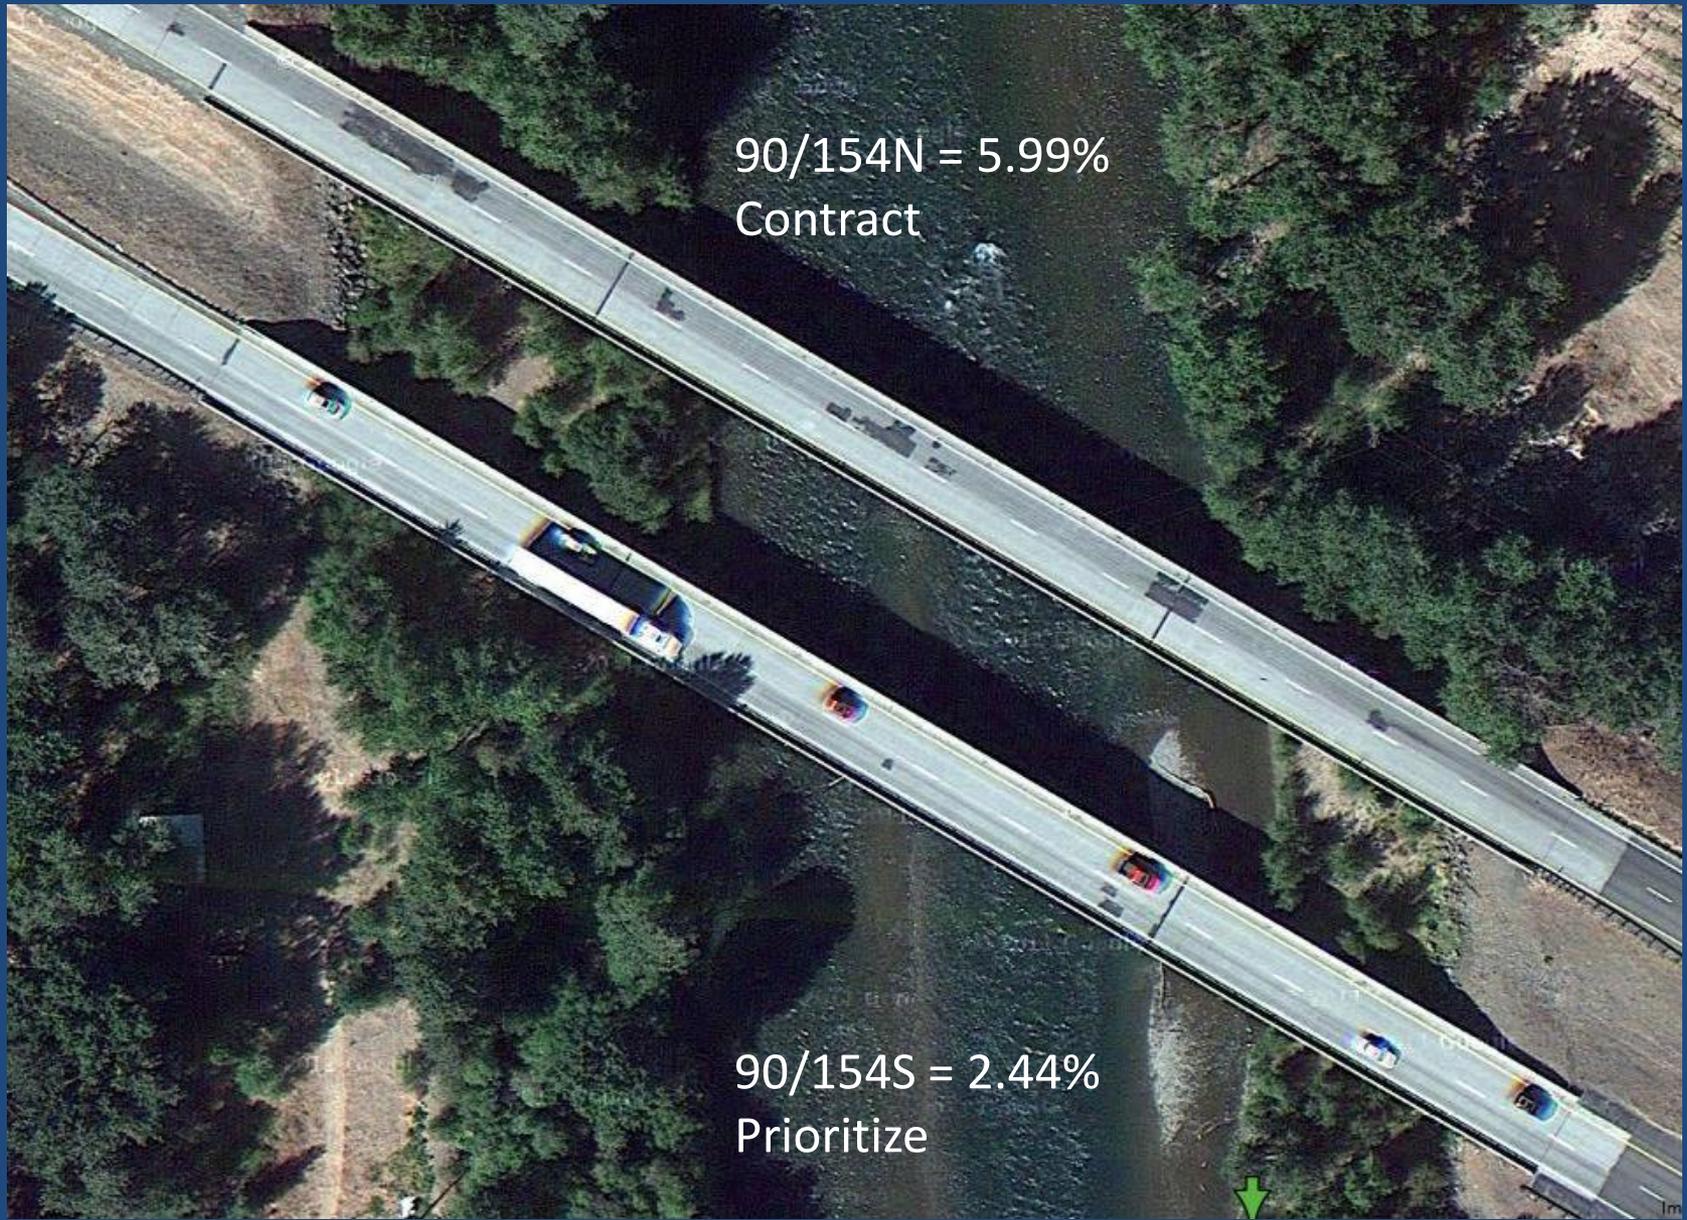
90/154N Contract @ 5%

90/154N = 5.99%
Contract

90/154S = 2.44%
Prioritize

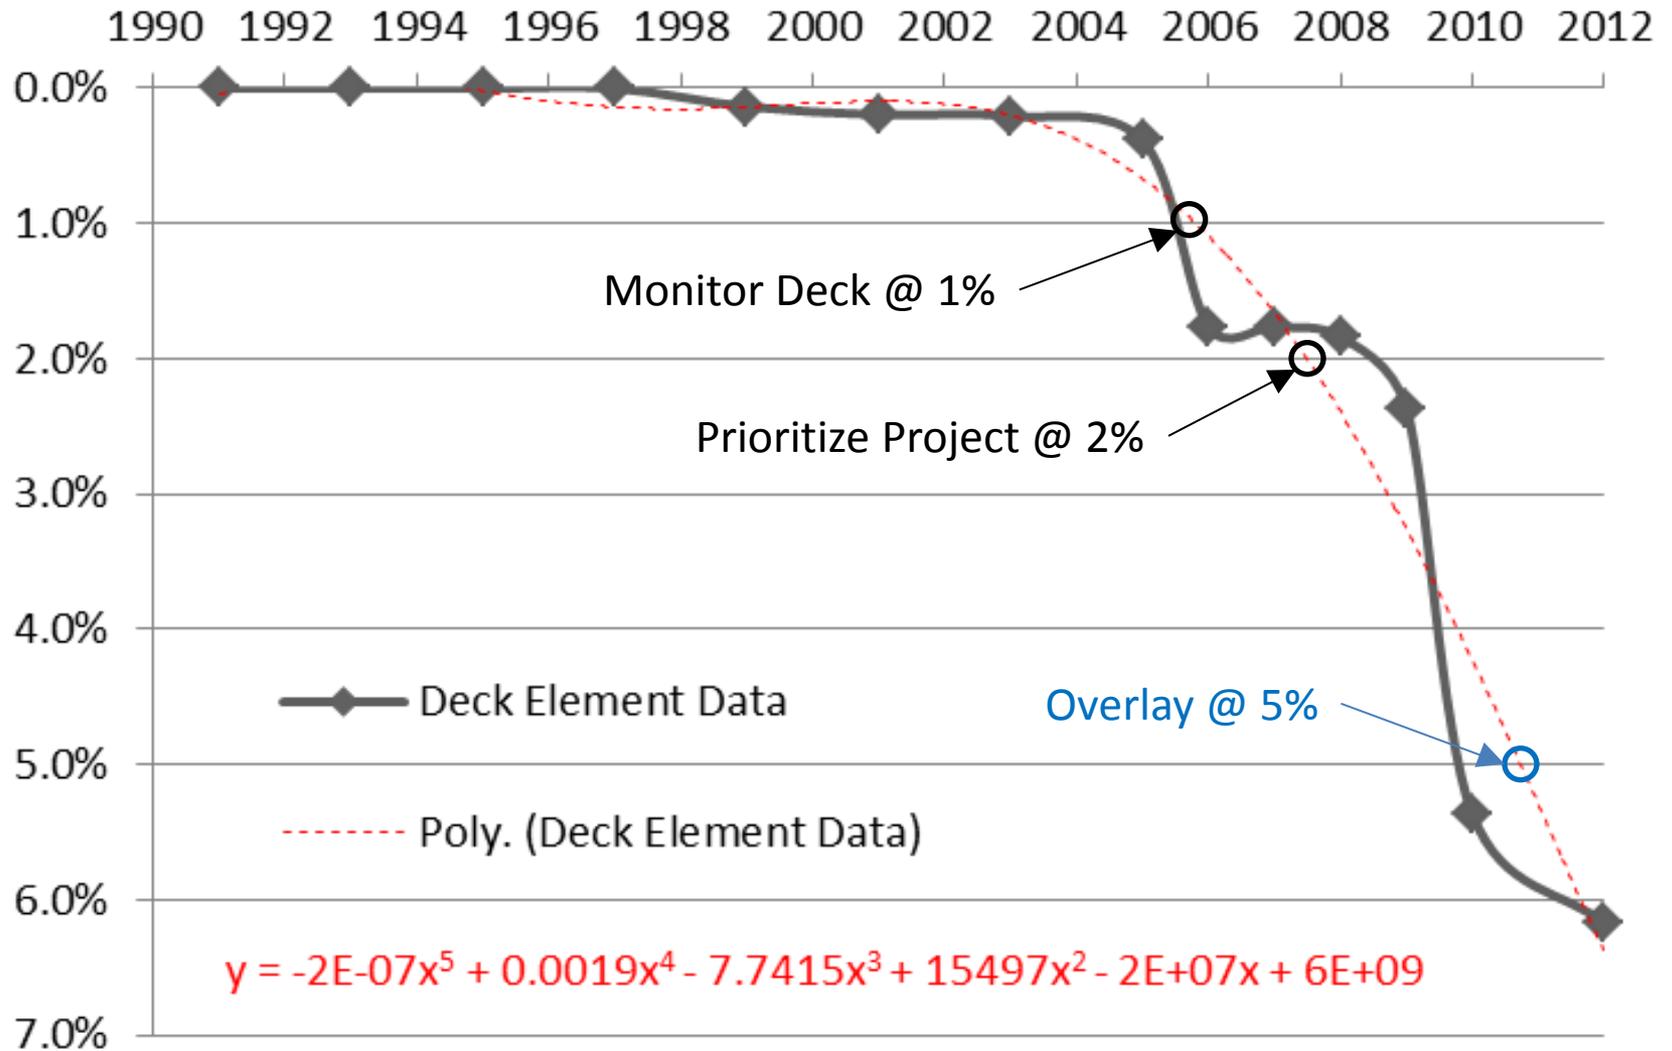
Deck Deterioration Curve- 395/545

INSPECTION YEAR

DETERIORATION - PERCENT OF DECK AREA

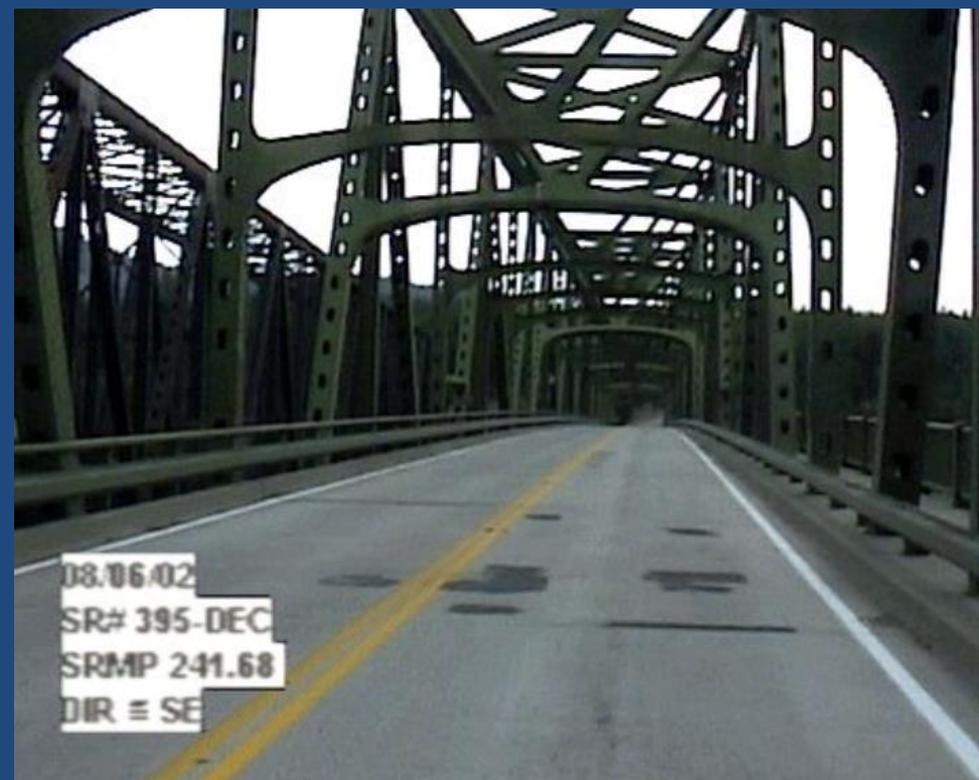
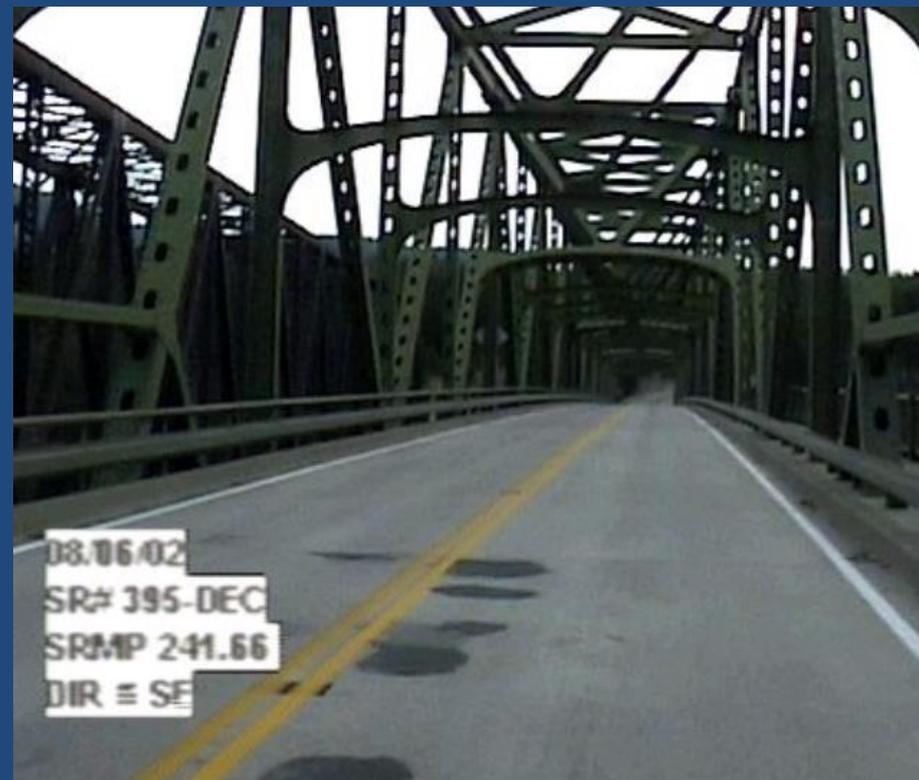
Kettle Falls 395/545 - 2002

- Two truss panels: 60 SF patching = 0.194%
- Not on the Radar
- Built 1941 Length = 1267 ft. Area = 30,408 SF

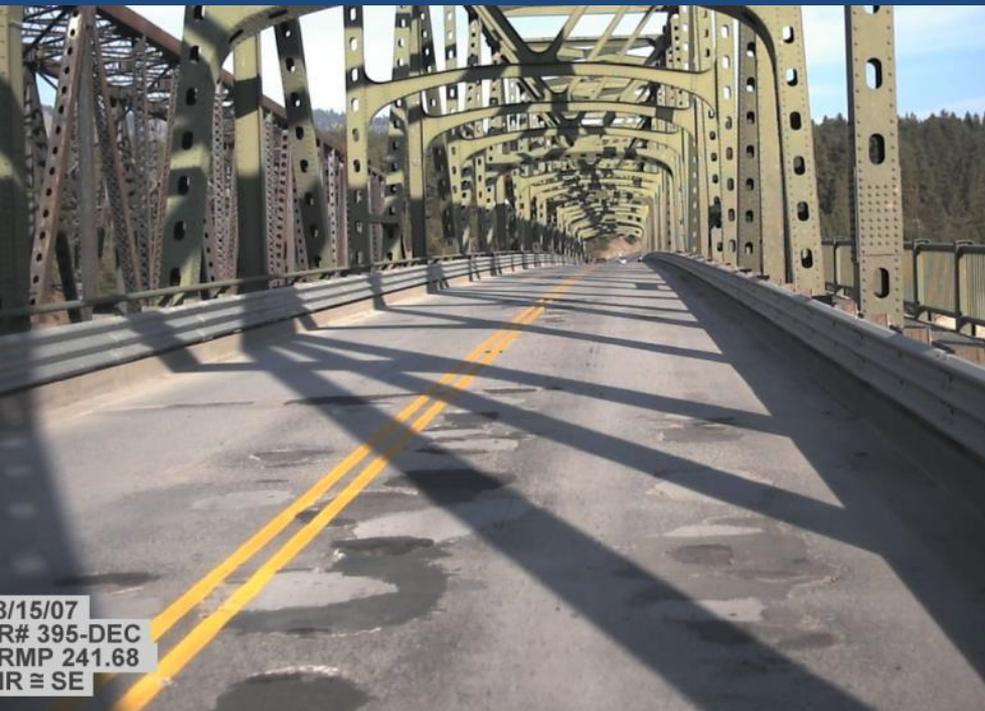
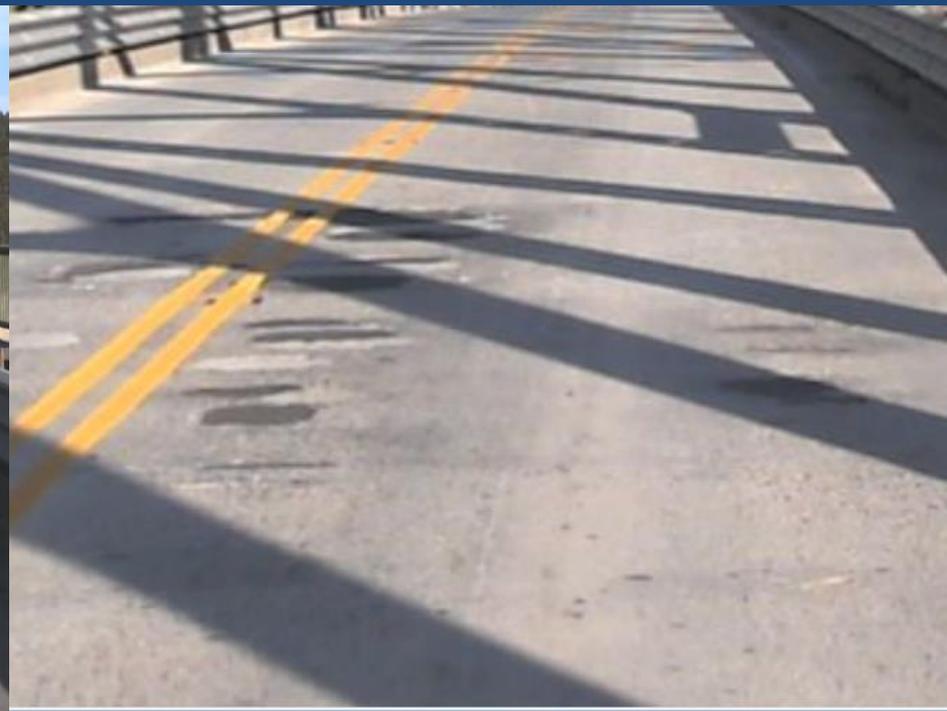
Kettle Falls 395/545 – 2007

- Same two truss panels: (2002 @ 60 SF)
- 2007: Five Panels & other patching, 536 SF = 1.8%
- On the Radar – Prioritized in 2008

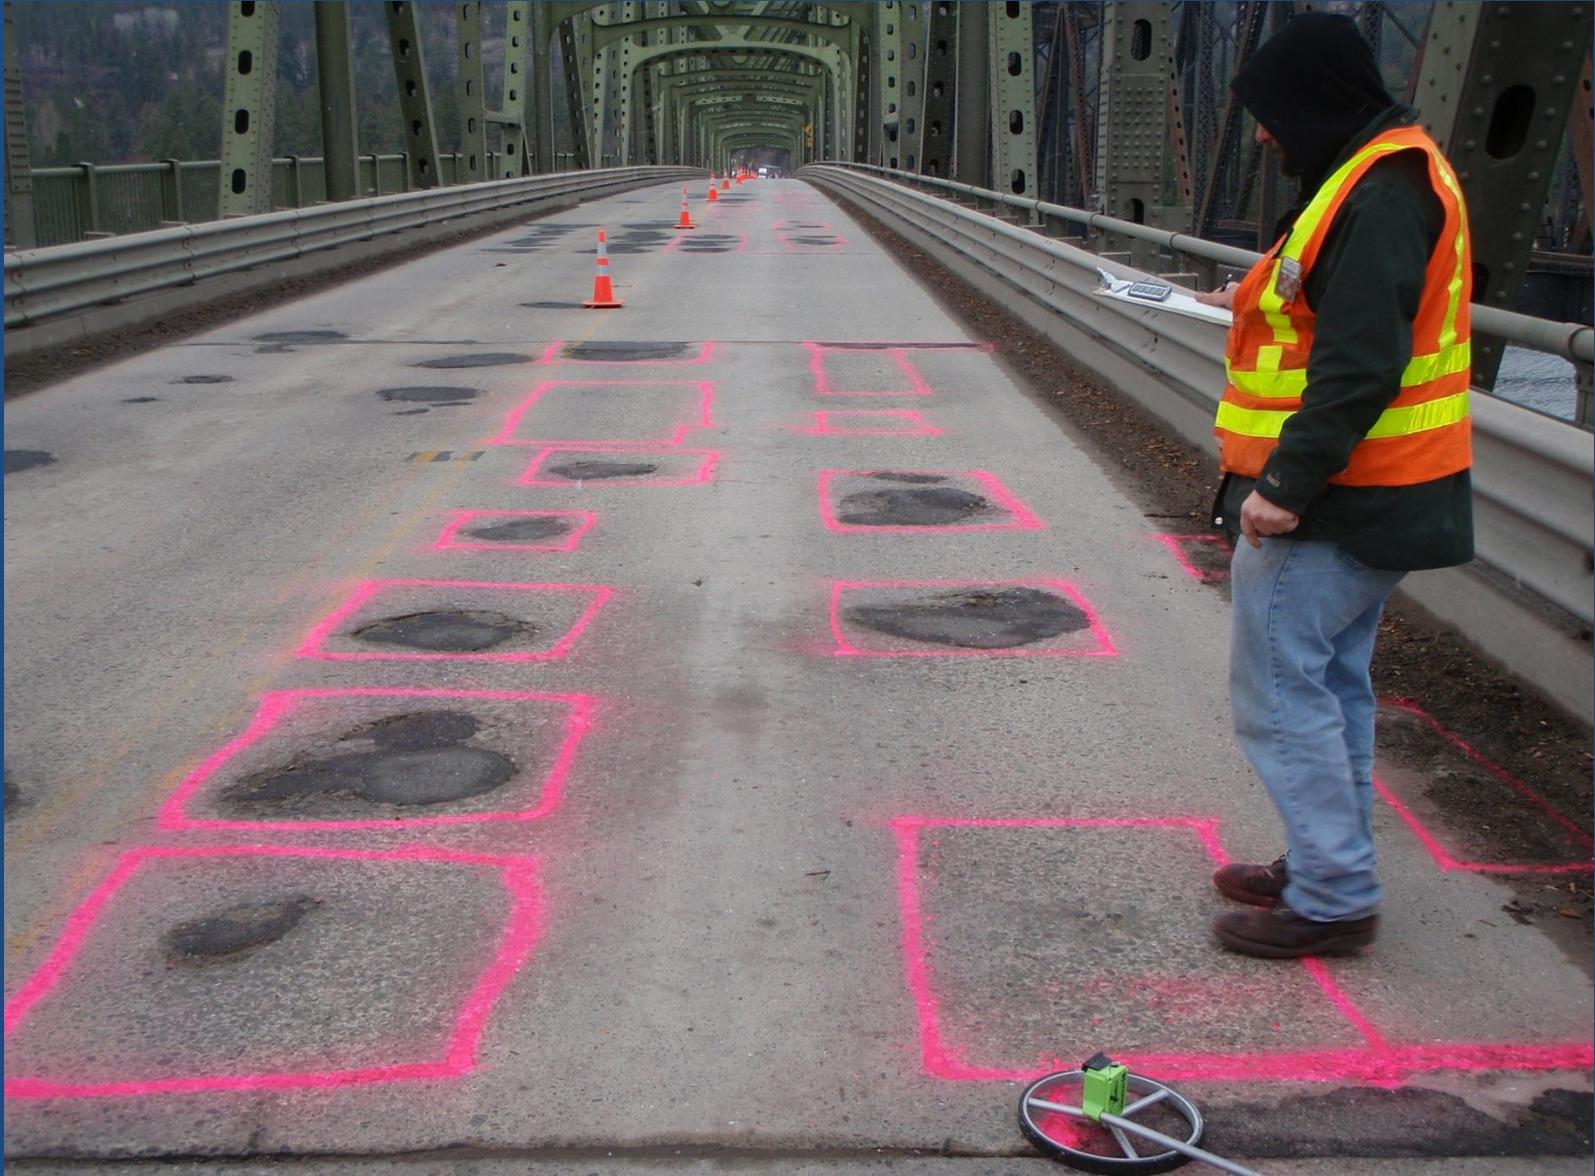
Delams by Chain Drag Pattern in the Patches?

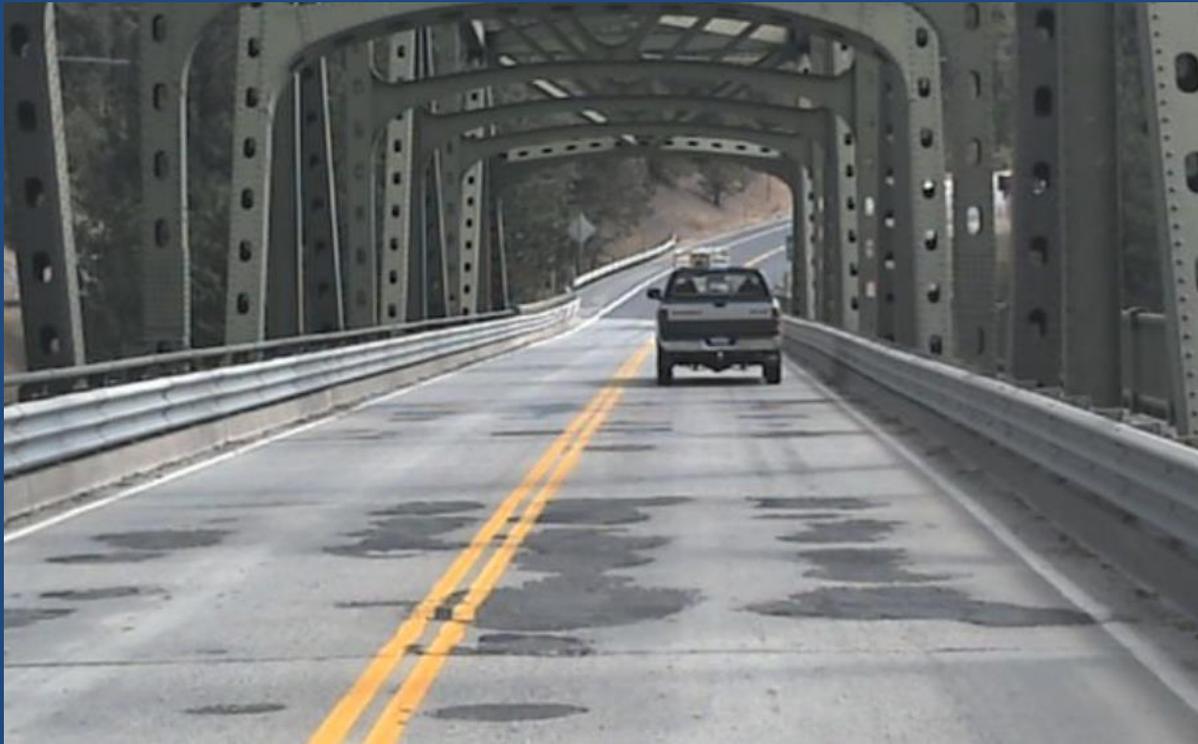
Kettle Falls 395/545 – 2010

- 2010 Chain Drag Results = 5.4% Deterioration
 - Patch = 1159 SF, Spall = 156 SF, Delam = 324 SF
- New deteriorated truss panels
- Raised the priority in 2010

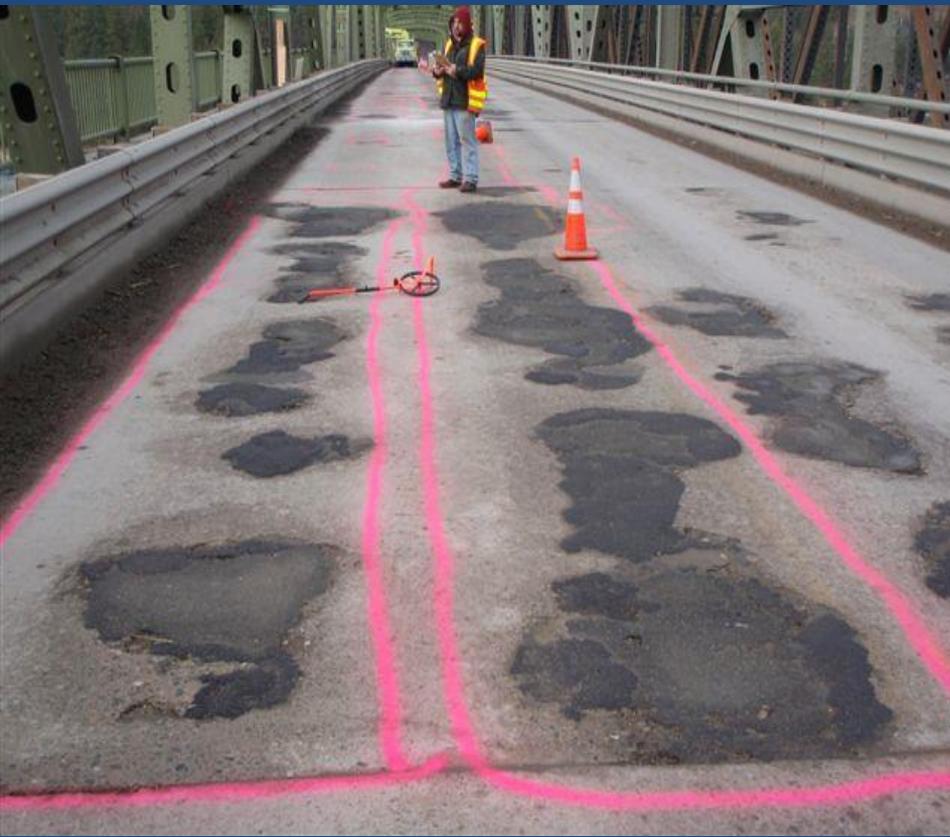
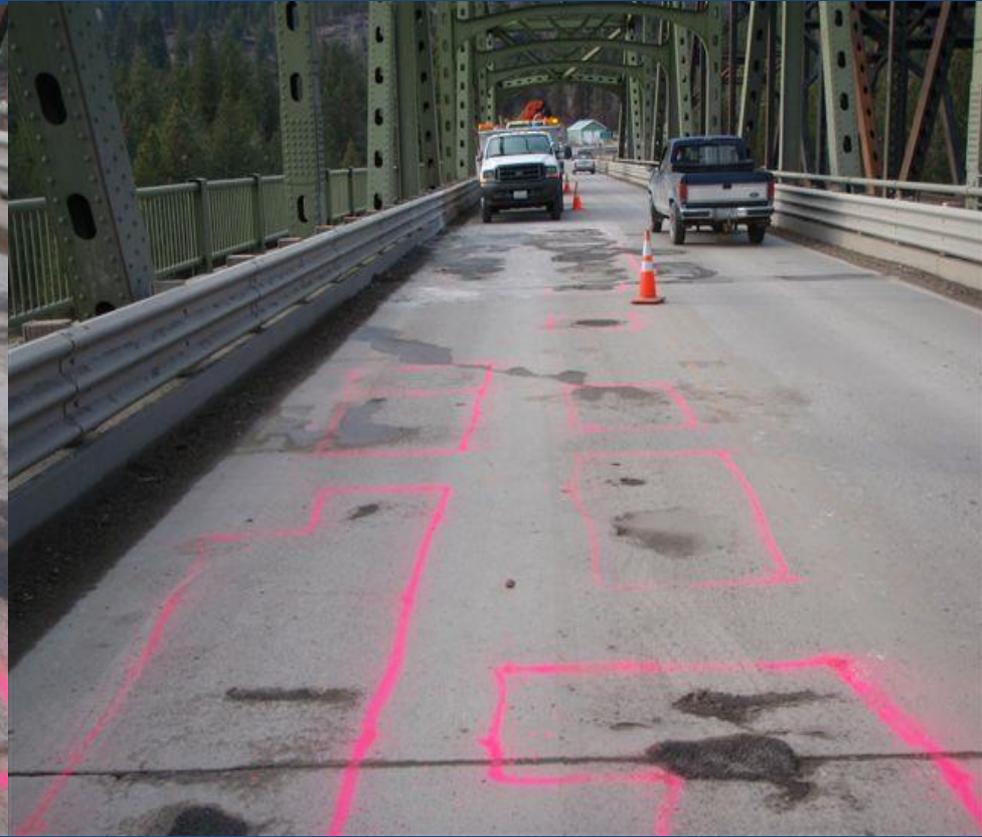
395/545 - Soffit Element

- Deck Replacement or Overlay?

- With patching this bad, can the deck be saved?
- Deck replacement ruled out based on soffit quantity @ 0.35% or 105 SF and cost.
- Additional \$20,000 provided for full depth deck repairs.

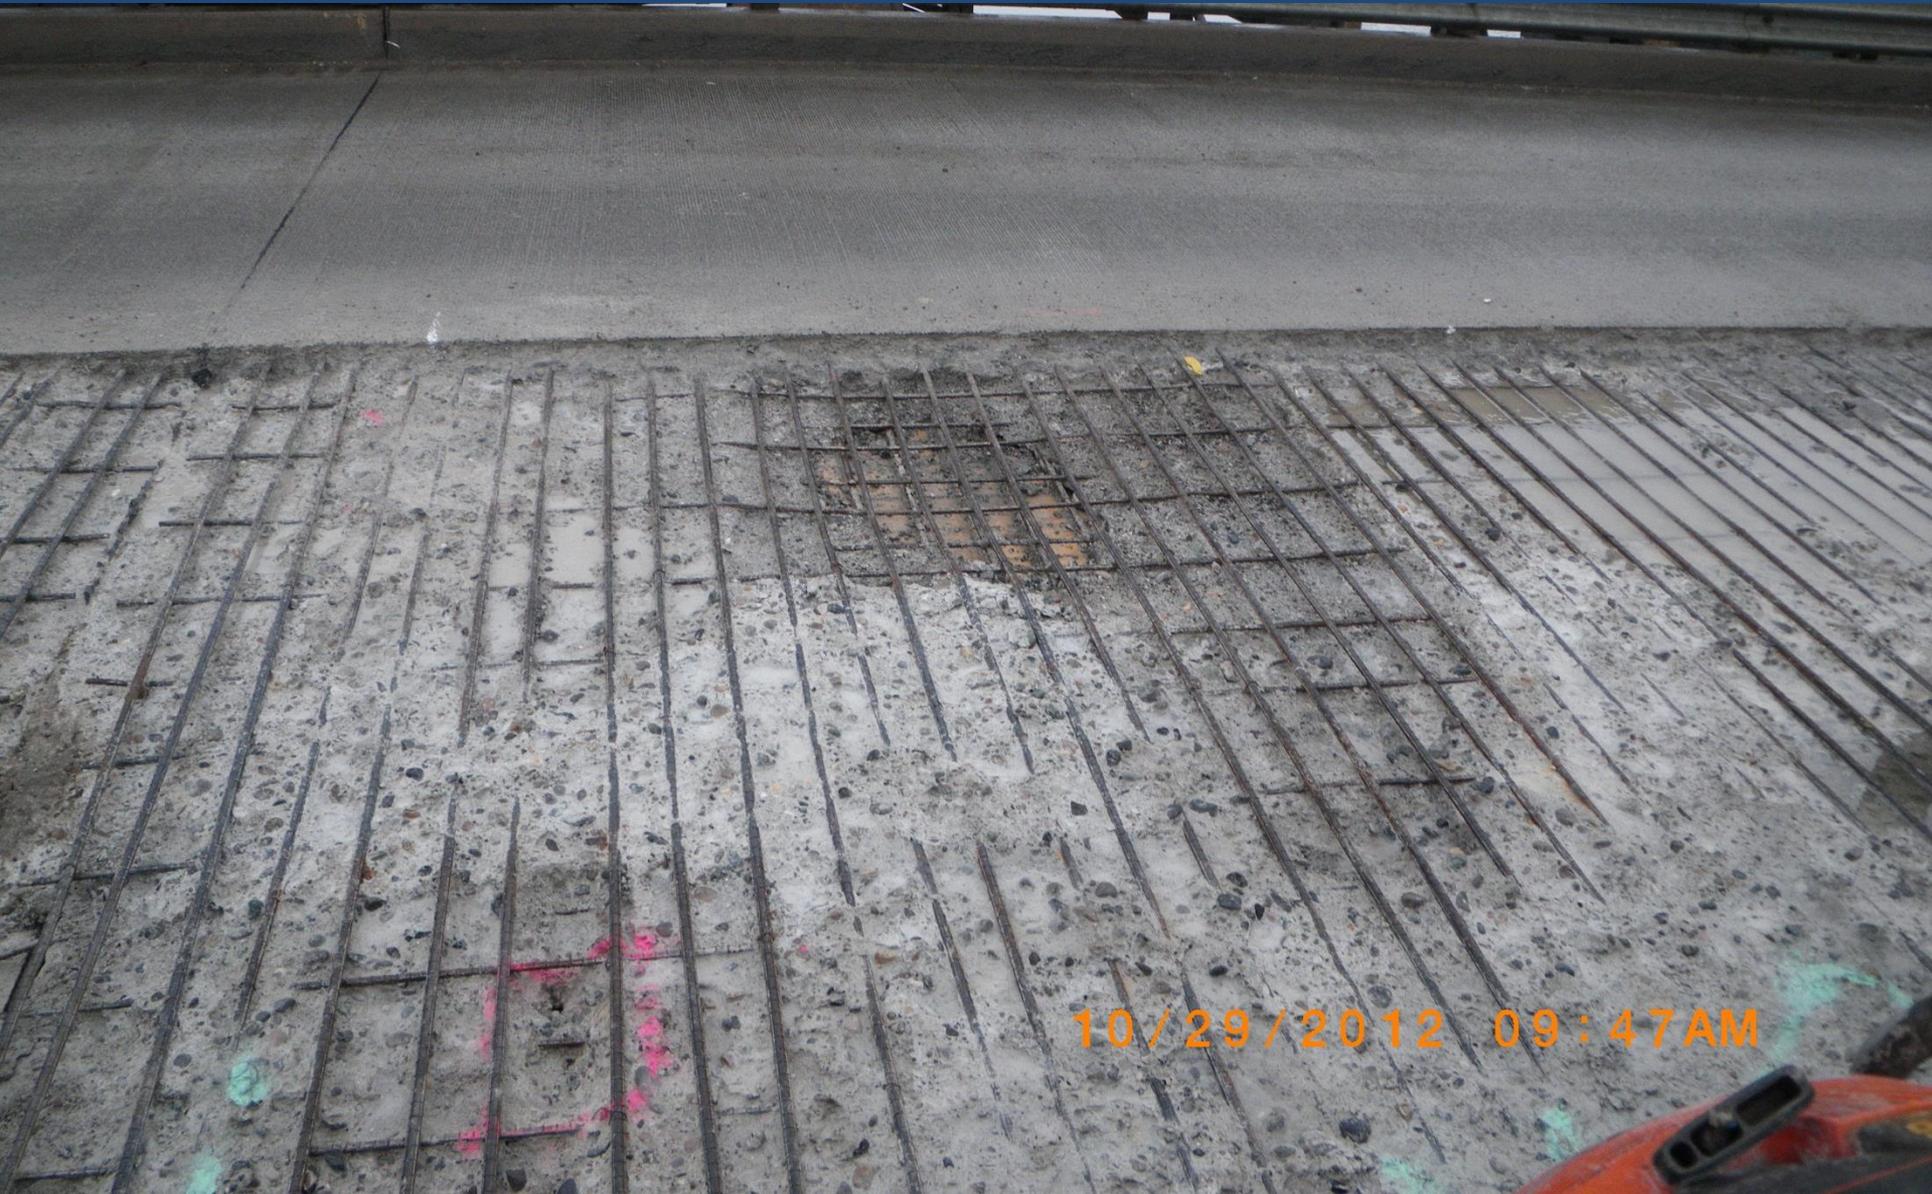
Hydromill 1.5" & Overlay 1.5"

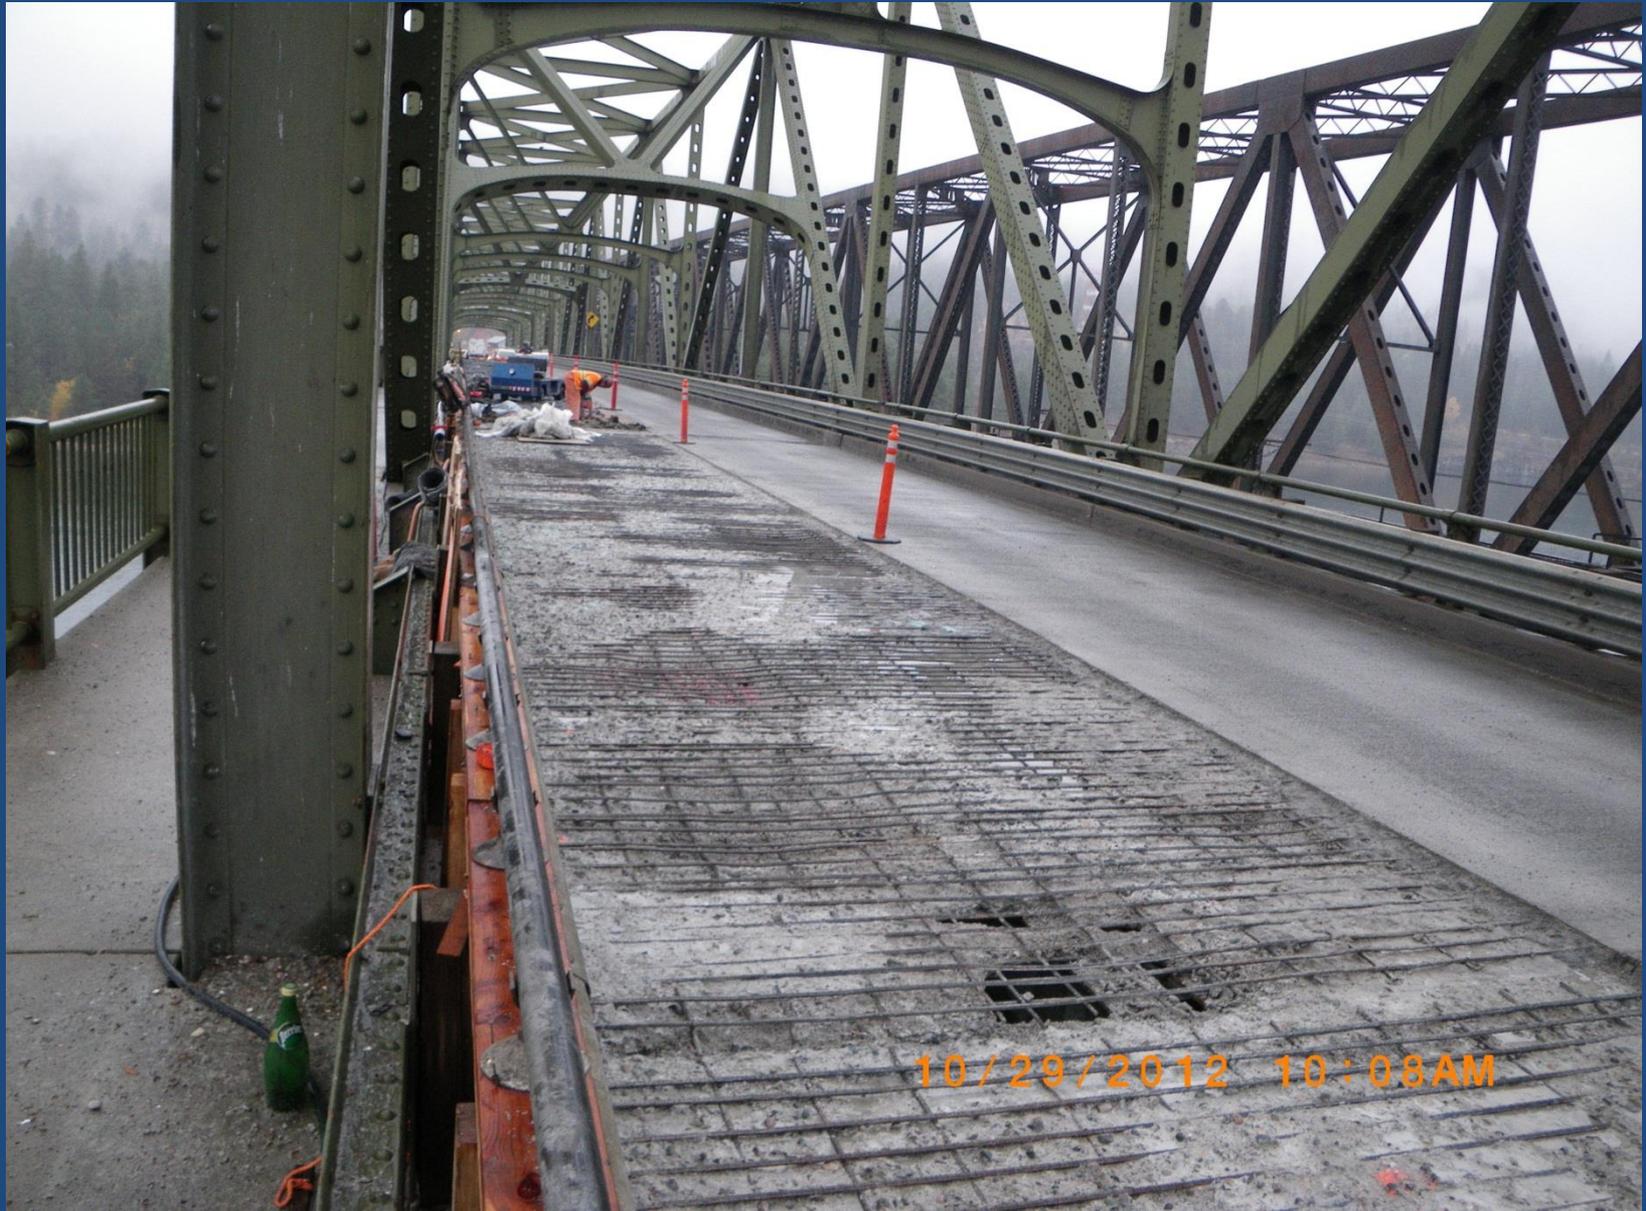
Hydromill 1.5" & Overlay 1.5"

- 2012 Bridge Inspection Patching was 337 SF and used for Contract.
 - Deep or Full depth Asphalt patching + Bad Deck
- 2012 Constructed quantity was 345 sf

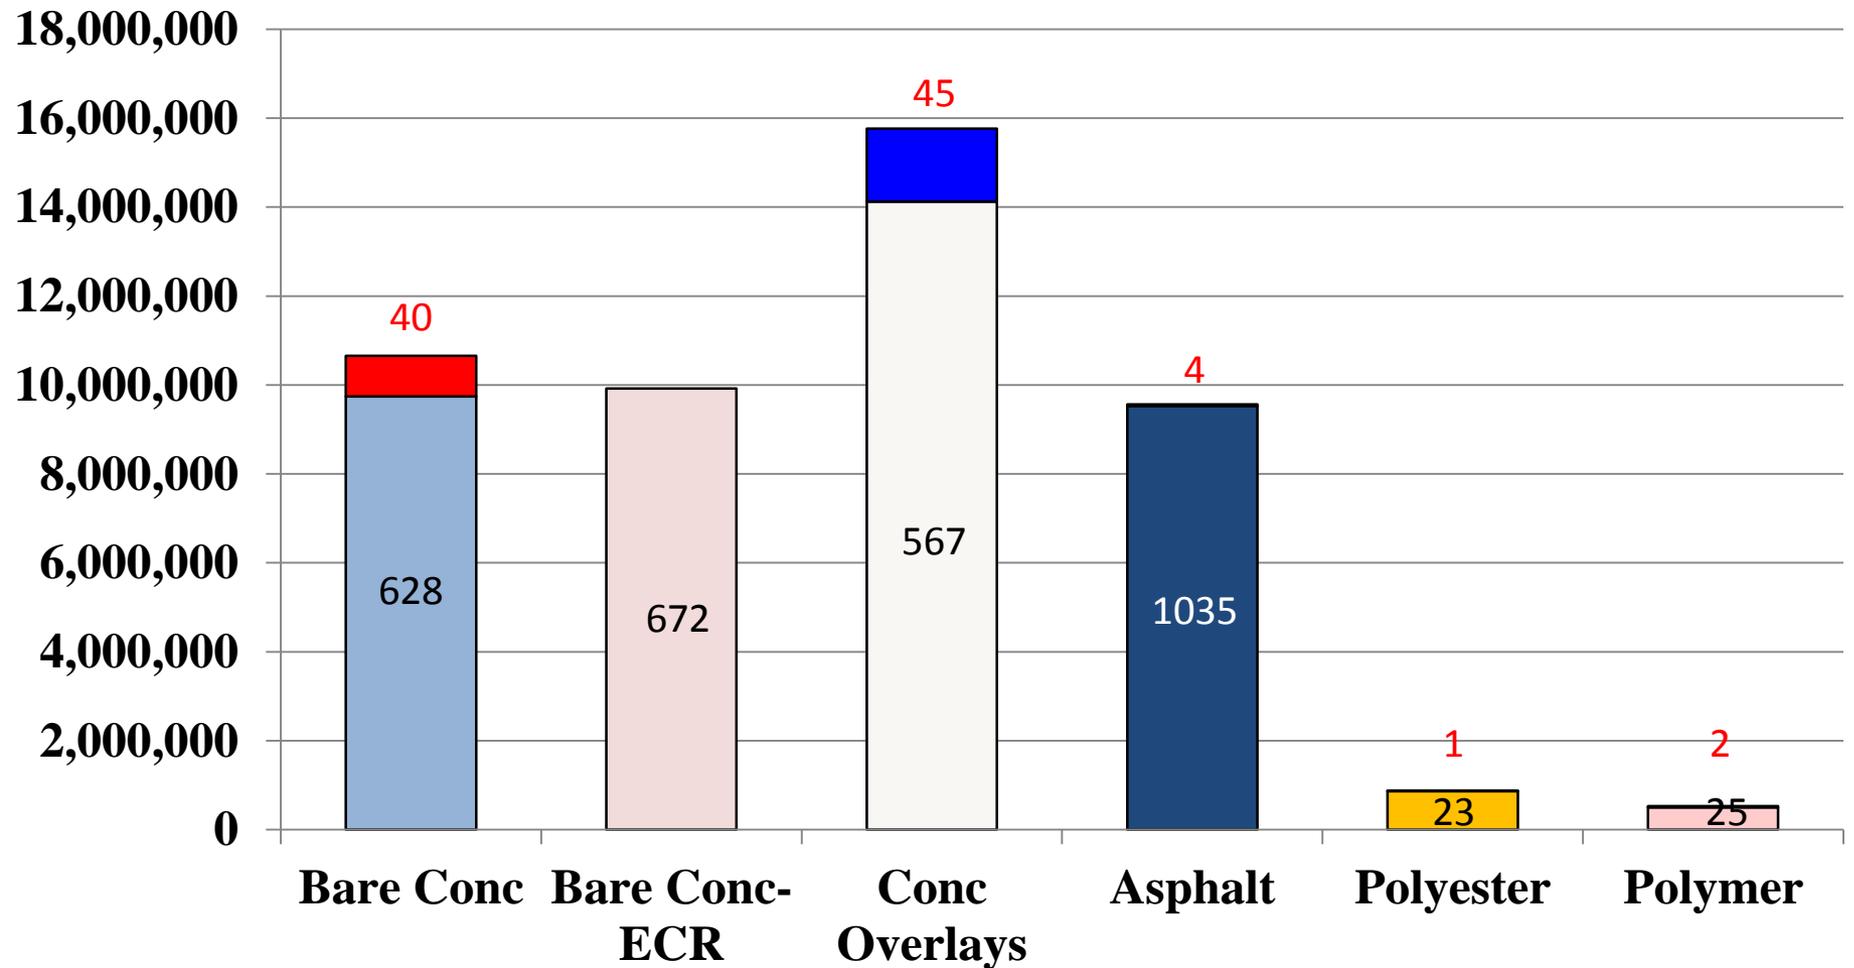
Washington State's Bridge Deck Preservation Needs

\$50.5M

\$104.6M

\$0.9M

\$156M

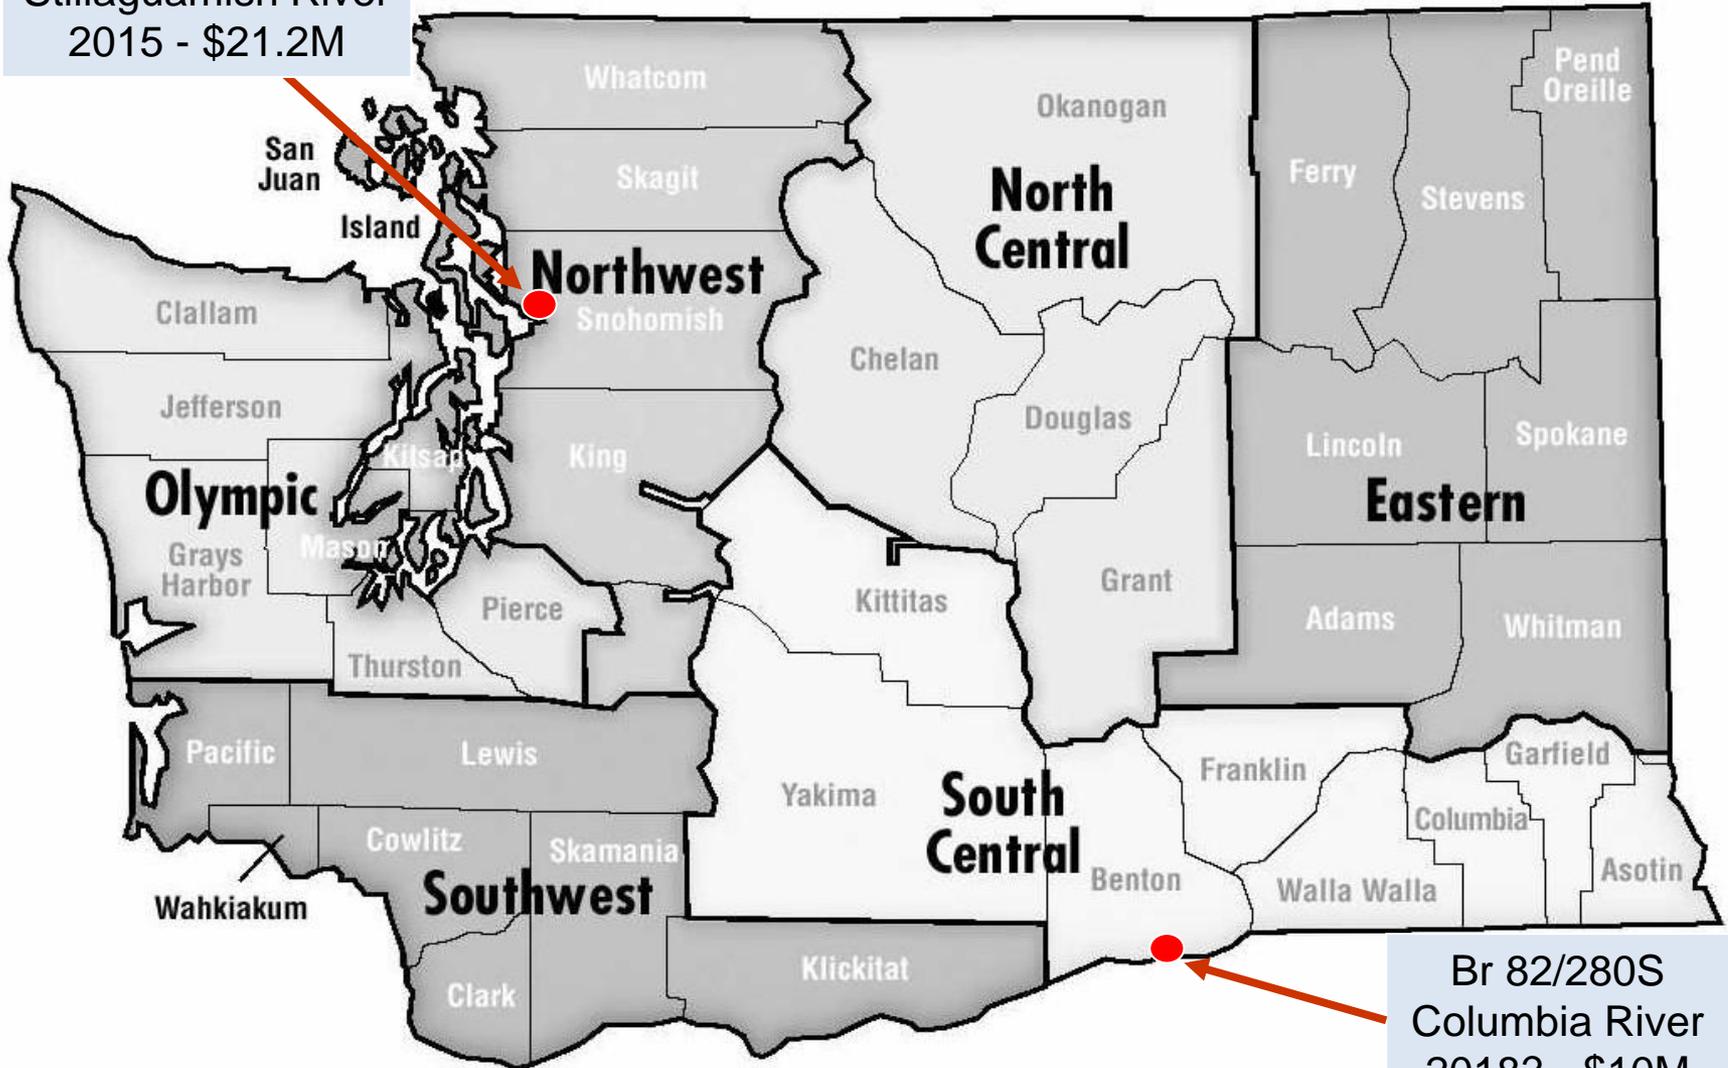
Br 5/670W
Stillaguamish River
2015 - \$21.2M
