MONTANA'S SEAL COAT WARRANTY

Rocky Mountain West
Pavement Preservation Partnership
October 21, 2015
Bozeman, MT

2008 Seal Coat Warranty Administration Guide

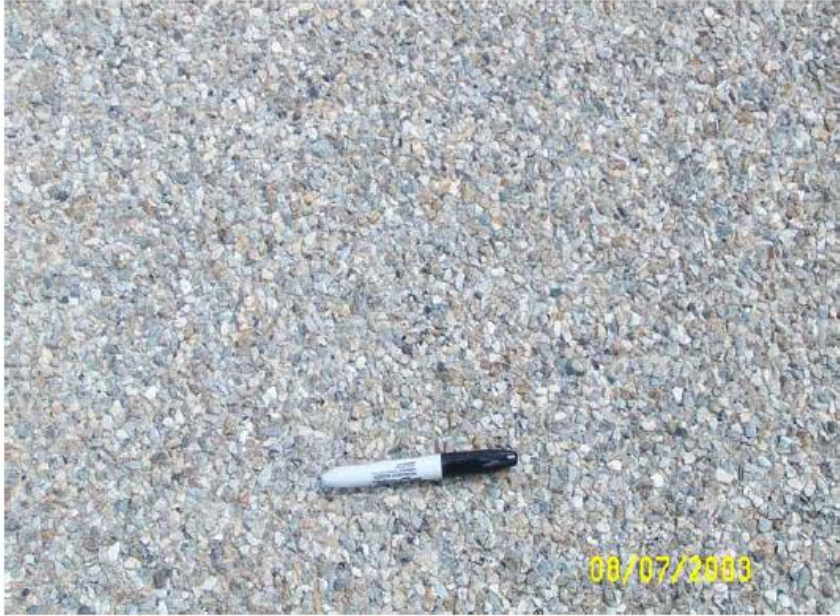
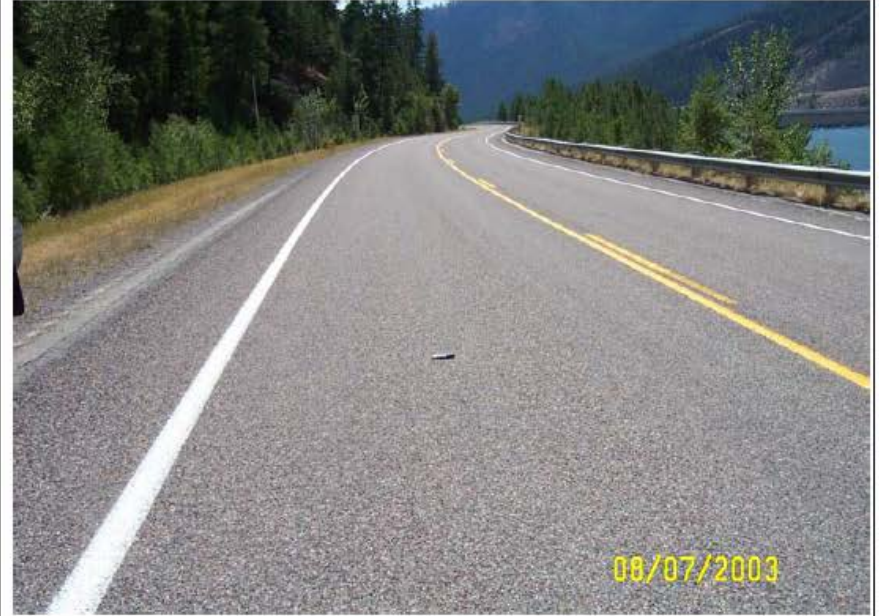
Condition: Desired Final Appearance

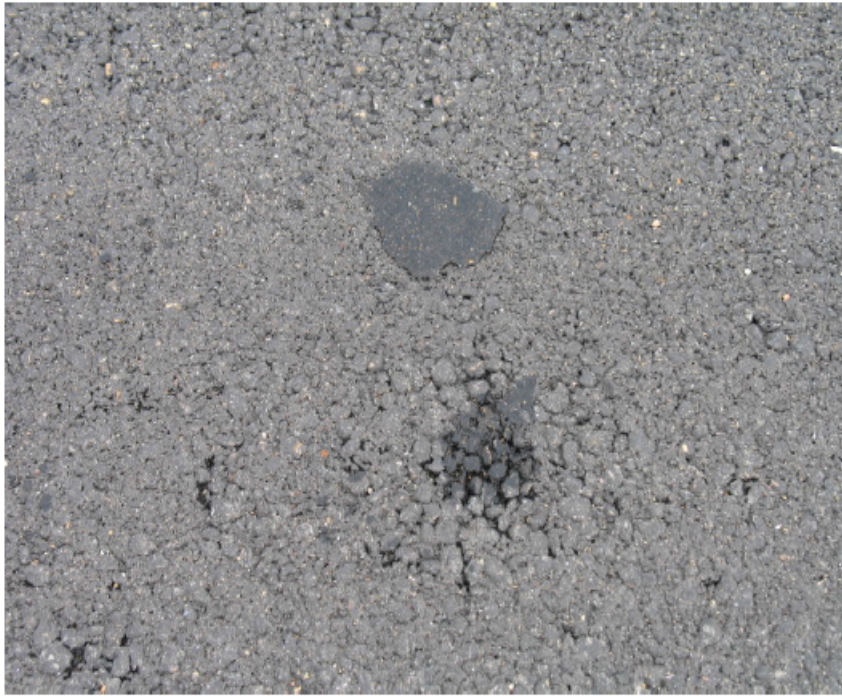
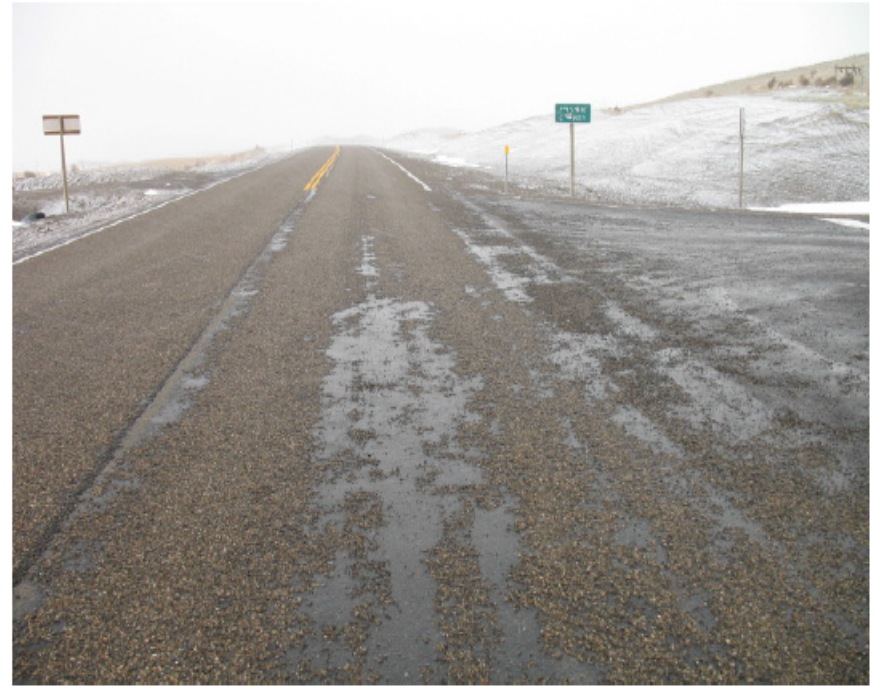
Condition: Cover Material Loss Attributed to Insufficient Embedment Caused From Plant Mix Surfacing Segregation.

- Water Poured on Plant Mix Surface Illustrates Effects of Segregation. Bituminous Materials Will Behave Similarly, Resulting in Insufficient Quantities Remaining on the Plant Mix Surface to Embed Cover Material.
- Segregated Plant Mix Surfacing Sections Should be Identified And Addressed Prior to Seal Coat Application.

- Cover Material Loss Attributed to Plant Mix Surfacing Segregation.
- Per Subsection 409.03.8 Warranty, Submit a Detailed Repair Plan to The Project Manager For Approval Within 14 Calendar Days of Notification of Required Repairs.
- This Condition is Unacceptable And Must be Repaired Prior to Final Acceptance.

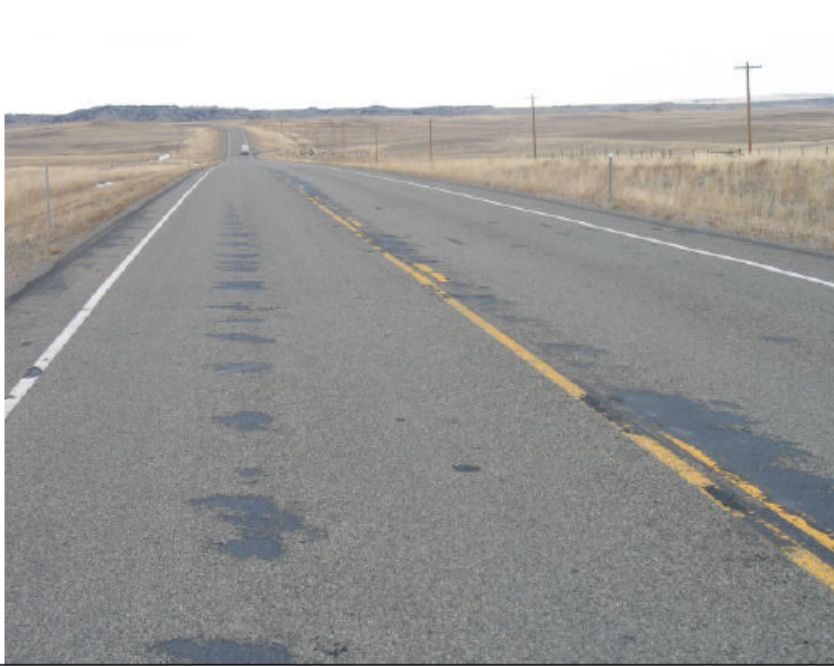
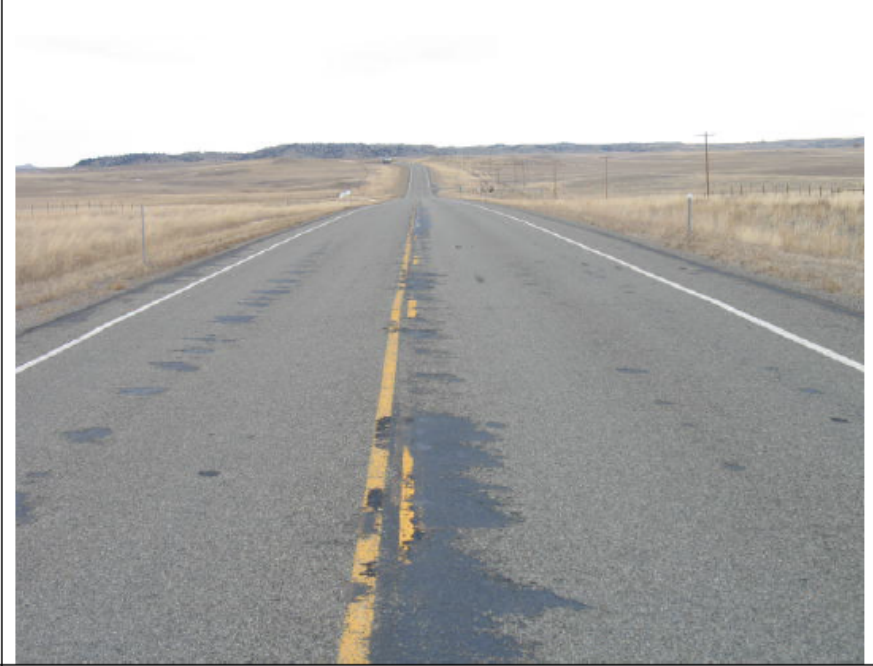
Condition: Cover Material Loss- Snow Plow Damage

- Condition Typically Presents Itself in a Transverse Fashion.
- Accompanied by Tell Tale “Chatter Mark” Effect.
- Damage Typically Located at, or Near, Roadway Crown, Quarter Line, And Shoulder.

- Contributing Factors Include Plant Mix Surfacing Smoothness & Snow Plow Speed.
- Areas Determined as Having Damage Resulting From Snow Plow Activities Are Not Subject to Seal Coat Warranty Provisions.
