# **Structural Health Monitoring in Virginia**

Bernie Kassner, Ph.D., P.E.

Southeast Bridge Preservation Partnership Meeting

April 14, 2015

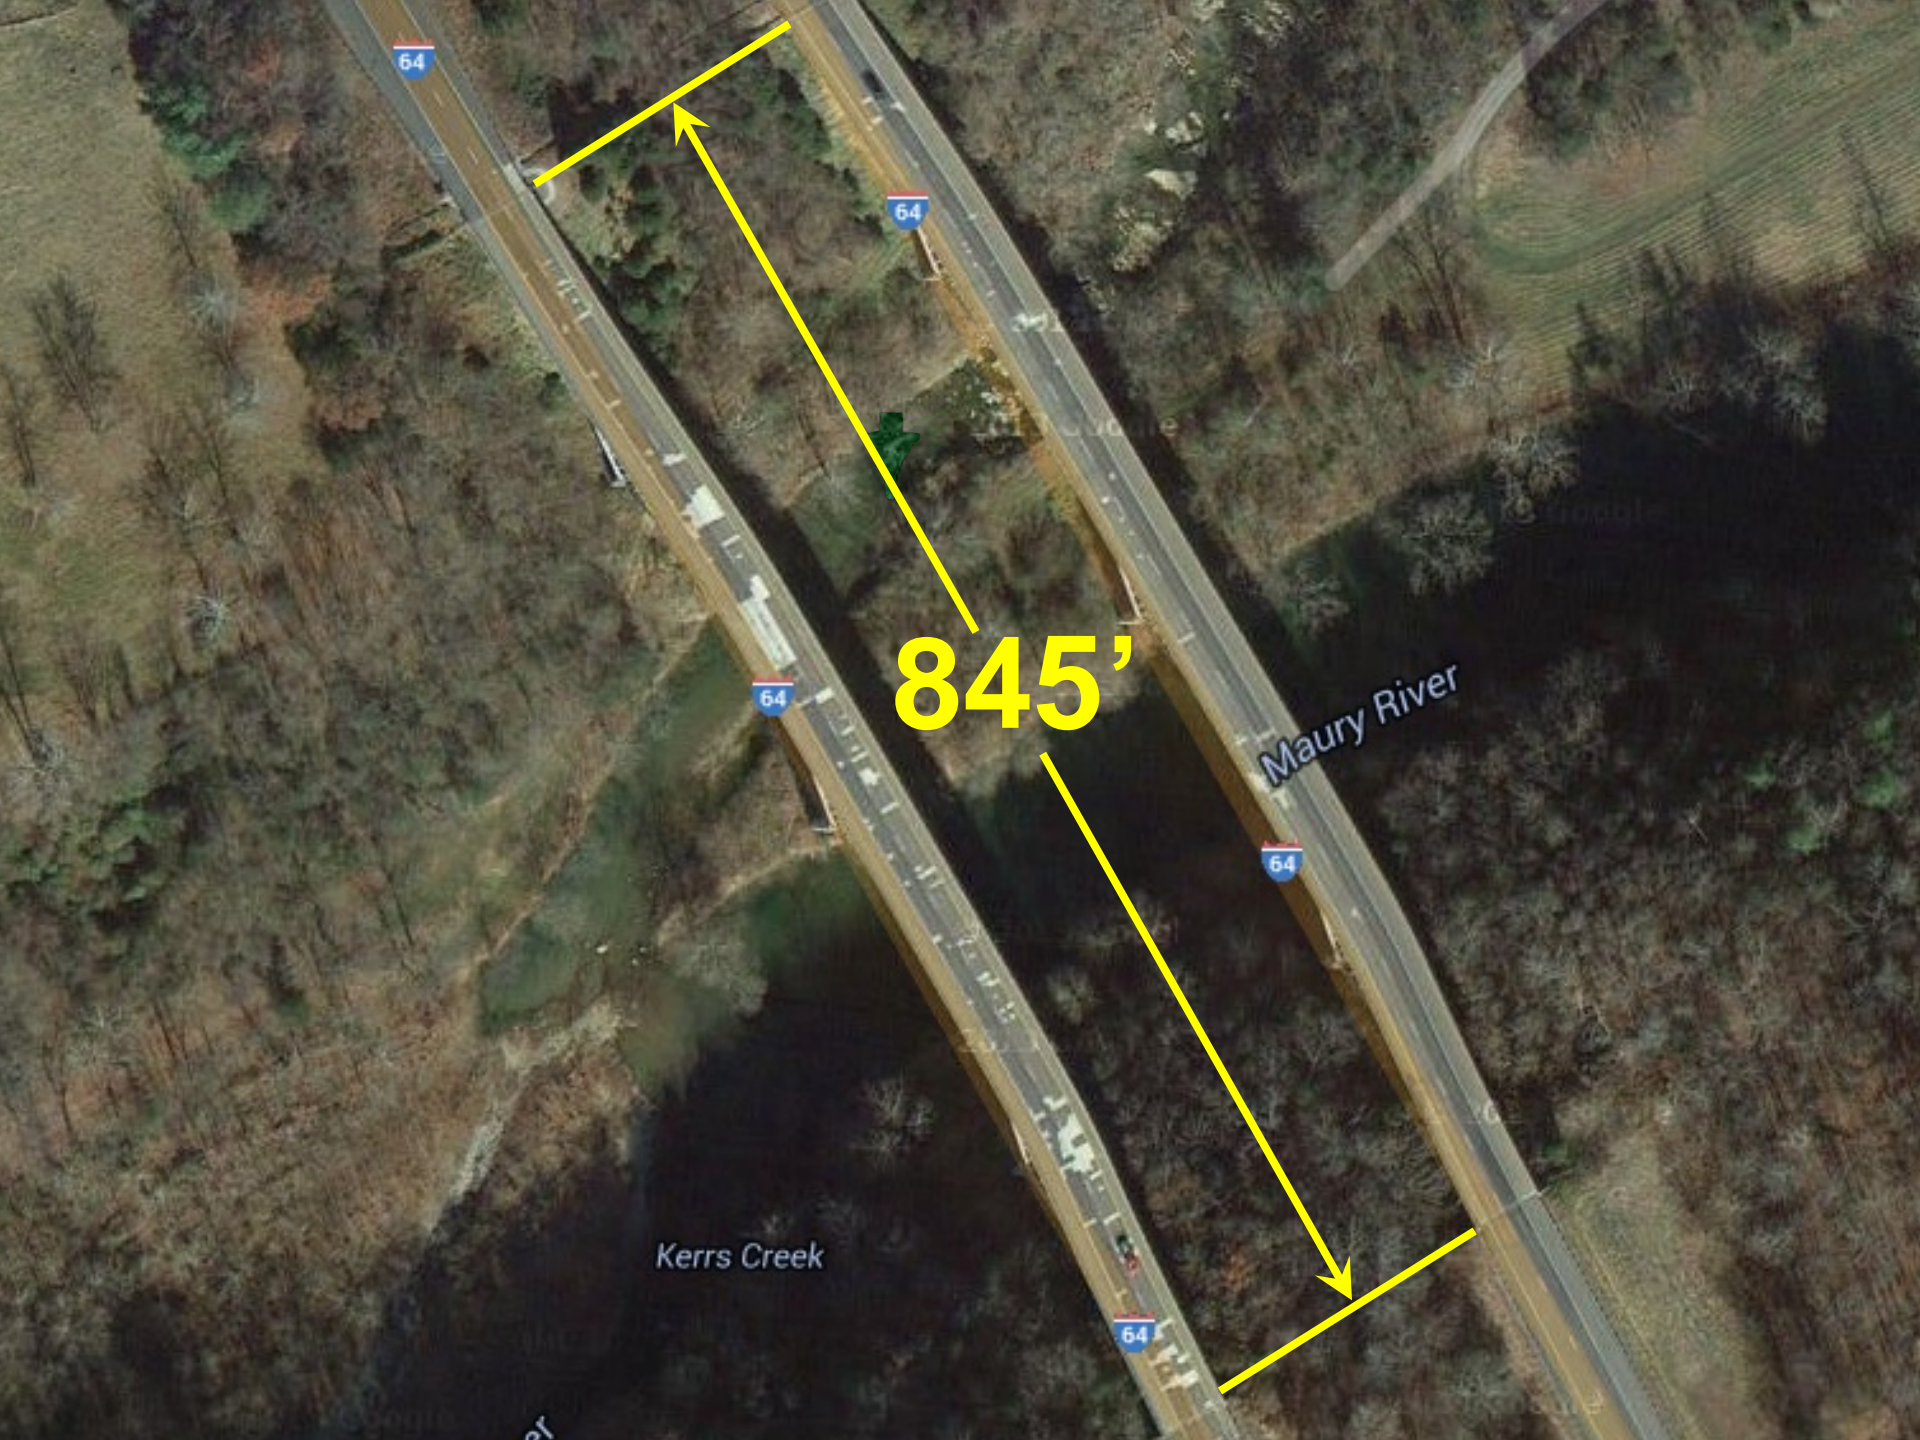
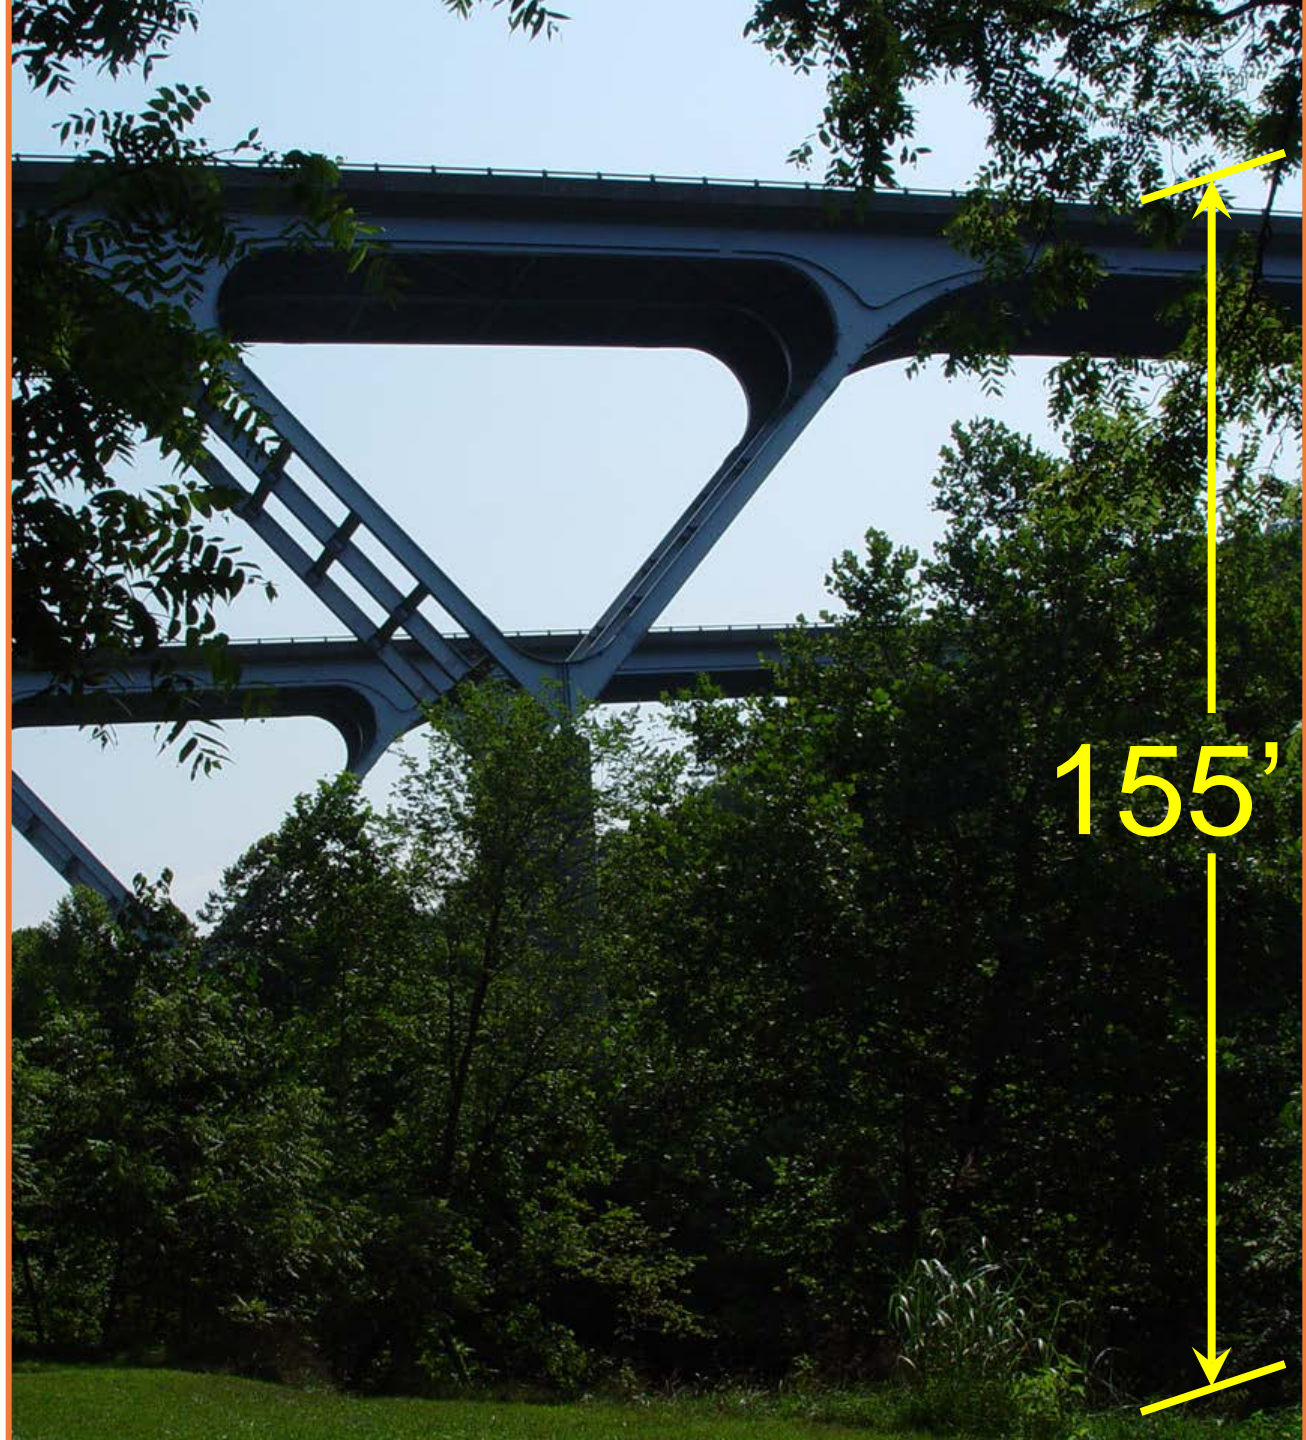
845'

Maury River

Kerrs Creek

155'

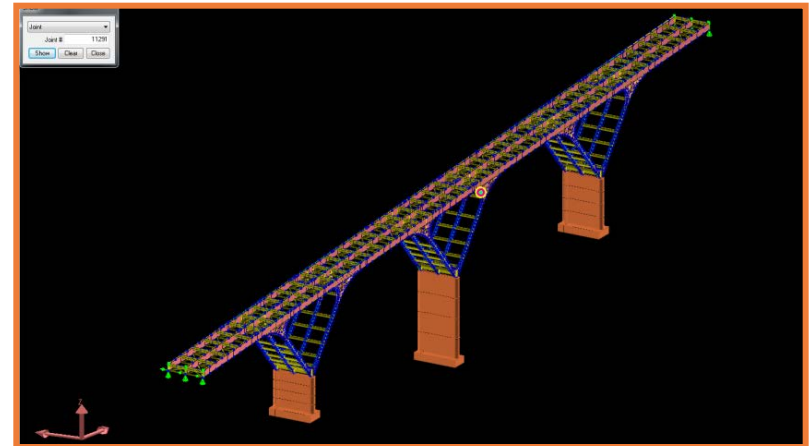
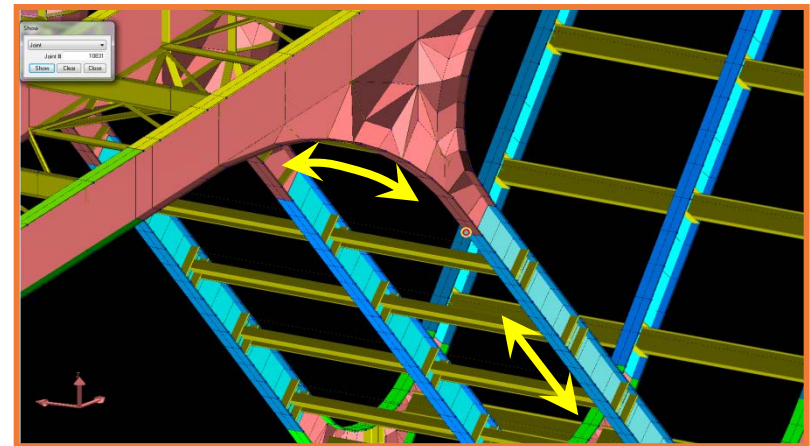
- Motivation for Monitoring
  - + Concrete deck replacement
  - + Complex structure
  - + Modeling showed areas of large stresses / movements
  - + Monitoring needed during construction

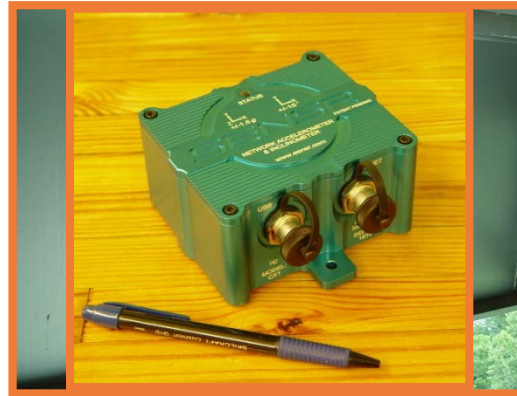
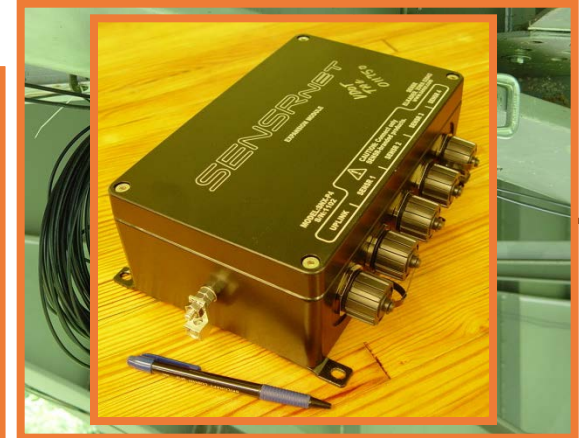
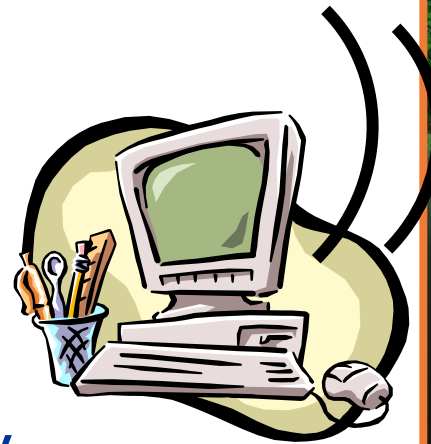
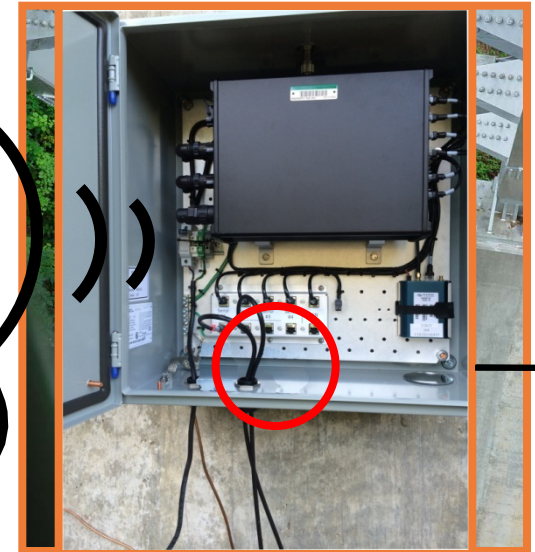
- Instrumentation:  
SENSR CX-1
  - + Acceleration in 3 directions
  - + Rotations in 2 directions
  - + Temperature
  - + Range of 750 ft
  - + Data collected remotely
  - + System is power-hungry

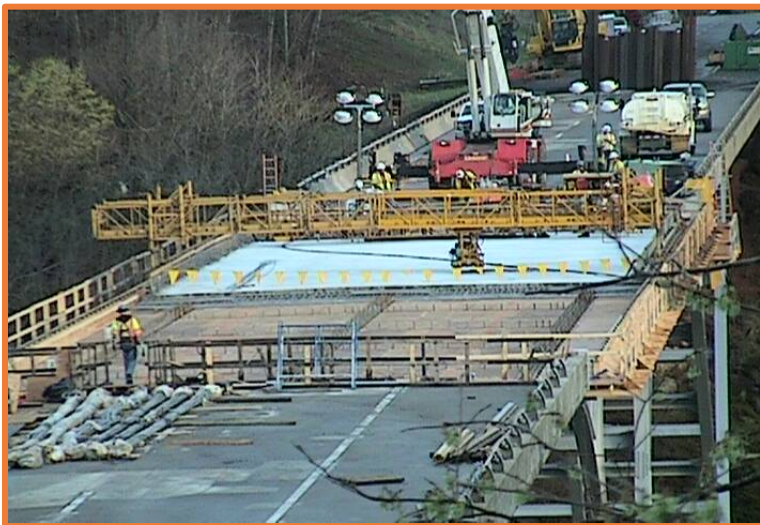
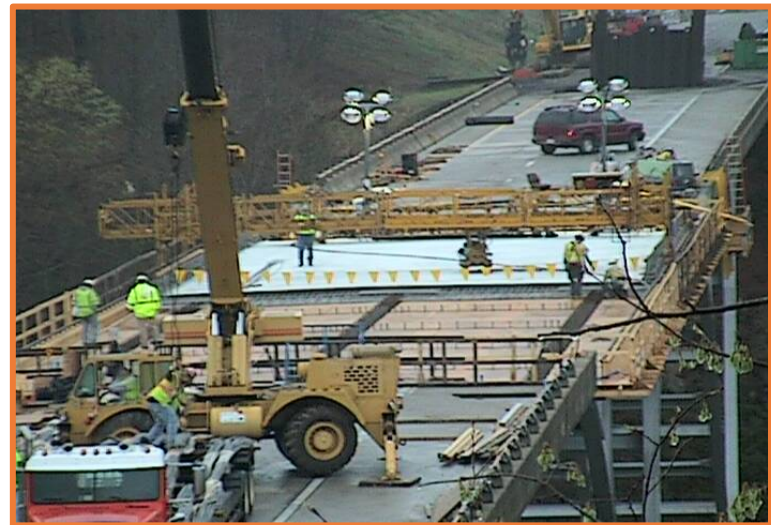
- Monitoring
  - + Continuous throughout each phase
  - + Alert can be sent if threshold limits are exceeded
  - + Video observation of construction activity
  - + Possible continued monitoring after completion

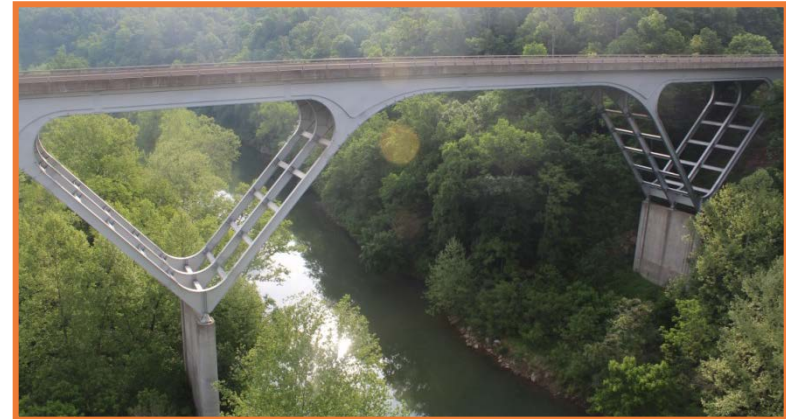
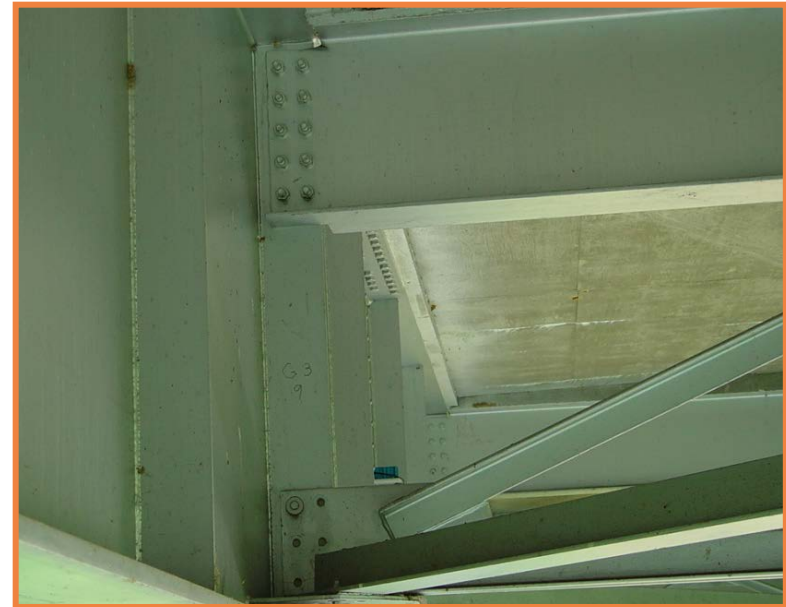
- Thermoelastic Stress Analysis (TSA)
  - + Detection of fatigue cracks
  - + Relies on principle of thermoelasticity:
$$\Delta T_{tE} = -KT\Delta(\sigma_1 + \sigma_2)$$
  - + Uses low-cost IR camera
  - + Some signal processing is required

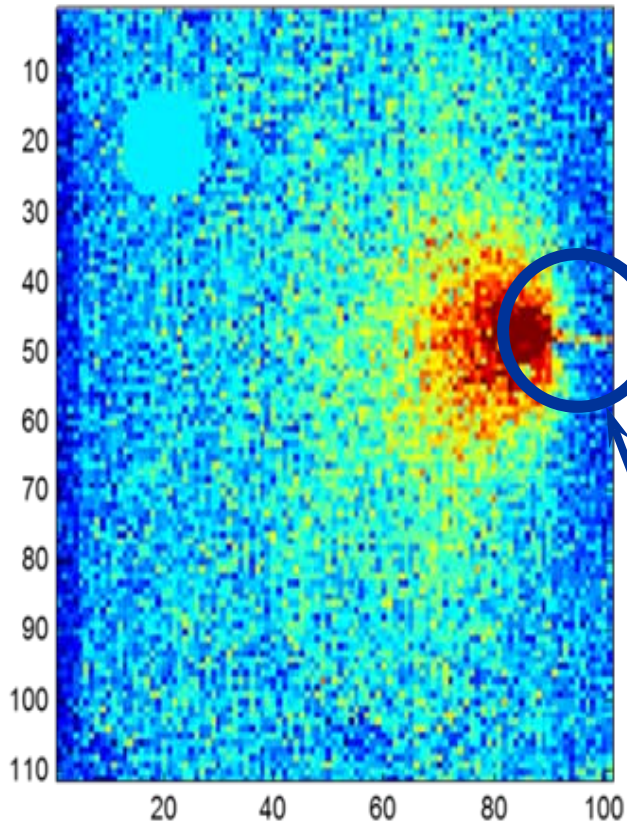
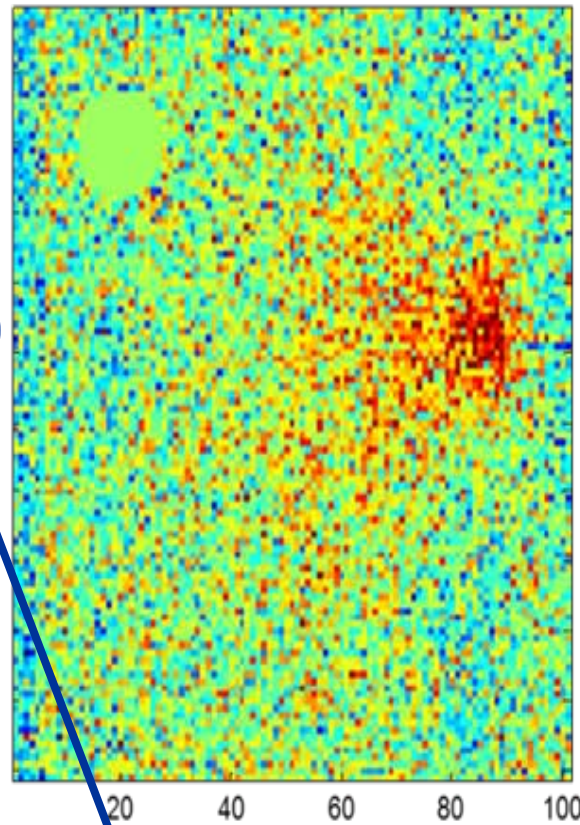
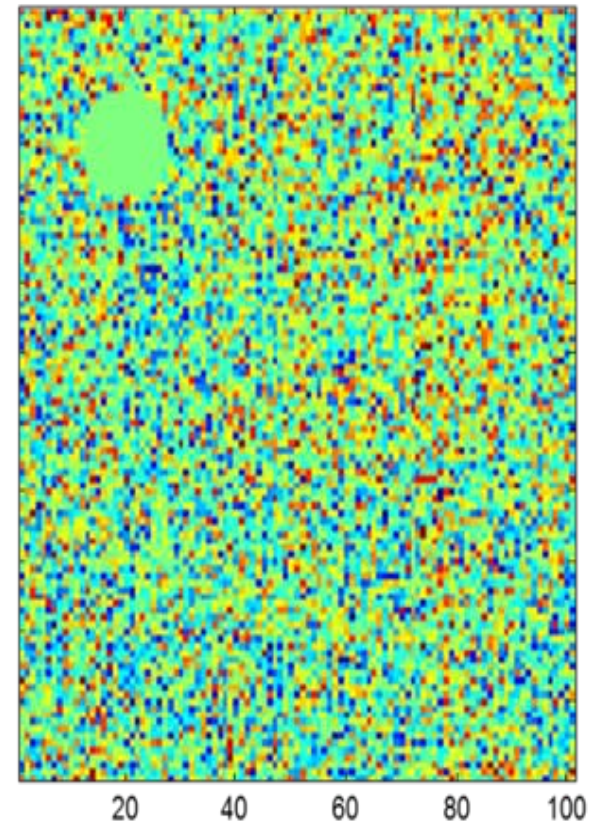
Gross Stress: 14 ksi

Gross Stress: 10 ksi

Gross Stress: 5 ksi

Crack

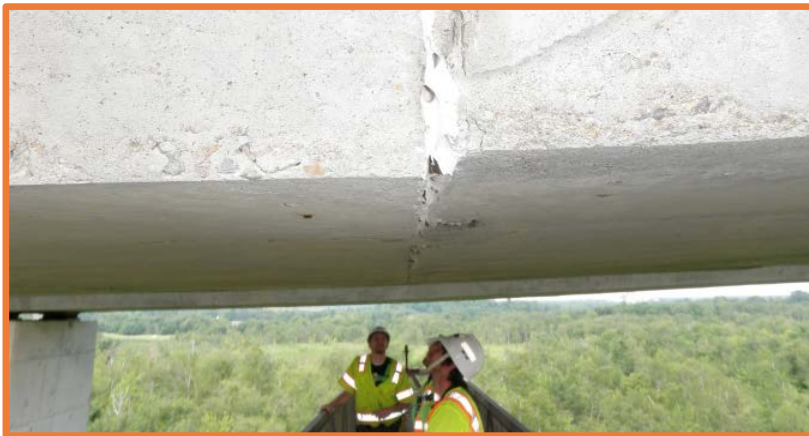
- Visual Inspection
  - + June 2012
  - + Observed 1/16-in. joint opening under normal traffic
  - + 103°F
- Load Test
  - + 294 kip live load
  - + Recorded 1/64-in. opening
  - + 85°F

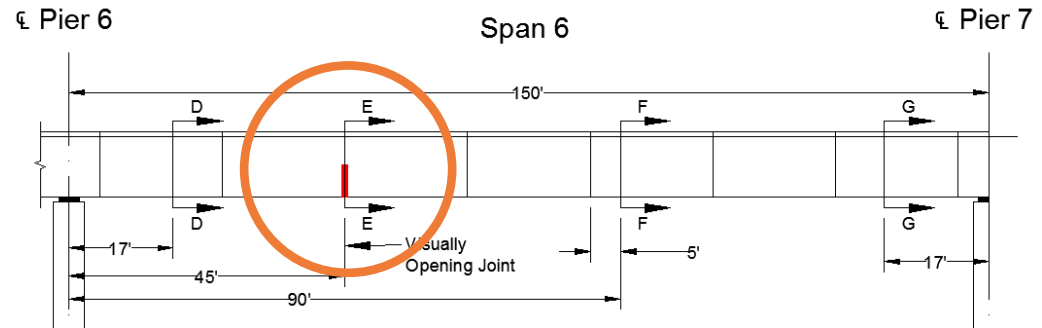
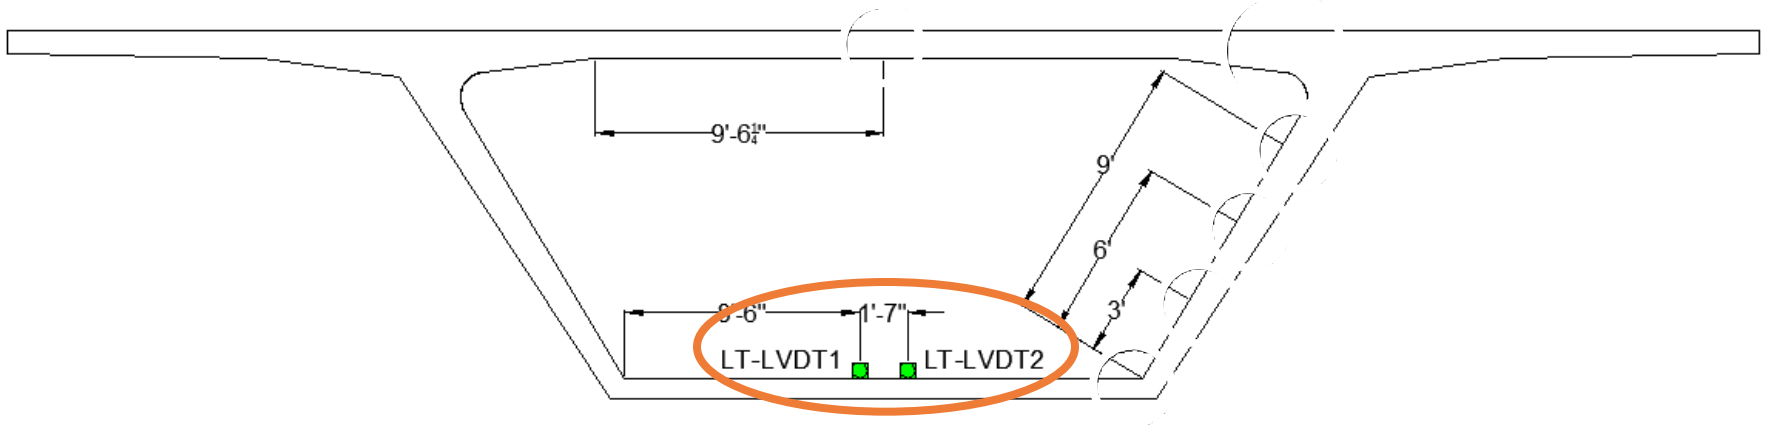
- +2 LVDTs monitoring joint opening

- +1 Strain transducer next to joint

- +24 Thermocouples measuring thermal gradient

- +1 Trigger strain transducer

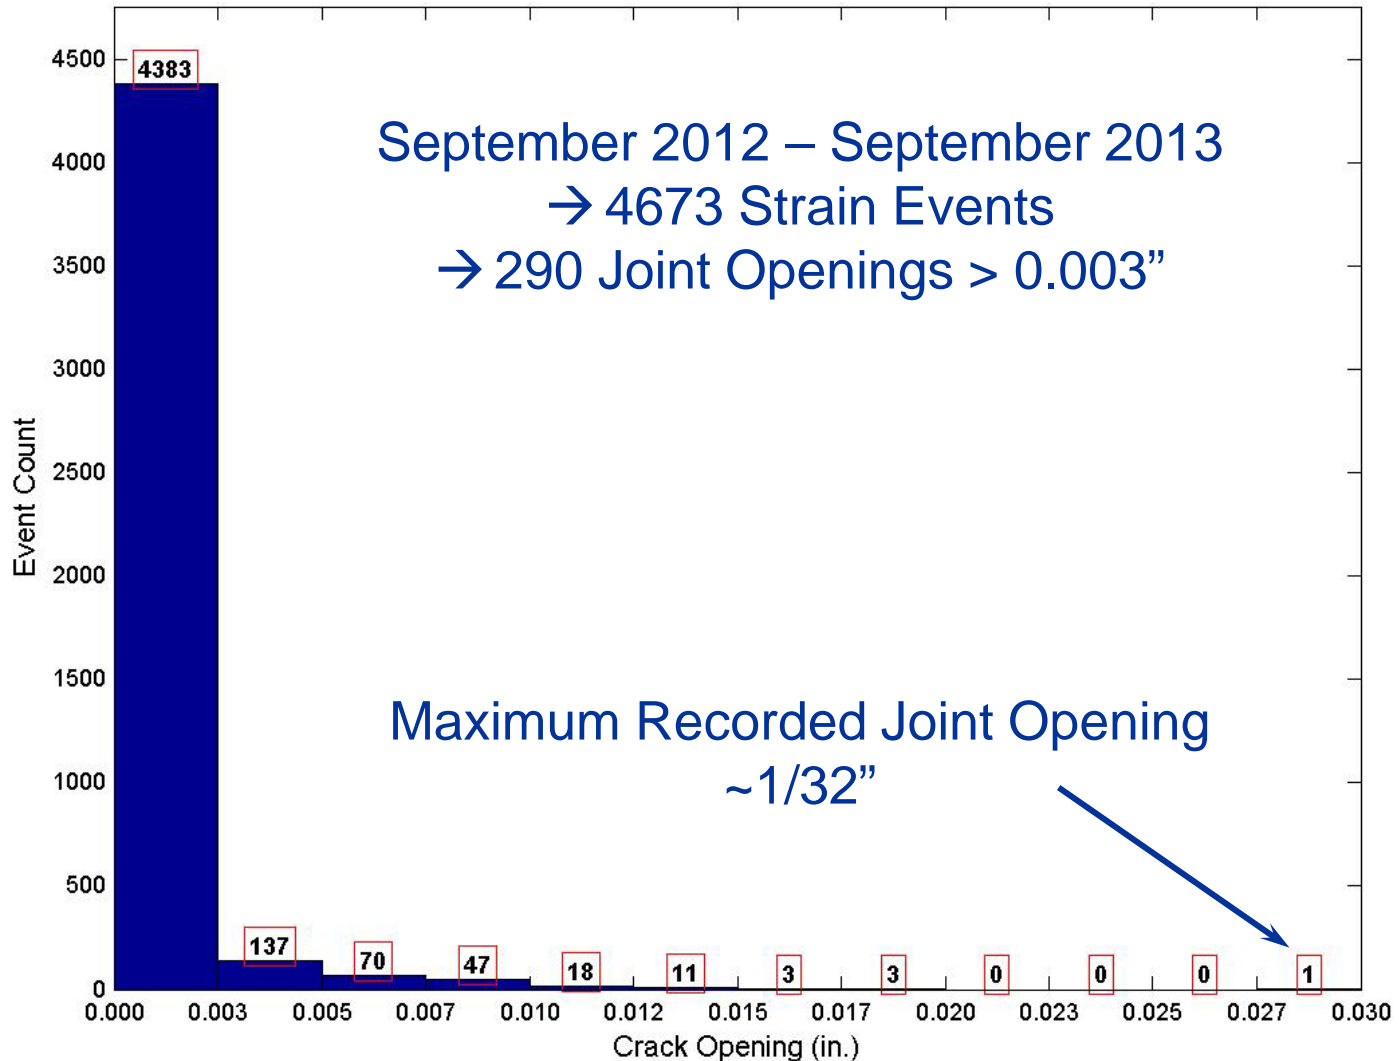
- Long-term Results

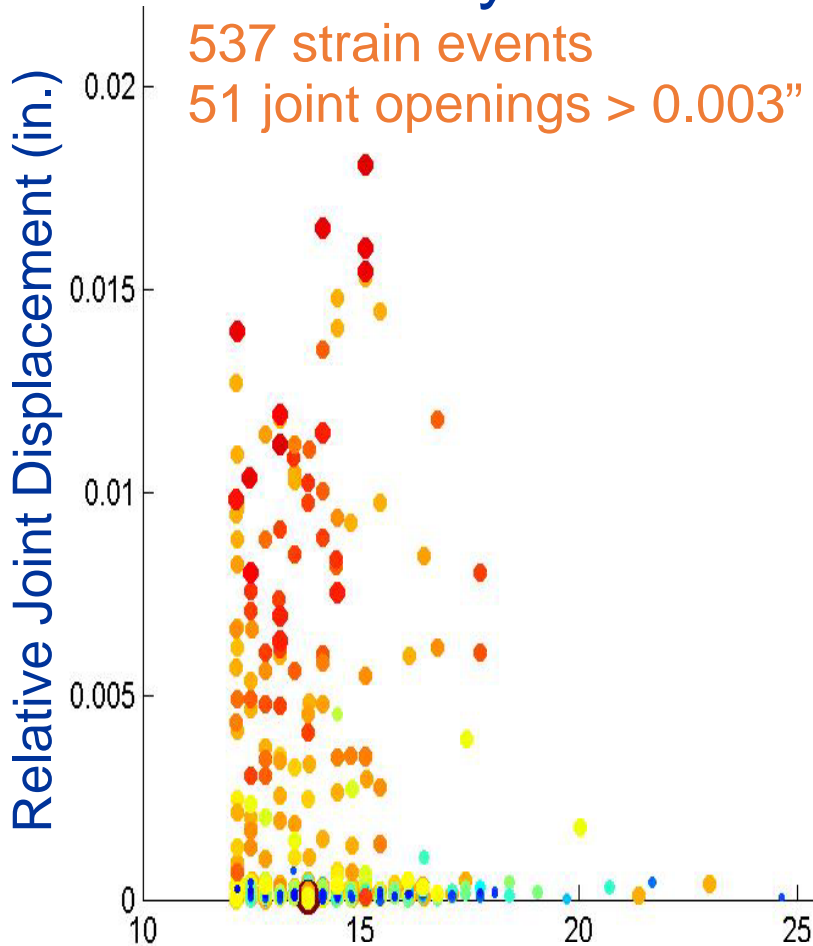
July

537 strain events  
51 joint openings > 0.003"

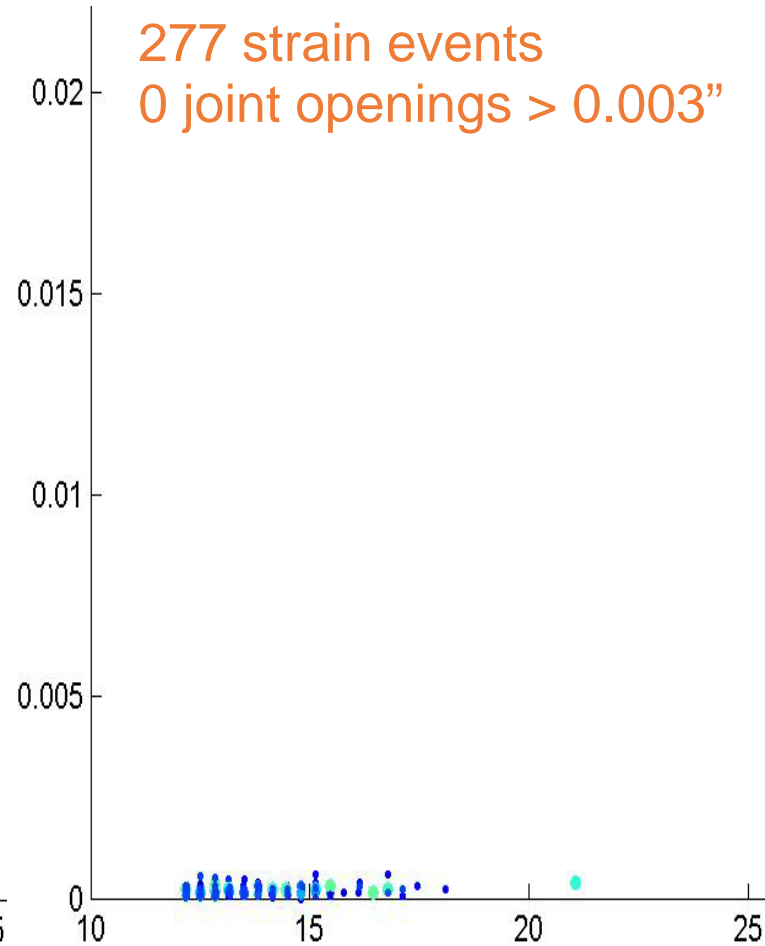
December

277 strain events  
0 joint openings > 0.003"
