Adapting Pavement Preservation Strategies to Significant Changes in Economic Conditions

Don Reid, Paving Manager Metro Nashville, Public Works

**National Pavement Preservation Conference 2016**

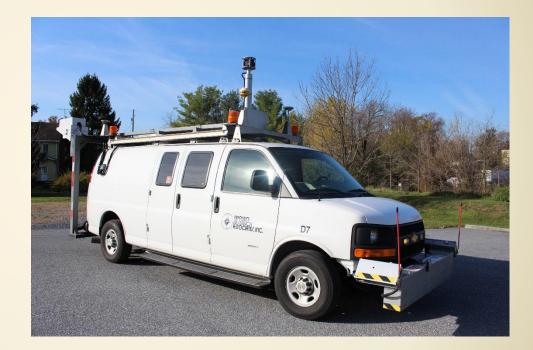
- Digital survey vehicle
- Evaluate ½ of network each year
- Collect imagery, location and laser based data

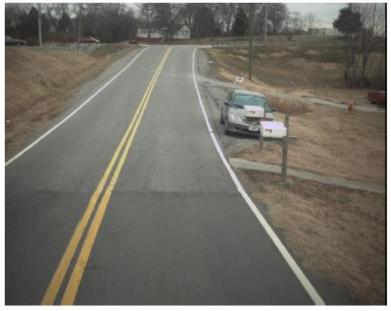
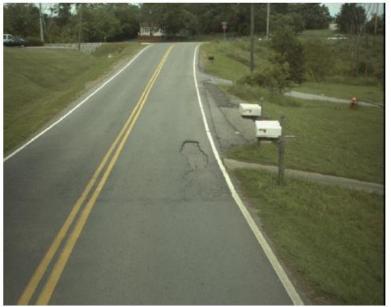
Condition in 2008

Condition in 2011

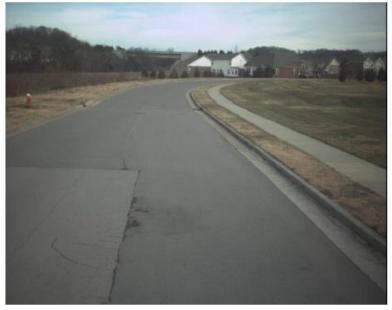
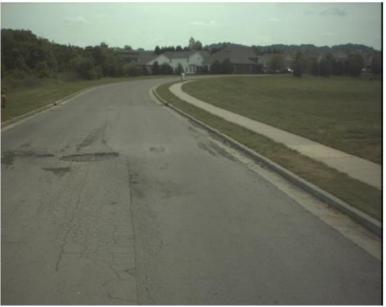
#### Condition in 2008

Condition in 2011

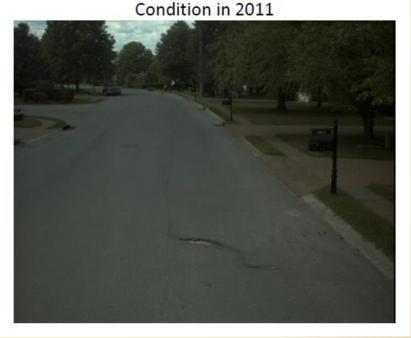
Condition in 2008

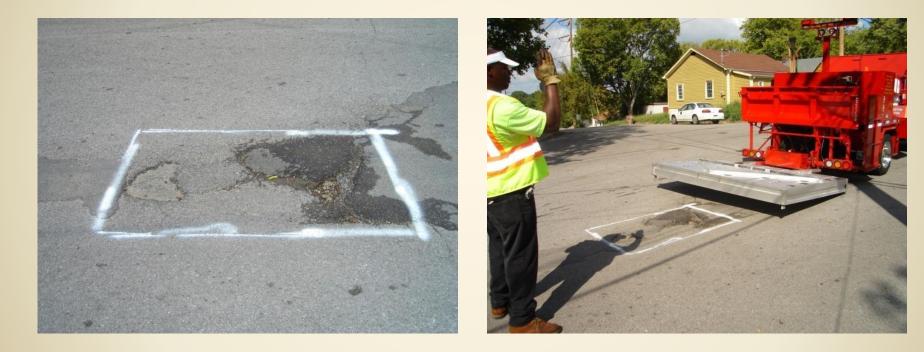
### **Infra Red Patching – Heating**

- Full-depth reconstruction for base failures
- Successful use of infrared patching technology
- Soften asphalt adjacent to pothole
- Steel rake to scarify the pavement
- Add new asphalt and compact
