Beam End Treatments for Steel Bridges

Theodore Hopwood II, P.E.

SEBPP Meeting

April 1, 2016

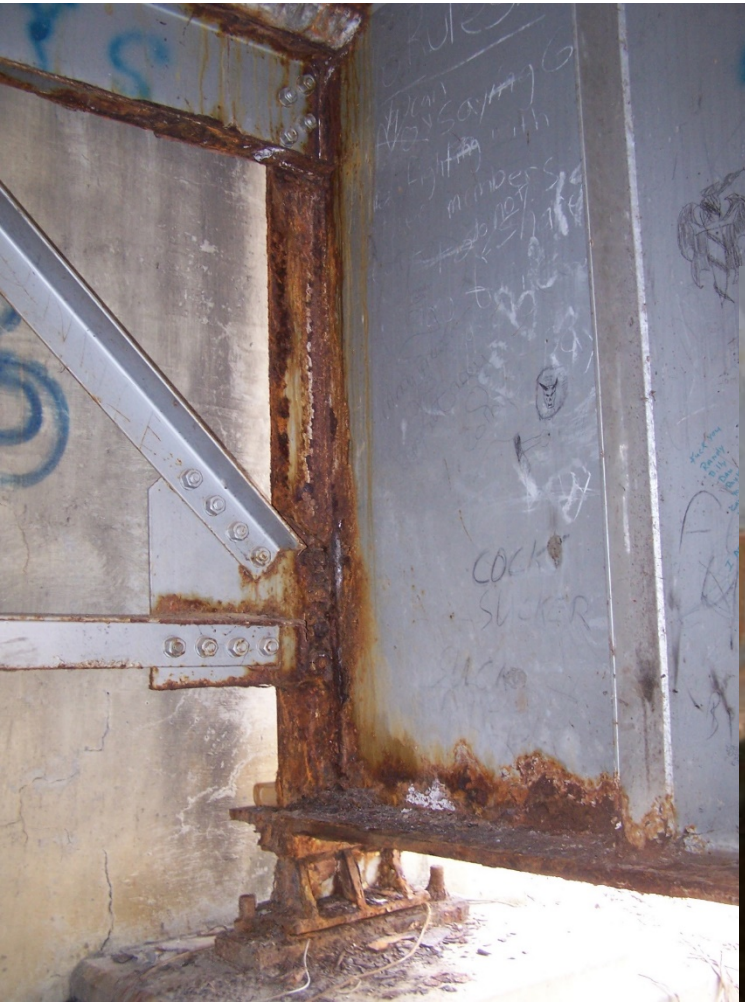
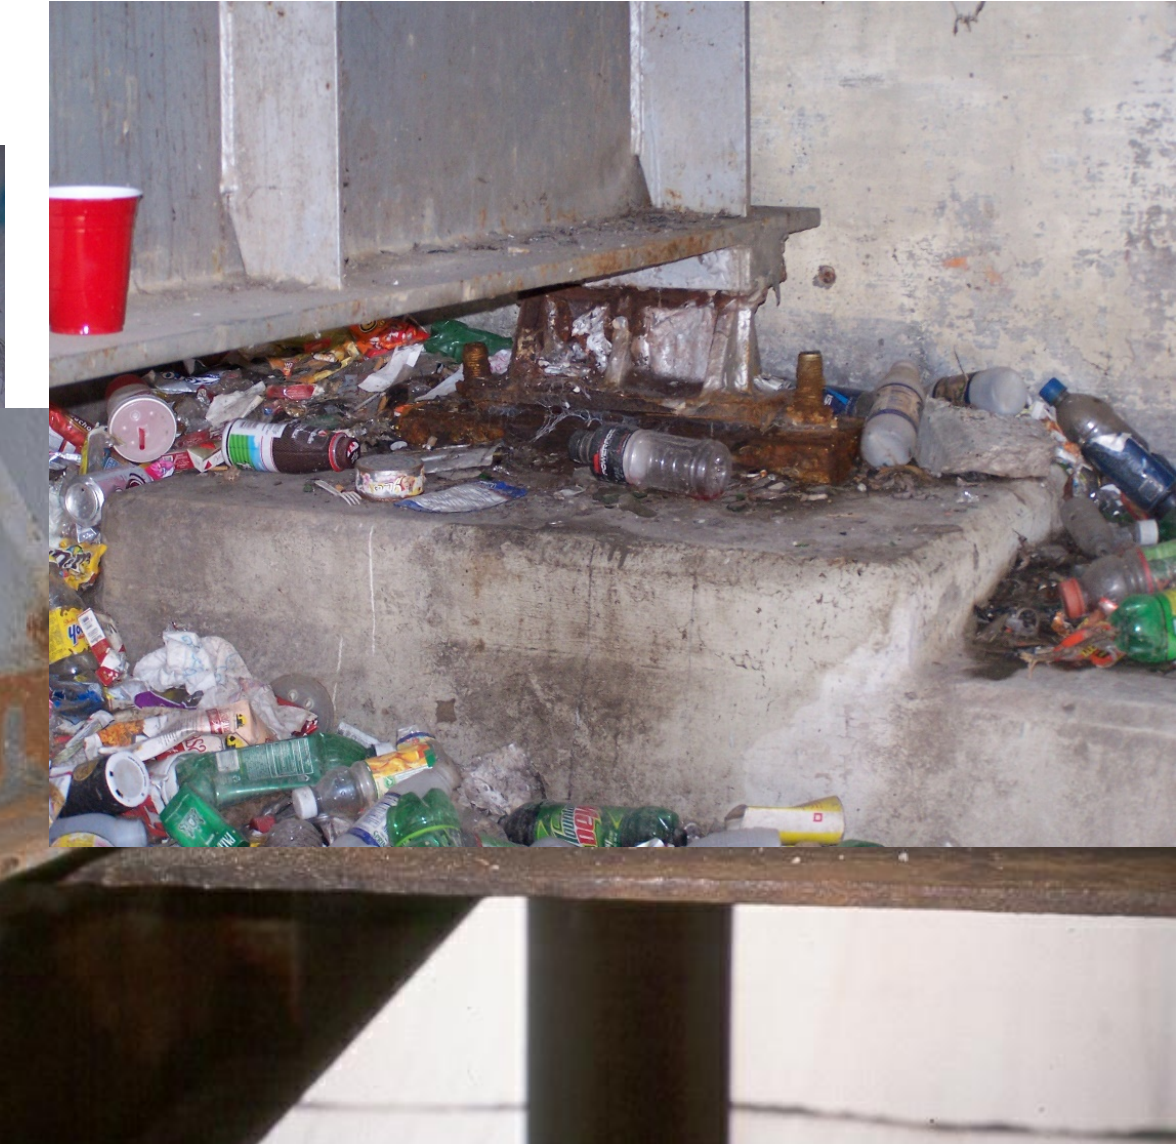
Typical Beam End Issues

- Debris build-up
 - Attracts/retains moisture
- Leaking joints
 - Deck run-off falls onto beam ends, bearings, etc.
 - Extended time of wetness
 - Exposure to deicing salts
- Results
 - Localized premature coating failures
 - Significant corrosion
 - Loss of section on steel members

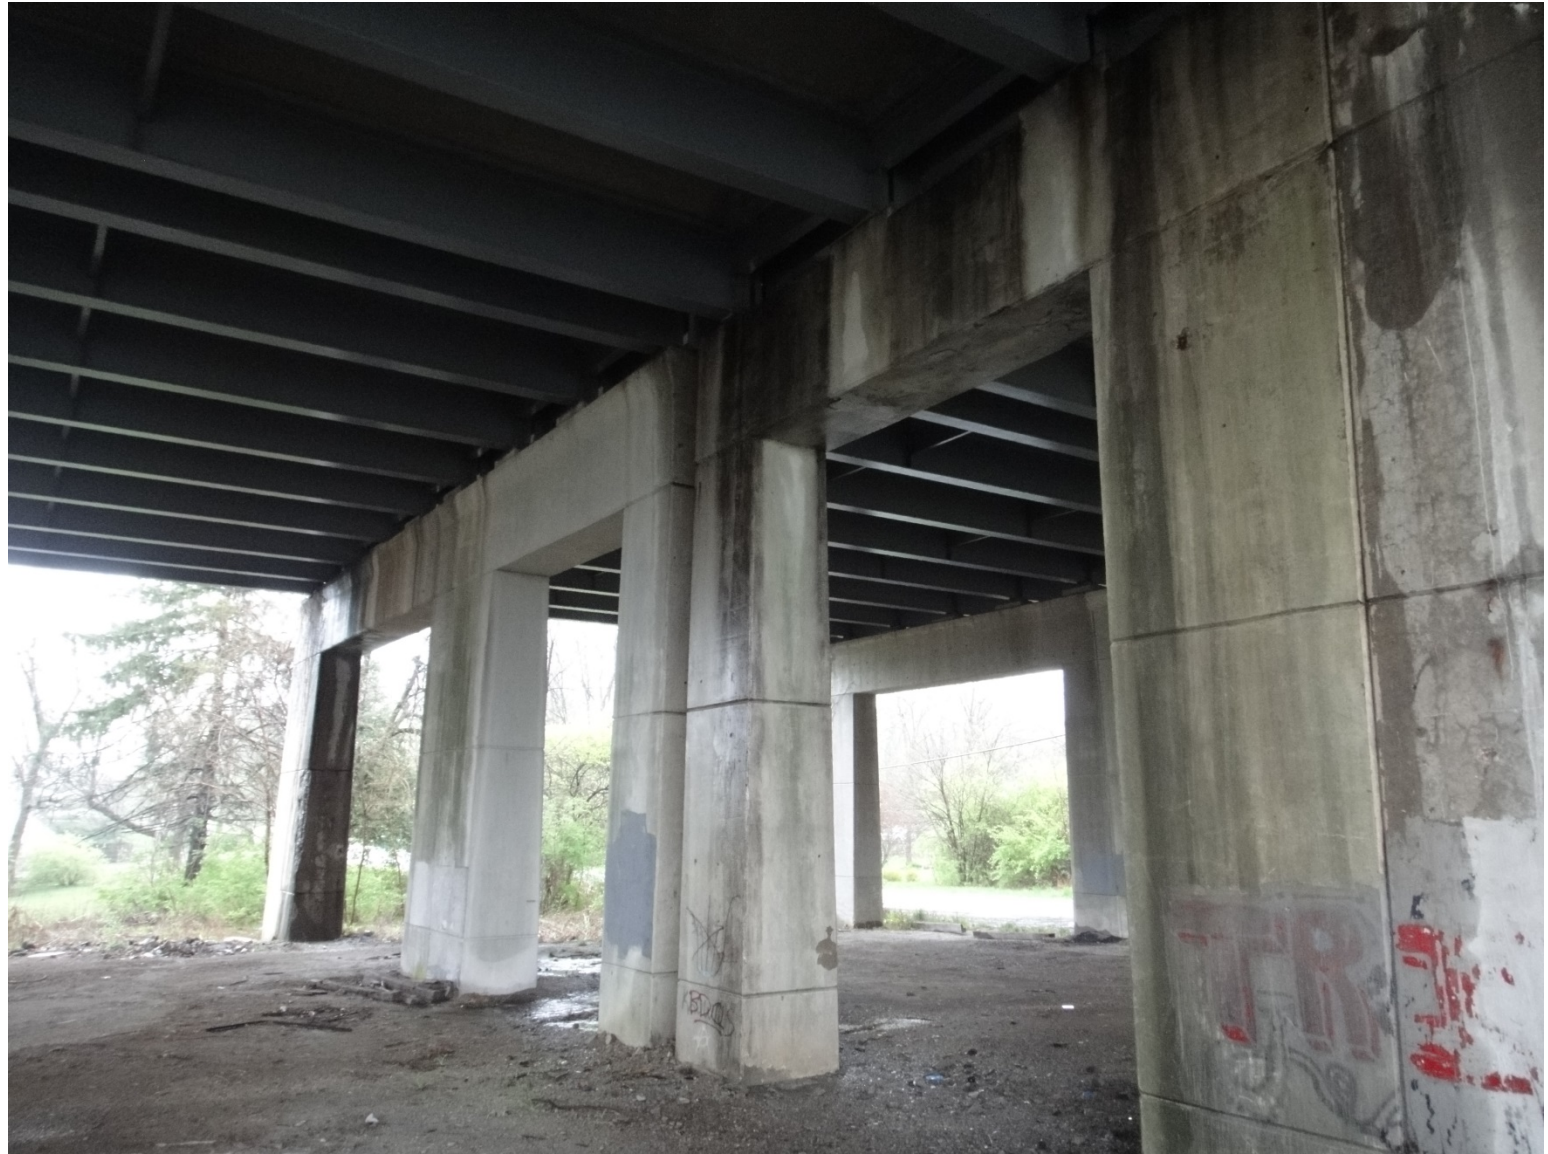
I-64/75 Over US 68

March 2013

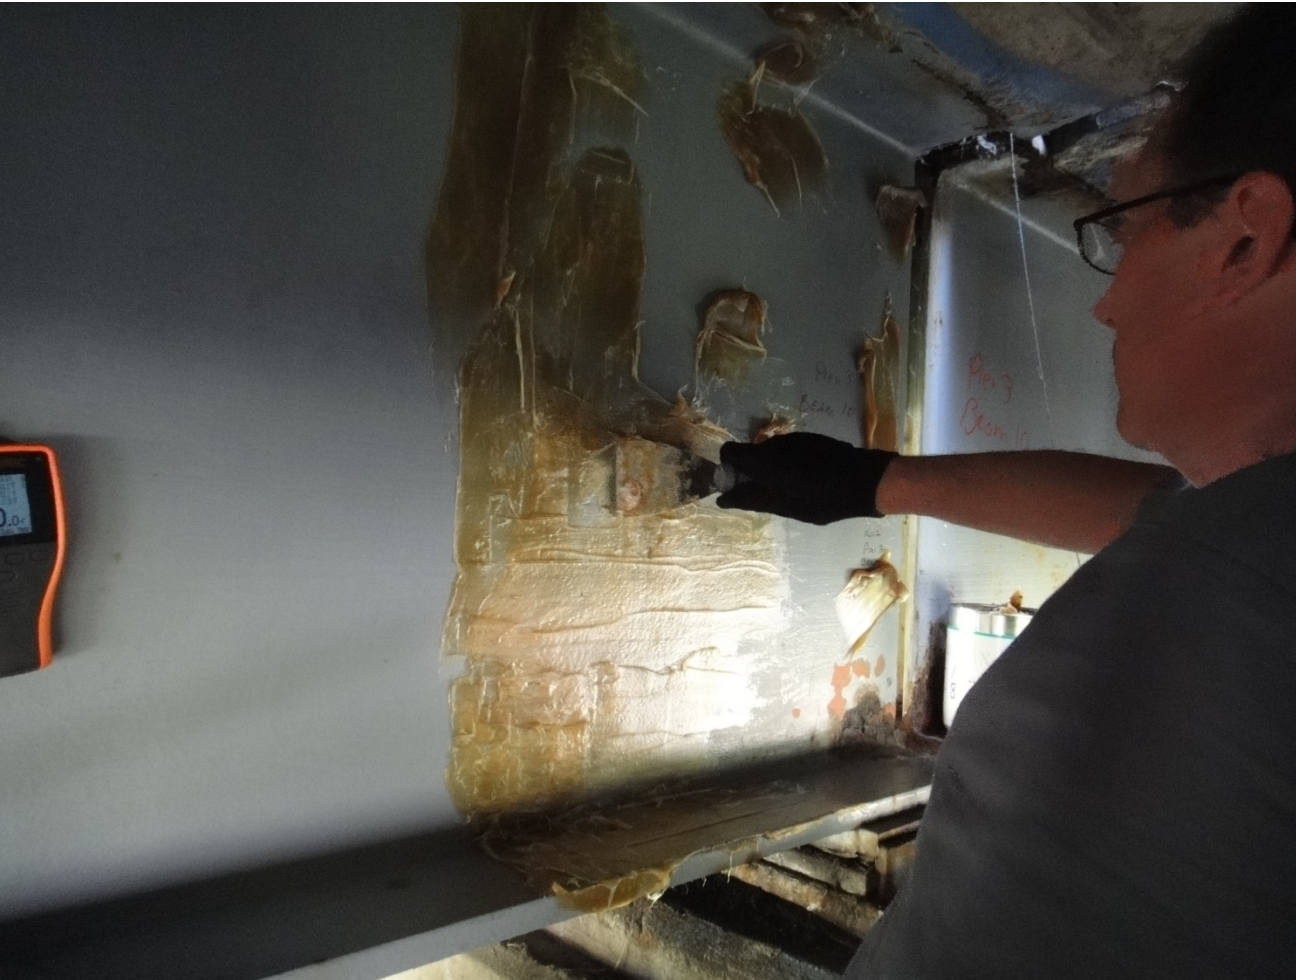
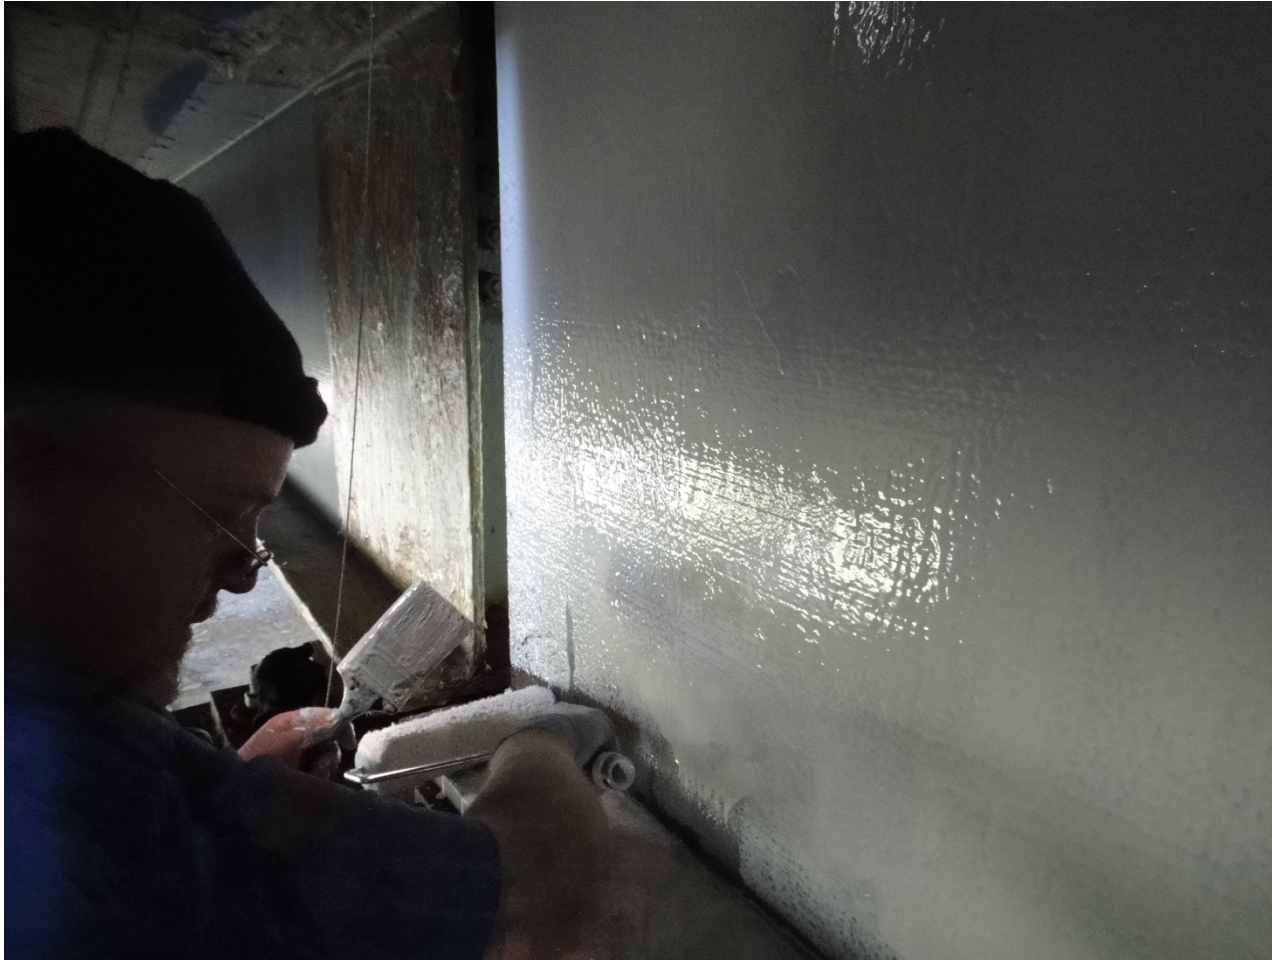
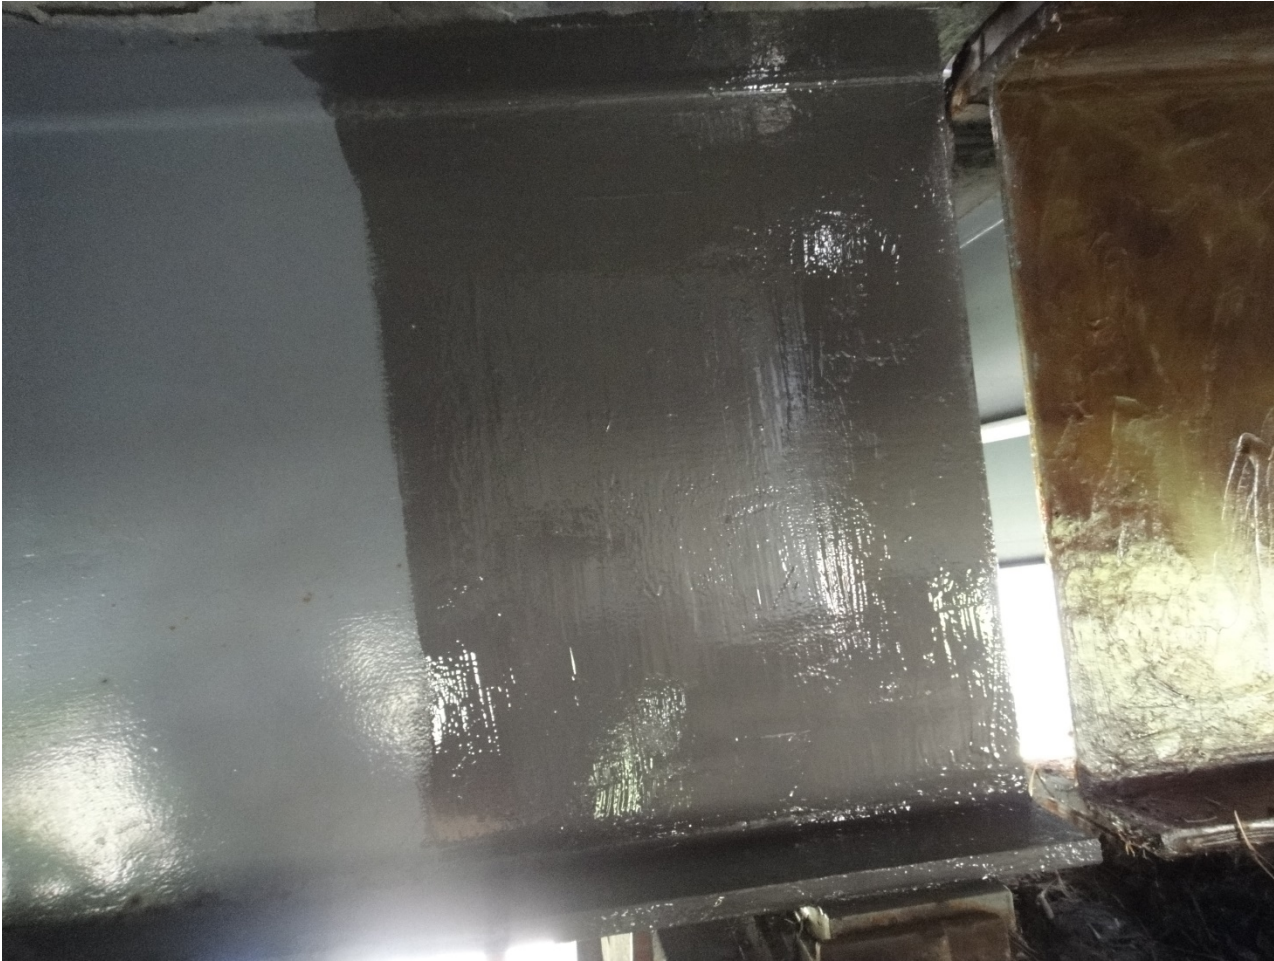
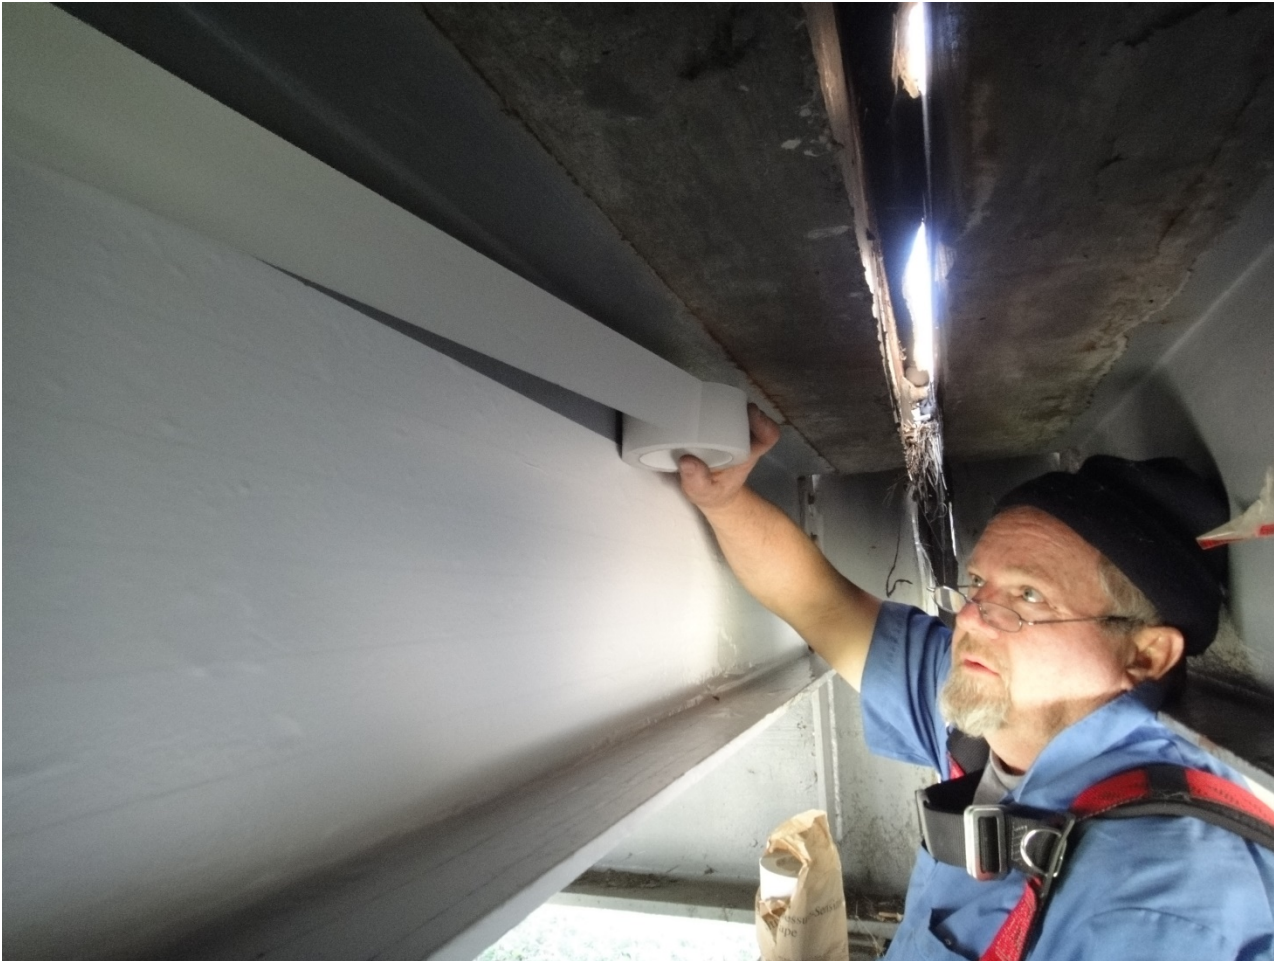
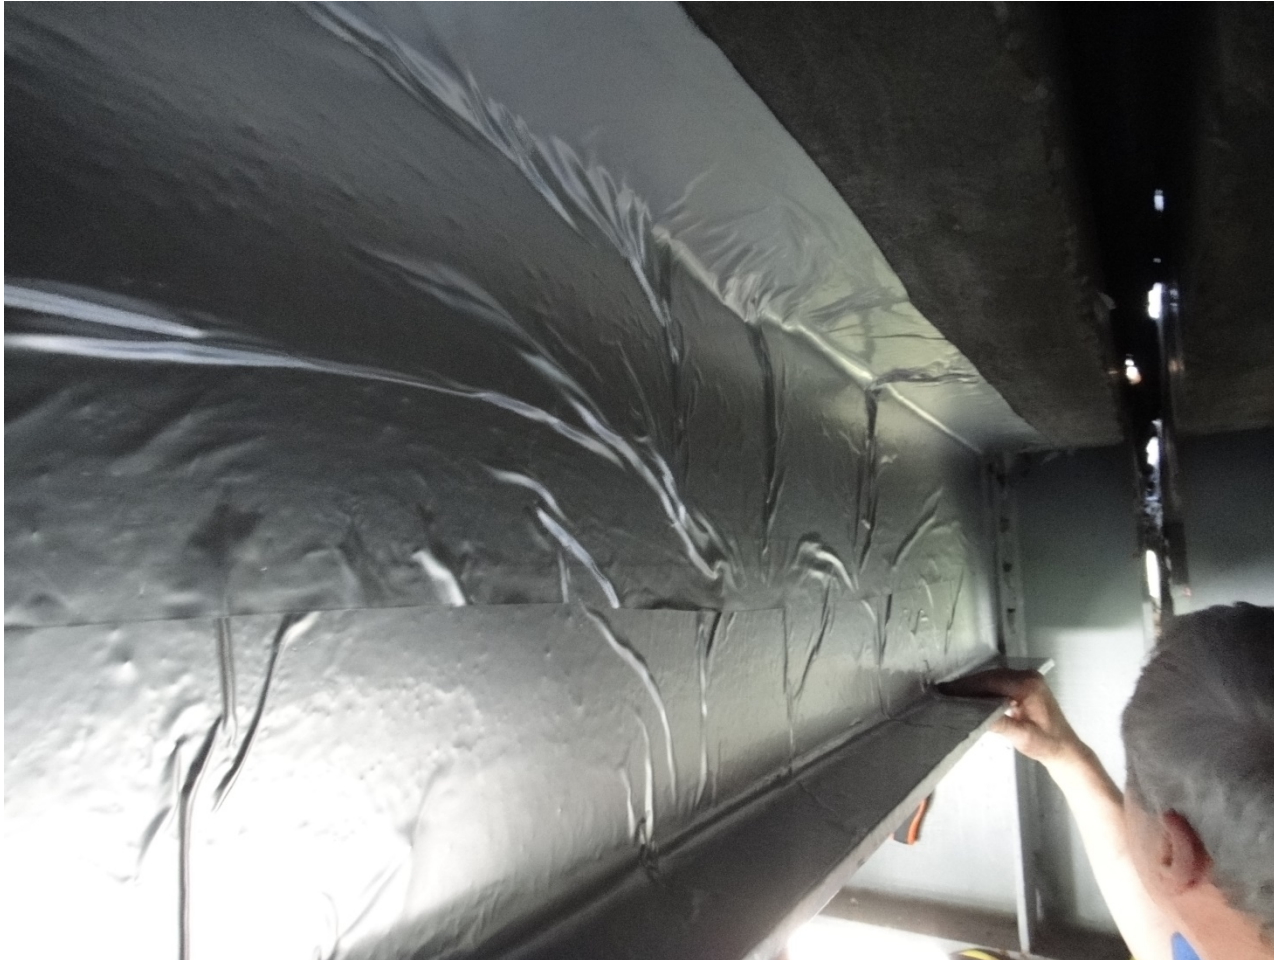
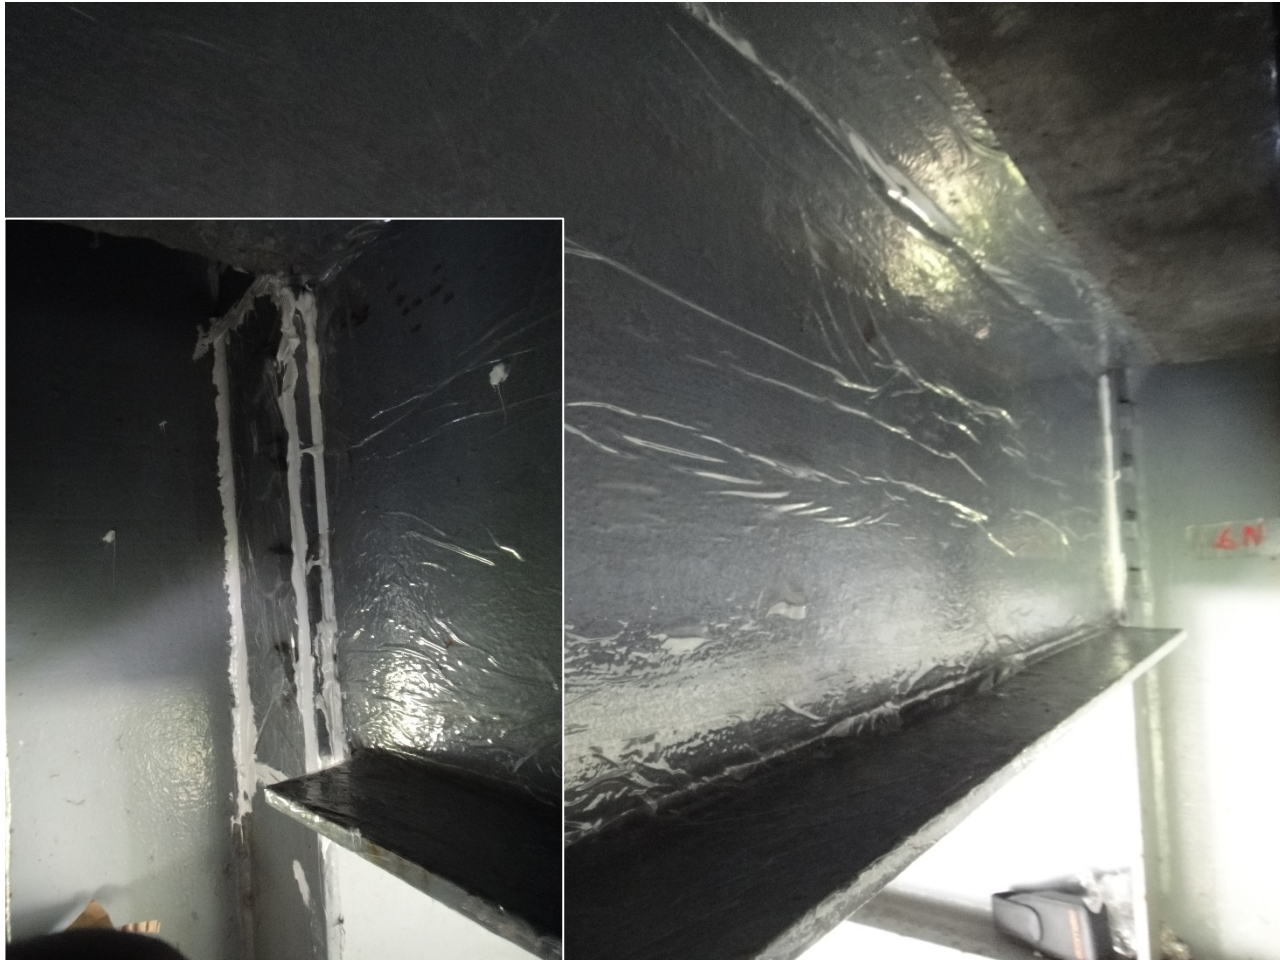
Products Applied to Steel

- KTC looked “outside the box” for solutions
 - Super barriers
 - Tapes (6 tested)
 - Greases (2 tested)
 - Non traditional liquid-applied coatings (2 tested)

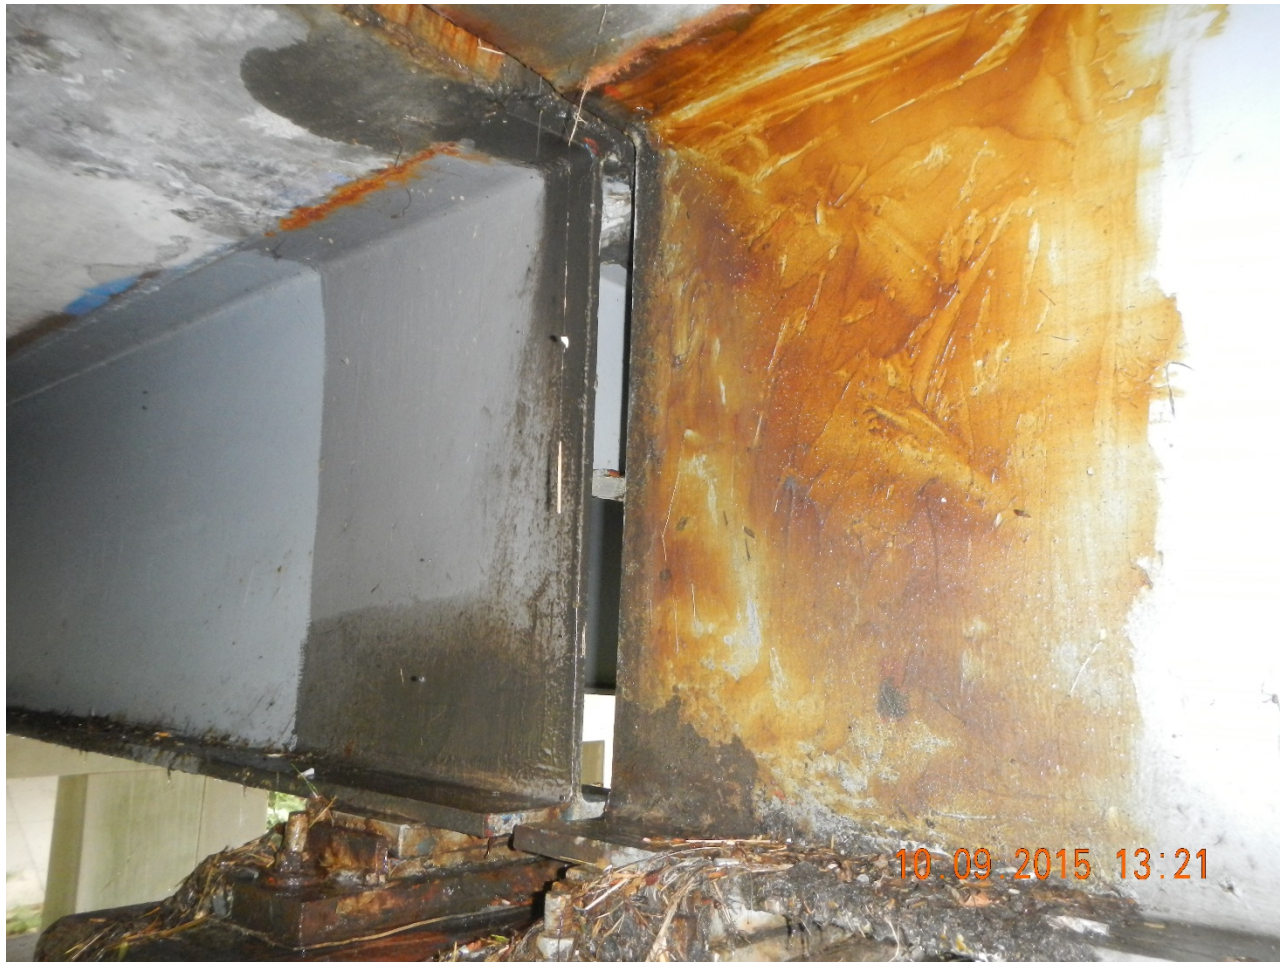
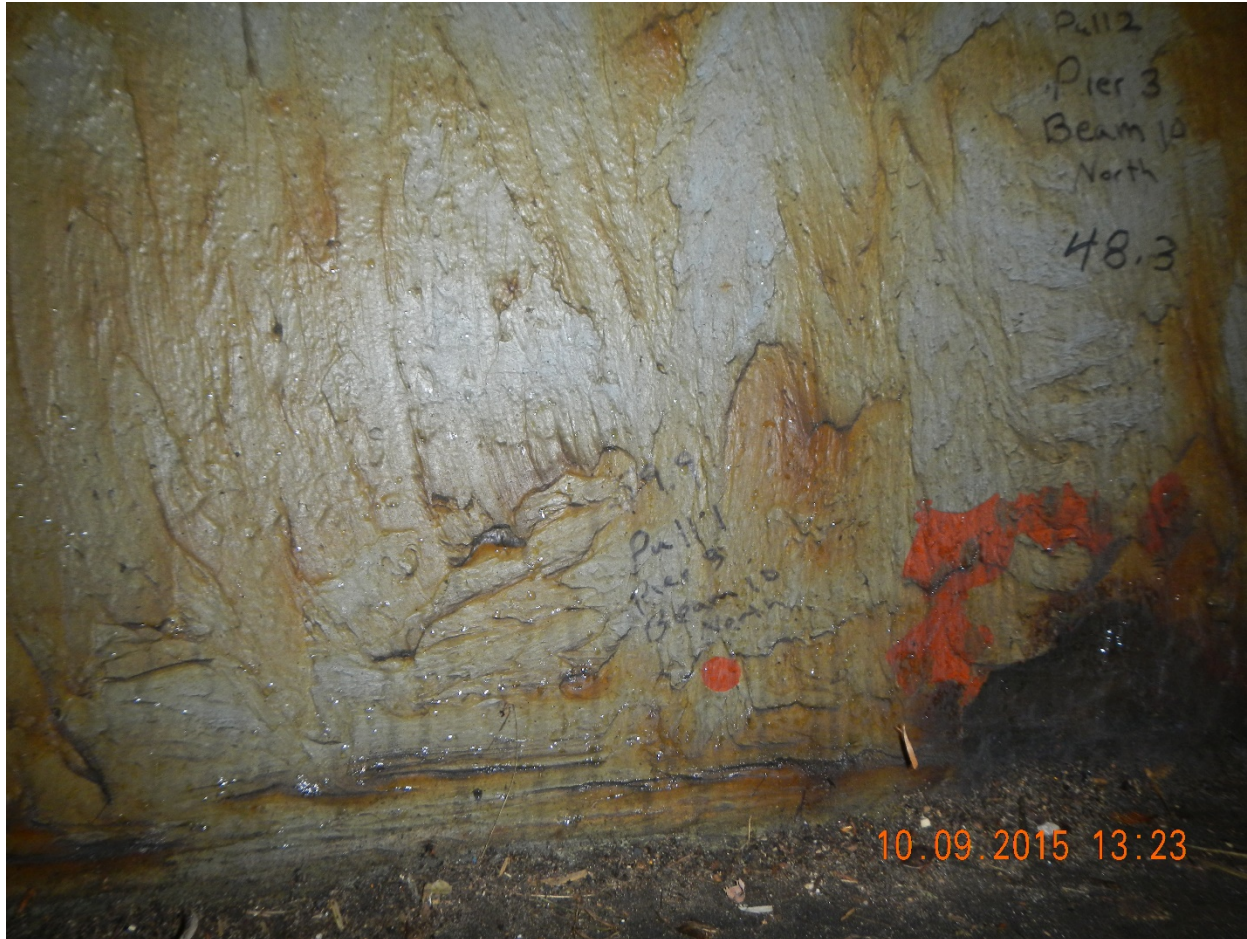
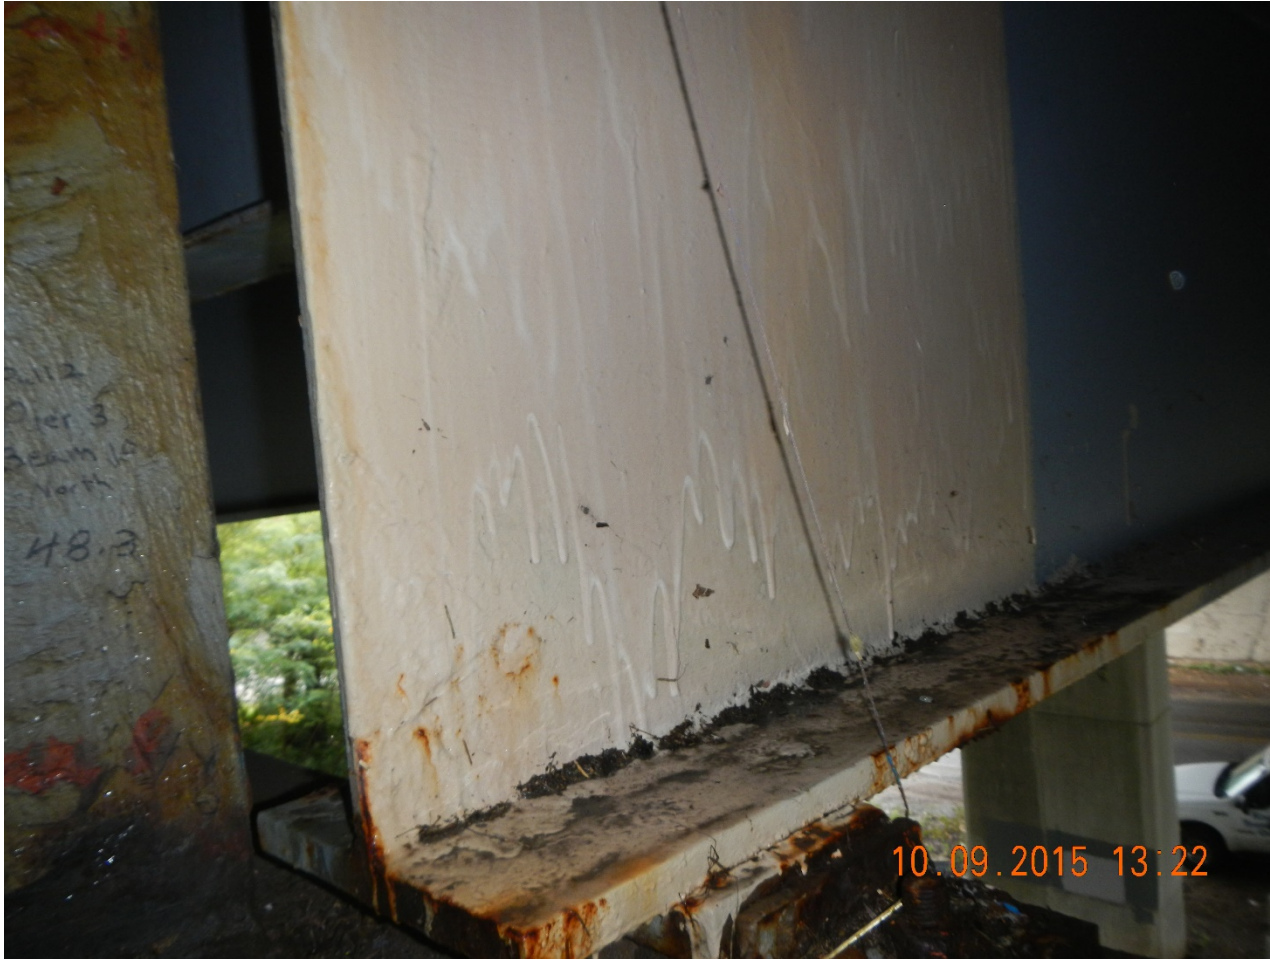
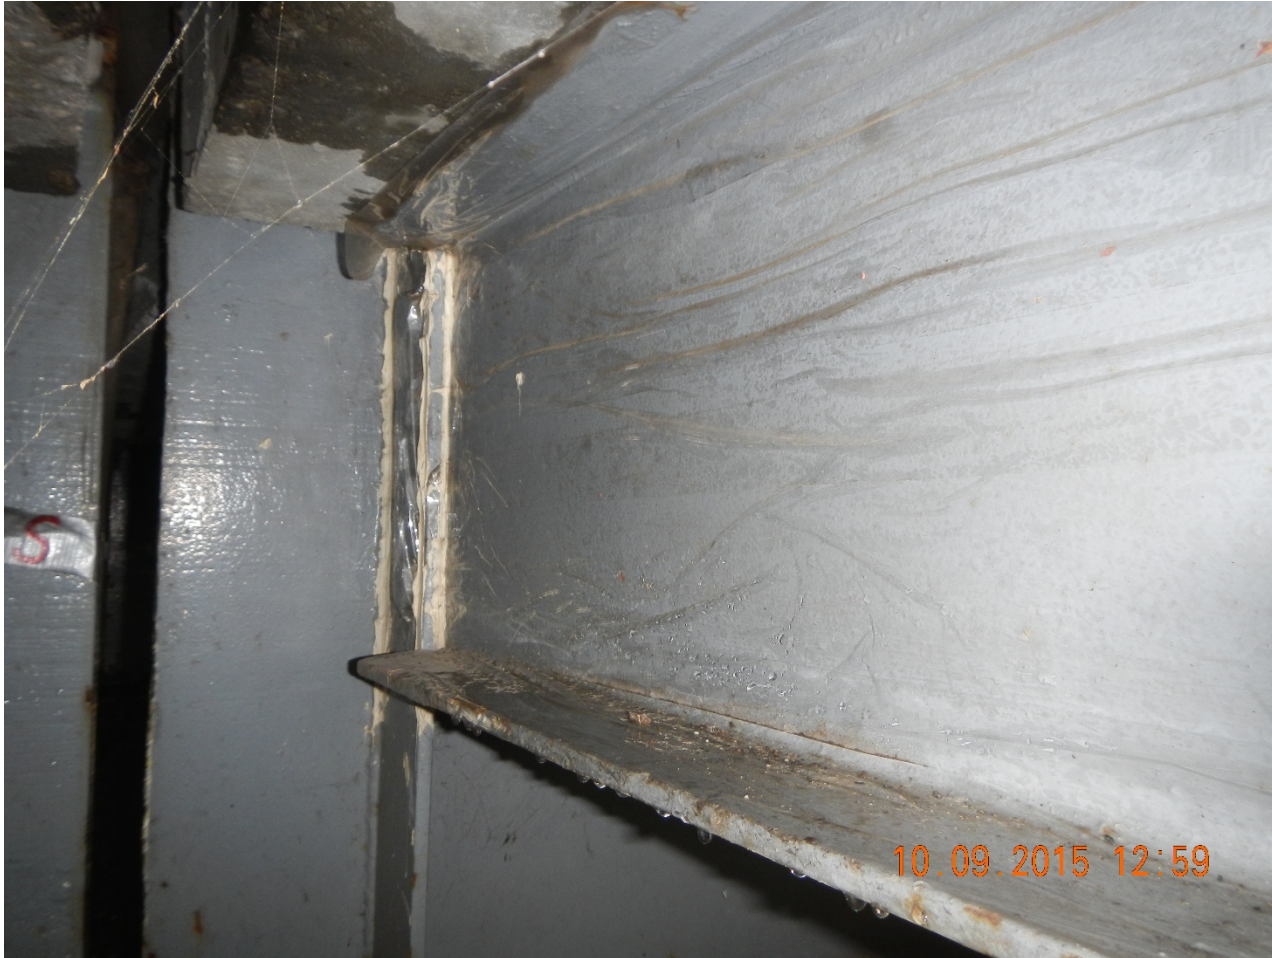
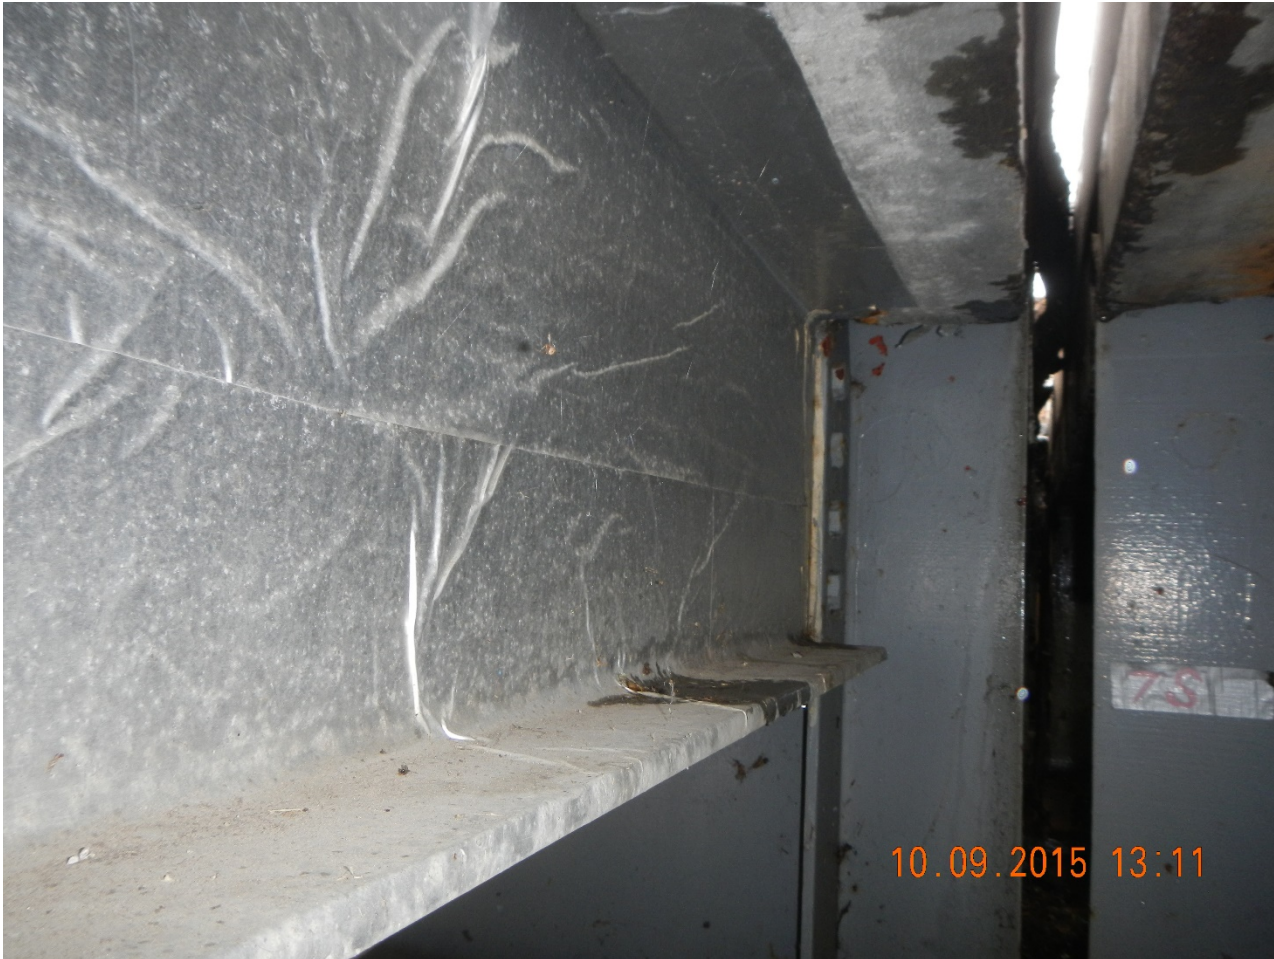
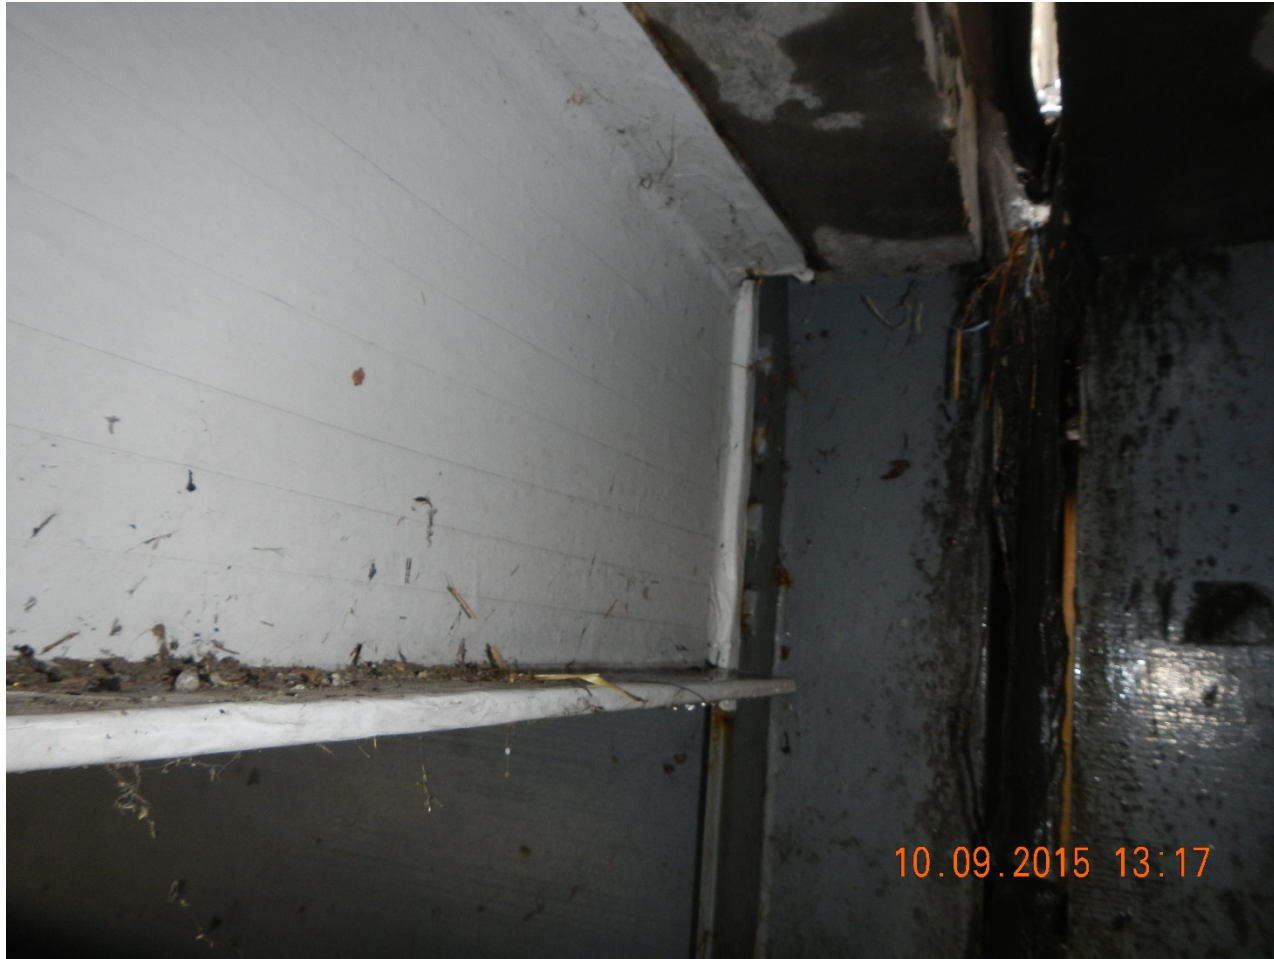
Follow-on Evaluation October 2015

- Effective beam end treatment materials have been identified
- They can be applied with low-tech surface preparation
- They can protect steel in a challenging environment
- The remaining issue will be their durability
