Domestic Scan Advances in FRP Composites

DeWayne Wilson WSDOT Bridge Asset Management Engineer

Western Bridge Preservation Partnership Salt Lake City 5/18/2016

Advances in FRP Composites in Transportation Infrastructure NCHRP 20-68A Domestic Scan 13-03

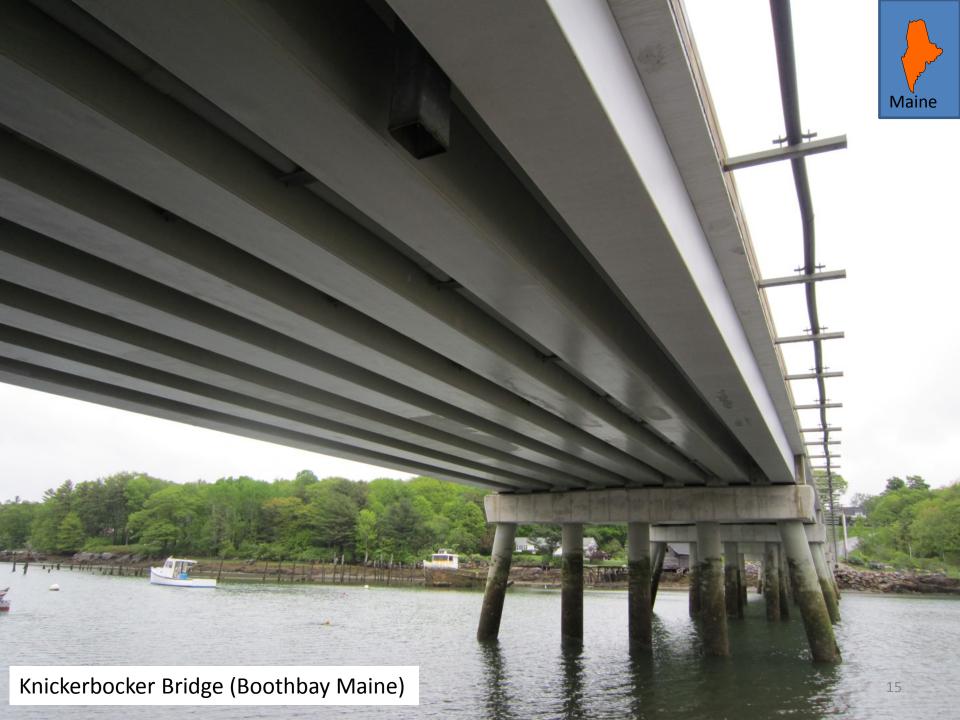
Knickerbocker Bridge (Boothbay Maine)

70ft Main Spans – 8 total spans

Completed 2011

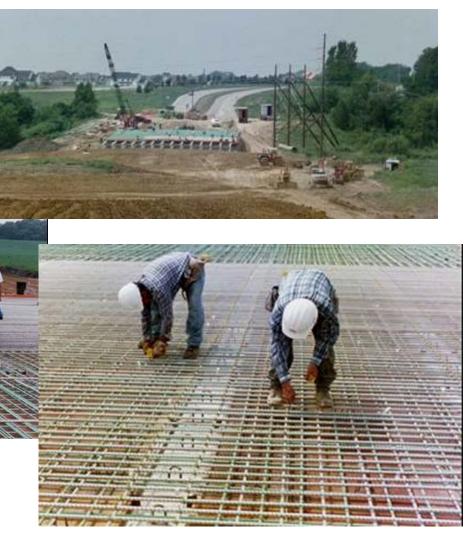
Hybrid GFR (Glass Fiber Reinforced Bar)-RC Bridge Deck

53rd Ave Bridge, City of Bettendorf, Iowa

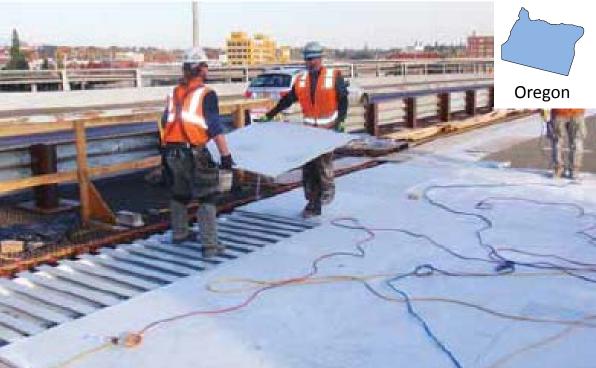
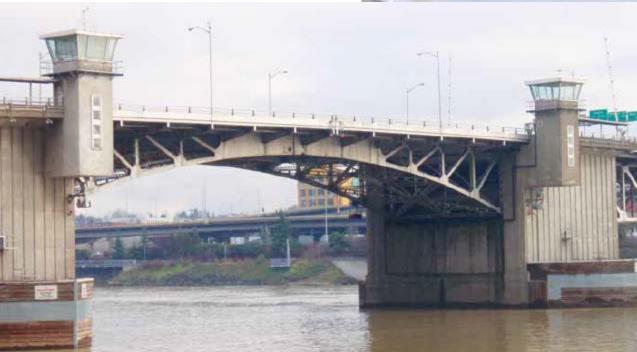
Morrison Bridge

FRP Deck installed in 2012

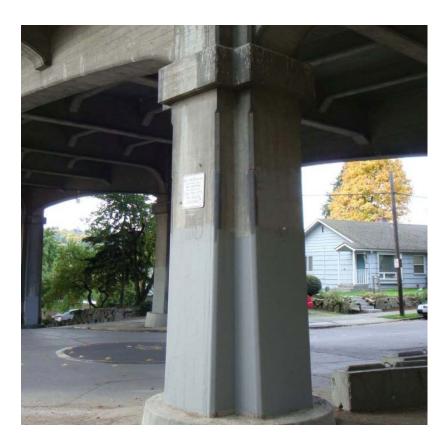
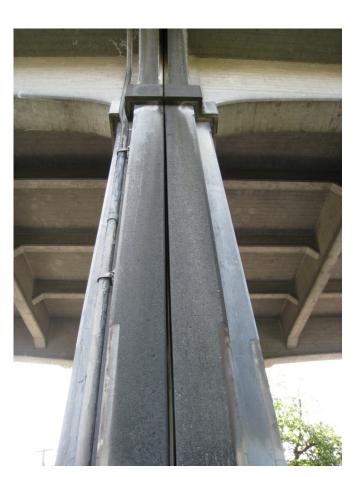
Aurora Avenue Bridge Approach Retrofit Considerations

- Aesthetics look of the columns can't change
- Split columns provide for thermal movements
- What to do?

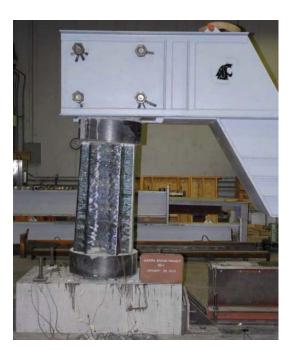
Aurora Avenue Bridge Column Testing Overview

- Washington State University
- Goal: Verify the effectiveness of FRP wrapping for improving shear performance in cruciform columns
