Bridge Joint Performance in Northeastern States

Scott Civjan and Brooke Quinn
University of Massachusetts Amherst

Massachusetts Department of Transportation

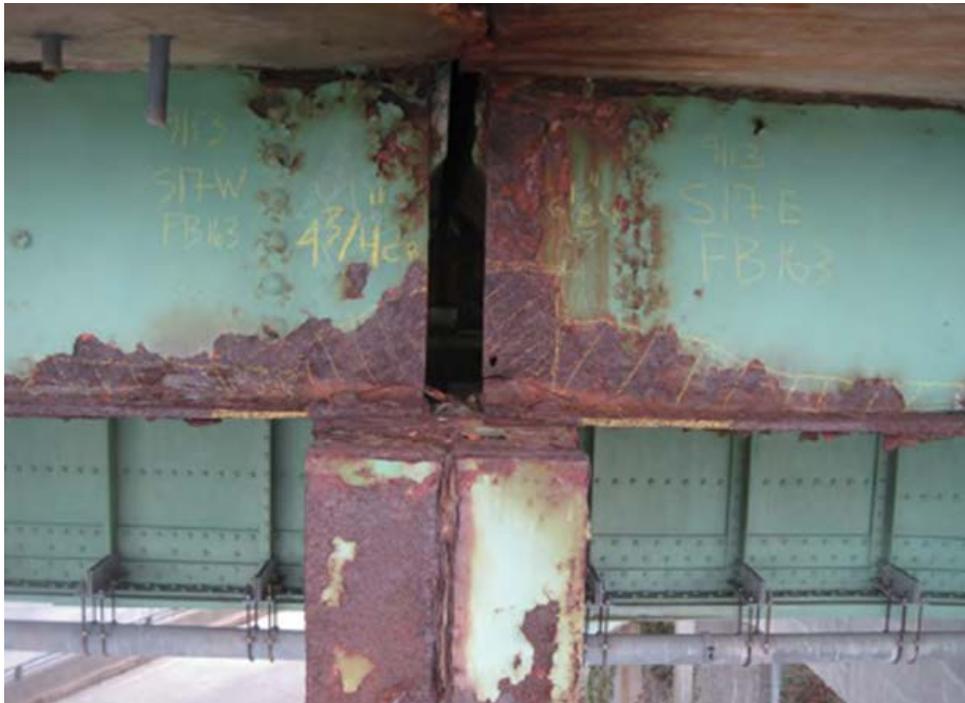
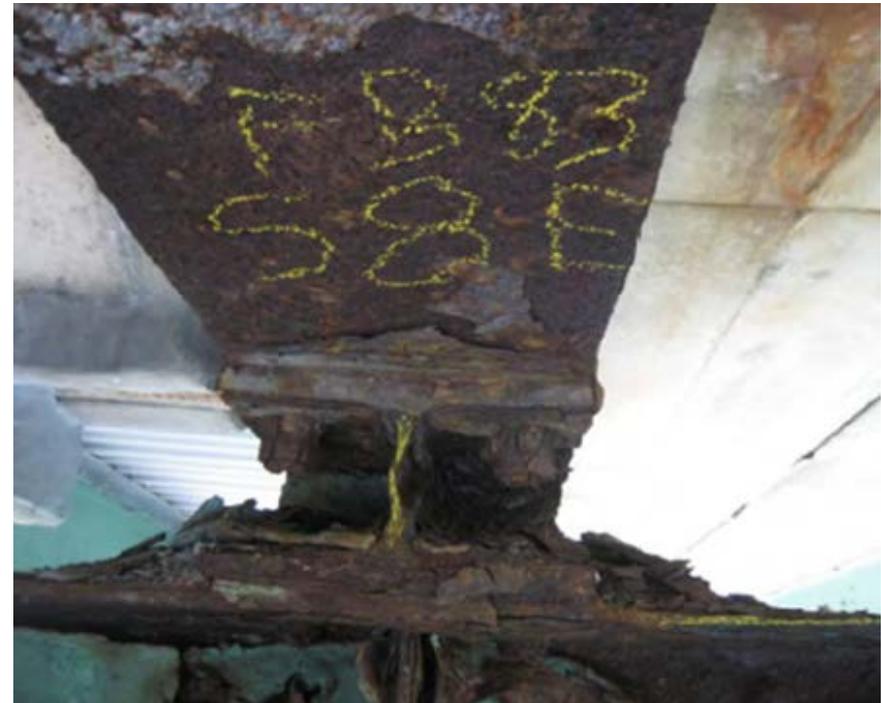
Effects of Joint Failure

- Superstructure damage (Photos courtesy of MassDOT)

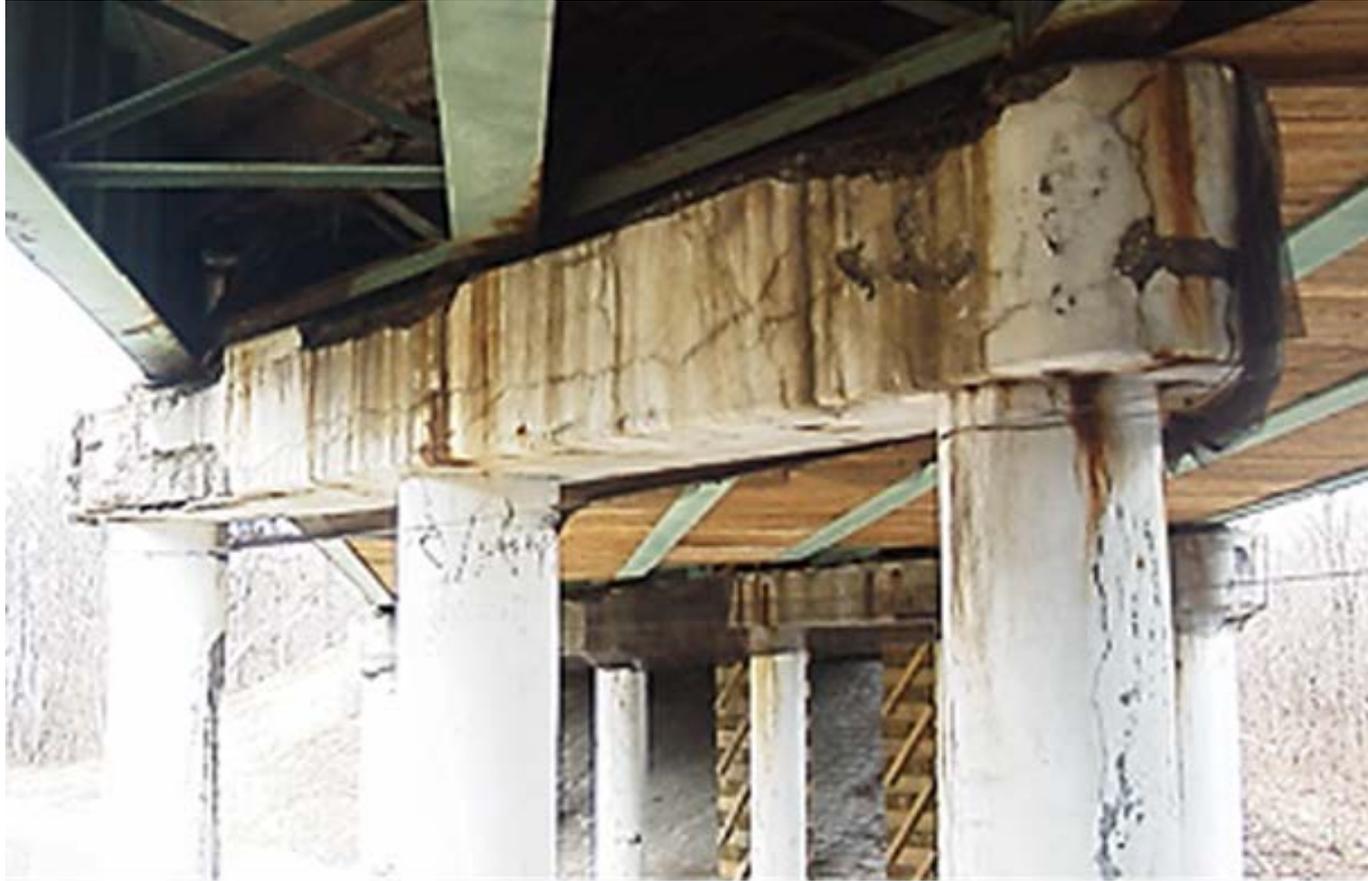
- Substructure damage

Rate of corrosion and degree of damage increase with time

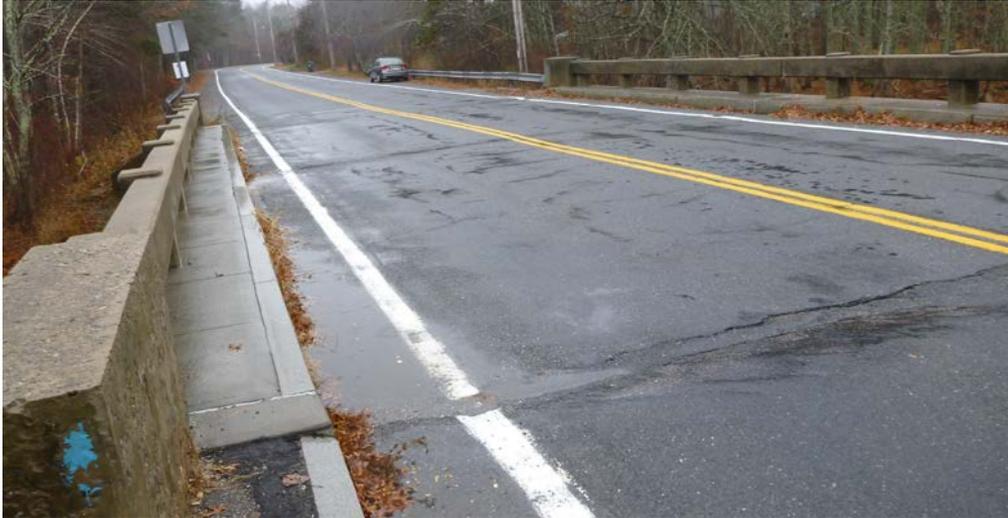
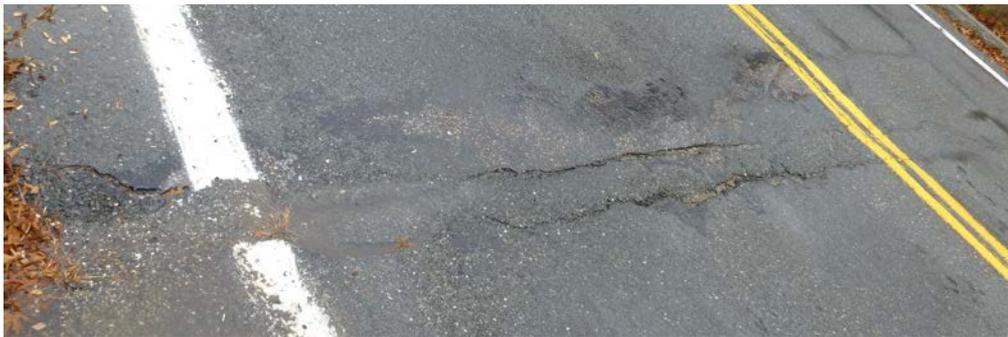
- Rutting/cracking in asphalt plug joint

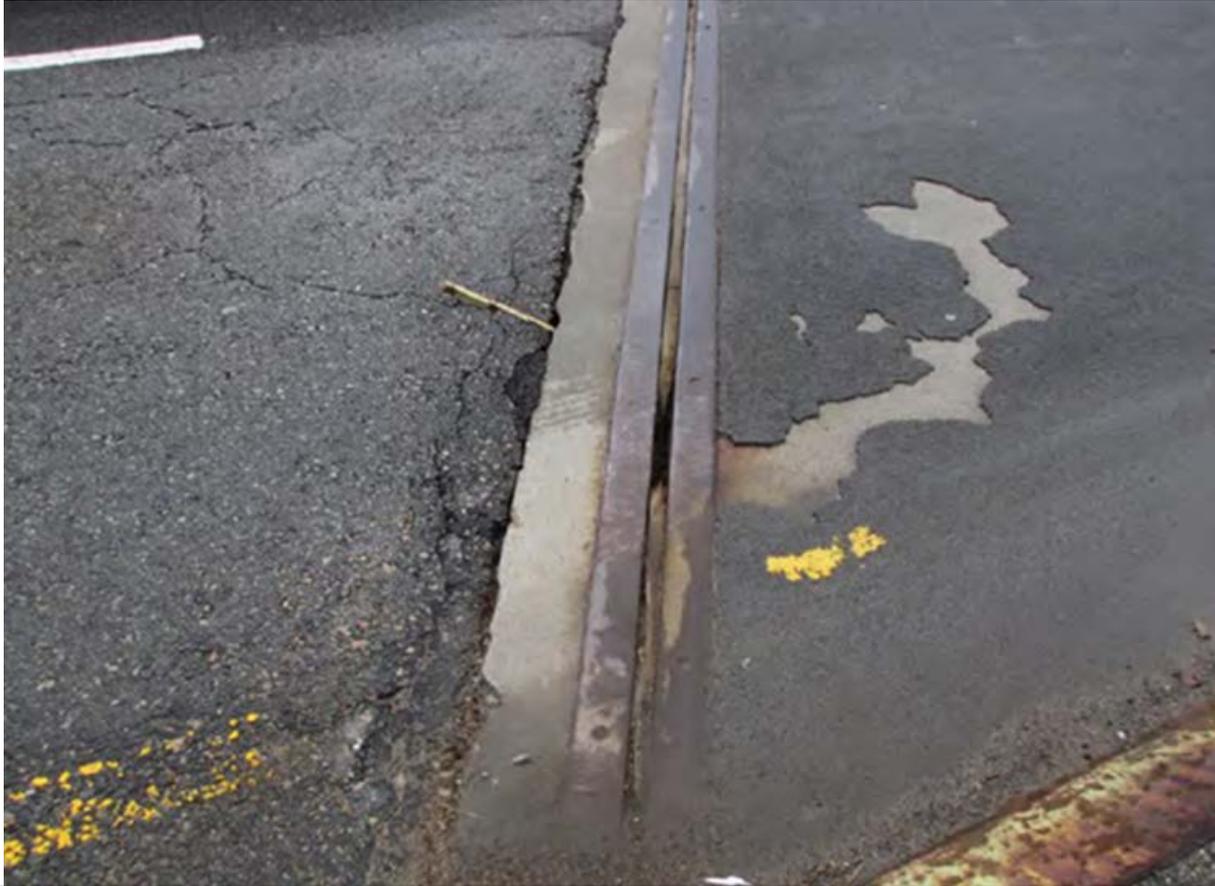
- Damaged strip seal (Photo courtesy of MassDOT)

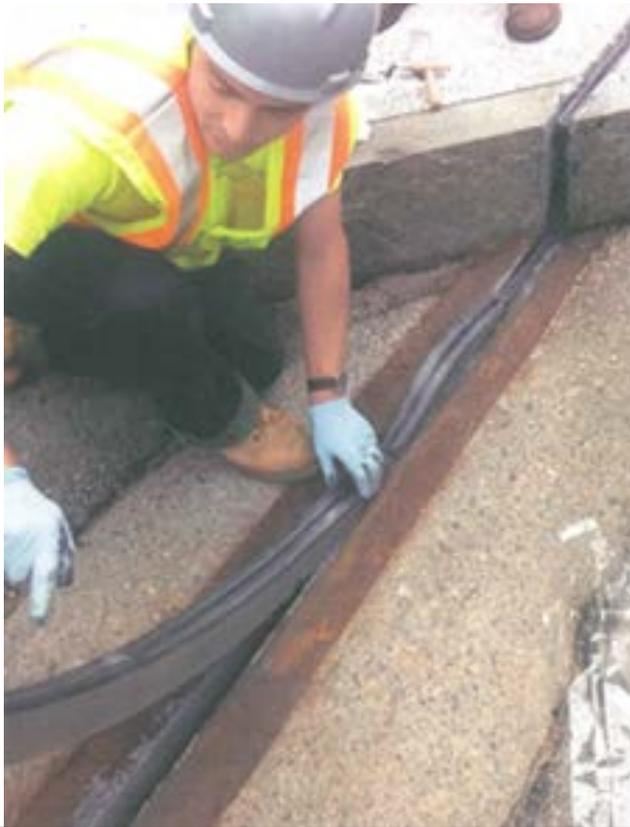
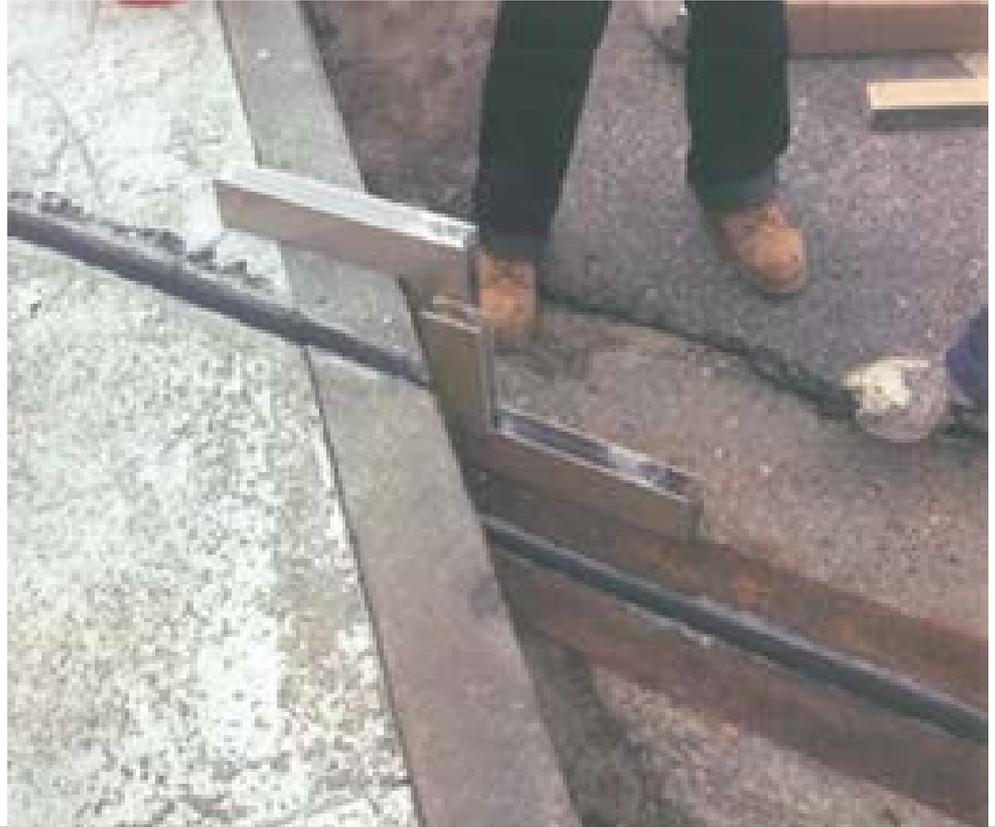
- EM-SEAL installation (Photo courtesy of MassDOT)
 - Pre-formed for curb and barrier installation

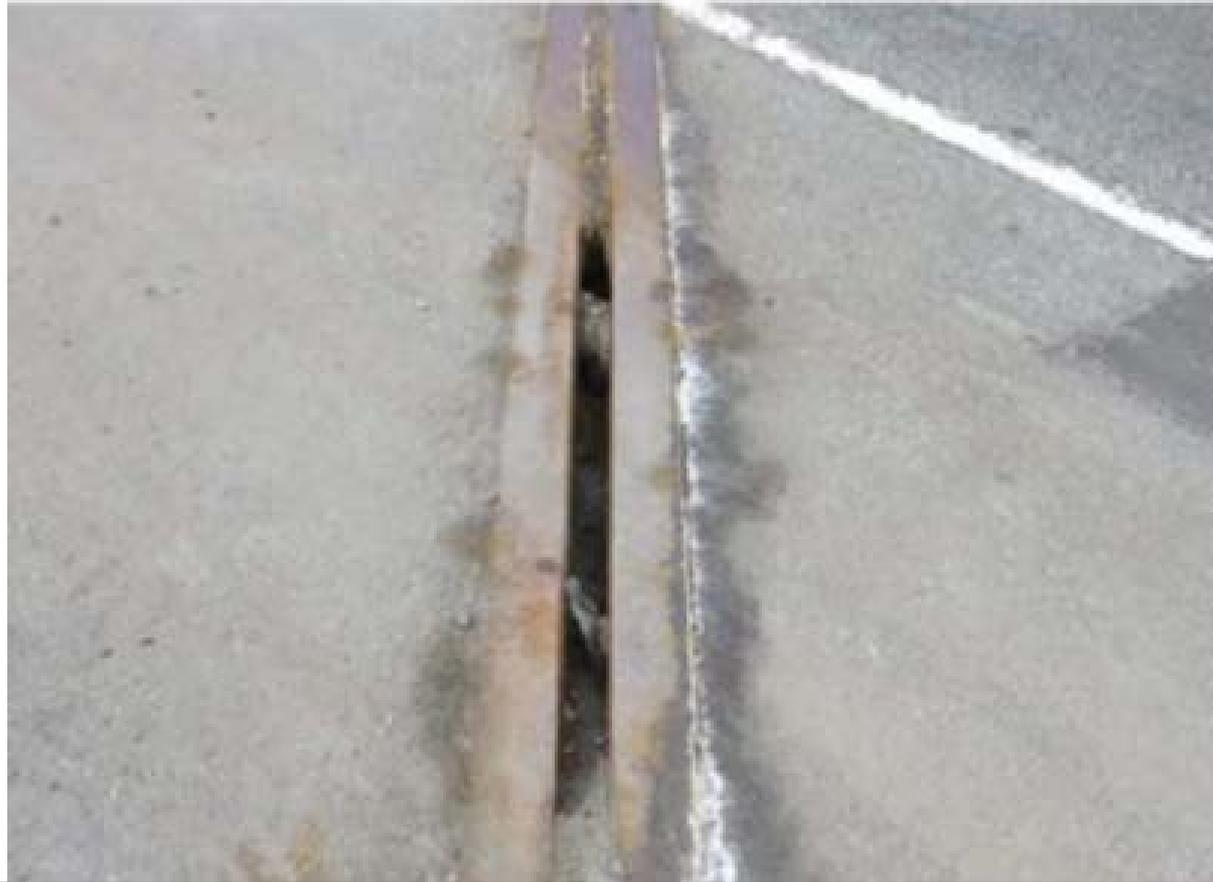
- Damaged pourable seal (Photo courtesy of MassDOT)

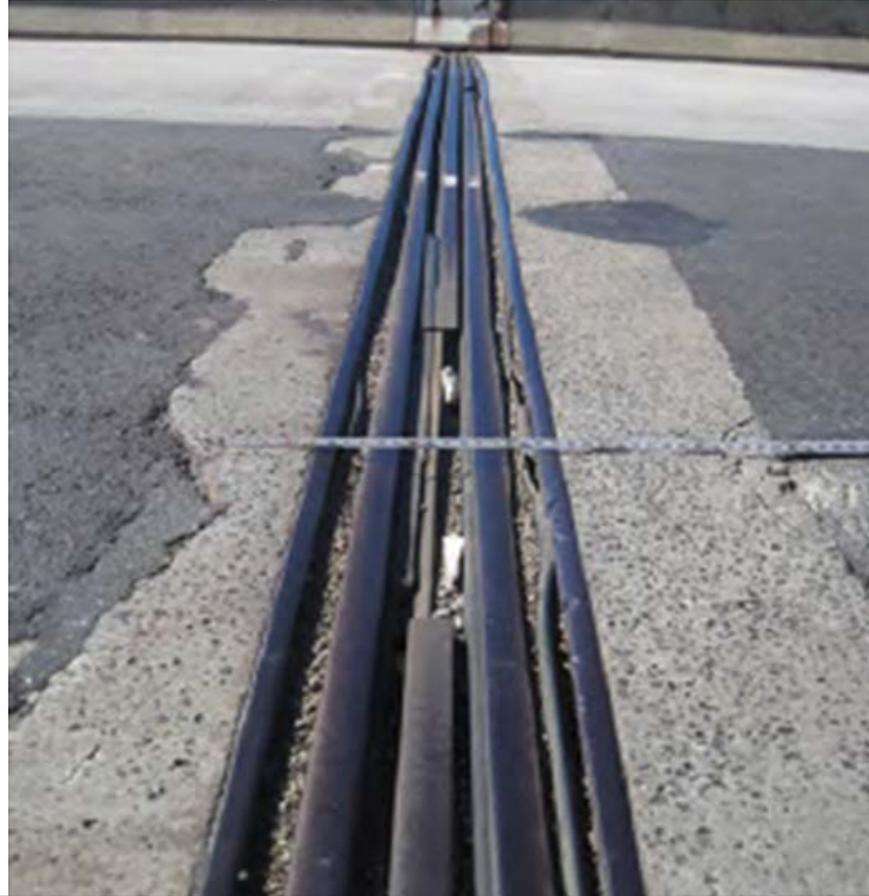
- Damaged modular joint (Photo courtesy of MassDOT)

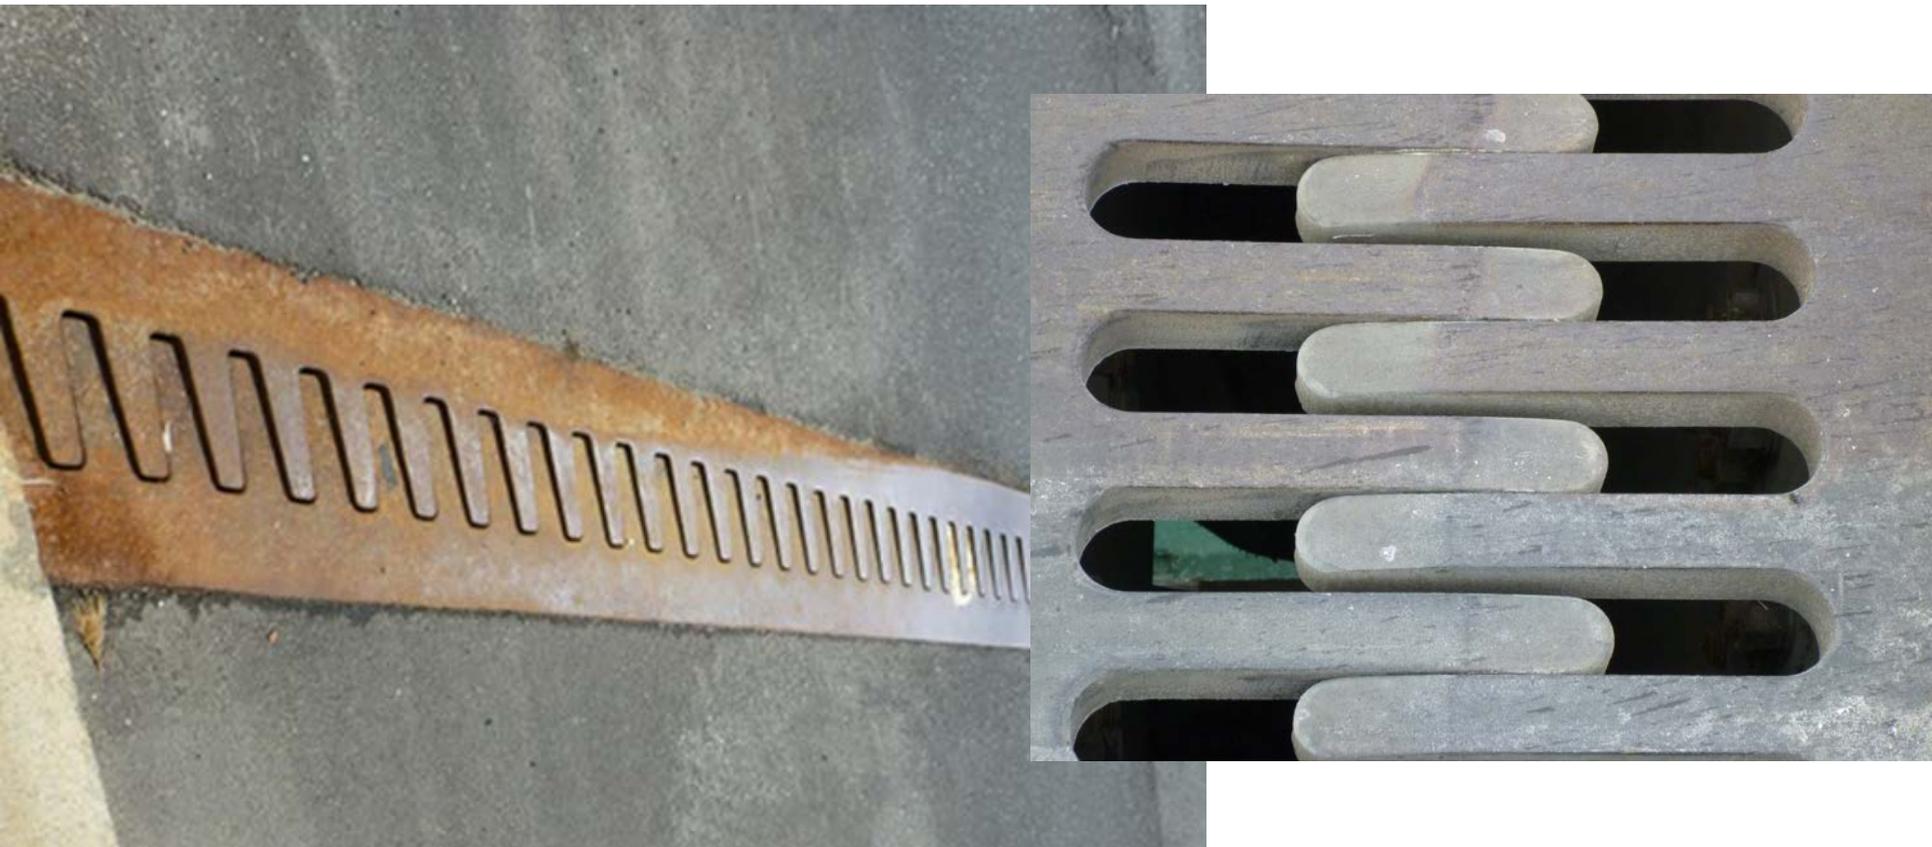
- Improper function of finger joint (75° F) and trough
