# METALLIZING AND COATING OF THE STICKNEY POINT DRAW BRIDGE

FRANK D. REA, PCS, GREENMAN-PEDERSEN, INC.

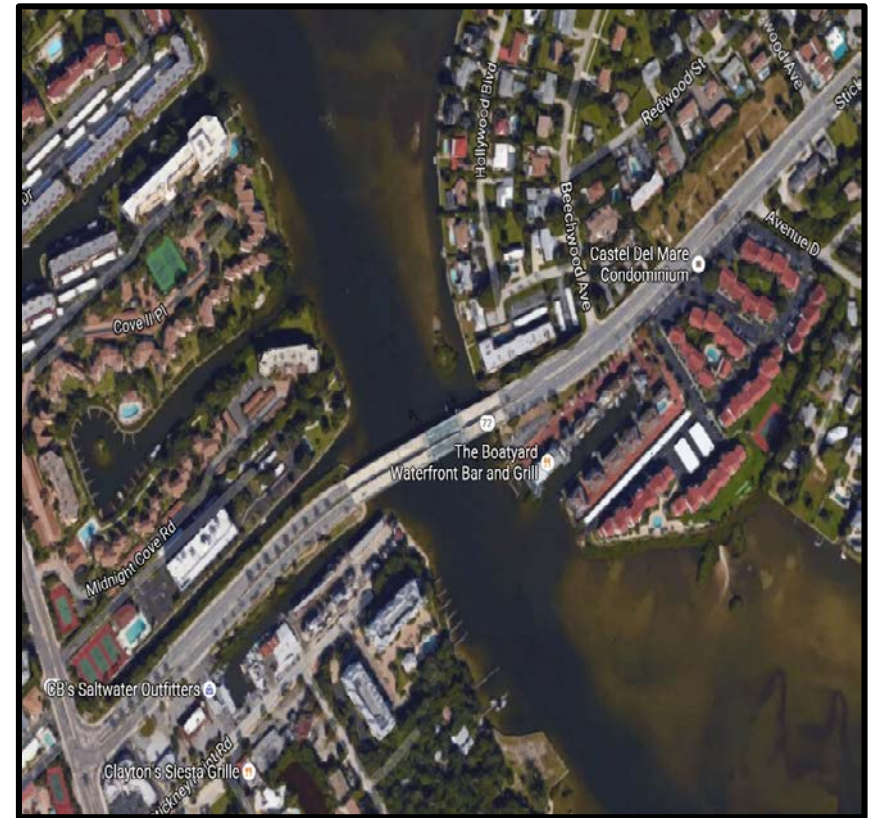
SR 72, Sarasota, Florida

- ISO 12944-2 C5-M Very High, Marine Coastal/Offshore Areas with High Salinity
- SSPC Environmental Zone 2B Frequently Wet by Saltwater
- Marinas, Restaurants, Residences, Manatees, Sea Turtles
- Traffic – Bottleneck
- Navigable Waterway
- Counterweights Dip into Saltwater

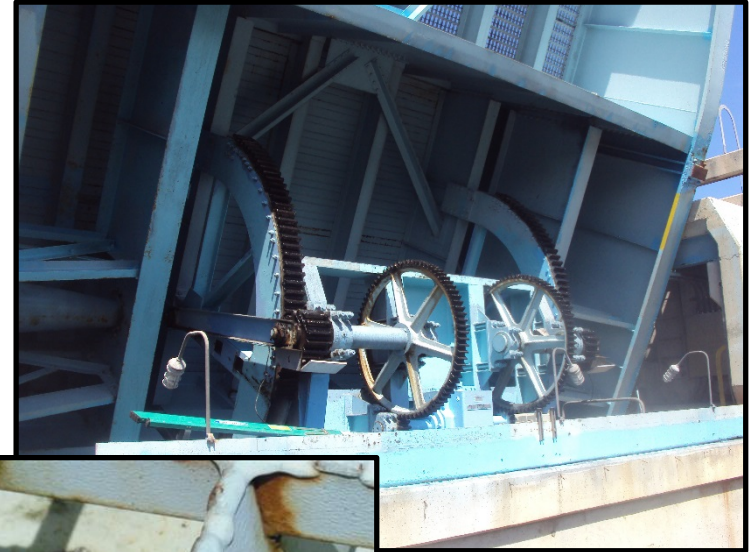
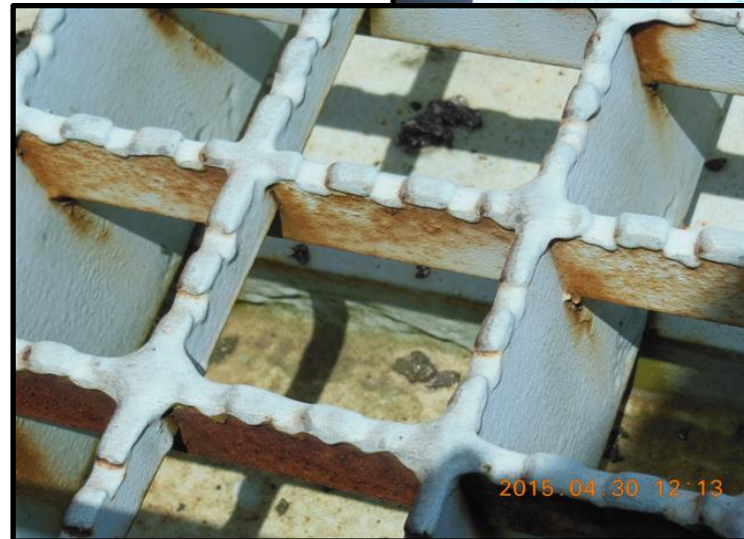
- Bascule Bridge
  - Machinery, Electrical
  - Grating
  - Openings/Closings

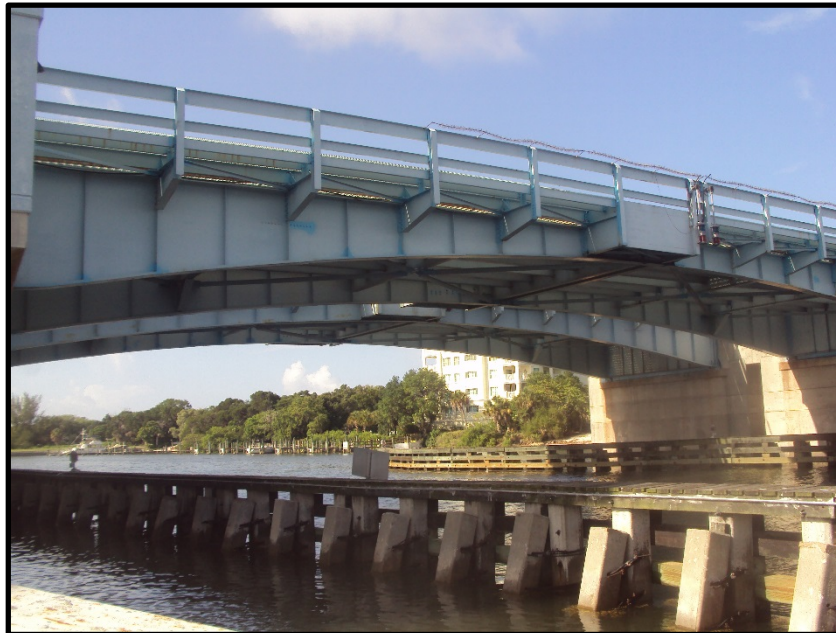
- Not Recommended for Incentive/Deceptive Contracts
  - Changes are Under Restraint

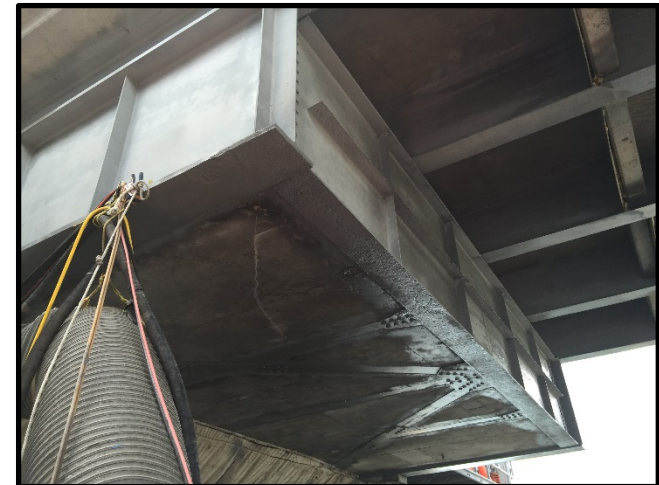
- Counterweights Dipping Into Water
  - Coal Tar Epoxy Originally Specified
    - Possible Odor Problems
    - Undesirable Finish Color
  - Contractor Offered to Metallize at No Extra Cost
  - Holiday Testing was Required

100% Holiday Detection Testing was a condition of approval of the change order
