2017 SEBPP ANNUAL MEETING

# Preserving the New River Gorge Bridge

Chad Robinson, PE – WVDOT

Matt Lewellyn, PE – B&N

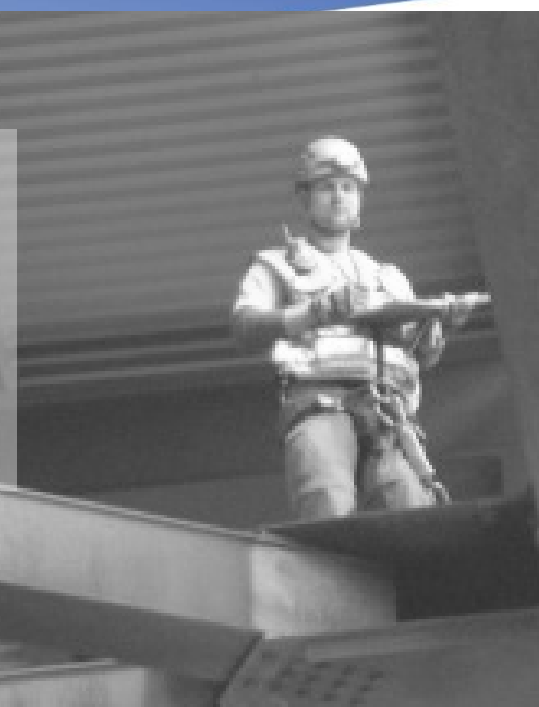
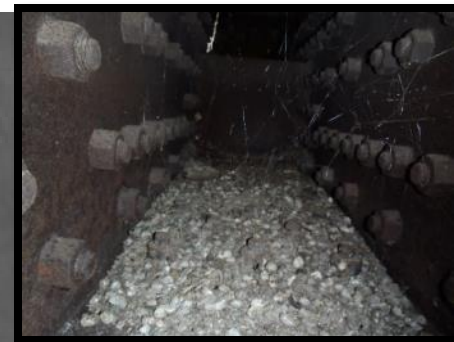
- ❖ Weathering Steel
- ❖ Prolonged Wetting
- ❖ Poor Bolt Sealing

**Pigeon Nesting**

**Nut Loss**

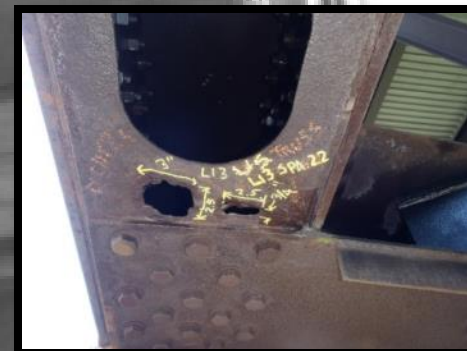
**Section Loss**

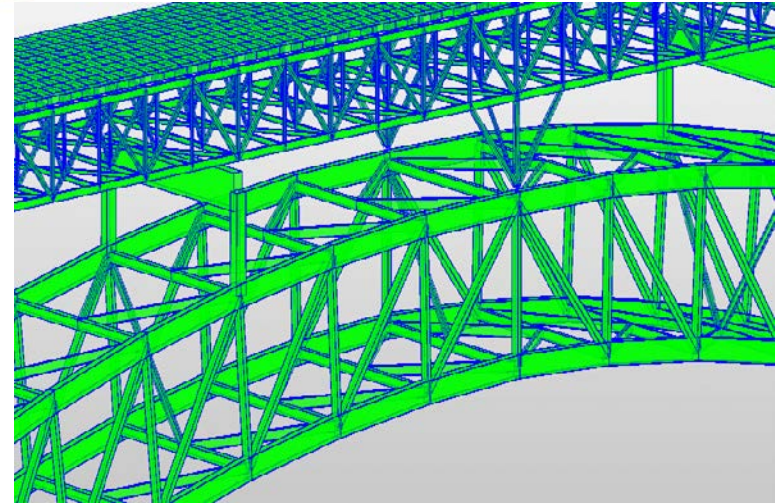
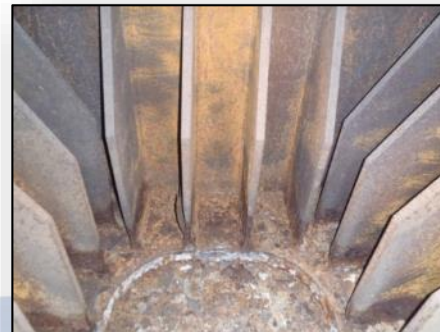
BENT BASE

# Primary Issue = Section and Nut Loss

- ❖ Deck Truss
  - Sealed in 2012
  - Punch list locations
- ❖ Bents and Arch
- ❖ Cleaning and Sealing
- ❖ Follow-up with Magnets
- ❖ Not Controlling the Load Rating

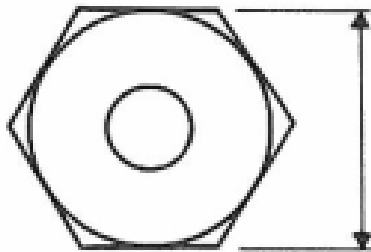
"N" = FLAT TO FLAT DIMENSION OF NUT

1. THE FOLLOWING GUIDES SHALL BE USED TO DETERMINE THE NEED FOR BOLT REPLACEMENT AT LOCATIONS NOT MARKED IN THE FIELD AND/OR NOT SHOWN IN THE PLANS:

1 1/8" = 50% LOSS = REPLACE

1 1/2" = 50% LOSS = REPLACE

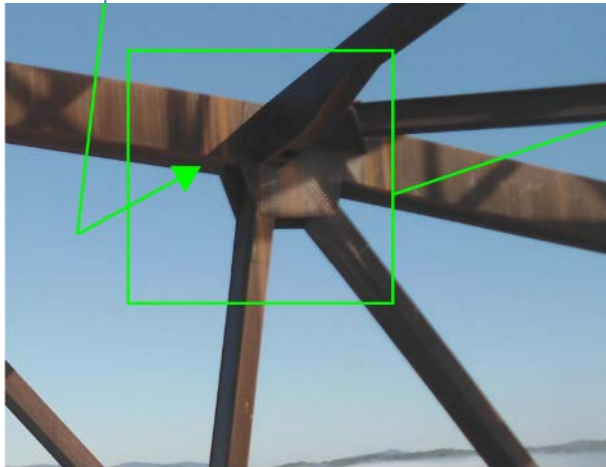
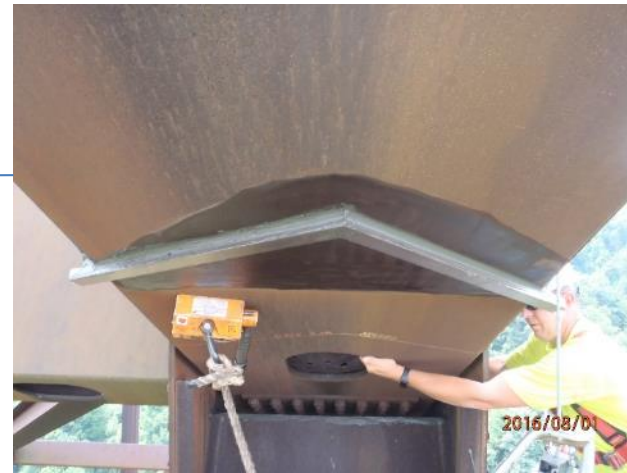
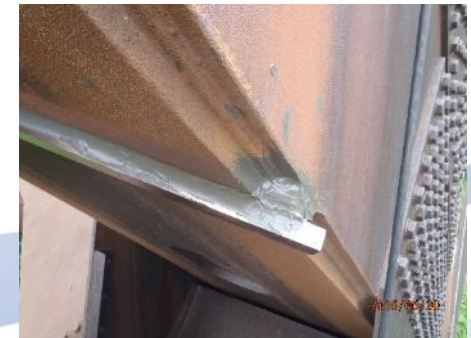
- **Problem:** Water Flowing Under Arch Rib
- **Solution:** Divert Water with Magnetic Drip Bar

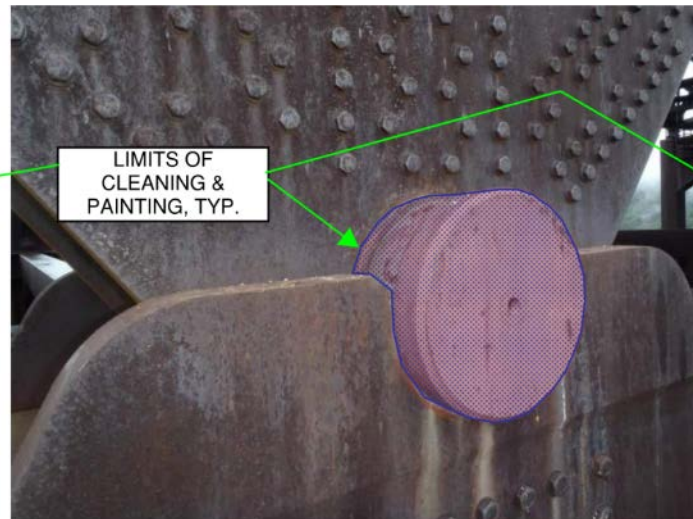
TYPICAL ARCH PIN AT U20 OF ARCH  
(OUTBOARD VIEW)

# A few places are not weathering steel

- Power Tool Clean
- Epoxy Mastic Prime
- Urethane Top

CLEANING SHALL BE PER SSPC-SP 15. EPOXY MASTIC PRIME COAT SHALL BE 5 MILS MINIMUM DRY FILM THICKNESS. URETHANE TOP CHOAT SHALL BE 3 MILS MINIMUM DRY FILM THICKNESS.

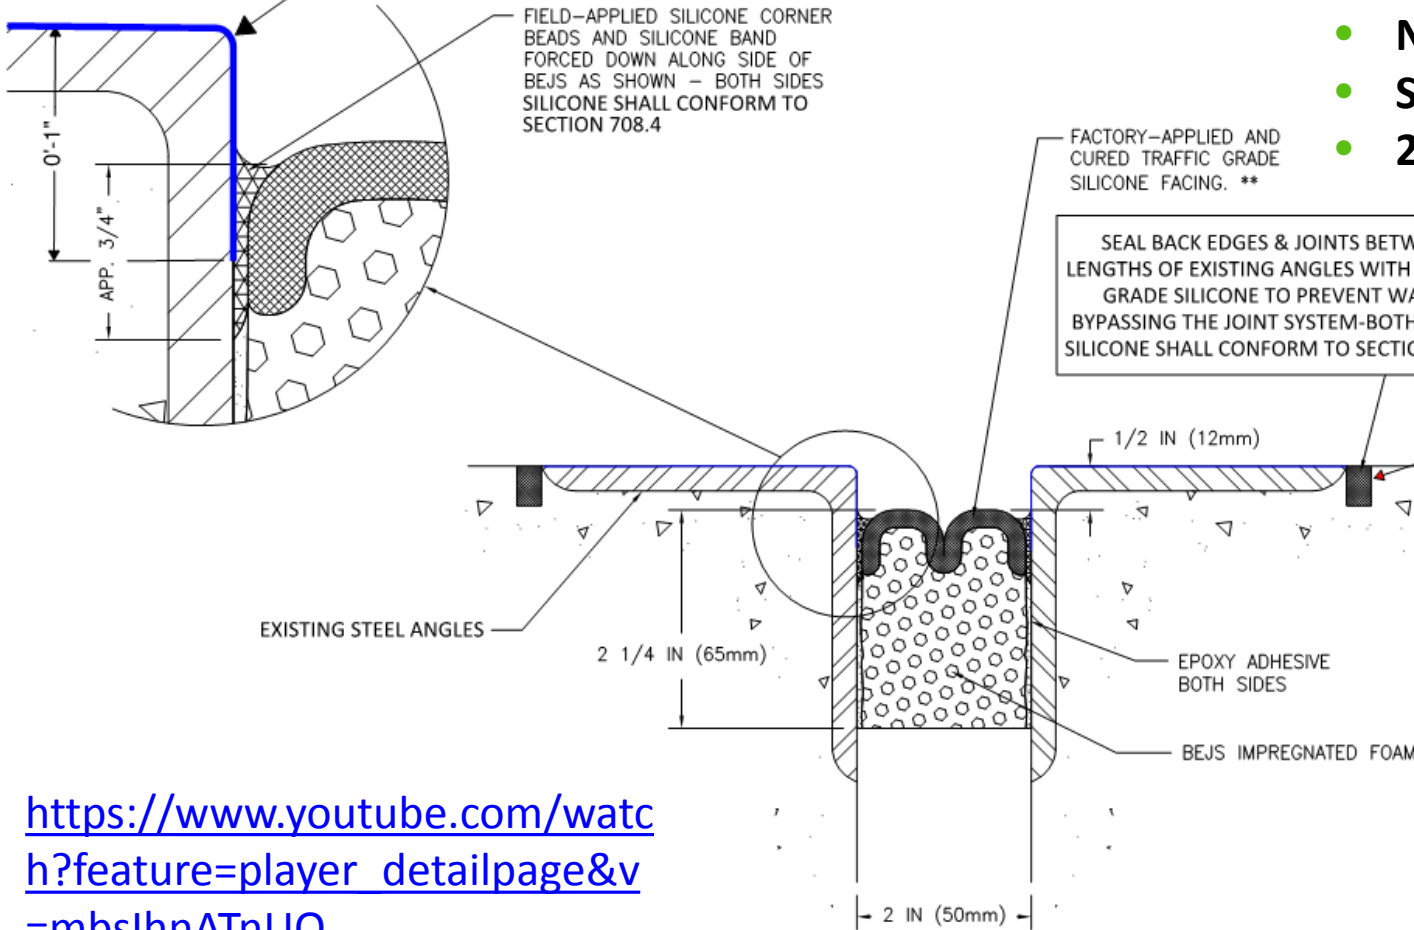
**PROPOSED ABUTMENT JOINT DETAIL (EJ1)**

# Leaking Joints causing Pack Rust at Bearings

PRIOR TO INSTALLING THE PROPOSED ABUTMENT JOINT, THE TOP 1" OF VERTICAL LEG AND ALL OF THE 8" HORIZONTAL LEG OF EXISTING ANGLE IS TO BE SAND BLASTED TO A NEAR WHITE FINISH (SSPC-SP 10/NACE NO. 2) AND METALIZED PER SECTION 689 OF THE STANDARD SPECS. THE SEALER AND TOP COAT CAN BE ELIMINATED FOR THIS APPLICATION - BOTH SIDES.

SEAL BACK EDGES & JOINTS BETWEEN LENGTHS OF EXISTING ANGLES WITH TRAFFIC GRADE SILICONE TO PREVENT WATER BYPASSING THE JOINT SYSTEM-BOTH SIDES. SILICONE SHALL CONFORM TO SECTION 708.4

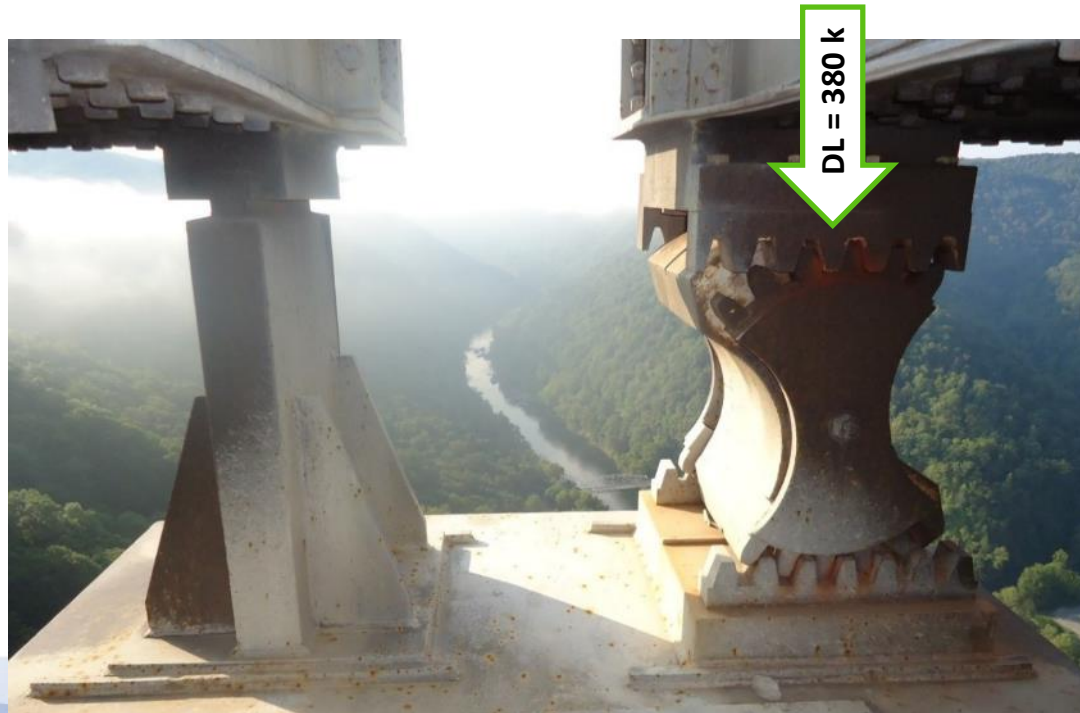
- Excessive tilt.
- Plates were misaligned at mean temperatures.
- Roller had slipped.
- Retainer plates should prevent slippage, but they were not functioning properly.

- Vertical jacking would be very difficult due to height of the bent and the steel pier cap.

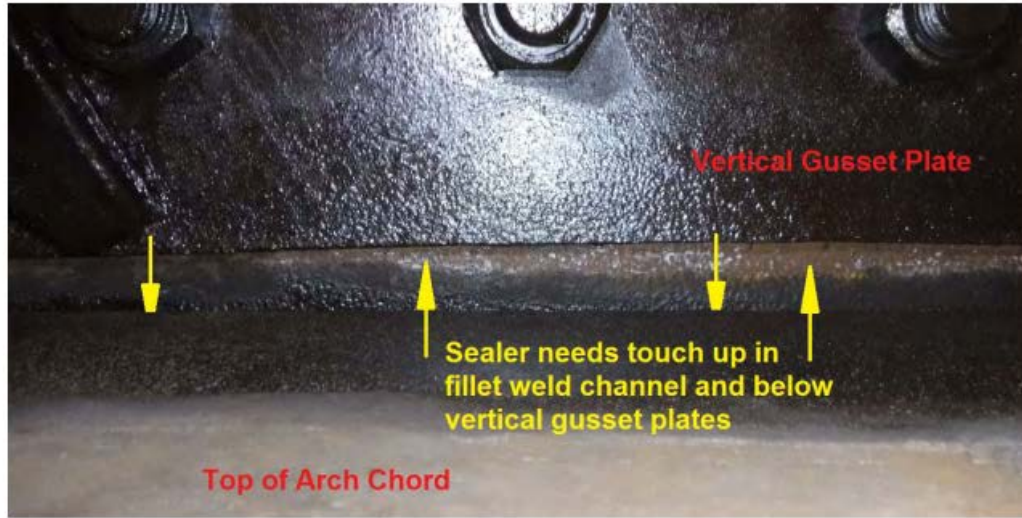
**Photo 16**

Typical area where sealer needs touched up at outside fillet weld channels and at bottom of vertical gusset plate inside spandrel bent bottom cell.
