2018 National Bridge Preservation Partnership Conference

New River Gorge Bridge Rehabilitation

Billy Varney, PE, West Virginia DOT

Matt Lewellyn, PE, Burgess & Niple

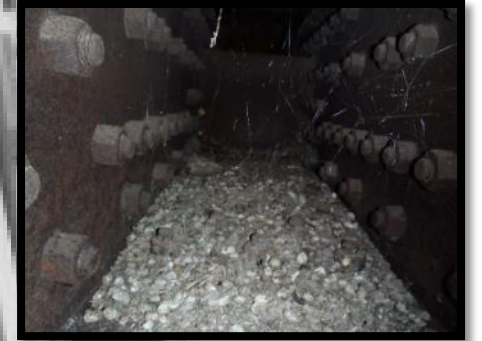
Pigeon Nesting

- Weathering Steel
- Prolonged Wetting
- Poor Bolt Sealing

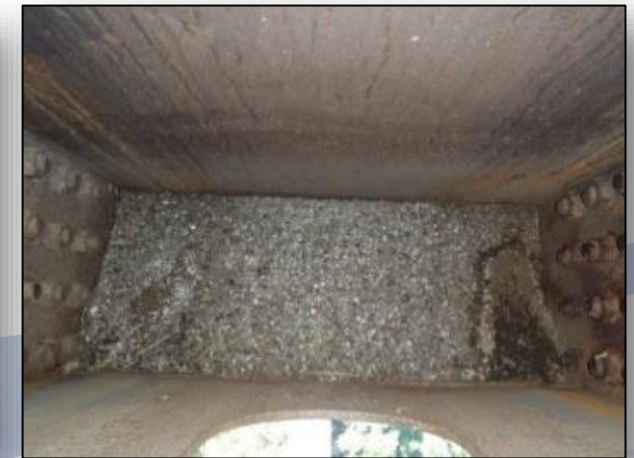
ARCH DIAGONAL

Primary Issue = Corrosion and Section Loss inside Boxes

- Loss in Bents and Arch
- Cleaning and Sealing
- Follow-up with Magnets
- Not Controlling the Load Rating

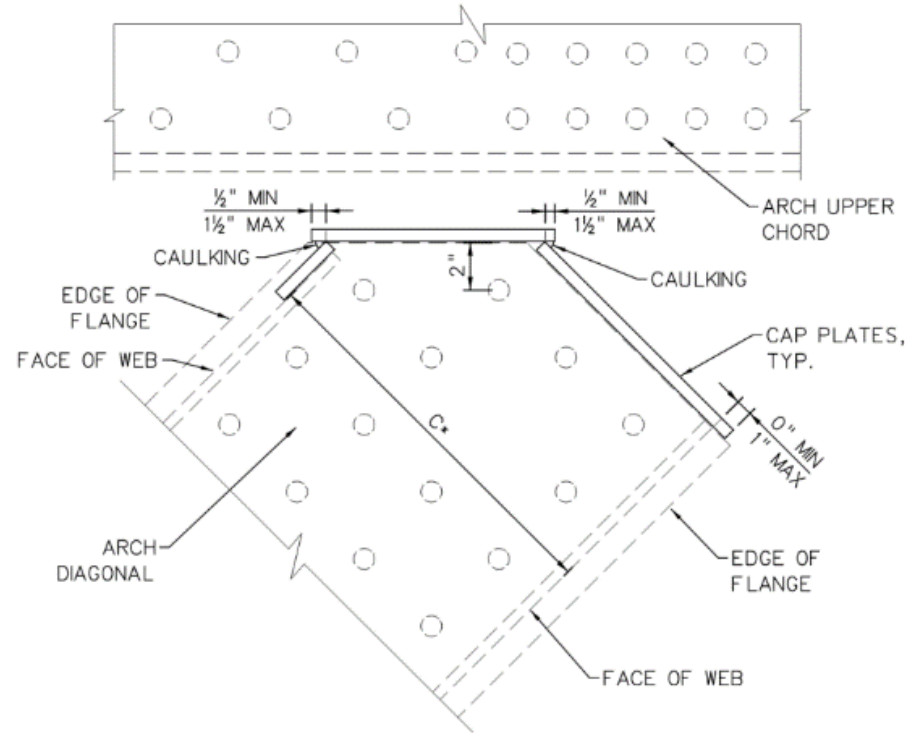
DETAIL C
 SCALE: 3"=1'-0"

- **Problem:** Water/Birds Entering Top of Arch Members
- **Solution:** Install HDPE Cap Plates

C* = 1'-4⁷/₈" FOR DIAGONALS EXCEPT AT THE FOLLOWING LOCATIONS:
 2'-1¹/₈" @ U2 & U38
 1'-9⁵/₈" @ U5, U8, U35, & U32
 1'-5⁵/₈" @ U11, U29, & U20
 1'-5" @ U14, U17, U26, & U23

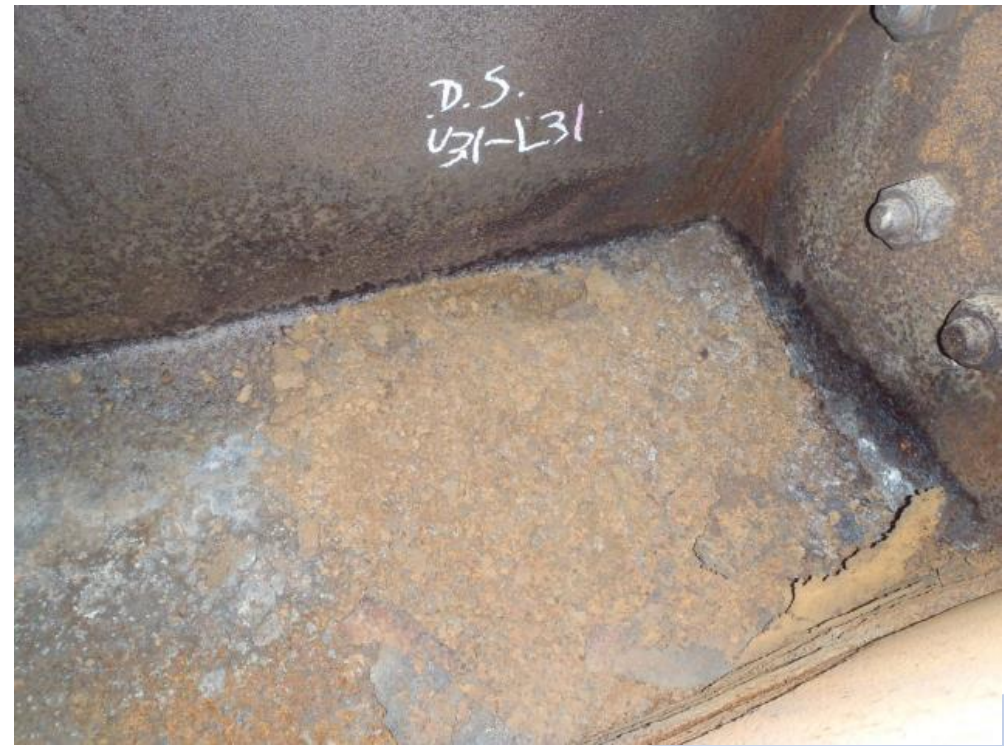
TYPICAL UPPER ARCH WEEPHOLE

- **Problem:** Members Not Draining, Weep Holes too High

- Problem: Members Not Draining, Weep Holes too High
- Solution: Extend Weep Holes

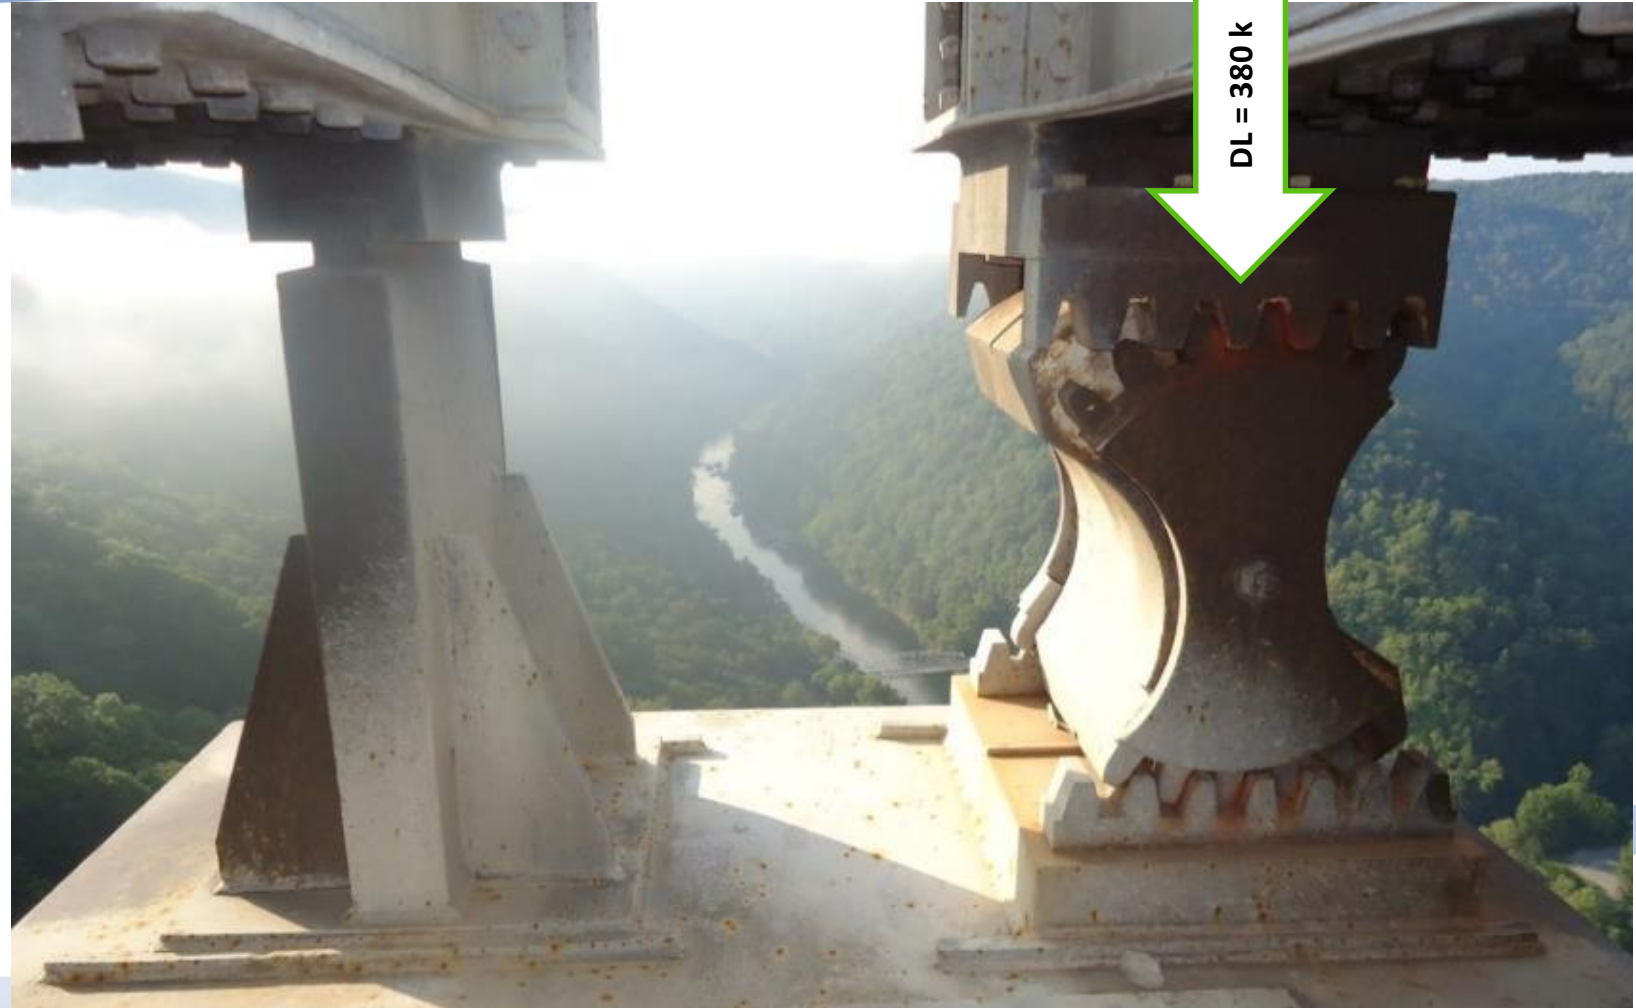
Schematic layout of Bent 5 / Bent 19 bearings:
