Timber Substructure Repairs

Travis Kinney, Oregon DOT

NATIONAL BRIDGE PRESERVATION PARTNERSHIP CONFERENCE 2018

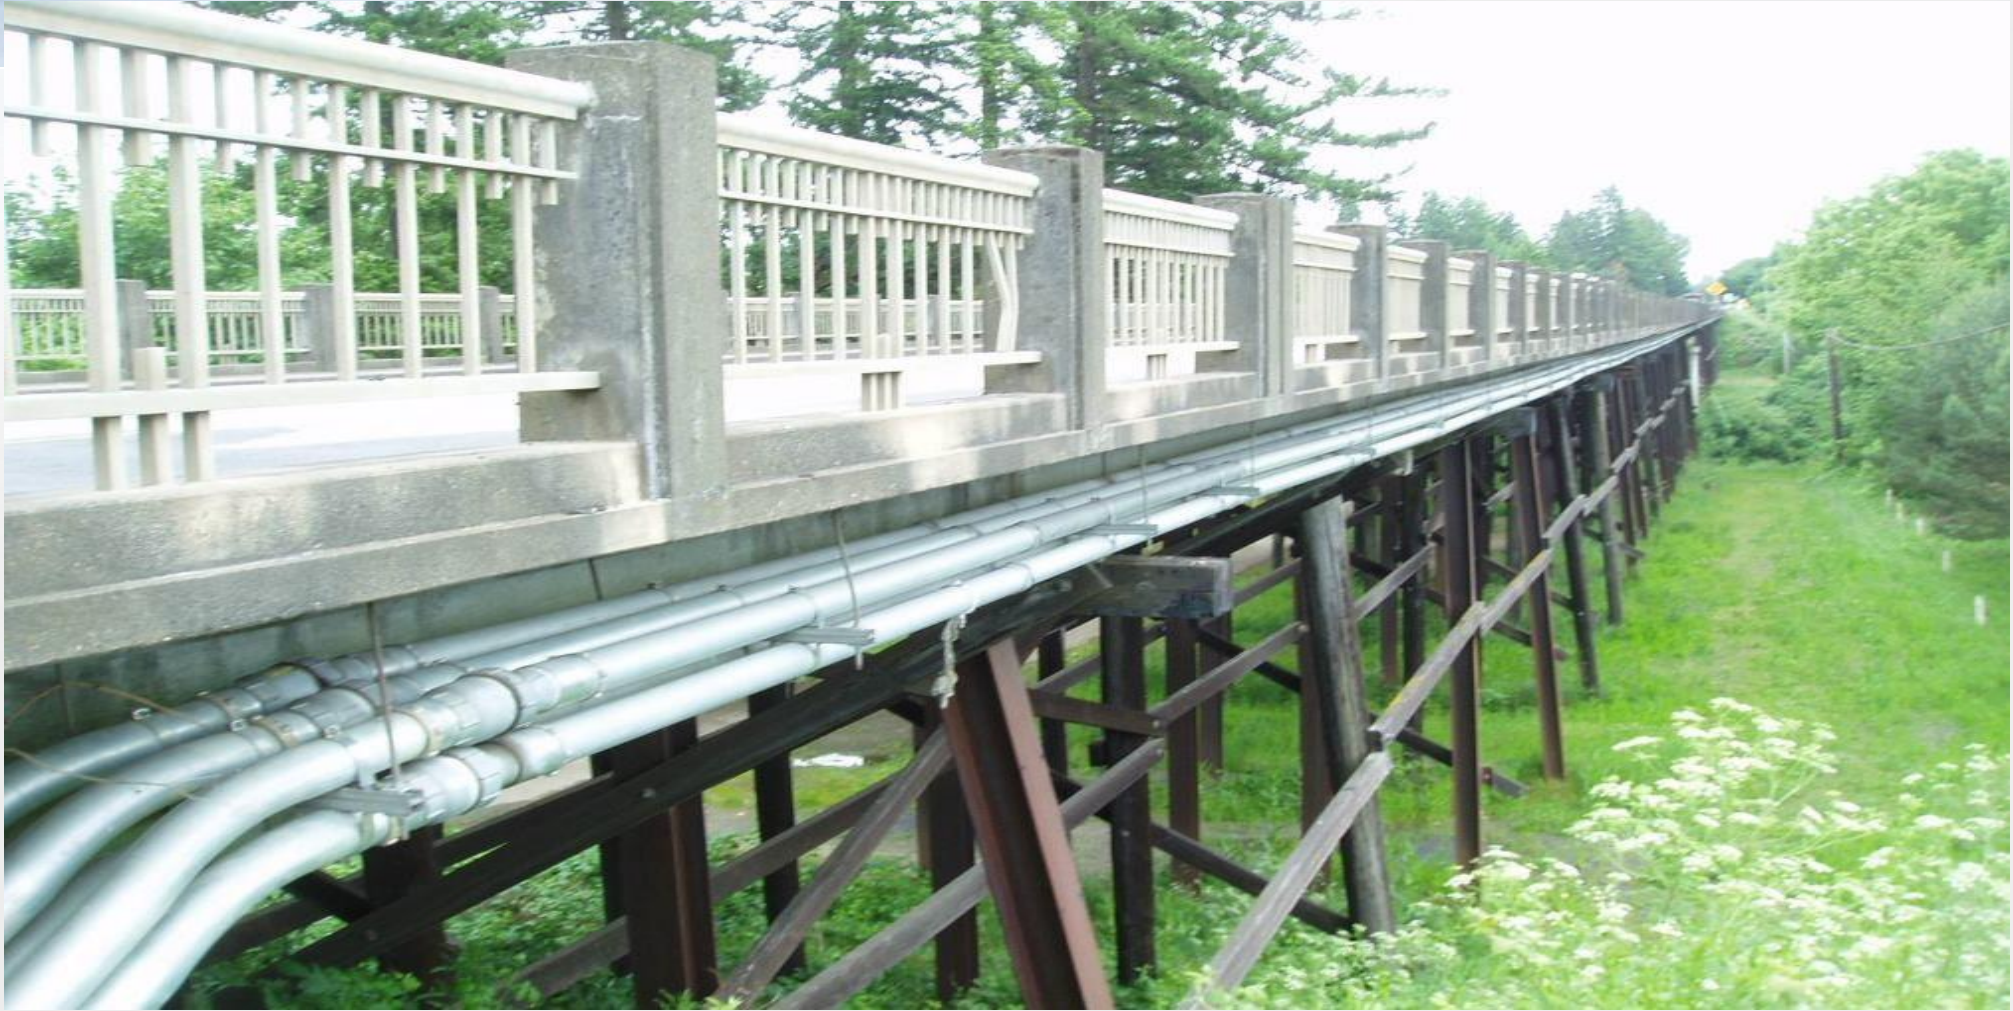
South Yamhill Bridge:

- Built in 1951.
- Located in Willamette Valley.
- Reinforced Concrete Deck Girder on Timber Pile Trestles.
- 990 ft. in length.
- 34 Timber Bents.
- 204 timber piles (As constructed).
- Estimated cost of replacement = \$35 Million.

- 85 of the original 204 timber piles have been repaired.
- 16 of the Original 34 Timber caps have been replaced.

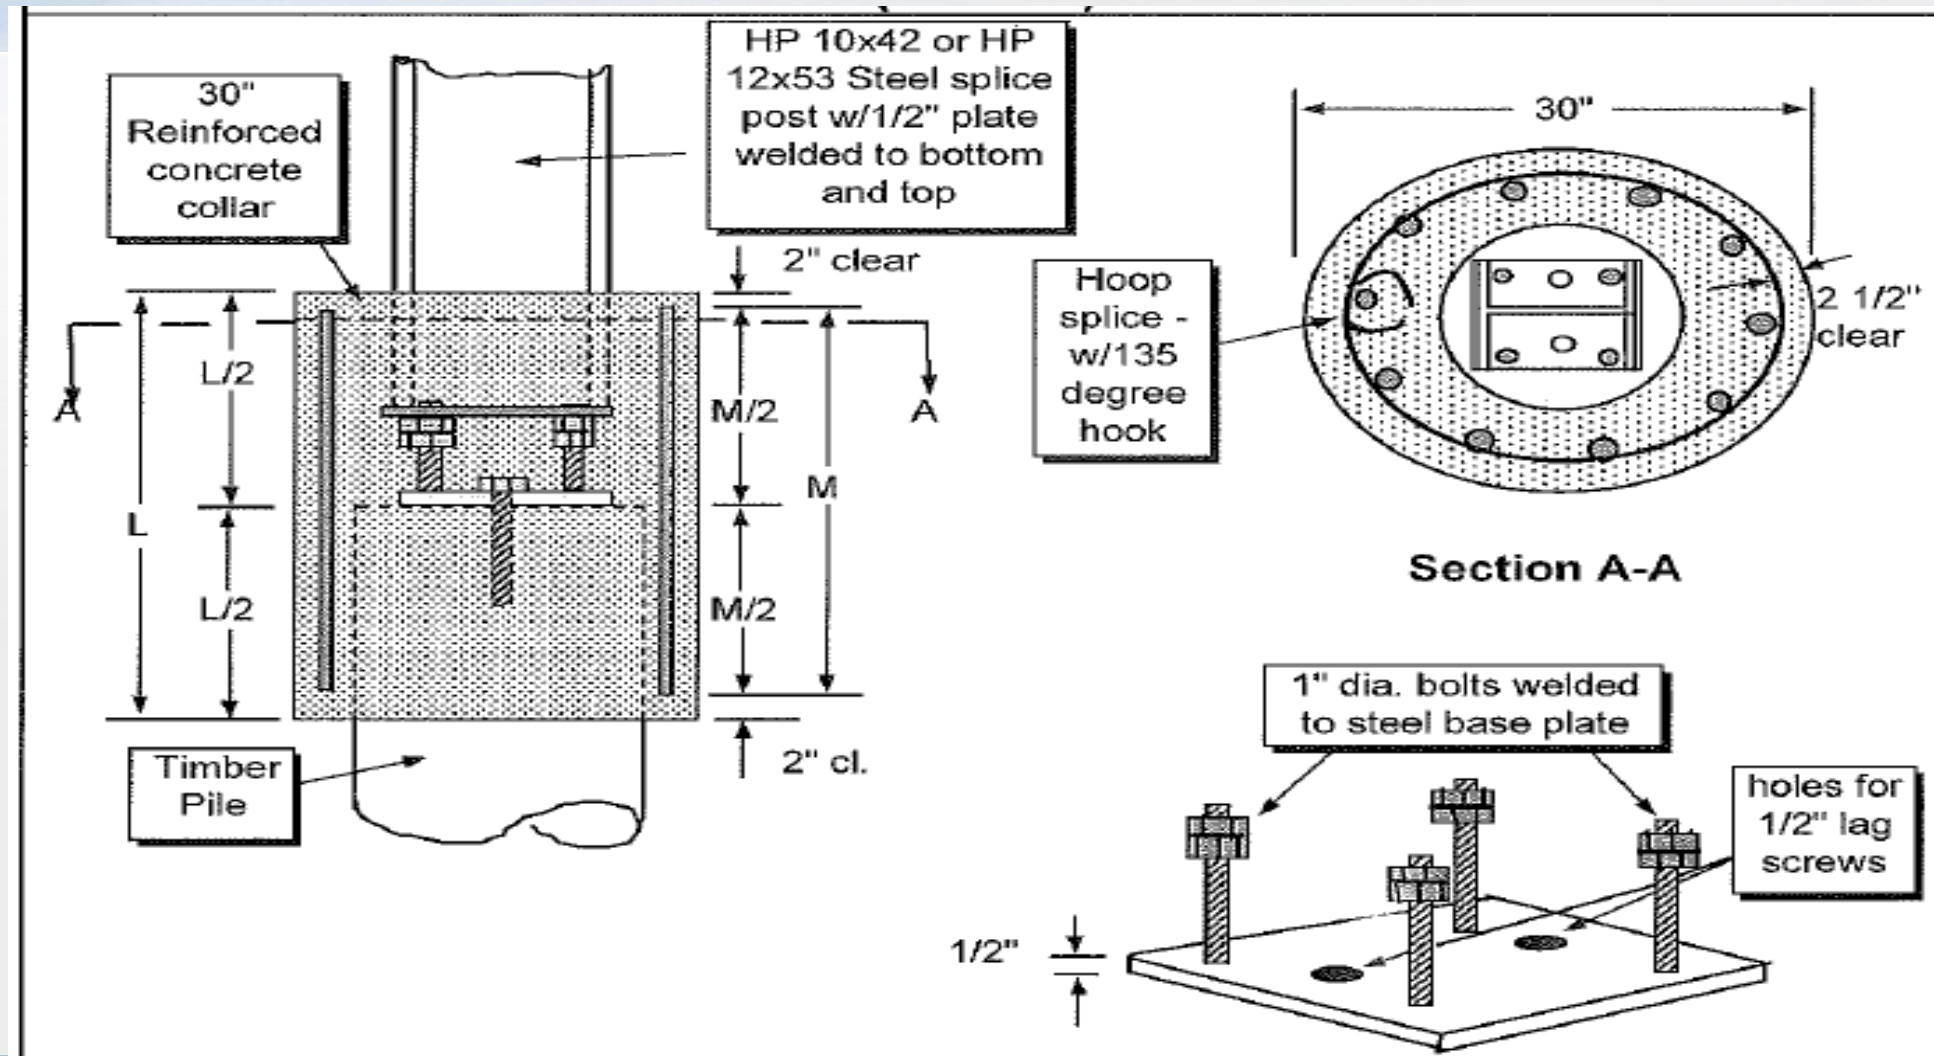
Previous Posting Detail:

Drawbacks

- Difficult to install in tight spaces (abutments)
- Steel cage difficult to stage.

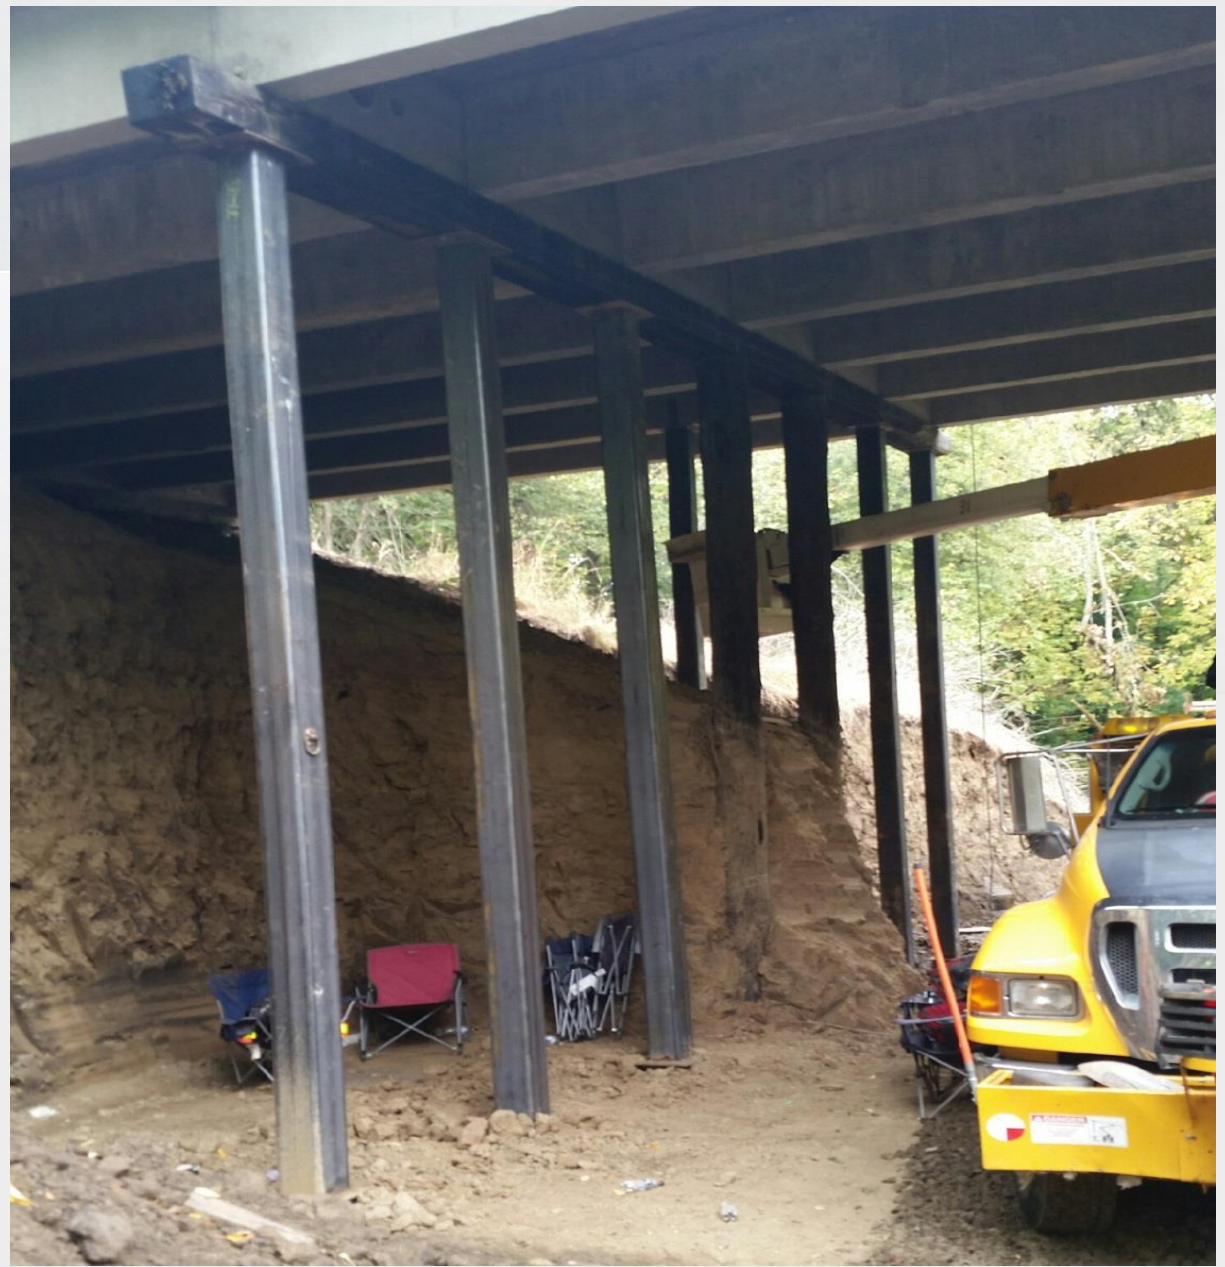
Modifications: “Dumbbell Repair”

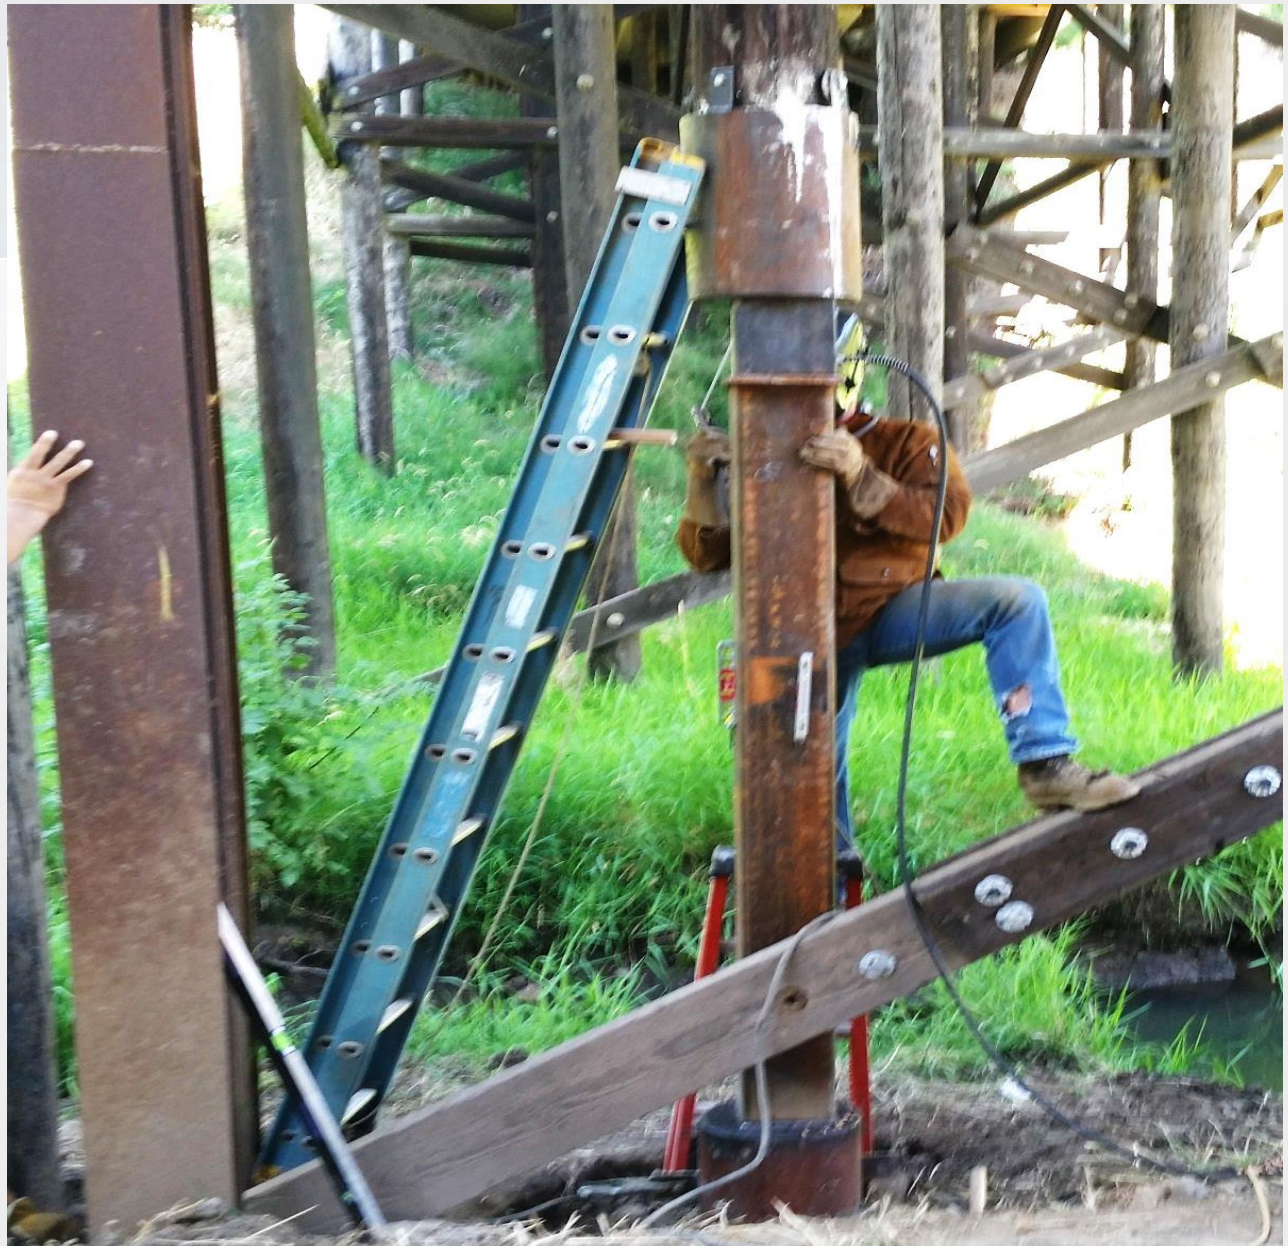
Modifications: "Square post"

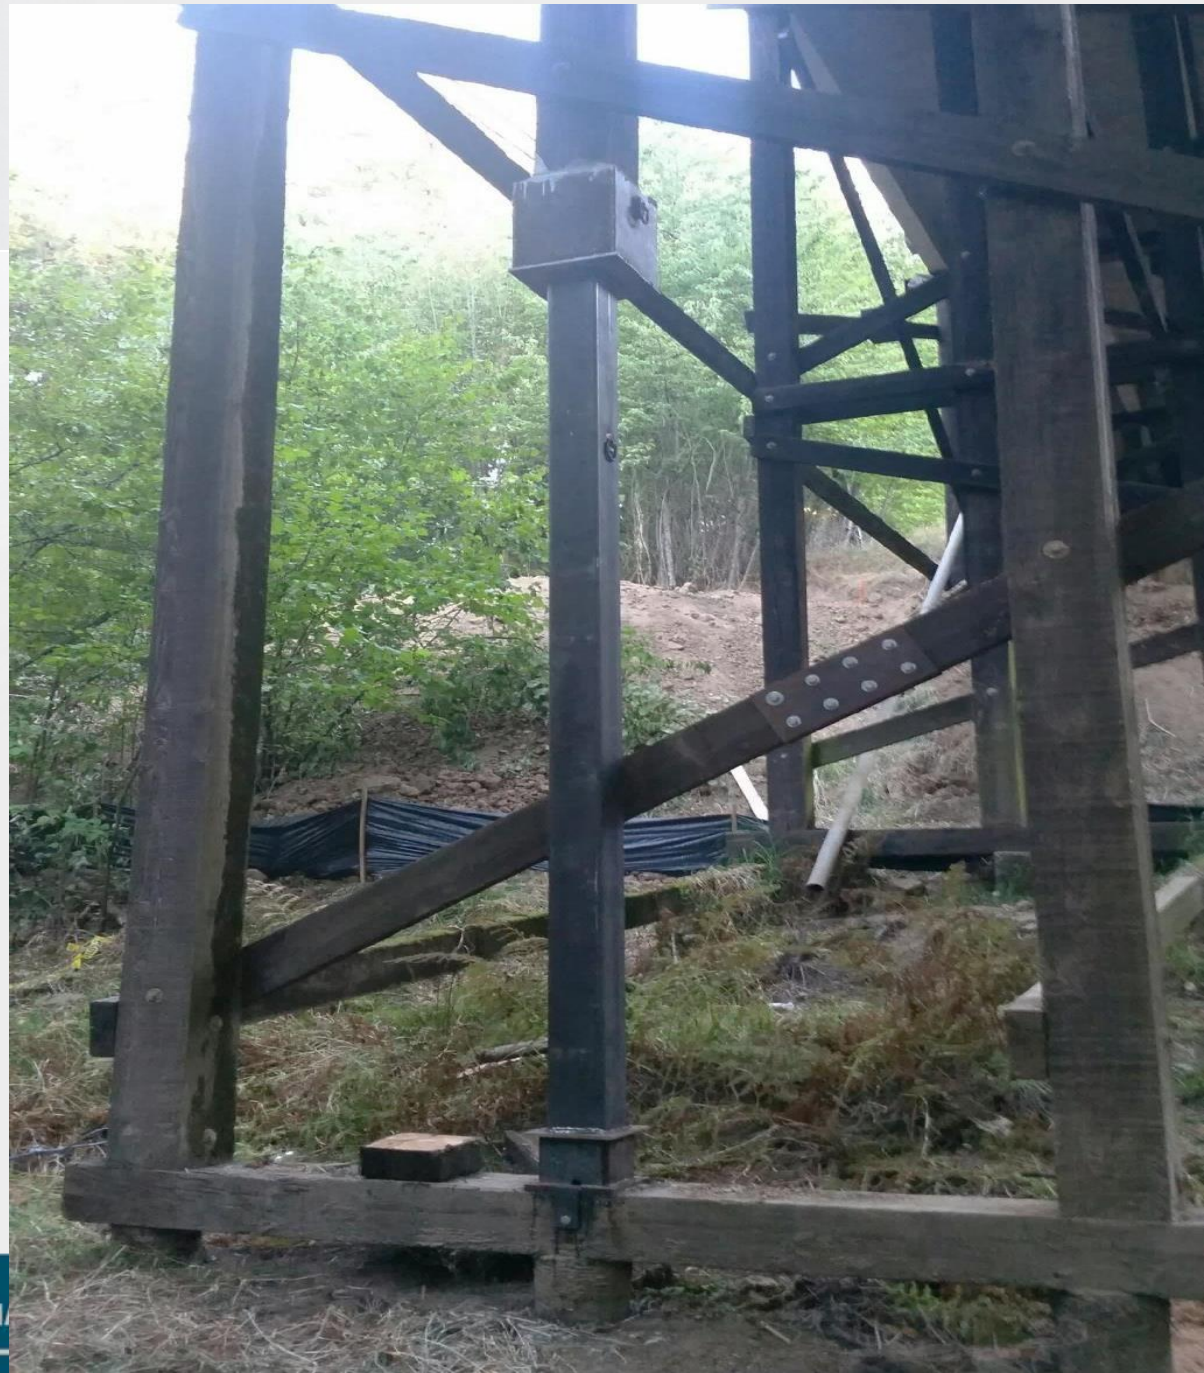
How much
rot is too
much to
repair?

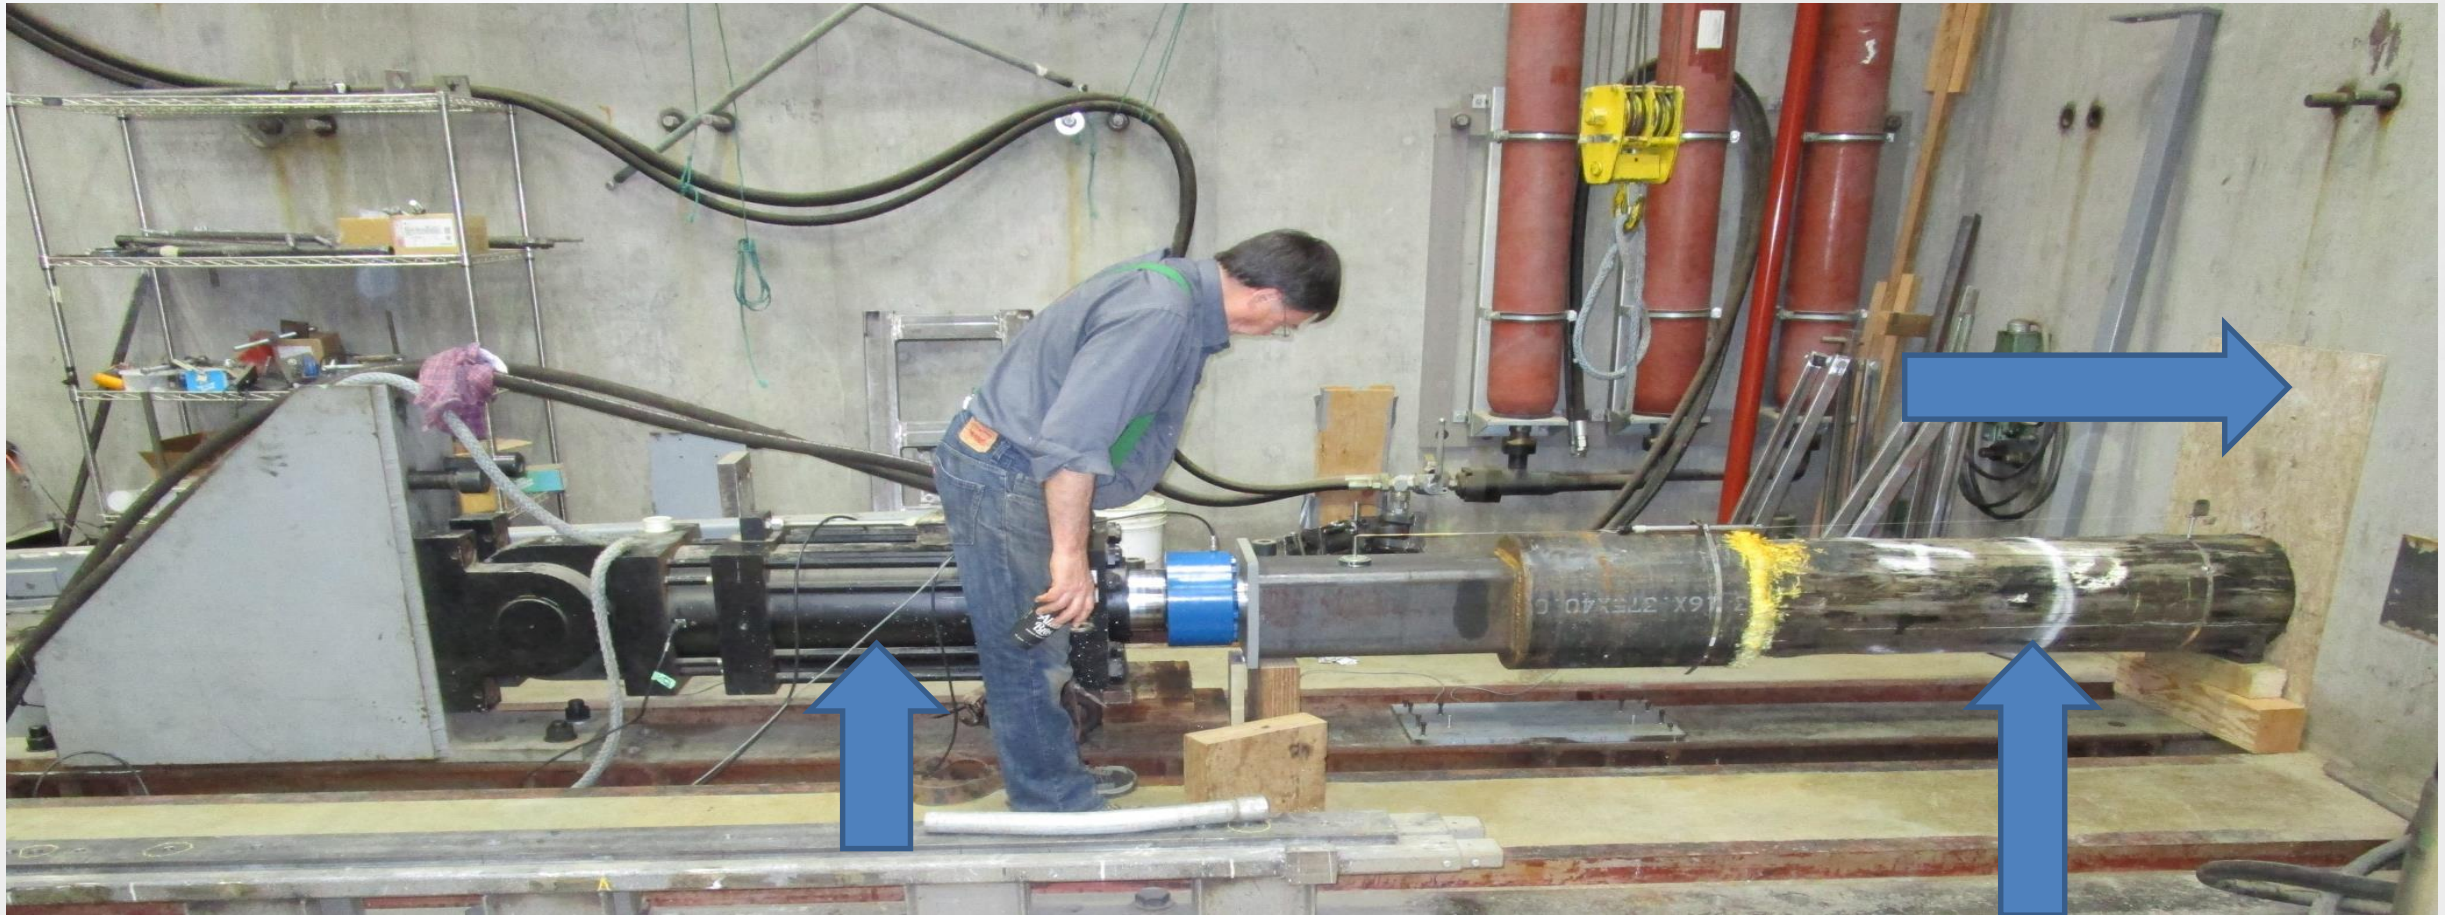
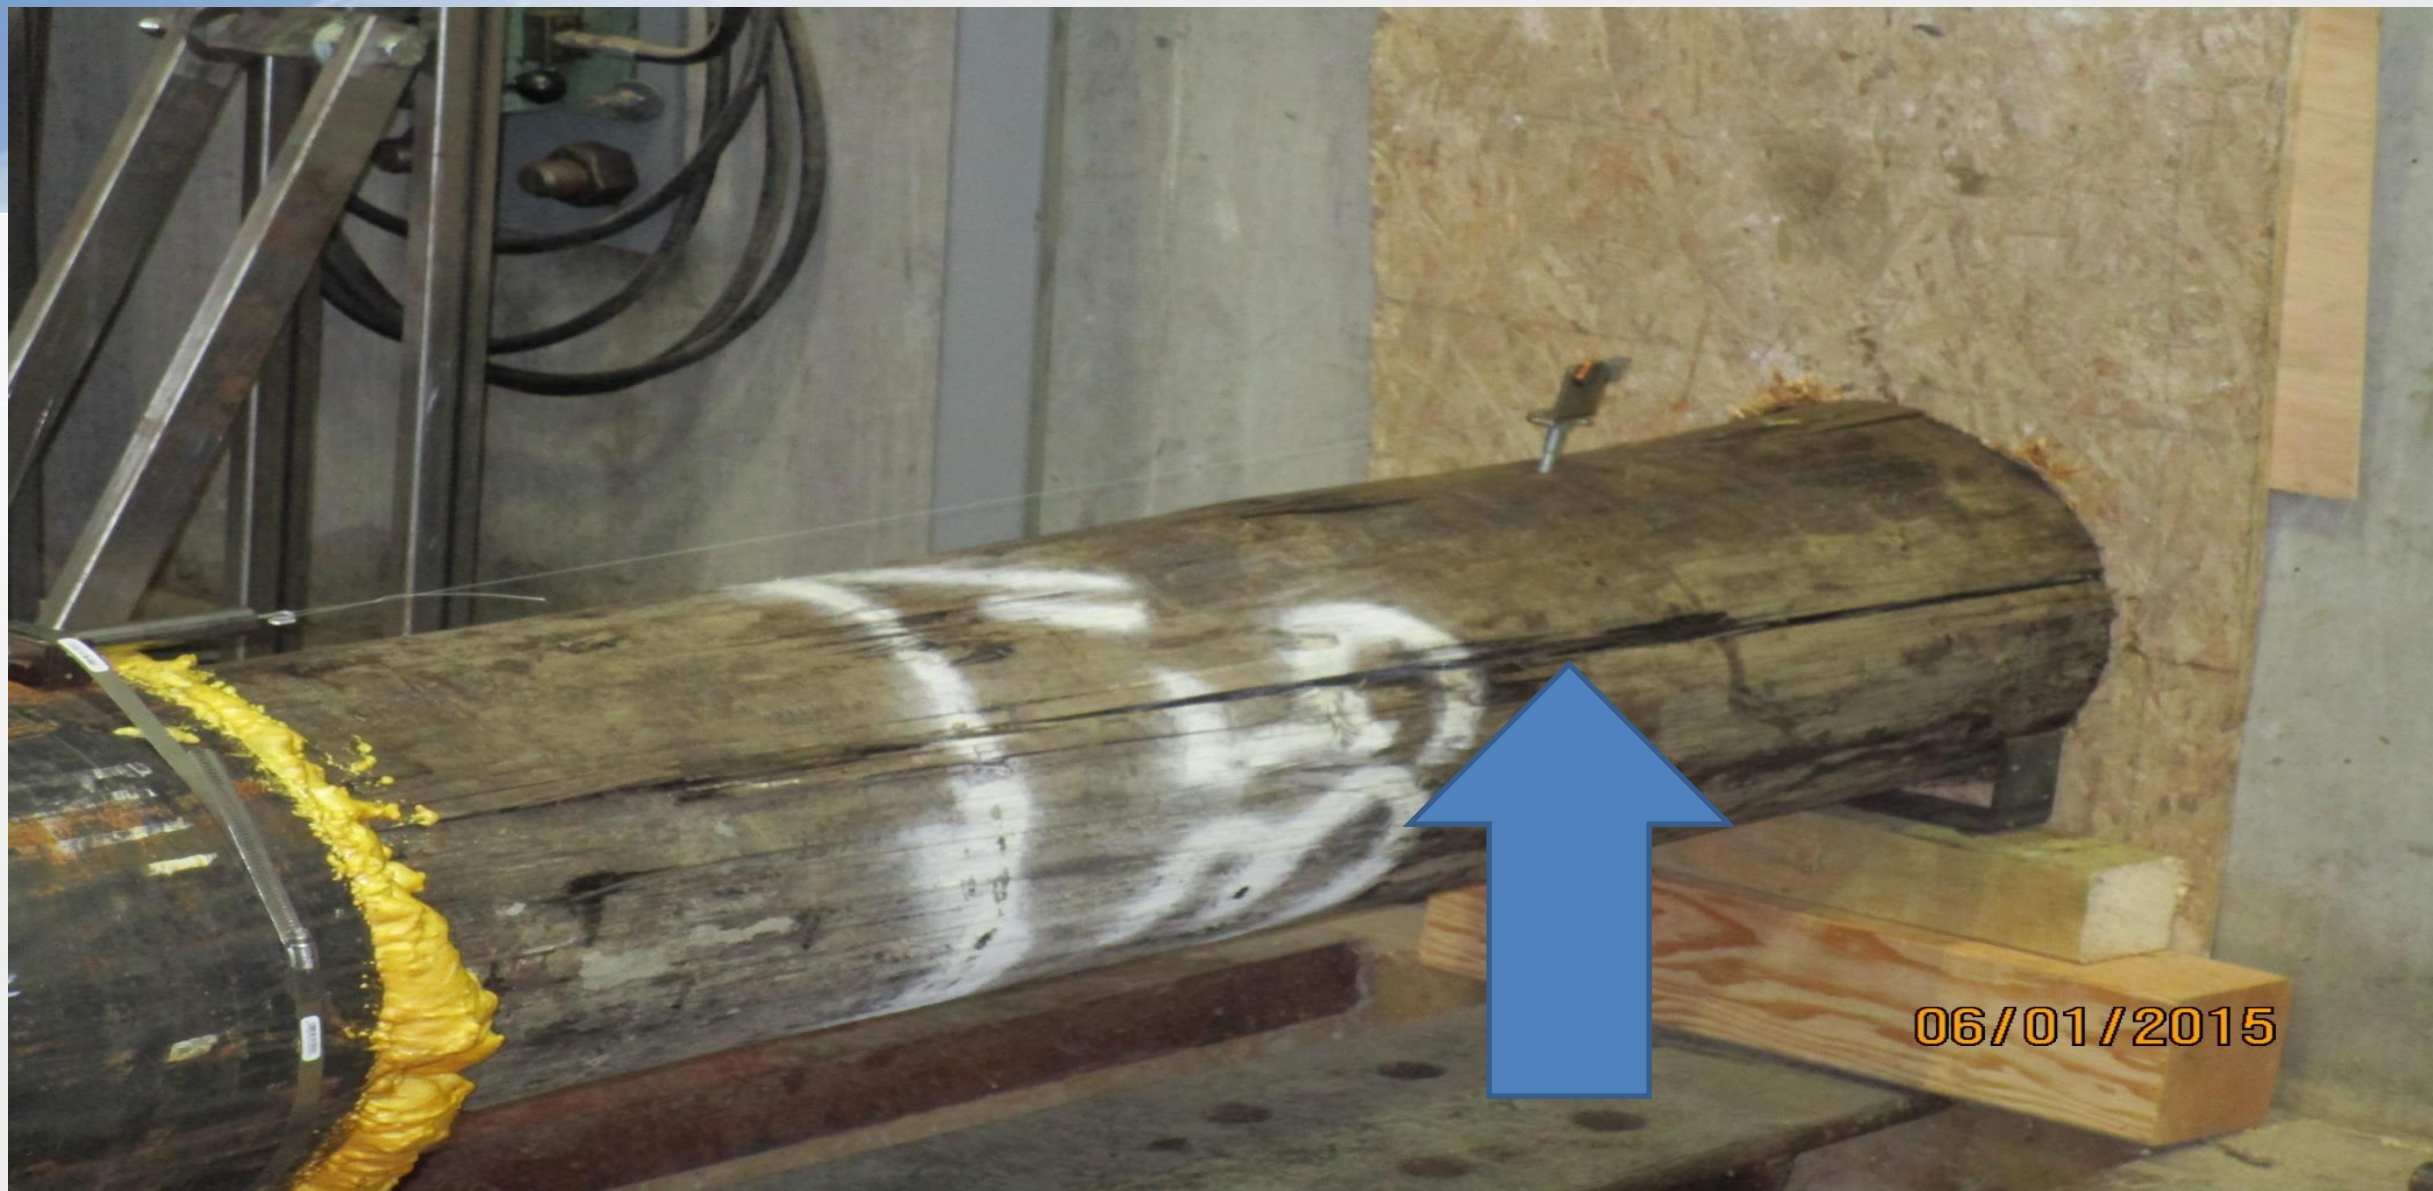
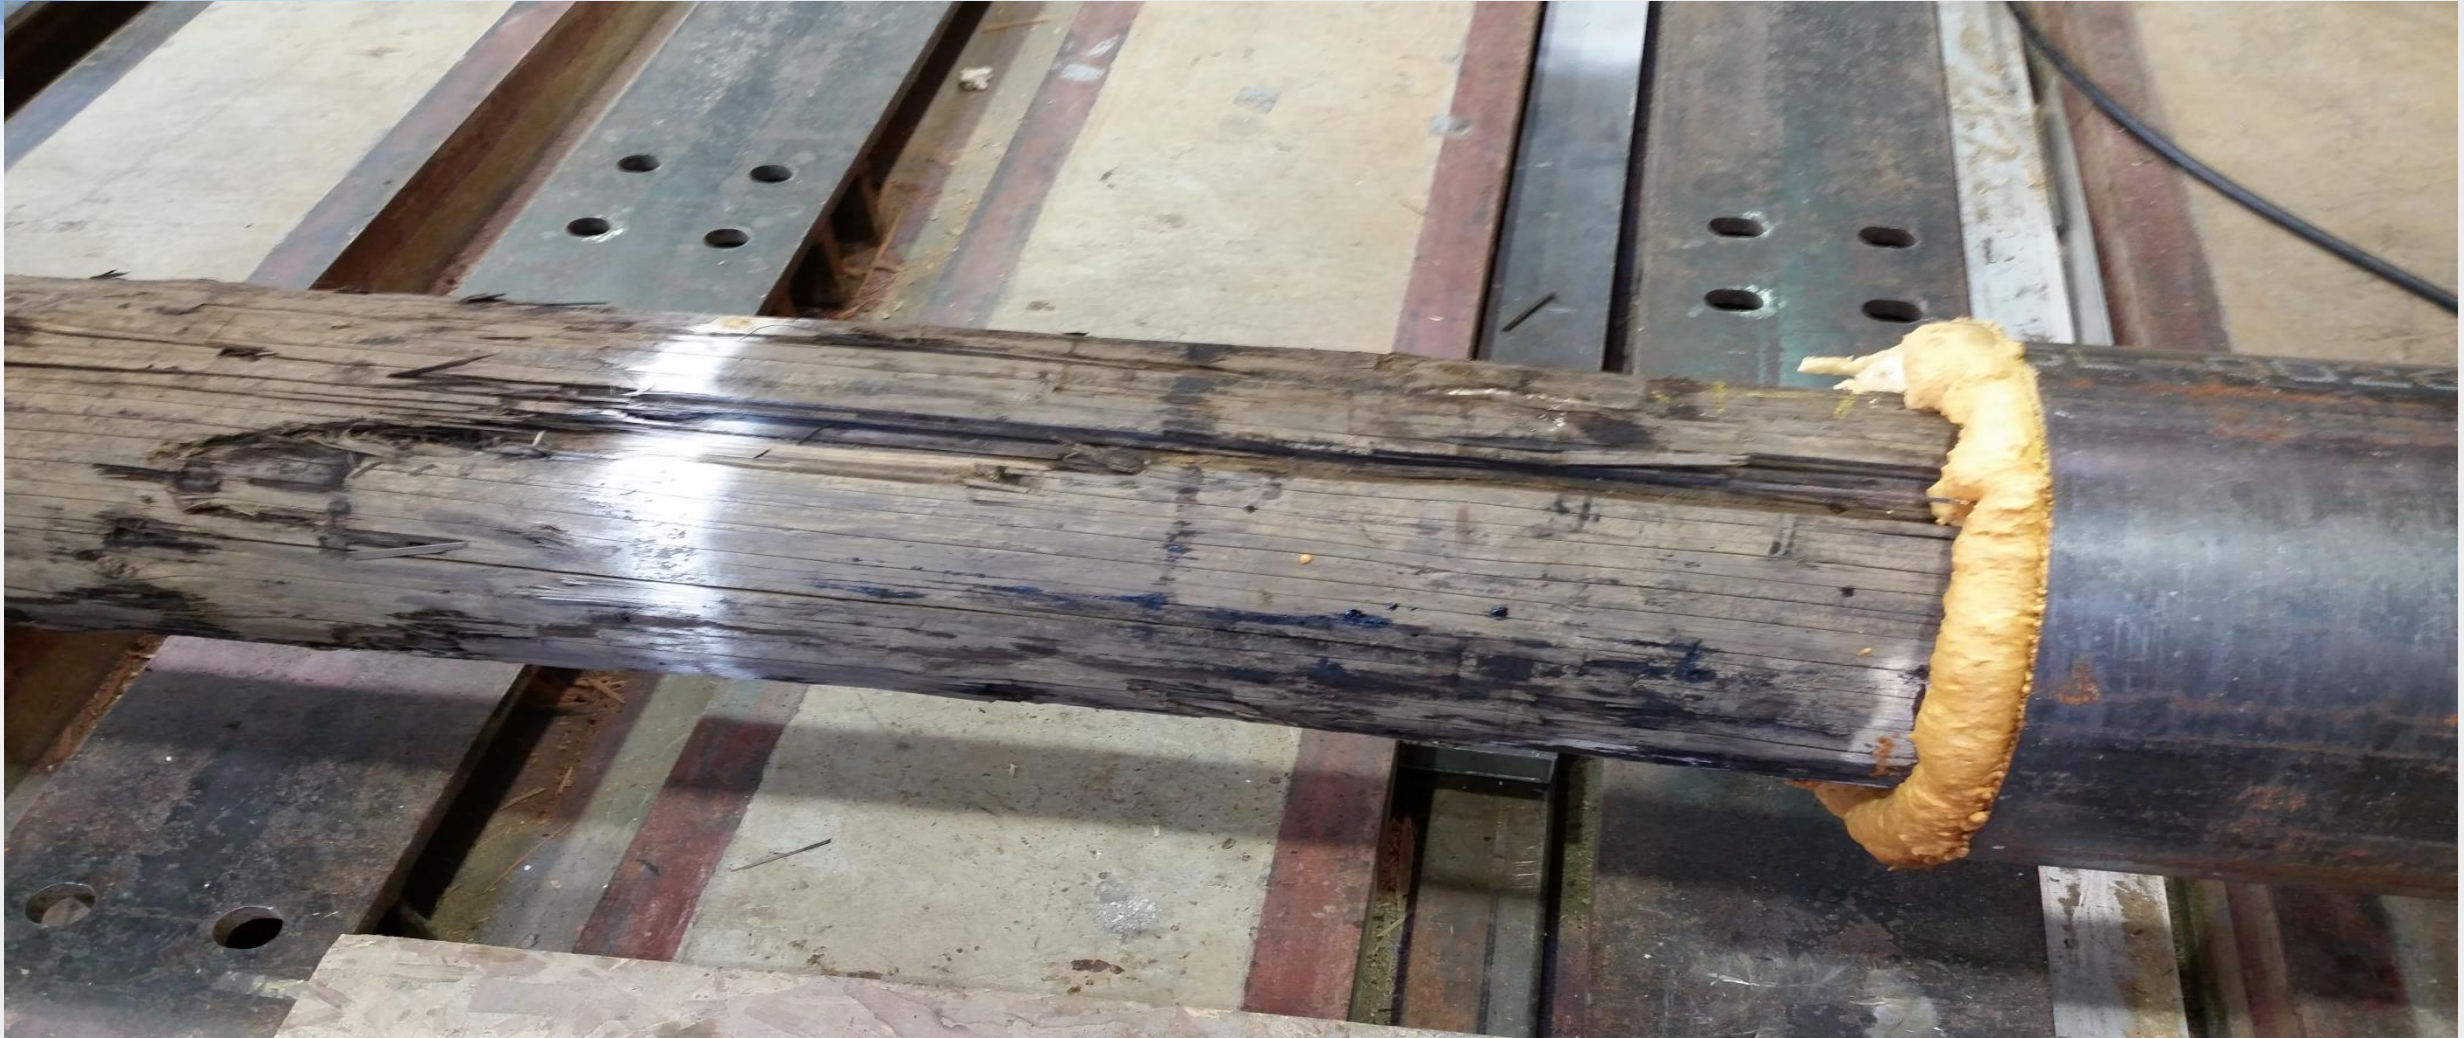
Compression Test Setup

Compression Test Results:

- The jack wasn't big enough!
- No piles failed at maximum load of 300,000 lbs.

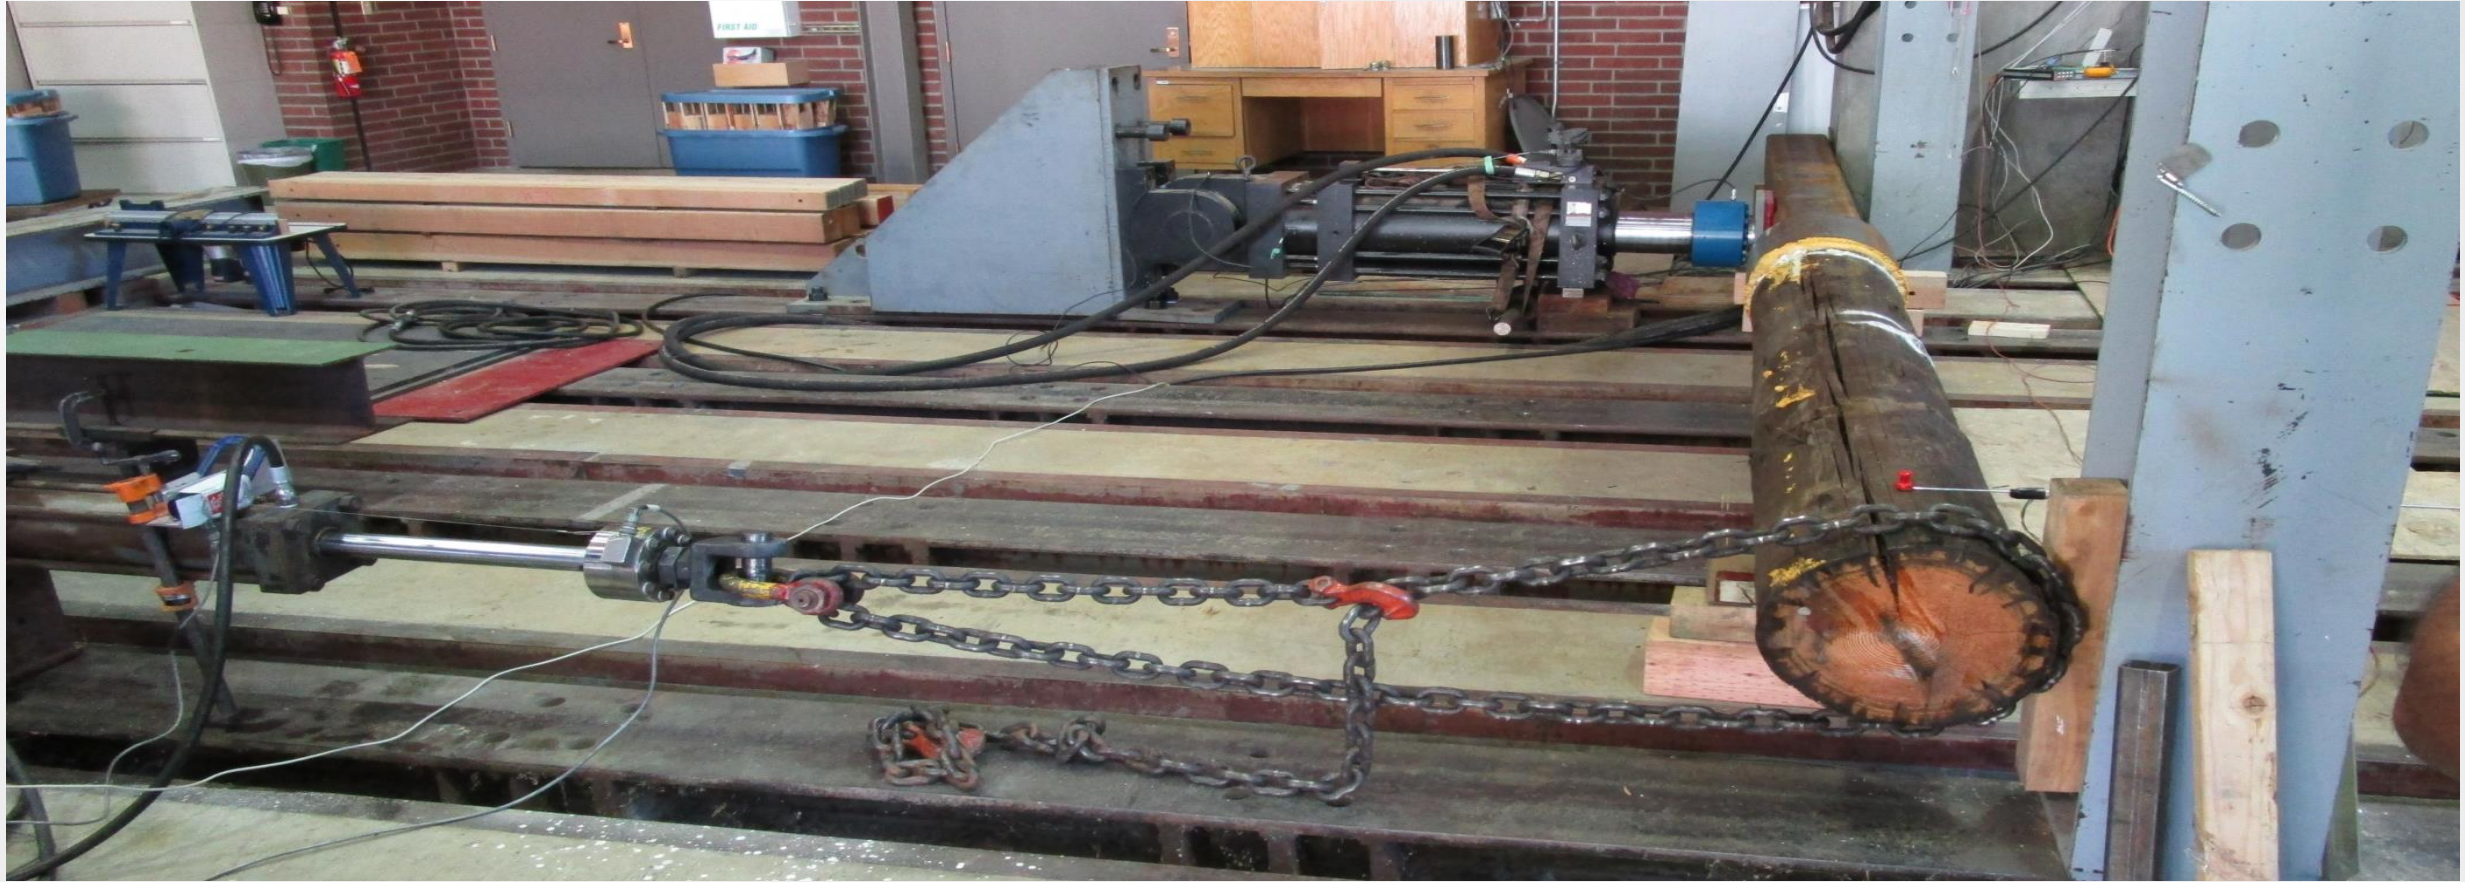
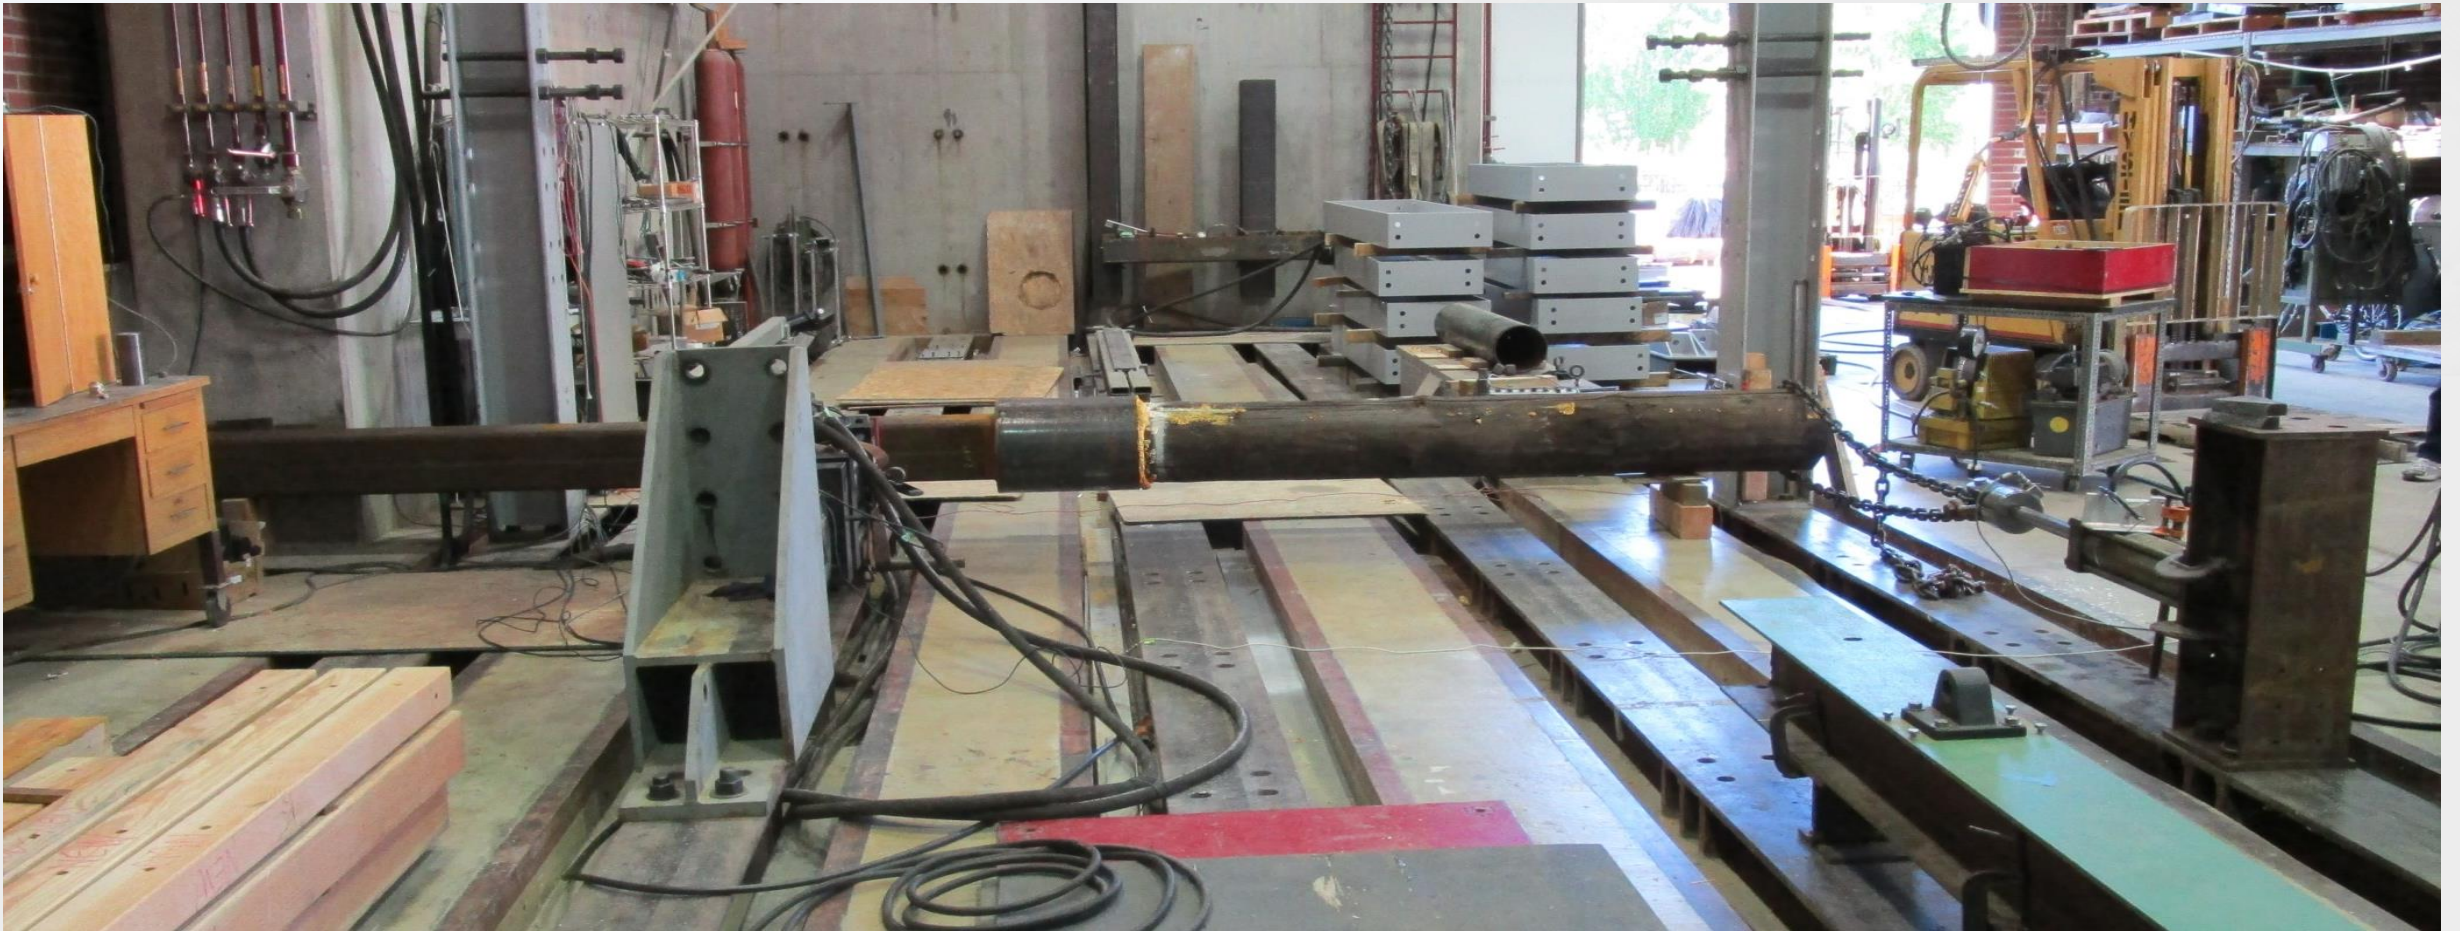
Lateral Test Setup

Bending Test Results

- All three failed at the base of the splice.
- Loading at failure was about what you'd expect for an unrepaired pile with 2" shell.
- Load remained about constant through 12" – 24 " of deflection
