Timber Substructure Repairs

Travis Kinney, Oregon DOT

NATIONAL BRIDGE PRESERVATION PARTNERSHIP CONFERENCE 2018

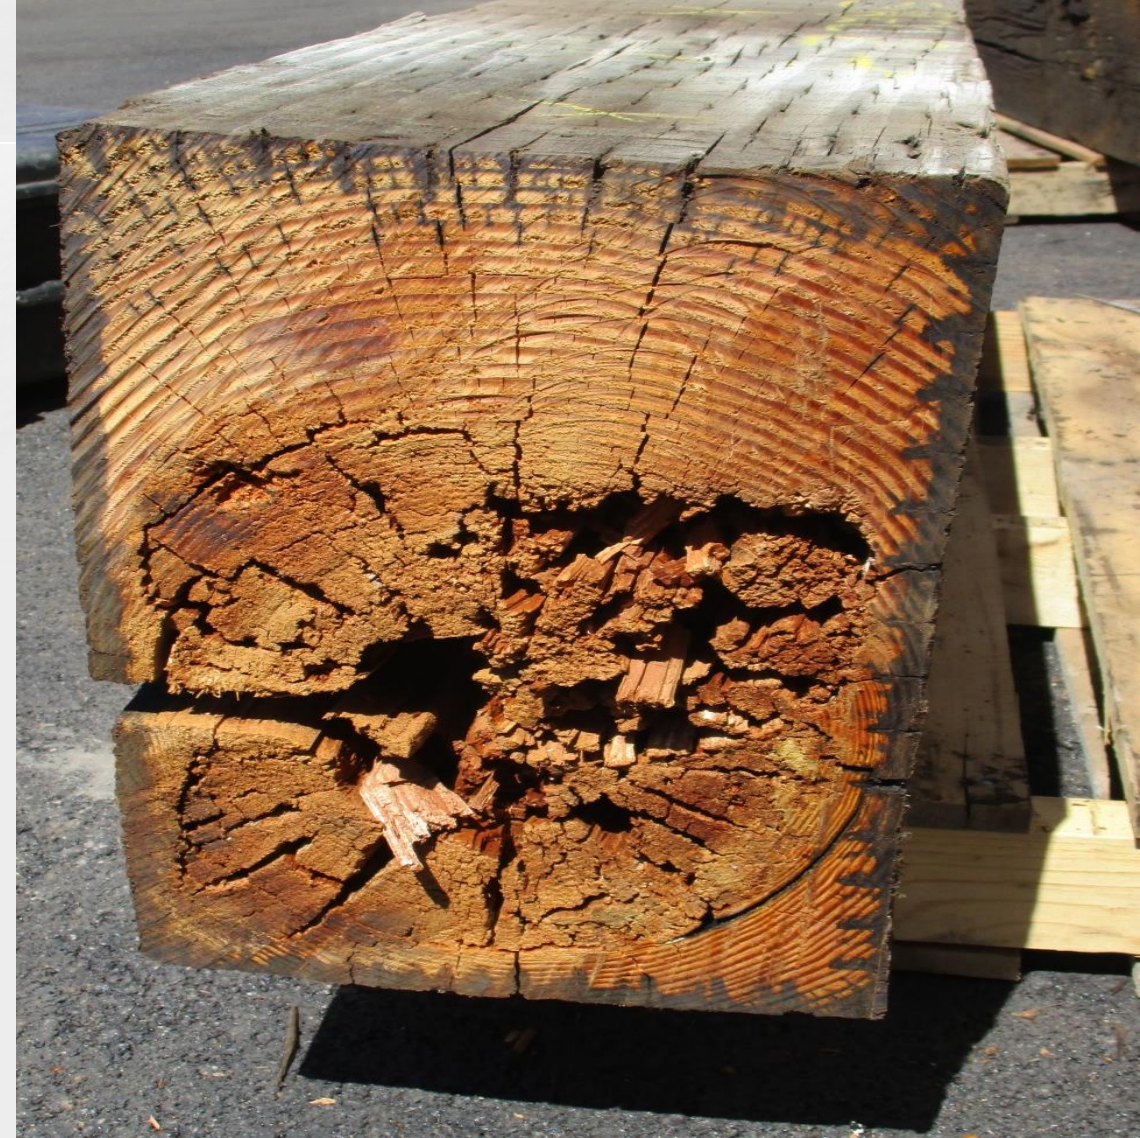
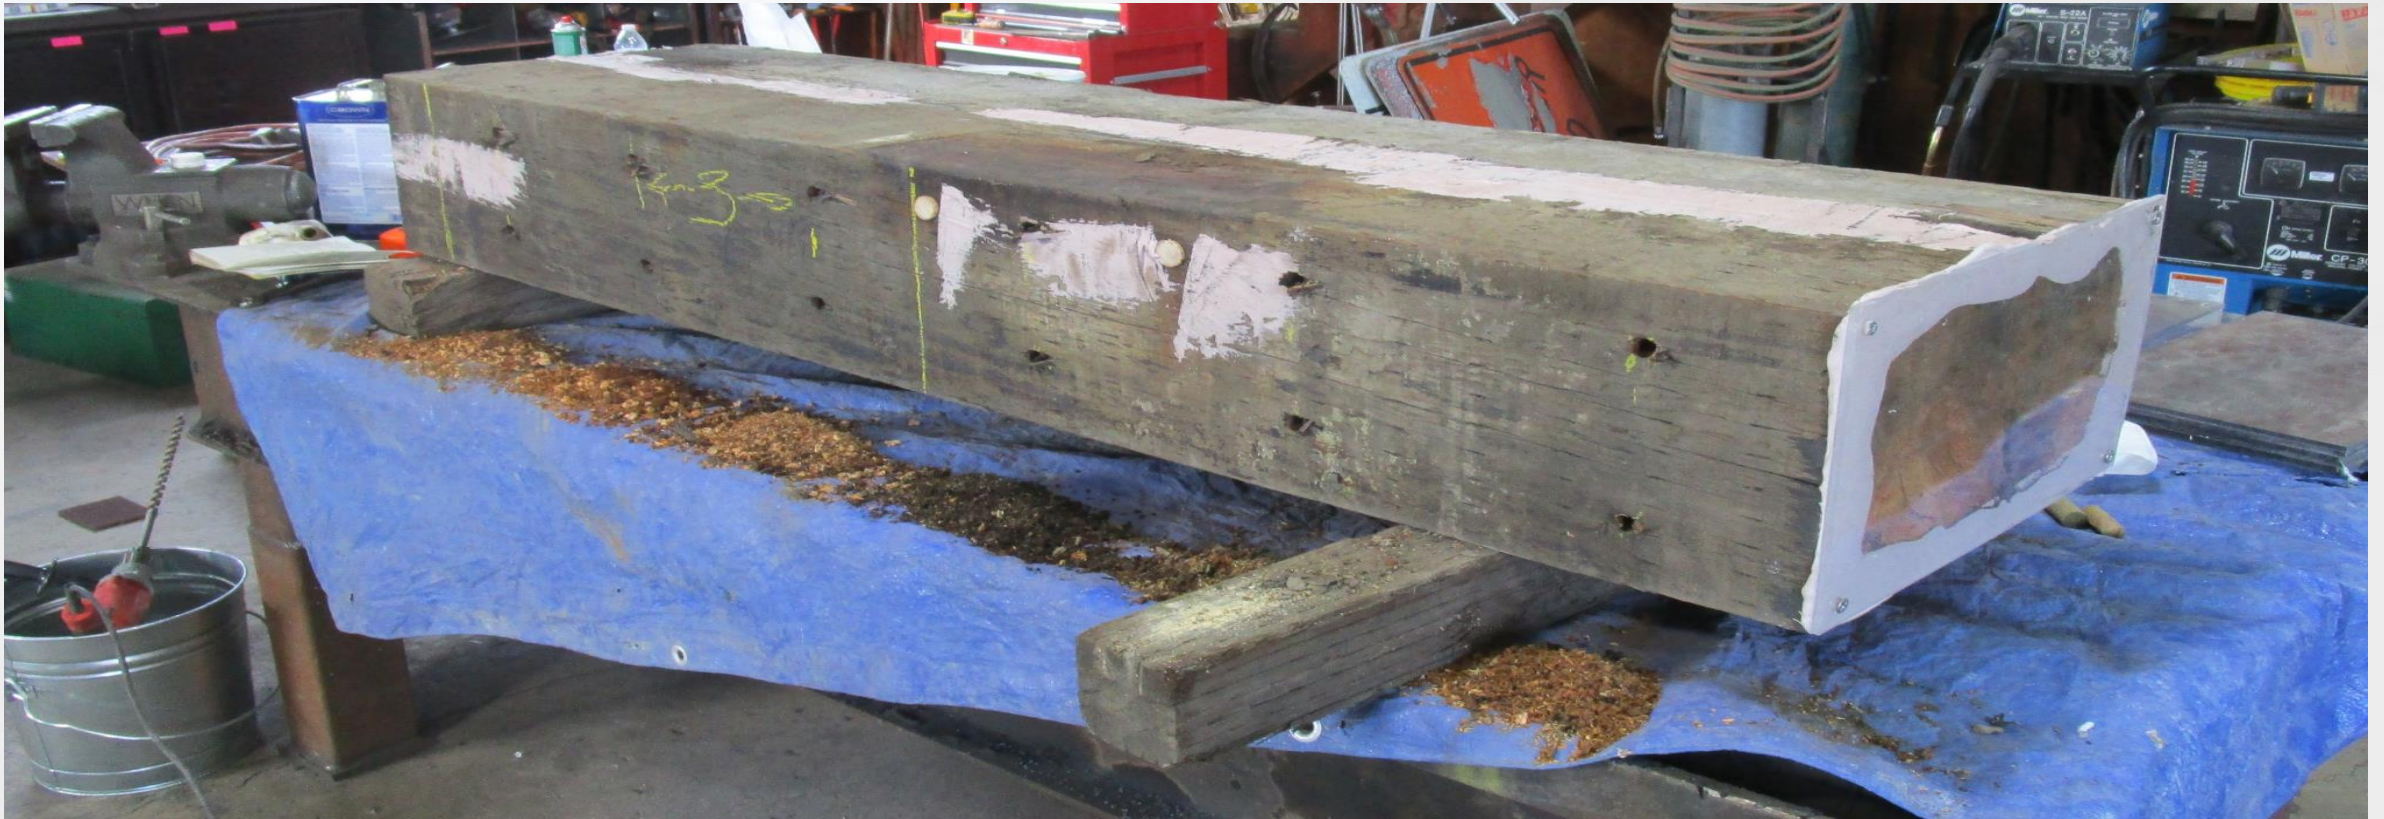
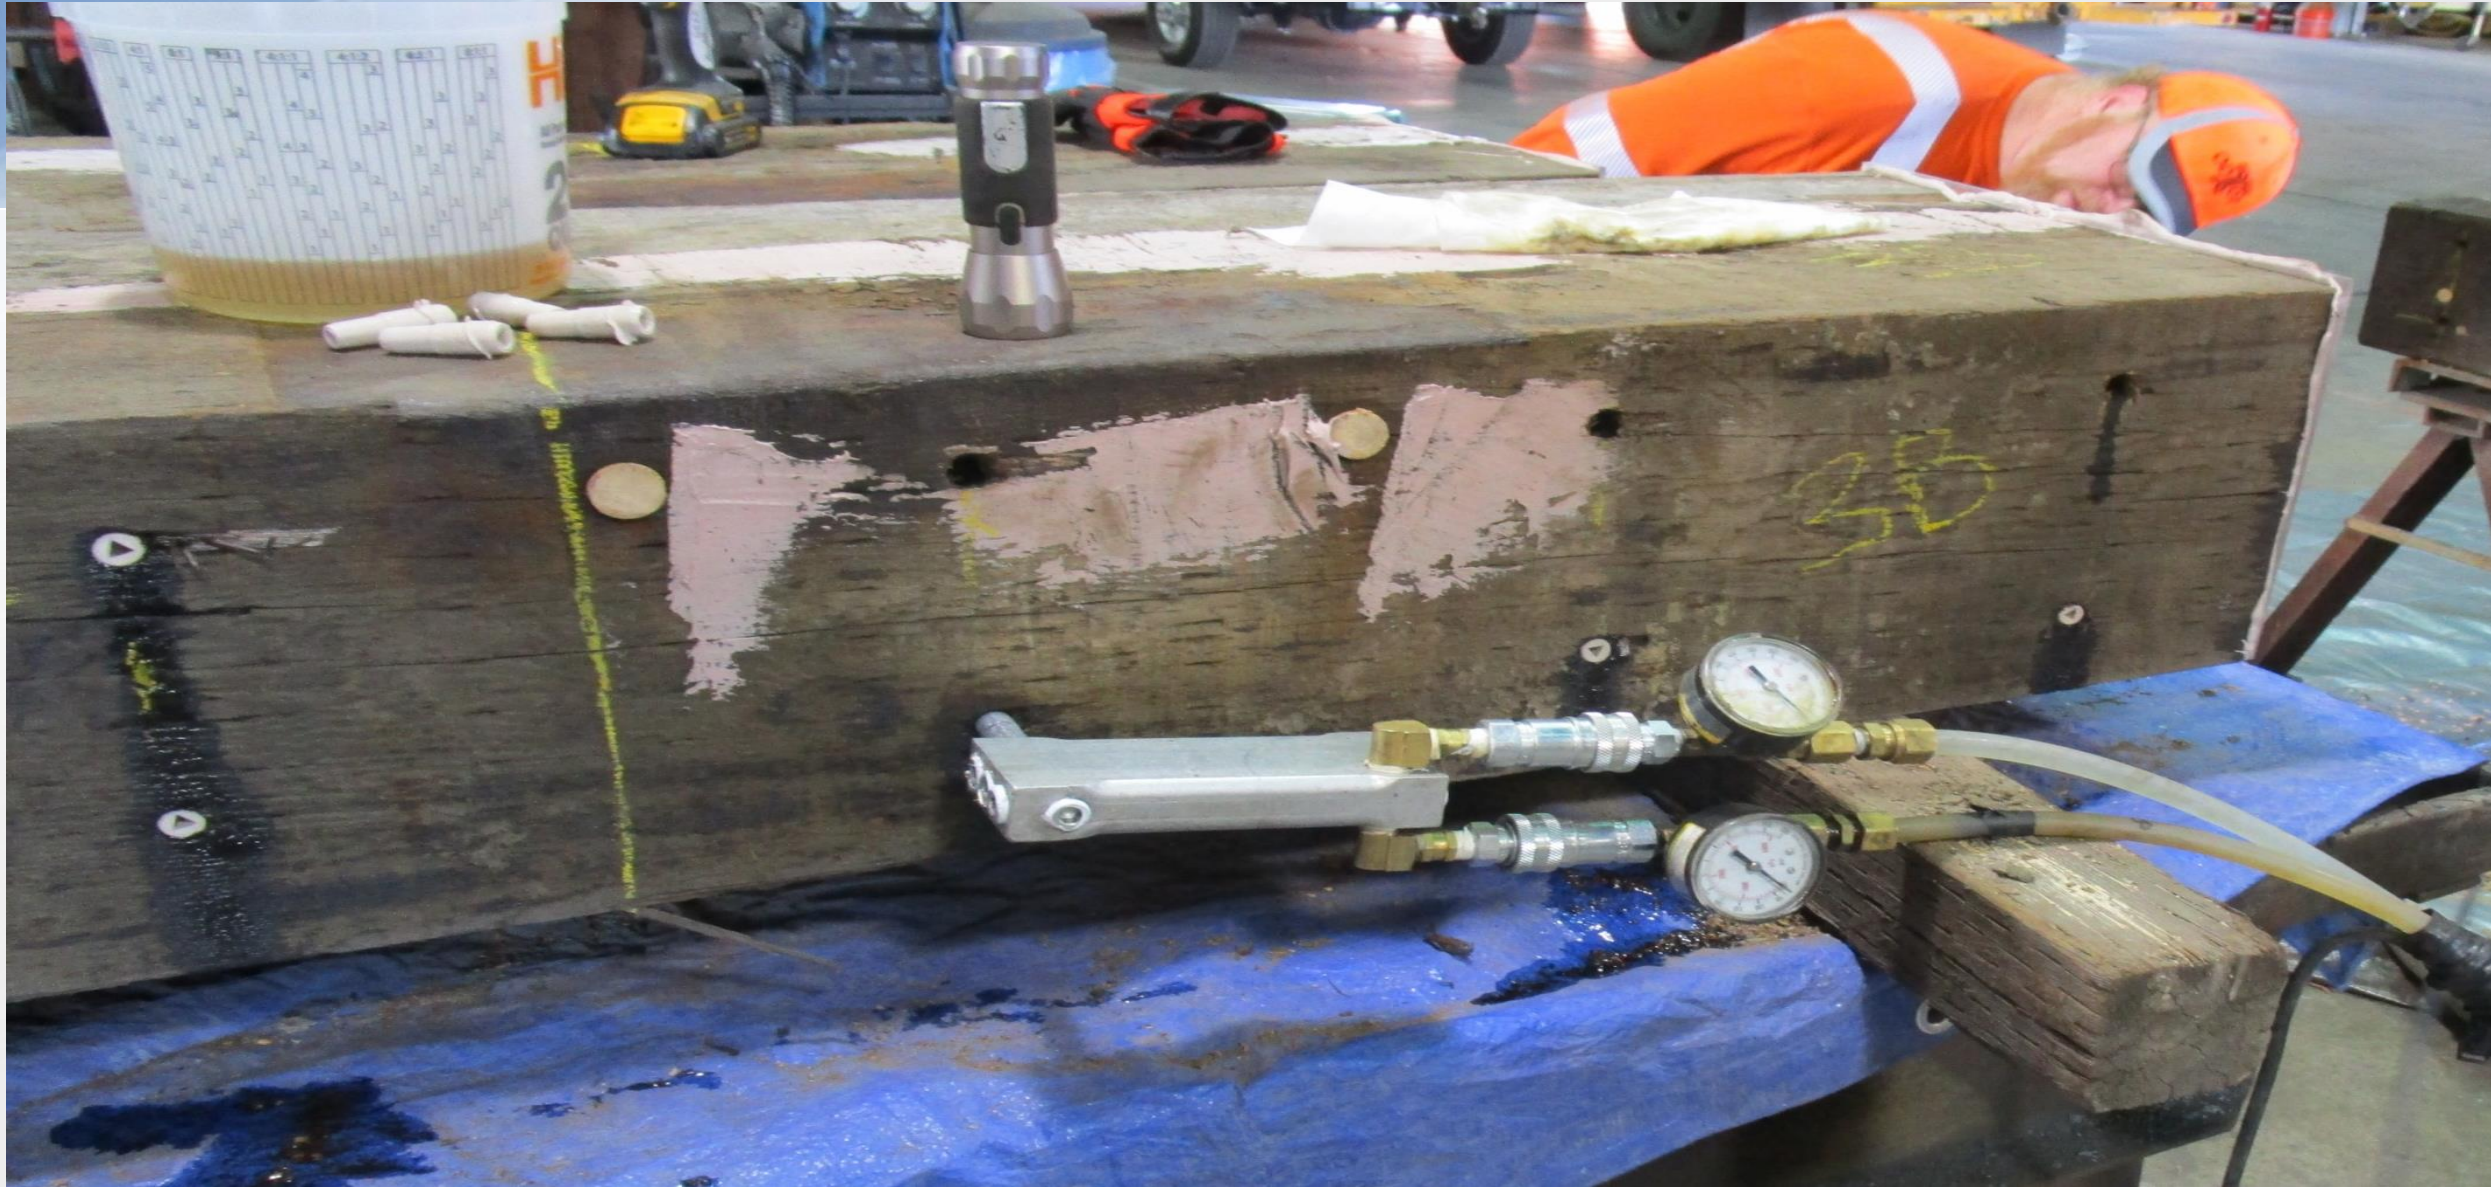
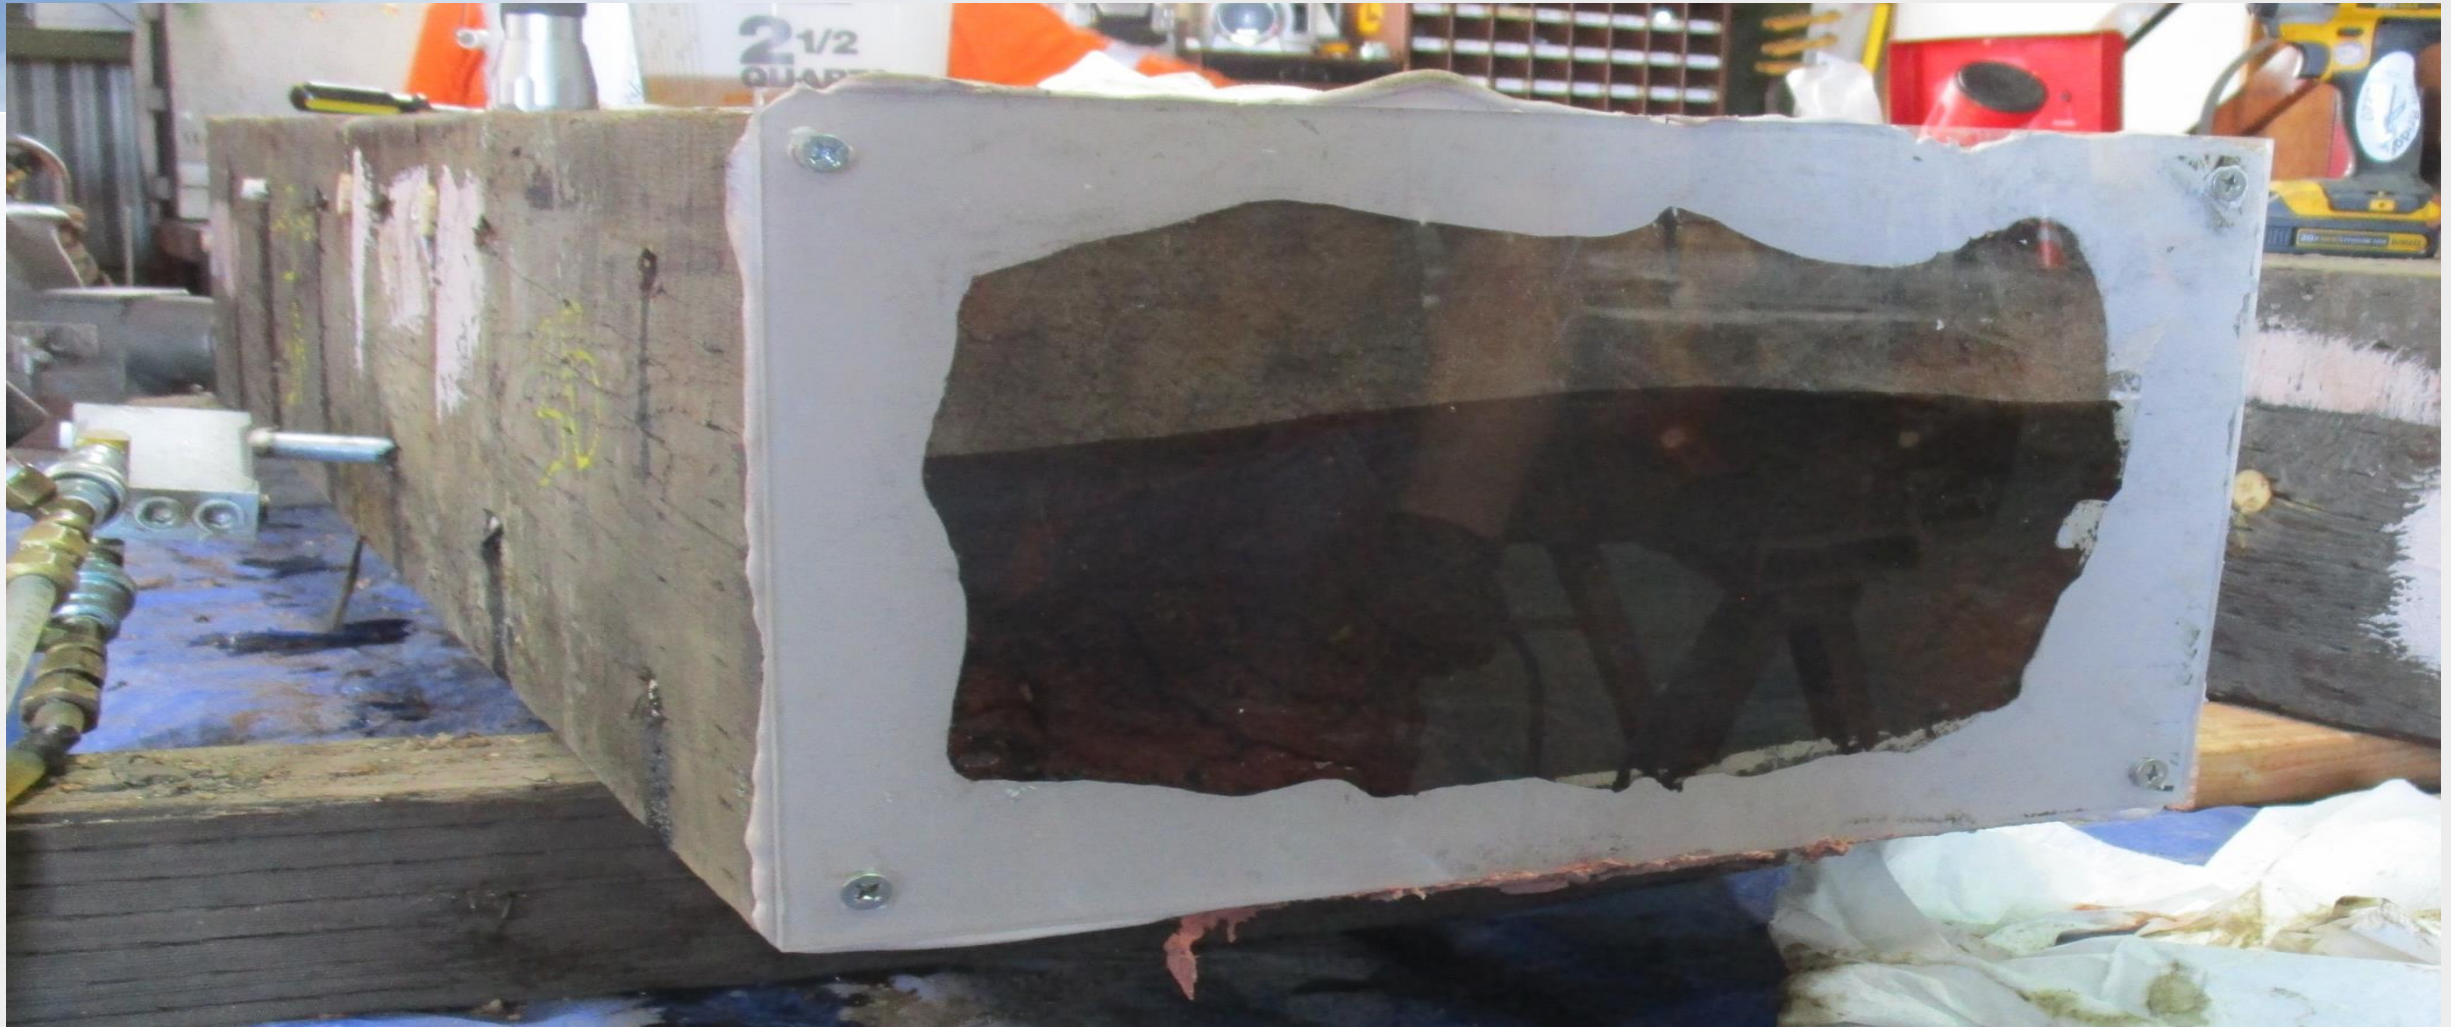
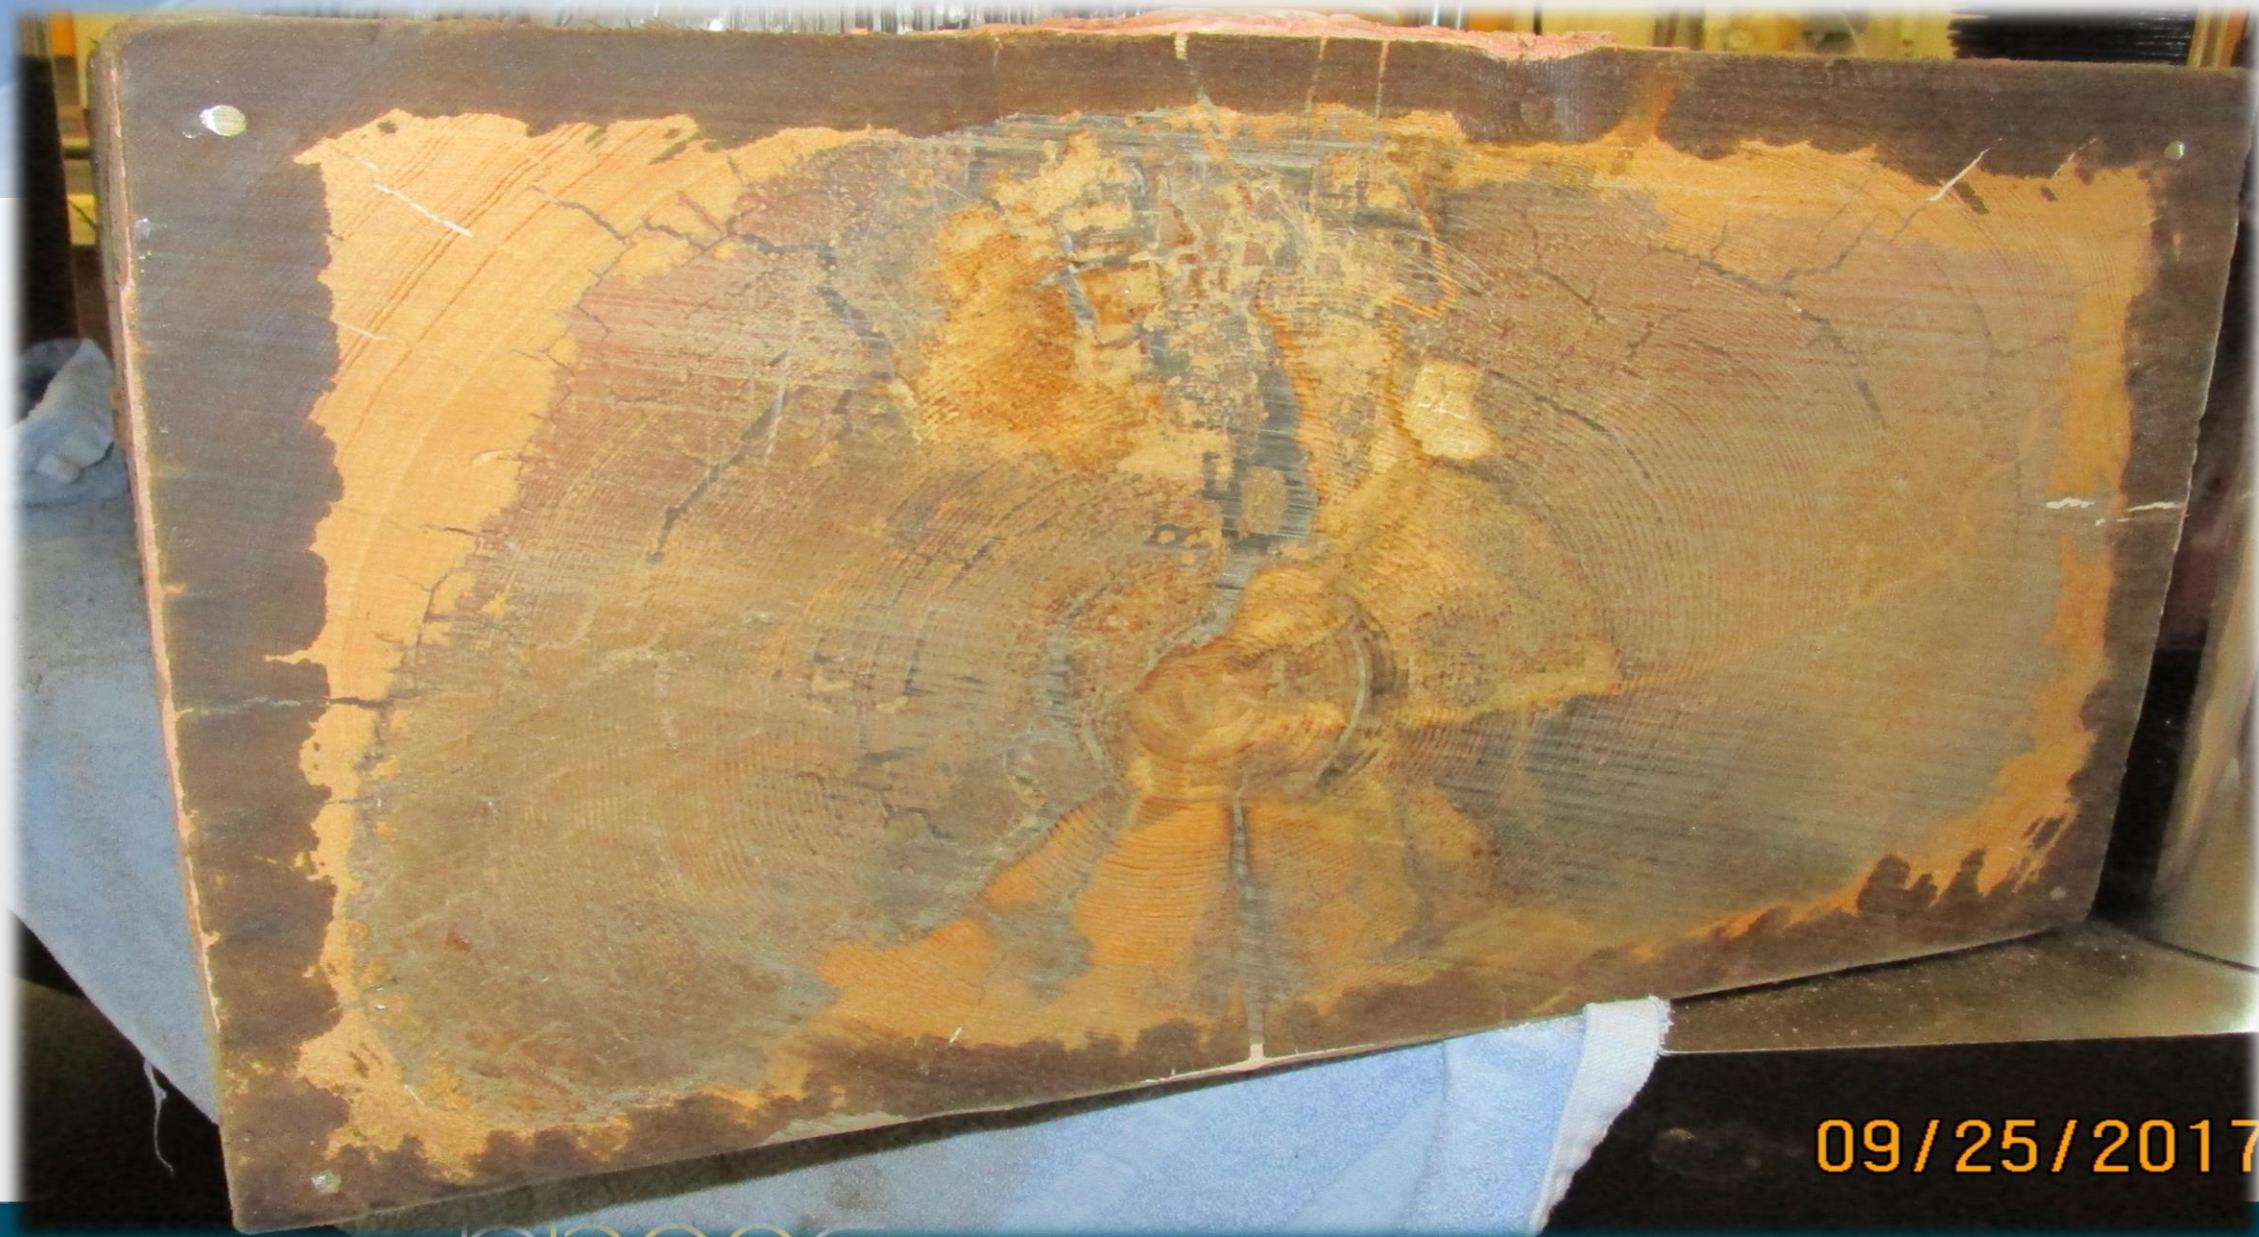
Epoxy Injection?

- Repair in place.
- Some caps don't function like beams but instead were used for construction and now act as a spacer between pile and girder.

Lets try it...

- Encapsulation:
 - Useful when utilities or shoring constraints make full removal problematic.
 - \$50,000 - \$80,000.
 - Connection to piles can be difficult.
 - Not feasible on abutments.
- Cap Replacement:
 - \$25,000 - \$65,000
 - Shoring dominates design constraints and overall cost.
- Epoxy Injection:
 - Not recommended at this time as a viable cap repair.

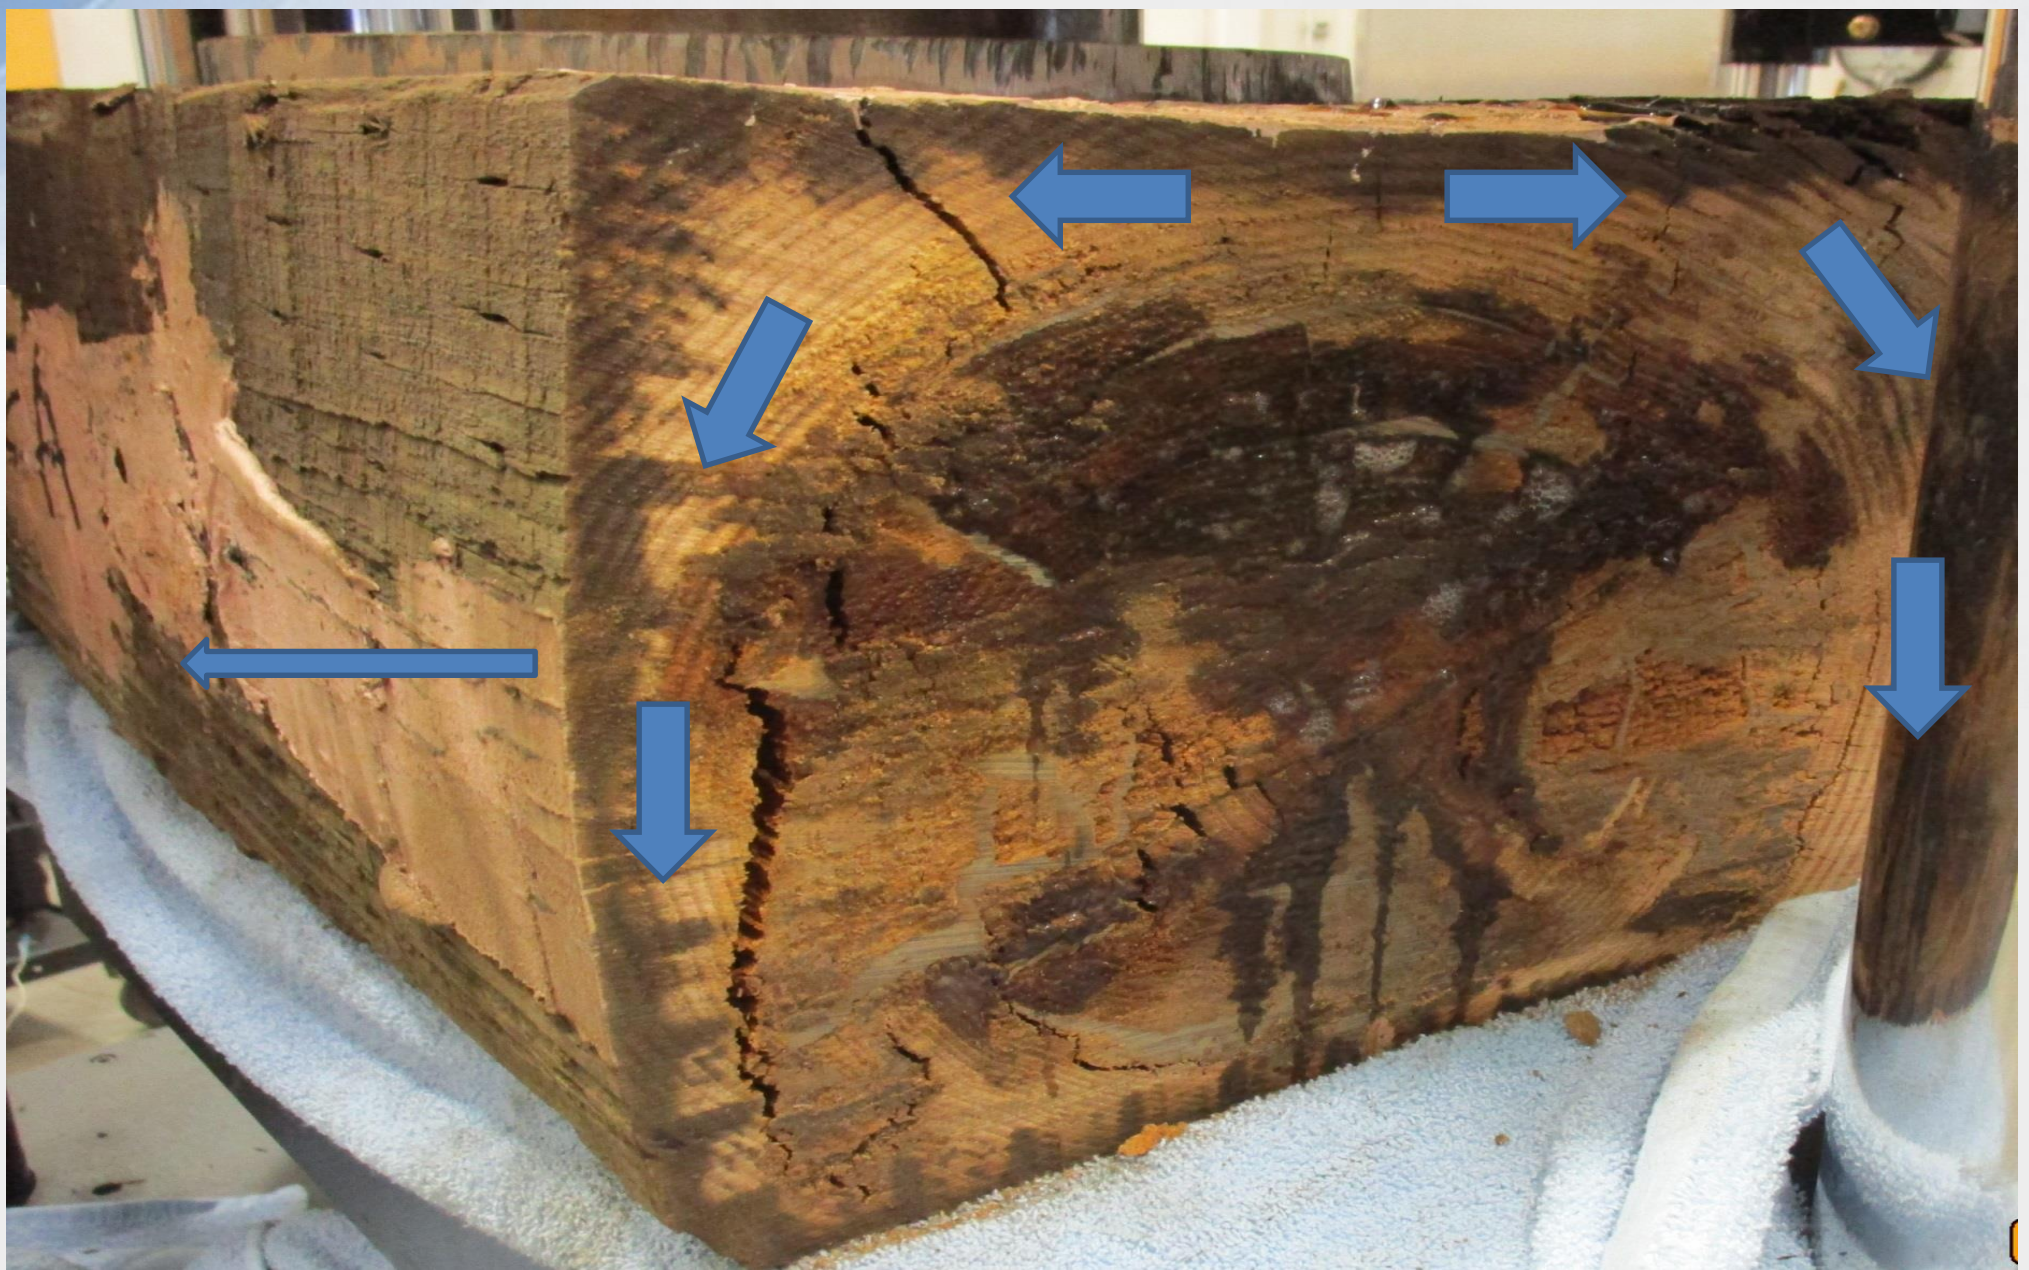
09/25/2017

Destructive Testing Results
