# Successful Implementation of Steel Coating and Bridge Rehab Projects

Rex A. Costley, P.E.  
Director of Maintenance  
Texas Department of Transportation

Queen-Isabella-Causeway

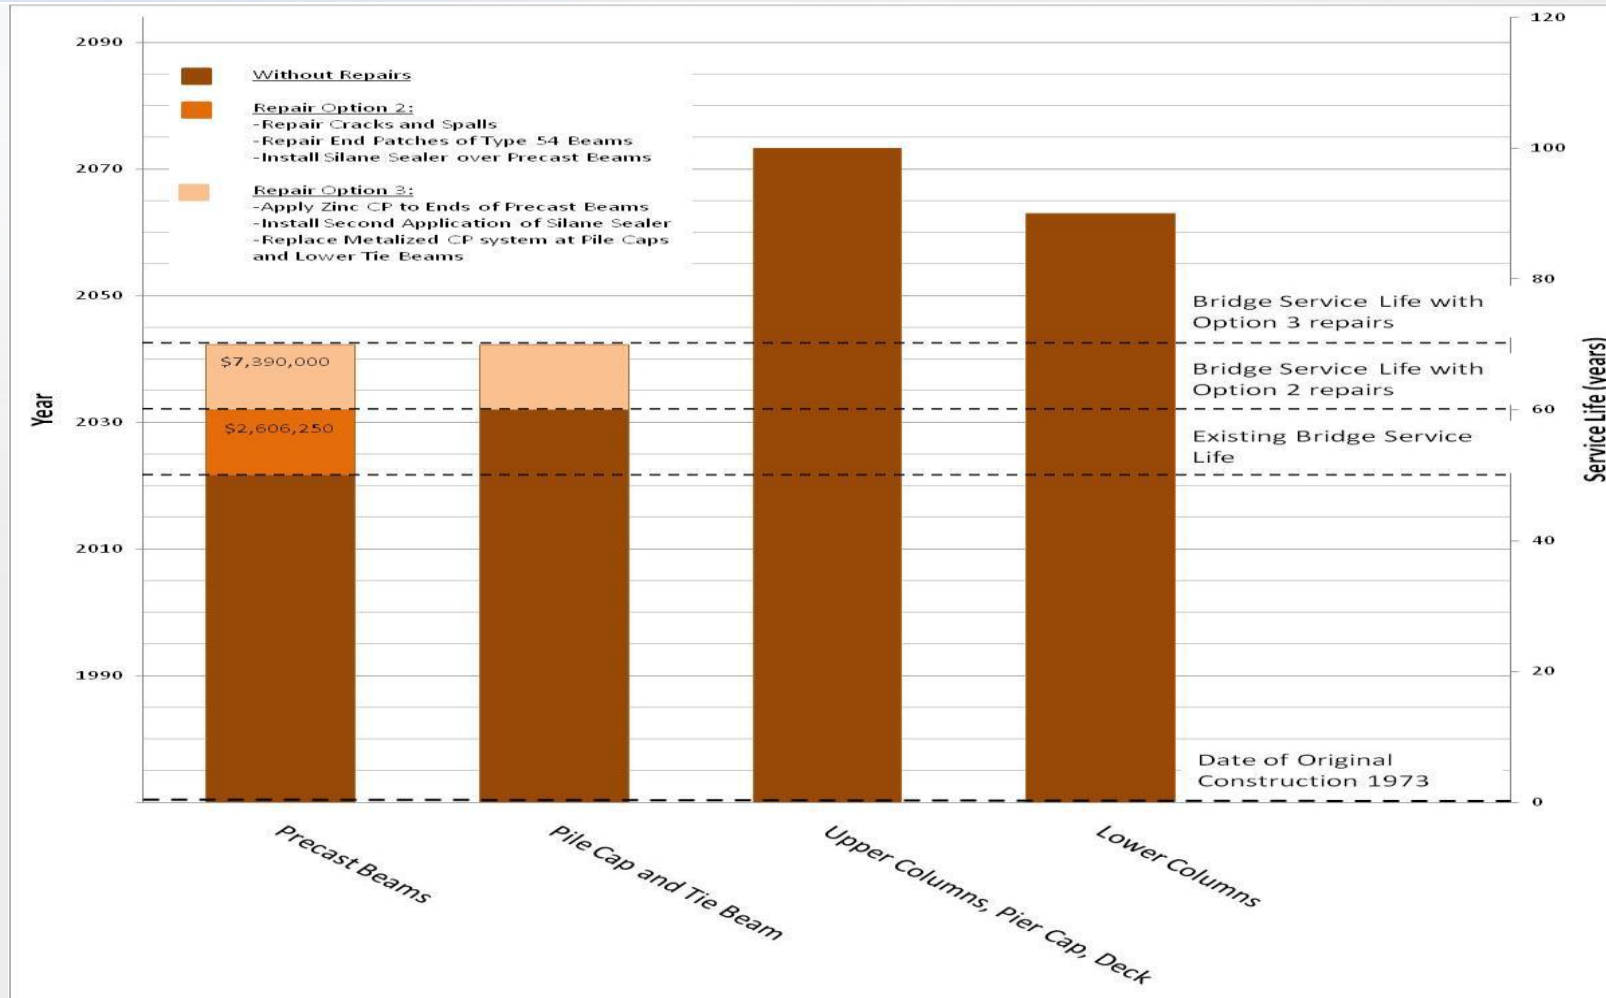
# QIC Service Life Assessment

- Based on the assessment findings, the Causeway is in good condition considering its age and service environment

- The three options presented provides TxDOT a pathway for the QIC to systematically achieve an estimated service life of an additional 70 years (1973 to 2043)
- Controlling bridge elements are the pre-stressed beam and substructure elements
- The QIC is in good condition considering its age and service environment

- Repair and paint steel girders (\$4,500,000)
- Replace deteriorated anchor bolts and guard rails with a T-4 three-bolt railing system (\$627,500)
- Remove and replace deteriorated light standards (\$680,000)
- Repair and paint exposed end connections for lateral tie roads (\$117,000)
- Miscellaneous work (structural and Cathodic Protection (\$75,000)
- **COMPLETED** via BPM 6207-63-001 and CSJ 0331-04-065 (2010 to 2013)

- Includes all items captured in Option 1 and extends the service life an additional 10 to 15 years (2033). Again, the pre-stressed beams are the controlling element. This includes the repair and repainting of the steel unit. This will be the fourth repainting effort (1983, 1995, 2010, 2020+ TBD). Total cost for this work is estimated at \$14M.
- Perform all items in Option 1 (\$6,946,600) **COMPLETED**
- Repair all existing spalls and major crack elements utilizing conventional repair techniques (\$1,203,750)
- Repair end patches at all Type 54 beams (\$600,000)
- Apply a single application of a penetrating silane sealer to all exposed surfaces of the Type 54 beams and diaphragms (\$802,500)
- **COMPLETED** above work VIA CSJ 0331-04-065 (2010-2013)

- Perform all items in Option 1 and 2, except as noted below, within a one or two year time period (\$14,079,850) - **COMPLETED**
- Apply CP system (zinc alloy thermal spray) to all Type 54 beams at ends, sides, and soffits (bottoms) for a distance of 3 feet from each end in approximately six to eight years following the first silane application (\$2,000,000) (**PLANNED**)
