Route 37 EB & WB Bridges over Barnegat Bay *Superstorm Sandy Emergency Repairs to Scour damaged Piers*

Township of Toms River, County of Ocean, New Jersey

PRESENTED APRIL 2018

OWNER: NEW JERSEY DEPARTMENT OF TRANSPORTATION
DESIGNER: WSP USA (FORMERLY PARSONS BRINCKERHOFF)

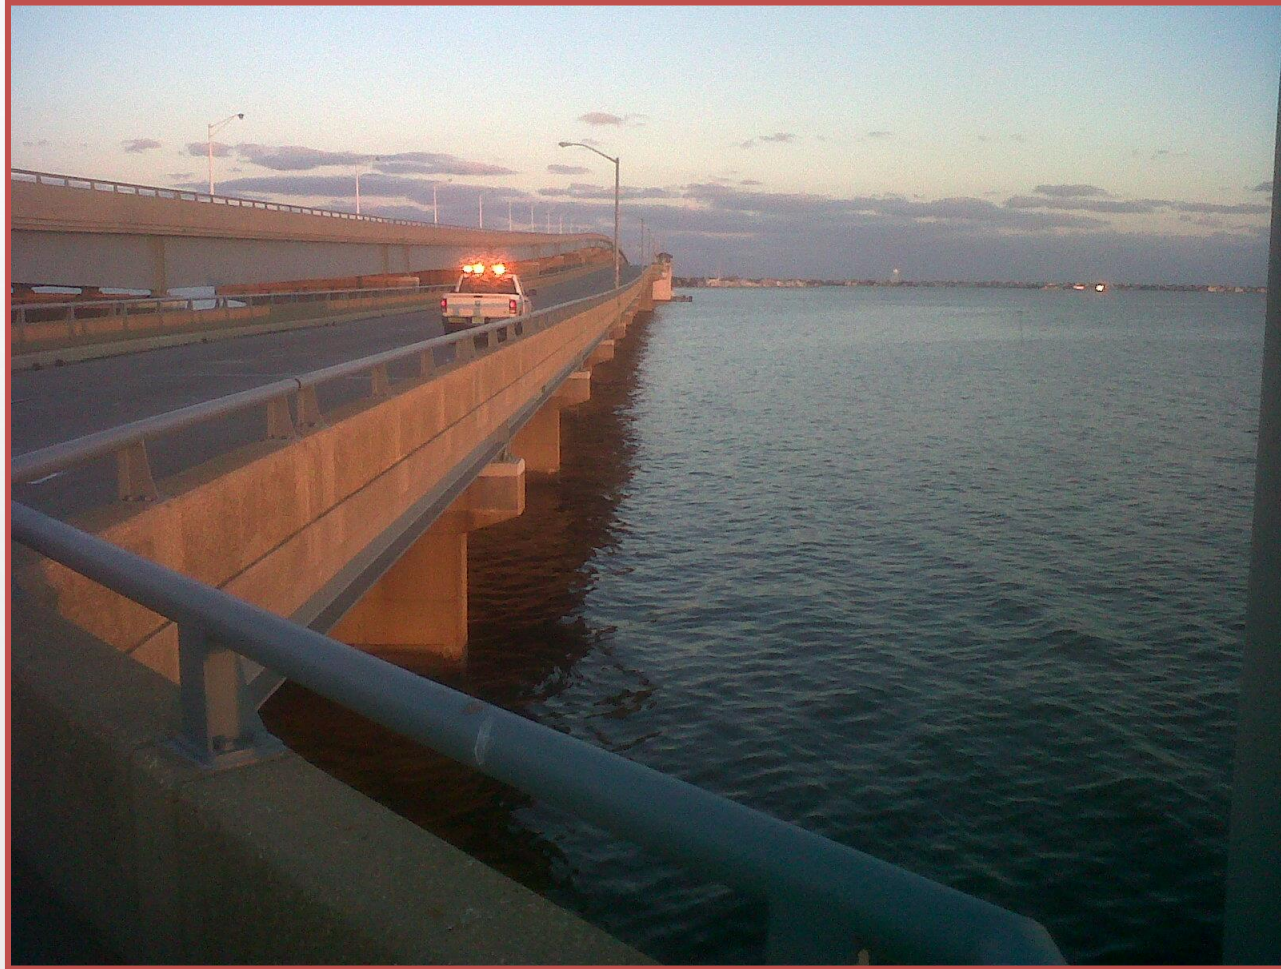
Post Sandy Emergency Inspection

- Team's Familiarity with Project Site
- As-built Bridge Plans Included Subsurface Information
 - Length of pier timber piles were estimated from as-built quantities
- Analysis Included:
 - Post-Sandy scoured condition – Dec. 2012 inspection data used
 - Post-construction condition with scour repairs installed
 - Determined ultimate geotechnical axial capacity of single pile for critical pier
 - Analyzed pile group for pile cap deflection, axial load, shear, and bending
 - Critical Pier 11– fully undermined, 10' max. pile exposure, 15' scour

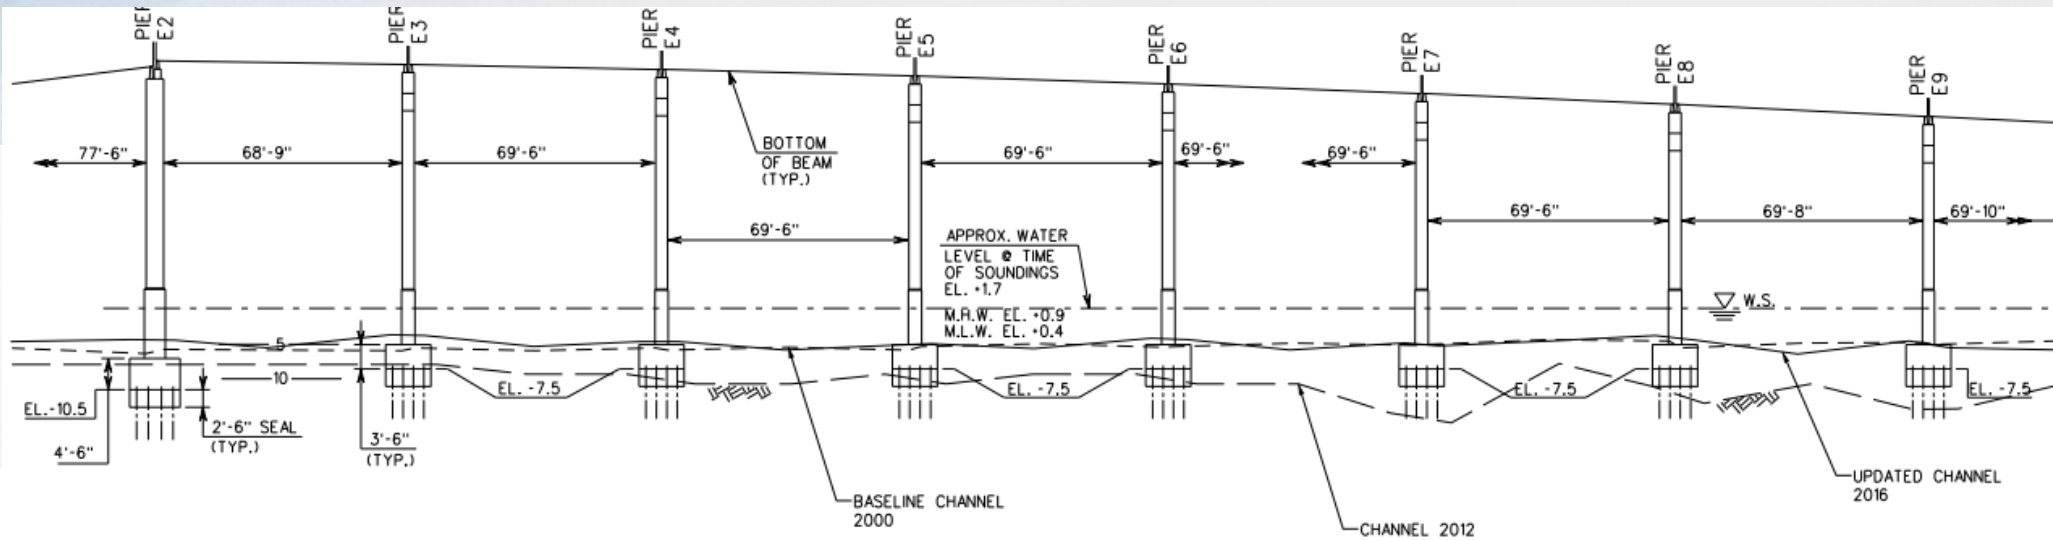
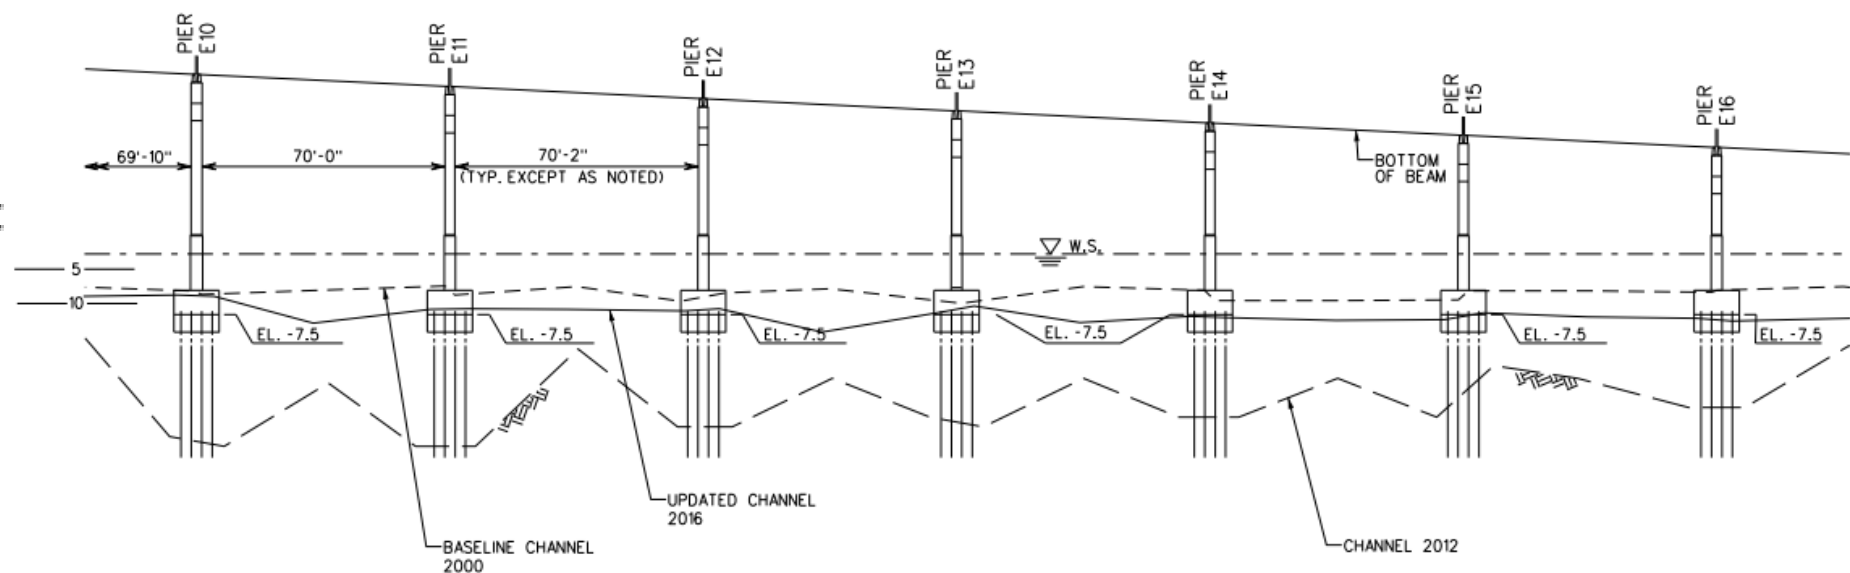
Recent Channel bed profiles – North side

- Six year performance – favorable
- Material deposition encouraged by repairs
- Multi-disciplinary Effort with Extensive Coordination
- Design Team & Client Coordination
 - Response Time
 - Hands-on Approach
- Fast Track Reviews/Approvals of Shop Submittals
- Very Favorable Response from Construction Team
