# 2019 Midwest Bridge Preservation Partnership Meeting Bismarck, ND

Fouad Jaber, PE

# Damage Inspection Report

**Situation:** On Friday, June 1<sup>st</sup>, 2018, an RV caught fire on the I-80 WB shoulder directly adjacent to the pier of the 10<sup>th</sup> street bridge (S080 45433). The fire caused damage to the I-80 WB pavement, barrier rail, north face of the bridge pier, steel elements of the superstructure, bridge deck, and utilities attached to the bridge. The fire department used 7 fire trucks to put out the fire.

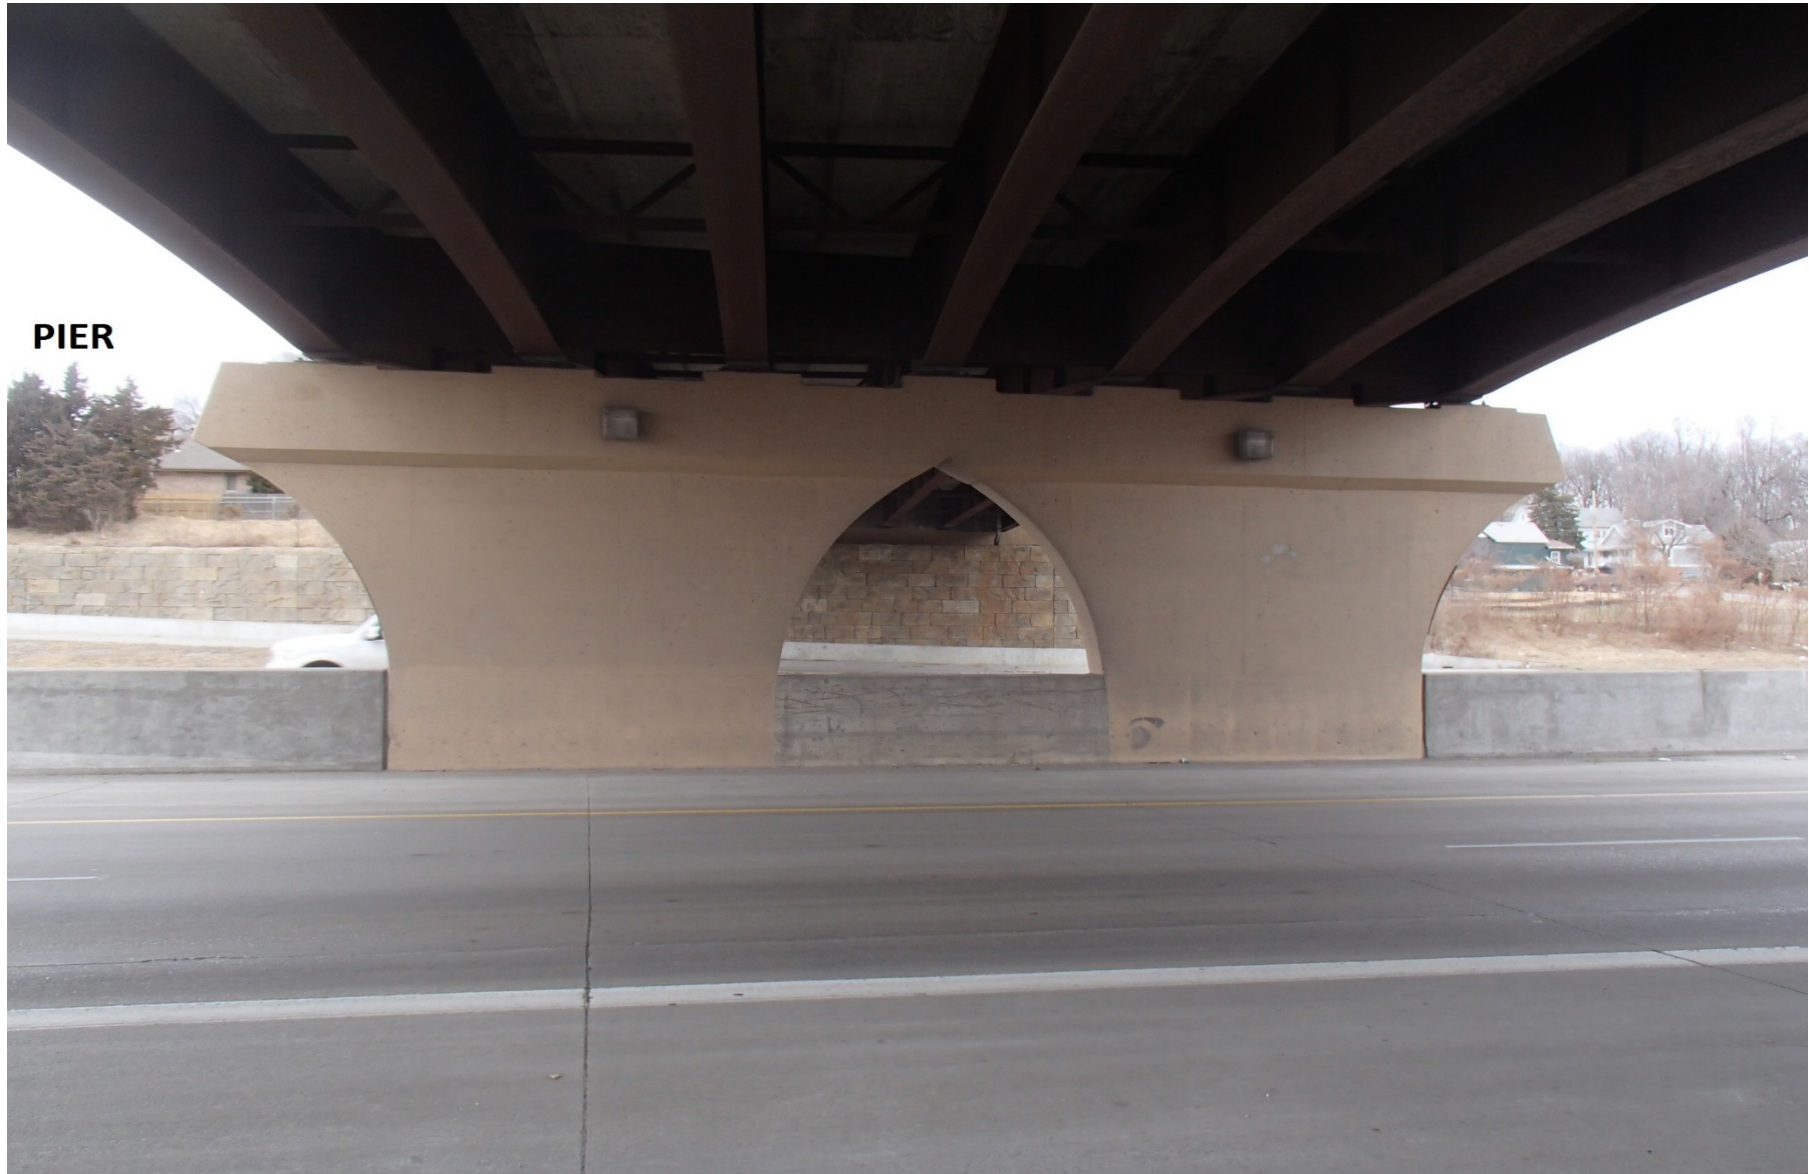
S1

**PIER**

**Substructure:** Large areas of the north face of the east pier column have shallow spalling. Spalling is occurring at the pedestals near the bearings. Hammer sounding the concrete revealed no areas of delamination.

Widespread fire damage and CS 3 spalls to the north face of the east pier column. 4 cores taken for testing.

- The concrete bridge pier may be repaired by removing of concrete on the north face down to the reinforcing. Concrete anchors embedded into the remaining concrete may be necessary to anchor the repair concrete to the existing concrete.

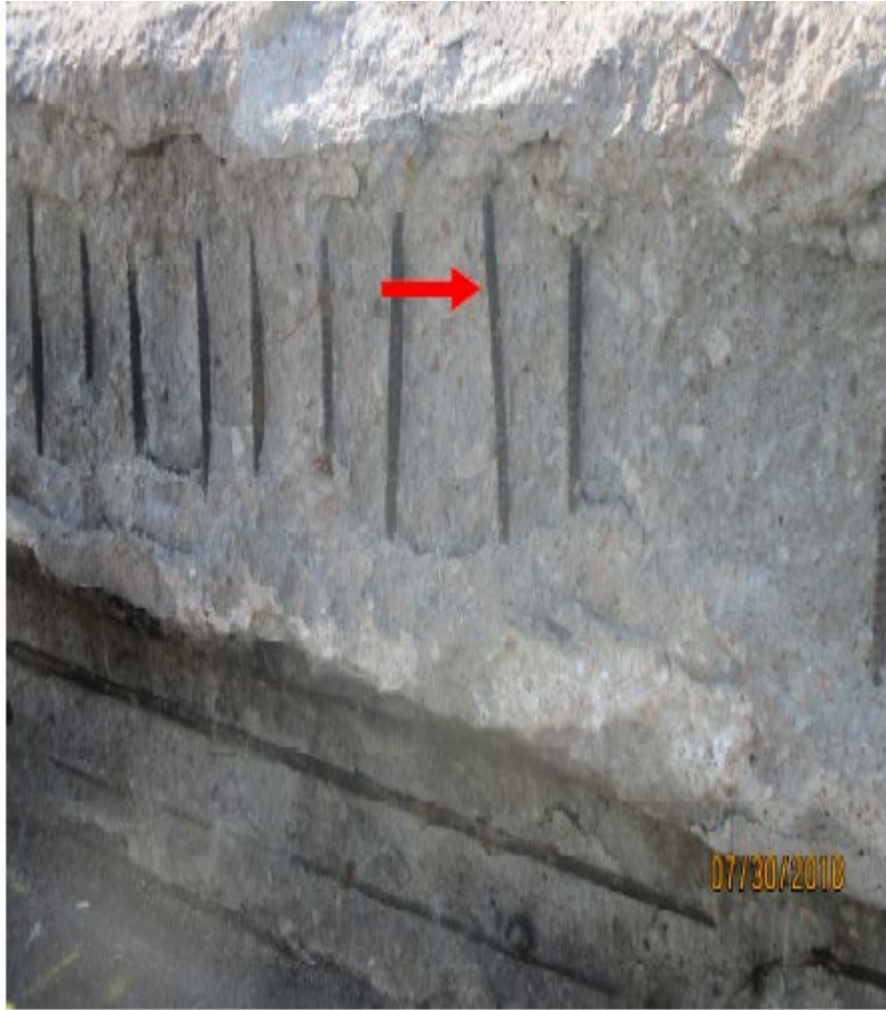
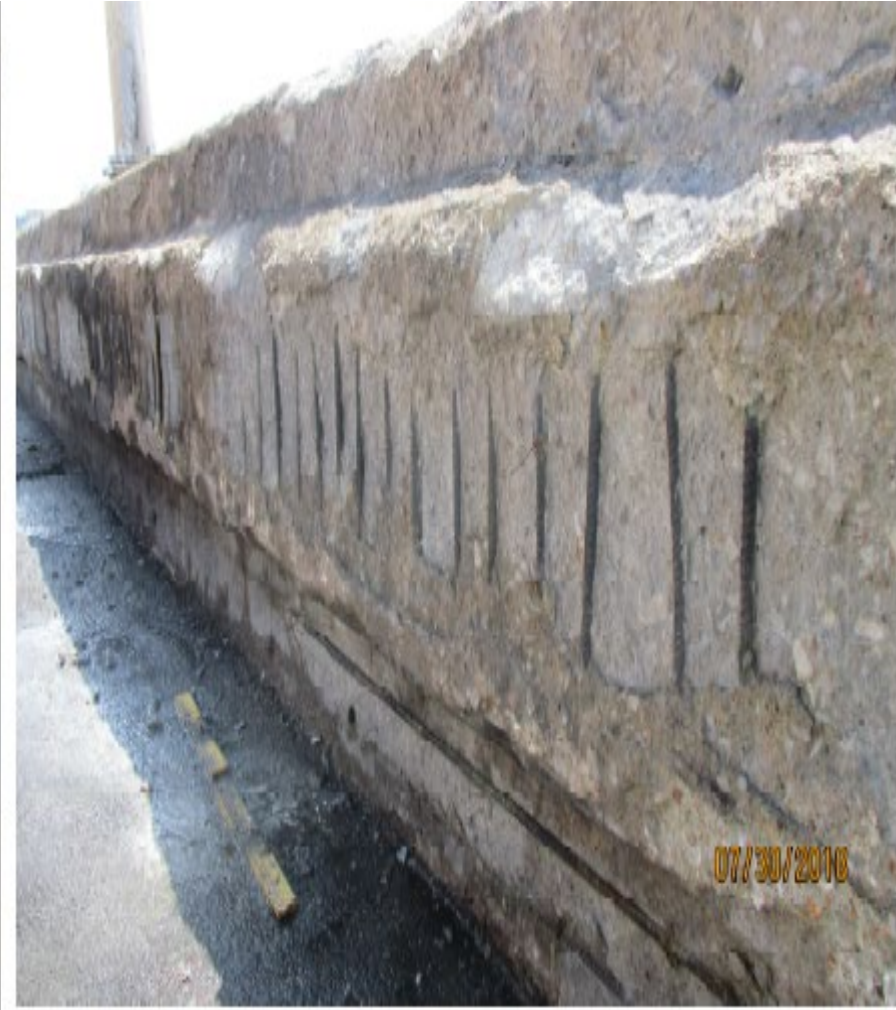
Sequential Photo No.(s): 2,3 Type of Defect: Barrier damage

Description:  
South rail scorched

- The roadway median barrier and roadway surface may be repaired in a similar manner as the concrete bridge pier. However, it may be more cost effective to fully replace the damaged areas.
