Investigations of Fractures in Three Kentucky Transportation Cabinet Steel Bridges

Theodore Hopwood II P.E.
Kentucky Transportation Center
NEBPP Annual Conference
September 9, 2019

I-75 NB Bridge Over Lynn Camp Creek in Whitley County KY

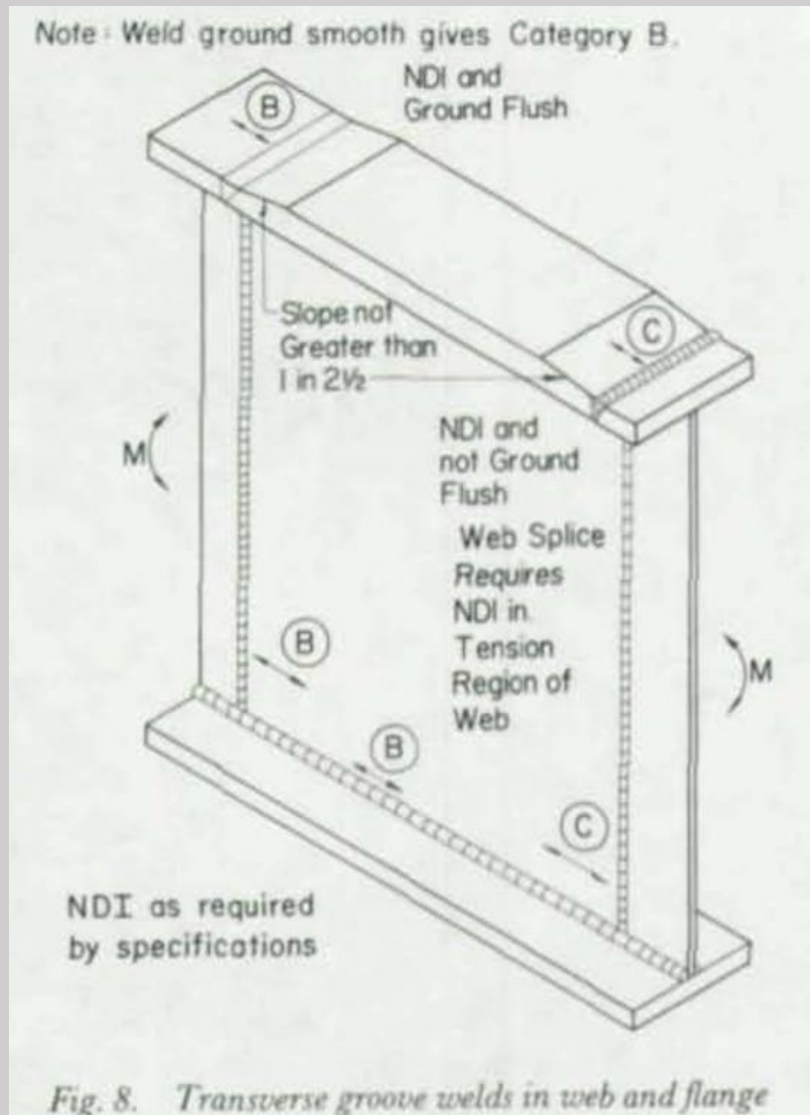
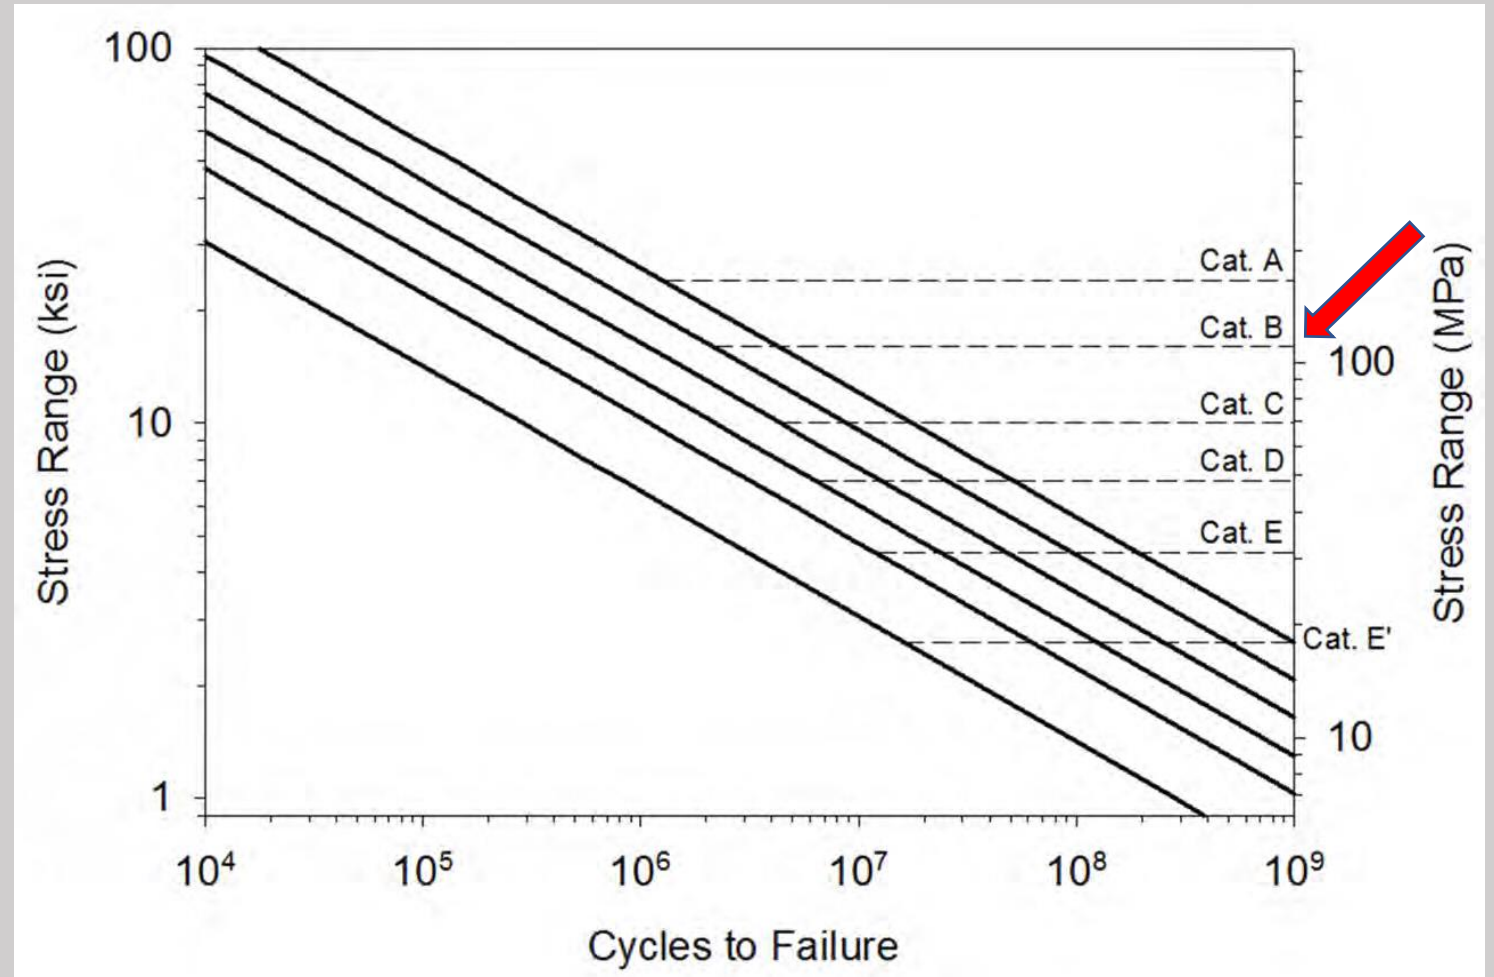
AASHTO S-N Diagram for Steel Bridge Details

Calculation of Initial Defect Size

$$(1) K_{lmax} = 1.12 M_k \sigma (\pi \alpha)^{0.5}$$

Solving for α_i = initial crack depth where:

α_f = final crack size= 0.375"

- Girder experienced unstable brittle fracture
 - Initiated at a defect in the lower flange butt weld or flange-to-web fillet weld
- Web base metal was found to:
 - Meet the physical & mechanical properties met the ASTM A373 “Structural Steel for Welding” Standard
 - Satisfy the requirements for Charpy V-Notch toughness for Zone II (non-fracture critical structures)
 - 15 ft-lb. @ 40° F
- Number of stress cycles and equivalent stress range too low to cause fatigue initiation at weld details
 - Possible weld defect missed by QC & QA (shop NDE)
 - Gradual crack growth by fatigue to critical size for unstable brittle fracture
