MD 355 Over the Monocacy River Emergency Repairs

Collaboration and Innovation in Emergency Response

December 6, 2017

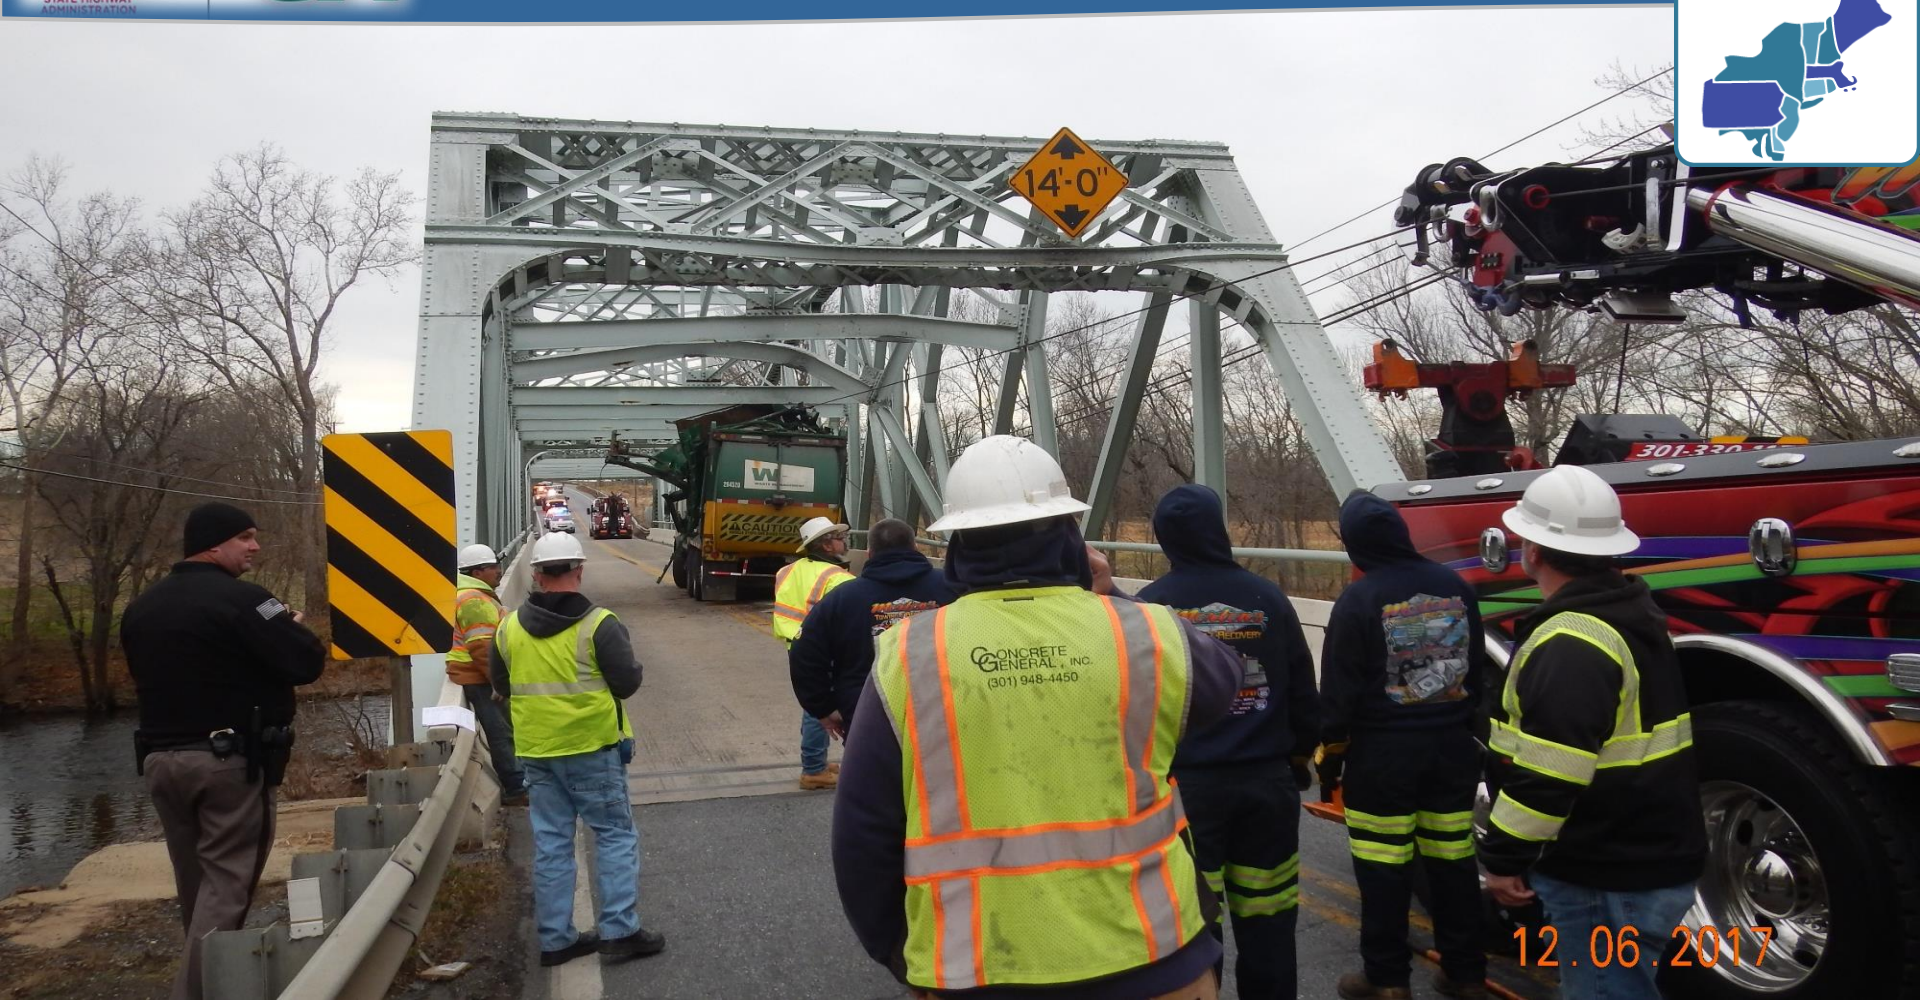
Lateral Sway Bracing

Portal

Garbage Truck

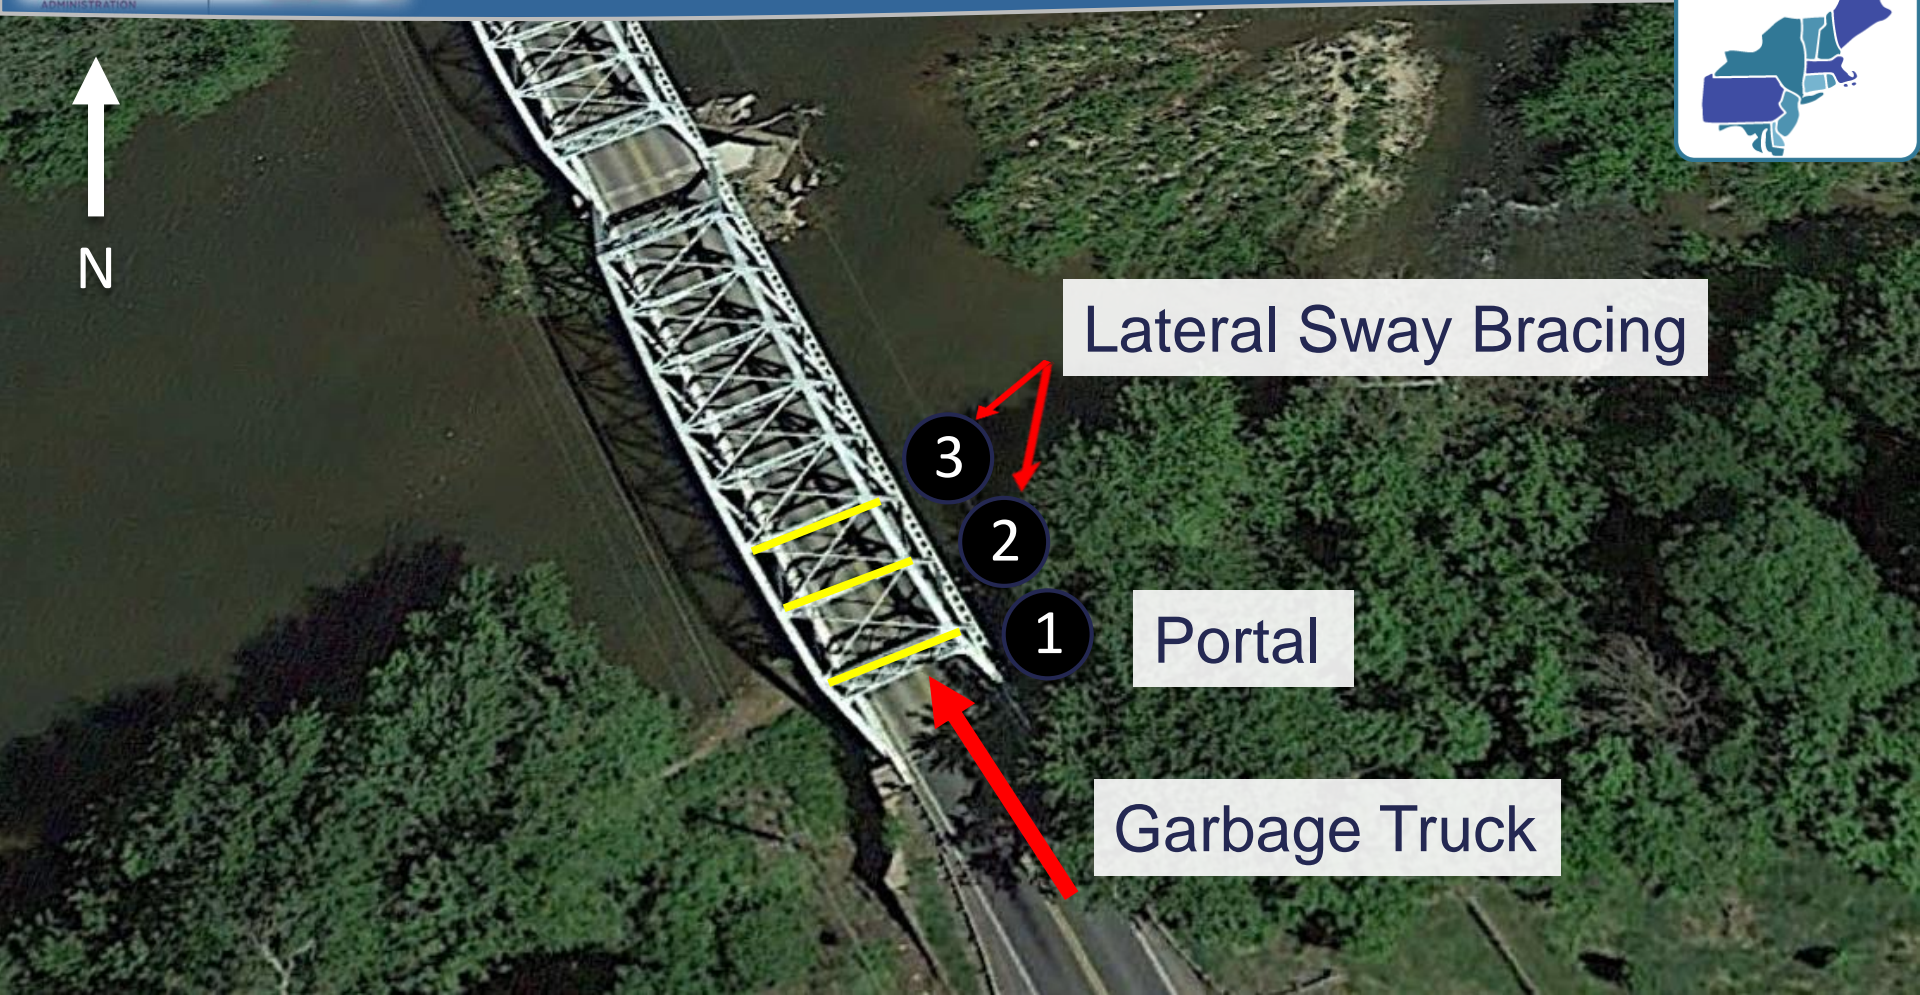
Portal

Lateral Sway
Bracing Members

Vertical Chord
Members

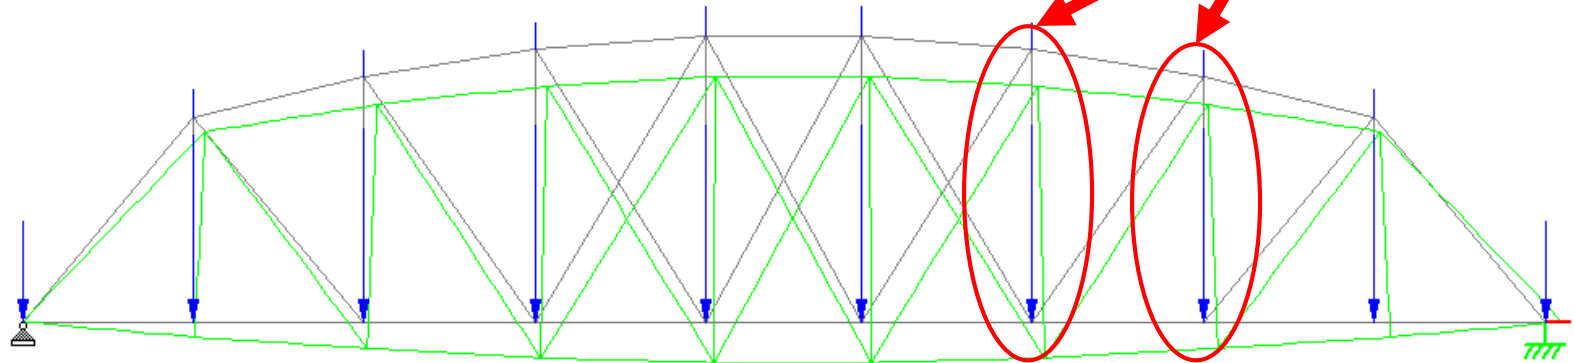
Damaged
Vertical Members
to Stabilize

Load 1 : Displacement

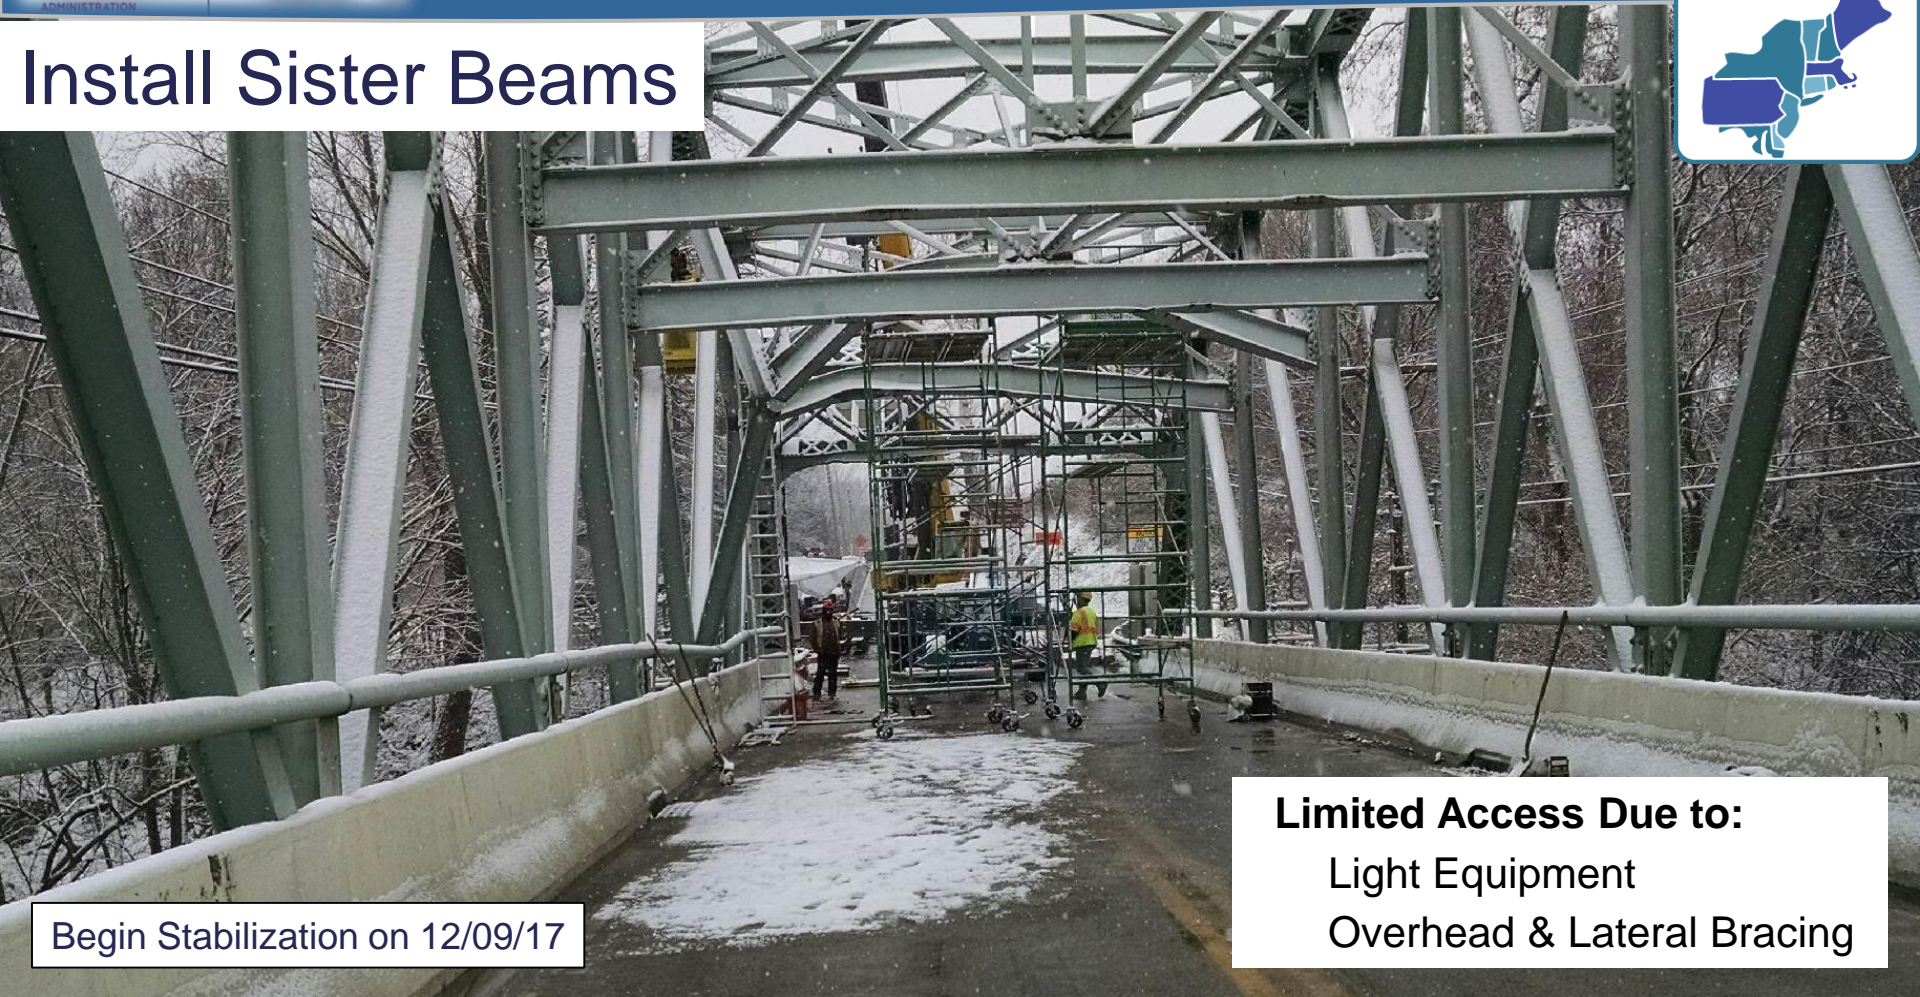
Limited Access Due to:
Light Equipment
Overhead & Lateral Bracing

Install Sister Beams

Begin Stabilization on 12/09/17

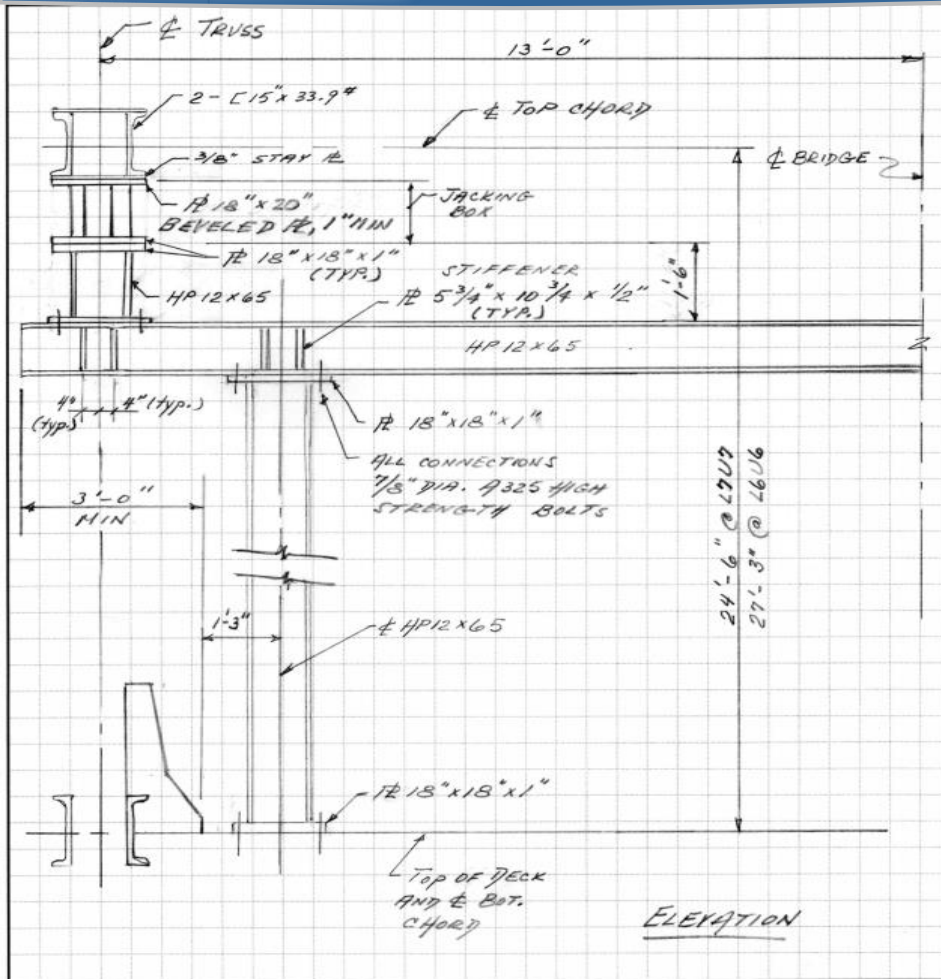
- Physical Constraints
- Bridge Geometry
- Stability & Load Eccentricity
- Concurrent Construction

Jacking Frame: Preliminary Concept

Sketch sent to
SHA on 12/07/17

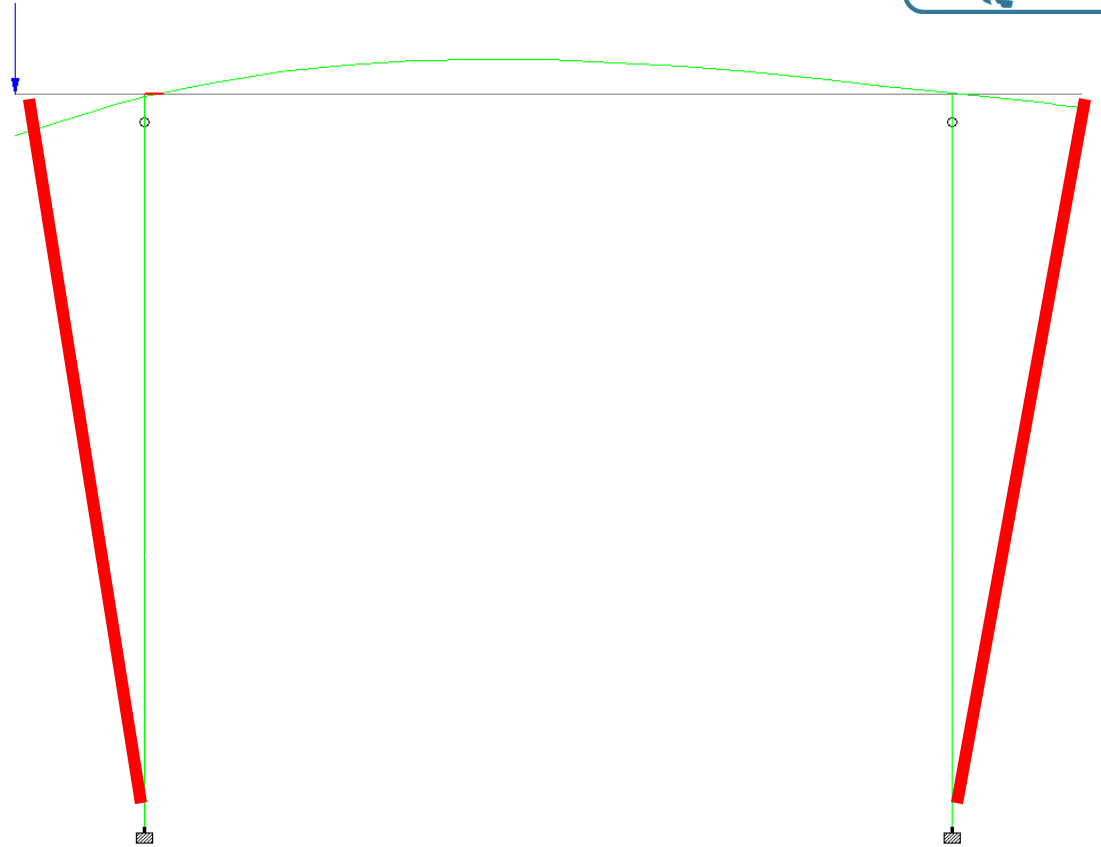
Jacking Frame Design

Excessive Deformations

Add Struts

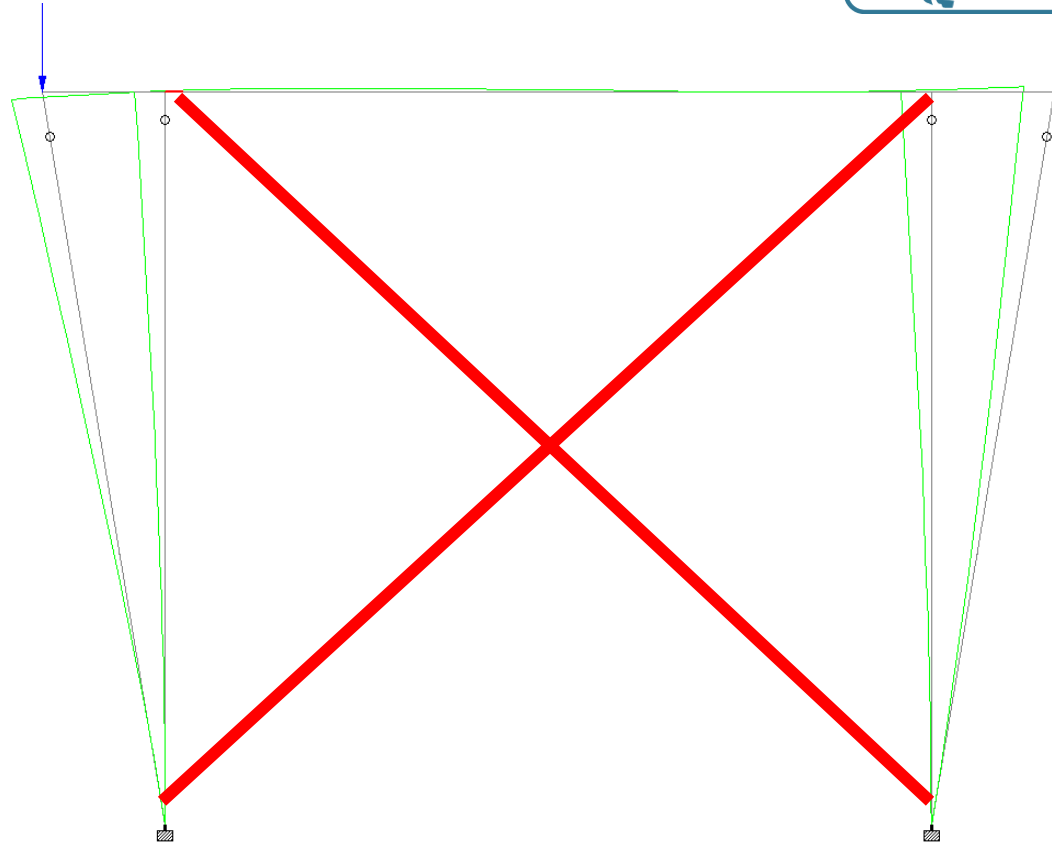
Jacking Frame Design

- Less Vertical Deflection
- Deformation Still an Issue

Add Bracing

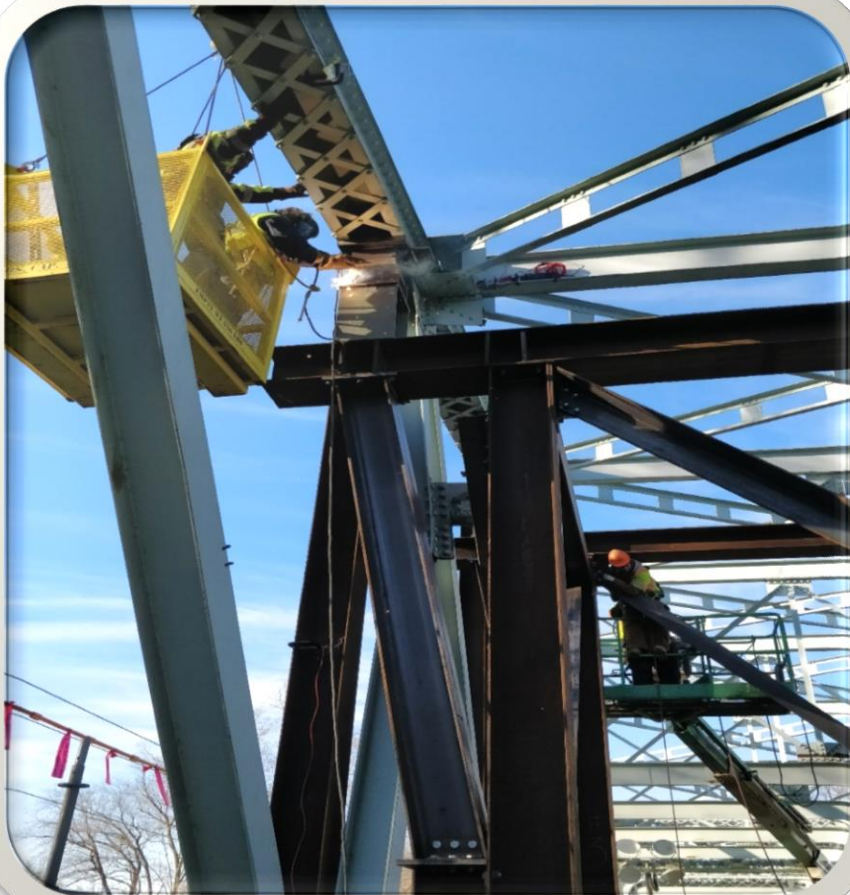
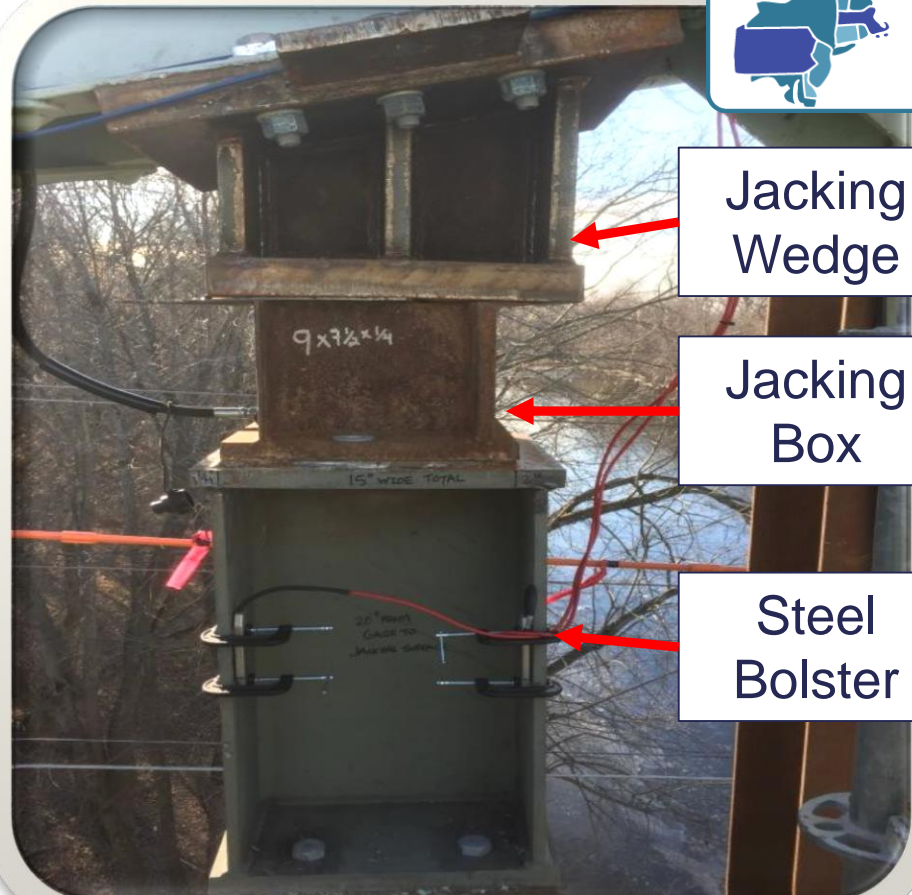
Jacking
Wedge

Jacking
Box

Steel
Bolster

Install Jacking Frame

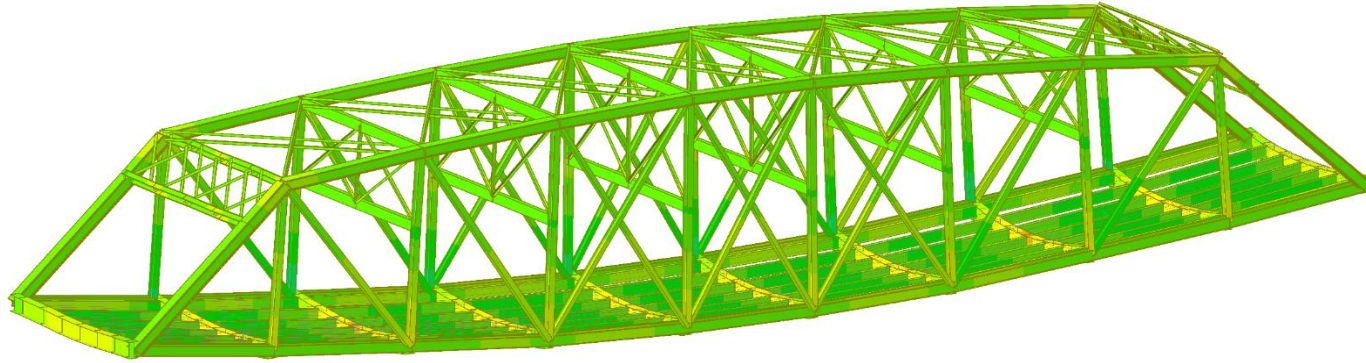
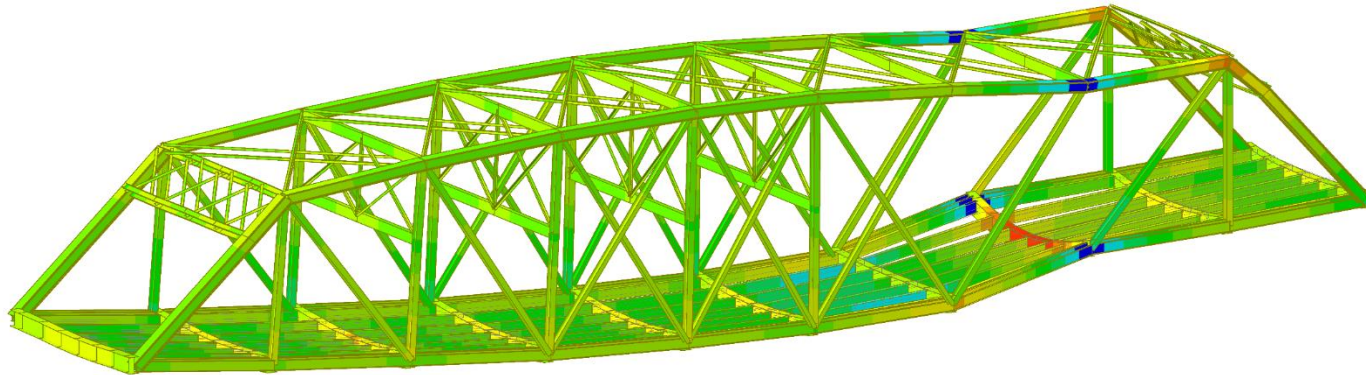
3D Model: As-Built vs. Damaged State

- Asymmetric damage
- Capture effects of transverse load sharing
- Assess overall behavior of structure during replacement operations

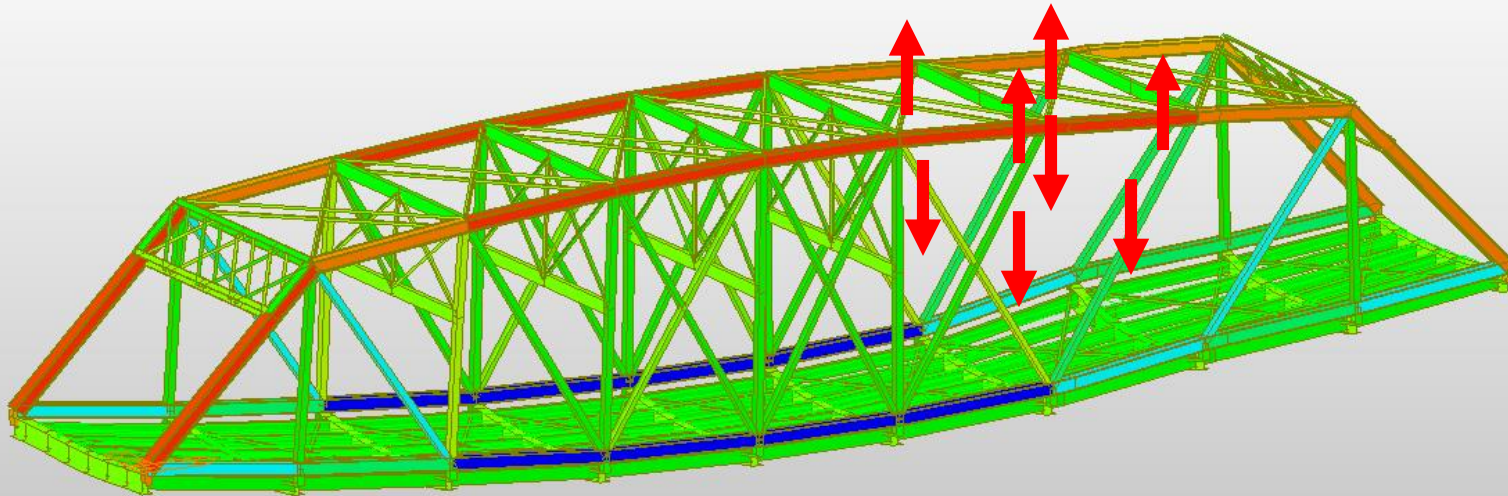
Step 4: Perform Repairs (Jacking Operation)

- Determine Jacking Forces & Effects on Adjacent Members
- Prevent Overstressing Connections (set limits)

- Lift Top Chord
- Remove & Replace Damaged Members

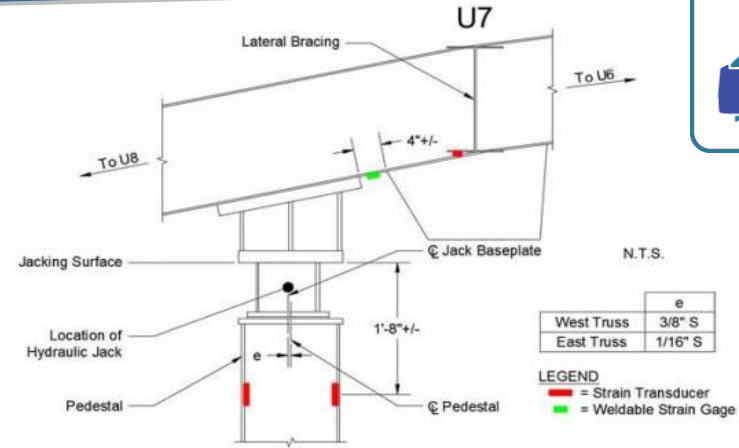
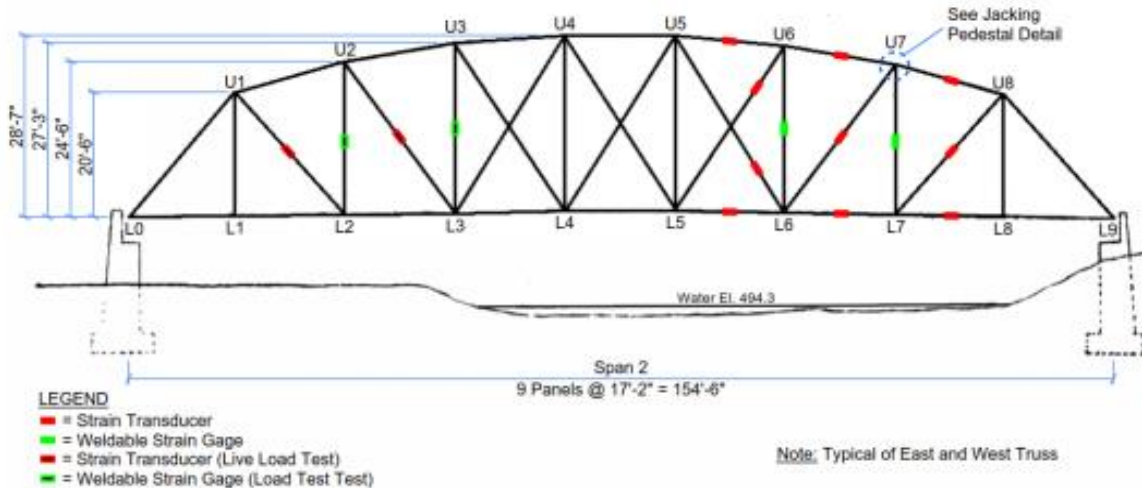
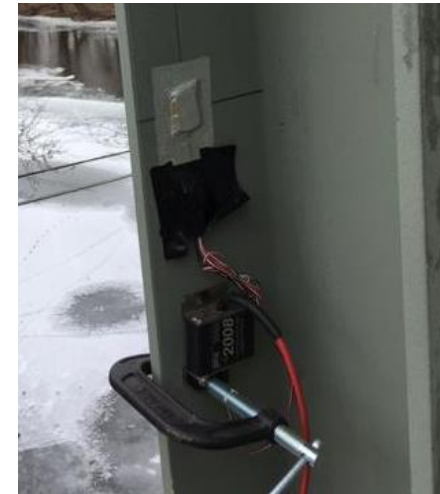
Monitoring Plan:

- 32 Sensors Installed
- Monitor Structure During Repairs
- Observe Real-Time Strain Response

Note: Typical of East and West Truss

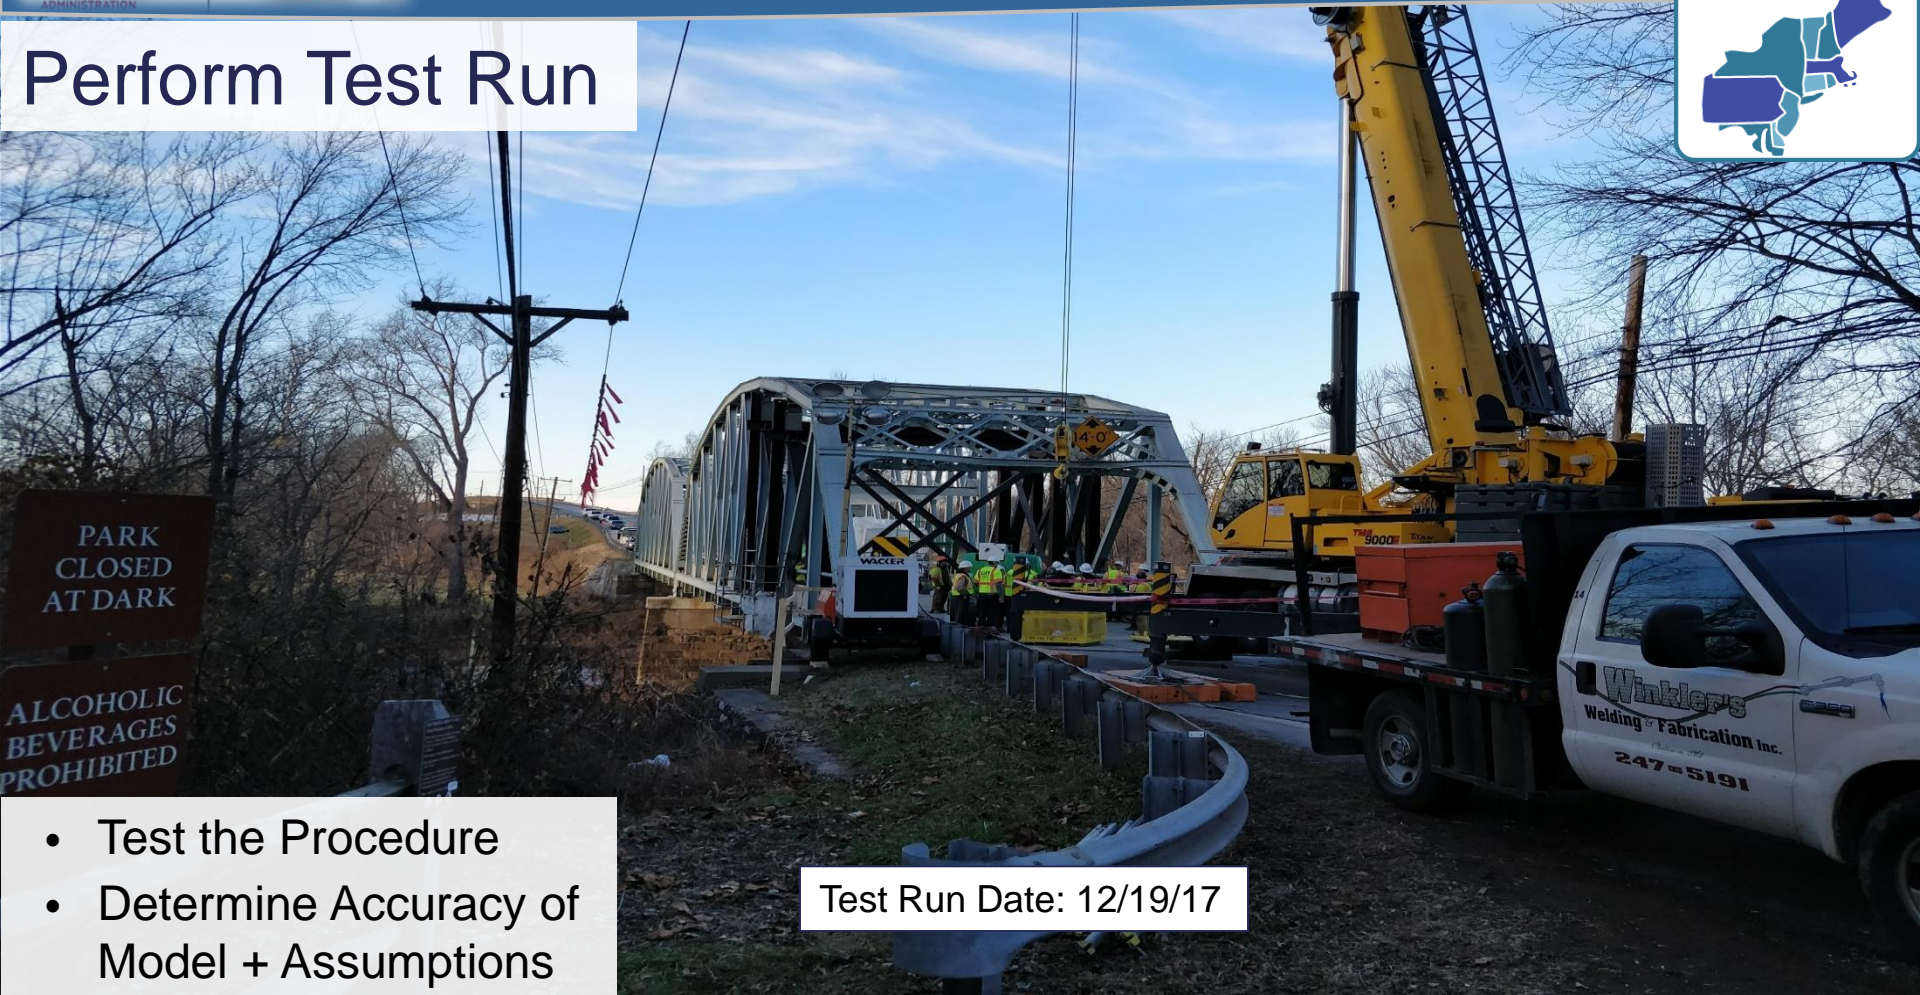
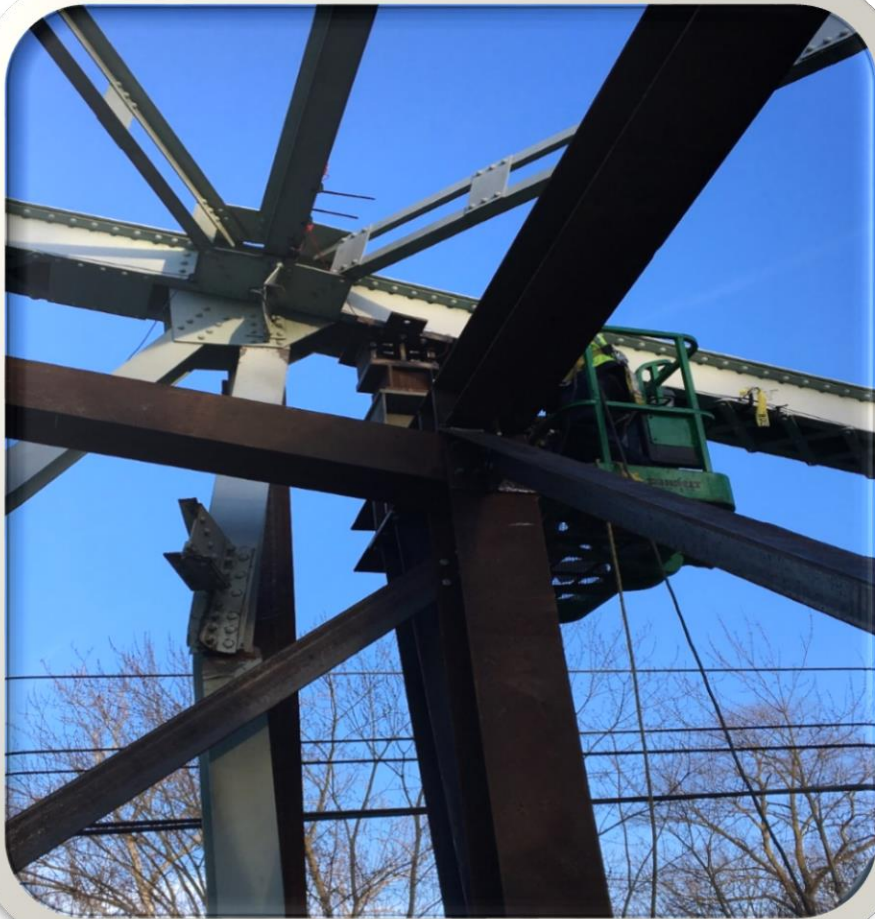
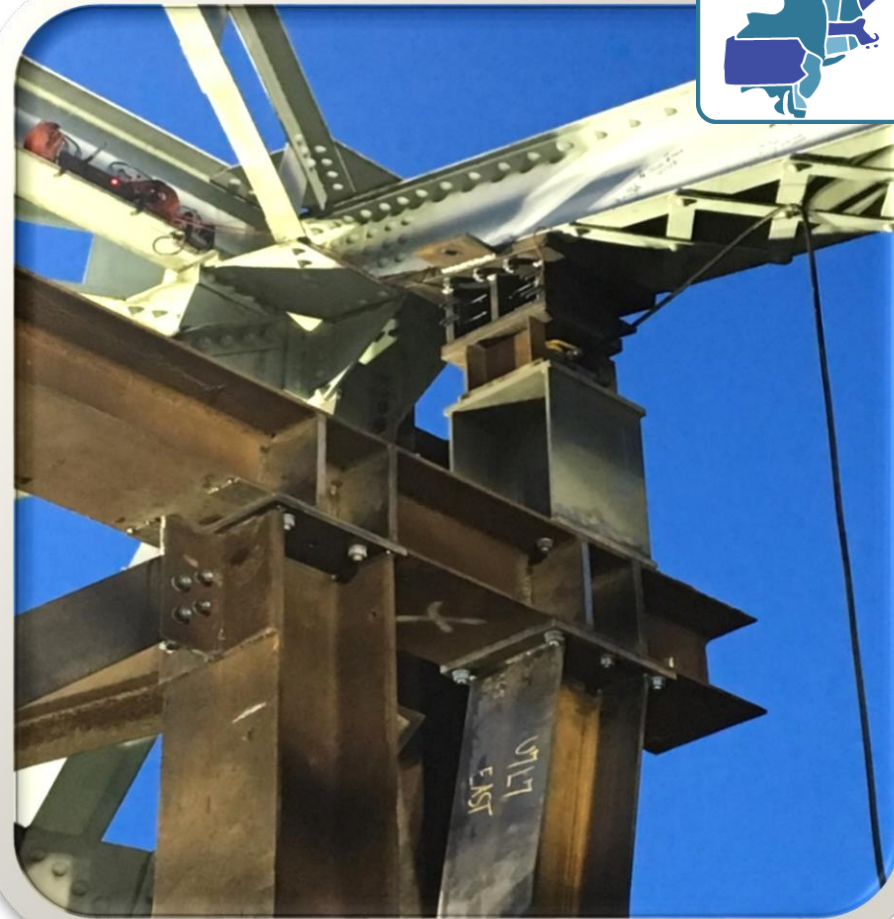
Perform Test Run

- Test the Procedure
- Determine Accuracy of Model + Assumptions

Test Run Date: 12/19/17

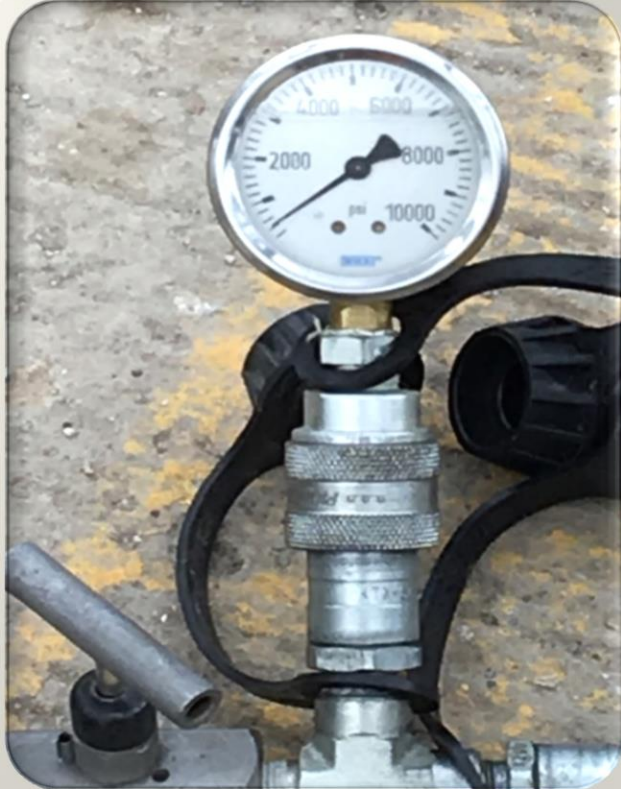
Test Run: Lessons Learned

- Understand the Equipment
 - How to Apply Intended Forces
 - Equipment Shortcomings
- Use Properly Sized Equipment
- Test to Verify Function
- Refine Procedure in Less Critical Regions
- Coordination Essential for Controlled Runs

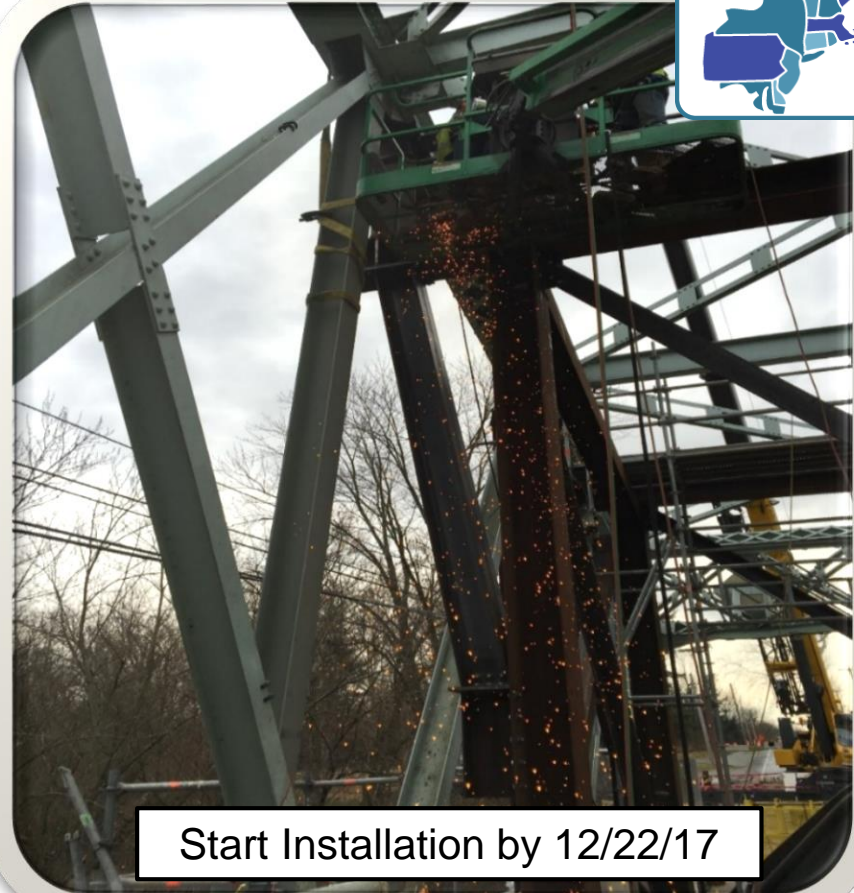
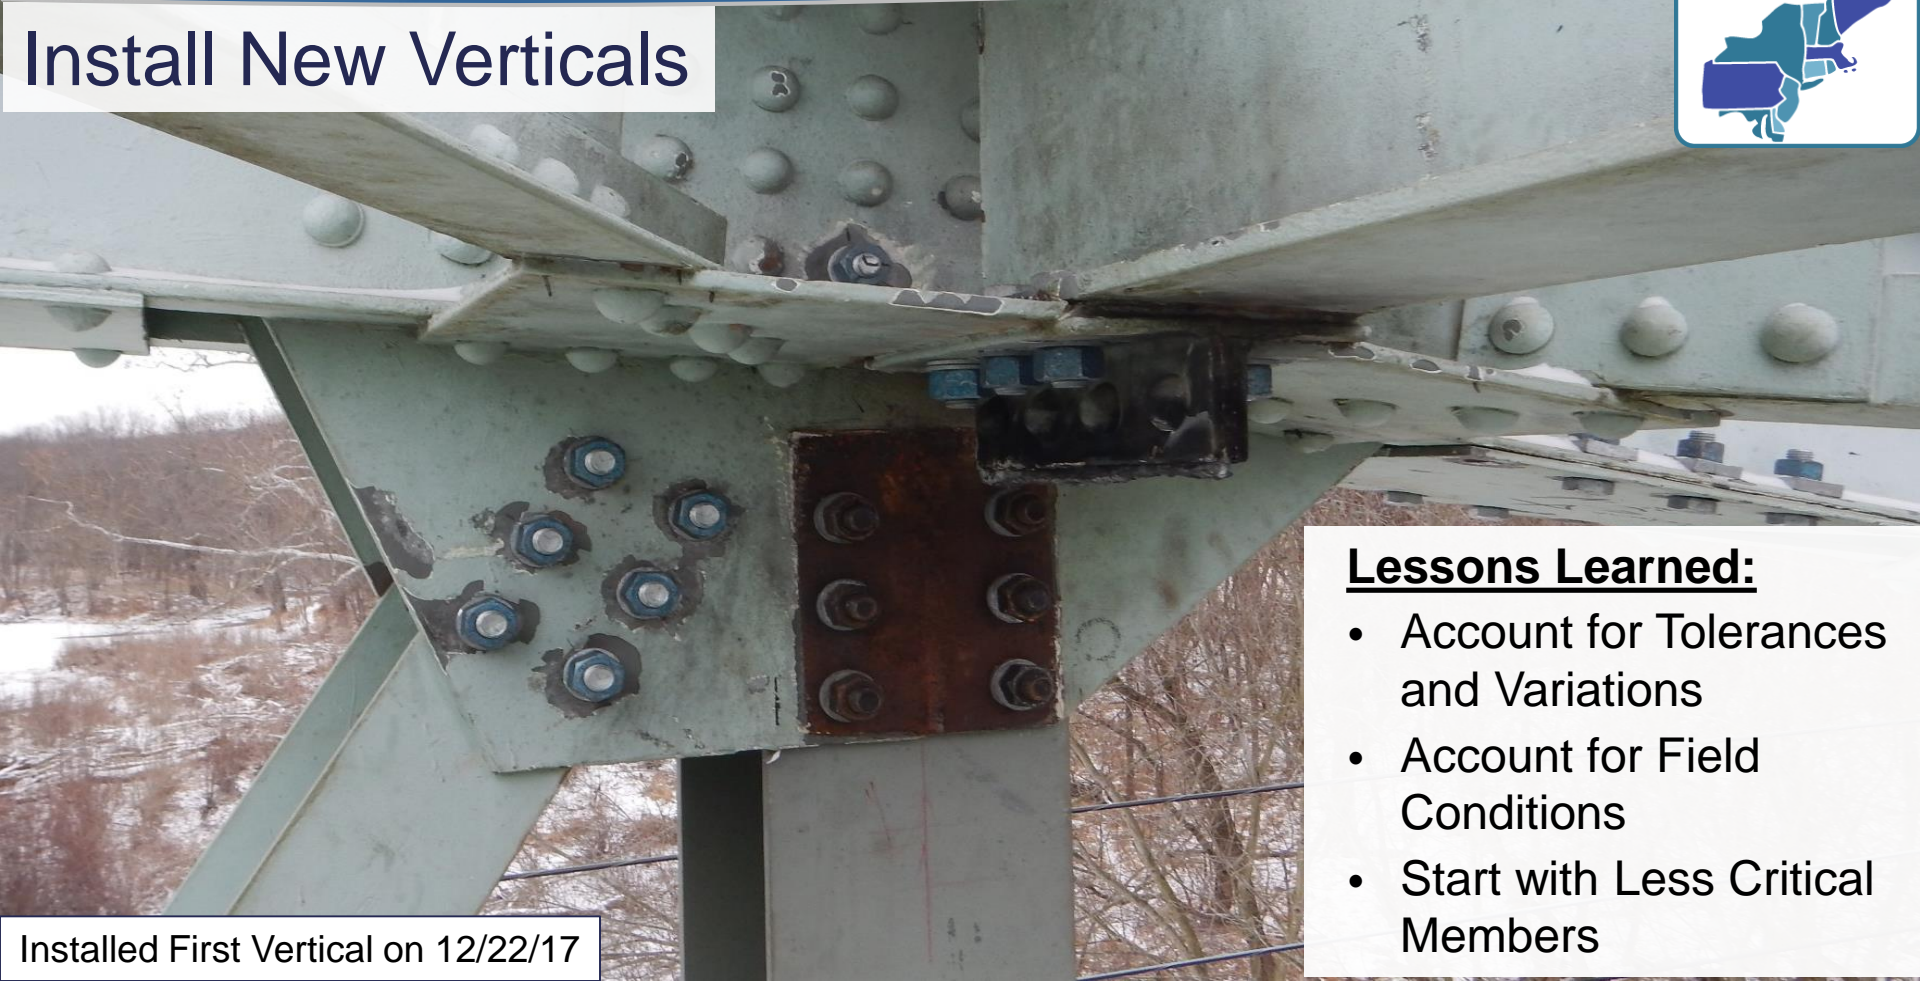
Install New Verticals

- Account for Tolerances and Variations
- Account for Field Conditions
- Start with Less Critical Members

Start Installation by 12/22/17
