MD 355 Over the Monocacy River Emergency Repairs

Collaboration and Innovation in Emergency Response

December 6, 2017

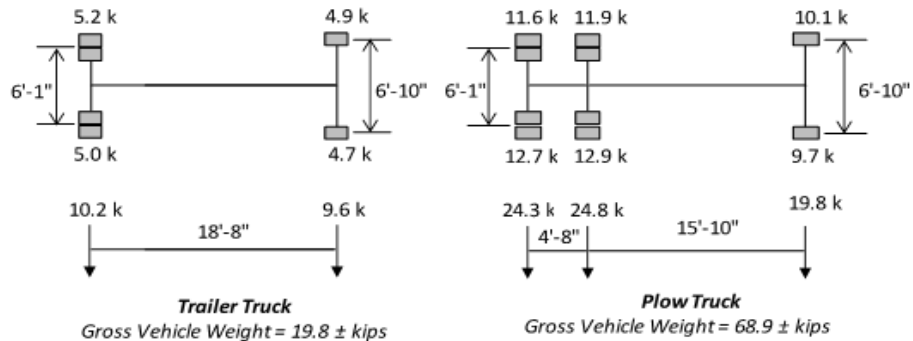
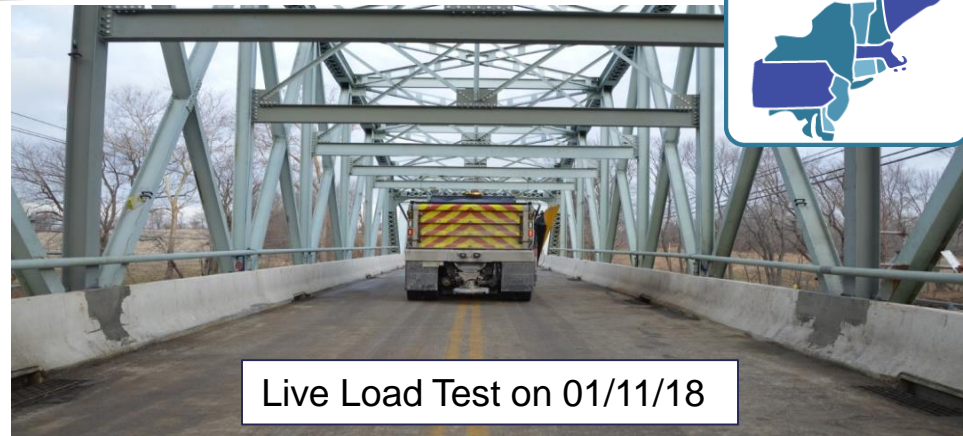
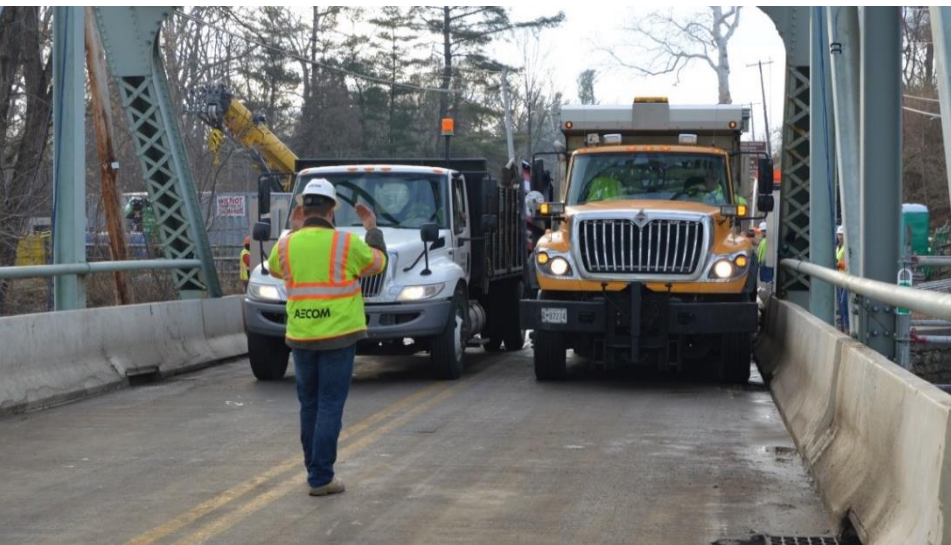
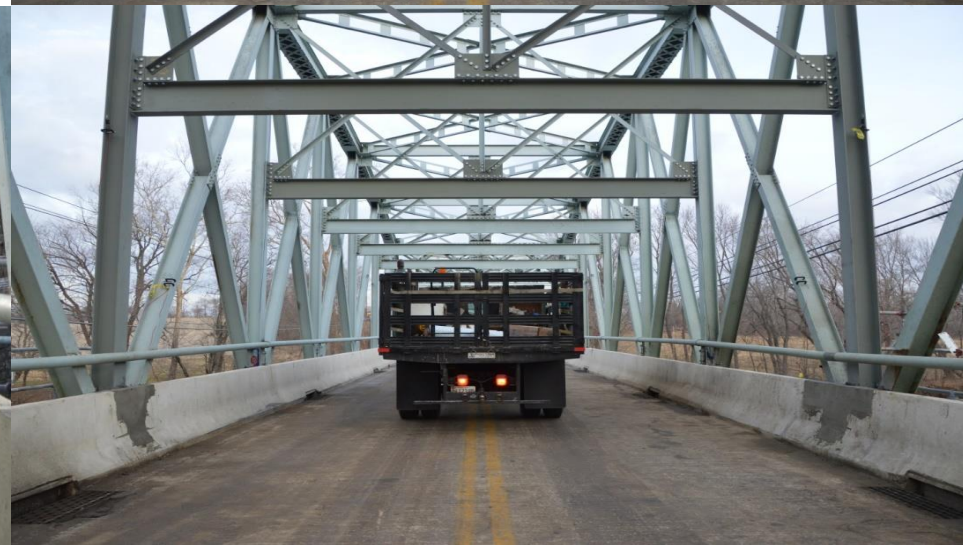
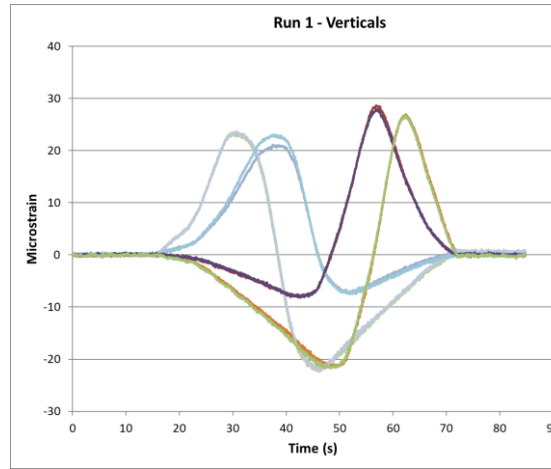
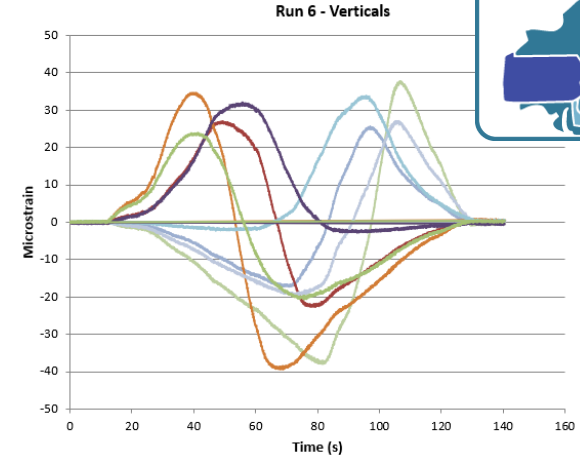
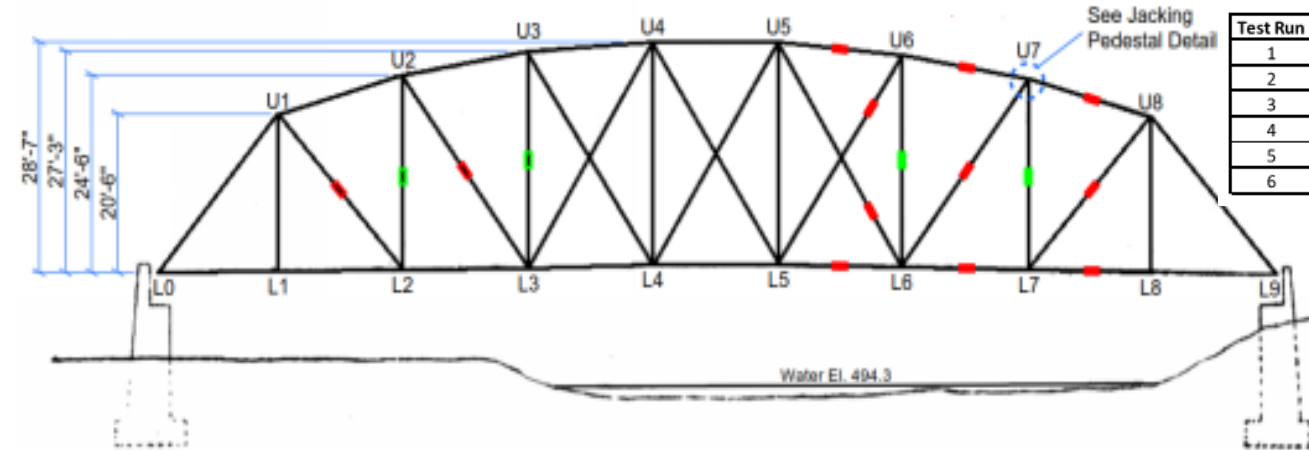
Perform Live Load Test

Test Run	Time	Direction	Speed	Plow Truck Position	Trailer Truck Position
1	8:25 AM	SB	Crawl	Centered on bridge	-
2	8:29 AM	SB	Crawl	-	Centered on bridge
3	8:31 AM	NB	Crawl	Centered on bridge	-
4	8:33 AM	NB	Crawl	-	Centered on bridge
5	8:48 AM	SB	Crawl	NB Lane	SB Lane
6	8:54 AM	NB	Crawl	SB Lane	NB Lane
