HEAT STRAIGHTENING OF A DAMAGED BOTTOM FLANGE

NBPP 2019 MEETING BURLINGTON, VT Timothy Boodey, P.E. NHDOT

NH 16,Sp Tpk over Long Hill Road

Concord 041/123 US 4 over I-93 (Exit 17 SB)

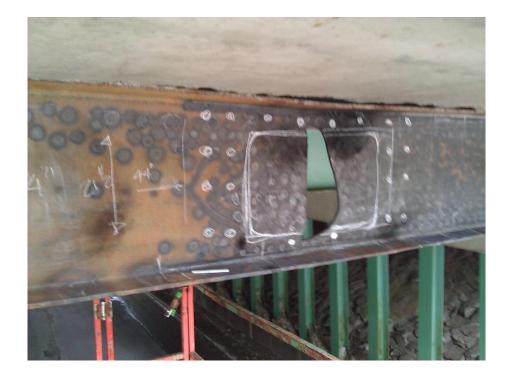
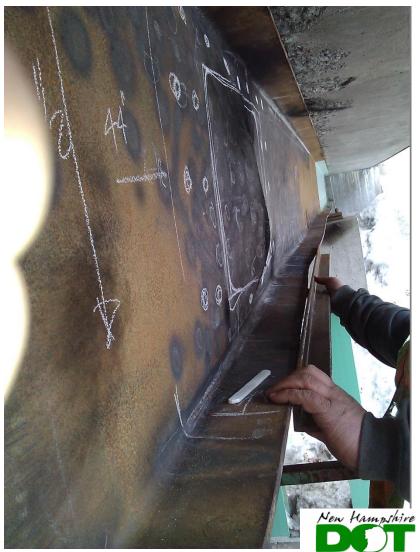
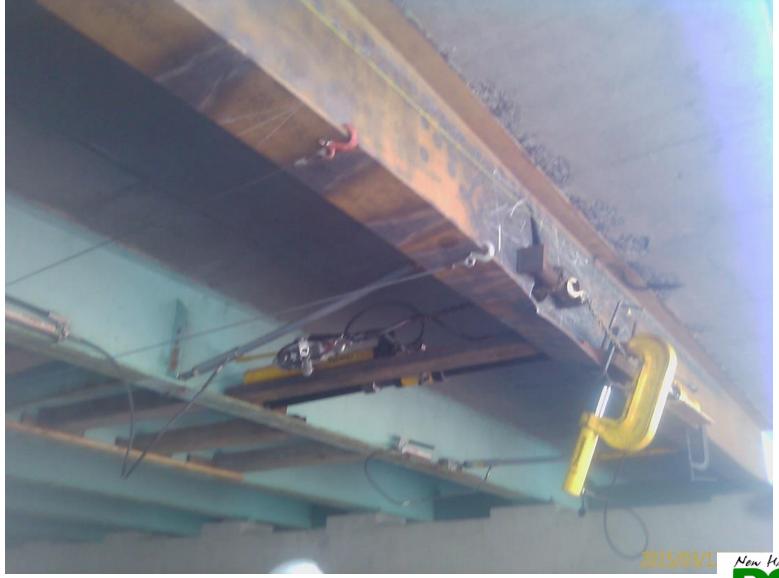
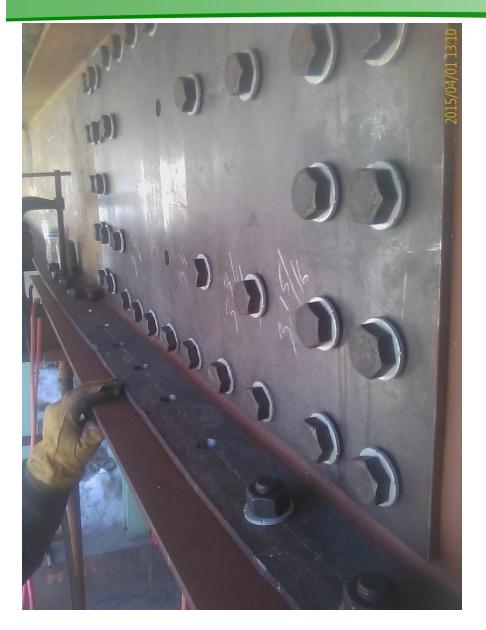
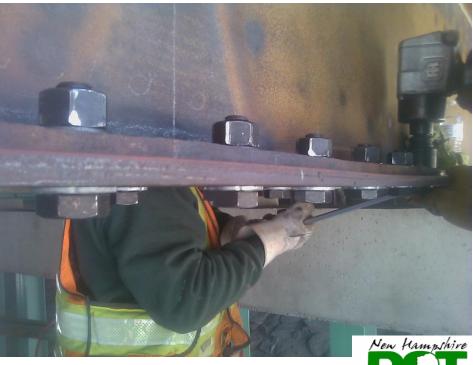
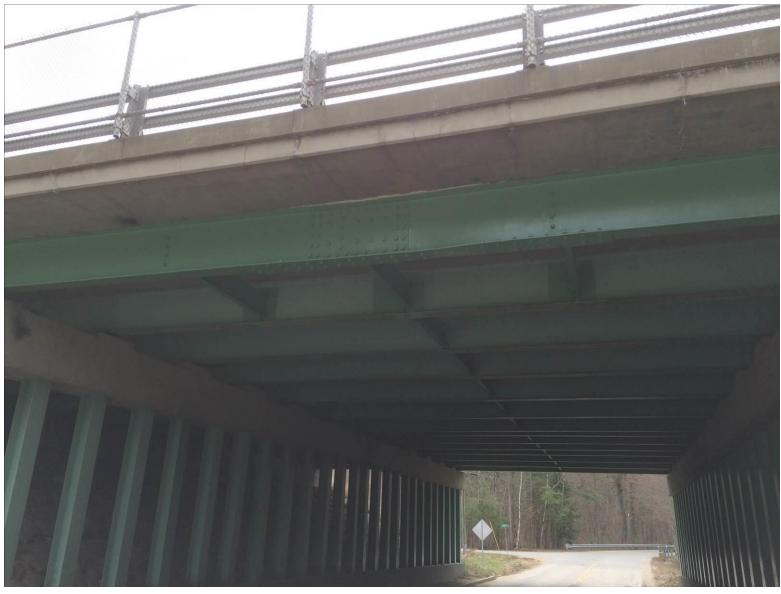
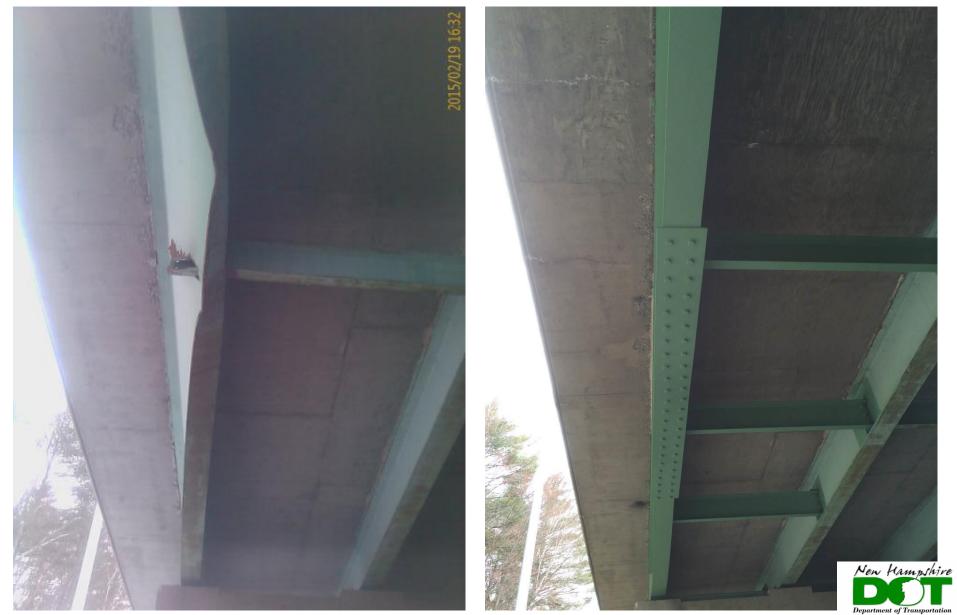
Damage to Girder 14, span 2 (32'), ~18" horizontal displacement, lower flange rotation, puncture

19 working days for all work using daytime road closures (3 days paint removal, 9 days heat straightening)

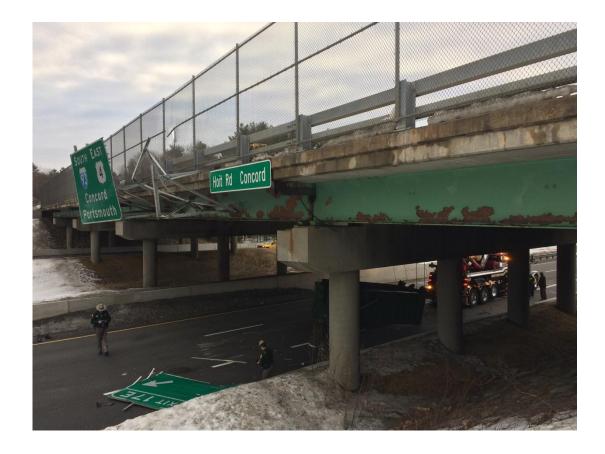
Damage to Girder 8, Span 4, ~11.5" horizontal displacement, puncture
